DOT HS 813 360

December 2022

# **NHTSA Special Crash Investigations: Comprehensive Study of 2019 U.S. Pediatric Vehicular Hyperthermia Fatalities**

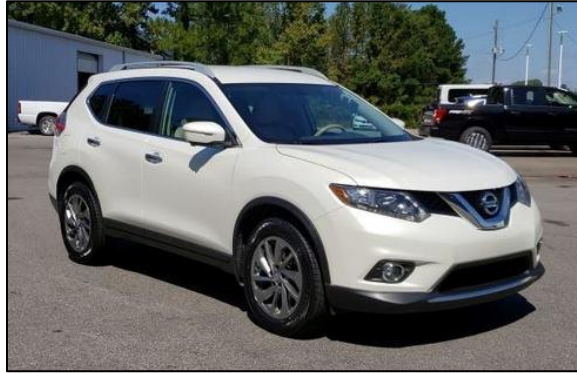
The vehicle in this incident was a 2015 Nissan Rogue, 4-door SUV (Figure 4). The Nissan was white in exterior color with a black interior. The second-row door windows, rear quarter windows, and the backlight were OEM AS3 deep-tint glazing. The front-door windows were AS2 tinted without aftermarket deep-tint applique. The Nissan did not have a sunroof. Per specifications, the Nissan was powered by a 2.5-liter, gas engine linked to a continuously variable-speed automatic transmission. The interior of the Nissan had keyless ignition and seating for five occupants (2/3). The front row had bucket seats with adjustable head restraints. The second row was a split bench with forward folding seat backs and adjustable head restraints for all positions. Safety systems included manual 3-point lap and shoulder seat belts for all five positions and Certified Advanced 208-Compliant frontal air bags, front-seat-mounted side impact air bag and roof side-rail mounted inflatable curtain air bags with roll sensing. The Nissan had LATCH. The owner's manual for the vehicle noted that the second-row left and right positions were LATCH-compatible. The second-row center position was not LATCH-compatible. The child was secured in a forward-facing CRS in the second-row right position of

*Figure 4. Front right oblique view of an exemplar 2015 Nissan Rogue.*

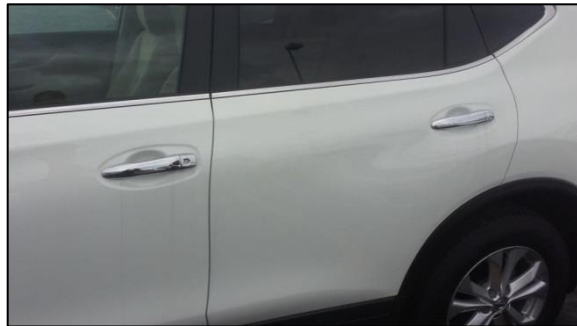
The Nissan had horizontal-pull style handles for the four doors (Figure 5). Based on an exemplar vehicle inspection, the vertical height of the front door handles was 98-102 cm (38.5-40 in) above the pavement and the rear door handles were 106-109 cm (41.75-43 in) above the pavement.

*Figure 5. Left plane exterior door handles of an exemplar 2015 Nissan Rogue.*

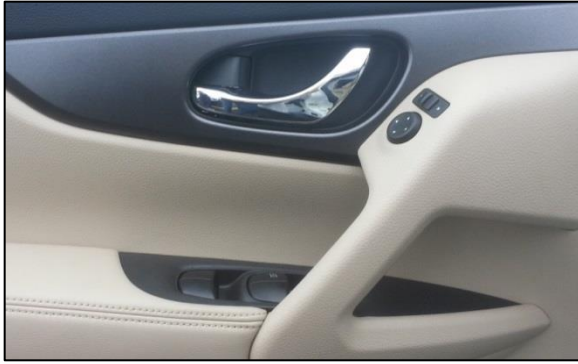
Based on the exemplar inspection, the interior door release levers were flush-mounted into the upper-mid aspects of the front door panels and into the upper-forward third of the rear door panels. The levers were 13 cm (5 in) in overall length and 6 cm (2.25 in) in height and were molded plastic, formed in an upward curve shape. All four door release levers were finished in chrome. The hinge point for the levers was at the aft aspect. The interior door release levers are depicted in Figures 6 and 7.

*Figure 6. Front-row (driver's) door release lever and rotating locking lever in an exemplar 2015 Nissan Rogue.*

A manual rotating locking lever was mounted in the recess of all four door panels (Figures 6 and 7) directly above the aft aspect of the door release levers. These rotating lock levers were finished in gray and blended into the door panel with no specific identification or highlight marking. The levers were 4 cm (1.6 in) in length and 2 cm (0.9 in) in height.

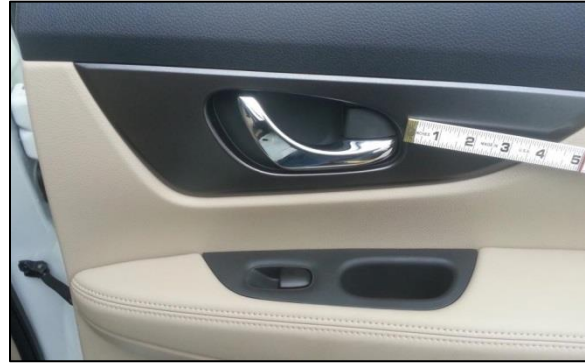
*Figure 7. Second-row right door release lever and the rotating locking lever of an exemplar 2015 Nissan Rogue.*

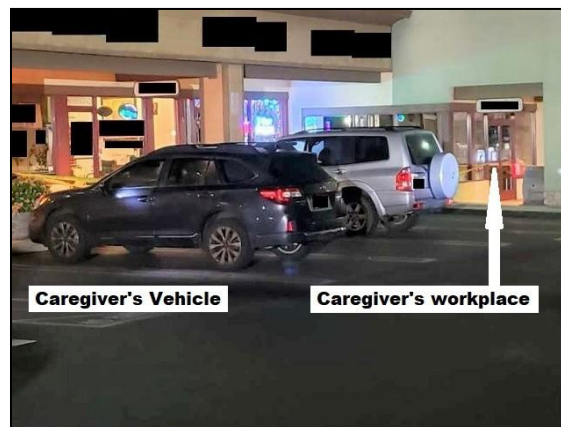
*Figure 2. Incident site, caregiver's vehicle (foreground) and caregiver's workplace entrance (background). Image obtained from an online news outlet.*

The Subaru was parked approximately 13 m (43 ft) from the father's workplace entrance, in the fifth space west (Figure 2). It was unknown which other parking spaces may have been occupied during the incident. The incident occurred on a Wednesday during daytime and the businesses in the building appeared to conduct business during the day. Due to the commercial location and weekday occurrence of the incident, other vehicle and foot traffic likely came and went throughout the incident. It appeared likely that several other vehicles and passersby were close to the Subaru throughout the duration of the incident. During their investigation, police searched the area for surveillance cameras and found none. A sign located at the main entrance to the father's workplace indicated the business was closed to the public on Monday, Thursday and Sunday. An incident site diagram and incident site satellite view are included at the end of this report.

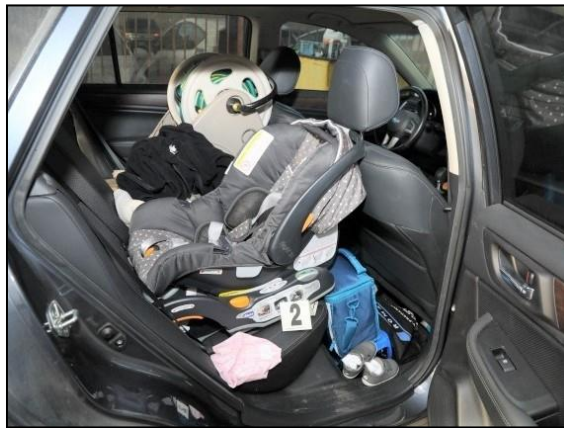
*Figure 3. Chicco CRS (foreground) and garden hose cart (background), second row, 2016 Subaru Outback. Image obtained from local law enforcement.*

The vehicle had a second-row bench seat and split folding backs. At the time of the incident, the left seat back was folded forward making it level with the rear cargo floor. A garden hose cart configured with wheels and hose was positioned in the second-row left position over the left seat back, adjacent to the CRS (Figure 3). The cart and hose stood taller than the CRS and police

photos suggest that, when looking through the second-row left window from the outside, the cart and hose possibly blocked the CRS from view. The cart and hose appeared to be unsecured in the vehicle. A black fleece jacket, a soft white blanket and a box of latex examination gloves were present on the seat between the hose cart and CRS. The jacket appeared to be sized for an adult. A blue soft-sided bag with carry strap containing unknown items was present in the second-row right floor space forward of the CRS. Next to the blue bag were the child's shoes which were gray in color and his socks which were white in color. Unsecured items present in the cargo area were a foam pool noodle, a duffle style gym bag containing unknown items and a paper shopping bag containing unknown items. Unsecured items present in the front row included two small cardboard boxes and a black jacket on the front passenger seat cushion and a medium size cardboard box on the passenger floor.
