| 1. Title and Subtitle<br><b>Skew Detection System Replacement on Vertical Lift Bridges (Phase 2)</b> | 5. Report No.<br><b>FHWA/LA.24/703</b> |
| 3. Performing Organization Name and Address<br>Wiss, Janney, Elstner Associates, Inc. (WJE)<br>800 Hyde Park<br>Doylestown, PA 18902 | 7. Performing Organization Code<br>LTRC Project Number: 22-2ST<br>SIO Number: DOTLT1000428 |

# **Skew Detection System Replacement on Vertical Lift Bridges (Phase 2)**

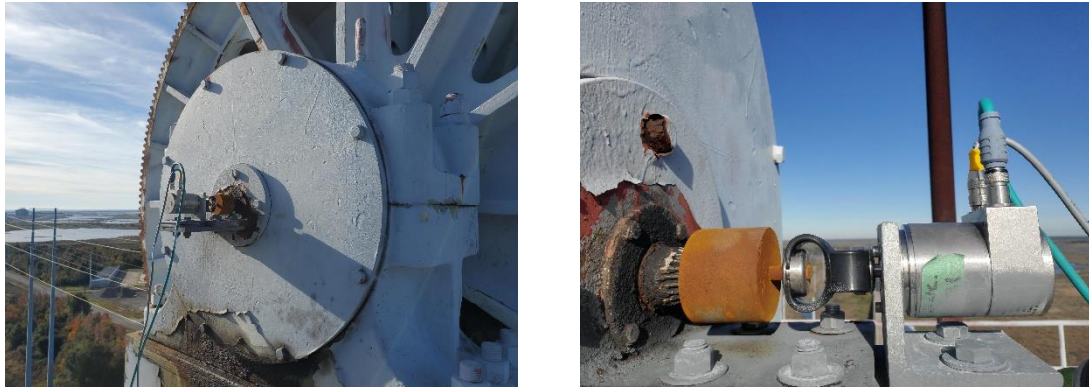
**Figure 2. Northwest absolute encoder installation**

(a) Encoder installation at NW sheave trunnion

(b) Close up of encoder at NW sheave trunnion

were installed at the northwest and southwest sheave trunnions. Both installations included a cover to protect the components from environmental elements; see Figures 2 and 3.

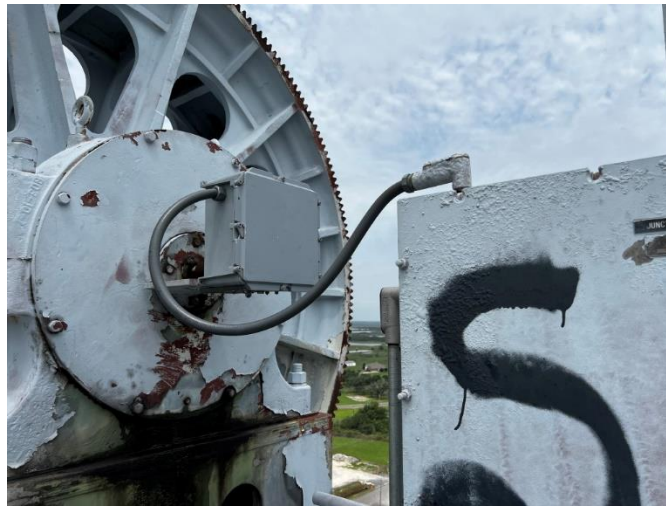
**Figure 3. Southwest encoder final installation with cover**

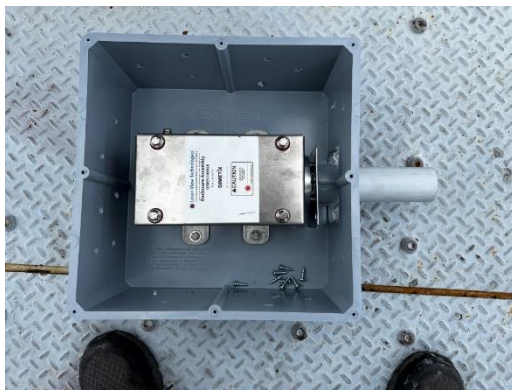
**Figure 5. Laser installation photos at tower**

(a) View of NEMA 4X laser located within one of the non-metallic enclosures, prior to installation

The lasers were procured with NEMA 4X enclosures to provide protection from the harsh environmental conditions to which they were exposed. Additional custom non-metallic enclosures were provided to reduce heat from sunlight exposure. To optimize performance, the lasers also included a dust tube to reduce any interference produced by sunlight and debris; see Figure 5.

**Laser Field Installation Modifications.** The location of the laser installations, which was necessary to satisfy operating requirements, subjected them to harsh environmental exposure, including direct sunlight. While the laser assembly was protected by the NEMA 4X enclosure provided by the manufacturer, enhancements were made to their installation in close coordination with the device manufacturer. These enhancements included the installation of non-metallic enclosures to shield the lasers from sunlight, dust, and debris; this was done at all four laser locations. The enclosure was also updated to provide dust shield tubes that surround the output of the lasers; see Figure 5. These modifications took place during Site Visit 4.

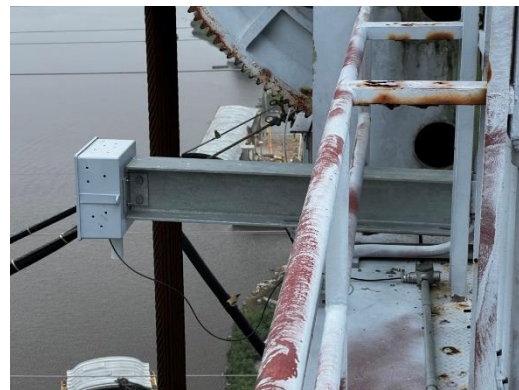
(b) Final laser installation at NW location

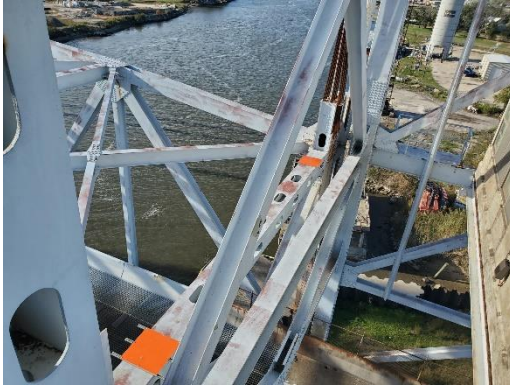
**Figure 6. Laser installation photos at lift span target**

(a) North lift span laser target plates

target plates (24 in. x 24 in.) was selected to ensure engagement of the laser beam with the target due to shifts from lift span movement and vibrations during operation; see Figure 6.

**Laser Target Adjustments.** To improve laser signal capture, targets specifically designed by the manufacturer were installed. The targets were comprised of retro-reflective orange layers on top of the aluminum targets; see Figure 6.

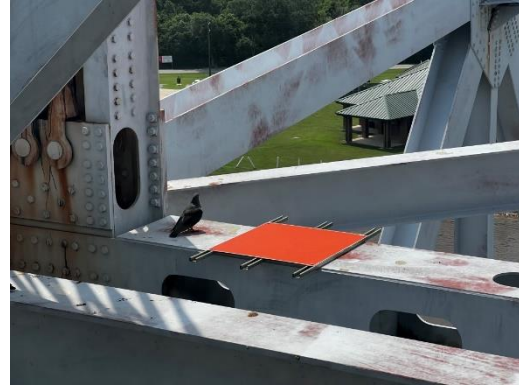
(b) Close up of NE lift span laser target plate

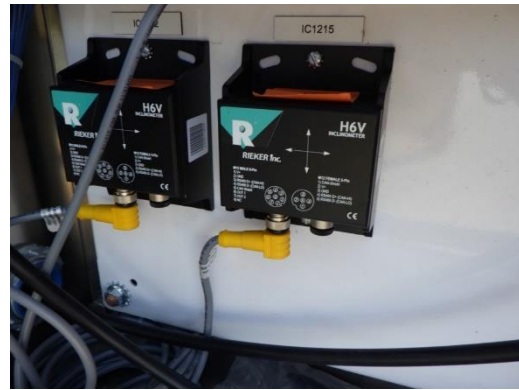
(b) Close up of inclinometers

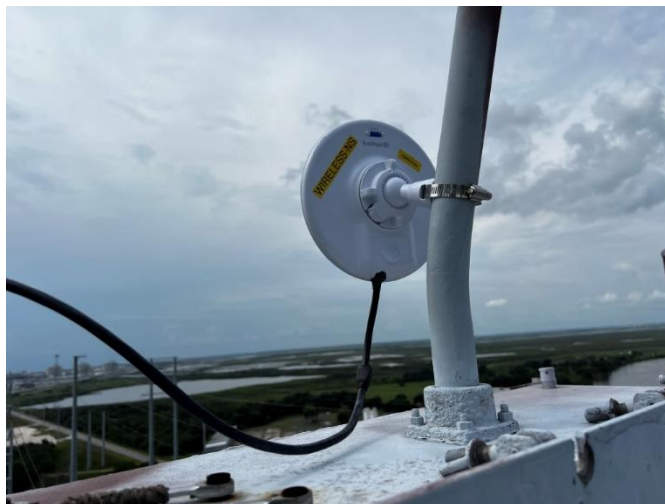
**Figure 8. Tower-to-tower antenna, north tower**

**Tower-to-Tower Communications.** A pair of NanoBeam AC Gen 2 (Model: NBE-5AC-Gen2) units were installed for wireless communication between the two towers; see Figure 8. This wireless link was used to transmit the south tower laser and encoder data to the north tower. The NanoBeam unit directs RF energy in a tighter bandwidth than most other antennae. While a smaller bandwidth requires a more precise alignment, it improves noise immunity. Additionally, the NanoBeam features a multi-radio architecture that includes a dedicated radio and CPU to analyze the full 5GHz spectrum and provide RF analytics. This allows the end user to diagnose issues and auto-configures the units to block or spatially filter any RF noise encountered.

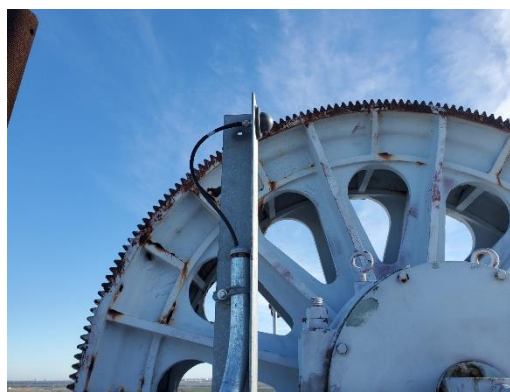
(b) Inclinometer wireless antenna at north tower

**Lift span to north tower communications.** A pair of wireless local area network (WLAN) access points (Model: FL WLAN 1011) and associated omni-directional antennae (Model: RAD-ISM-2459-ANT-FOOD-6-0-N) manufactured by Phoenix Contract were procured; see Figure 9. The wireless access points provided the communication path for the inclinometer data from the moving span to the north tower. The antennae selected were multiband with a gain of 8 dBi. Additionally, each antenna was equipped with an inline surge suppression device to mitigate damage caused by nearby lightning strikes.

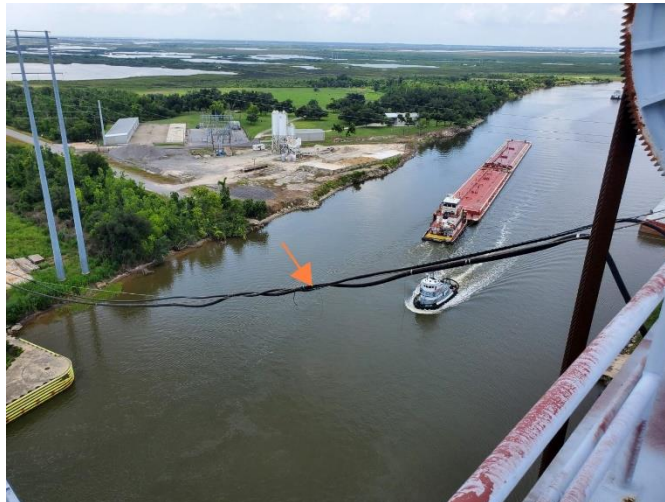
**Figure 10. Aerial cables**

The SHDSL units are Ethernet Extenders (Model: TC Extenders 2001 ETH-2S) manufactured by Phoenix Contact. A SHDSL modem unit was installed in each tower to transmit network data tower-to-tower via existing spare conductors in the bridge aerial cables; see Figure 10.

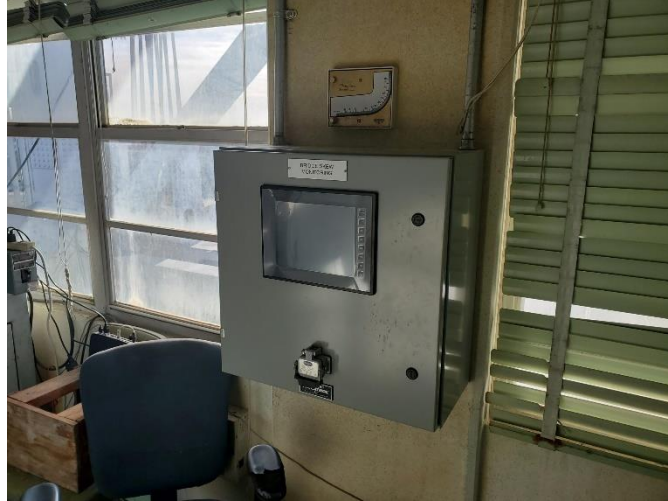
**Figure 11. Operator’s main SMART relay HMI and skew enclosure**

**Enclosures.** Four skew system enclosures were installed at the bridge. The main skew enclosure, a NEMA 4 rated enclosure, was in the operator’s house. This rating was selected to provide added protection; see Figure 11. The other three skew enclosures were located outdoors and thus exposed to harsh environmental conditions. These outdoor enclosures were stainless steel NEMA 4X rated enclosures; see Figures 7 and 12. All skew enclosures and associated panels were manufactured by Saginaw Control & Engineering and wired by Panatrol. In addition, a non-metallic enclosure was installed over the encoders and lasers to provide further environmental hardening.

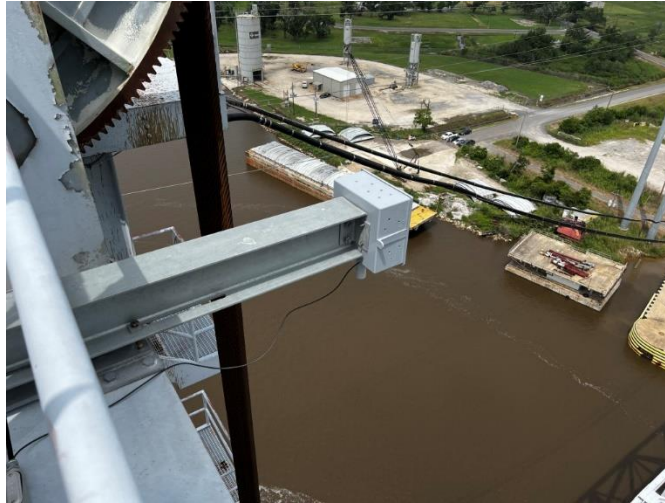
**Figure 16. Typical laser beam extension installation**

**Laser Configuration Adjustments.** In the initial design, configuration adjustments required access to the lasers for a direct connection between the lasers and a laptop. These adjustments were cumbersome because they required pulling back the extension beams to which they were mounted, then realigning them following the desired changes; see Figure 16. To address this issue, the design was updated to add serial media converters in each tower that allowed remote interfacing with the lasers. The installation of these devices occurred during Site Visit 4.

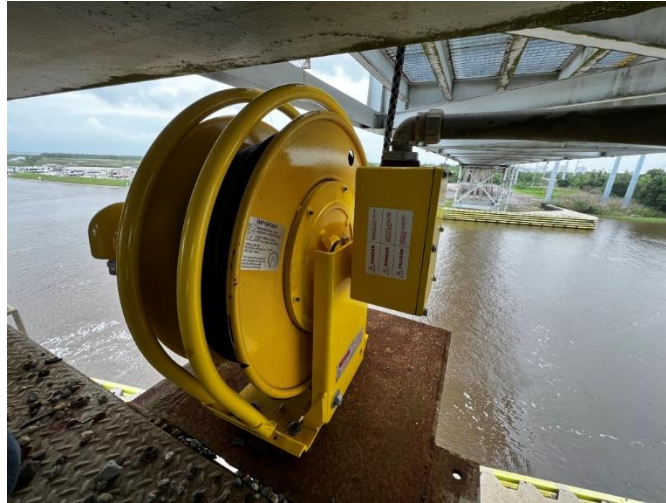
**Figure 17. Cable reel used in attempted Power Line Communication**

Per the design, the inclinometer data was also transmitted using Power Line Communication over the navigation light feeder conductors, which traveled through a bridge cable reel. Initial attempts at achieving communication through the Power Line Communication scheme were unsuccessful, and it was considered possible that the poor condition of the cable reel was a factor (see Site Visit 3). The installation was reviewed again by others following the replacement of the cable reel; see Figure 17. Communication through the cable reel remained unsuccessful even after the new cable reel installation (see Site Visit 5). It is unclear if the issue was due to interference with other devices, the length of the cables, or something else.
