Hydraulic Inspection Vehicle Explorer (HIVE) Culvert Upgrade

Research Project

Final Report 2021-01

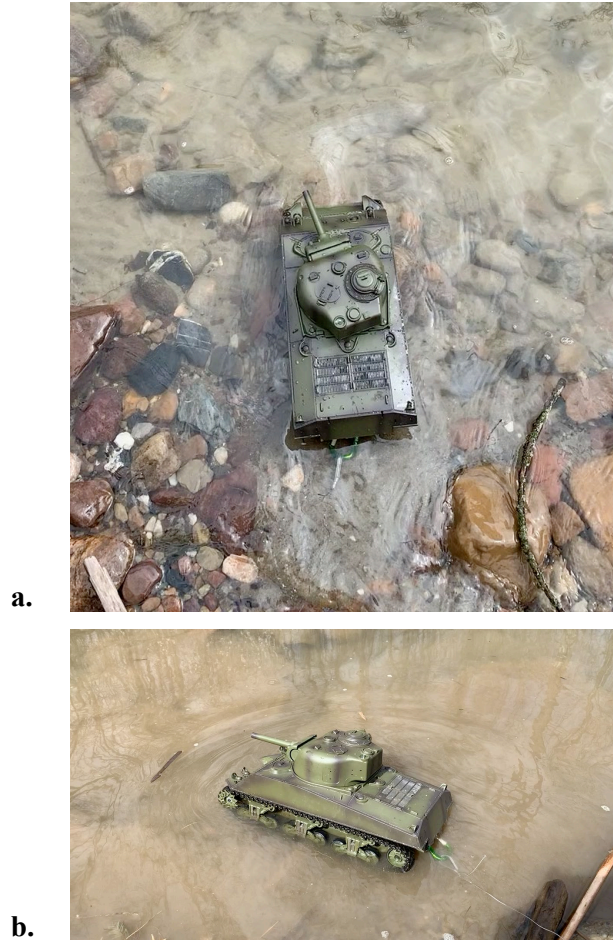
Figure 11 Waterproofed HIVE 2.0 tested for water tolerance in a stream

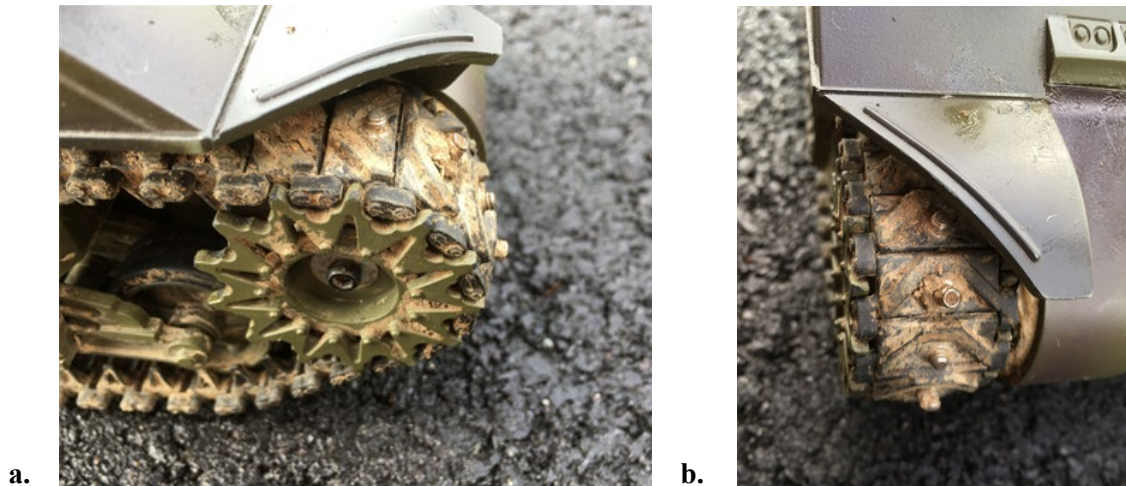
Figure 19 Short bolts glued to tank treads improve traction, especially when climbing over debris and slippery surfaces.

Mobility testing identified tank tread slippage when maneuvering over debris and wet objects to also be a potential. The addition of studs in the form of short bolts (4-40 1/8 inch) glued to the treads improved the overall traction,

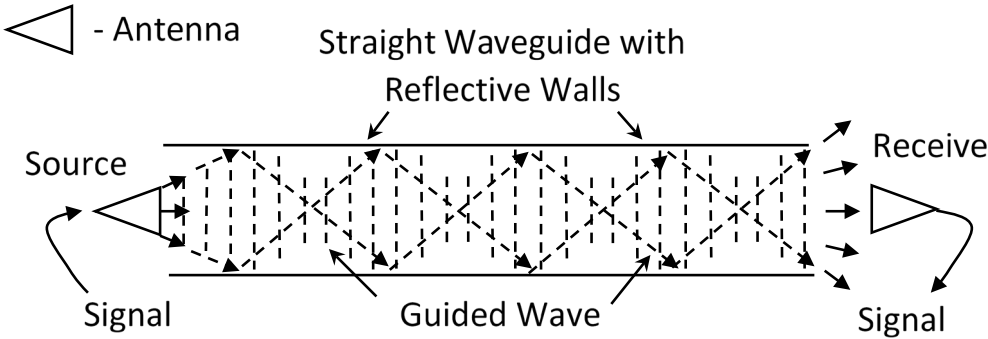
Figure 24 Waveguide with reflective walls transmits waves with frequencies above the cutoff frequency long distances without losses

The above waveguide analysis assumes that the walls of the culvert are perfectly conductive. This leads to the mathematical boundary conditions of perfect reflection in the walls, which then drives many of the classical waveguide results. Two primary results are: 1. Waves with frequencies above the cutoff frequency propagate along the waveguide without any loss of energy or signal strength, Figure 24 and Figure 25; and 2. The waveguide can be curved without affecting the propagation of waves, as long as the radius of curvature is several times longer than the wavelength, Figure 26. Metal walls on a culvert can be a reasonable approximation to perfectly conductive and reflective walls, but the losses will attenuate the strength of the signals.

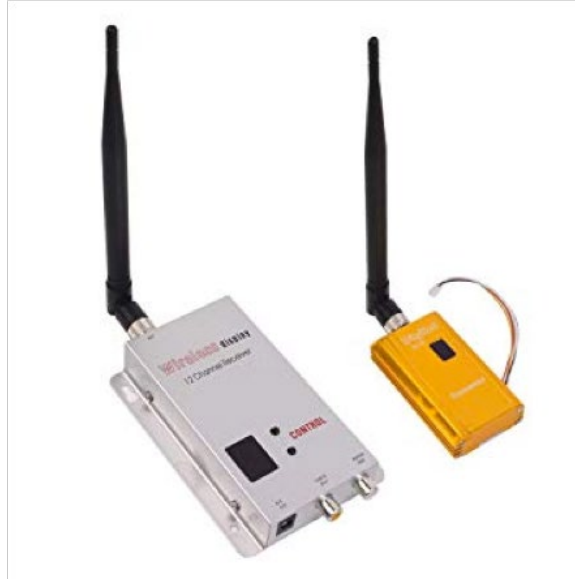
Figure 32. 1.2 GHz video transmitter and receiver

The video telemetry options at 1.2 GHz are somewhat limited. Transmitters and receivers at 1.2 GHz generally are used for closed-circuit television (CCTV) video surveillance and tend to be too large to mount on a vehicle for small culvert inspections. There was one small system available, Figure 32. The yellow device is the transmitter which mounts to the vehicle, while the grey device is the receiver which connects to the monitor. This system has an output power of 1.5 W and an advertised range of 965 m (0.6 miles) in open space. The transmitter has dimensions of 12.7 x 50.8 x 102 mm³ (0.5 x 2 x 4 inches³). The system costs \$70.

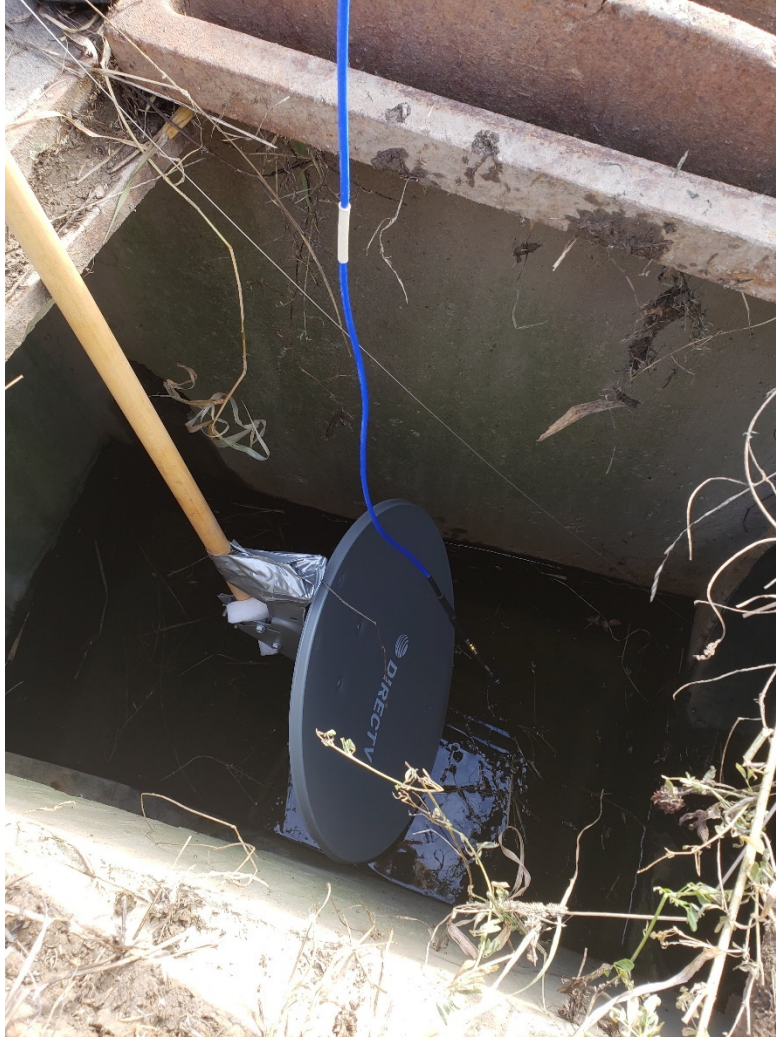
Figure 63 Antenna on extension cable and reflector dish inserted through drop inlet utility hole into telemetry beam line projecting from culvert

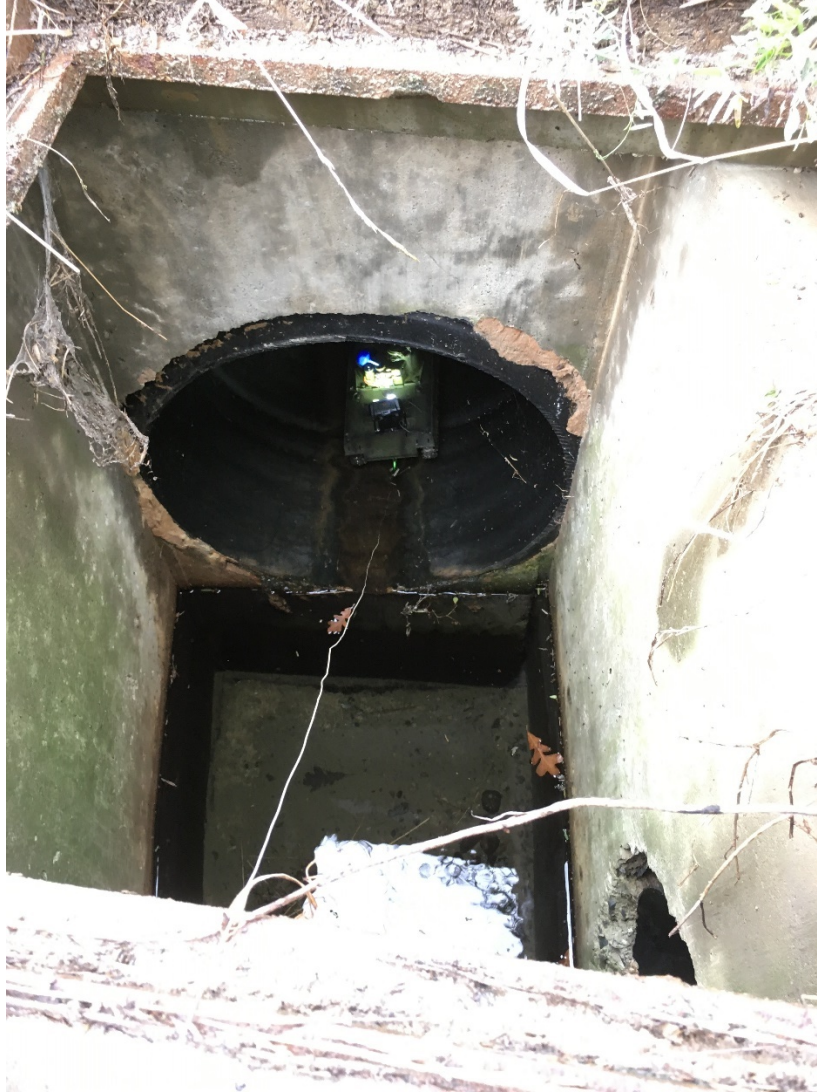
Figure 65 HIVE 2.0 tank at entrance of culvert through drop inlet

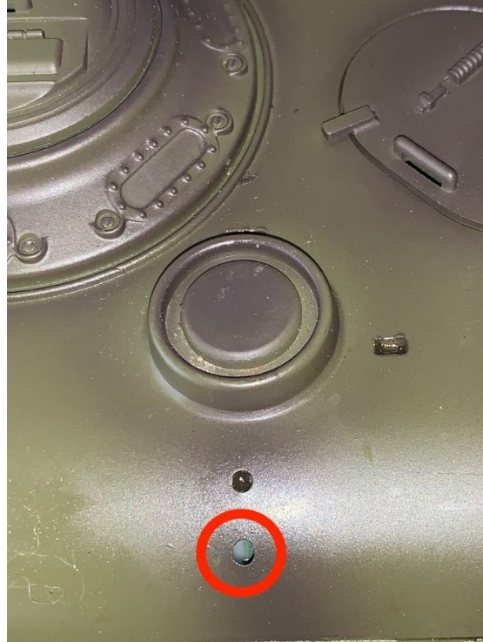
Figure 75 Stock hole for Camera 1 position

Mounting the top camera requires drilling a hole through the turret shell. Start by drilling a pilot hole through the turret shell to locate the position and angle of the top camera. If the stock hole, as shown circled in red in Figure 75, is in the desired position, it can serve as the pilot hole. The stock hole produces a camera elevation angle of about 60 degrees which is recommended. Drill out the pilot hole with a 1/2-inch drill bit. Note that Figure 76 shows the 1/2-inch hole drilled in a pilot hole below the stock hole for a camera elevation angle of about 45 degrees.

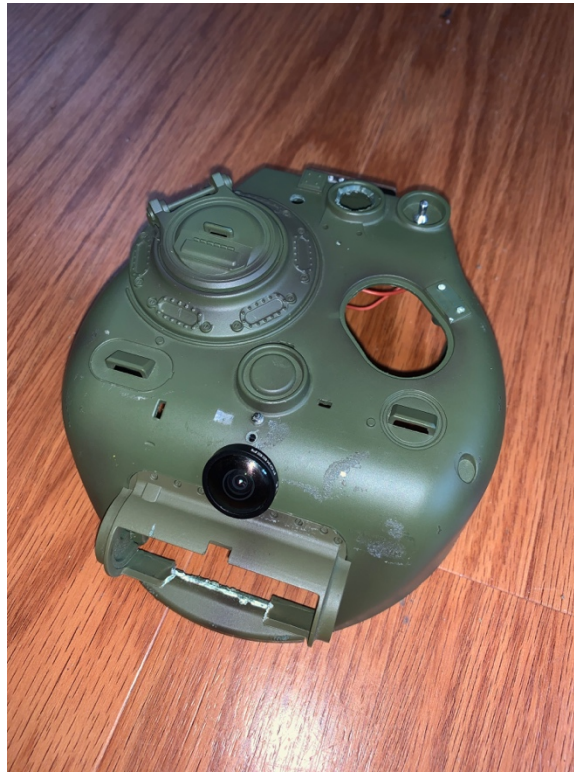
Figure 82 Camera 2 cover bonded to turret shell

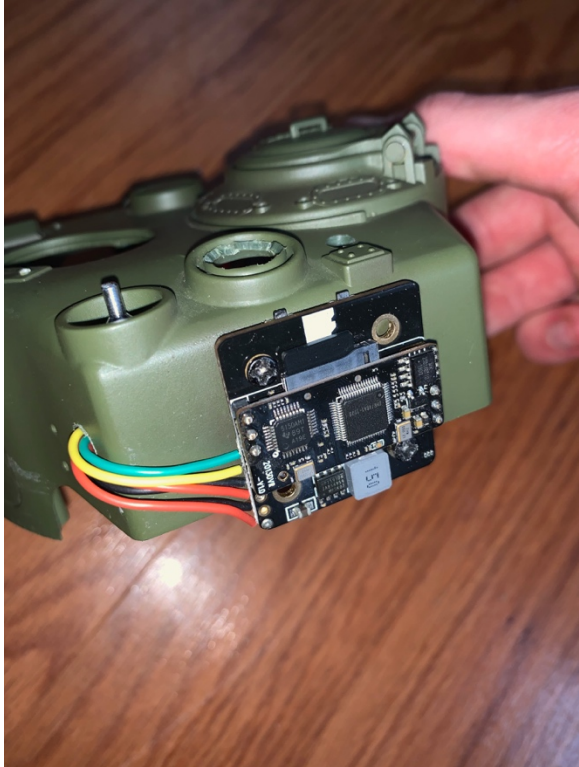
Figure 84 Transmitter screwed to back of turret

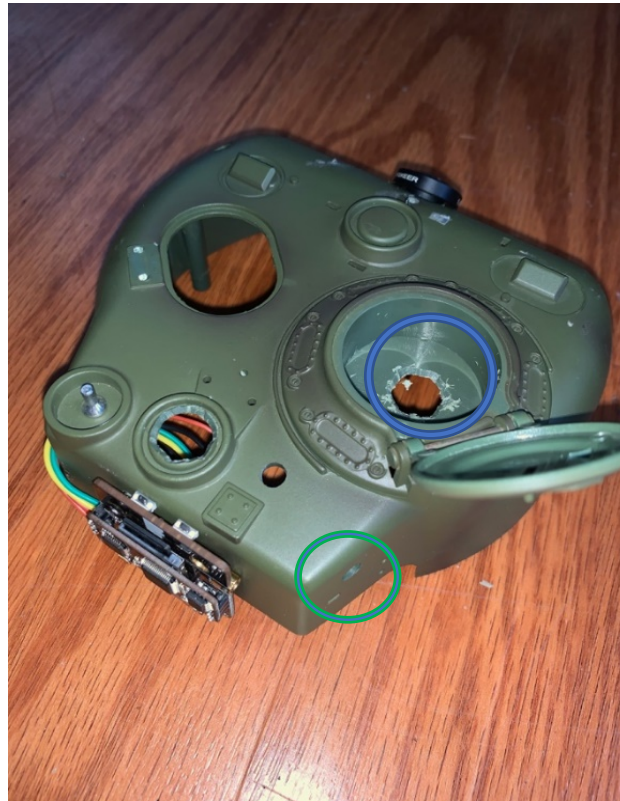
Figure 86 Holes drilled for antenna

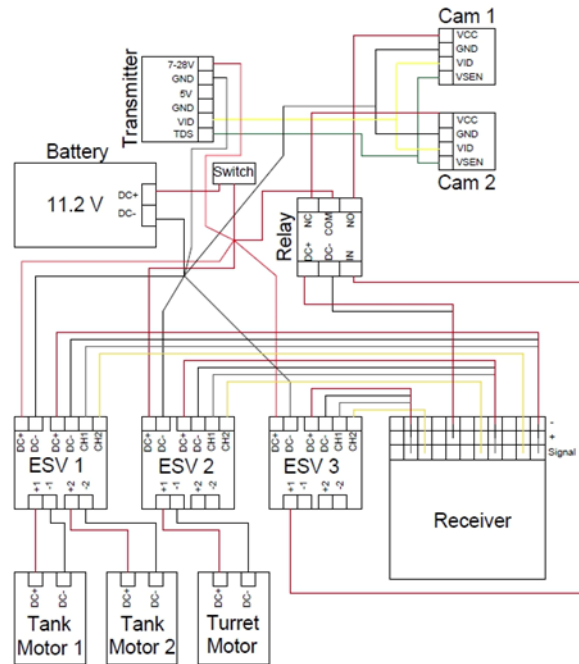
Figure 90 HIVE 2.0 wiring diagram
