Test Report No. 440873-01

**DEVELOPMENT OF A *MASH* TL-4 PORTABLE CONCRETE BARRIER  
WITH LARGE SCUPPER**

Sponsored by the  
**Texas Department of Transportation (TxDOT)**

**TEXAS A&M TRANSPORTATION INSTITUTE PROVING GROUND**

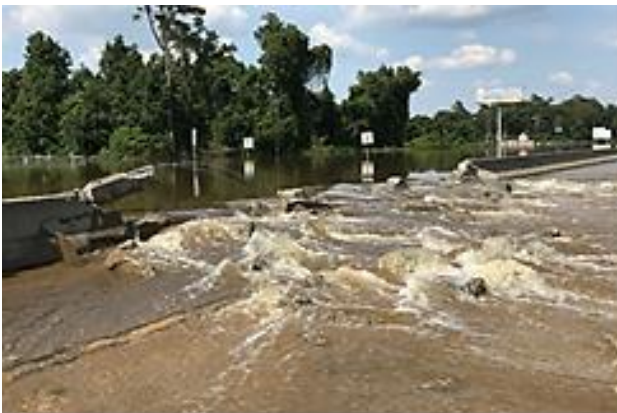
A severe storm in Louisiana along IH 12 resulted in a similar scenario to the one experienced in Texas. A 19-mi length of solid concrete median barrier that was constructed to divide the eastbound and westbound lanes of IH 12 to prevent head-on crashes on the heavily traveled highway acted as a dam, causing greater flood damage to areas north of the highway. Figure 1.1 illustrates examples of flooding where solid concrete median barriers were implemented.

a. Beaumont, Texas

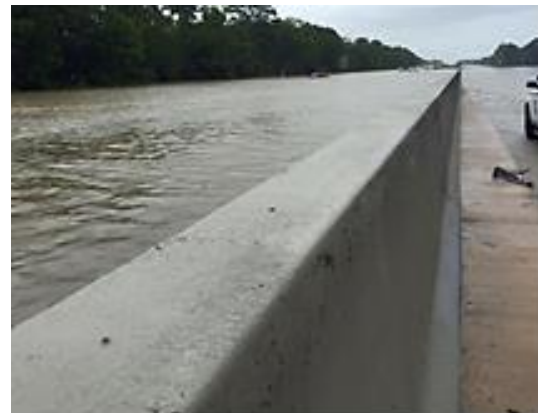
b. Louisiana

**Figure 1.1. Examples of Flooding Where Solid Concrete Median Barriers Were Installed (2, 3).**

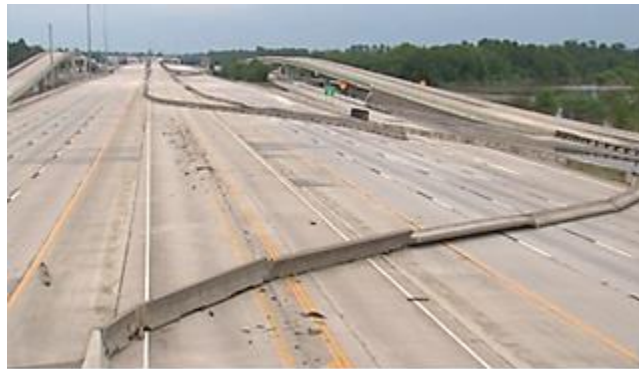
could be reopened and a level of safety restored for motorists. Figure 1.2 illustrates examples of flooding where PCBs were installed as permanent median barriers.

a. Portable concrete median barrier in Humble, Texas.

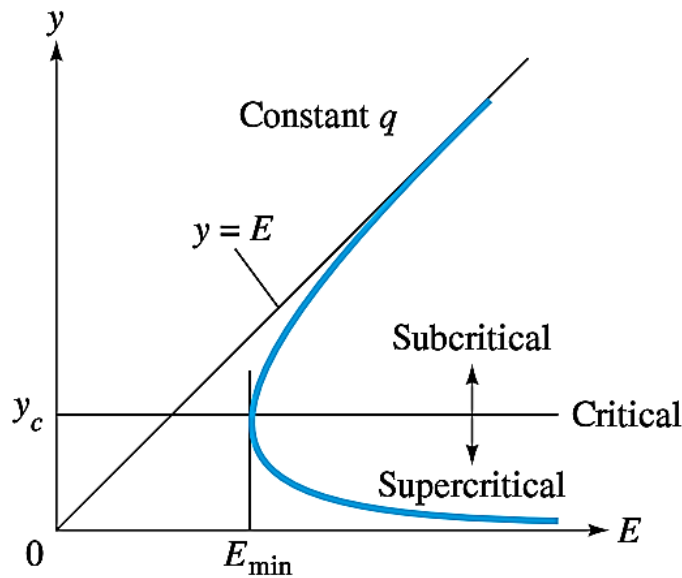
**Figure 2.1. Specific Energy Curve (9).**

The diagonal line shown in Figure 2.1 is an  $E = h$  line, and it represents the potential energy if a fluid is completely static. To keep the notation constant throughout,  $y$  in Figure 2.1 is referred to as the water depth,  $h$ . This line's abscissa is the water depth, and the difference between this value and the curve's abscissa is the kinetic energy. Therefore, the addition of these two values results in the total specific energy. The critical depth can then be found by taking the derivative of Equation 2.4 with respect to  $h$ , where  $dE/dh = 0$ .

The minimum specific energy, or critical energy, can also be found by setting the derivative of Equation 2.4 equal to 0. Any flow at a water depth above this point is known as a subcritical flow, and water depths below this critical point are referred to as supercritical flows. Subcritical flows tend to have a lower velocity, while supercritical flows have a larger velocity.

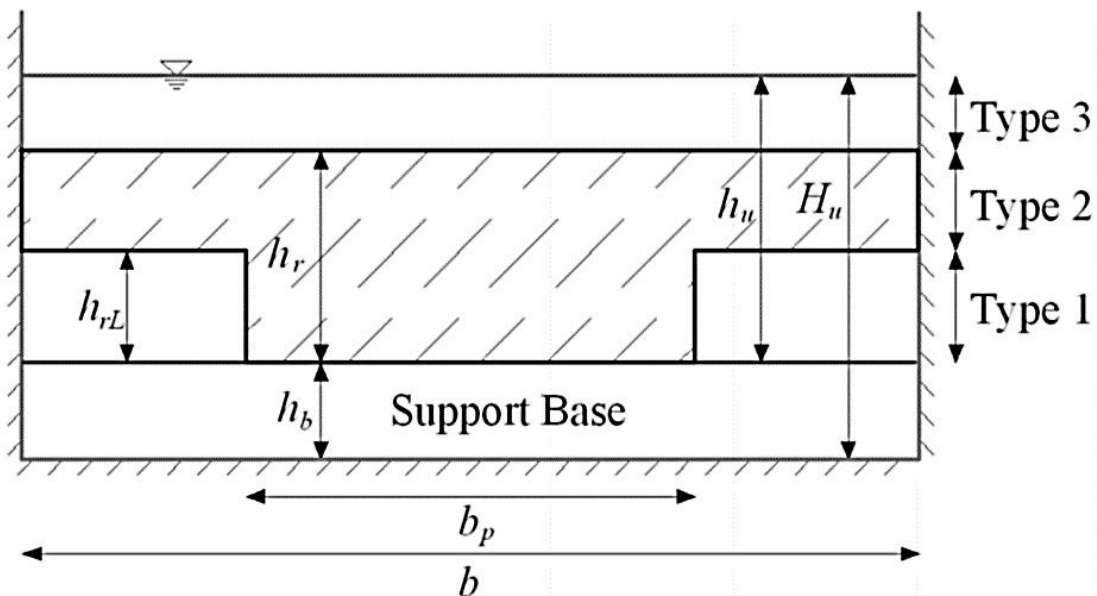
Figure 2.3. Three Flow Cases in Charbeneau Model (9).

Three different flow types, defined as Type 1, 2, and 3, were previously studied (9). Type 1 flow occurs when the water depth at the rail is less than the height of the bridge rail opening ( $h_u < h_{rL}$ ). This is an unsubmerged flow condition that can be described by  $Q = vA$ . Type 2 flow is a submerged condition where the water depth at the rail is greater than the height of the opening but less than the total rail height ( $h_{rL} < h_u < h_r$ ). This condition is governed by the orifice flow equations. Type 3 flow is a fully

submerged condition in which the water depth at the rail is greater than the total rail height.

The hydraulic performance of various bridge rail and median barriers was studied by Charbeneau et al. (9) to determine how different rails impact surrounding floodplains during storms. The primary result of this research was a three-parameter model that predicts the free-flow rail rating curve. With the energy equations discussed previously, the model can be used to estimate flow through bridge rails given an upstream water depth. The model is an extension of a previous two-parameter model developed by Charbeneau et al. (14). The model developed rating curves to define the hydraulic performance in an inlet-controlled highway culvert. Charbeneau et al. (9) added a third parameter to this model to define all possible flow scenarios through a bridge rail, as shown in Figure 2.3.

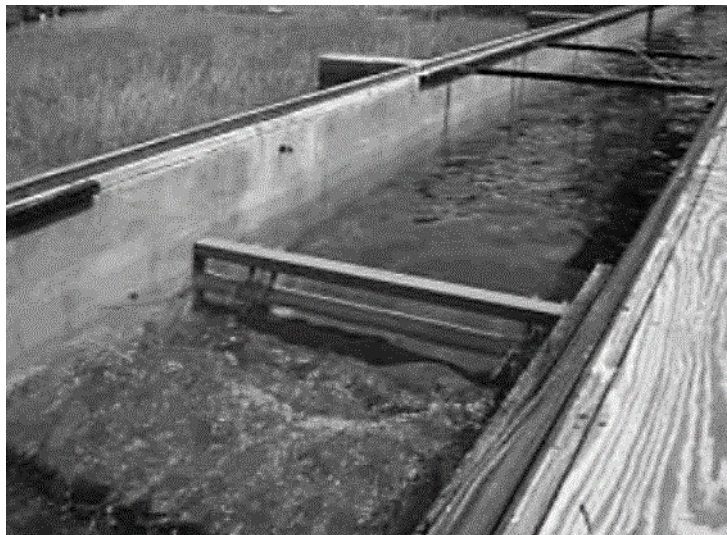
**Figure 2.4. Experimental Setup for Bridge Rail in Rectangular Channel (18).**

To use the Charbeneau model, the parameters must be experimentally obtained (18). Experimental testing was conducted for nine bridge rails in a zero-slope rectangular channel with a width of 150 cm (5 ft), shown in Figure 2.4. The nine bridge rails that were tested were the single-slope traffic rail (SSTR), T221, T501, T411, T203, T101, T101D, weir rail, and Wyoming rail. In these experiments, upstream and downstream water depths were collected using pitot tubes connected to an inclined manometer board, and the model rails were scaled to half the size of standard TxDOT dimensions. The rails were constructed with wood; however, the T101 and Wyoming rails were constructed using metal. All wooden surfaces were coated with waterproof primer to mitigate swelling and maintain the structural integrity of the wood. The bases of all the rails were anchored to the channel to ensure hydraulic stability.

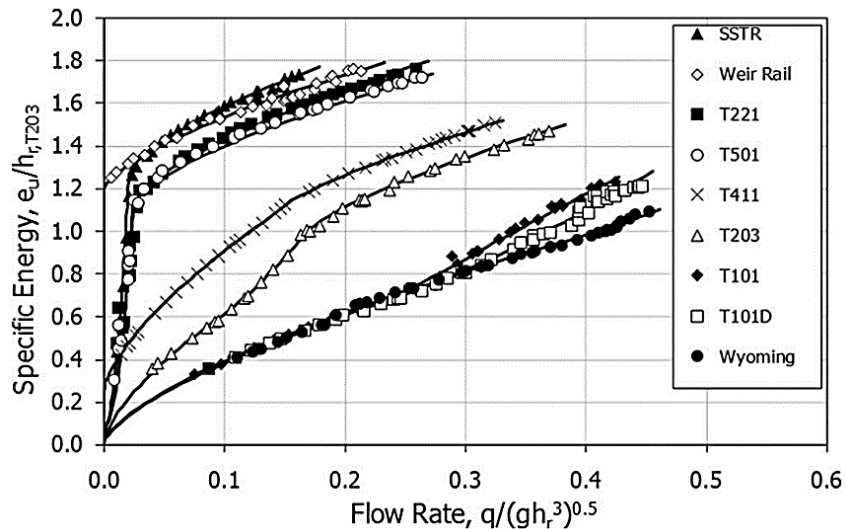
Figure 2.5. Bridge Rail Rating Curves (9).

The primary determining factor of hydraulic efficiency is the fractional open space, which can be observed by simply comparing the data in Figure 2.5 with the bridge rails seen in Figure 2.6. The five rails not shown in the figure are all mostly solid with minimal open space, hence their lower hydraulic efficiency. Also, while the open spaces between rails T203 and T411 are similar, the lower location and greater width of the opening can improve the hydraulic efficiency, especially at lower flow rates.

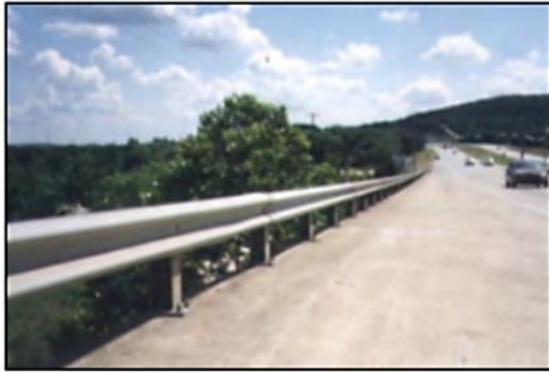
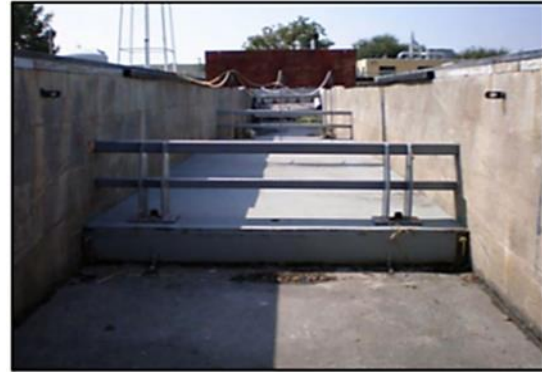
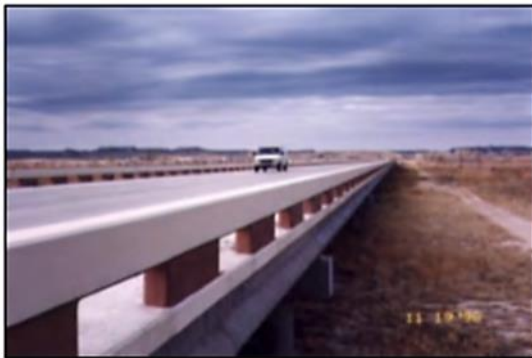
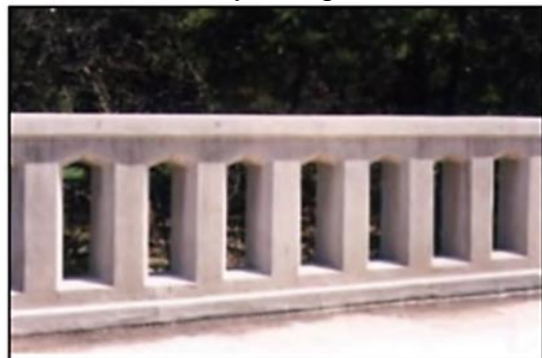
**Figure 2.6. Bridge Rail Examples (9).**

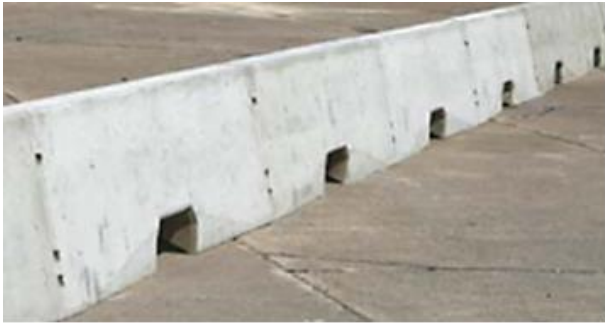
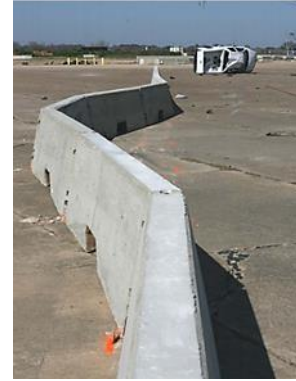
**Figure 2.8. WSDOT Barrier Test 3-11 (23).**

A 2004 Dodge RAM 1500 quad-cab truck impacted the barrier at a speed of 60.2 mi/h and an angle of 26.2 degrees at the critical point of impact—4.3 ft upstream of a segment joint. The vehicle was contained and redirected but rolled onto its side after exiting from the barrier. Although the barrier did not satisfy *MASH* testing evaluation criteria, the researchers observed that the “drainage slots and scupper opening did not appear in any way to adversely affect the crash performance of the barrier system” (23). Figure 2.8 provides photos from this test (23).

In 2011, a variation of the Washington pin-and-loop barrier was retested (24). In this second crash test, the 1-inch-diameter AISI 4142 pins were replaced with 1 $\frac{1}{4}$ -inch-diameter F1554-grade 105 steel rods. The vehicle appeared to perform better than in the previous test; however, the vehicle still overturned after exiting the barrier, and the barrier did not meet *MASH* Test Level 3 (TL-3) requirements. Figure 2.8 and Figure 2.9 show photos of the 2011 test (24).

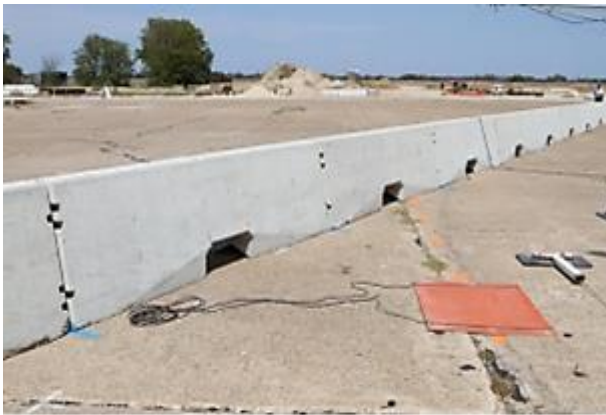
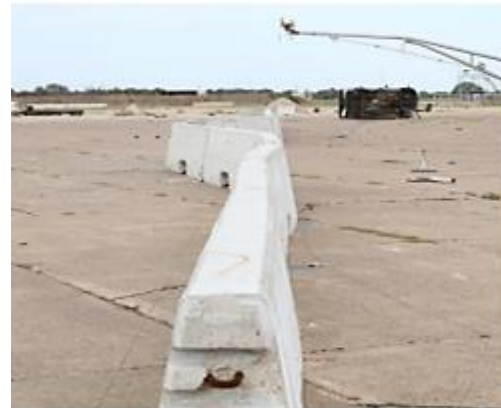
**Figure 2.9. Revised WSDOT Barrier Test 3-11 (24).**

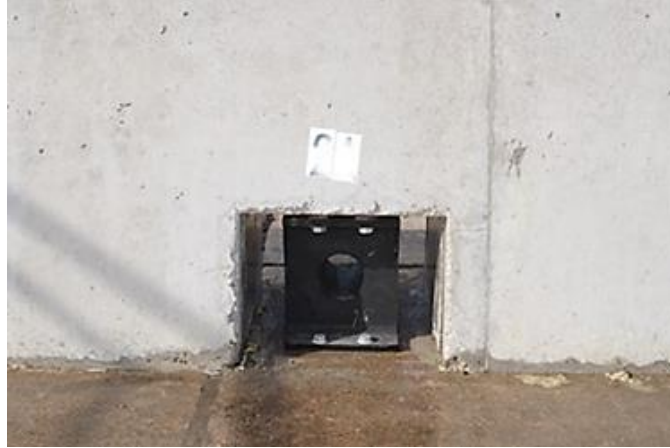
**Figure 2.11. Opening in Concrete Barrier to Allow for Rubber Block Installation (26).**

Under a TxDOT-sponsored project, Texas A&M Transportation Institute (TTI) researchers evaluated a new median barrier that was developed (26). The barrier was analyzed using computer simulation and full-scale crash testing. The final design included anchoring a 42-inch-tall SSCB with a set of rubber anchor blocks bolted to the ground. Typically, rigid SSCBs are anchored with steel anchorage rebar connecting the barrier to the concrete pavement. This anchorage results in the barrier behaving rigidly, with no significant deflection. The new design with rubber blocks was intended to allow some barrier movement to reduce occupant severity while retaining the low-maintenance characteristic of a concrete barrier. Figure 2.11 shows an opening in the barrier with the installed rubber block. Although these openings were not introduced for drainage purposes, they have similar effects in terms of creating stress concentrations and affecting barrier capacity. When the system was tested following *MASH* Test 3-11 conditions with the 2270P pickup truck, large cracks originated from the corners of these openings. This information was used under the current project in terms of methods and areas of reinforcement.

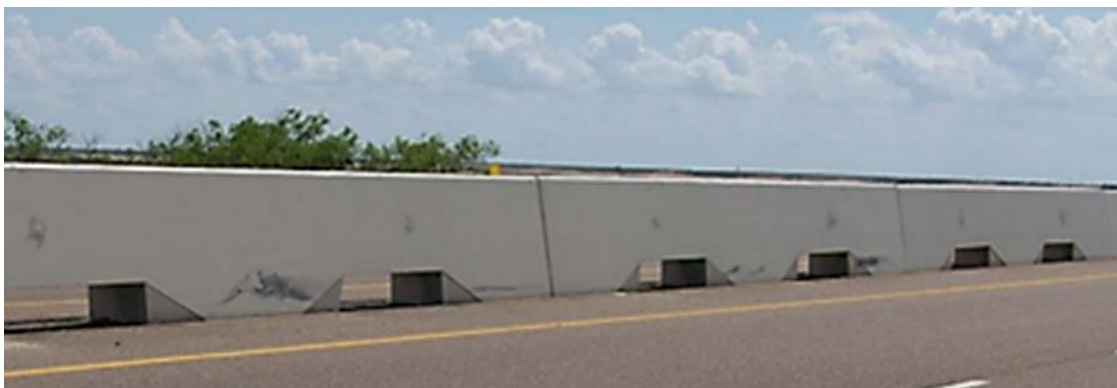
**Figure 2.12. TxDOT SSCB (Wildlife Crossing) (25).**

The TxDOT wildlife crossing barrier is 42 inches in height and has openings for wildlife access through the barrier (see Figure 2.12). A 30-ft length of barrier contains two openings that are 12 inches high and 5 ft long. Based on a review of the geometric features of this barrier, it was determined that the TxDOT wildlife crossing barrier was crashworthy with respect to NCHRP Report 350 TL-3 criteria.

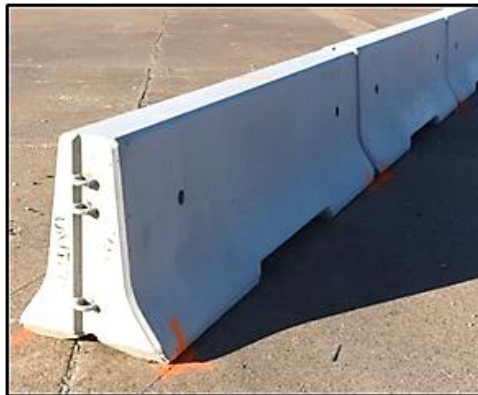
**Figure 2.13. MassDOT F-shape PCB (27).**

concentration during an impact event. The Massachusetts Department of Transportation (MassDOT) Highway Division tested its 32-inch-tall, precast F-shape PCB system, shown in Figure 2.13, to determine if it was *MASH* compliant (27). The 10-ft-long barrier segments were precast with a single drainage relief/forklift slot in the center of the barrier that was 3 ft 4 inches long  $\times$  3 inches high. The barrier was crash tested and performed acceptably for *MASH* TL-2 impact conditions. However, it was noted that the impact segment was cracked completely through the cross section near the center of the segment after *MASH* Test 2-11 (see Figure 2.14) (27).

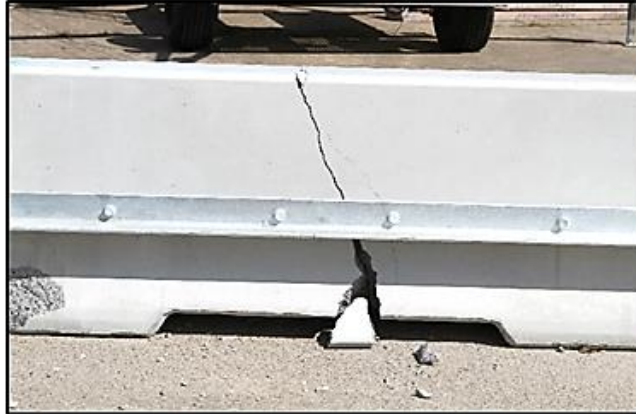
**Figure 2.15. Concrete Crack after *MASH* Test 3-11 on MassDOT Retrofit PCB System (27).**

This barrier was then retrofitted and tested in accordance with *MASH* TL-3 impact conditions (27). A 9-ft-long, 6-inch  $\times$  4-inch  $\times$   $\frac{1}{2}$ -inch steel angle was secured to the back (field) side of each barrier segment with six screw anchors to increase barrier capacity. The retrofit MassDOT PCB performed acceptably for *MASH* TL-3 impact conditions. A significant fracture near the center of the impact segment (see Figure 2.15) confirmed the need for the additional capacity provided by the steel angle (27).

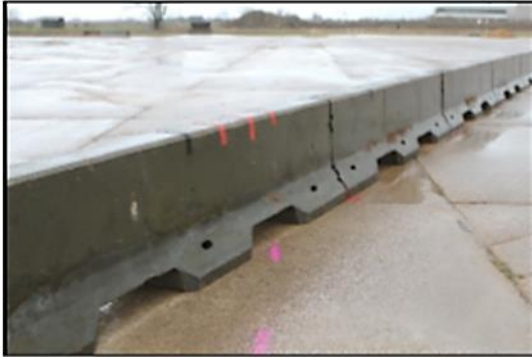
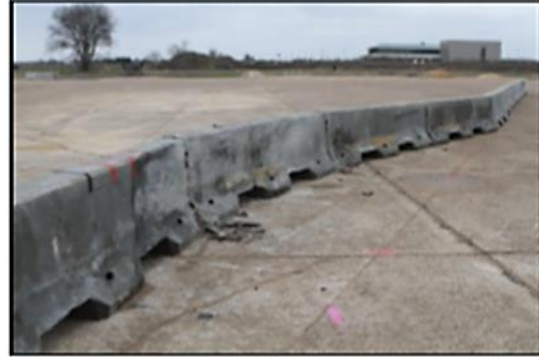
**Figure 2.16. Test Installation for Free-Standing F-shape Barrier with Drainage Scuppers (28).**

The F-shape barrier segments were 32 inches tall, incorporated two 6-inch-tall drainage scuppers, and were attached to each other using pin-and-loop connections. This system was evaluated by performing *MASH* Test 3-11. Figure 2.16 shows the free-standing F-shape barrier test installation before and after *MASH* Test 3-11. The free-standing F-shape barrier with drainage scuppers passed the performance criteria for *MASH* Test 3-11 for longitudinal barriers.

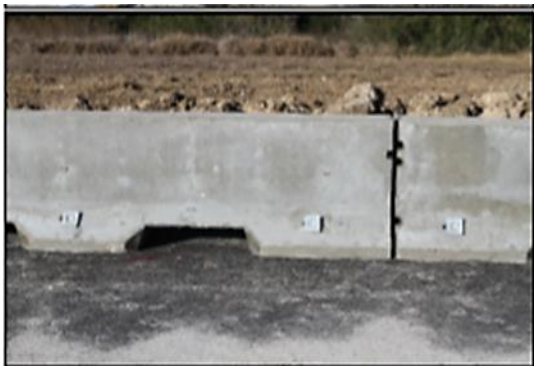
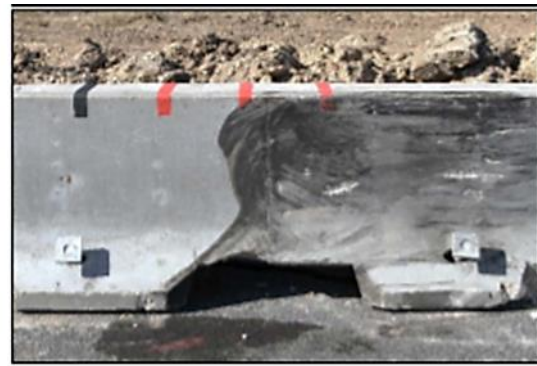
**Figure 2.17. Test Article for F-shape Barrier with Drainage Scuppers (28).**

The same 32-inch-tall F-shape barrier with drainage scuppers and pin-and-loop connections was anchored to a 4-inch-thick layer of asphalt pavement using three anchoring pins per segment. Figure 2.17 depicts the F-shape barrier test article before and after *MASH* Test 3-11. The F-shape barrier with drainage scuppers, pinned on 4 inches of asphalt, passed the performance criteria for *MASH* Test 3-11 for longitudinal barriers (28).

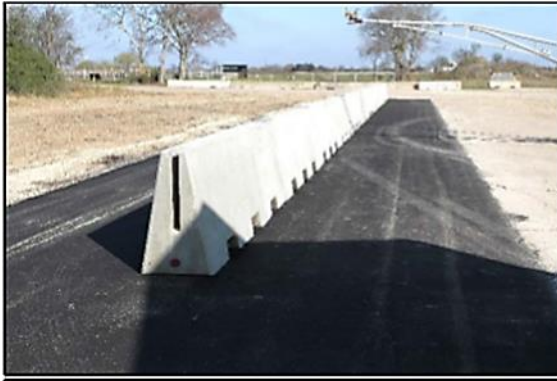
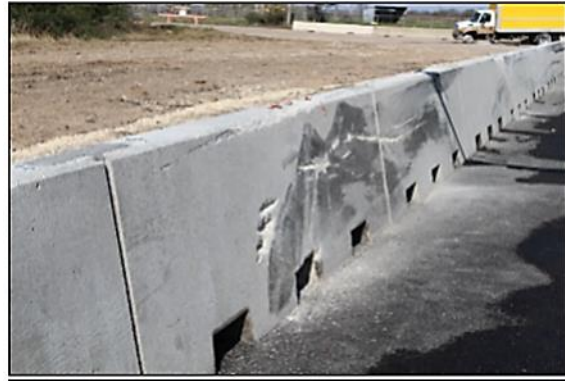
**Figure 2.18. Test Article for Embedded Single-Slope Barrier (28).**

A 42-inch-tall single-slope concrete barrier system with grouted rebar-grid connections and drainage scuppers was embedded 4 inches in asphalt for an above-grade measurement of 38 inches (28). Each precast barrier segment had three 10-inch-tall drainage scuppers at the bottom, which provided 6-inch openings above grade after the segments were embedded in asphalt. This system was evaluated by performing *MASH* Test 4-12. Figure 2.18 depicts the single-slope barrier test installation before and

after *MASH* Test 4-12. The embedded single-slope barrier with drainage scuppers passed the performance criteria for *MASH* Test 4-12 for longitudinal barriers (28).

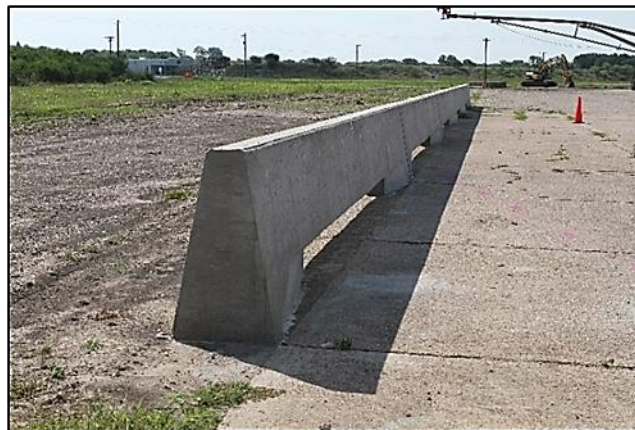
**Figure 2.19. TxDOT Large-Scupper Median Barrier Test Article for *MASH* TL-4 Testing (29).**

The hydraulically efficient barrier (HEB) has a single-slope profile, an overall height of 42 inches above grade, a bottom width of 24 inches, and a top width of 8 inches. The HEB incorporates a 13-inch-high, 18-ft-long scupper on 30-ft centers. A photo of the HEB test installation is shown in Figure 2.19 (29).

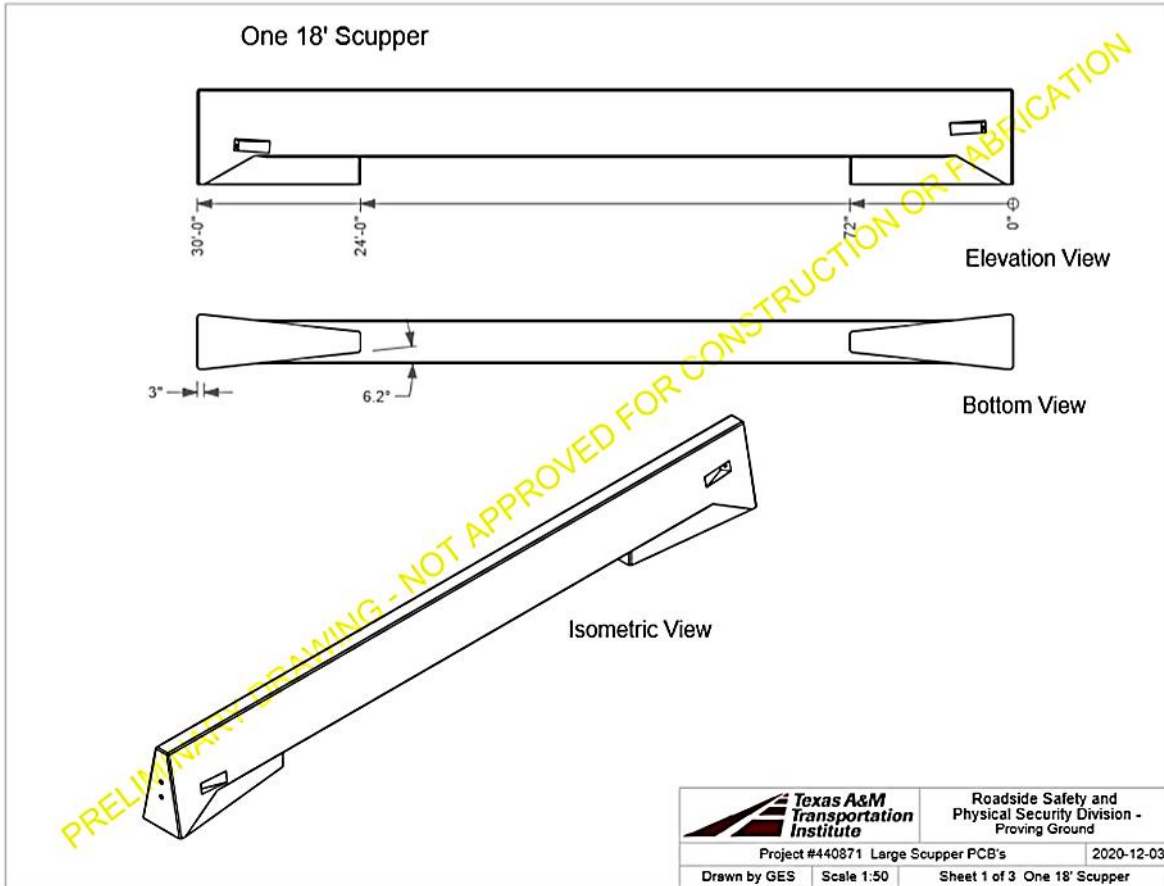
**Figure 3.1. Option A Preliminary Drawing.**

Advantages	Disadvantages
Post sections flared laterally at shallowest rate may reduce vehicle snagging during an impact	Long span may require additional reinforcement from a structural capacity perspective
Largest opening allows the most water to flow through	Longest length of slope transition to opening may increase chance of contact and possible spalling and other damage during impact
Single span may allow for simplest reinforcement layout	Most complex to precast because of required flow length for concrete beam associated with opening when precasting segment upside down in mold

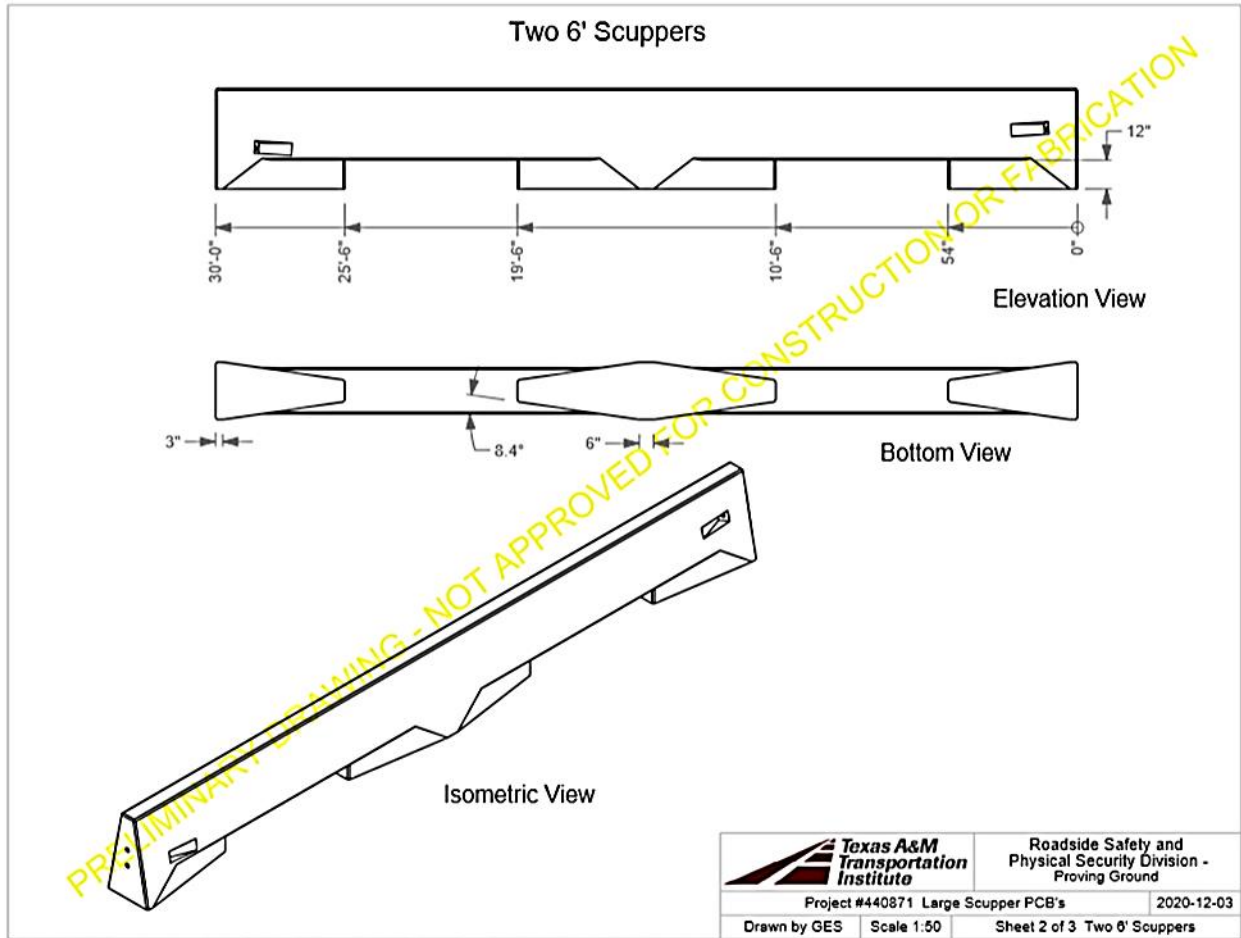
**Figure 3.2. Option B Preliminary Drawing.**

Figure 3.2 depicts Option B, which incorporated two scuppers that were conceptually each 12 inches tall and 6 ft long. The determination of appropriate opening size (height and length) would be dictated by large-scale hydraulic testing, finite element computer simulations, and engineering analyses. The transition slope to the full single-slope profile was 1:6.75 (8.4 degrees). This angle was influenced by the available transition length while trying to maximize the length of the openings. Table 3.2 lists the advantages and disadvantages of Option B.

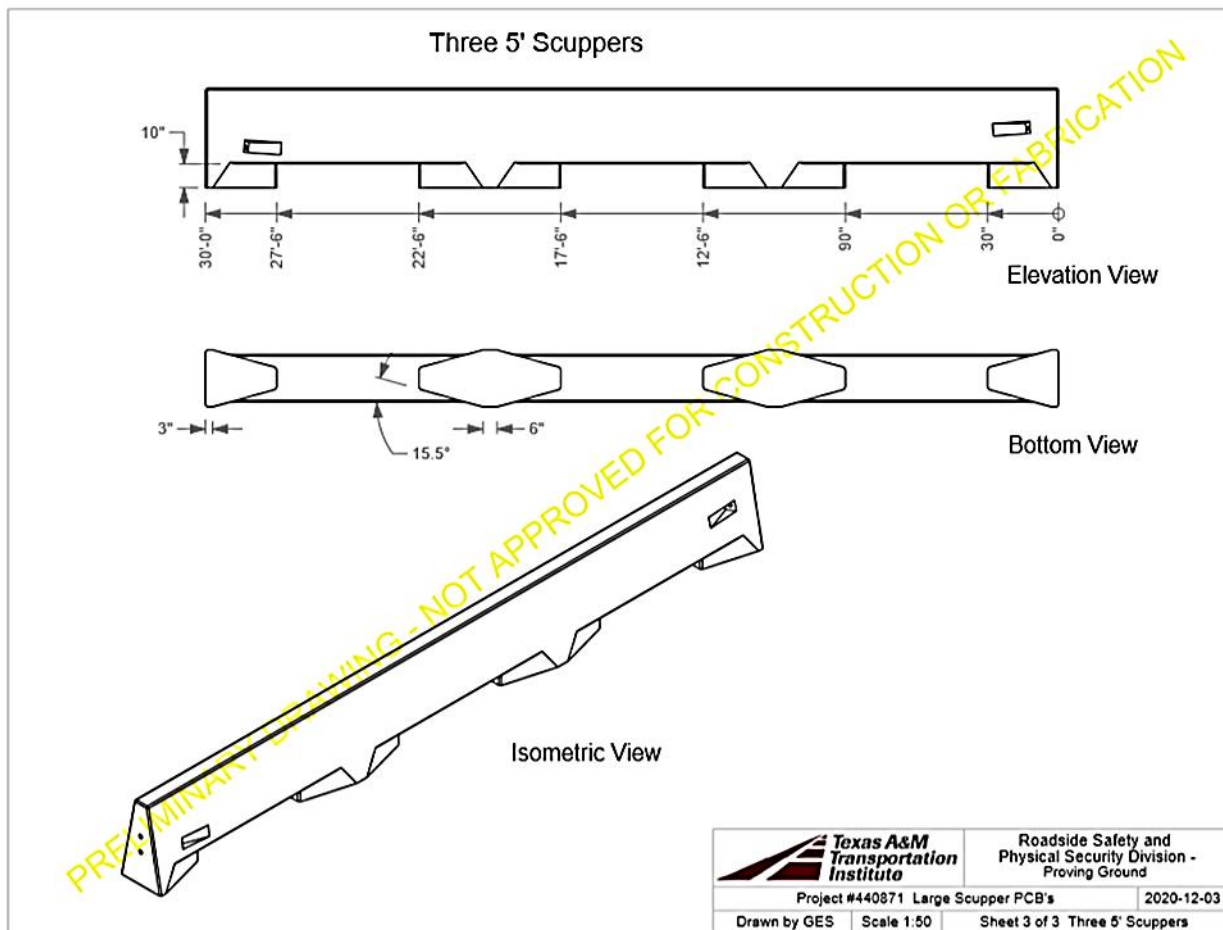
Figure 3.3. Option C Preliminary Drawing.

Figure 3.3 depicts Option C, which incorporated three identical scuppers that were conceptually 10 inches tall and 5 ft long. The determination of appropriate opening size (height and length) would be dictated by large-scale hydraulic testing, finite element computer simulations, and engineering analyses. The transition slope to the full single-slope profile was 1:3.6 (15.5 degrees). This angle was influenced by the available transition length while trying to maximize the length of the openings. Table 3.3 lists the advantages and disadvantages of Option C.

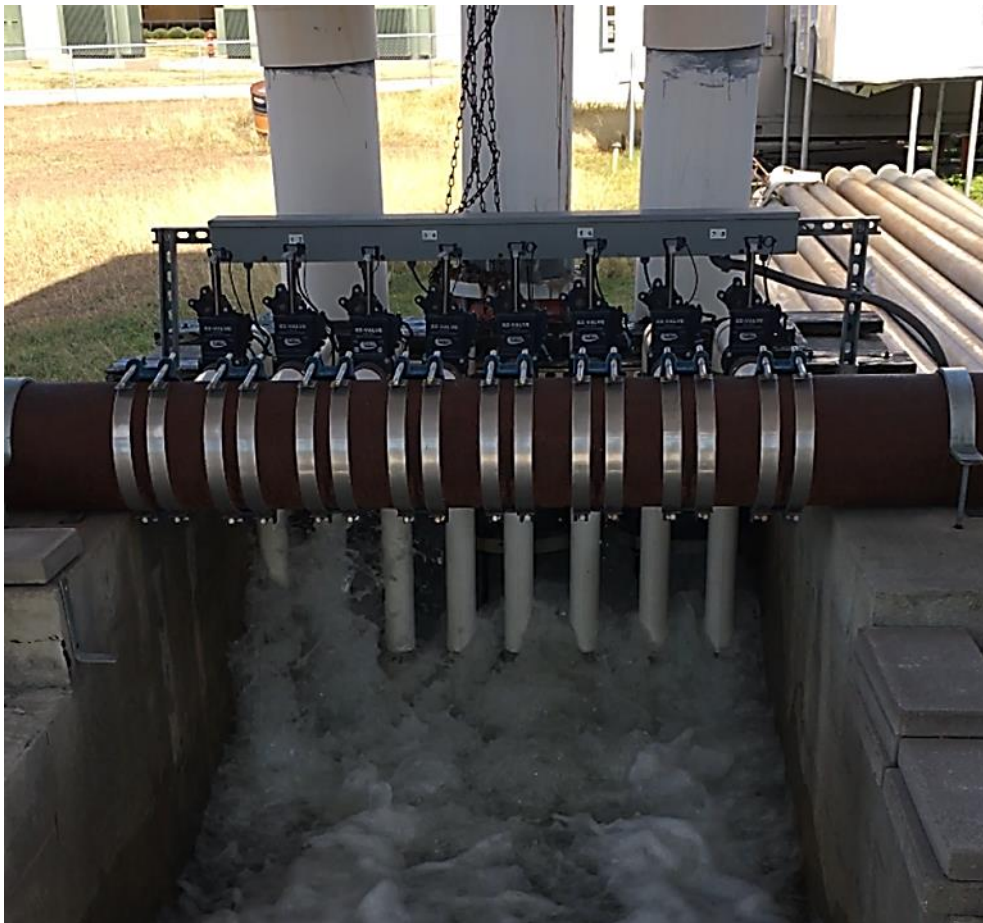
**Figure 4.2. Pump Outlets (15).**

The outdoor channel was a rectangular concrete flume that was 5 ft wide, 2 ft 8 inches high, and approximately 125 ft long. The channel bed slope in both the spanwise and lengthwise directions was approximately 0 degrees, and the walls were all at approximately 90-degree angles with the channel bed. The water entered the flume through two pipe outlets at the head of the channel, as shown in Figure 4.2, and it flowed through the entire length of the channel before spilling into the return channel.

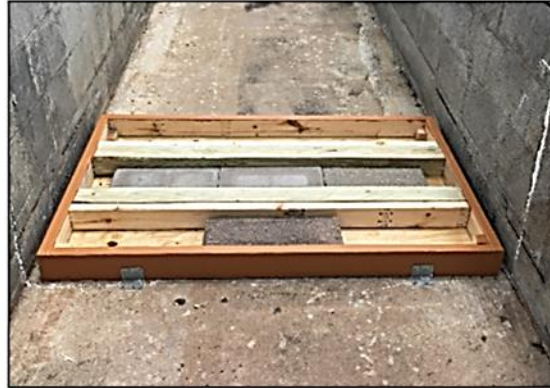
**Figure 4.4. Support Base Design and Installation (15).**

The support base was previously used for hydraulic testing on median barriers (15), and since it was still intact, it was resealed and waterproofed for use. The purpose of the base was to anchor the median barrier in place while allowing for its removal at the end of testing. The dimensions of the base were 57 inches  $\times$  36 inches  $\times$  4.25 inches. Wood planks were installed on both sides of the base to fill the 5-ft-wide channel when in place while allowing the water to drain completely from the channel when removed. The frame of the base was built using two 3.5-inch  $\times$  3.5-inch wood planks on top of and underneath 0.75-inch plywood sections. The base was fastened to the channel with concrete bolts approximately 90 ft downstream of the pumps. Eight

removable machine screws were used to secure the barrier to the support base, with four screws in each plank. The front, back, and center sections of the support base were filled with concrete blocks to provide added weight. Figure 4.4 shows the support base design and the physical base without the top section of plywood.

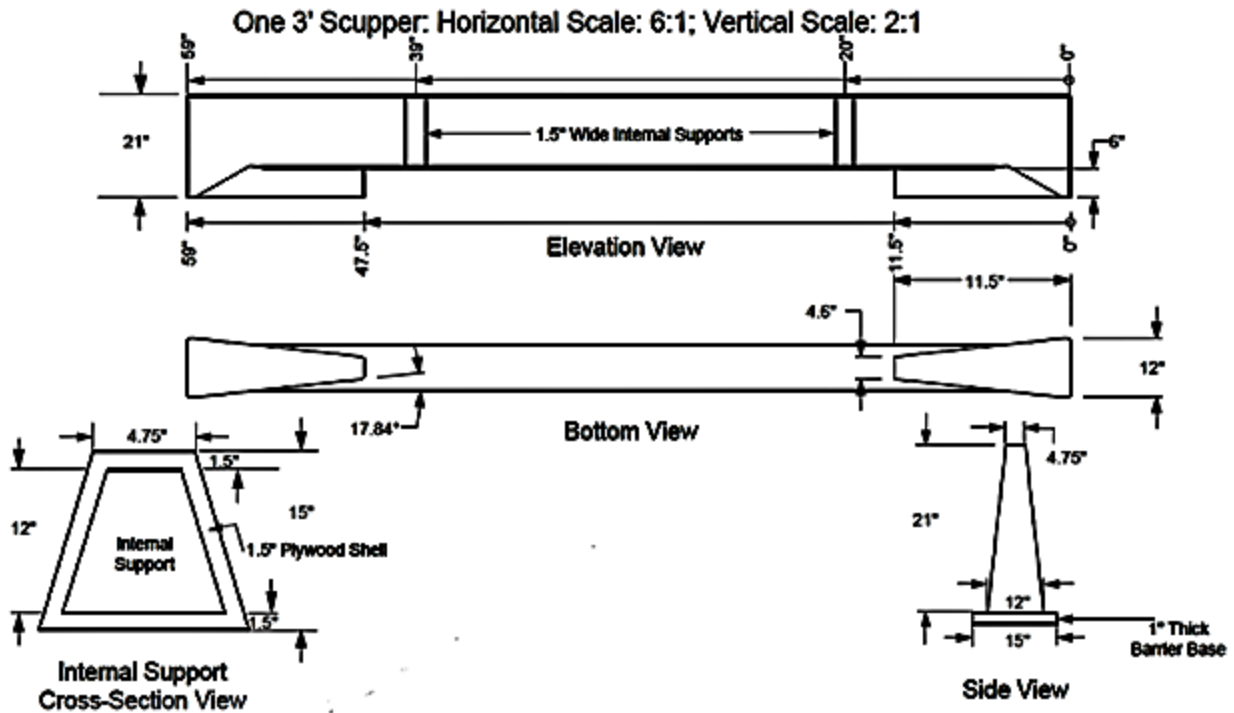
Figure 4.5. SSCB Model Barrier Dimensions (not to scale).

The dimensions of the SSCB model barrier are shown in Figure 4.5. The barrier was 59 inches long and 21 inches tall, and it was 12 inches wide at the base. It then sloped to a width of 4.75 inches at its crest. The scupper was 3 ft wide and 6 inches tall, and the barrier sat in the middle of the support base. The barrier supports at the barrier edge were 1 ft wide and tapered to a width of 4.6 inches at the scupper edge. To ensure the structural integrity of the barrier, 1.5-inch-wide internal supports were placed 20 inches from the barrier edges, and these further reinforced the plywood sheet faces of the barrier. In addition, the barrier was anchored to a 1-inch-thick sheet of plywood that was the base of the barrier. This barrier base fit in place in the support base, with eight screws being drilled through this plywood and into the support base. While the purpose of this study was to investigate portable median barriers, the model barrier was anchored to the base to prevent damage to the barrier and channel in the event of overturning or sliding, with predictions of barrier failure determined from analysis of data collected via barrier instrumentation and flow parameters.

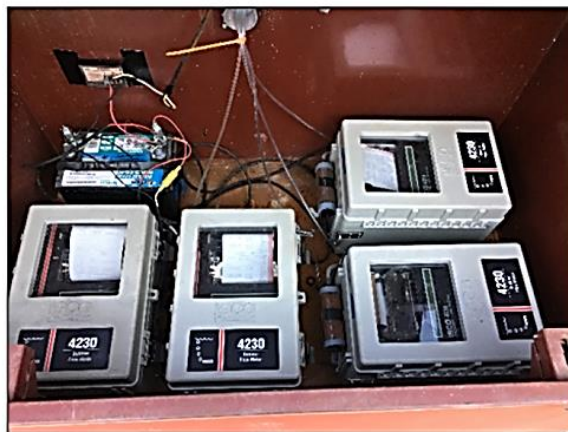
Figure 4.6. Bubble Flow Meters and Solar Panel Housing Unit (15).

Each flow meter was set to measure at a frequency of 1 Hz, while the reporting frequency was 0.2 Hz. Under these settings, the flow meters reported the mean value from five measurements every 5 seconds. The tubes were fed through the housing unit and into the channel. They ran down the channel walls and across the channel bed, perpendicular to the direction of the flow, which therefore negated interference from the fluid velocity at the tube outlet. Silicone caulk was applied to the tubing to keep it completely attached to the channel bed. Figure 4.6 shows the flow meters and housing unit.

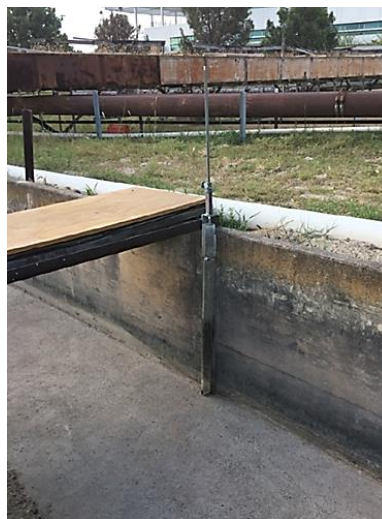
**Figure 4.9. Point Gage (15).**

A point gage was located 16 ft upstream of the discharge weir, and it measured the water depth in the return channel to one thousandth of a foot. At this location, it was assumed that there were no negligible drawdown effects from the weir; however, there were slight variations in the water depth at any given moment due to turbulent effects from a 90-degree bend in the channel 27 ft upstream. To suppress these small waves, the point gage resided in a 2-inch-diameter plastic stilling well. This setup is shown in Figure 4.9. The datum was set at the weir crest so that the water depth over the weir could be measured. To measure this datum, the return channel was filled completely with water, at which point the pumps were shut off and water was allowed to drain to the weir height. Due to the small slope of the weir, the datum was set at the center of the weir span. The measurement process was repeated multiple times to increase accuracy, and the gage reading for the weir crest was determined to be 0.958 ft.

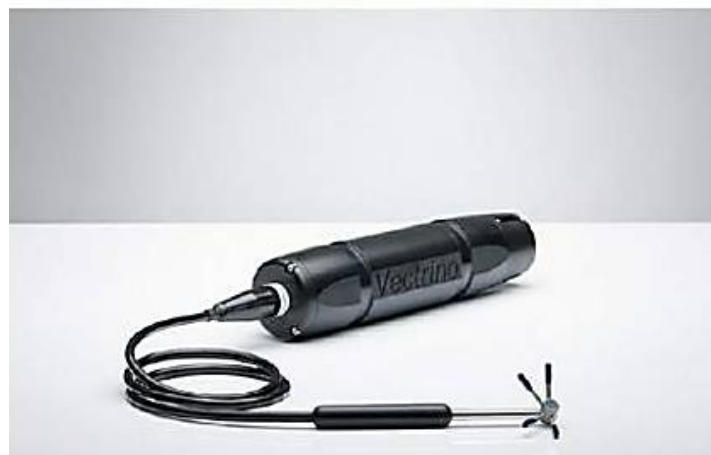
Figure 4.10. Nortek Vectrino (ADV) (31).

To collect point velocity data, a Nortek Vectrino ADV was installed to collect measurements at several locations, including upstream of the model barrier and inside the scupper opening (see Figure 4.10). It was attached to a 2-inch x 4-inch wood plank fastened to a platform that spanned the width of the channel. This allowed both the height above the channel bed and the lateral position of the ADV within the channel to be precisely controlled. The ADV was attached to a power source and a laptop with the Vectrino software and “plus” firmware by using a RS232-USB converter so that data could be simultaneously collected, recorded, and stored. The software allowed the sampling frequency, the velocity range, and a number of other data collection parameters to be controlled. The data from the ADV were then exported in a .dat file and loaded into a MATLAB script developed in-house that performed the necessary data filtering and analysis.

The ADV captured data in a sampling volume located 5 cm below the probe (31). The plus firmware allowed for a sampling rate of 1–200 Hz, and 200 Hz was chosen as the sampling rate for all data collection. To provide optimal data quality, the nominal velocity range was changed depending on the location of the ADV in the channel. Near the barrier base and inside the scupper opening, the nominal velocity range was 2.50 m/s. Near the channel wall, the nominal velocity range was 1.00 m/s. All other locations were sampled at a nominal velocity range of 4.00 m/s. These ranges ensured the highest possible correlation between data points and signal-to-noise ratio. Two ADVs were employed throughout testing. The ADV upstream of the barrier consisted of a waterproof electronics housing unit connected to a metal rod that had the metal probe on its other end. On the other hand, the ADV that was placed inside the scupper used a cord to attach the housing unit to the probe. This allowed the scupper ADV to be easily positioned without interfering with flow through the scupper. The ADV had an accuracy of  $\pm 1$  percent of the measured value. This instrument worked via scattering of acoustic waves on seeding matter suspended in the water; because the water in this channel was stored in an outdoor reservoir, the natural seeding from organic matter was enough to ensure sufficient data quality.

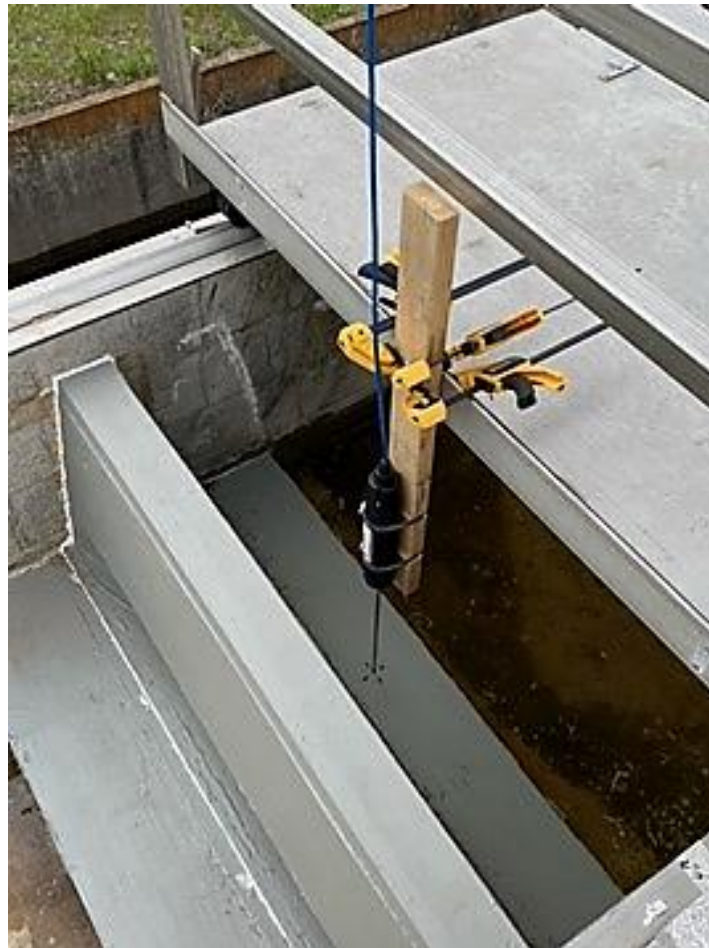
**Figure 4.11. ADV Setup to Record Point Velocities Upstream of the Median Barrier.**

The ADV was used to measure point velocities in the  $x$  (downstream or  $u$ ),  $y$  (cross-stream or  $v$ ), and  $z$  (vertical or  $w$ ) directions in the channel, although the downstream direction was of utmost importance in quantifying how quickly the water approached the barrier. By collecting flow velocities at different lateral positions and depths through the channel, velocity profiles could be created to explain how water moved through the channel and, in particular, through the scupper opening. Figure 4.11 shows the ADV mounted above the channel to record upstream point velocities, and Figure 4.12 shows the ADV mounted inside the scupper opening.

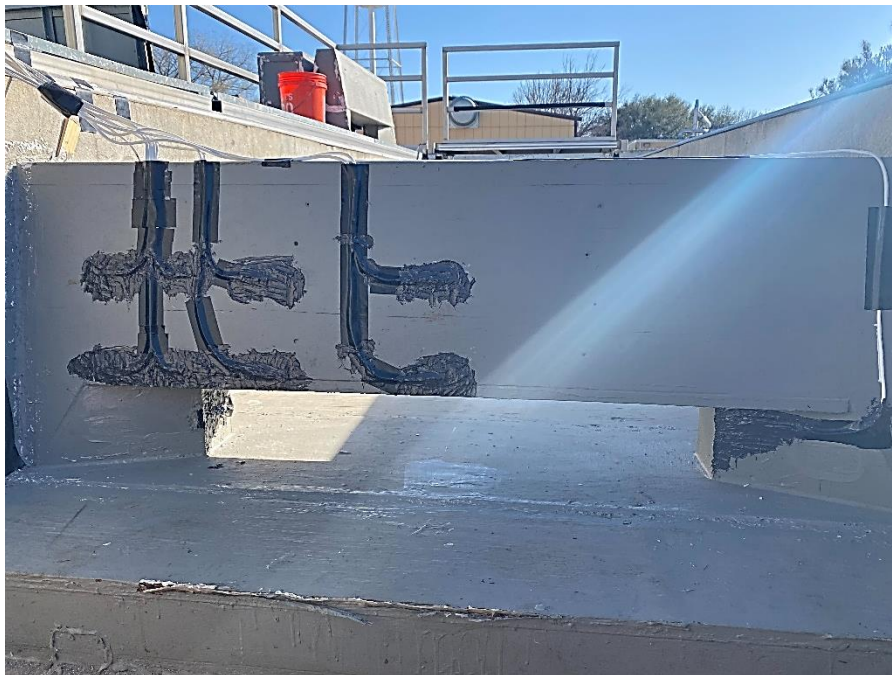
**Figure 4.14. Strain Gage Setup after Environmental Coating.**

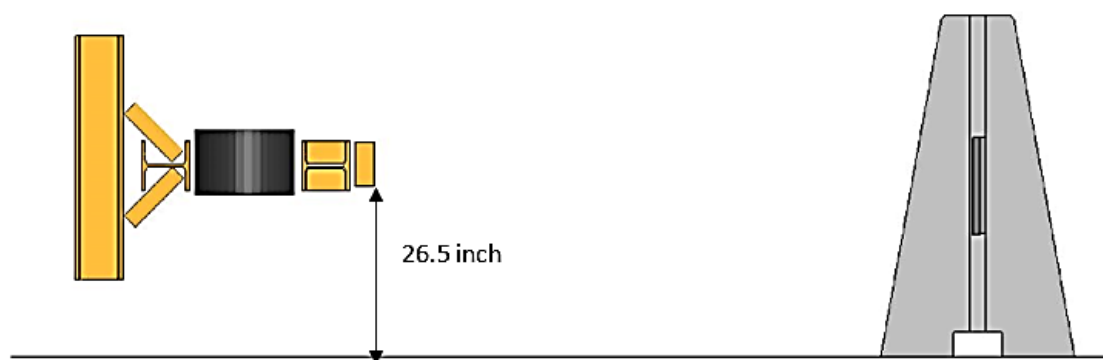
**Figure 5.1. Bogie Model Positioned to Impact Center of Four-Segment Barrier Model.**

Results from TxDOT Project 0-7059 were used for the validation of the single-slope concrete barrier segments with J-J Hooks connections (33). In that project, a bogie vehicle weighing 5000 lb impacted the center joint of a four-segment barrier assembly at a nominal speed of 18 mi/h and an impact angle of 90 degrees. The height of the bottom edge of the bogie nose was 26.5 inches above the ground. A model of the bogie vehicle nose assembly was developed for use in calibrating the barrier model. The model captured the strength and stiffness of the actual bogie vehicle nose, and mass was assigned to represent the missing mass of the bogie vehicle. Figure 5.1 shows the initial setup of the bogie model and barrier assembly.

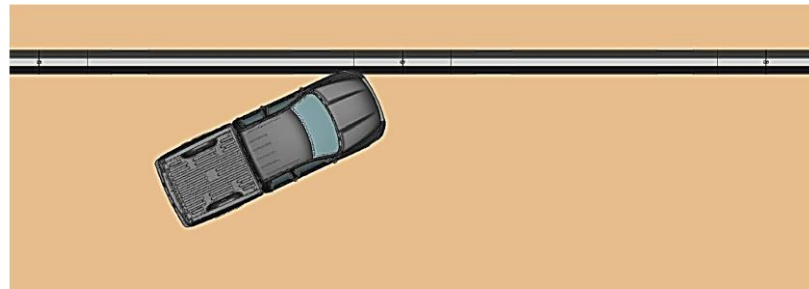
Figure 5.3 and Figure 5.4 provide sequential images of the impact simulation at selected times from an overhead and end view, respectively. Lateral displacement of the impacted barrier was 28 inches. TRAP was used to calculate OIV, RA, and maximum roll, pitch, and yaw angles. Table 5.1 summarizes the results from the simulation.

a.  $t = 0.090$  s, event = pickup truck strikes the barrier

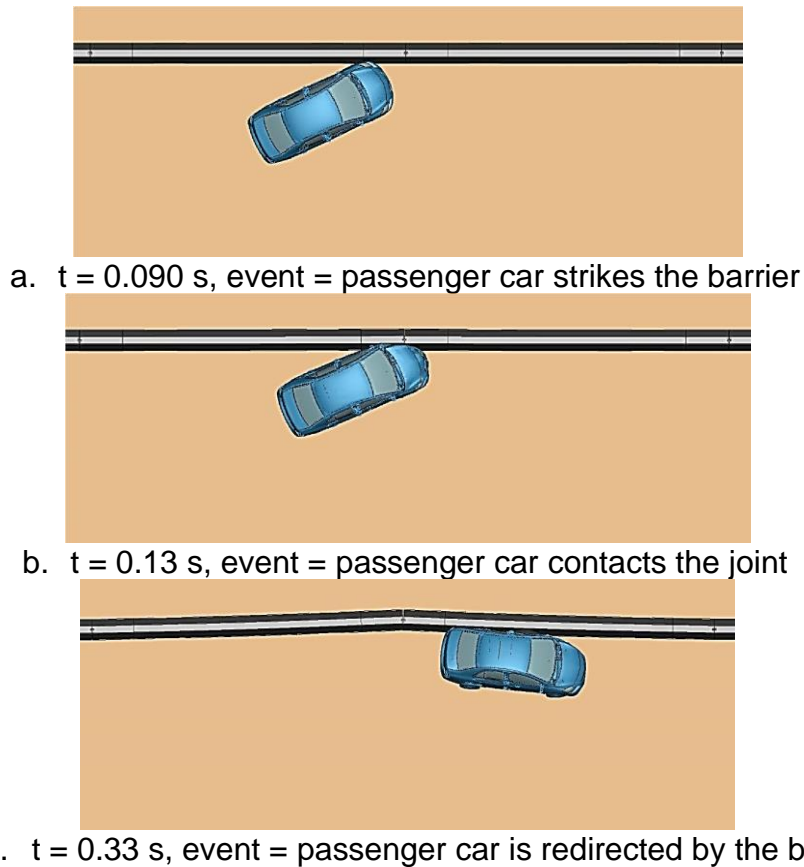
**Figure 5.5. Overhead Images of *MASH* Test 3-10 Simulation with Single-Slope Barrier.**

Figure 5.5 and Figure 5.6 provide sequential images of the impact simulation at selected times from an overhead and end view, respectively. Lateral displacement of the impacted barrier was 28 inches. TRAP was used to calculate OIV, RA, and maximum roll, pitch, and yaw angles. Table 5.2 summarizes the results from the simulation.

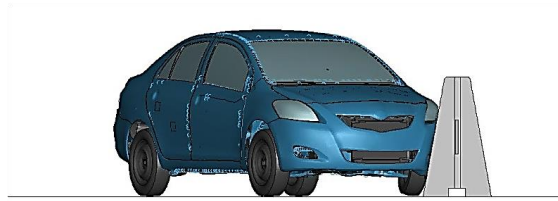
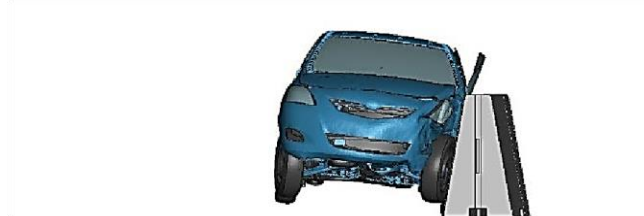
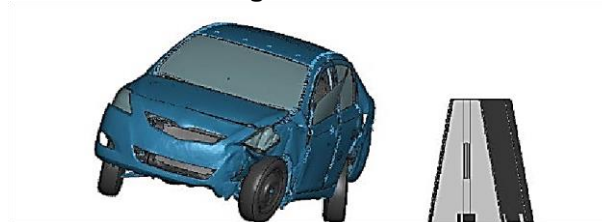
a.  $t = 0.10$  s, event = front right tire contacts the barrier

b.  $t = 0.23$  s, event = rear right tire contacts the barrier, windowpane snags against the barrier

c.  $t = 0.91$  s, event = rear right tire stabilizes on ground

**Figure 5.6. End-View Images of *MASH* Test 3-10 Simulation with Single-Slope Barrier.**

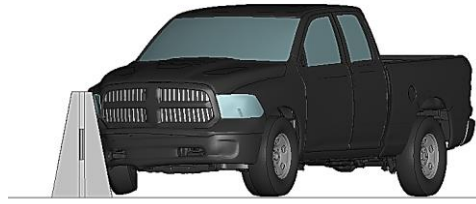
a.  $t = 0.18$  s, event = pickup truck impacts barrier

Figure 5.7 and Figure 5.8 provide sequential images of the impact simulation at selected times from an overhead and end view, respectively. Lateral displacement of the impacted barrier was 12 inches. TRAP was used to calculate OIV, RA, and maximum roll, pitch, and yaw angles. Table 5.3 summarizes the results from the simulation. The simulated impact of the pickup truck at the center of the barrier segment satisfied *MASH* criteria.
