Test Report No. 440873-01

**DEVELOPMENT OF A *MASH* TL-4 PORTABLE CONCRETE BARRIER  
WITH LARGE SCUPPER**

Sponsored by the  
**Texas Department of Transportation (TxDOT)**

**TEXAS A&M TRANSPORTATION INSTITUTE PROVING GROUND**

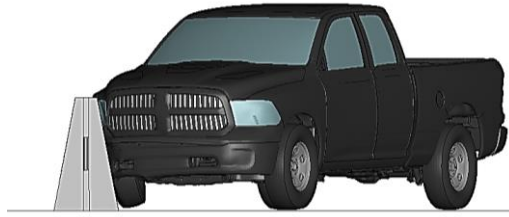
a.  $t = 0.18$  s, event = pickup truck impacts barrier

Figure 5.9 and Figure 5.10 provide sequential images of the impact simulation at selected times from an overhead and end view, respectively. Lateral displacement of the impacted barrier was 20.2 inches. TRAP was used to calculate OIV, RA, and maximum roll, pitch, and yaw angles.

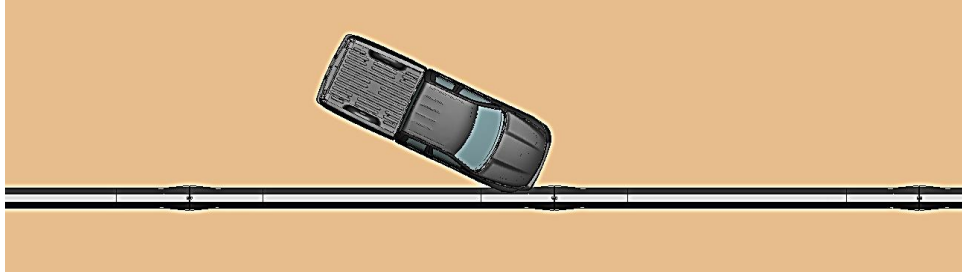
a.  $t = 0.17$  s, event = pickup truck impacts barrier

**Figure 5.11. Overhead Images of *MASH* Test 3-11 Simulation of Single-Slope Barrier with Scupper—Impact Location C.**

Figure 5.11 and Figure 5.12 provide sequential images of the impact simulation at selected times from an overhead and end view, respectively. Lateral displacement of the impacted barrier was 27.8 inches. TRAP was used to calculate OIV, RA, and maximum roll, pitch, and yaw angles. Table 5.5 summarizes the results from the simulation. The simulated impact of the pickup truck at the barrier segment connection satisfied *MASH* criteria.

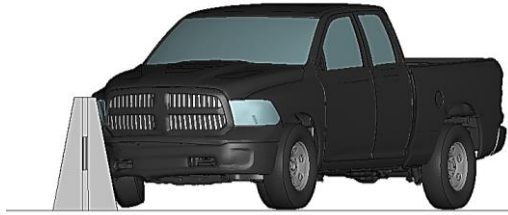
a.  $t = 0.18$  s, event = pickup truck impacts barrier

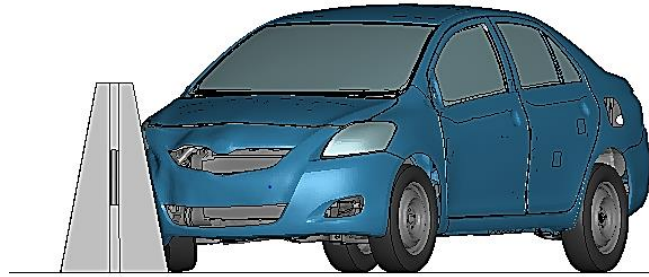
a.  $t = 0.19$  s, event = passenger car impacts barrier

Impact location A was 3.6 ft upstream from the center of the barrier. Figure 5.13 and Figure 5.14 provide sequential images of the impact simulation at selected times from an overhead and end view, respectively. Lateral displacement of the impacted barrier was 4.8 inches. TRAP was used to calculate OIV, RA, and maximum roll, pitch, and yaw angles. Table 5.6 summarizes the results from the simulation. The simulated impact of the passenger car at the center of the barrier segment satisfied *MASH* criteria.

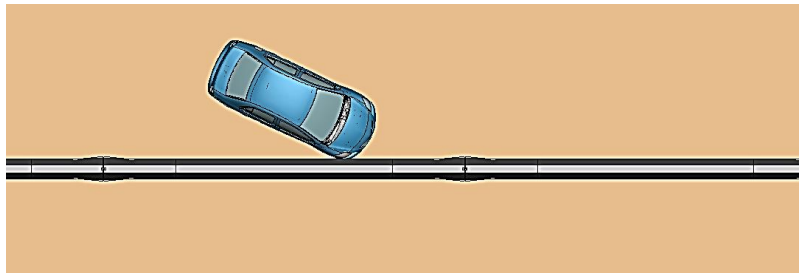
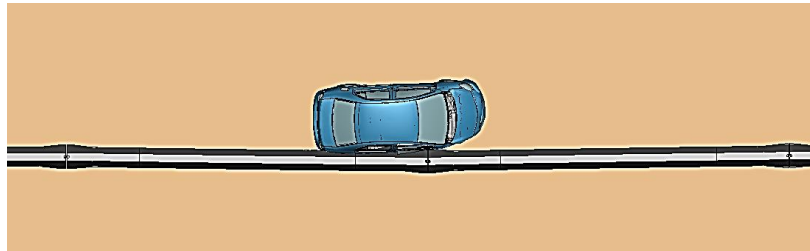
a.  $t = 0.17$  s, event = passenger car impacts barrier

b.  $t = 0.33$  s, event = passenger car parallel is with barrier

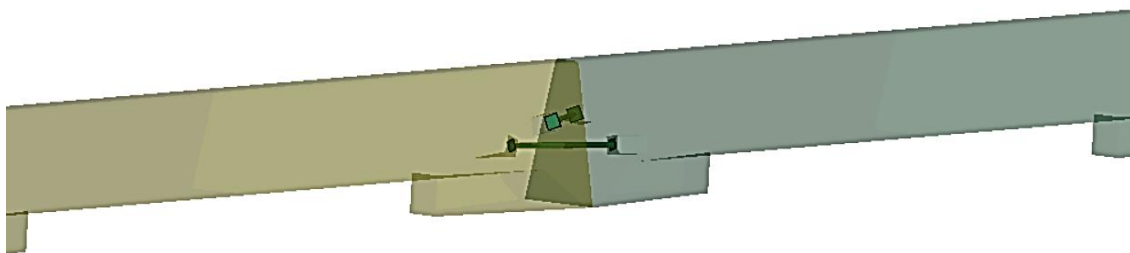
**Figure 5.19. Single-Slope PCB Model with X-bolt Connection.**

As with the system with J-J Hooks connections, various reference points along the length of the single-slope PCB segment were investigated for the barrier with X-bolt connections. These included the center of the long beam spanning the drainage opening, the connection between segments, and the end of the drainage opening or scupper. The impact location was 4.3 ft upstream of each reference location for the pickup truck and 3.6 ft upstream of each reference location for the passenger car. These distances were determined using Table 2-7 in *MASH*. Details of these simulations are presented next.

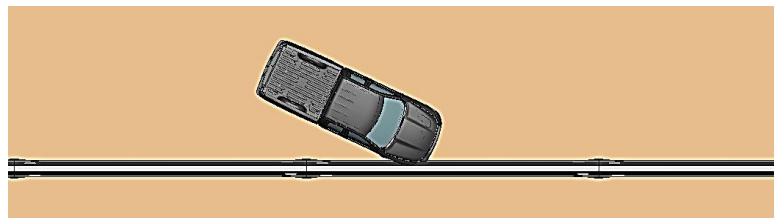
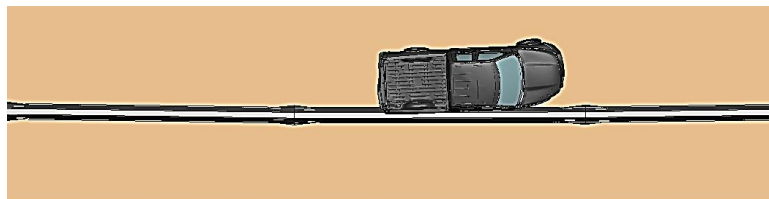
**Figure 5.20. Overhead Images of *MASH* Test 3-11 Simulation of Single-Slope Barrier with Scupper and X-bolt Connections—Impact Location A.**

a.  $t = 0.17$  s, event = pickup truck strikes the barrier

b.  $t = 0.34$  s, event = pickup truck rear contacts the barrier

Figure 5.20 and Figure 5.21 provide sequential images of the impact simulation at selected times from an overhead and end view, respectively. Lateral displacement of the impacted barrier was 8.7 inches. TRAP was used to calculate OIV, RA, and maximum roll, pitch, and yaw angles. Table 5.9 summarizes the results from the simulation. The simulated impact of the pickup truck at the center of the barrier segment satisfied *MASH* criteria.

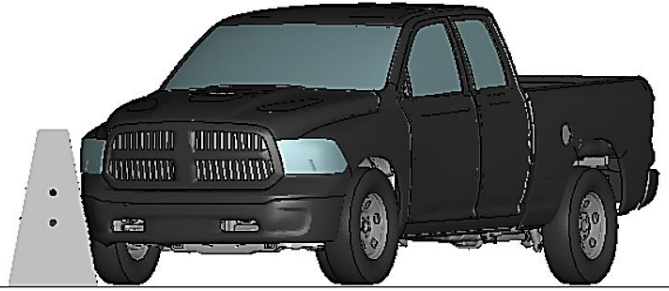
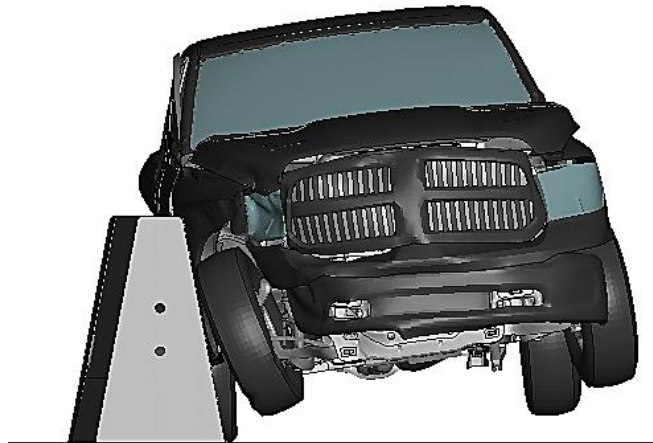
a.  $t = 0.17$  s, event = front right tire contacts the barrier

b.  $t = 0.35$  s, event = rear right tire contacts the barrier

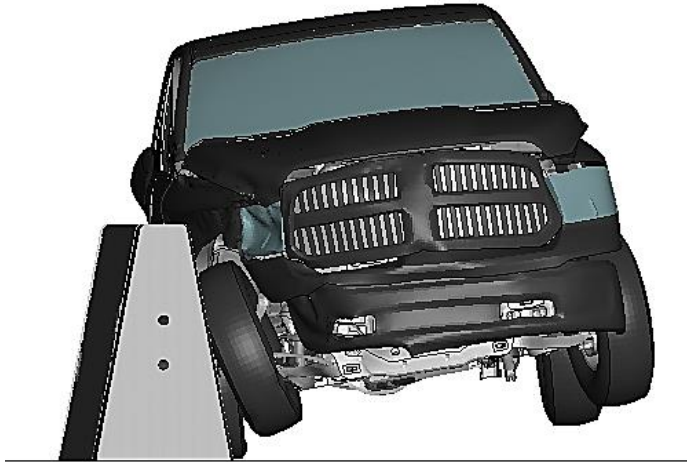
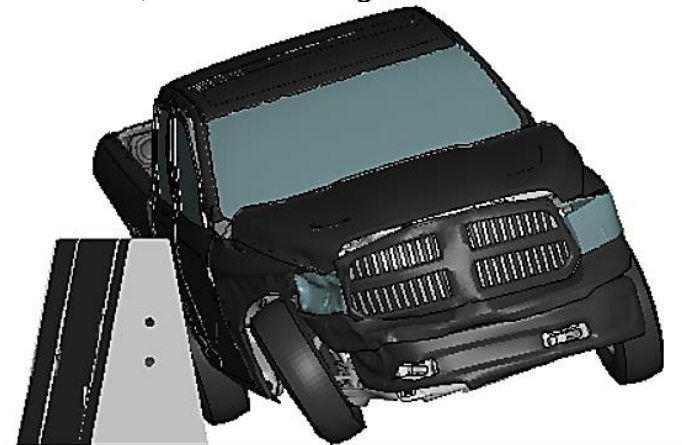
**Figure 5.23. End-View Images of *MASH* Test 3-11 Simulation of Single-Slope Barrier with Scupper and X-bolt Connections—Impact Location B.**

b.  $t = 0.35$  s, event = rear right tire contacts the barrier

c.  $t = 0.57$  s, event = front right tire touches the ground

Figure 5.22 and Figure 5.23 provide sequential images of the impact simulation at selected times from an overhead and end view, respectively. Lateral displacement of

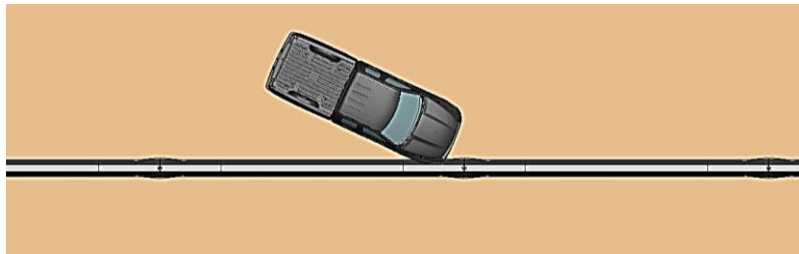
**Figure 5.24. Overhead Images of MASH Test 3-11 Simulation of Single-Slope Barrier with Scupper and X-bolt Connections—Impact Location C.**

a.  $t = 0.17$  s, event = pickup truck strikes the barrier

Figure 5.24 and Figure 5.25 provide sequential images of the impact simulation at selected times from an overhead and end view, respectively. Lateral displacement of the impacted barrier was 12.1 inches. TRAP was used to calculate OIV, RA, and maximum roll, pitch, and yaw angles. Table 5.11 summarizes the results from the simulation. The simulated impact of the pickup truck at the barrier segment connection satisfied *MASH* criteria.

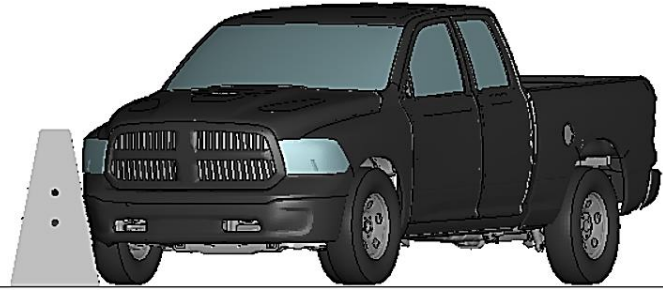
**Figure 5.25. End-View Images of *MASH* Test 3-11 Simulation of Single-Slope Barrier with Scupper and X-bolt Connections—Impact Location C.**

a.  $t = 0.17$  s, event = front right tire contacts the barrier

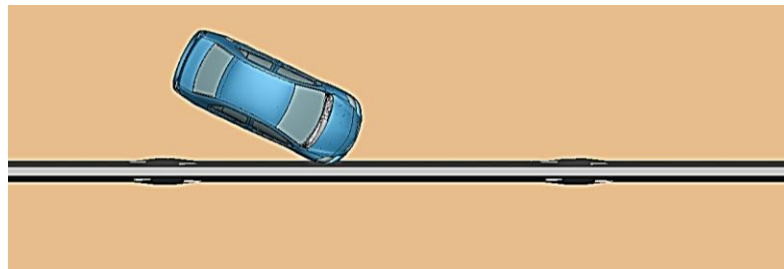
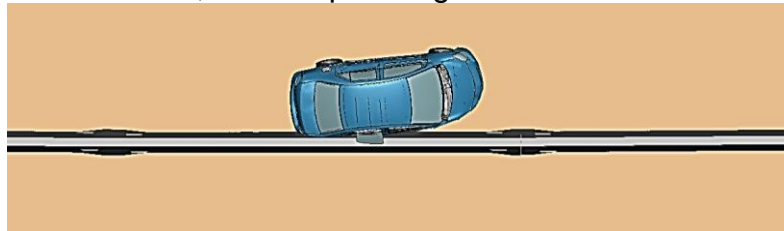
**Figure 5.26. Overhead Images of *MASH* Test 3-10 Simulation of Single-Slope Barrier with Scupper and X-bolt Connections—Impact Location A.**

a.  $t = 0.17$  s, event = passenger car strikes the barrier

b.  $t = 0.33$  s, event = passenger car completely engages the barrier

Impact location A was 3.6 ft upstream from the center of the barrier. Figure 5.26 and Figure 5.27 provide sequential images of the impact simulation at selected times from an overhead and end view, respectively. Lateral displacement of the impacted barrier was 3.6 inches. TRAP was used to calculate OIV, RA, and maximum roll, pitch, and yaw angles. Table 5.12 summarizes the results from the simulation. The simulated impact of the passenger car at the center of the barrier segment satisfied *MASH* criteria.

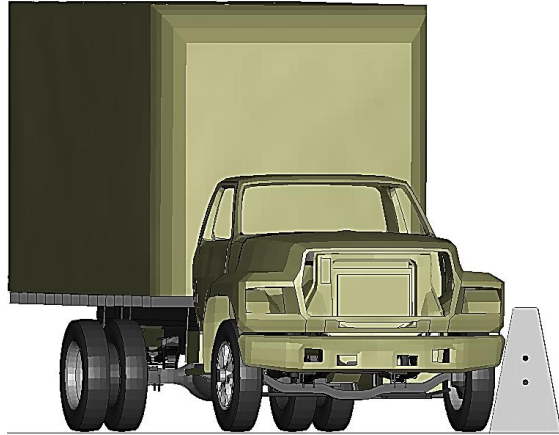
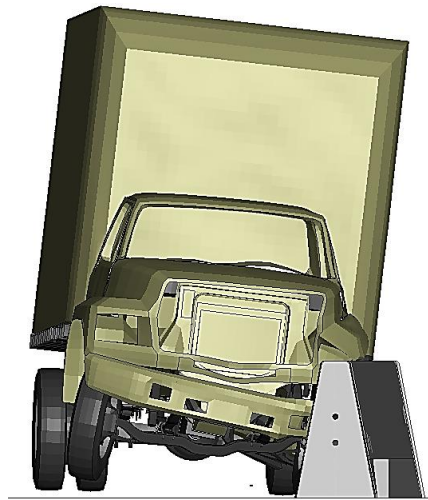
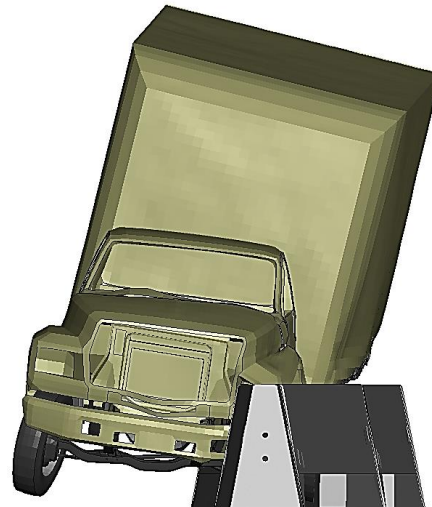
**Figure 5.34. End-View Images of *MASH* Test 4-12 Simulation of Single-Slope Barrier with Scupper and X-bolt Connections.**

a.  $t = 0.27$  s, event = SUT strikes the barrier

b.  $t = 0.53$  s, event = SUT completely engages with the system

c.  $t = 0.94$  s, event = front SUT tire stabilizes on the ground

Figure 5.33 and Figure 5.34 provide sequential images of the impact simulation at selected times from an overhead and end view, respectively. Lateral displacement of the impacted barrier was 43 inches. Note that occupant risk indices are not included in the evaluation criteria for Test 4-12. However, TRAP was used to calculate OIV, RA, and maximum roll, pitch, and yaw angles for information purposes. Table 5.20 summarizes the results from the simulation. The simulated impact of the SUT at the center of the barrier segment satisfied *MASH* criteria. Based on these results, a decision was made to proceed with *MASH* Test 4-12.

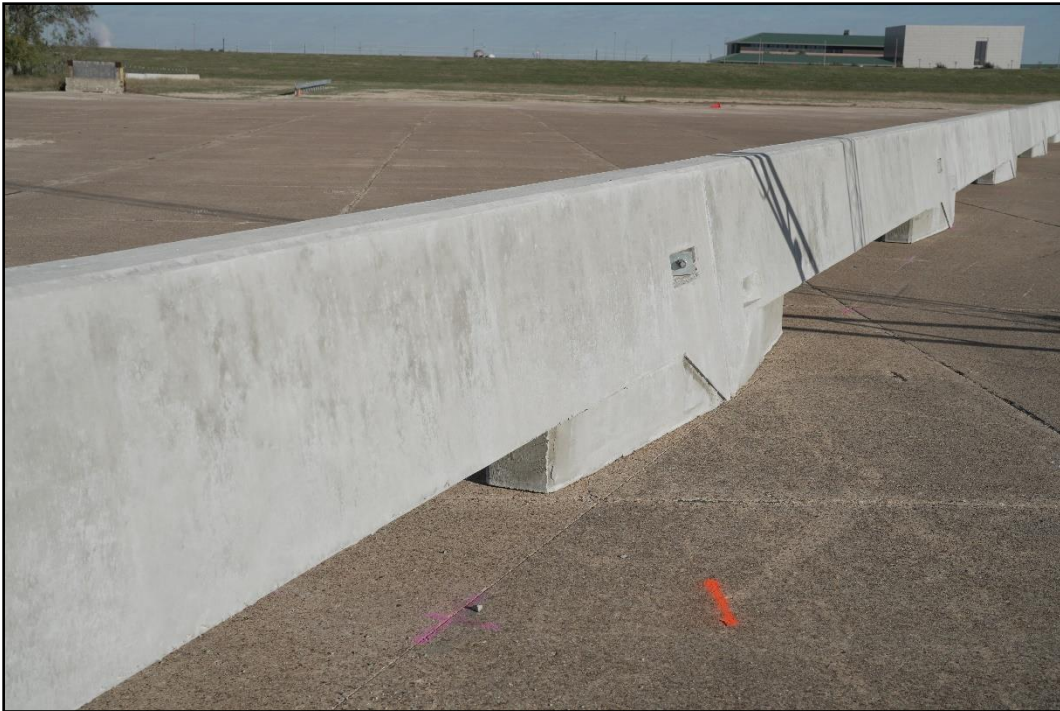
**Figure 6.2. Large-Scupper Portable Concrete Barrier prior to Testing.**

Figure 6.1 presents the overall information on the large-scupper portable concrete barrier, and Figure 6.2 through Figure 6.7 provide photographs of the installation. Appendix A provides further details on the large-scupper portable concrete barrier. Drawings were provided by the TTI Proving Ground, and the assembly of the test article was performed by TTI Proving Ground personnel.

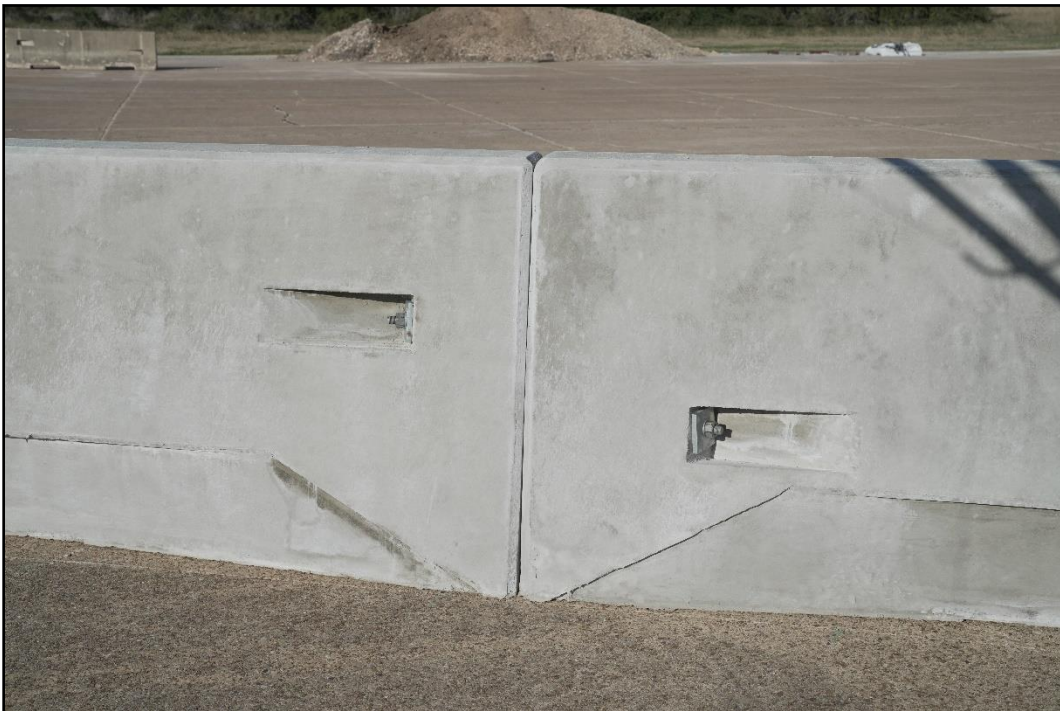
**Figure 6.3. Large-Scupper Portable Concrete Barrier at the Joint of Barriers 3 and 4 prior to Testing.**

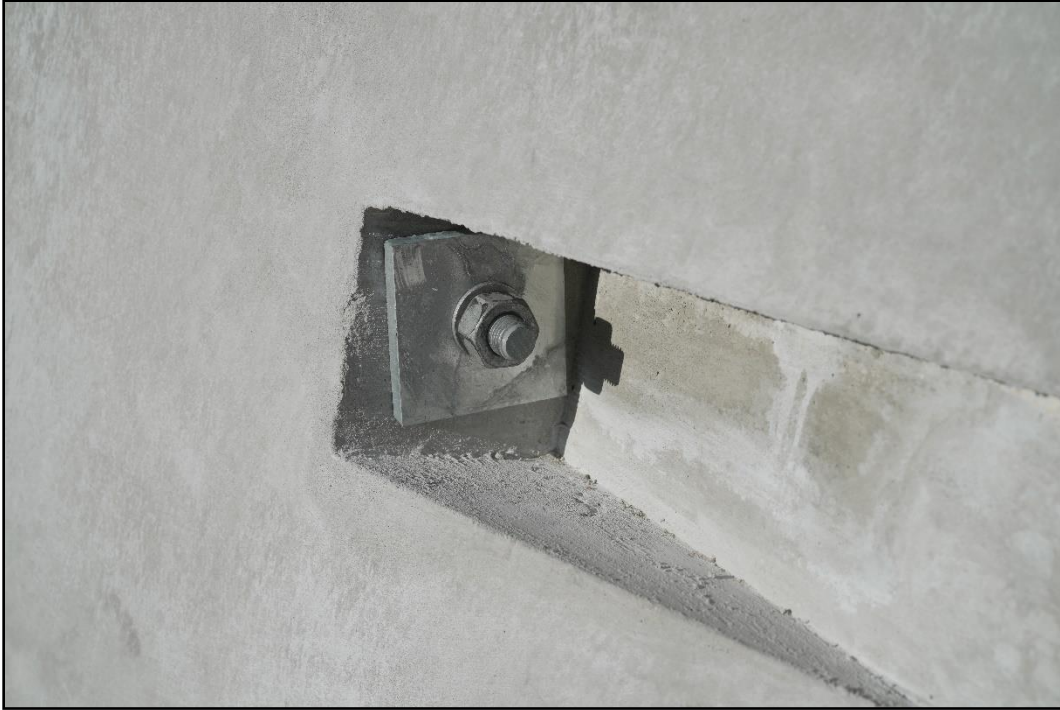
**Figure 6.4. X-bolt Connection on the Large-Scupper Portable Concrete Barrier prior to Testing.**

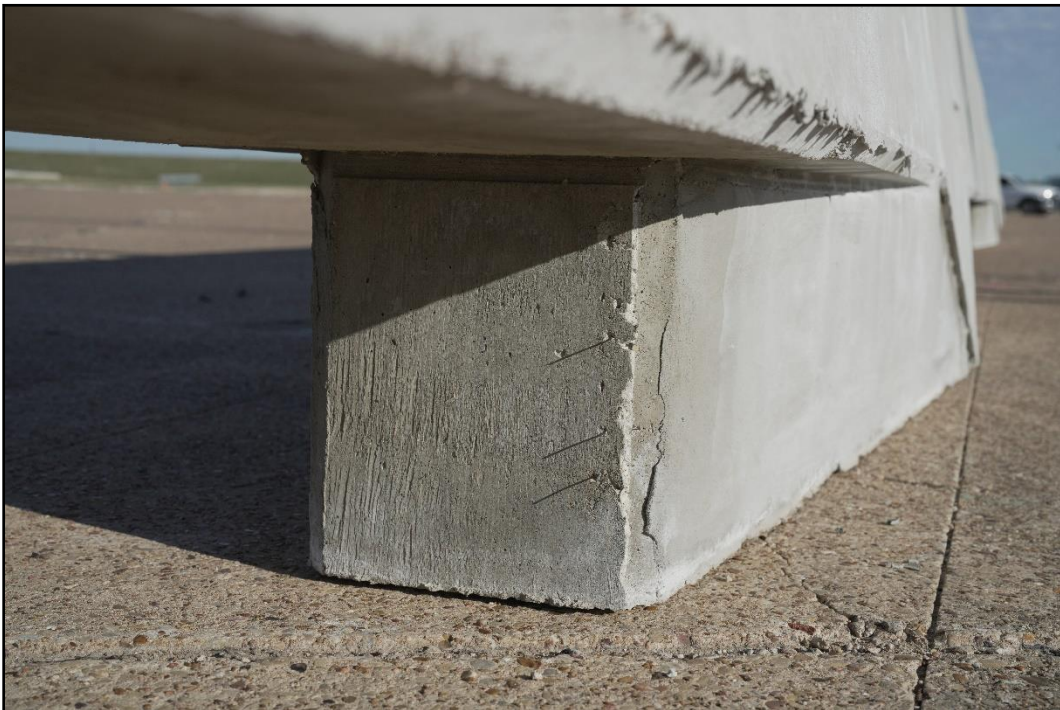
**Figure 6.5. Close-Up of the End of the Scupper on the Large-Scupper Portable Concrete Barrier prior to Testing.**

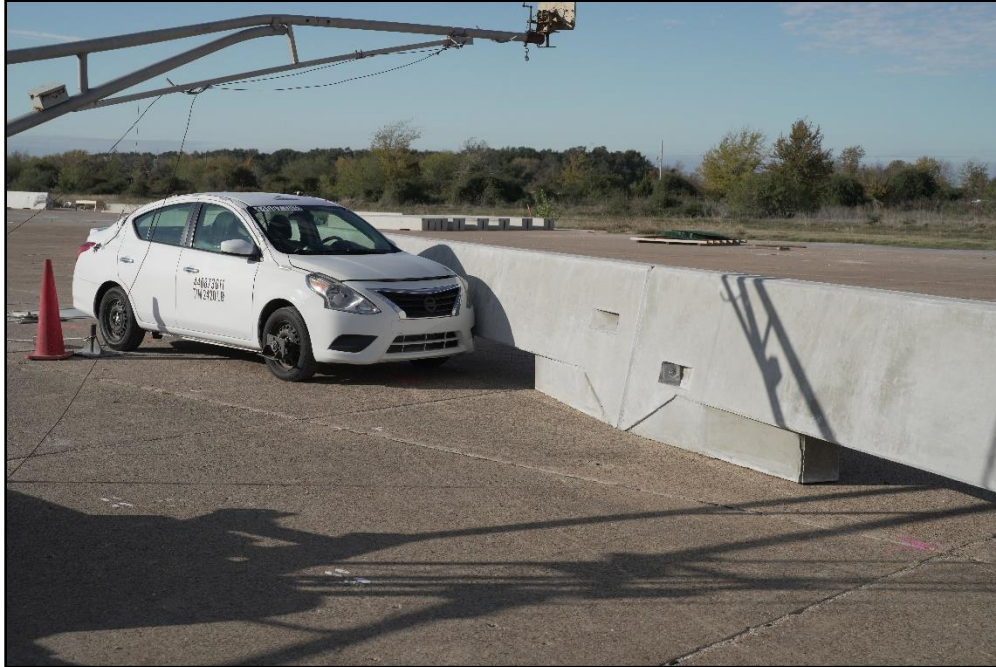
**Figure 9.1. Large-Scupper Portable Concrete Barrier/Test Vehicle Geometrics for Test 440873-01-1.**

See Table 9.1 for details on the impact conditions and Table 9.2 for the exit parameters for Test 440873-01-1. Figure 9.1 and Figure 9.2 depict the target impact setup.

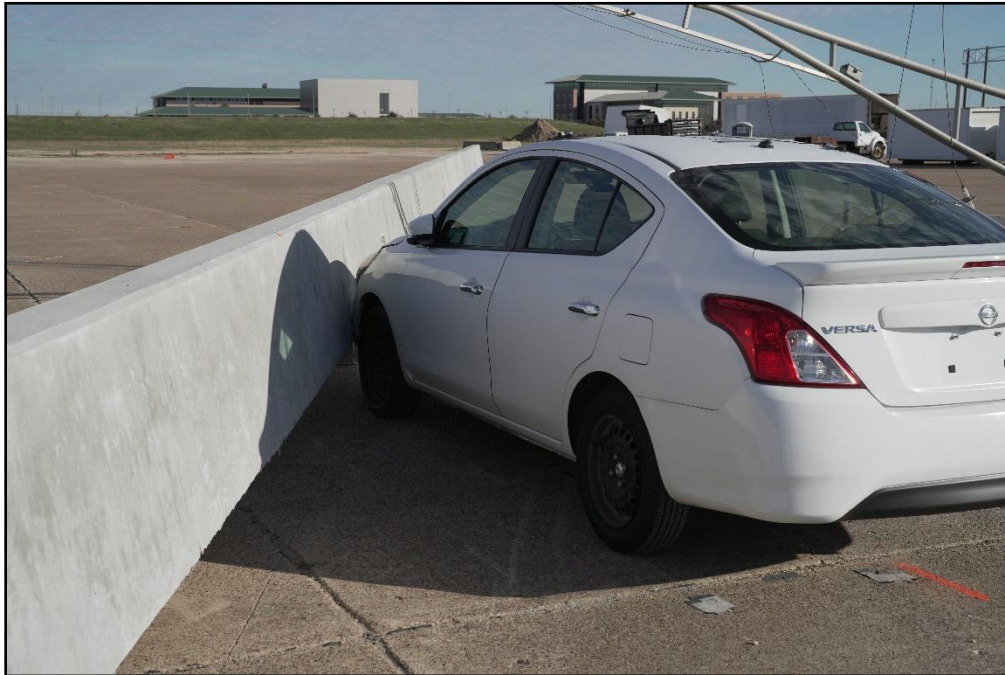
**Figure 9.2. Large-Scupper Portable Concrete Barrier/Test Vehicle Impact Location for Test 440873-01-1.**

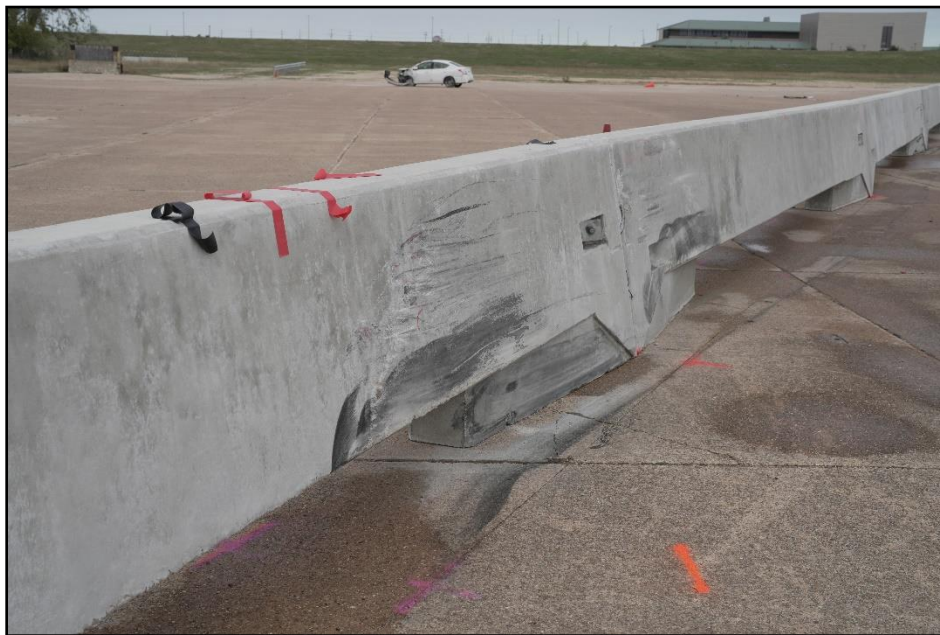
**Figure 9.5. Large-Scupper Portable Concrete Barrier after Test at Impact Location for Test 440873-01-1.**

There was some scuffing and gouging at impact and spalling on the traffic side of barrier 4 at the joint between barriers 3 and 4. Additional scuffing resulted from the second and third impacts on the barrier. Table 9.6 describes the barrier movement at the joints of the large-scupper portable concrete barrier. Table 9.7 describes the damage to the large-scupper portable concrete barrier. Figure 9.5 and Figure 9.6 show the damage to the large-scupper portable concrete barrier.

<b>Test Parameter</b>	<b>Measured</b>
Permanent Deflection/Location	9.5 inches toward field side at joint between segments 3 and 4
Dynamic Deflection	10.2 inches toward field side at top of barrier at joint between segments 3 and 4
Working Width <sup>a</sup> and Height	33.5 inches, at a height of 0 inches, at the field side toe at joint between segments 3 and 4

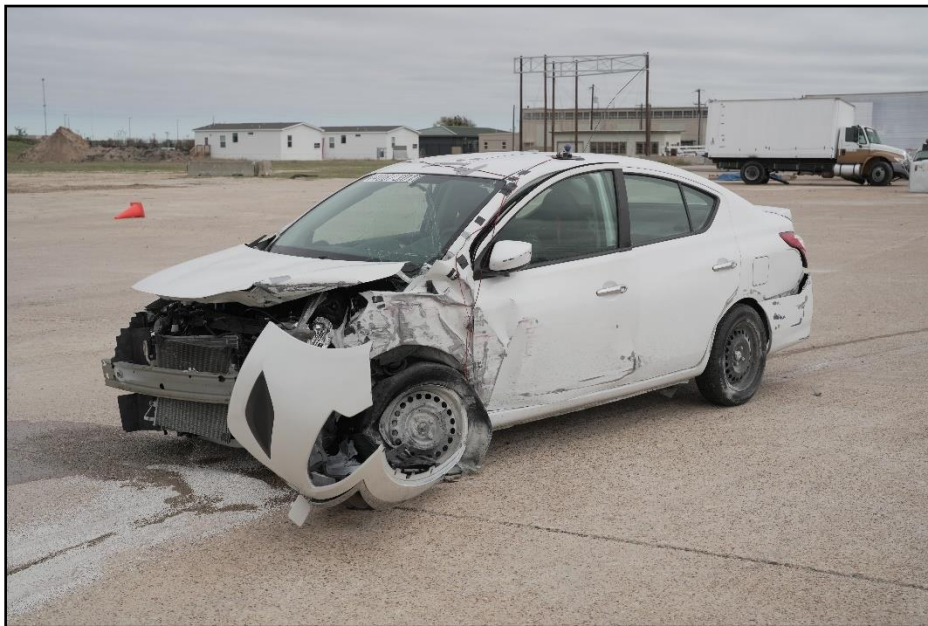
**Figure 9.7. Impact Side of Test Vehicle after Test 440873-01-1.**

Figure 9.7 and Figure 9.8 show the damage sustained by the vehicle. Figure 9.9 and Figure 9.10 show the interior of the test vehicle. Table 9.8 and Table 9.9 provide details on the occupant compartment deformation and exterior vehicle damage. Figures C.2 and C.3 in Appendix C.1 provide exterior crush and occupant compartment measurements.

<b>Side Windows</b>	Side windows remained intact
<b>Maximum Exterior Deformation</b>	10 inches in the front plane at the left front corner at bumper height
<b>VDS</b>	11LFQ4
<b>CDC</b>	11FLEW3
<b>Fuel Tank Damage</b>	None
<b>Description of Damage to Vehicle:</b>	The front bumper, hood, grill, right and left headlights, radiator and support, left front quarter fender, left front tire and rim, left front strut and tire, windshield, left front door, left front floor pan, left rear door, left rear quarter fender, left taillight, and rear bumper were damaged. The windshield had a 24-inch by 12-inch crack caused by the hood, but there was no hole or tearing in the lining. The left front door had a 5-inch gap at the top.

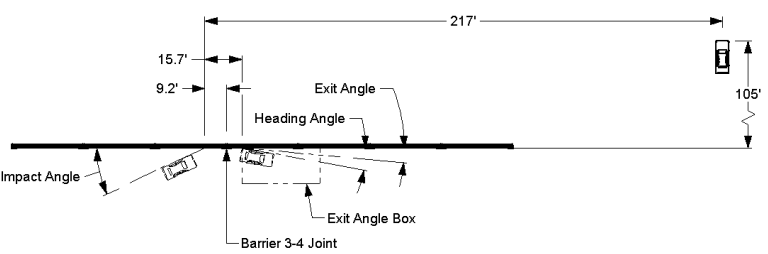
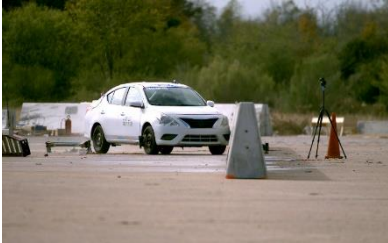
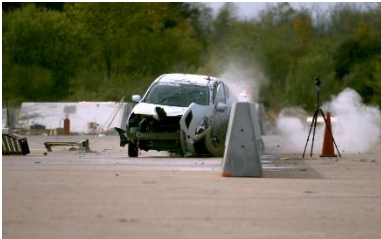
**Figure 9.11. Summary of Results for MASH Test 4-10 on Large-Scupper Portable Concrete Barrier.**

<p><b>0.000 s</b></p>	Test Agency		Texas A&M Transportation Institute (TTI)					
	Test Standard/Test		MASH 2016 Test 4-10					
	TTI Project No.		440873-01-1					
	Test Date		2022-12-01					
<b>TEST ARTICLE</b>								
		Type	Longitudinal Barrier					
		Name	Large-Scupper Portable Concrete Barrier					
		Length	210 ft					
		Key Materials	30 ft large-scupper barriers with X-bolt connections x 7					
		Soil Type and Condition	Concrete, damp

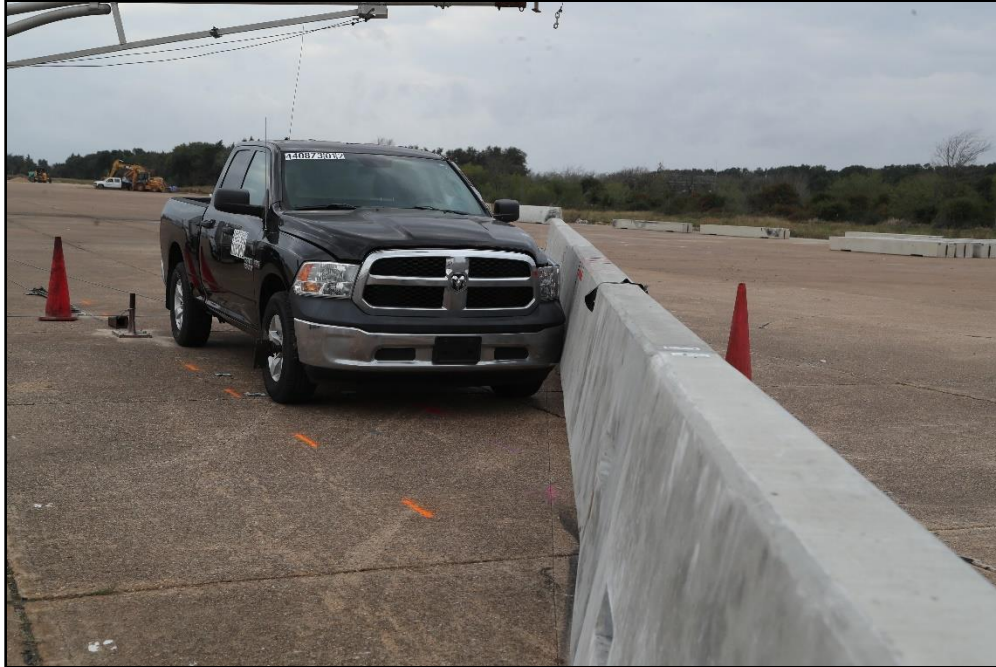
**Figure 10.1. Large-Scupper Portable Concrete Barrier/Test Vehicle Geometrics for Test 440873-01-2.**

See Table 10.1 for details on the impact conditions and Table 10.2 for the exit parameters for Test 440873-01-2. Figure 10.1 and Figure 10.2 depict the target impact setup.

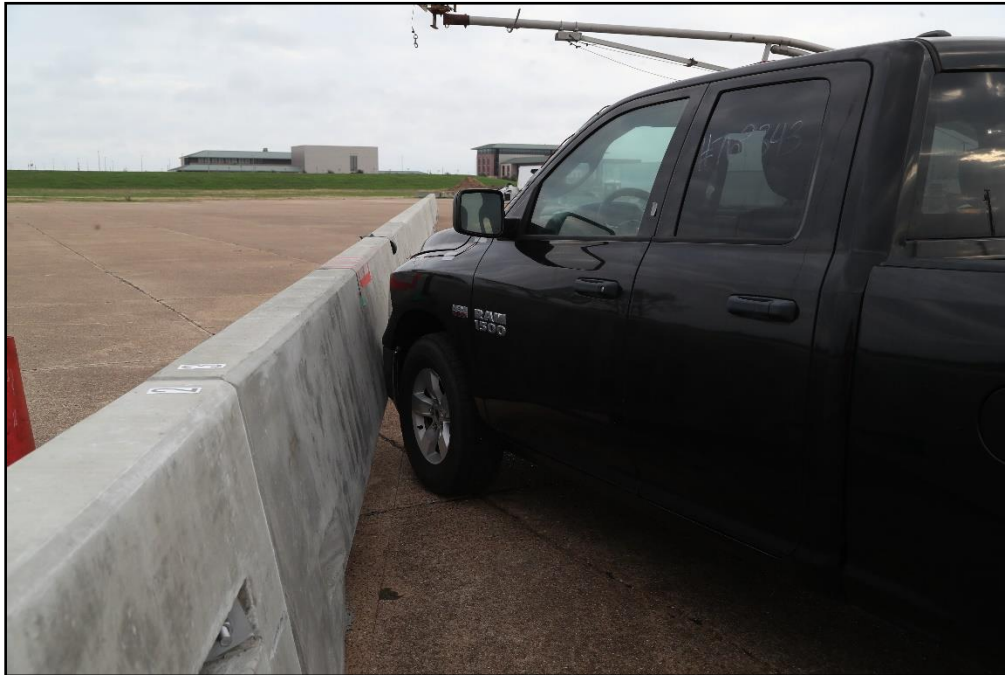
**Figure 10.2. Large-Scupper Portable Concrete Barrier/Test Vehicle Impact Location for Test 440873-01-2.**

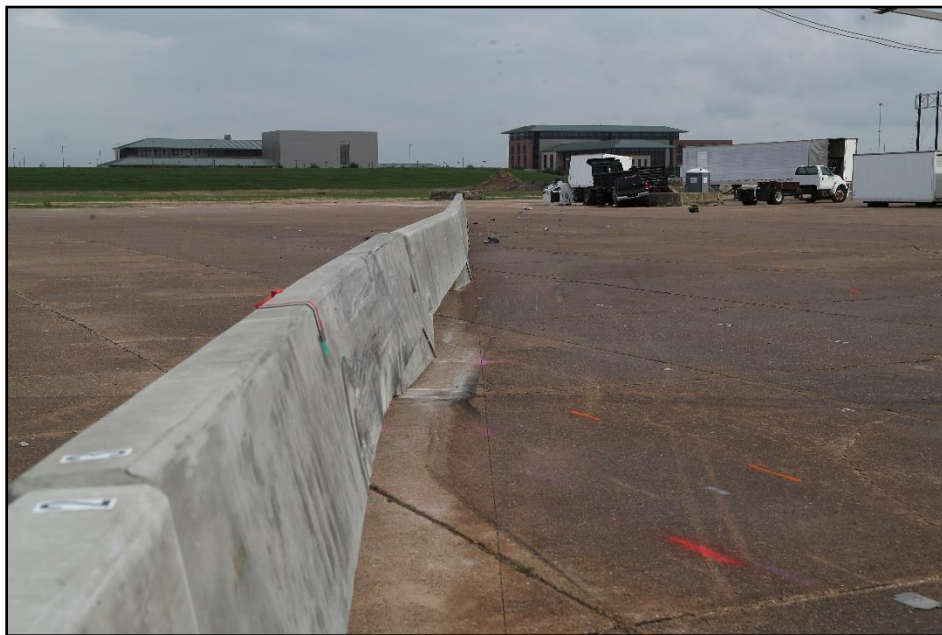
**Figure 10.5. Large-Scupper Portable Concrete Barrier after Test at Impact Location for Test 440873-01-2.**

Table 10.6 describes the barrier movement at the joints of the large-scupper portable concrete barrier. Table 10.7 describes the damage to the large-scupper portable concrete barrier. Figure 10.5 and Figure 10.6 show the damage to the large-scupper portable concrete barrier.

<b>Test Parameter</b>	<b>Measured</b>
Permanent Deflection/Location	15.5 inches toward field side at the joint between segments 3 and 4
Dynamic Deflection	22.2 inches toward field side at the top of segment 3 near midspan
Working Width <sup>a</sup> and Height	36.7 inches, at a height of 42 inches, on the field side at the top of segment 3 near midspan

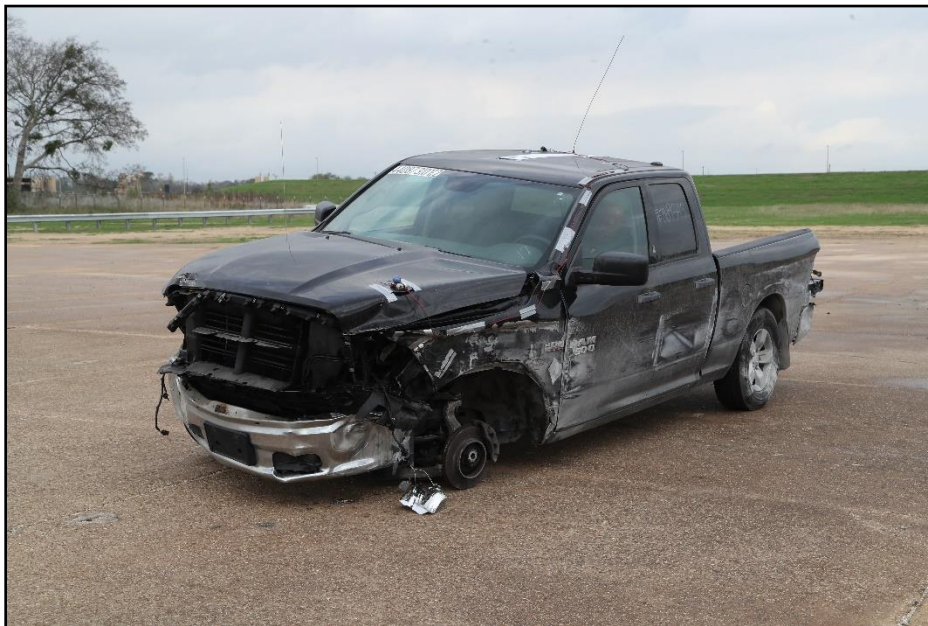
**Figure 10.7. Impact Side of Test Vehicle after Test 440873-01-2.**

Figure 10.7 and Figure 10.8 show the damage sustained by the vehicle. Figure 10.9 and Figure 10.10 show the interior of the test vehicle. Table 10.8 and Table 10.9 provide details on the occupant compartment deformation and exterior vehicle damage. Figures D.2 and D.3 in Appendix D.1 provide exterior crush and occupant compartment measurements.

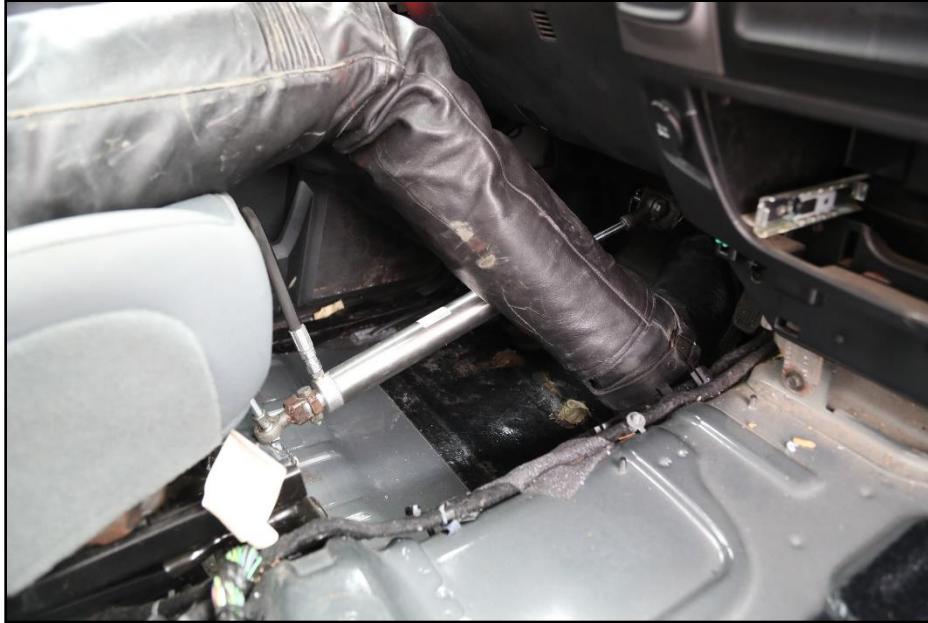
**Figure 10.10. Interior of Test Vehicle on Impact Side after Test 440873-01-2.**

**Table 10.9. Exterior Vehicle Damage for Test 440873-01-2.**

<b>Side Windows</b>	The side windows remained intact
<b>Maximum Exterior Deformation</b>	12 inches in the front plane at the left front corner at bumper height
<b>VDS</b>	11LFQ4
<b>CDC</b>	11FLEW3
<b>Fuel Tank Damage</b>	None
<b>Description of Damage to Vehicle:</b>	The front bumper, hood, grill, left headlight, radiator and support, left front quarter fender, left front lower control arm, left front door, left rear door, left cab corner, left rear quarter fender, left rear rim, left taillight, and rear bumper were damaged from the initial impact. The right side of the front bumper, right headlight, right edge of the hood, and windshield were damaged after the second impact with the installation. The windshield was cracked due to flexing of the body, but there was no deformation and no holes or tears in the laminate.

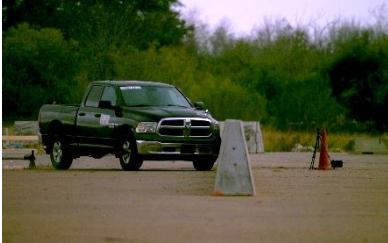
<p style="text-align: center;"><b>0.000 s</b></p>	Test Agency	Texas A&M Transportation Institute (TTI)					
	Test Standard/Test	MASH 2016, Test 4-11					
	TTI Project No.	440873-01-2					
	Test Date	2022-12-13

<p style="text-align: center;"><b>0.400 s</b></p>	Key Materials	30 ft large-scupper barriers with X-bolt connections x 7					
	Soil Type and Condition	Concrete, damp					
	<b>TEST VEHICLE</b>						
	Type/Designation	2270P

<p style="text-align: center;"><b>0.600 s</b></p>	Year, Make and Model	2017 RAM 1500					
	Inertial Weight (lb)	5031					
	Dummy (lb)	165					
	Gross Static (lb)	5196					
<b>IMPACT CONDITIONS</b>							
Impact Speed (mi/h)	61.7						
Impact Angle (deg)	26.5						
Impact Location	19.5 ft upstream from the joint of barriers 3 and 4

Impact Severity (kip-ft)	127.5						
<b>EXIT CONDITIONS</b>							
Exit Speed (mi/h)	42.1						
Trajectory/Heading Angle (deg)	5.2/11.2						
Exit Box Criteria	The vehicle crossed the exit box						
Stopping Distance	271 ft downstream 32 ft to the traffic side						
<b>TEST ARTICLE DEFLECTIONS</b>							
Dynamic (inches)	22.2						
Permanent (inches)	15.5						
Working Width/Height (inches)	36.7/42						
<b>VEHICLE DAMAGE</b>							
VDS	11LFQ4						
CDC	11FLEW3						
Max. Ext. Deformation	12						
Max Occupant Compartment Deformation	No occupant compartment deformation						
<b>OCCUPANT RISK VALUES</b>							
Long. OIV (ft/s)	16.7	Long. Ridedown (g)	3.4	Max 50-ms Long. (g)	-8.1	Max Roll (deg)	12
Lat. OIV (ft/s)	18.8	Lat. Ridedown (g)	9.3	Max 50-ms Lat. (g)	10.7	Max Pitch (deg)	6
THIV (m/s)	7.6	ASI	1.4	Max 50-ms Vert. (g)	3.5	Max Yaw (deg)	36

**Figure 10.11. Summary of Results for MASH Test 4-11 on Large-Scupper Portable Concrete Barrier.**

Figure 10.11 summarizes the results of *MASH* Test 4-11 (440873-01-2).

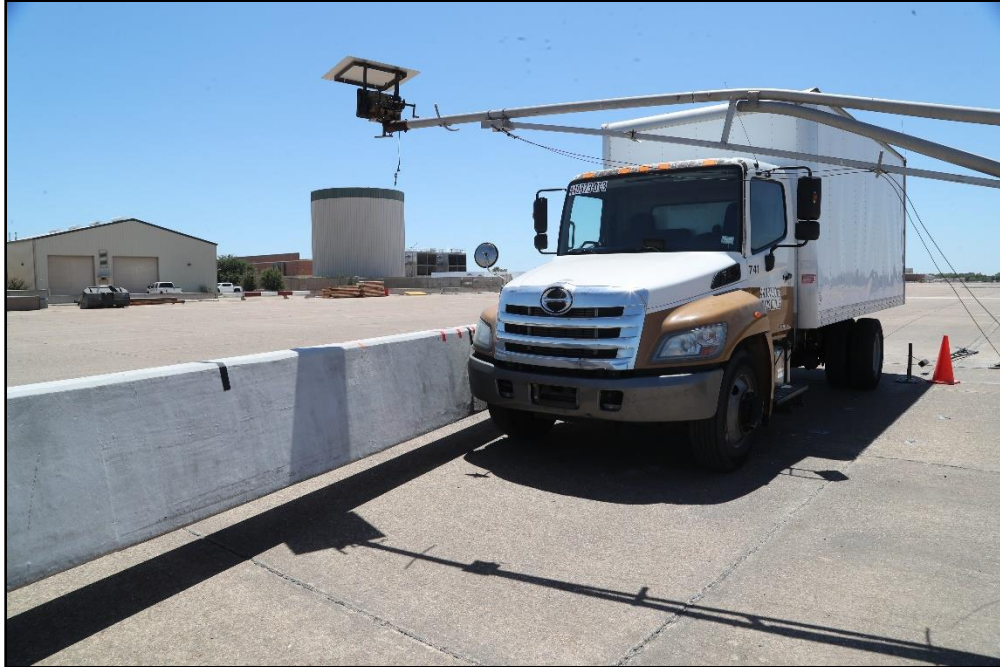
**Figure 11.1. Large-Scupper Portable Concrete Barrier/Test Vehicle Geometrics for Test 440873-01-3.**

See Table 11.1 for details on the impact conditions and Table 11.2 for the exit parameters for Test 440873-01-3. Figure 11.1 and Figure 11.2 depict the target impact setup.

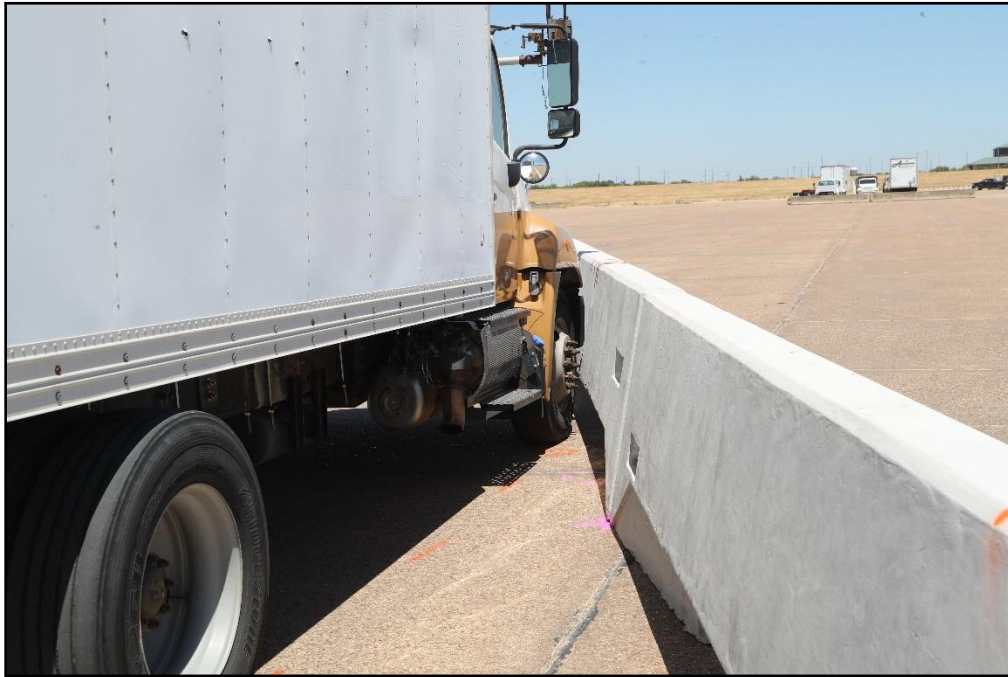
**Figure 11.2. Large-Scupper Portable Concrete Barrier/Test Vehicle Impact Location for Test 440873-01-3.**

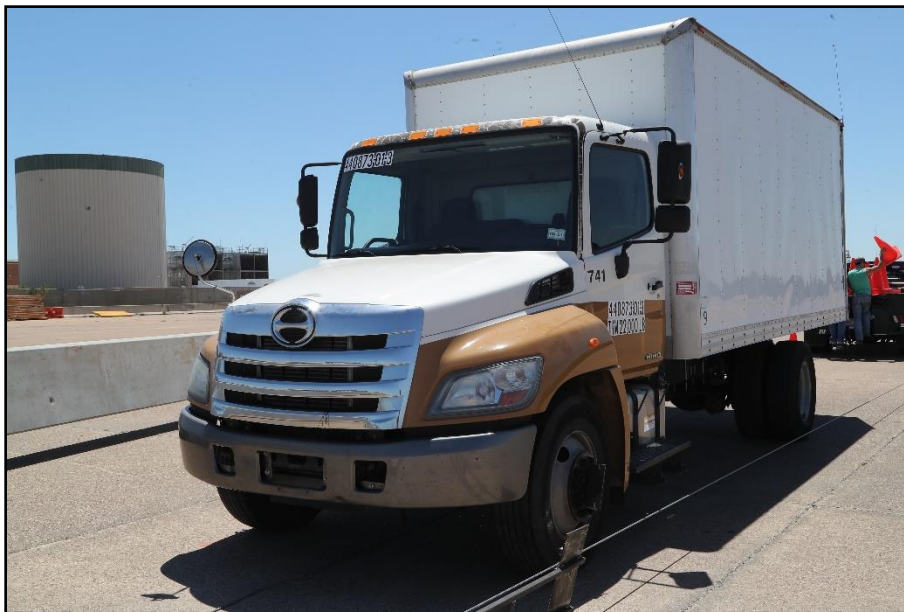
**Figure 11.3. Impact Side of Test Vehicle before Test 440873-01-3.**

Figure 11.3 and Figure 11.4 show the 2013 Hino L Series used for the crash test. Table 11.4 shows the vehicle measurements. Figure E.1 in Appendix E.1 gives additional dimensions and information on the vehicle.

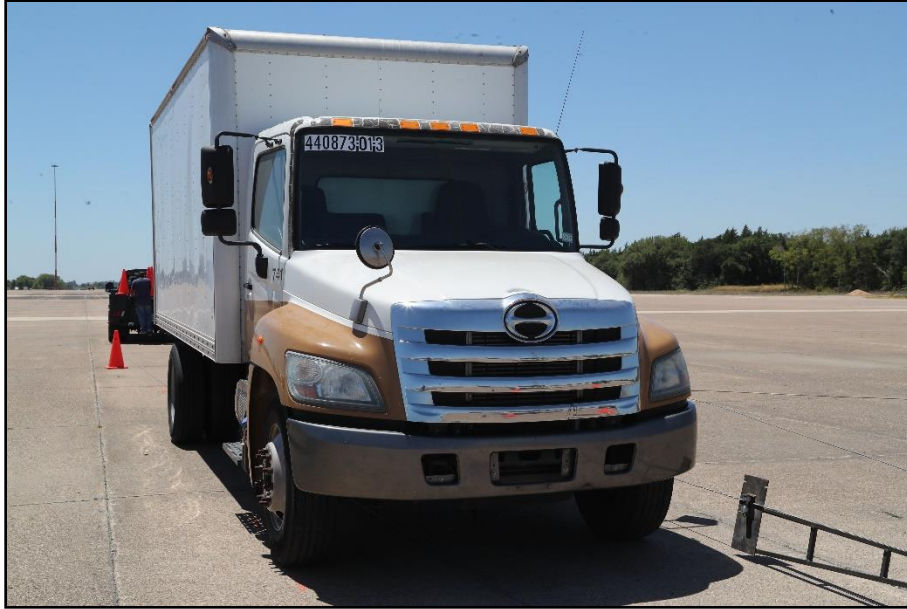
**Figure 11.4. Opposite Impact Side of Test Vehicle before Test 440873-01-3.**

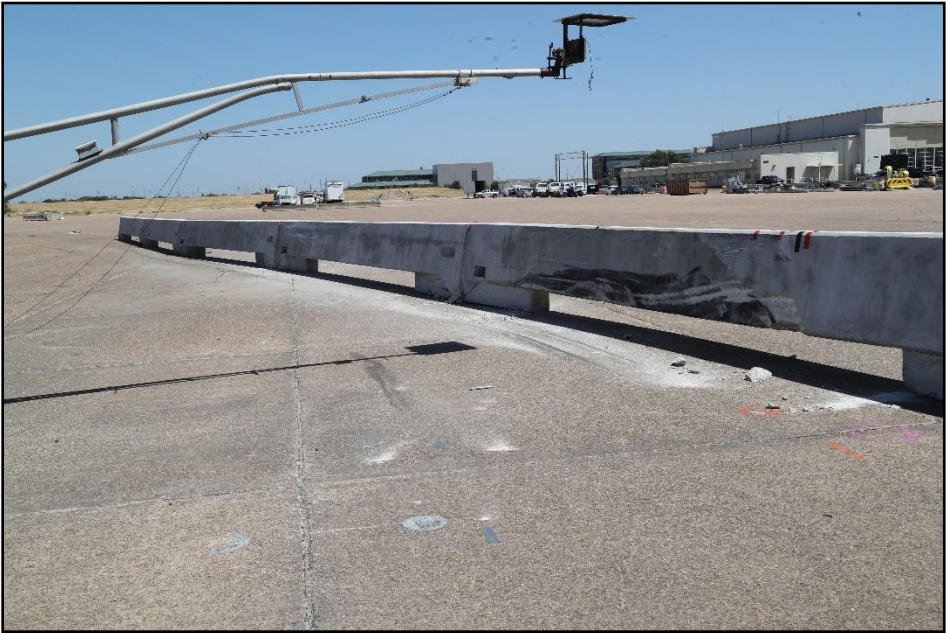
Barrier 2 had spalling on the traffic-side downstream end. Barrier 3 had minor concrete damage on the field-side upstream end and on the traffic-side downstream end. Barrier 4 had scuffing and gouging with spalling and exposed rebar in multiple places. It was bowed 3.5 inches toward the field side, and there were multiple vertical cracks on the field side. Barrier 5 had some major spalling on the upstream end, with exposed rebar on the field side and minor damage on the traffic side. Barrier 6 had spalling on the field side at both ends, and Barrier 7 had spalling with exposed rebar on the upstream field side. Table 11.6 describes the barrier movement at the joints of the large-scupper portable concrete barrier. Table 11.7 describes the deflection and working width of the large-scupper portable concrete barrier. Figure 11.5 and Figure 11.6 show the damage to the large-scupper portable concrete barrier.

**Figure 11.5. Large-Scupper Portable Concrete Barrier at Impact Location after Test 440873-01-3.**

Test Parameter	Measured
Permanent Deflection/Location	40 inches toward field side at joint between segments 4 and 5
Dynamic Deflection	44.3 inches toward field side at the top of barrier 4 at the joint between segments 4 and 5
Working Width <sup>a</sup> and Height	94.2 inches, at a height of 128.9 inches, at the top rear passenger-side corner of the truck box

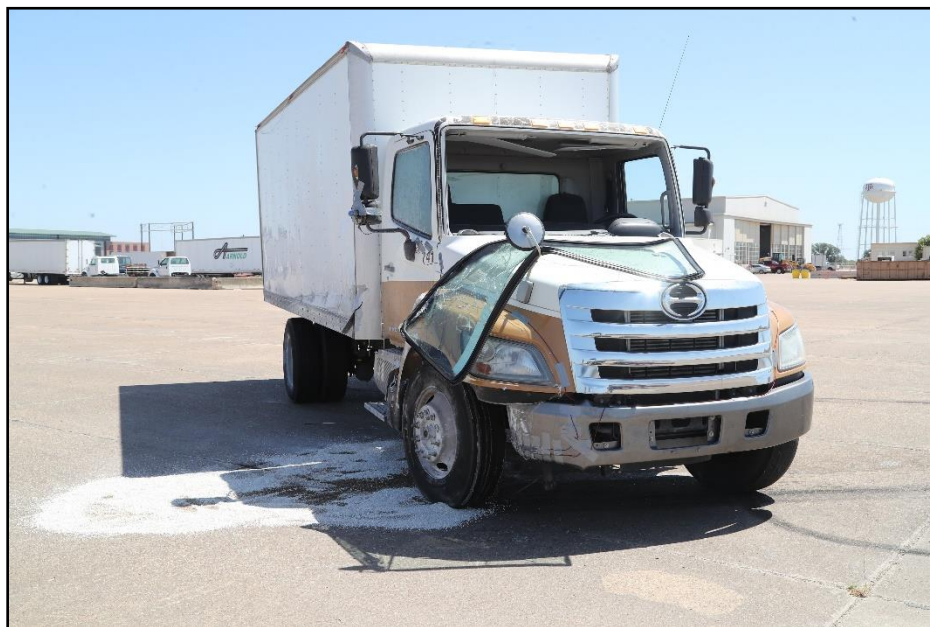
**Figure 11.7. Impact Side of Test Vehicle after Test 440873-01-3.**

Figure 11.7 and Figure 11.8 show the damage sustained by the vehicle. Figure 11.9 and Figure 11.10 show the interior of the test vehicle. Table 11.8 and Table 11.9 provide details on the occupant compartment deformation and exterior vehicle damage.

<b>Side Windows</b>	The side windows remained intact
<b>Maximum Exterior Deformation</b>	13 inches in the front plane at right side at bumper height
<b>VDS</b>	01RFQ2
<b>CDC</b>	01FREW1
<b>Fuel Tank Damage</b>	None
<b>Description of Damage to Vehicle:</b>	The windshield, right fender, front bumper, right front shock, right front wheel, def tank, and right side of the box were damaged. The windshield popped out of place and fell off the vehicle. This was due to flexing of the cab and not penetration of the test article.

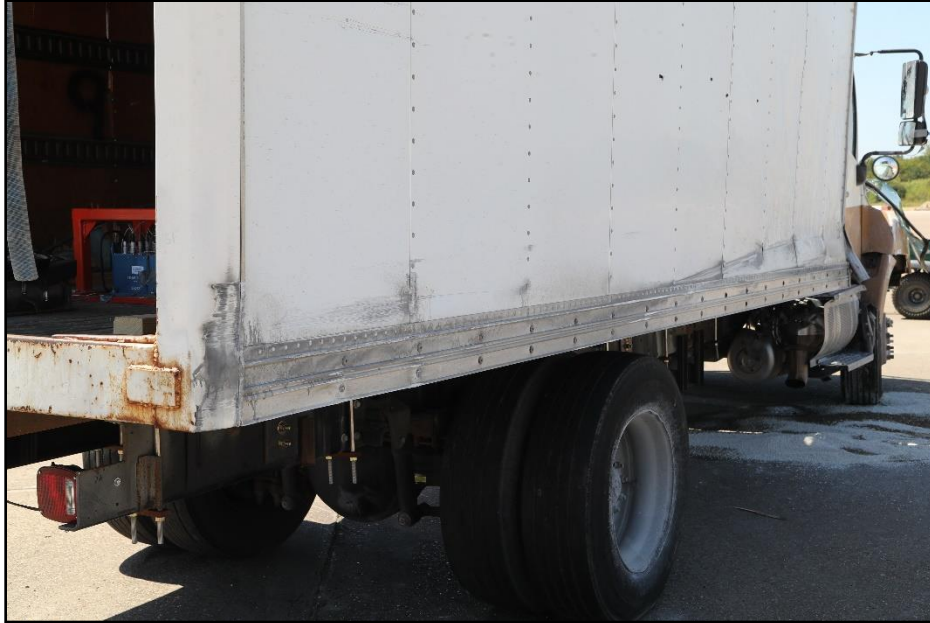
**Figure 11.8. Rear Impact Side of Test Vehicle after Test 440873-01-3.**
