Test Report No. 440873-01

**DEVELOPMENT OF A *MASH* TL-4 PORTABLE CONCRETE BARRIER  
WITH LARGE SCUPPER**

Sponsored by the  
**Texas Department of Transportation (TxDOT)**

**TEXAS A&M TRANSPORTATION INSTITUTE PROVING GROUND**

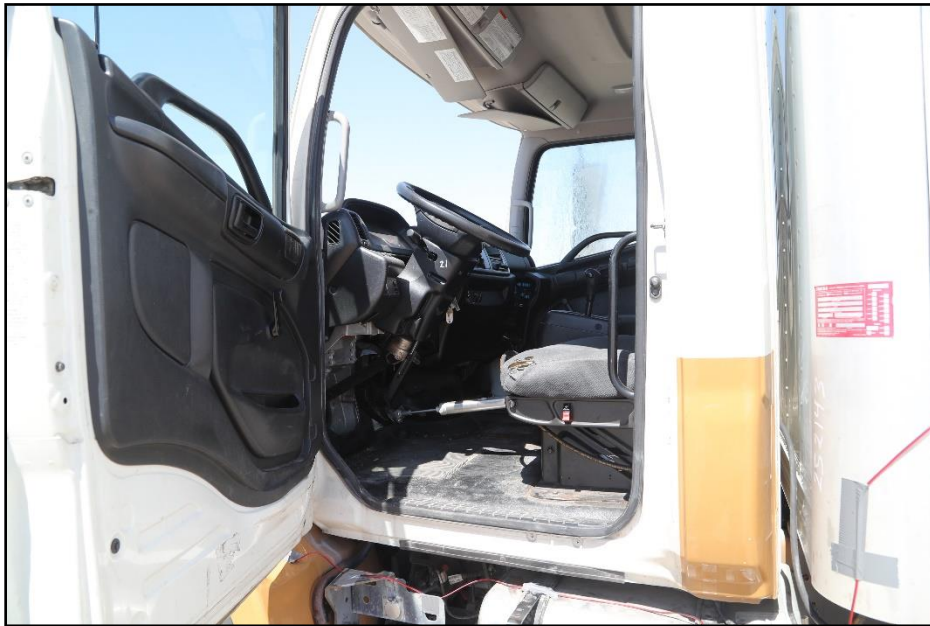
**Figure 11.9. Overall Interior of Test Vehicle after Test 440873-01-3.**

Figure 11.7 and Figure 11.8 show the damage sustained by the vehicle. Figure 11.9 and Figure 11.10 show the interior of the test vehicle. Table 11.8 and Table 11.9 provide details on the occupant compartment deformation and exterior vehicle damage.

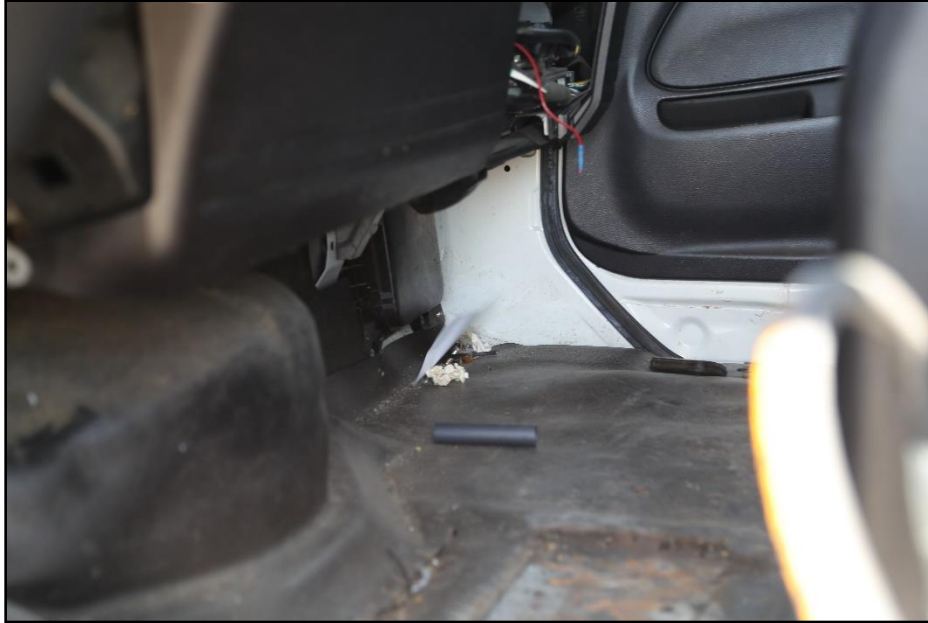
**Figure 11.10. Interior of Test Vehicle on Impact Side after Test 440873-01-3.**

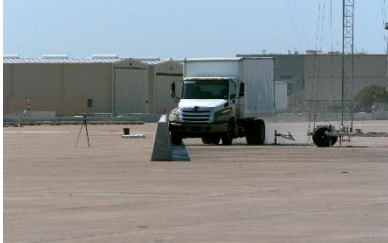
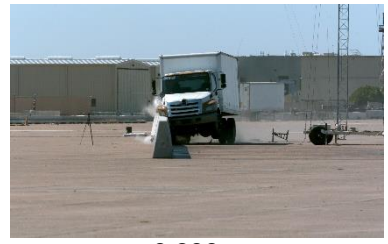
<p style="text-align: center;"><b>0.000 s</b></p>	Test Agency	Texas A&M Transportation Institute (TTI)					
	Test Standard/Test	MASH 2016, Test 4-12					
	TTI Project No.	440873-01-3					
	Test Date	2023-08-17

<p style="text-align: center;"><b>0.200 s</b></p>	<b>TEST ARTICLE</b>						
	Type	Longitudinal Barrier					
	Name	Large-Scupper Portable Concrete Barrier					
	Length	210 ft

<p style="text-align: center;"><b>0.600 s</b></p>	Year, Make and Model	2013 Hino L Series					
	Curb (lb)	13,490					
	Inertial Weight (lb)	22,150					
	<b>IMPACT CONDITIONS</b>						
Impact Speed (mi/h)	56.1						
Impact Angle (deg)	14.9						
Impact Location	239 inches upstream from the centerline of the joint between barriers 4 and 5

Impact Severity (kip-ft)	154.1						
<b>EXIT CONDITIONS</b>							
Exit Speed (mi/h)	Not measurable, out of frame						
Trajectory/Heading Angle (deg)	Not measurable, out of frame						
Stopping Distance	308 ft downstream 50 ft to the traffic side						
<b>TEST ARTICLE DEFLECTIONS</b>							
Dynamic (inches)	44.3						
Permanent (inches)	40						
Working Width/Height (inches)	94.2/128.9						
<b>VEHICLE DAMAGE</b>							
VDS	01RFQ2						
CDC	01FREW1						
Max. Ext. Deformation (inches)	13						
Max Occupant Compartment Deformation	No occupant compartment deformation						
<b>OCCUPANT RISK VALUES</b>							
Long. OIV (ft/s)	6.8	Long. Ridedown (g)	1.8	Max 50-ms Long. (g)	-2.0	Max Roll (deg)	29.2
Lat. OIV (ft/s)	9.4	Lat. Ridedown (g)	6.5	Max 50-ms Lat. (g)	-4.1	Max Pitch (deg)	5.6
THIV (m/s)	3.6	ASI	0.4	Max 50-ms Vert. (g)	-2.5	Max Yaw (deg)	24.1

**Figure 11.11. Summary of Results for MASH Test 4-12 on Large-Scupper Portable Concrete Barrier.**

Figure 11.11 summarizes the results of *MASH* Test 4-12 (440873-01-3).

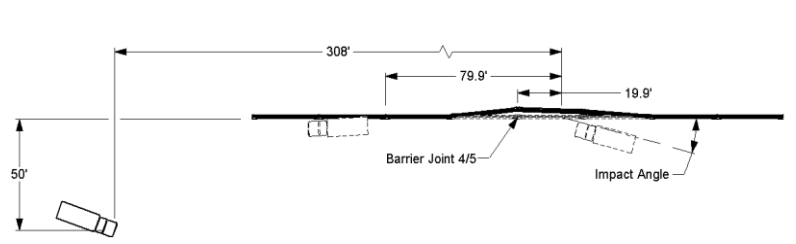
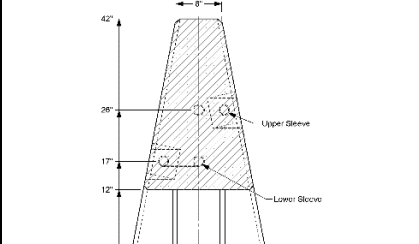
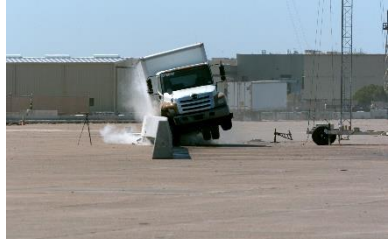
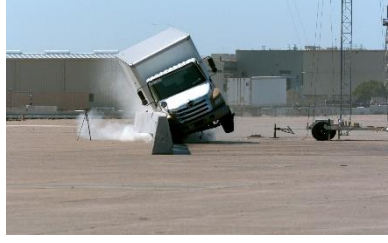
<p style="text-align: center;"><b>0.400 s</b></p>	Key Materials	30 ft large-scupper barriers with X-bolt connections x 8					
	Soil Type and Condition	Concrete, damp					
	<b>TEST VEHICLE</b>						
	Type/Designation	10000S

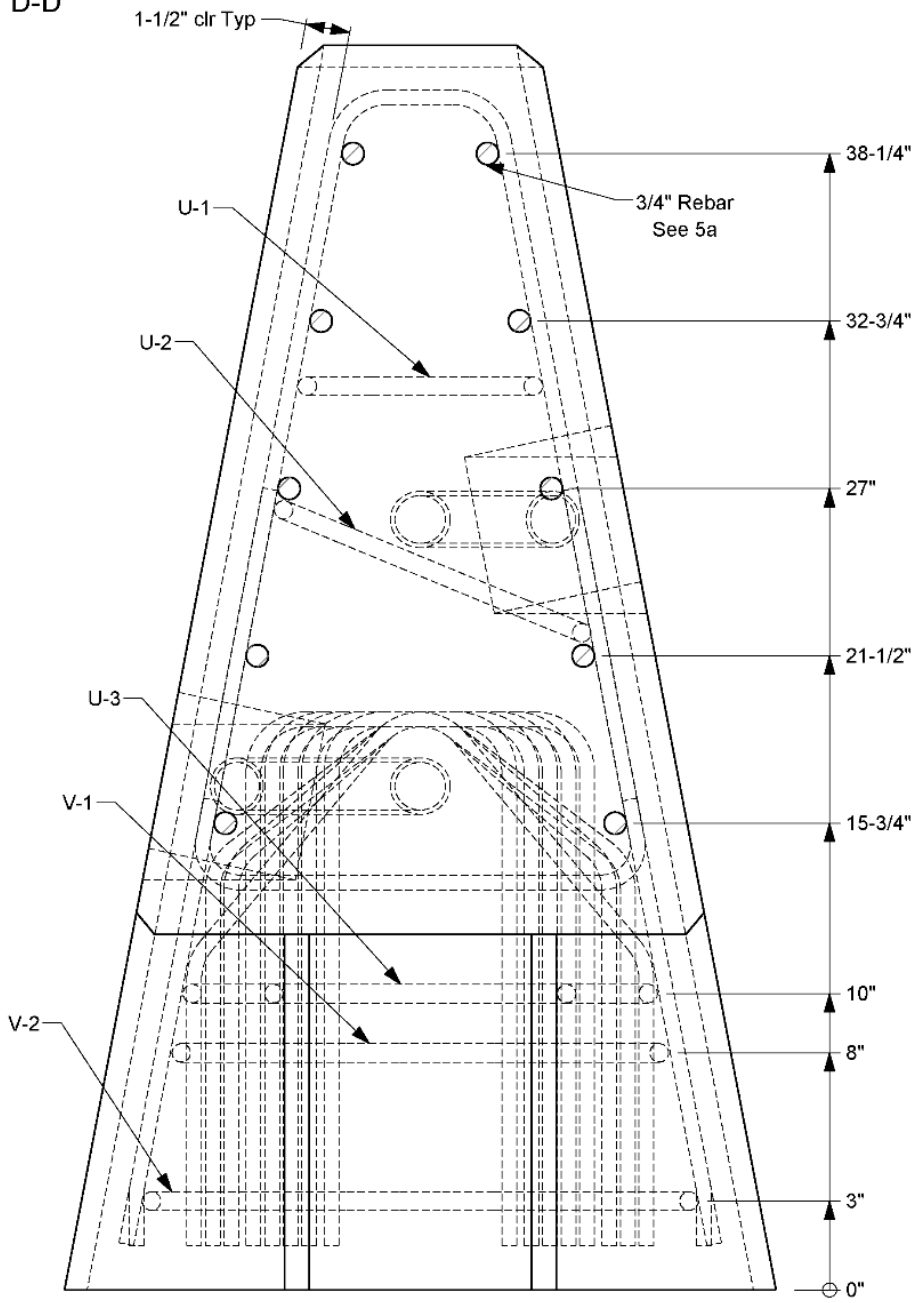
Section D-D

**5a.** Ten longitudinal bars; six full length and four shorter bars at connection pockets (see previous sheet and next sheet).

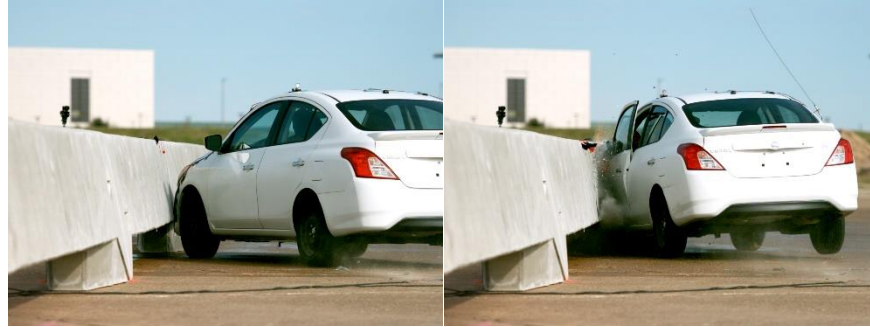
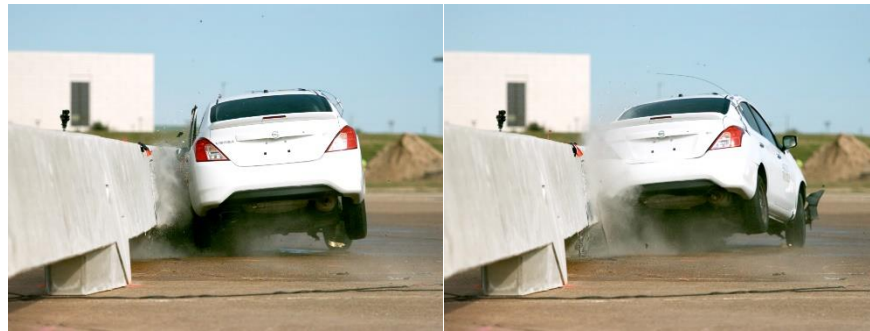
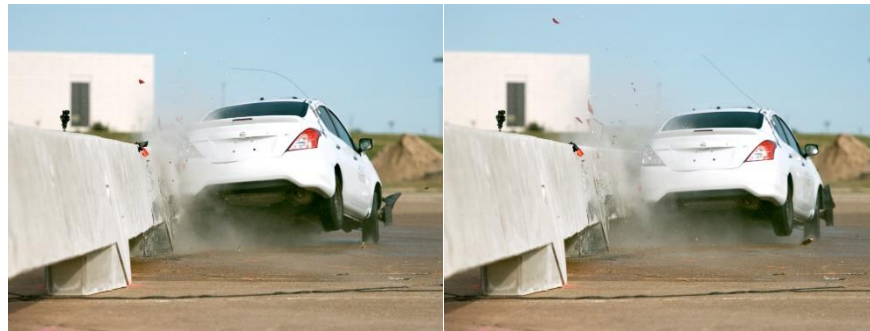
**Figure C.5. Sequential Photographs for Test 440873-01-1 (Frontal Views).**

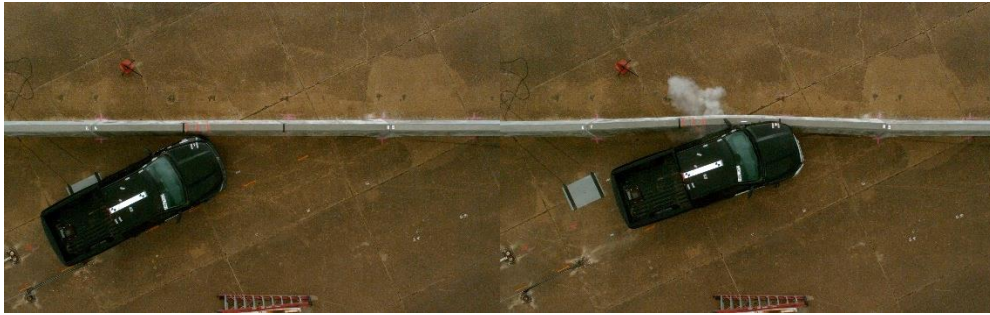
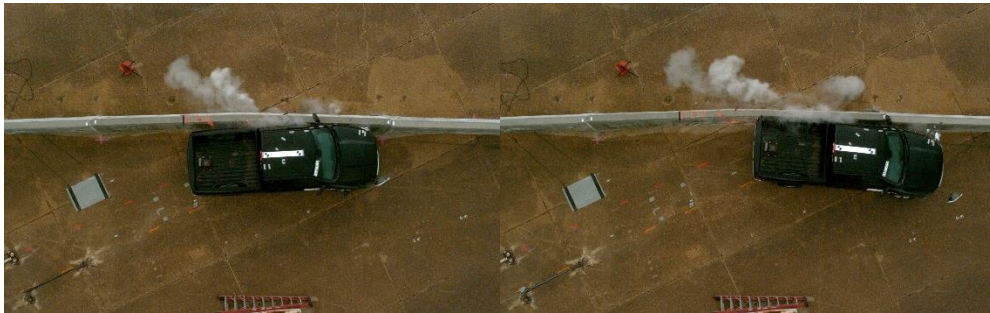
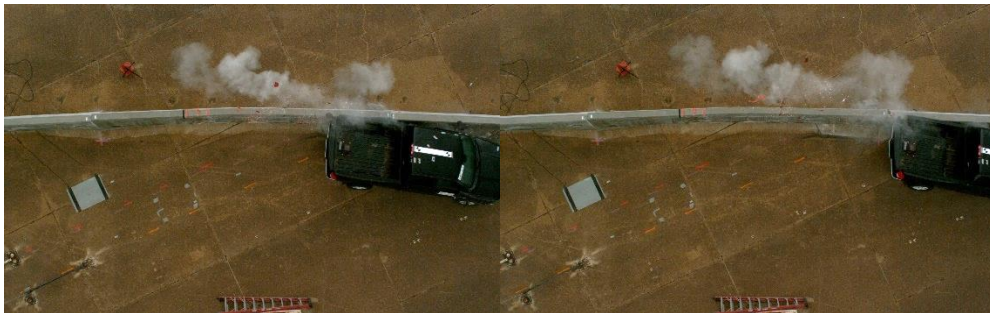
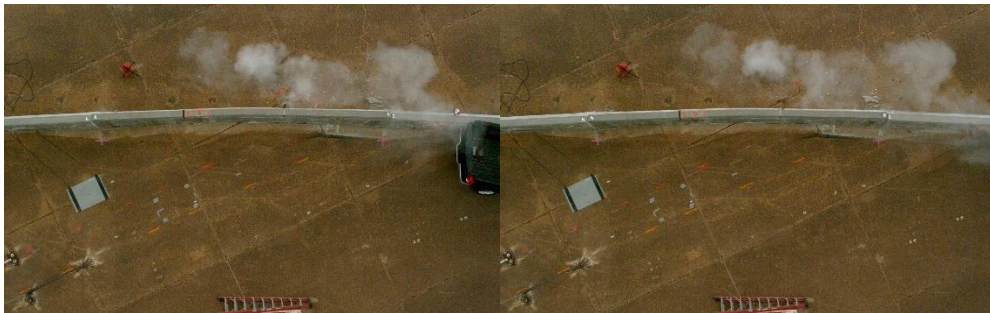
**Figure D.4. Sequential Photographs for Test 440873-01-2 (Overhead Views).**

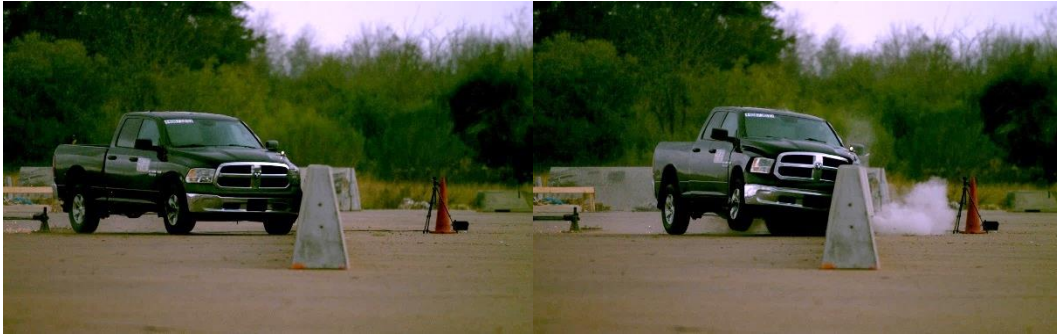
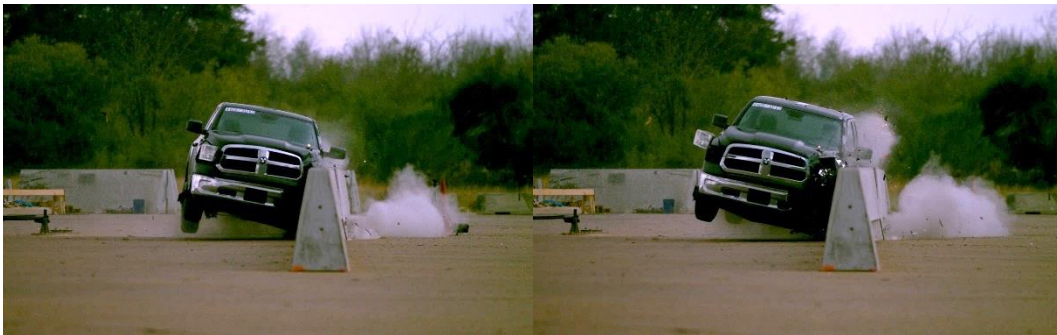
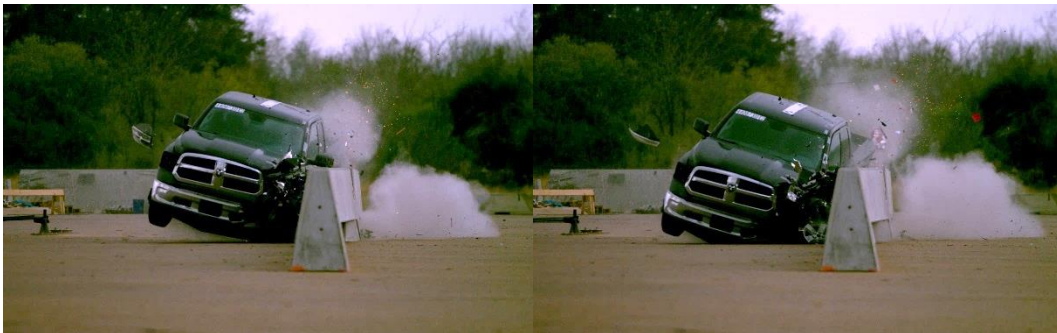
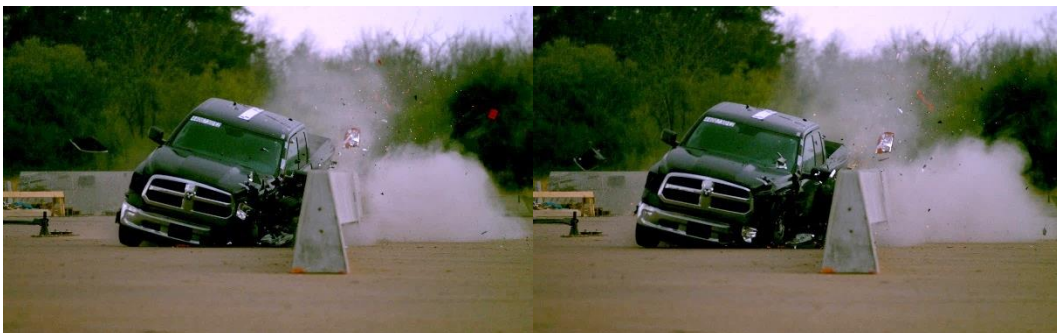
**Figure D.5. Sequential Photographs for Test 440873-01-2 (Frontal Views).**

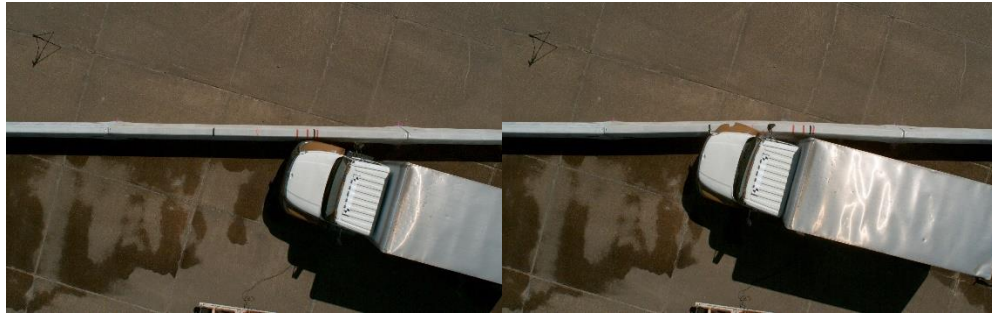
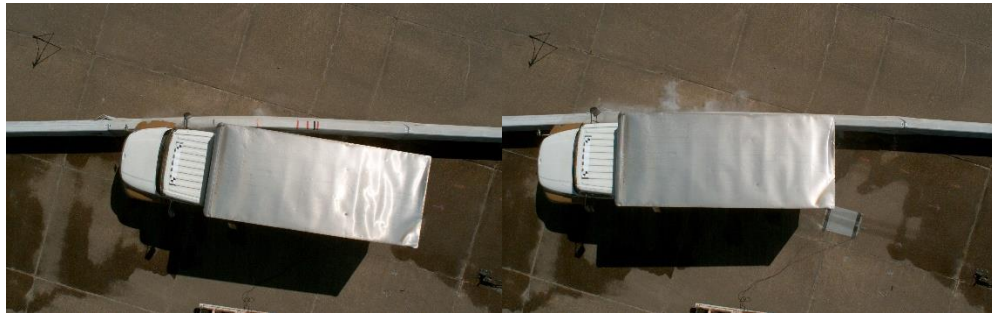
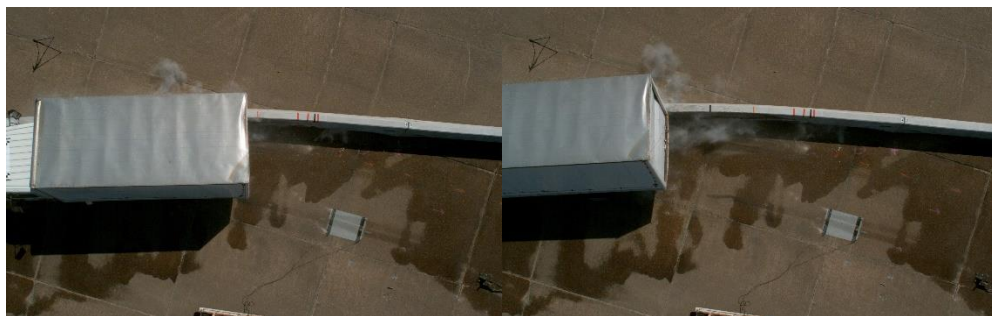
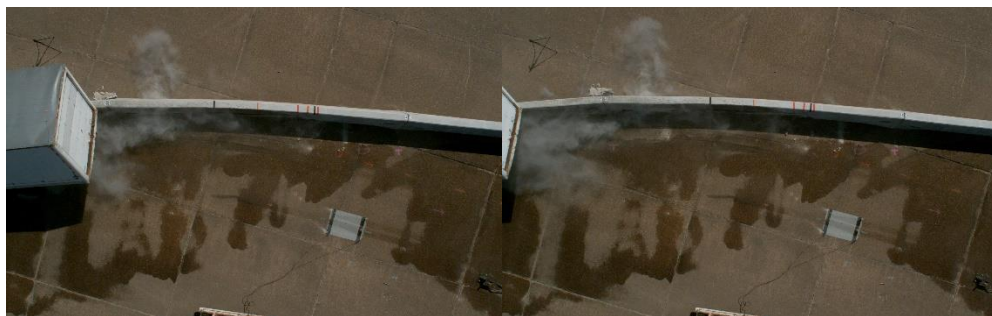
**Figure E.2. Sequential Photographs for Test 440873-01-3 (Overhead Views).**

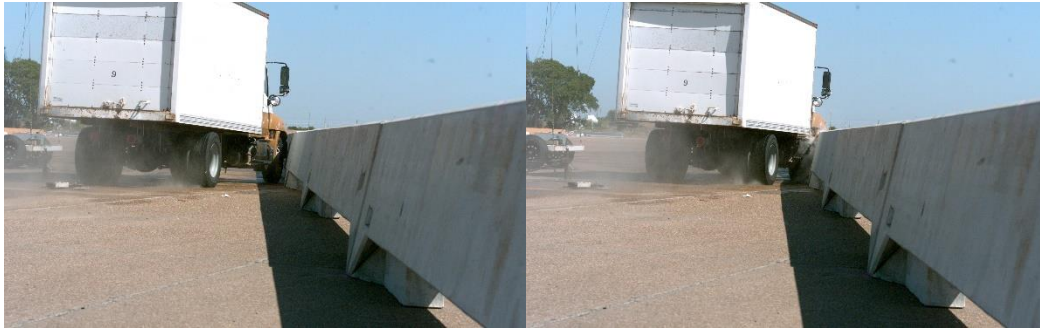
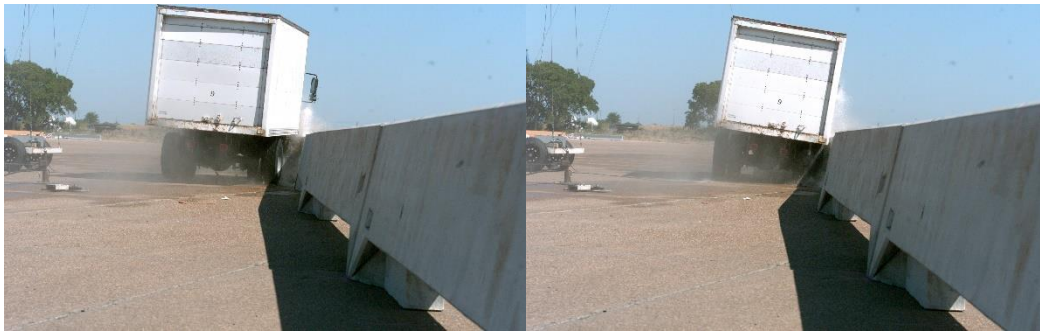
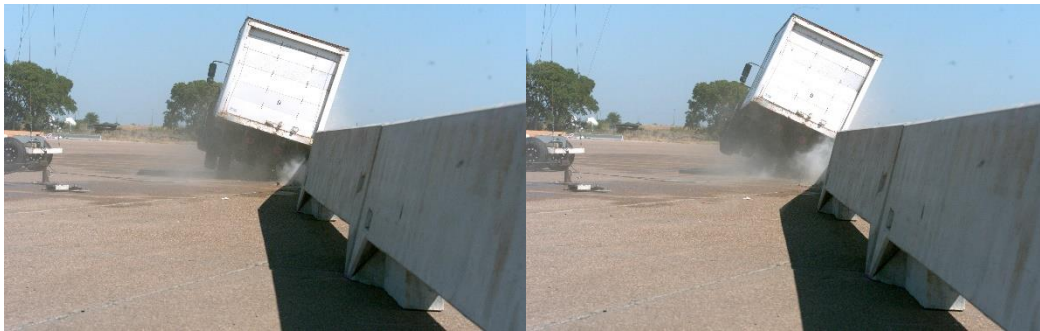
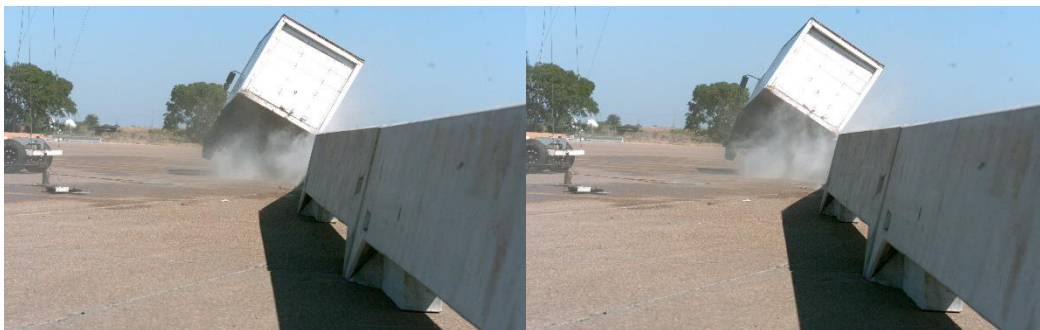
**Figure E.3. Sequential Photographs for Test 440873-01-3 (Frontal Views).**

(a) 0.000 s

(b) 0.100 s

(c) 0.200 s

(d) 0.300 s

(e) 0.400 s

(f) 0.500 s

(g) 0.600 s

(h) 0.700 s
