Dowel – Concrete Interface Performance Validation in Concrete Rehabilitations

Bernard Izevbekhai, Principal Investigator

Office of Materials and Roads Research
Minnesota Department of Transportation

Research Report
Final Report 2024-24

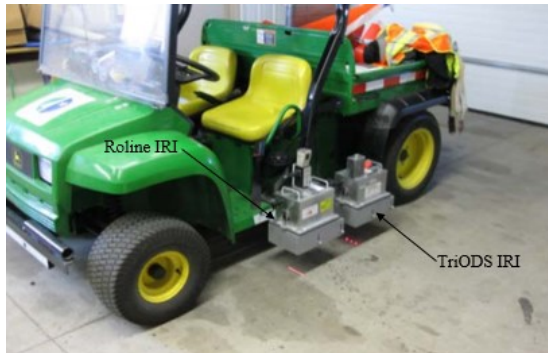
ROLINE system utilizes a line laser (Figure 2.5). The difference in values between the two systems (when small) is a quality assurance that the influence of texture is not unduly affecting IRI measurements.

Figure 2.5 Light weight profiler.

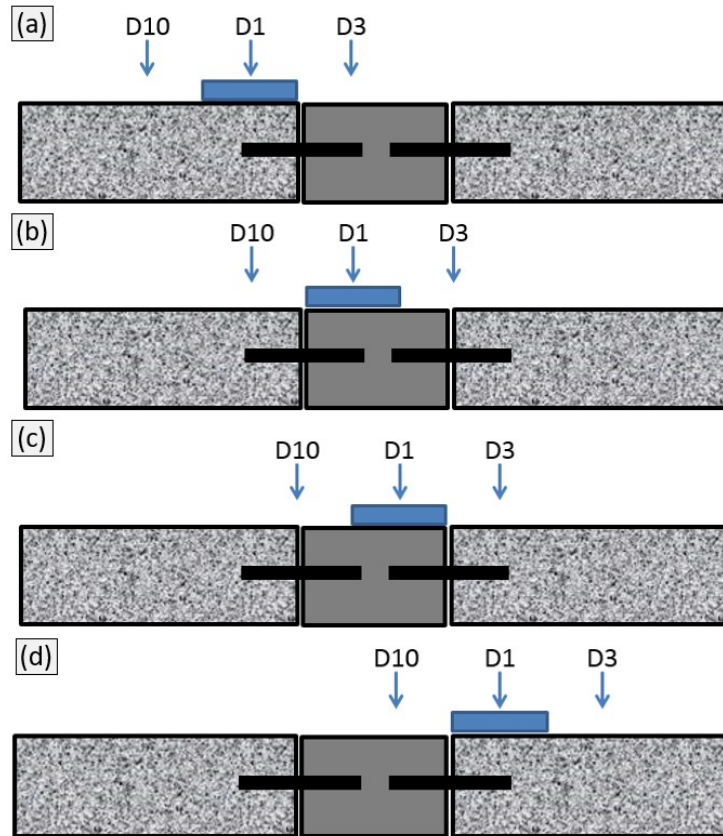
The existing sub-cells which were repaired within the scope of this report consisted of three joints, each of these joints were removed and replaced with a patch containing the dowel bar repairs being analyzed within this report, creating an additional three joints for each sub cell. The new configuration for the FWD process accounting for these additional joints is shown in Figure 2.8.

Figure 2.8 Falling weight deflectometer process for recording/calculating approach and leave load transfer efficiency values for sub cells: (a) pavement approach, (b) patch leave, (c) patch approach, (d) pavement leave.

The equation 1 was used for pavement and patch approach LTE values while equation 2 was used for pavement and patch leave LTE values.

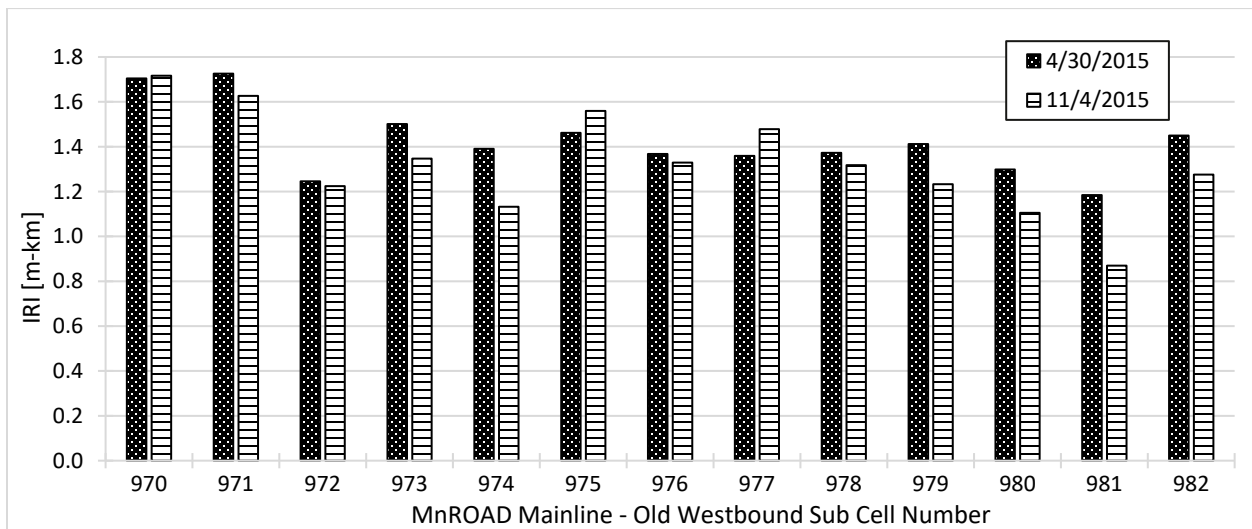
Figure 3.1 Spring and fall driving lane TriODS International Roughness Index (IRI) values for the various test cells.

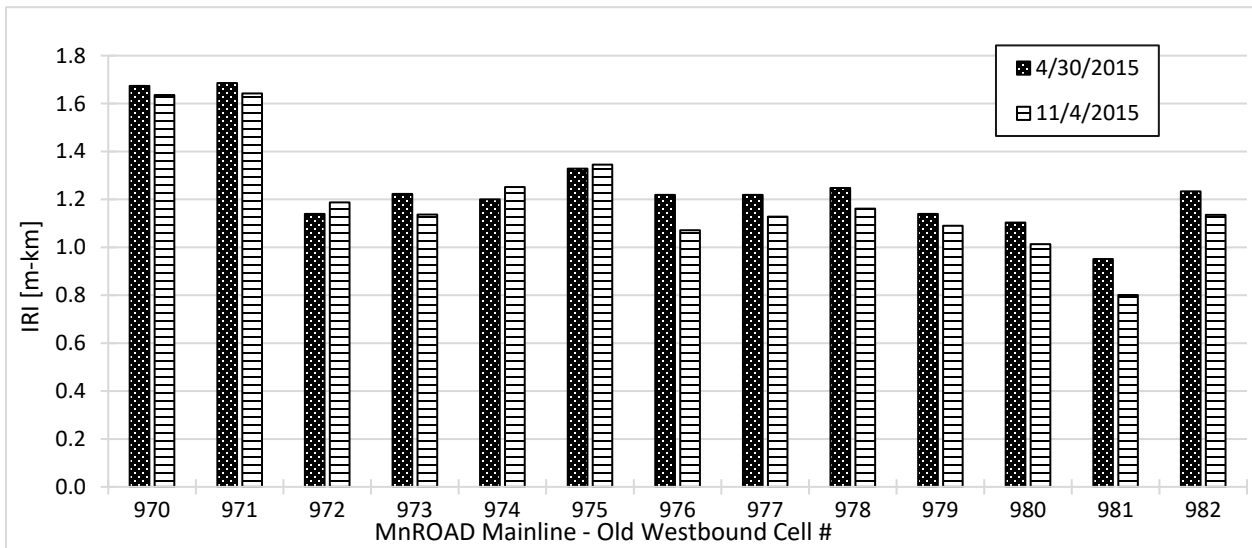
Figure 3.3 Spring and fall driving lane ROLINE International Roughness Index (IRI) values for the various test cells.

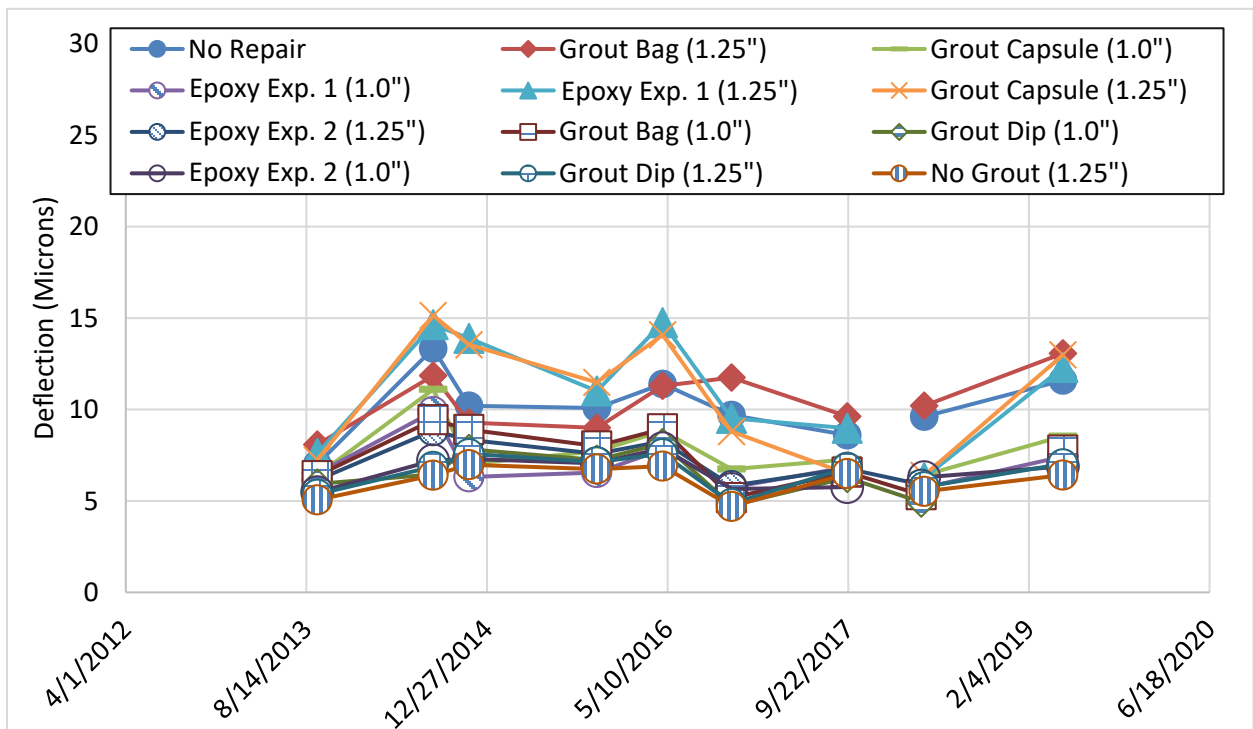
Figure 3.10 Deflection measurements for loading on patch leave side

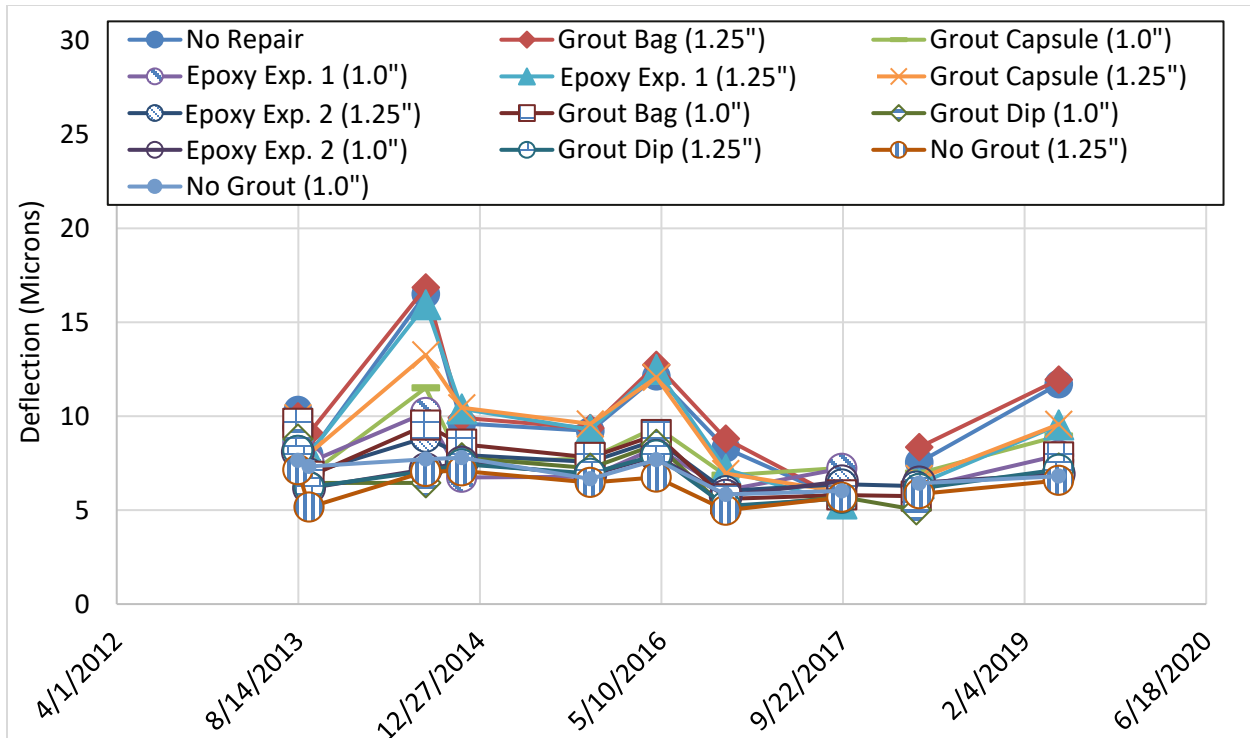
Figure 3.11 Deflection measurements for loading on pavement approach side

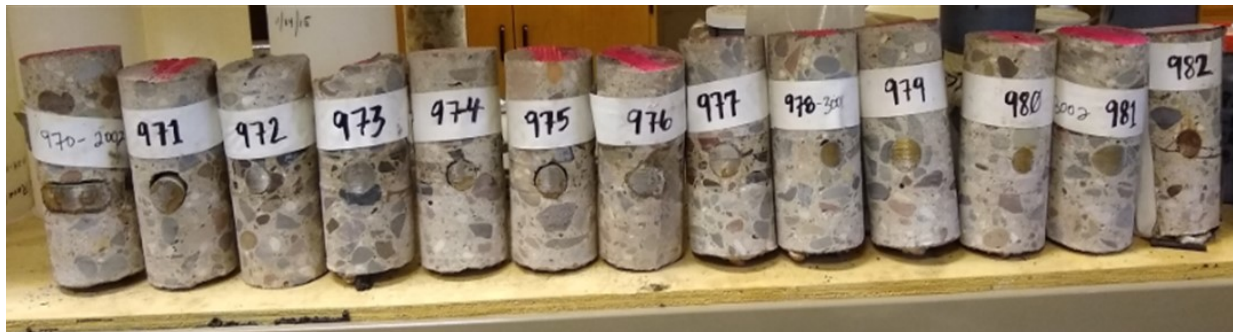
Thirteen cores were taken from Cells 970 through 982 for visual observation. Images of these cores are provided in Figure 3.23 and Figure 3.24. The core for Cell 970 was taken with the dowel on the side of the core which explains why only one side provides view of the dowel. Observations from the cores included the amount of concrete breakdown around the dowel, evenness of the grout or epoxy suspending the dowel within the hole, and the degree of void space surrounding the dowel. Quality was recorded under three categories of Good, Marginal, and Bad as shown in Table 3.4 along with the visual observation notes. These condition results were organized into counts for Table 3.4 to 3.6 to better compare the quality produced by differing dowel sizes, bonding materials, and overall methods.

Figure 3.23 Front view of cores from sub cells 970 through 982 (left to right).

As can be seen from Figure 3.23 and Figure 3.24 the core from sub cell 982 contains a large transverse crack across it. In recent years, cores extracted from older dowelled concrete structures have exhibited comparable patterns of cracking to those observed in the provided example. This may be caused by the need for stress release in the dowel, which normally manifests as a breakdown of the concrete surrounding the dowel but, in some cases, manifests as major transverse cracking.

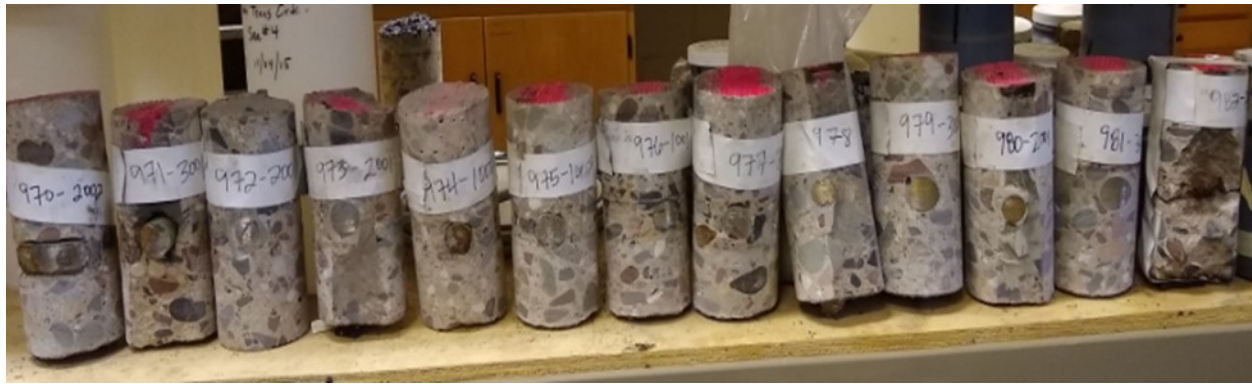
Figure 3.24 Back view of cores from sub cells 970 through 982 (left to right)

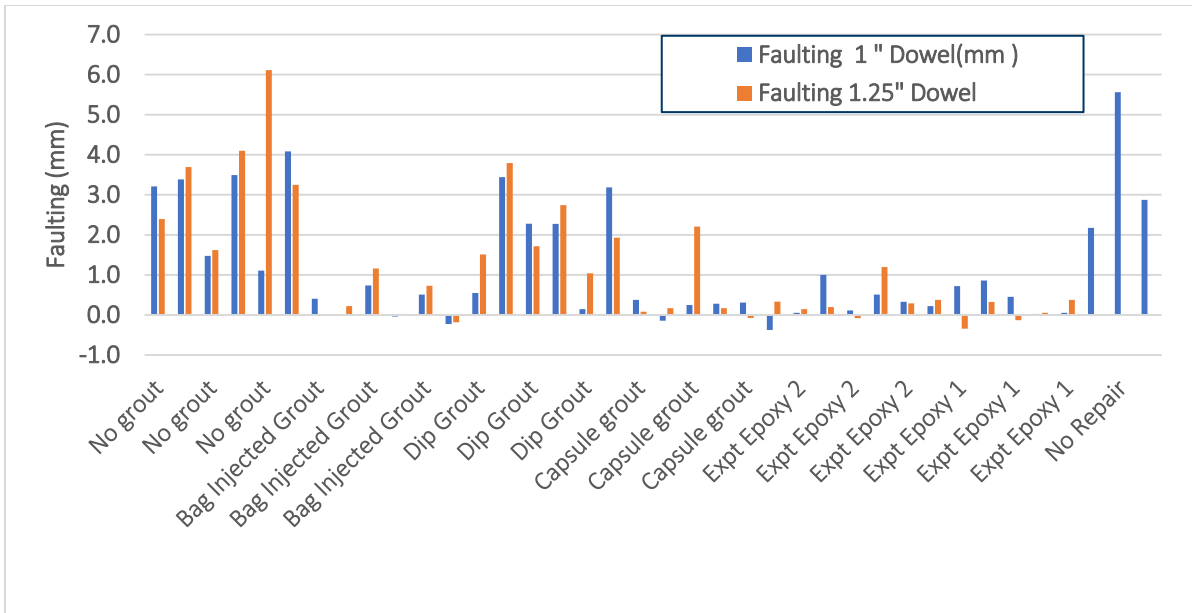
Figure 3.26 Comparison of faulting in cells with 1" diameter dowels to corresponding cells with 1.25" diameter dowels.

It was important to evaluate the test cells using faulting as a criterion. As can be seen in Figure 3.29 and 3.27 , various joint measurements were conducted in the test cells taking care to note pavement approach or pavement leave so that the relevant anchored dowels were evaluated.

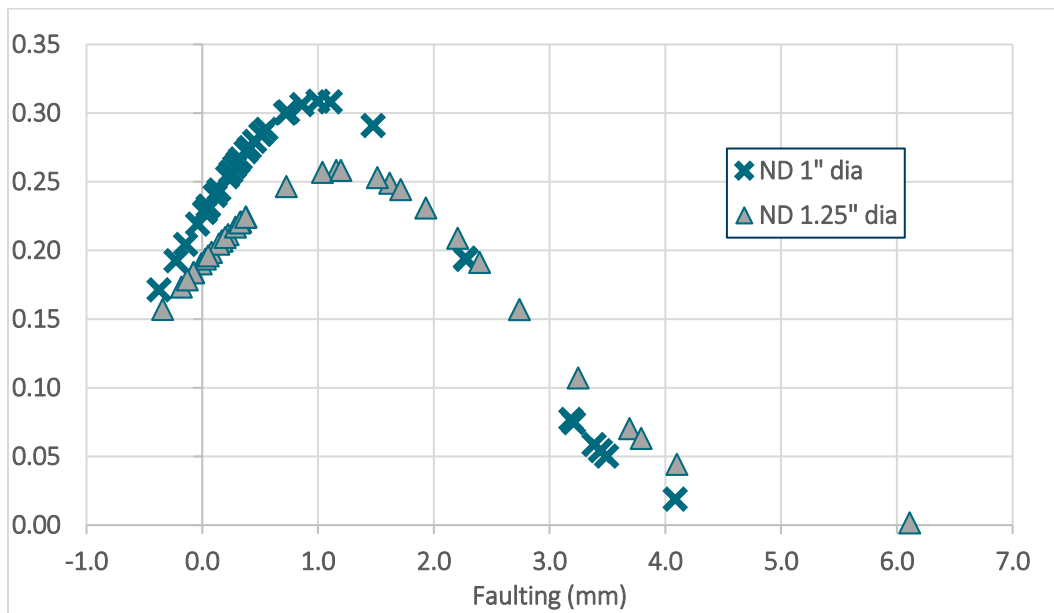
Figure 3.27 Normal Distribution of Faulting in 2 different Dowel sizes

Although there is huge variability in the disparity between the faulting of the 1.25 inch and the 1-inch dowel in each of the repair methods, it was evident that there is in a general trend, the faulting being larger in the larger diameter dowel. In Figure 3.26 a direct comparison of faulting done between 1' diameter and corresponding test sections with 1.25' diameter dowels. Results are also accentuated by Table 3.7 and Table 3.8. In Table 3.7 descriptive statistics showed low mean faulting in the lower diameter dowels. Relative distributions are shown in Figure 3.27. A t-test shows that the two data sets are dissimilar based on an alpha value of 0.05.
