GEORGIA DOT RESEARCH PROJECT 22-33

Final Report

**EXPERIMENTAL TESTS FOR AN
EFFECTIVE BARRIER DESIGN
TO EXCLUDE DIAMONDBACK TERRAPINS
(*MALACLEMYS TERRAPIN*) FROM ROADS**

January 2025

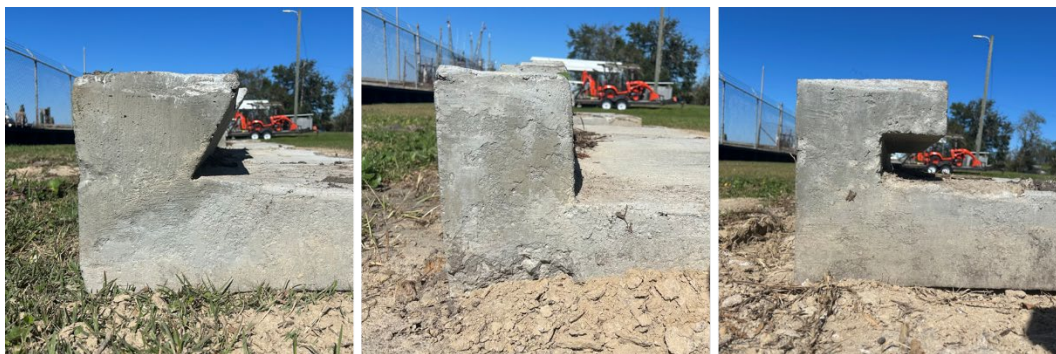
Figure 3. Photo. Curb cut sections. Cut section images of all three curb designs at the 6” height for reference to table in Figure 2.

Figure 2. Table. Curb dimensions. Dimensions of all three reverse curb designs cut sections per each of the four heights.

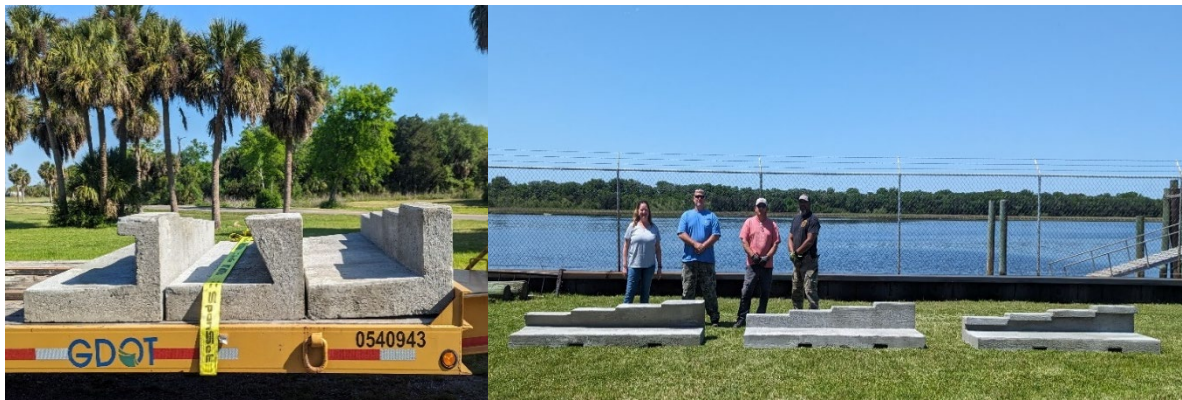
Figure 5. Photo. Curb installation. Left: The three types of reverse curb designs used in the experiment. Right: D5 Maintenance Crew with PI Andrews at the Brunswick test site when the curbs were being delivered.

since its initiation in 2005. The team's second site was at the UGA Marine Extension facility in Brunswick, Georgia (Glynn County) where PI Andrews and her Coastal Ecology Lab (in the Marine Extension and Georgia Sea Grant department) are located. The UGA team coordinated with the GDOT District 5 Maintenance team to cast the experimental reverse curb sections. They were delivered and put in place at both sites on April 15, 2024 (Fig. 5).

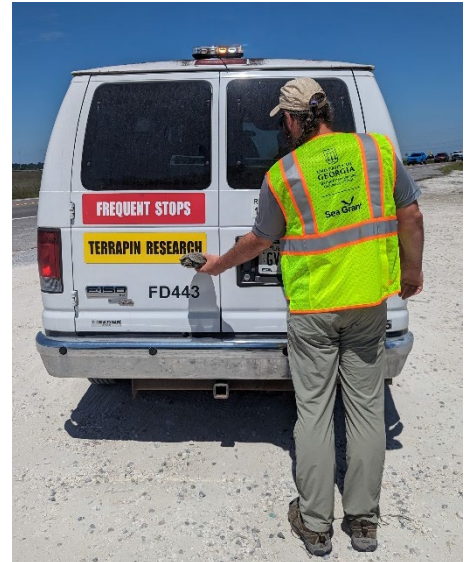
Figure 7. Photo. Research vehicle. Road cruising vehicle outfitted with strobe light and magnet next to field researcher in high visibility safety vest holding a terrapin that was found alive on the road (AOR) on US-80.

intervention in removing terrapins from the road (Fig. 7). The vehicle was maintained at a speed of 40 mph and if a terrapin was spotted on the road or on the shoulder, the vehicle was safely pulled over off the side of the road and the terrapin was collected. These individuals found on roads were recorded as “AOR” or “Alive-on-Road” under their capture information. Road cruising took place on a 4.3-mile stretch of US-80 from the East end of the causeway after the bridge over Bull River on a pull-off by a tidal creek off the main river (Bull Creek) to the Lazaretto Creek Fishing Pier at the end of the road by the Lazaretto Creek Boat Ramp Road (Fig. 8, red lines).

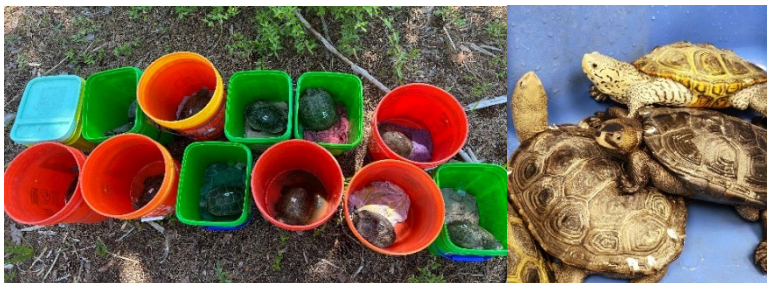
Figure 11. Photo. Terrapin containment. Terrapins in litter buckets and blue totes that were used to contain animals between initial capture and release. Wet towels and lids were included to keep terrapins

After a terrapin was captured, they were placed in storage containers (Fig. 11, Left). Three types of storage containers were used: 5-gallon circular buckets with handles and lids, repurposed square cat litter buckets with handles and lids that varied in size but were all approximately 5-gallons and measured 12"x10"x14", and tote bins with lids measuring 22"x17"x10." The buckets were primarily used during road cruising, pedestrian captures, and biking due to the carrying convenience of the handle, while the tote bins were primarily used during seining so that multiple smaller individuals could be stored in the same container (Fig. 11, Right) and so that containers could be stacked with lids for safe transportation on the boat. Each terrapin storage container

received a lid and was filled with either 1” of water (collected at the capture site) or a wet towel to prevent dehydration. Storage containers were kept in air conditioning whenever possible between capture and testing to prevent overheating or dehydration of the animals.

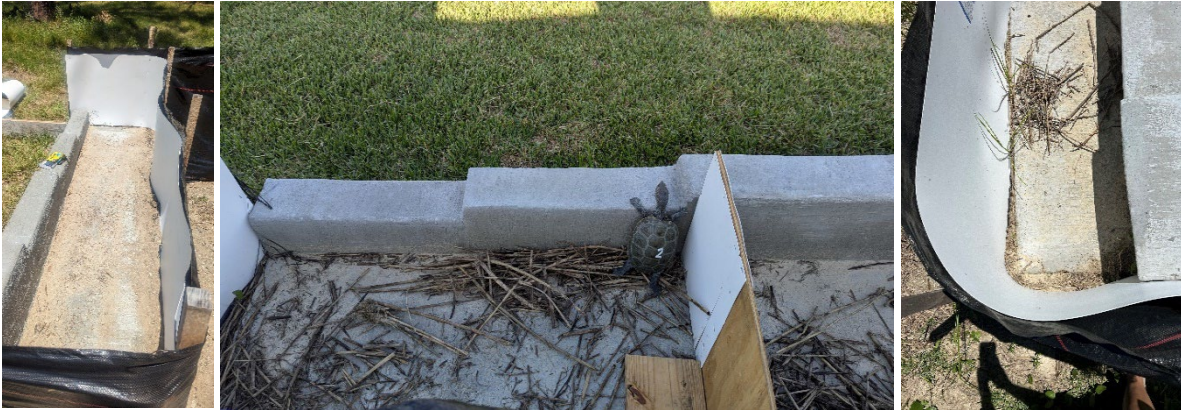
Figure 13. Photo. Runway trial. Left: Polywall[®] placed around entire inside perimeter of runway trial. Middle: Divider separating 6” and 8” height curbs from 10” and 12” curbs. Right: Polywall[®] curved at corners to replicate directional fencing.

One to three terrapins were tested at a time, with only one terrapin present on a single curb design at once. Each researcher present for trials was assigned to observe one terrapin at a time. Each trial site included the three sections of reverse curbing, with each curb section including different heights (6", 8", 10", and 12", Figs. 2,3,5). Within each curb section, the curb was separated in the middle with the 6" and 8" heights on one side, and the 10" and 12" heights on the other side (Fig. 13, Middle) to prevent terrapins from following the perimeter of the runway and only encountering the 6" and 12" heights. The perimeter of the experimental site was lined with silt fencing designed to contain the terrapins to one curb at a time, allow the terrapin a visual over the curb they are attempting to trespass, and also block the terrapin's view from the observing researchers to eliminate behavioral changes around humans (Fig. 13, Left). The inside perimeter of the silt fencing was lined with Polywall® (a brand of smooth flexible waterproof reinforced

plastic wall panels) to prevent terrapins from climbing the silt fence, with the corners rounded to redirect them towards the curbs (Fig. 13, Left and Right).

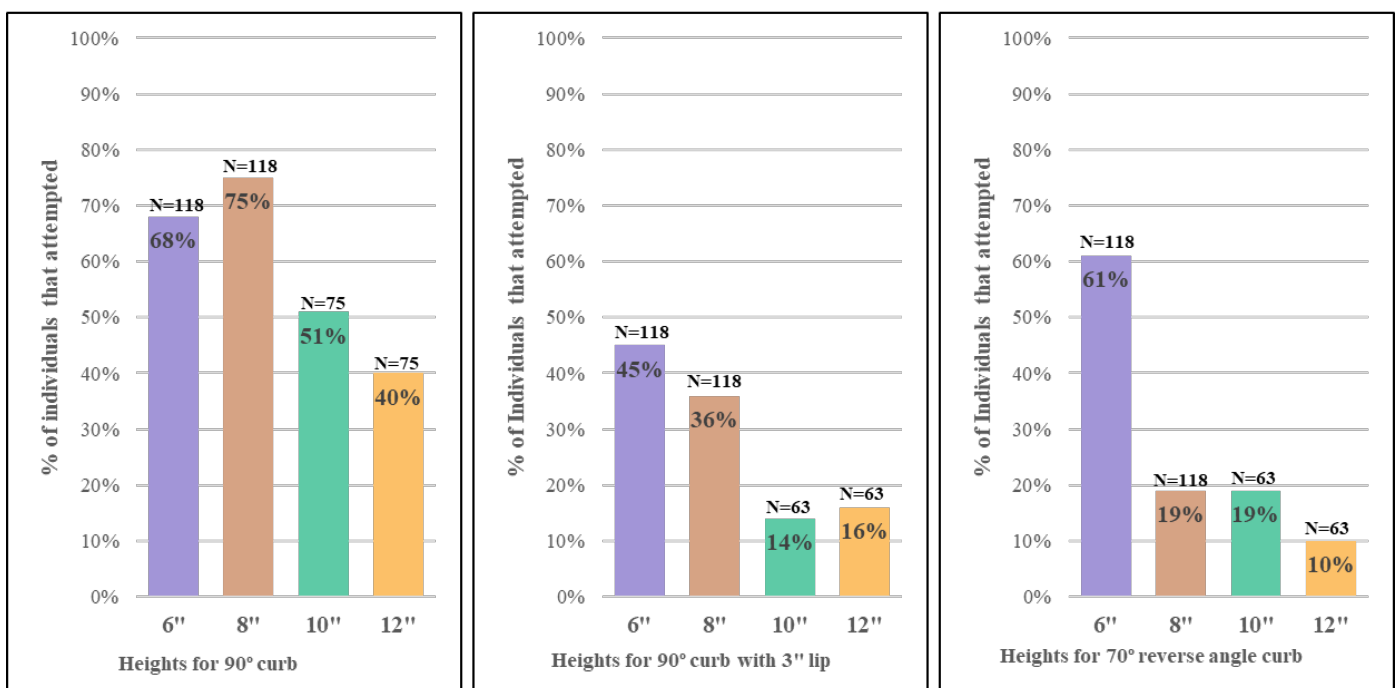
Figure 19. Graph. % of attempted trespasses. Bar graphs showing the percentage of individuals that attempted to climb the 90° curb (Left), the 90° curb with a 3” lip (Middle), and the 70° reverse angle curb (Right).

19% of the 63 terrapins tested attempted to climb the 10” height, and 10% of the 63 terrapins tested attempted to climb the 12” height.

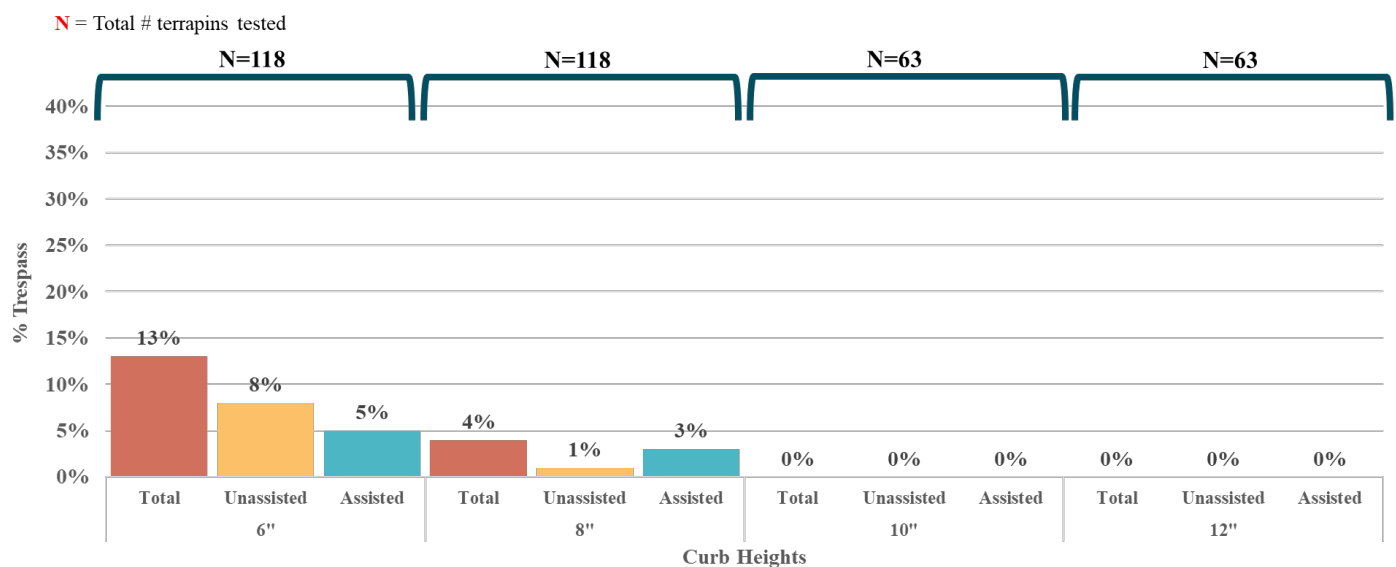
Figure 21. Graph. % of 90° with 3” lip trespasses. Percentage of the total (unassisted and assisted) trespasses on all four heights of the 90° curb with a 3” lip out of all individuals tested on a given height.

Of the 118 terrapins that were tested against the 6” height of the 90° curb with a 3” lip, a total of 13% of them successfully trespassed, with 8% of the trespasses being unassisted and 5% of them being assisted. Of the 118 terrapins that were tested against the 8” height of the 90° curb with a 3” lip, a total of 4% of them trespassed, with 1% of those trespasses being unassisted and 3% of them being assisted. Of the 63 terrapins that were tested against both the 10” and 12” heights of the 90° curb with a 3” lip, no terrapins trespassed either height (Fig. 21).

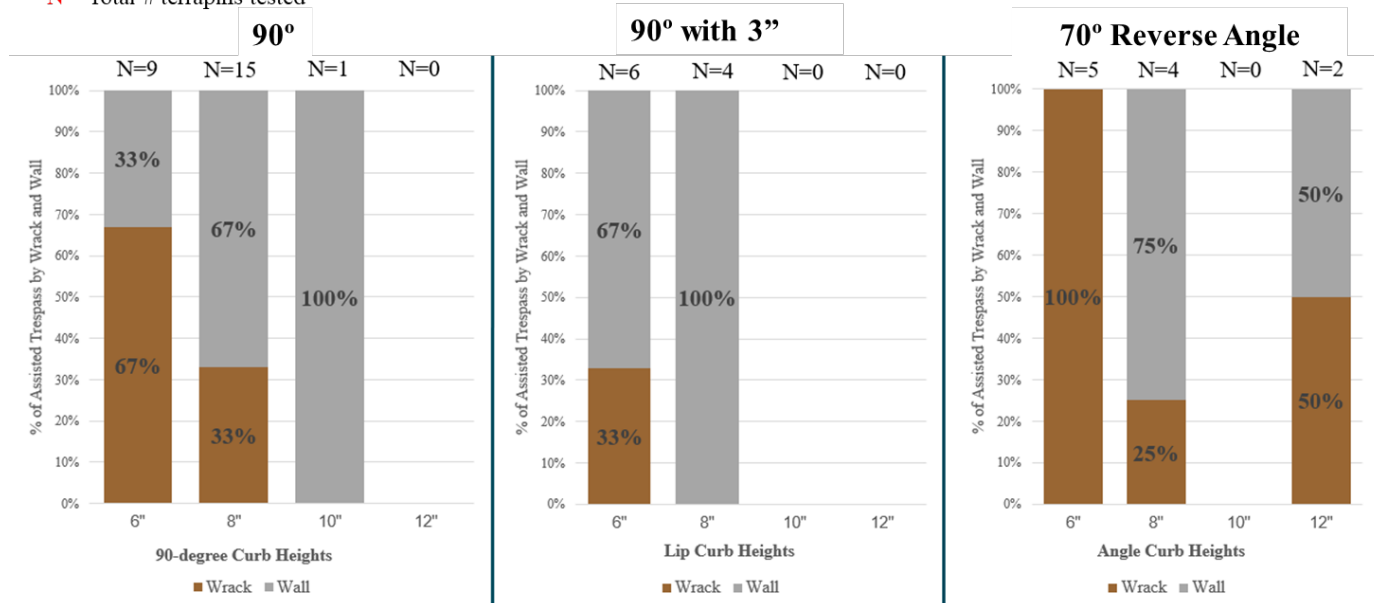
Figure 23. Graph. Total assisted trespasses. Total assisted successful trespasses on all four heights of the 90° curb, the 90° curb with a 3” lip, and the 70° reverse angle curbs. Grey bars represent wall assists, while brown bars represent wrack assists.

Figure 23 shows a series of three bar graphs for each curb design that visualize the total percentage of assisted trespasses and whether they were done using the wrack or the sidewall of the runway trial. N represents the total trespasses, while gray bars represent wall trespasses and brown bars represent wrack trespasses. For the 90° curb, a total of 9 assisted trespasses occurred for the 6" height; 33% of those trespasses were done using the wall, while 67% of the trespasses were done using the wrack. For the 8" height of the 90° curb, a total of 15 assisted trespasses occurred, with 67% of those being done using the wall and 33% of them using the wrack. One assisted trespass occurred on the 10" height of the 90° curb using the wall. No assisted trespasses occurred on the 12" height of the 90° curb. Six assisted trespasses occurred on the 6" height of the 90° curb with a 3" lip; 67% of those were done using the wall, while 33% of them were done using the wrack. Four total assisted trespasses occurred on the 8" height of the 90° curb with a 3" lip, with all of them using the wall. No assisted trespasses occurred on either the 10" or 12" heights of the 90° curb with a 3" lip. Five total assisted trespasses occurred on the 6" height of the 70° reverse
