Final Report

Investigation into the Contributing Factors to the Corrosion of
Steel Reinforced Concrete Structures at Elevations Greater than 12
Feet above the Mean High-Water Line
BDV27–977–18

Submitted to
Florida Department of Transportation
Research Center
605 Suwannee Street
Tallahassee, Florida 32399

January 2023

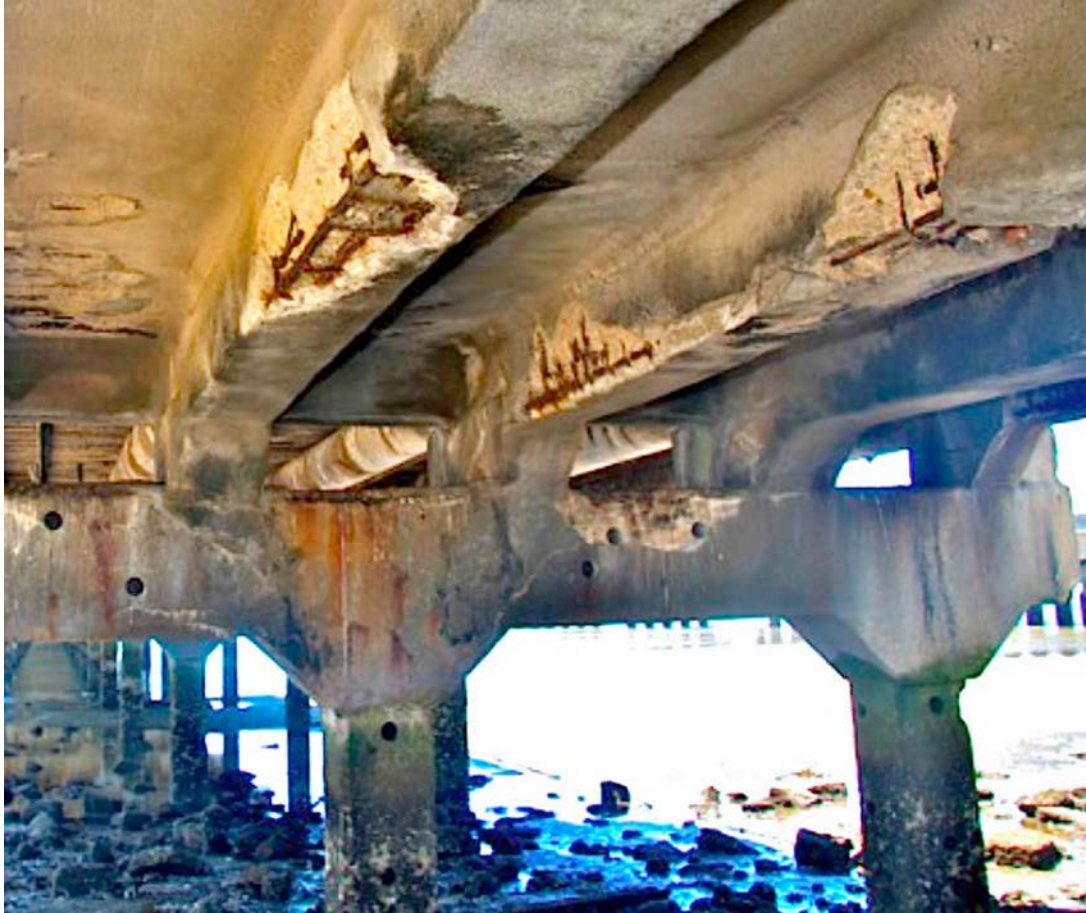
Figure 1. Hornibrook approach bridge; south-facing underside of the bridge [3]

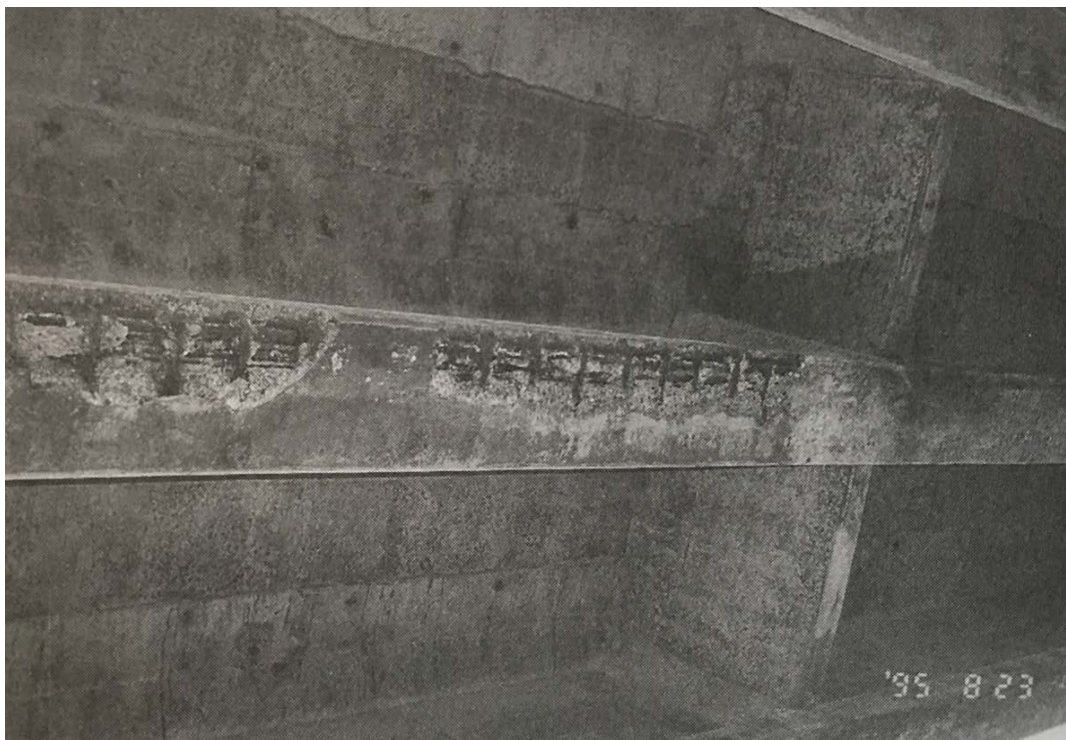
Figure 4. Corrosion damage on main girder on the bridge along the seashore of the Sea of Japan [55]

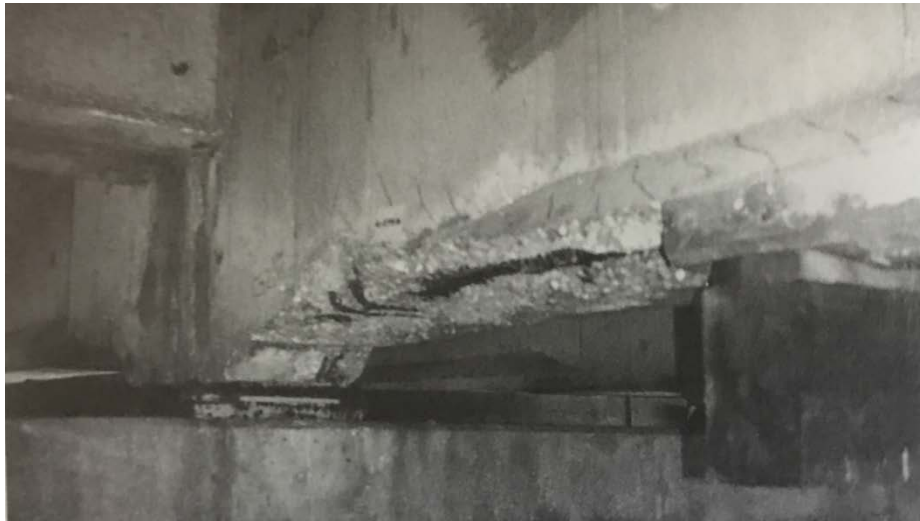
Figure 5. Corrosion damage on post-tensioned beam on Gandy Bridge [57]

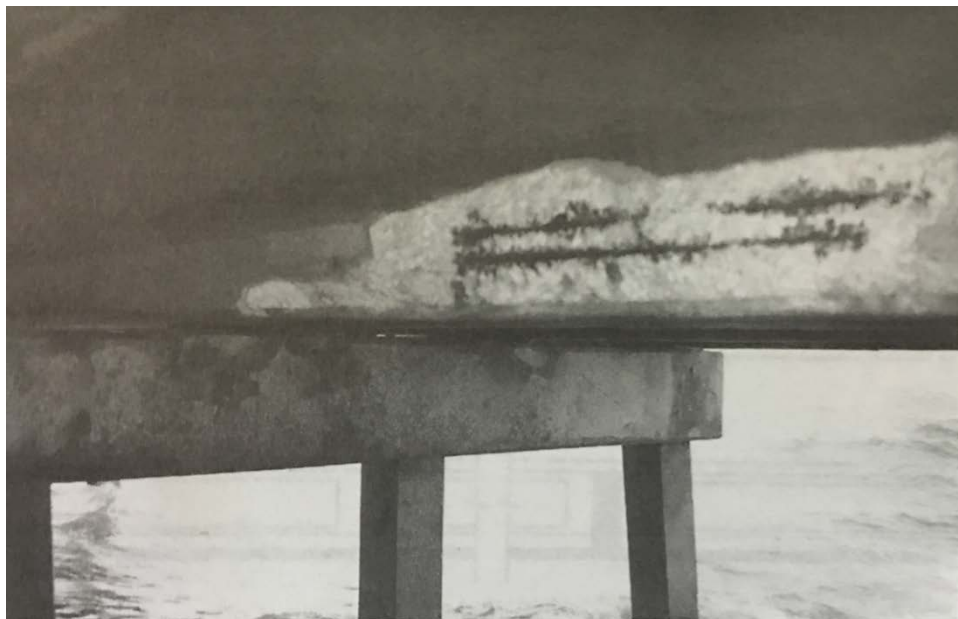
Figure 6. Spalled areas over pretension tendons on abutment span Old SSK bridge [57].

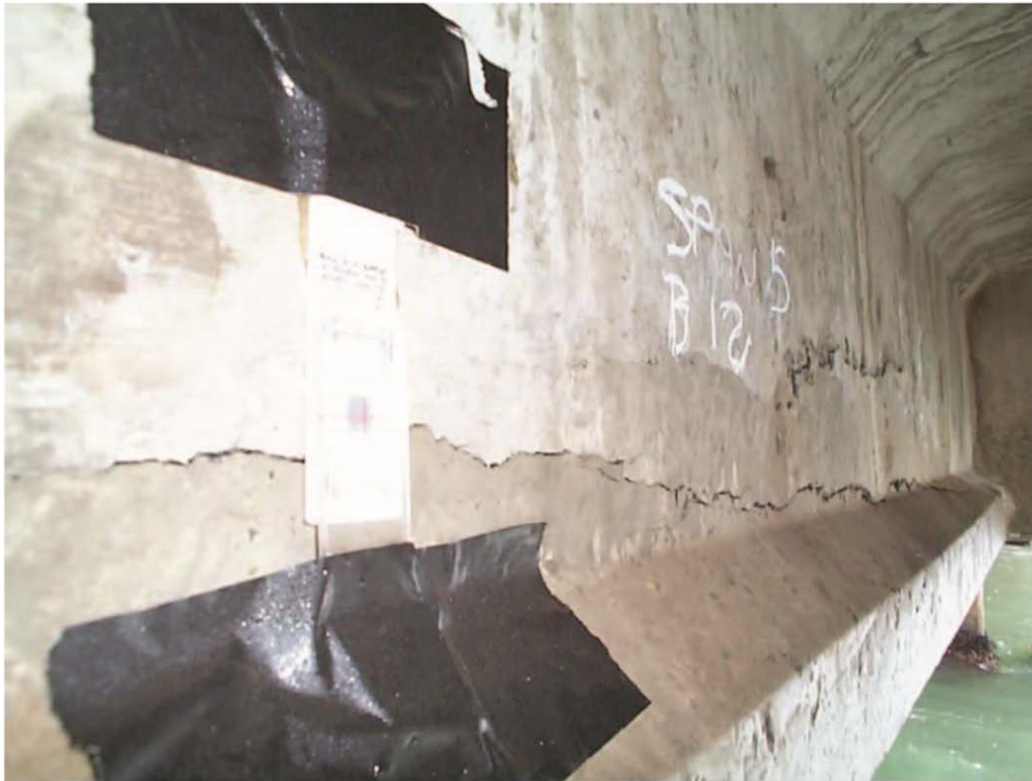
Figure 7. Typical longitudinal web crack along a beam [12]

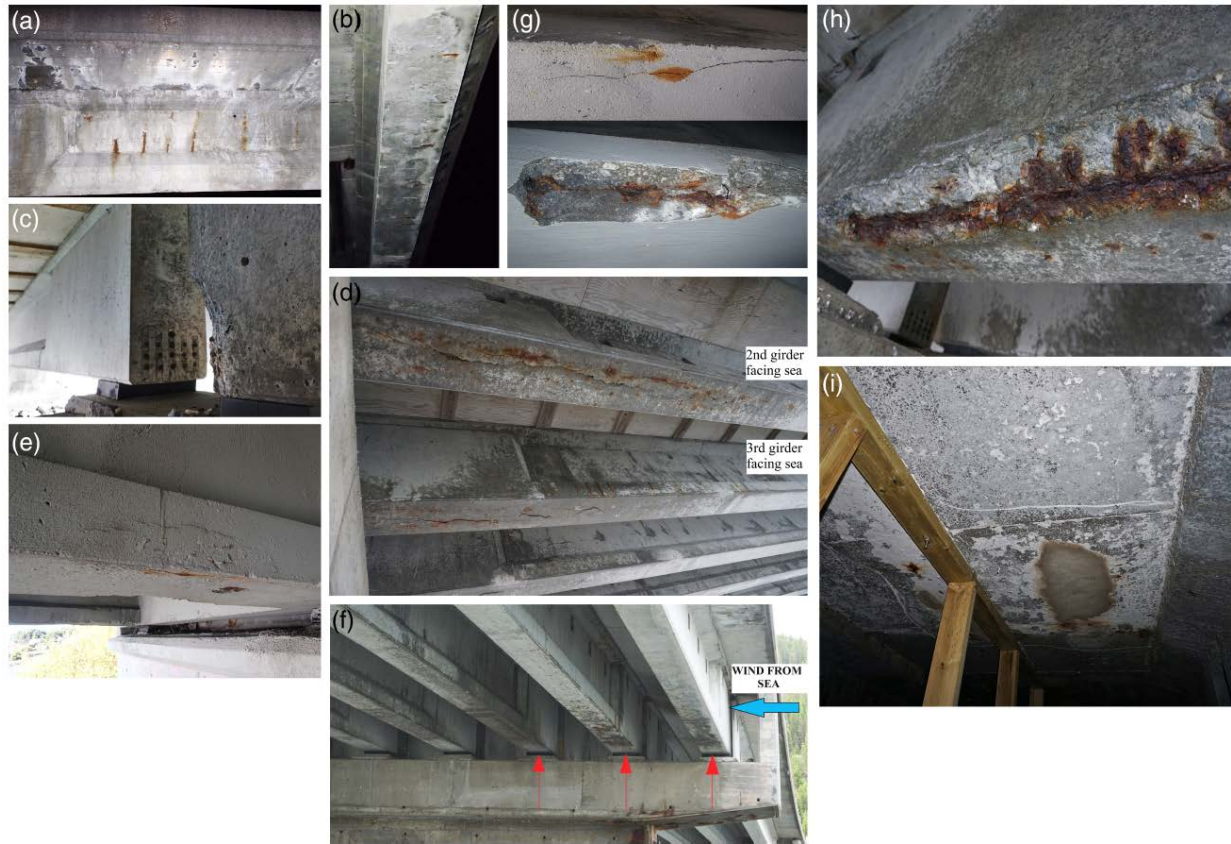
Figure 8. Typical damage reported by Osmolska et al. [1]

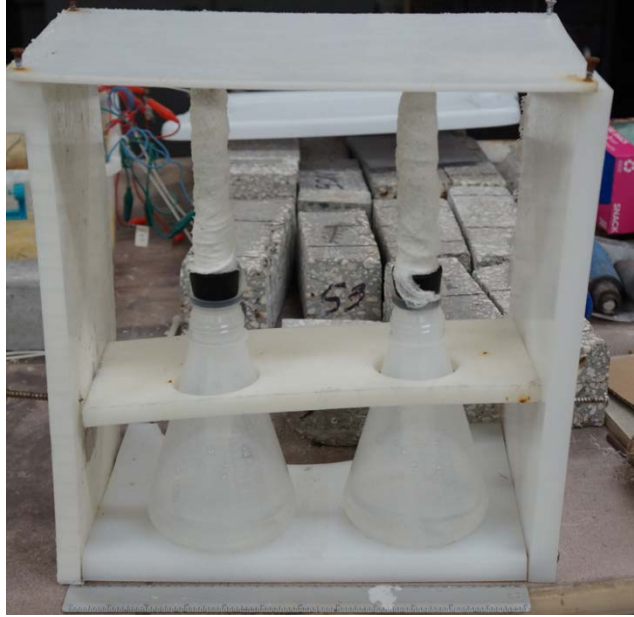
Figure 13. Wet candle setup deployed on the east site, at approximately 12 ft above MHWL.

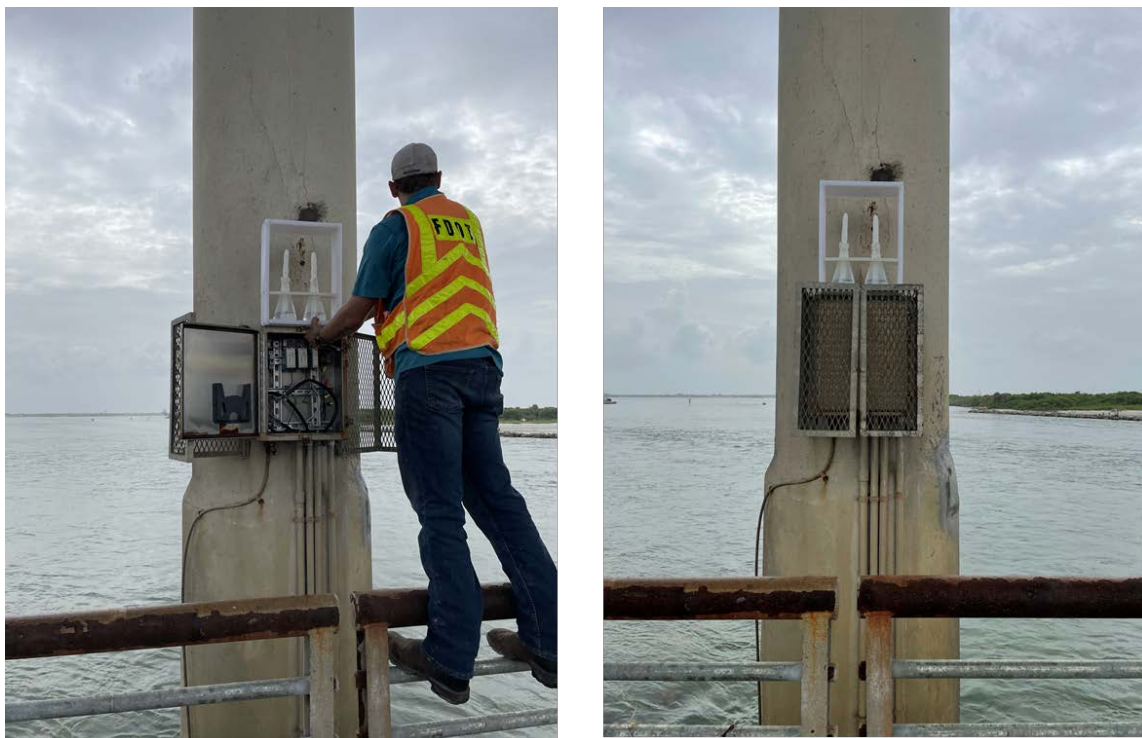
Figure 18. Wet candle setup installed on top of electric box, fishing area (elevation approx. 21 ft MHWL). (Core – fresh patch – was obtained at 22 ft MHWL)

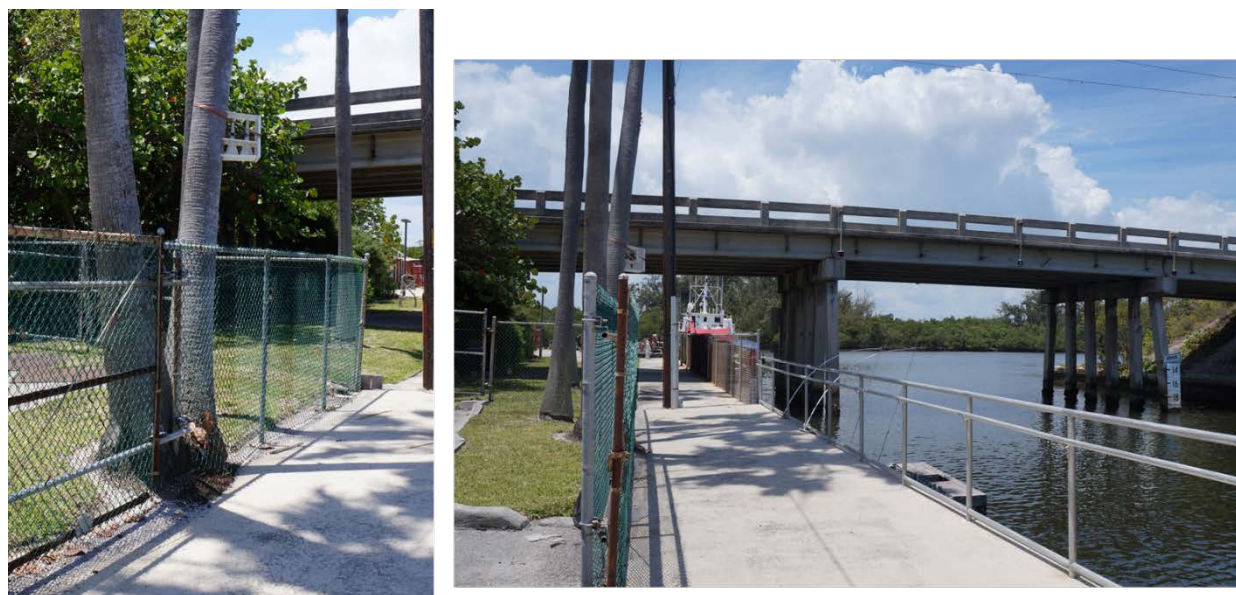
Figure 19. Pictures of the wet candle setup next to bridge #860160. Left closer view of the setup, right with bridge in the image

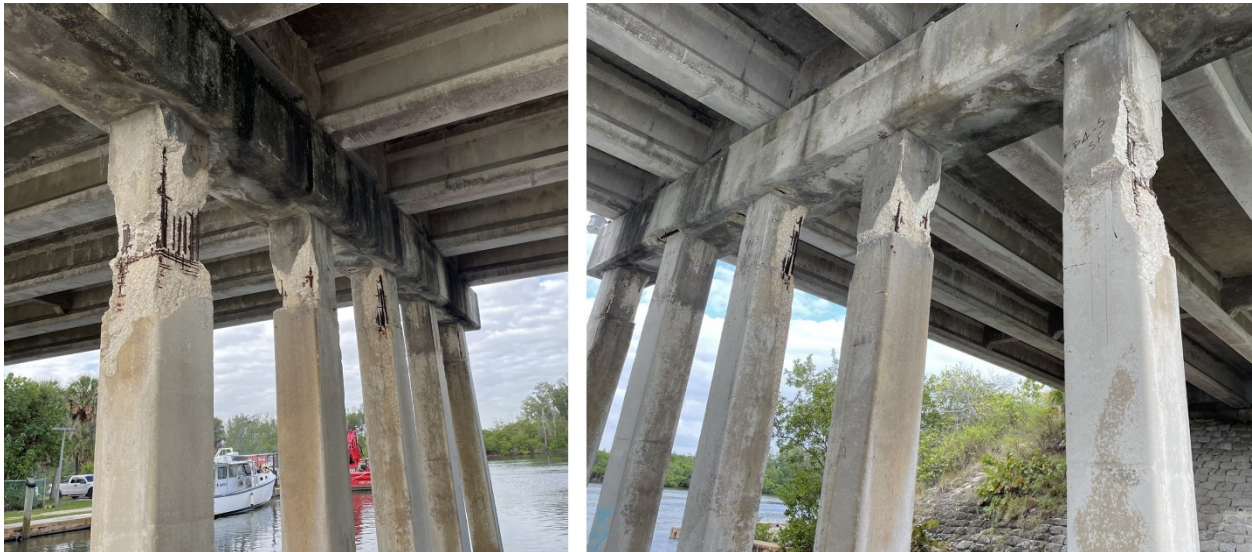
In November 2022, the bridge next to SeaTech was visited, Bridge #860160. The upper part of most piles in Bent 4 show spalls. Figure 5 shows a couple of images of Bent 4 Pile 4-1 to Pile 4-5 from the north and south. The cored pile in Bent 4 was Pile P-4-6 which is the eastern most pile and did not show any spalls. The north and south face were cored (two cores per face). Pile 3-6 was also cored, in this case along the east face. Figure 6 shows pictures after removing the cores on this bridge. The three images show that the reinforcement was reached in all cases. Cores were obtained from regions with the thicker cover.

Figure 62. Bent 4, left image shows north face (piles P4-5 to P4-1), right image south face (P4-5 to P4-1)

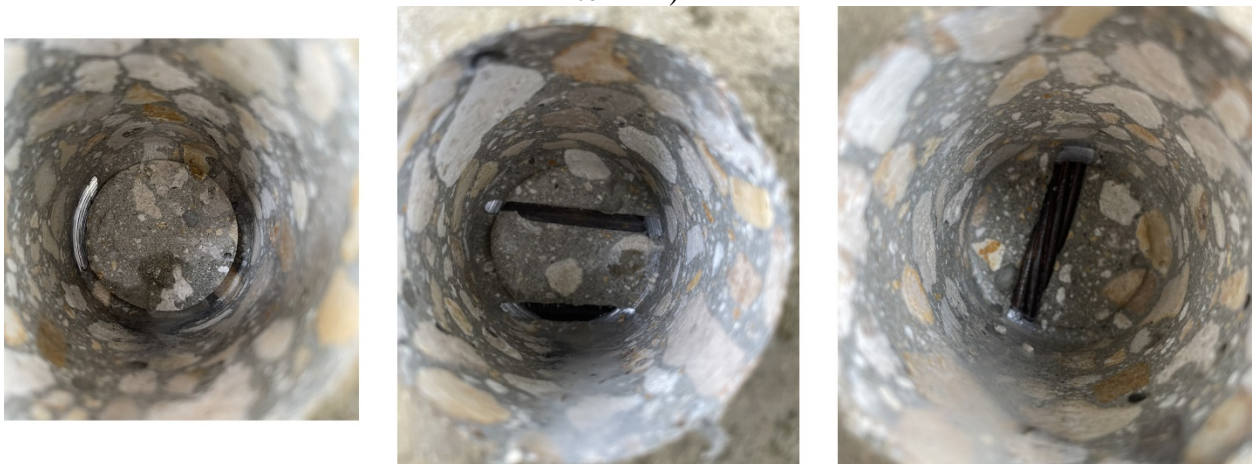
Figure 63. Pictures taken after removing the cores at the bridge in Dania Beach (bridge #860160).

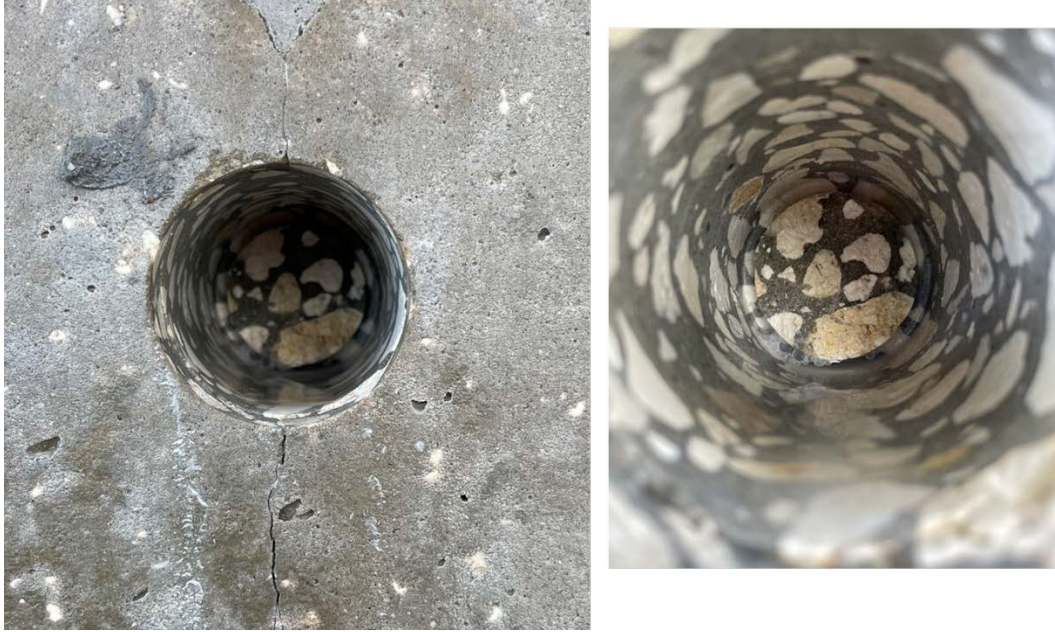
Figure 66. Bridge #100585, images taken after removing core obtained about 5 ft above MHWL, crack was only close to the surface.

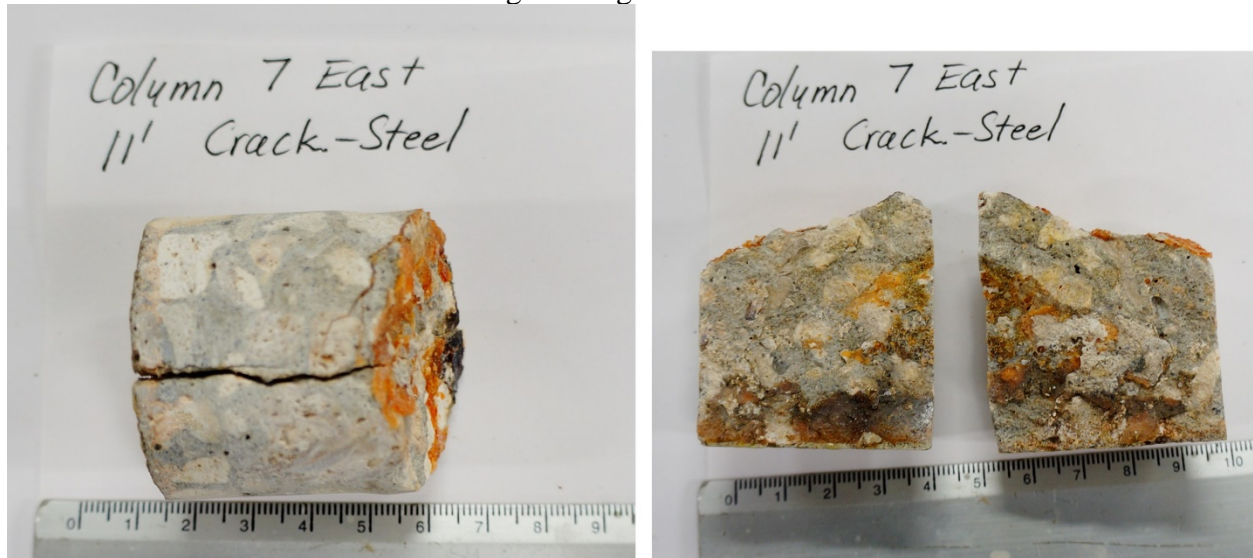
This section shows pictures of selected cores; additional images of the obtained cores can be found in Appendix A. Figure 10 shows pictures of a core with cracks. This core was obtained from the Sebastian Inlet Bridge (Bridge #880005). The corrosion products are orange and brown. Figure 11 shows a core obtained from Bent 8 west column (Sebastian Inlet Bridge) and cored on the east face. This core also shows a crack along the length of the core. Most of the cores had no cracks.

Figure 67. Core obtained column 7 at 11 ft above MHWL

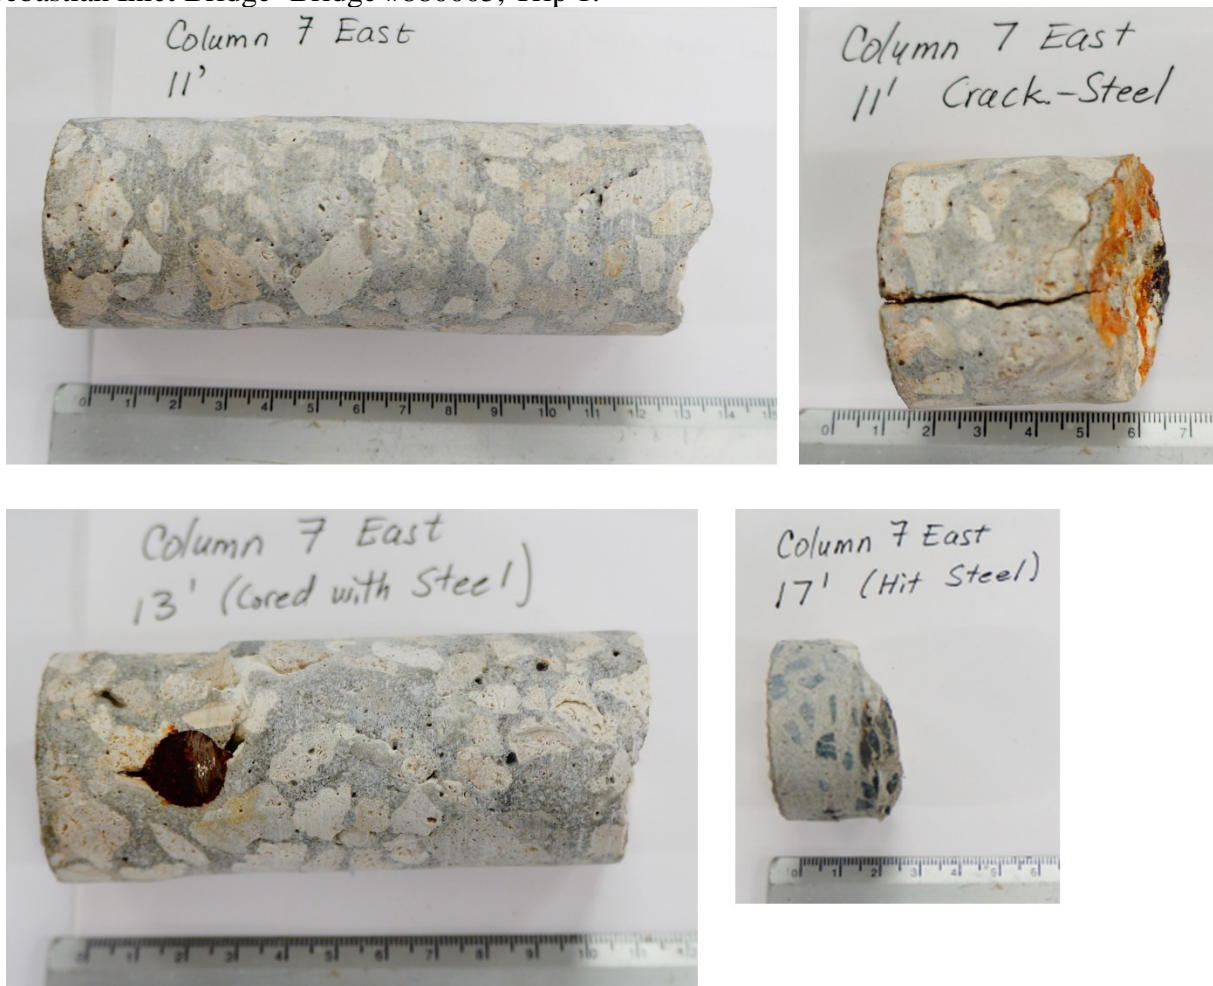
Figure 87. Bent 7 east column east face, Bridge #880005.

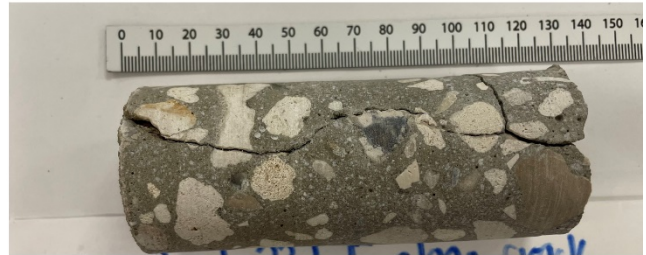
Gandy B, Bent 237 Top – Core with no crack

Gandy B, Bent 237 Top – Core with crack

Gandy B, Bent 237 Bottom – Core with no crack

Gandy B, Bent 237 Bottom – Core with crack

Figure 97. Cores obtained from Bent 237, Bridge #100585.

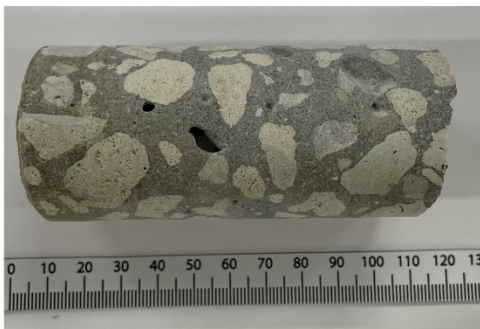
Gandy B, Bent 223 Middle – Core with no crack

Figure 98. Cores obtained from Bent 223, Bridge #100585.
