**TECHNICAL REPORT 0-7012-1**  
TxDOT PROJECT NUMBER 0-7012

# Proposed Design of Internally Redundant Steel Box Straddle Caps

May 2023

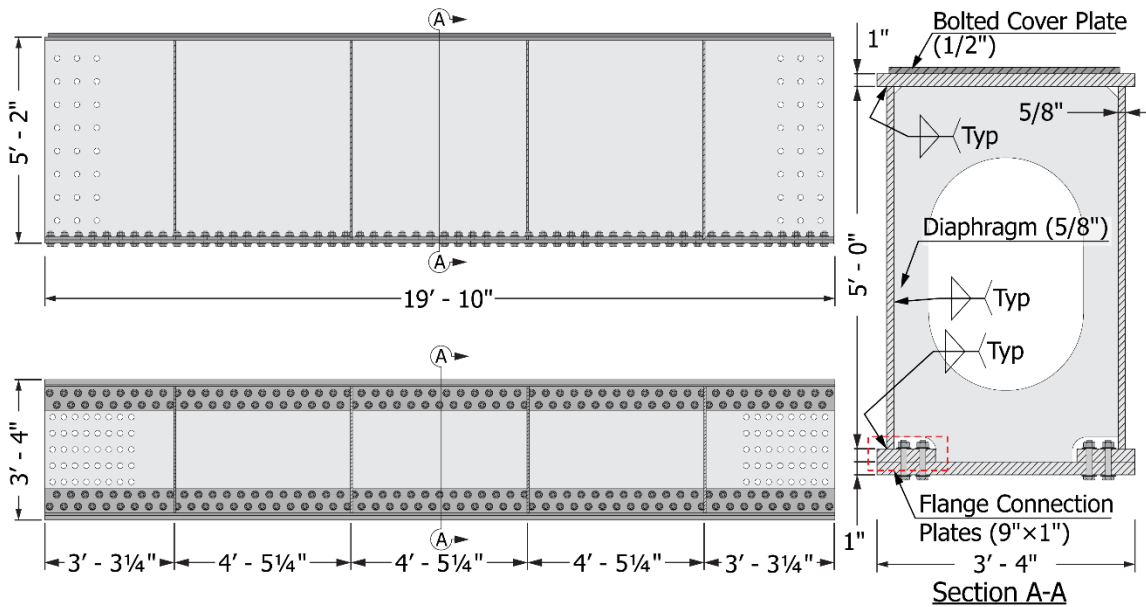
Figure 4.6: Specimen B1 details

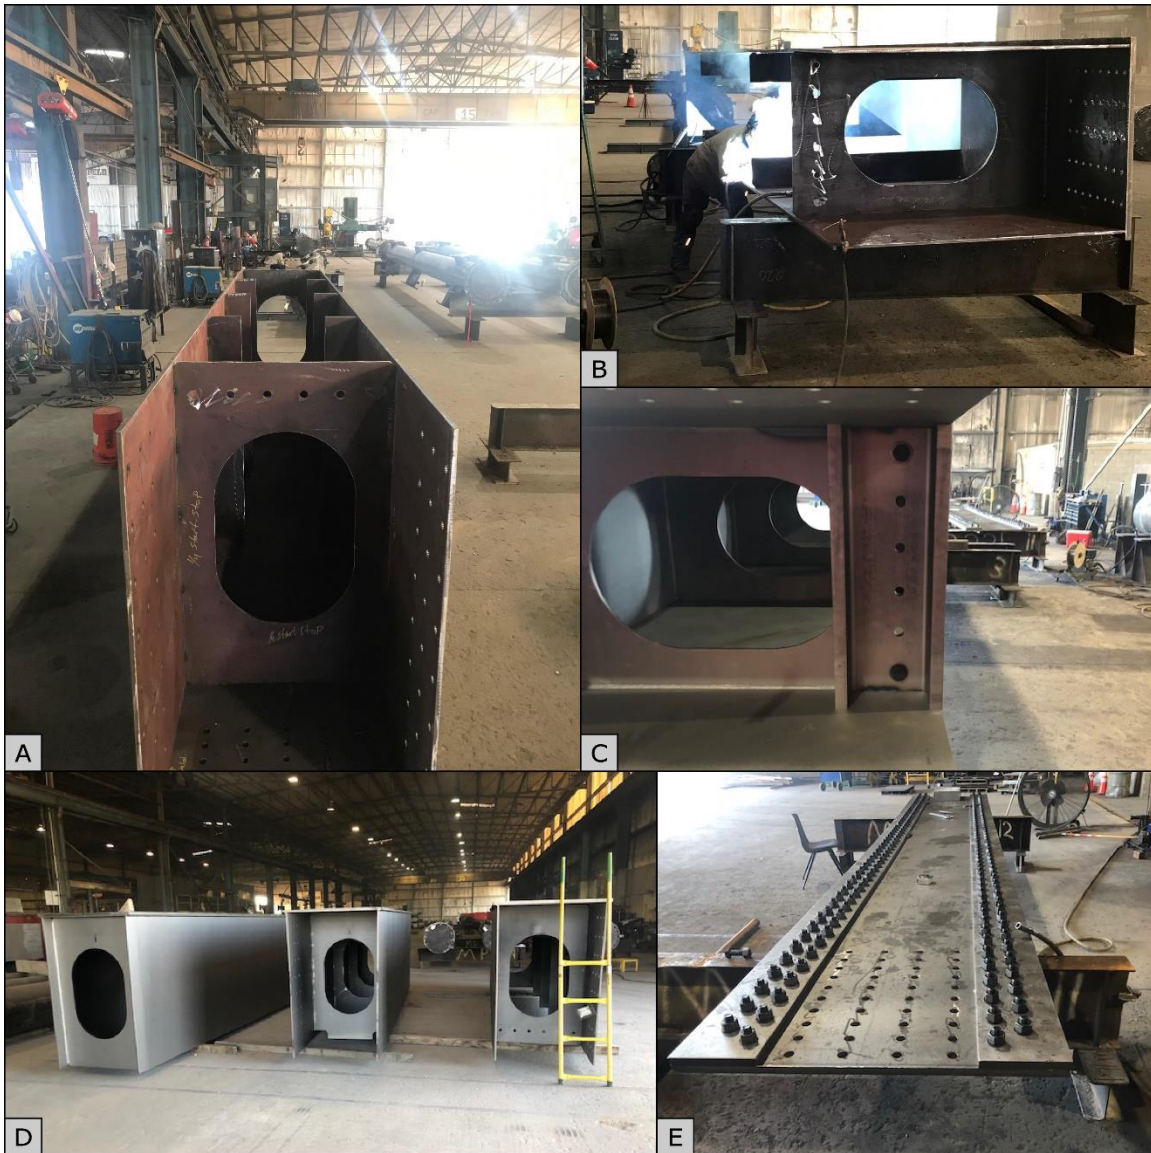
Figure 4.10: Fabrication of test segments at W&W AFCO Steel, San Angelo. Photos courtesy of Daniel Liendo.

W&W AFCO Steel fabricated all the test segments in their San Angelo location according to the applicable requirements of the AASHTO/AWS Fracture Control Plan (AASHTO/AWS 2015). Some stages of the fabrication process are shown in Figure 4.10: (A) the welding of the top flange to the webs using the internal diaphragms to maintain the shape of the box; (B) the section flipped on one side to facilitate the welding of the internal diaphragms and stiffeners; (C) the welding of the channel sections on Specimen A to anchor the PT bars; (D) segments ready to weld the bottom flange plates; and (E) bottom flange plate bolted to the flange connection plates for -Specimen B1- ready to be welded to the upper portion of the section.

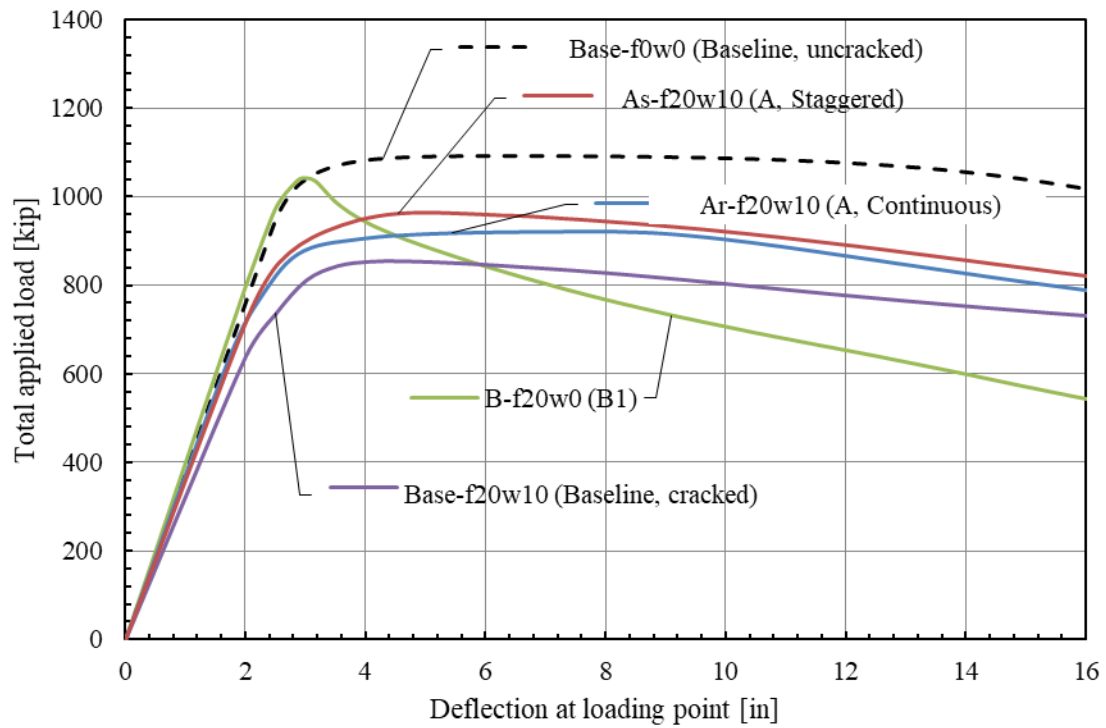
Figure 4.26: Load versus deflection curve for models with cracks that extend through half of the width of the bottom flange for all models and 10 in. in the web in the Baseline and Specimen A models.

Load-deflection curves for two different crack scenarios are shown in Figure 4.26 and Figure 4.27. In the cases displayed in Figure 4.26, the bottom flange is assumed to have a crack of 10 in. from each edge, corresponding to the case where one-half of the total width of the bottom flange is cracked. Therefore, the web crack length is defined at 10 in. from the intersection with the bottom flange (Figure 4.18-Center). The curves include a label “A” or “B” to depict the behavior of the two different concepts, with “A” representing the PT bar models and “B” representing the bolted bottom flange approach. As mentioned in Section 4.2, it was assumed that the crack could not propagate to the webs in Specimen B; therefore, the web crack is set at 0 in.

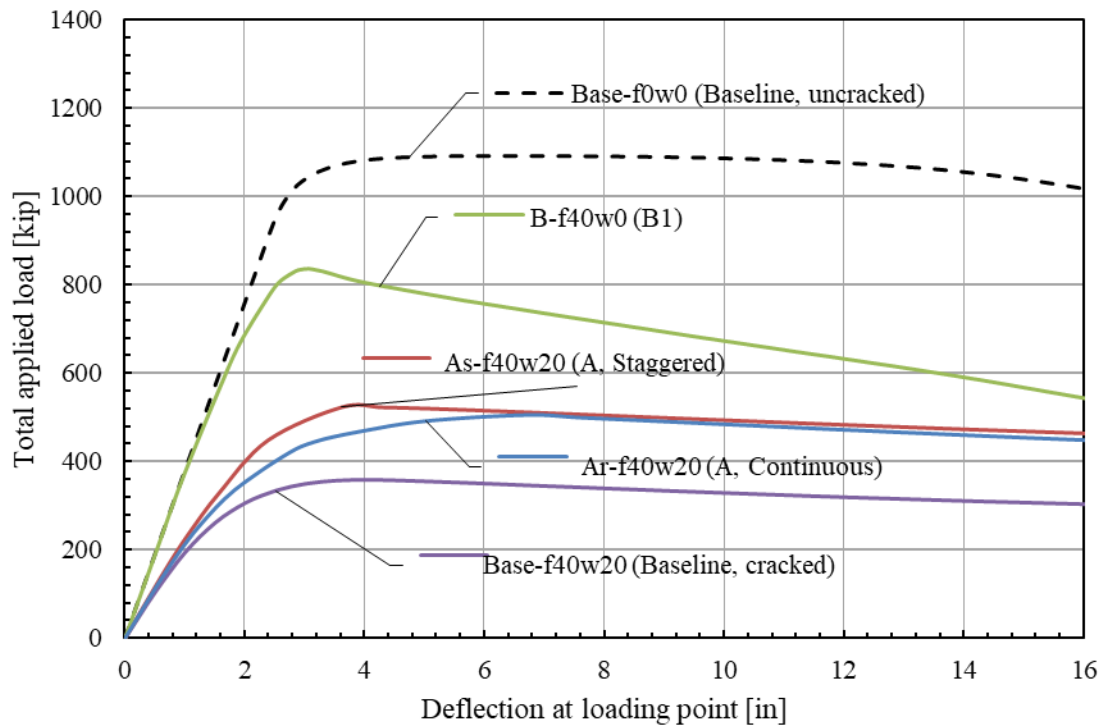
Figure 4.27: Load versus deflection curve for models with cracks that extend through the entire width of the bottom flange and 20 in. on the web in the Baseline and Specimen A models.

In Figure 4.27, the entire width of the bottom flange is considered cracked, and, except for Design Concept B, the web crack length is set at 20 in.

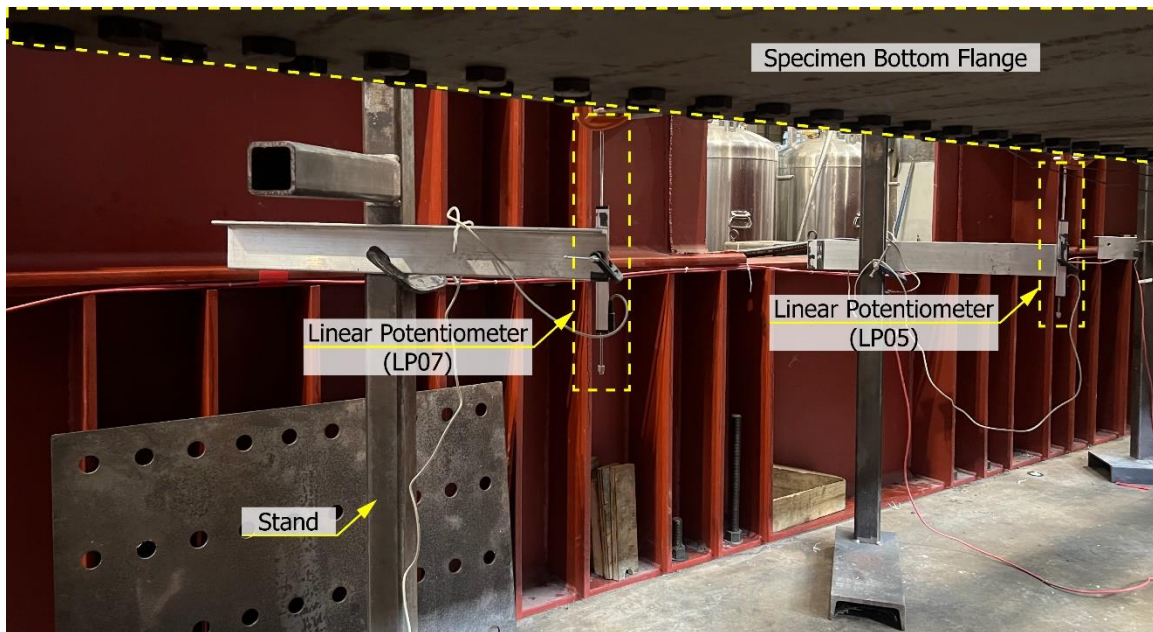
Figure 4.40: Instrumentation: linear potentiometers attached to the underside of the bottom flange

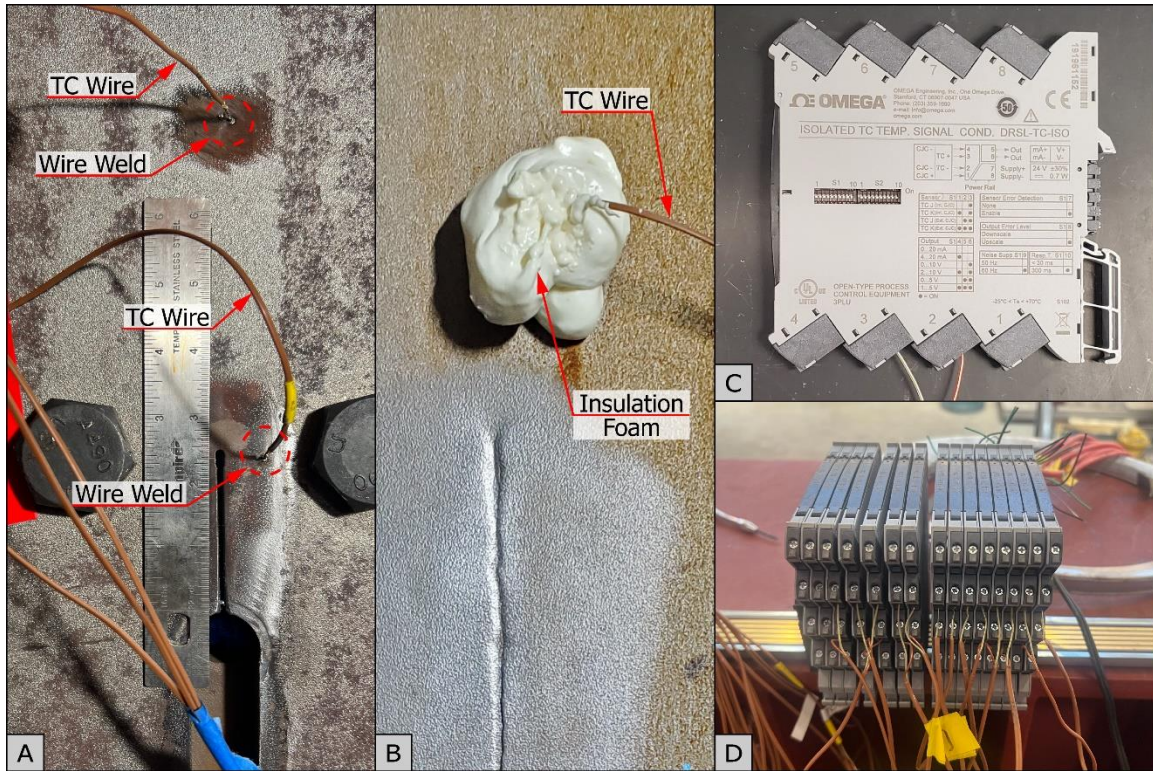
Figure 4.41: Instrumentation for temperature monitoring: (A) TC wires welded to the bottom flange of specimen B2; (B) TC wire tip insulated with foam; (C) Omega DRSL TC ISO Signal conditioner; and (D) stack of signal conditioners wired to the power supply and DAQ.

The temperature in the vicinity of the crack section was monitored as the liquid Nitrogen was poured inside the specimen using Type-K thermocouple wires welded to the outer faces of the webs and bottom flange (Figure 4.41-A). The tip of each TC wire was insulated with foam sealant to prevent eddy currents produced by the temperature difference between the specimen and the surrounding air from altering the temperature readings (Figure 4.41-B). Each wire was connected to an Omega DRSL TC ISO signal conditioner wired to the data acquisition system (Figure 4.41-C and D). Each signal conditioner read the voltage difference between the Chromel and Alumel wires and produced a normalized output voltage that the DAQ recorded.

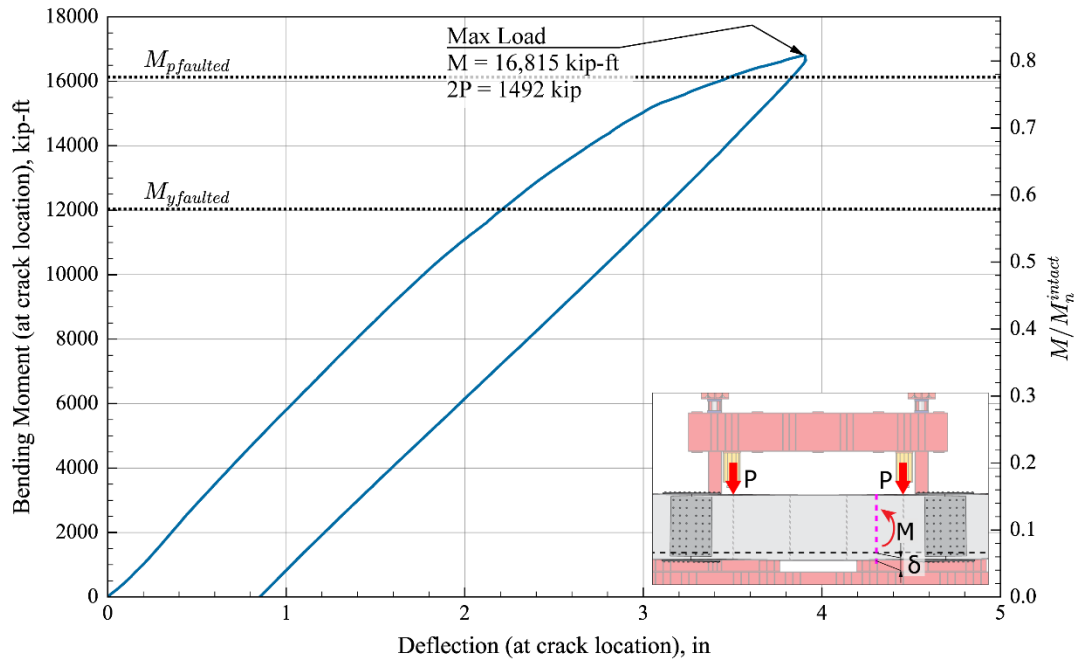
Figure 5.38: Specimen B2 Ultimate Strength Test: bending moment versus deflection at the cracked section

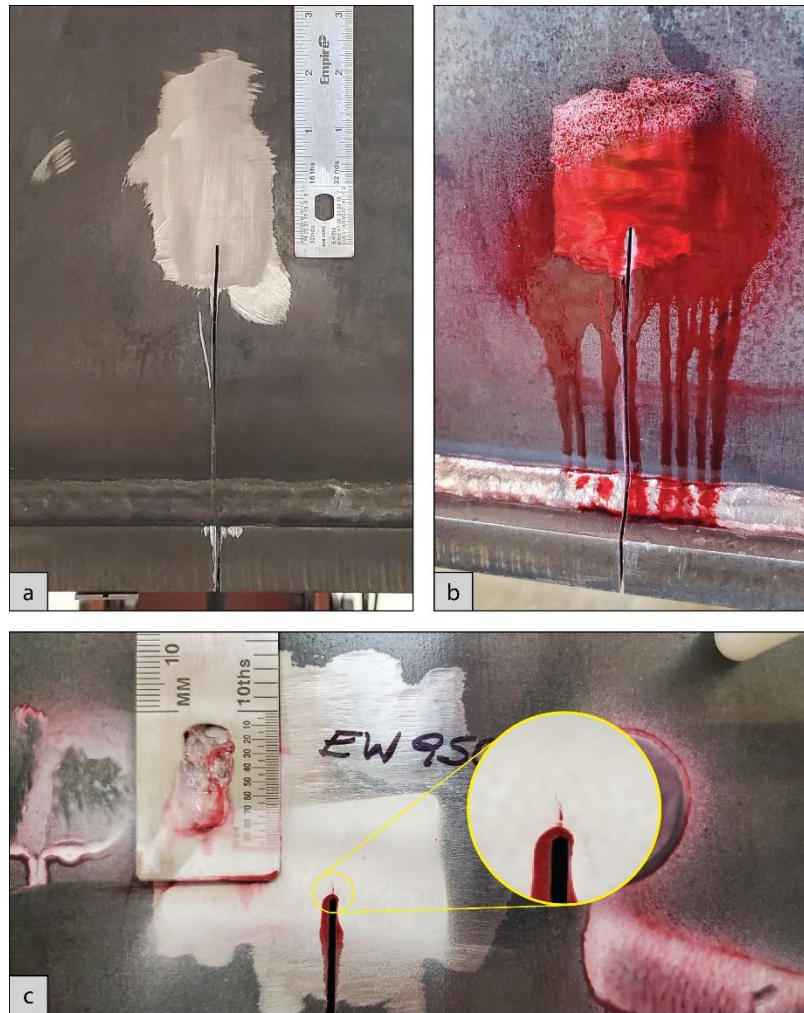
Figure B.13: Crack inspection using dye penetrant method. (a) Notch tip area polished and cleaned; (b) application of penetrant dye on the notch tip area; (c) developer application that allows the observation of the fatigue crack.

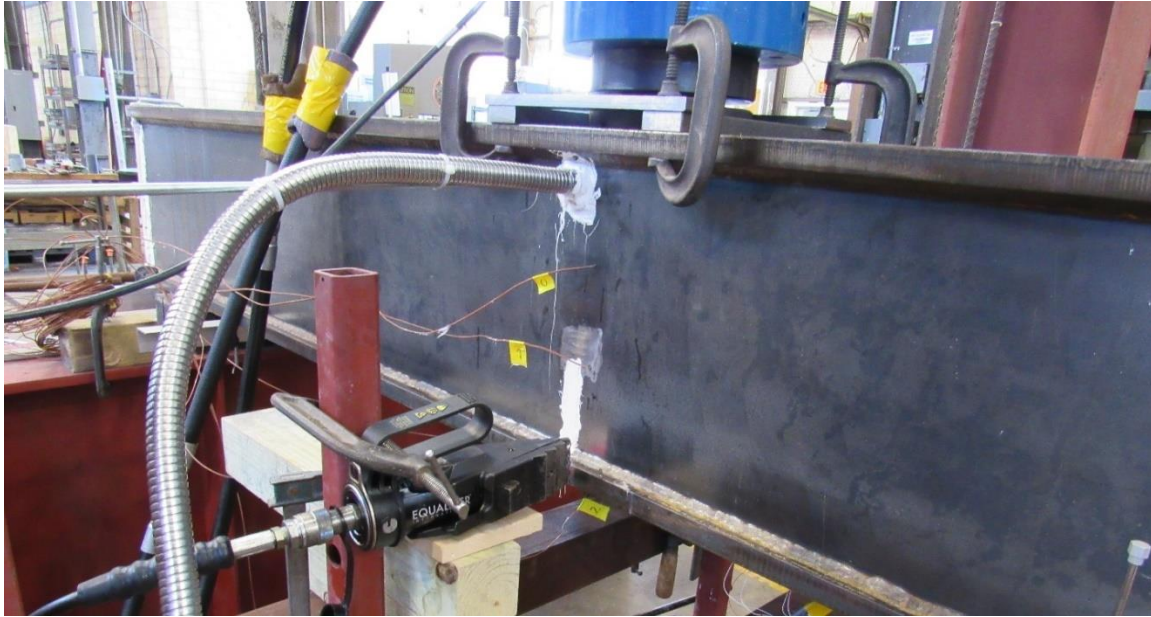
*Figure B.14: Cryogenic hose inserted through the West web of the specimen (there is another cryogenic hose going through the opposite web).*

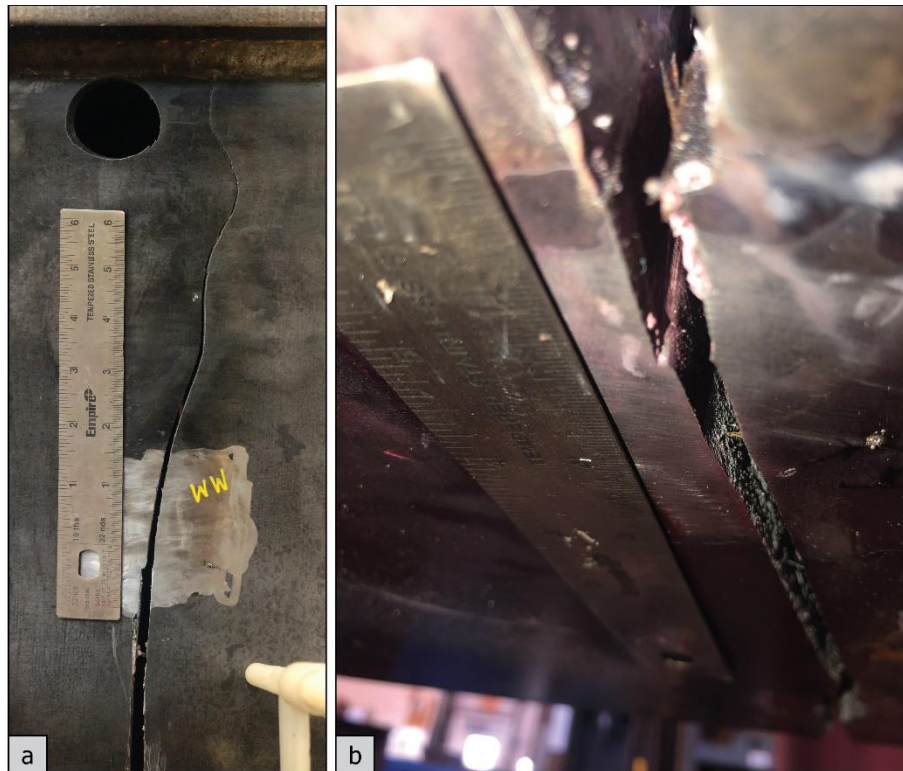
Figure B.22: Fracture obtained in the West web (a) and bottom flange (b)
