**ELUCIDATING SNOW HEIGHT FOR AVALANCHE
ASSESSMENT THROUGH AUTOMATED DATA
PROCESSING FROM A REMOTELY PILOTED AIRCRAFT
SYSTEM AND AUGMENTED WITH AN ADVANCED ROAD
WEATHER INFORMATION SYSTEM**

FINAL PROJECT REPORT

Eyal Saiset
University of Alaska Fairbanks

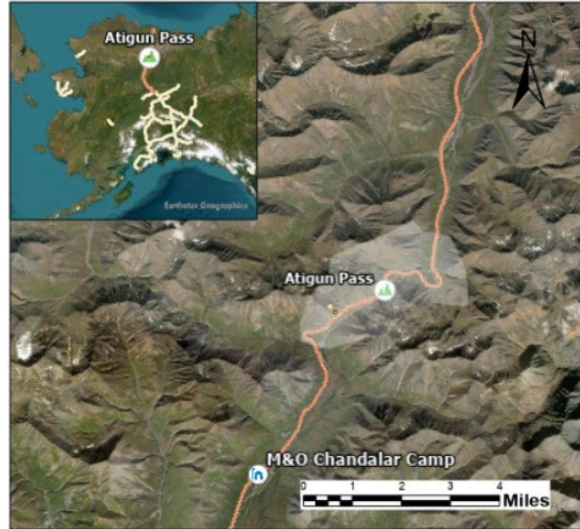
Figure 1.1. The Atigun Pass study area in northern Alaska. The Dalton Highway is a longitudinal highway connecting Interior Alaska with the Arctic Ocean. The road crosses the Brooks Range in Northern Alaska, above the Arctic Circle.

This project built on the knowledge and infrastructure that Beltz and McCormack (2019) laid and continued focusing on Atigun Pass in Alaska's Brooks Range. The Dalton Highway (brown-colored) crosses the Brooks Range at Atigun Pass (Figure 1.1). The highway connects Alaska's Interior with industry in northern Alaska. The highway enables year-round traffic of both heavy tractor-trailers and private vehicles. These trucks provide critical supply from the mainland to the Arctic coastline.

Atigun Pass avalanches prevent access to the northern sections of the Dalton Highway and the state. ADOT&PF has a Maintenance and Operations (M&O) camp (Figure 1.1), Chandalar Shelf Camp, at the south foothills of Atigun Pass. This M&O camp is dedicated to maintaining highway trafficability between Chandalar Shelf and Atigun Pass. The staff spends many personnel-hours during winter keeping Atigun Pass open to traffic. Much of the M&O staff activity in winter involves removing avalanches or snowdrift debris from the highway.

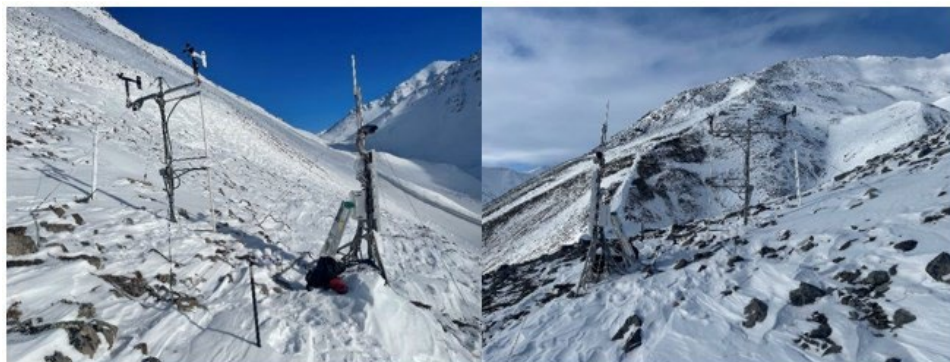
The site and the ARWIS station, as well as the views in both directions, are depicted in Figure 2.2. In Figure 2.2 on the left panel, looking northeast, one can notice Atigun Pass in the distance and where the winds that generate blowing snow originate. One can also notice the highway below the station.

Figure 2.2. Left: Picture of the ARWIS orientated northeast, with Atigun Pass at the top. Right: Picture of the ARWIS-oriented southwest, with the 115th behind the ARWIS over the edge.

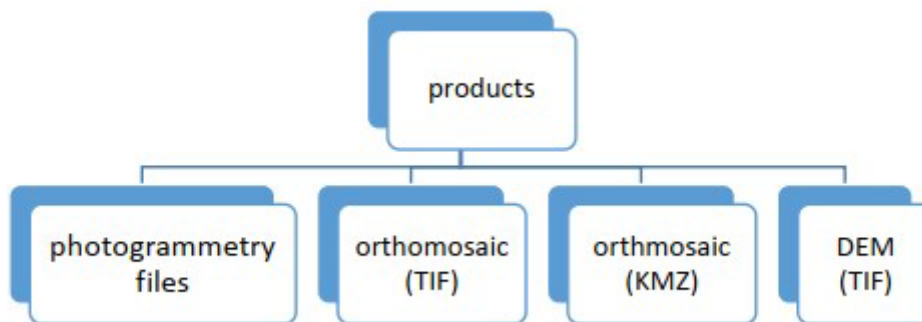
At the end of the photogrammetry step, APSI saves the relevant data in a new products folder, as discussed earlier. In the products folder are the photogrammetry required files and products in various file formats (Figure 2.5). The products are the orthomosaic and DEM in a TIF format to be read by any geospatial software. The orthomosaic is in a KMZ format that is more user-friendly and can be viewed in the Google Earth tool.

Figure 2.5. An example of the APSIR products output and data hierarchy.

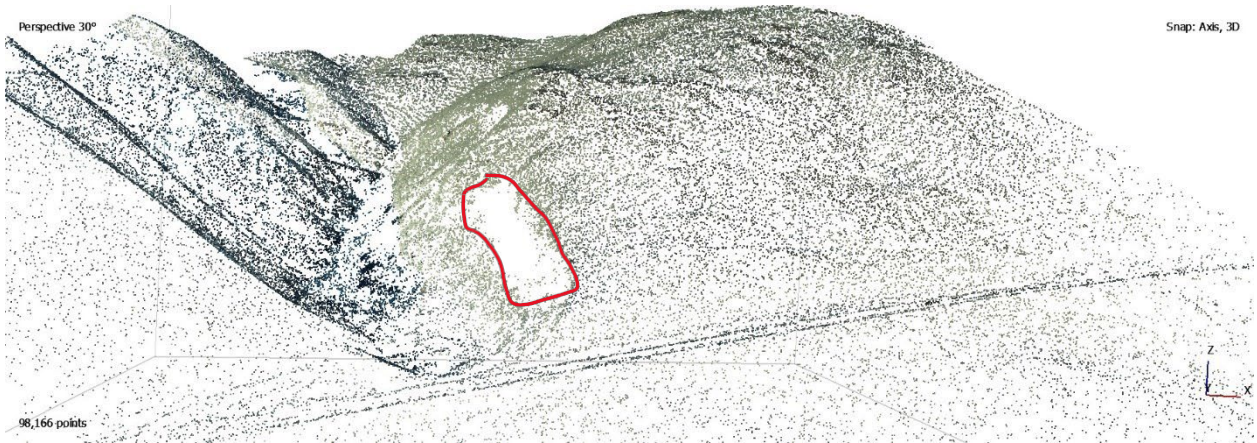
There was an increase in detail by February 4th, as seen in the sparse area in Figure 3.3. Here, the gully was better mapped with a higher number of tie points. But there a cavity still existed (bounded in a red line).

Figure 3.3. The sparse point cloud of couloir 115 as captured on February 4th.

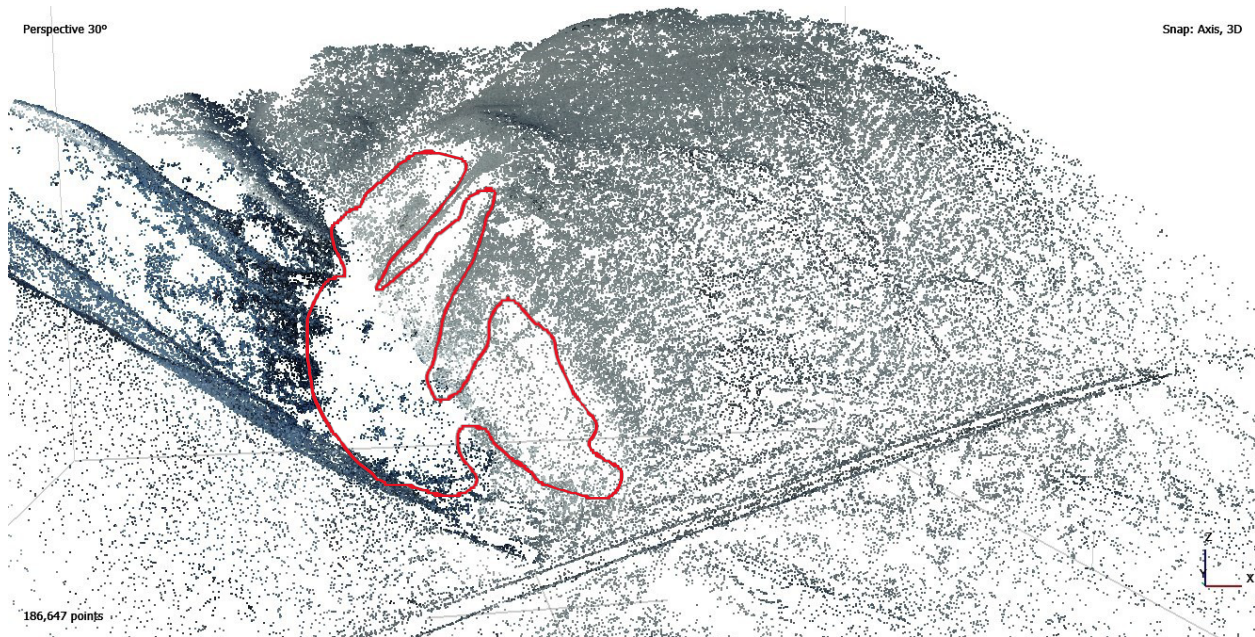
Despite the increase in light by March 7th, a smoother surface due to new snow and the presence of the shadow in the valley created a larger cavity in the data (Figure 3.4).

Figure 3.4. The sparse point cloud of couloir 115 as captured on March 7th.

The low number of tie points in the gully and the windward sidehill resulted in large voids. The Metashape photogrammetry software filled the voids by using interpolation. By default, Metashape fills the voids by using interpolation unless instructed otherwise. Without the software filling these voids, it would be difficult to assess snow conditions in the gully. However, it is unknown how representative that interpolation is, particularly in areas of steep change in elevation, such as a sidehill.

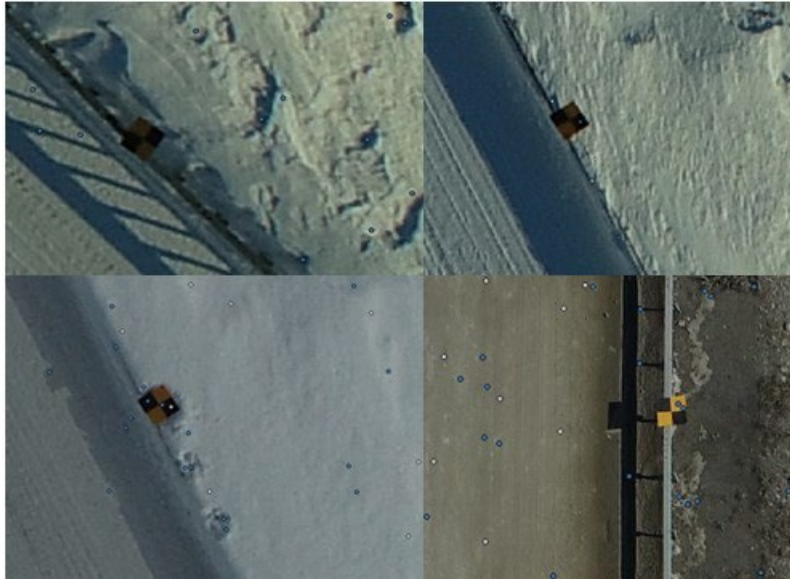
detect the GCP and manual selection was required. The principal failure of the GCP autodetect tool was due to the bright, snowy background and the darker GCP (Figure 3.5). Therefore, the GCP ended up being underexposed and undetectable. In the figure, the top panels have bright snow in the background; therefore, the GCPs were undetected. However, the lower panels are pictures of locations where the GCPs were successfully detected. Darker snow scenes or snow-less backgrounds seemed to be more conducive to GCP autodetect success.

Figure 3.5. A collage of pictures collected from the RPAS of a GCP on the guardrail. From upper left clockwise: February 4th, February 11th, March 3rd, and April 29th. Among the four pictures, only the GCPs at the bottom of the figure were automatically detected by Metashape.

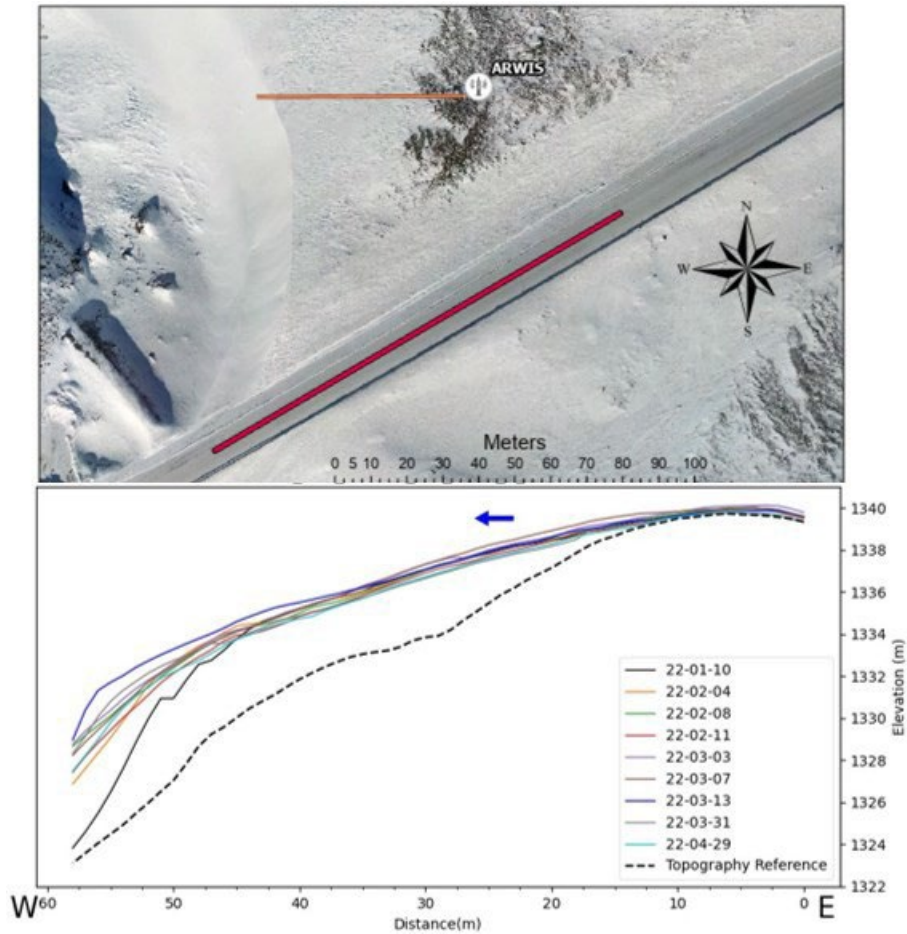
Couloir 115 doesn't avalanche on the Dalton Highway; however, because it collects snow downwind from the AWRIS, it was a case study site for exploring snow accumulation, erosion, and avalanche due to snow precipitation, wind, and blowing snow. It was our hope that couloir 115 could serve as an analogy to couloir 112, which does avalanche on the Dalton Highway. The cross-section of the eastern side of the couloir 115 is seen in Figure 3.8 in the two panels. The figure's upper panel depicts the cross-section's spatial extent in orange. The bottom panel depicts the snow surface height (elevation) as captured by the RPAS during the period of January 10th to April 29th. A blue arrow depicts the prevailing strong winds transporting the bulk of the snow.

Figure 3.8. Upper panel: The cross-section is in orange, and the road height measurement is in red along couloir 115 over the orthomosaic. Bottom: The stacked DEM cross-section profiles are labeled with the survey collection date. The blue arrow depicts the prevailing strong wind direction.

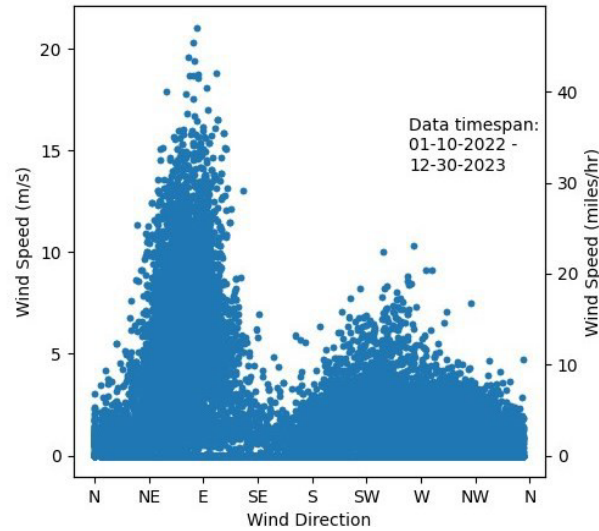
Wind transporting snow into couloirs is the prominent cause of avalanches in Atigun Pass. Therefore, we explored wind, as measured by the ARWIS. The most representative wind speeds and directions on the south side of Atigun Pass were measured by the ARWIS, depicted in Figure 3.11.

Figure 3.11. A year-long collection of wind speeds and directions at the ARWIS station.

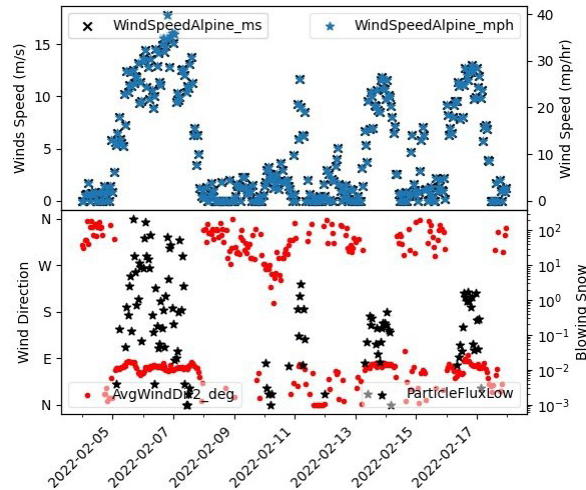
Blowing snow flux is generally a function of wind speed. This is nicely seen in Figure 3.12. The upper panel depicts measured wind speed, and the lower panel shows wind direction on the left (red) and blowing snow (black) on the right.

Figure 3.12. Upper panel: Measured wind speed in meters per second and miles per hour. Bottom panel: Measured wind direction on the left (red), and the measured blowing snow (in black) on the right.

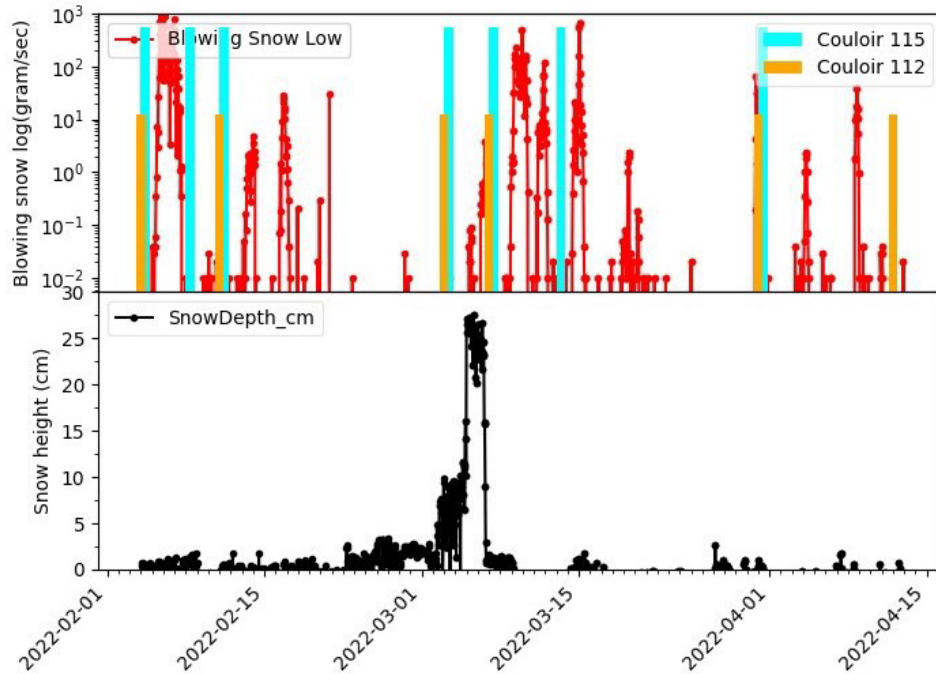
Blowing snow, wind speed, and snow height data from AWRIS between January 10th and April 15th are depicted in Figure 3.13. This is the period when the bulk of the RPAS surveys were conducted.

Figure 3.13. Upper panel: measured blowing snow (in red) and the RPAS survey dates (in cyan and orange) over the studied season. Bottom panel: The ARWIS measure of snow height during the respective study period.
