FINAL REPORT FOR IHRB TR-719

# DEVELOPMENT OF SELF-CLEANING BOX CULVERTS

Phase III

**M. Muste, H. Xu**  
IIHR-Hydroscience & Engineering, The University of Iowa  
Iowa City, IA 52242-1585

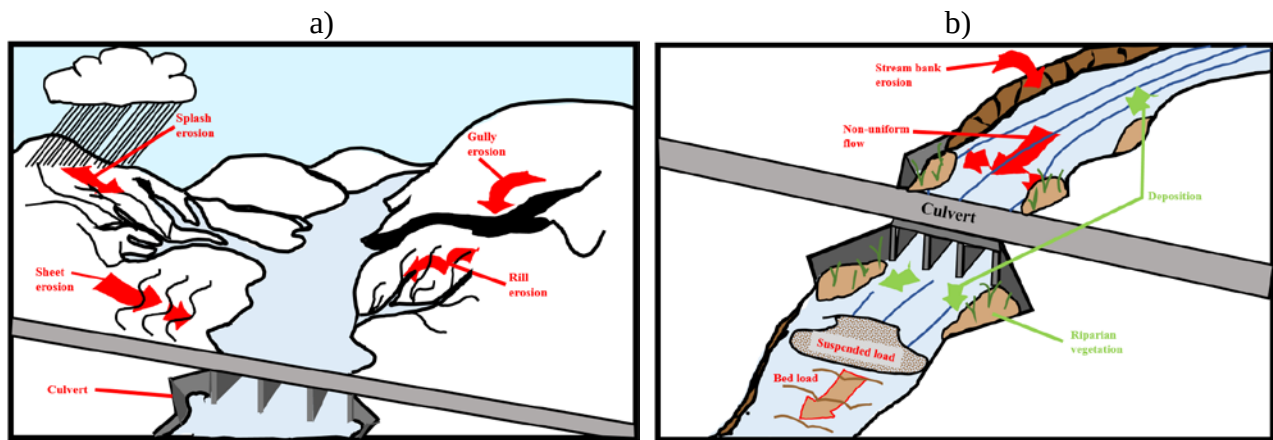
Figure 1. End-to-end culvert sedimentation processes: a) soil detachment (sediment production and overland transport) in the culvert drainage area; b) in-stream sediment transport to culvert vicinity and deposition processes in the vicinity of the culvert (Muste and Xu, 2017).

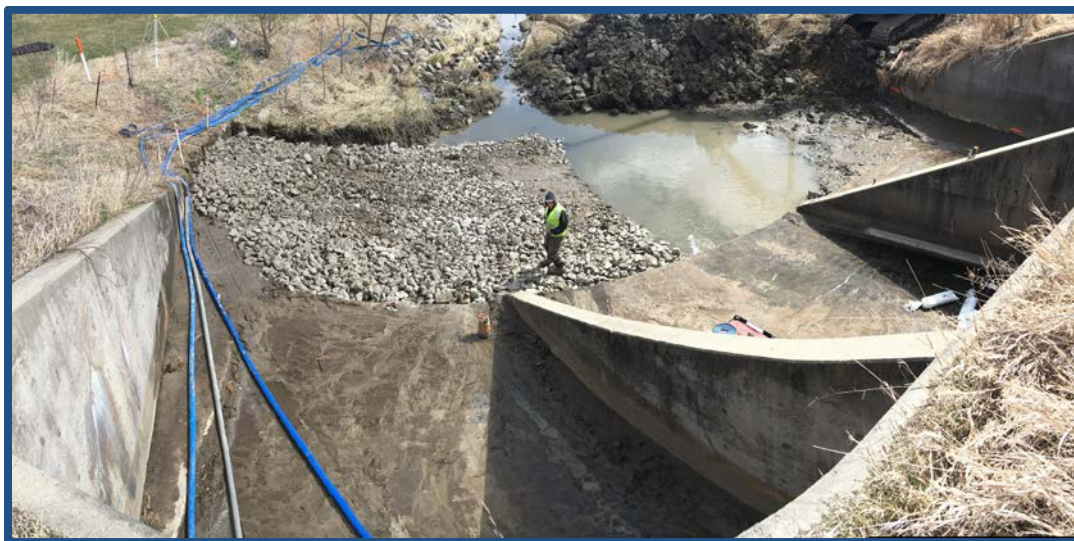
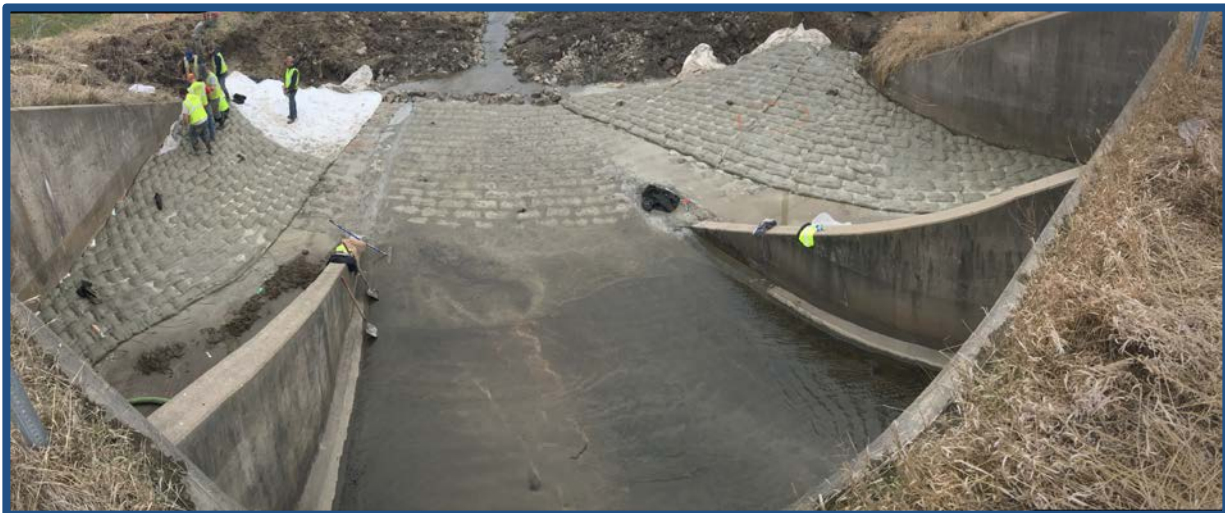
Figure 9. Aspects of the preparation and installation of the articulated block mat at FHWA #031711 site

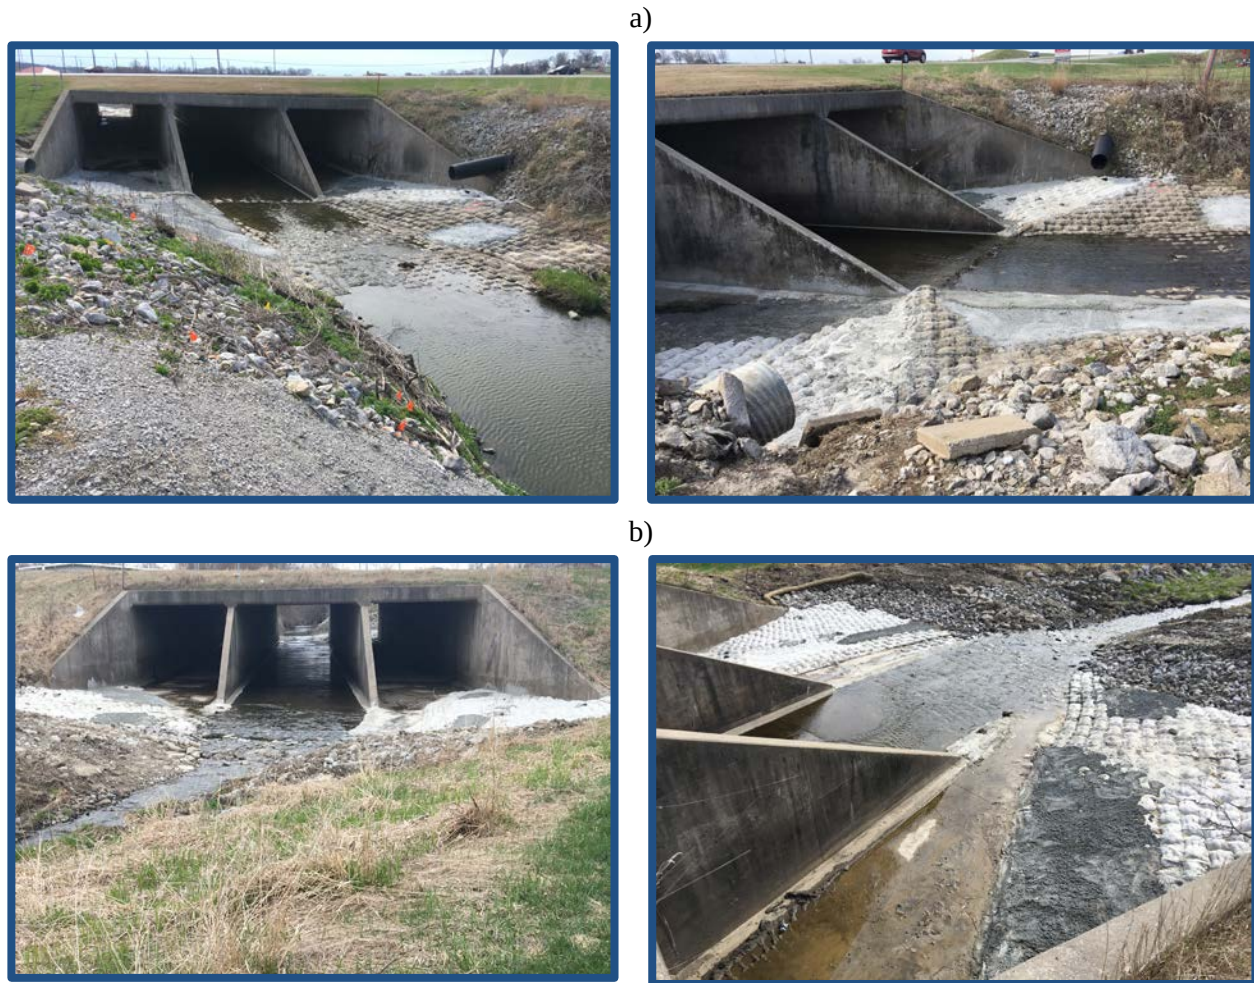
Figure 10. Views of the completed retrofitting at the FHWA #031711 culvert site: a) culvert inlet, b) culvert outlet

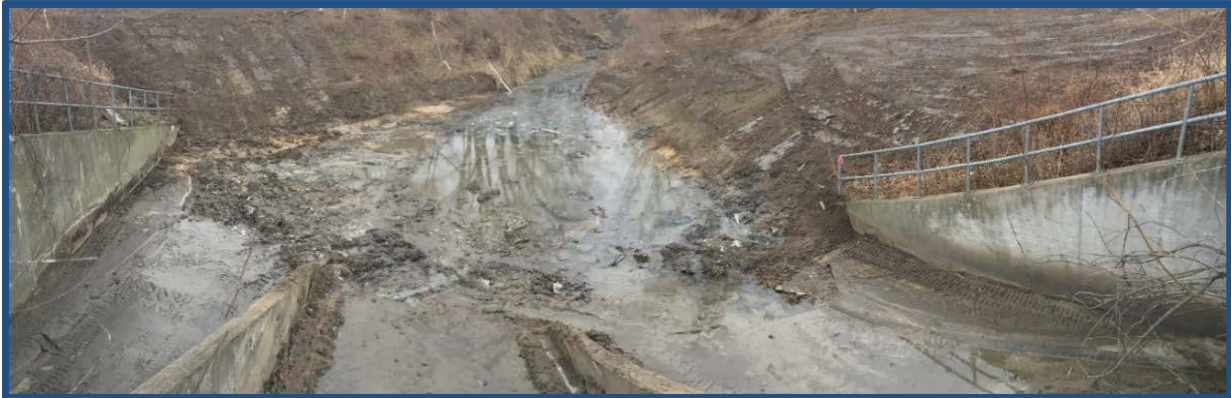
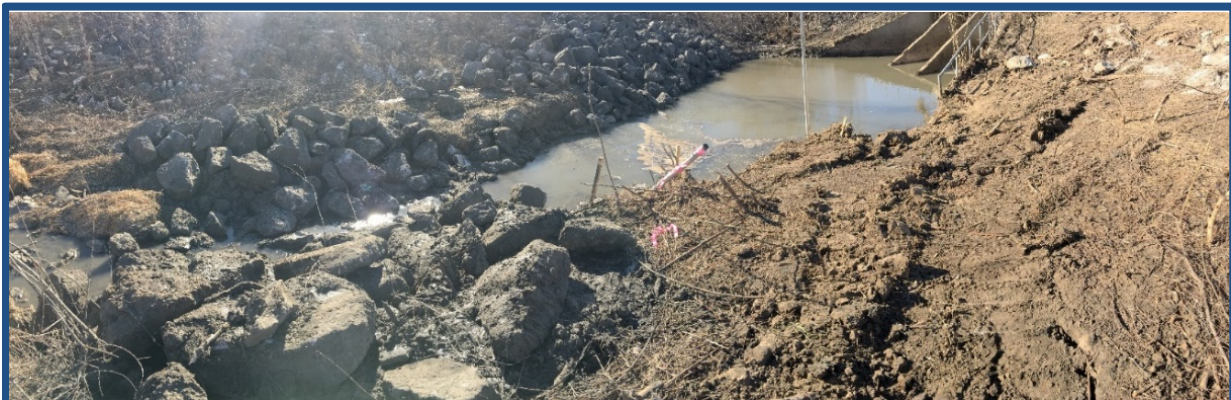
Culvert inlet at the end of cleanup

Culvert outlet at the end of cleanup

Figure 11. Views of the culvert site during the site cleanup (compare with Figure 8c)

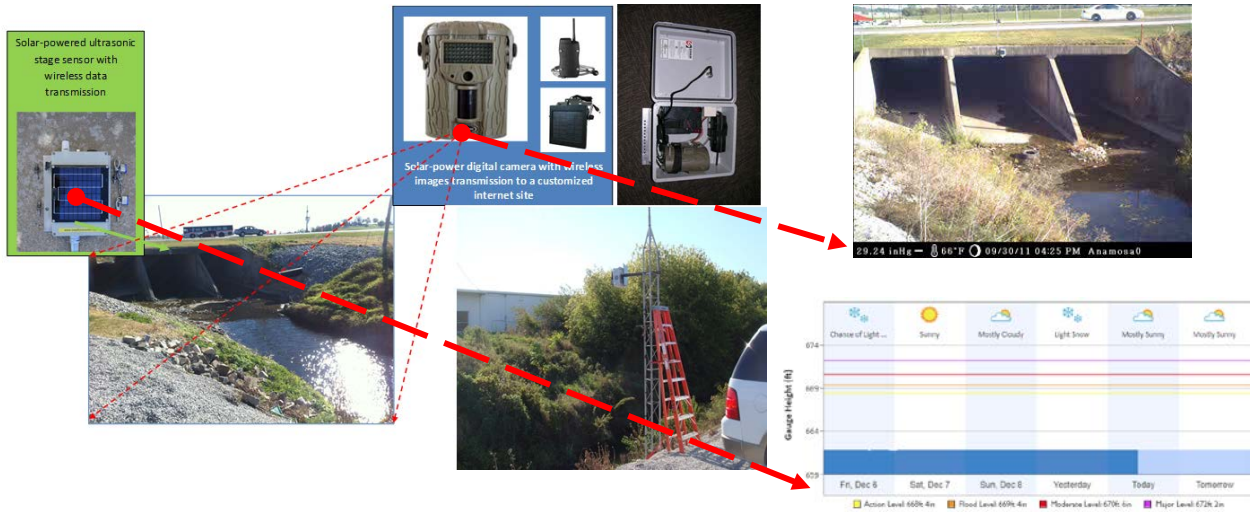
### a) Stream stage sensor & webcams (with modems)

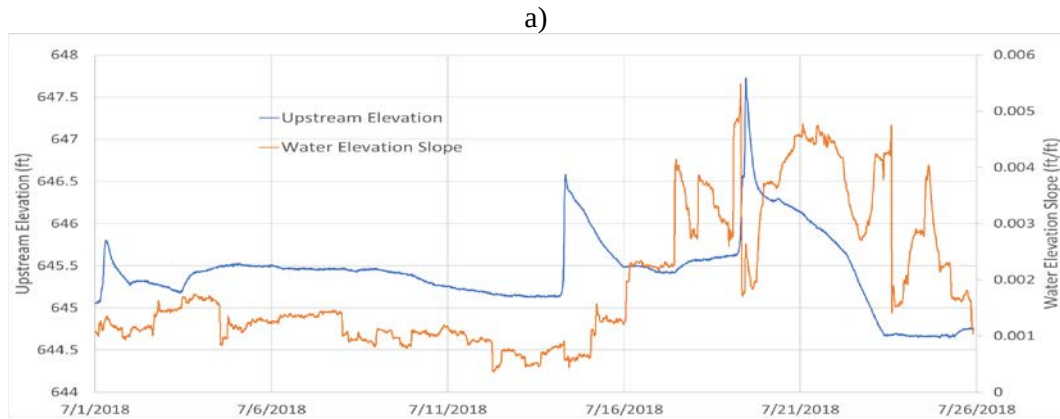
Figure 21. Recordings of water stages and turbidity at the retrofitted culvert for FHWA #364790 site: a) upstream stage and free-surface slope, b) stage and turbidity recording at the inlet of the culvert

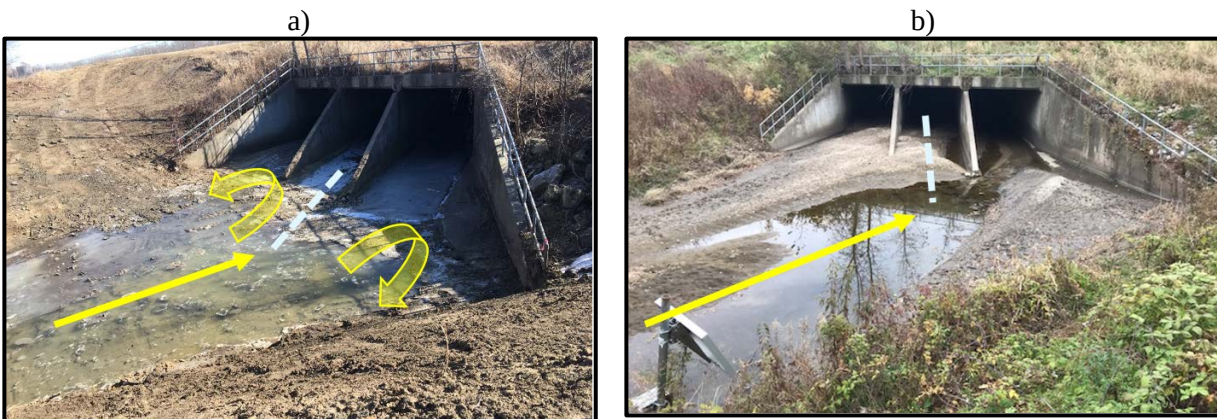
Figure 24. Preferential sedimentation of the sediment transport in the upstream area of the FHWA #364790 culvert during the first 12 months of culvert operation from the total cleanup: a) culvert after cleanup in February, 2018; b) sediment deposits in October, 2018. Yellow arrow: streamflow dominant direction; dotted white line: culvert orientation.

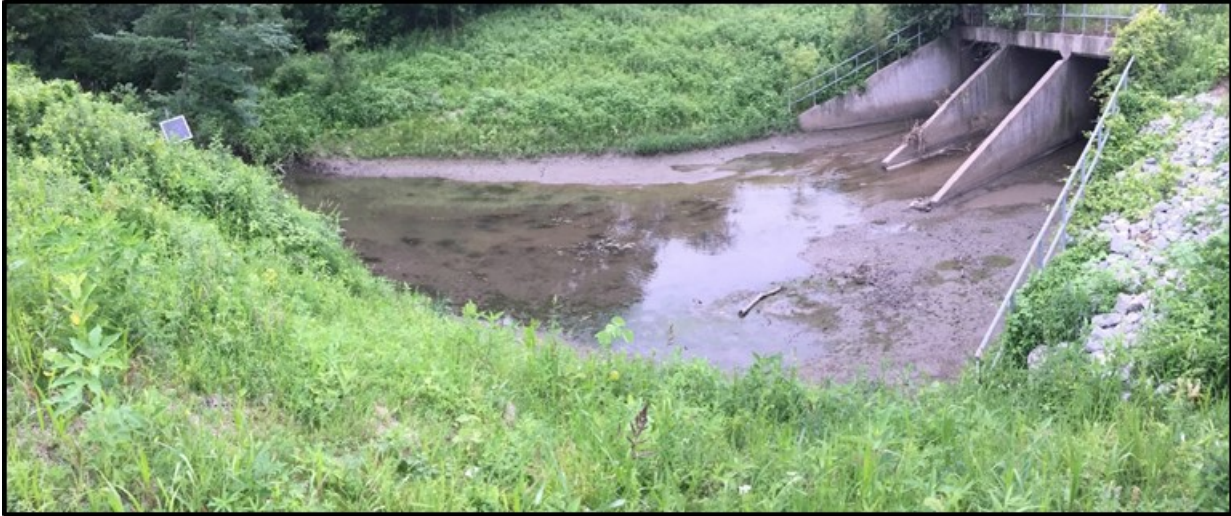
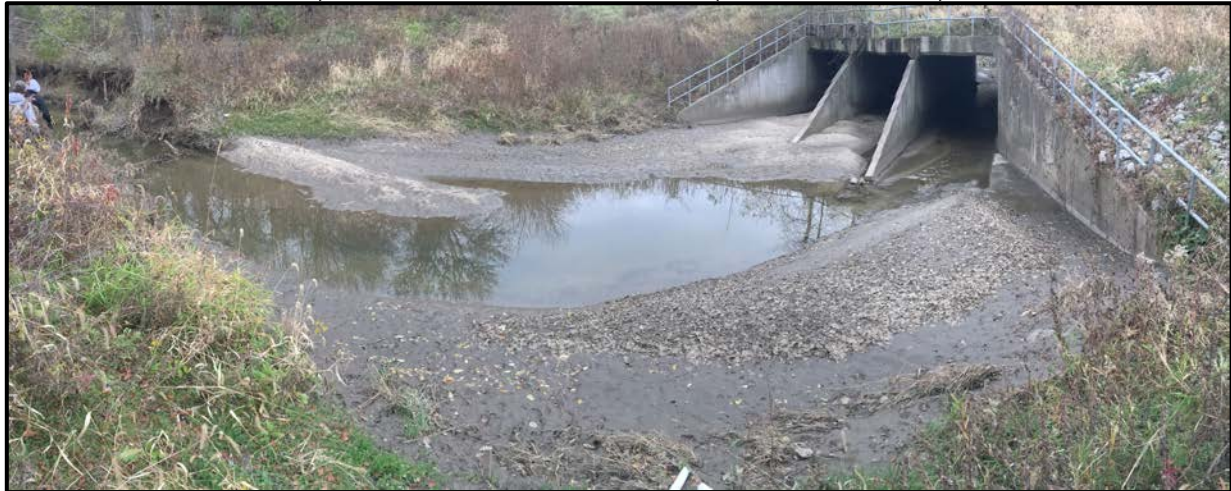
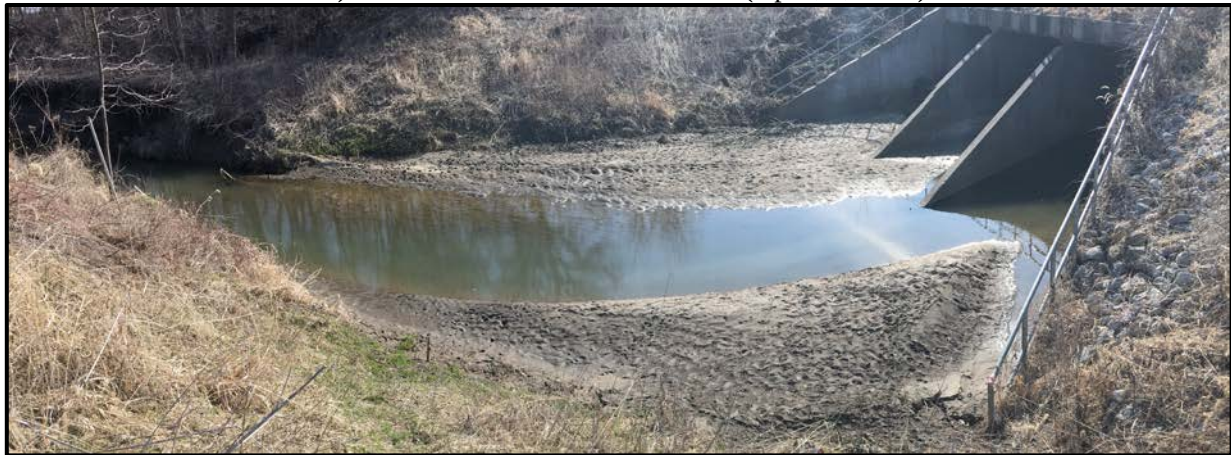
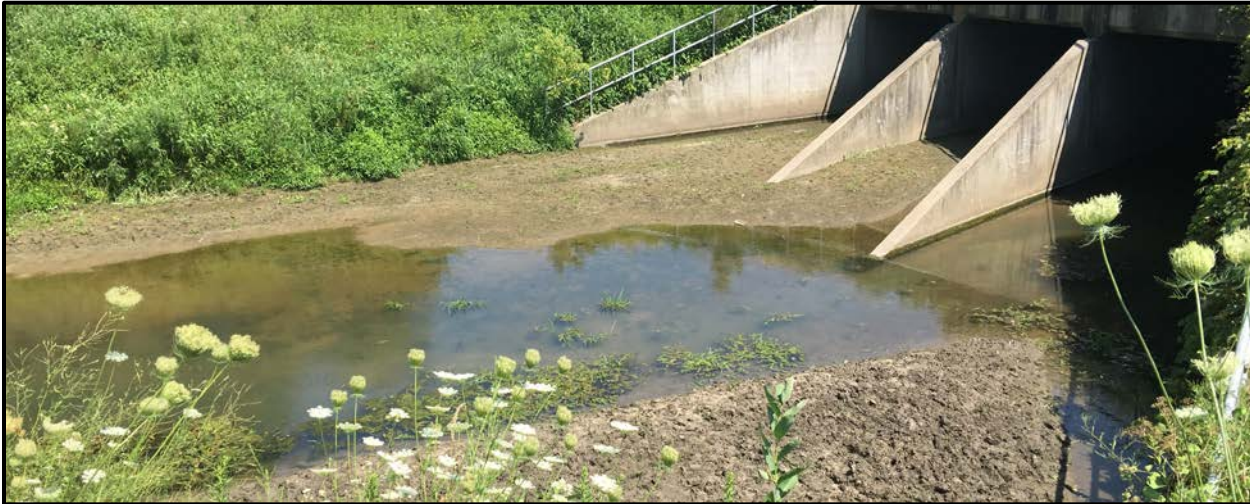
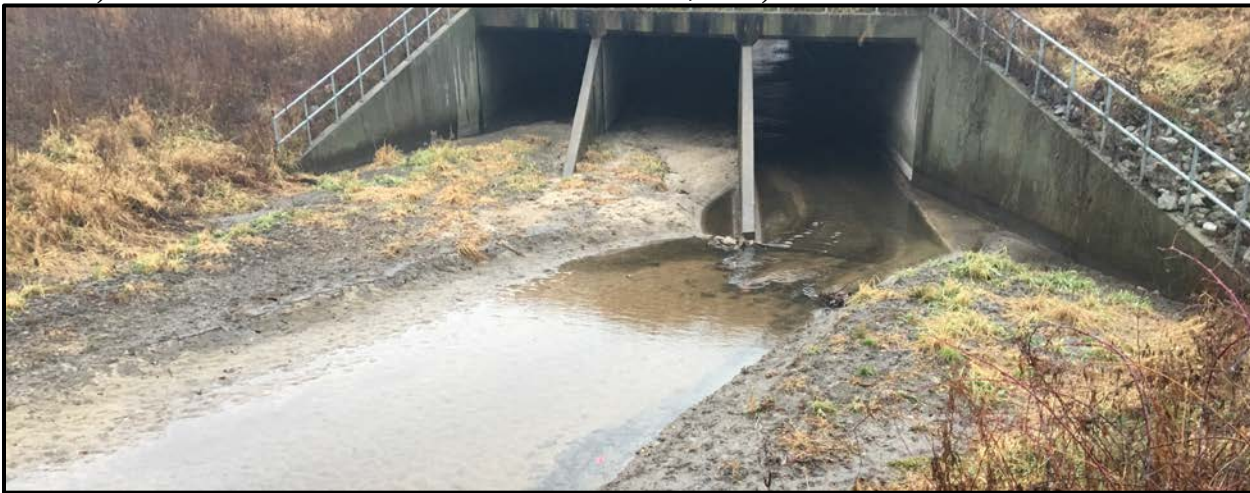
a) 2 months after weir installation (June 15, 2018)

b) 7 months after weir installation (November 8, 2018)

c) 12 months after weir installation (April, 1, 2019)

d) 18 months after the weir installation (July 26, 2019)

e) 24 months after the weir installation December 1, 2019) and 4 months after weir removal.

Figure 25. Development of the underwater sediment deposits in the upstream area of FHWA #364790 culvert site over the period of study. Note: the draining pipe shown in Figures 23 was used to empty the pooled area. The culvert downstream area is not shown as it remained submersed after pipe opening.

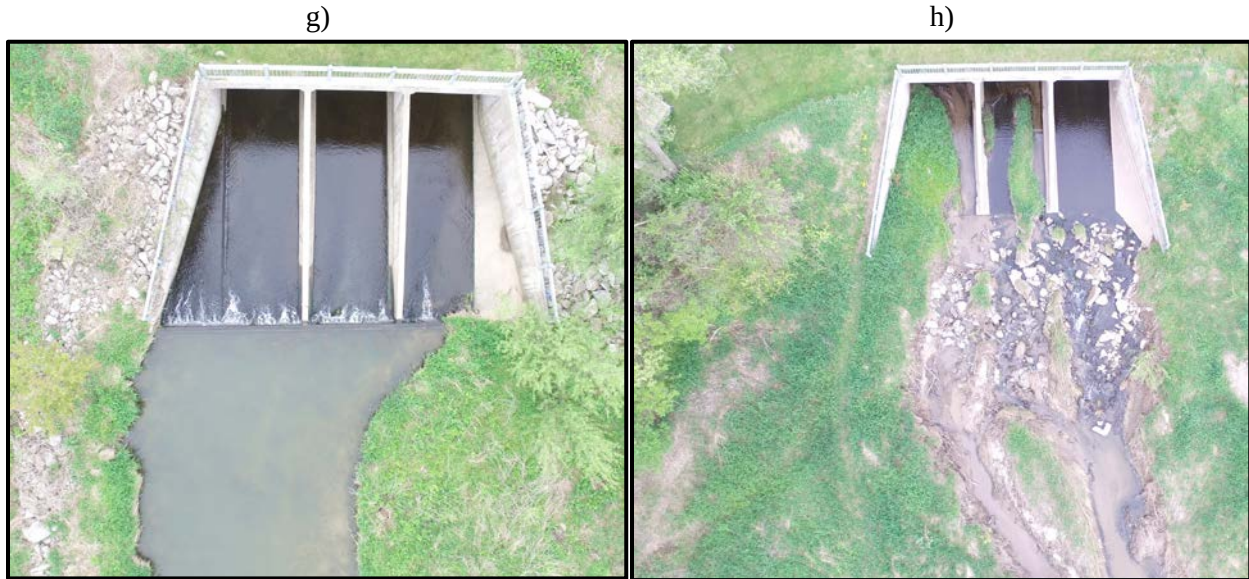
Figure 28. Drone surveys of the culverts monitored through the present study (see Figure 7a for locating the culverts on the map): a) and b) upstream and downstream areas of FHWA #31711 culvert Site #1 (Design A), respectively; c) and d) upstream and downstream areas of the 3-box culvert Site #2 (reference), respectively; e) and f) upstream and downstream areas of FHWA #364790 culvert Site #3 (Design C); and g) and h) upstream and downstream areas of the 3-box culvert Site #4 (Design B).
