# Satellite Radar Data Analysis For Change Detection Of Rural And Urban Railways

January 2025

1. Report No. UTCRS-USC-O4CY23	2. Government Accession No.	3. Recipient's Catalog No.
4. Title and Subtitle  Satellite Radar Data Analysis for Change Detection of Rural and Urban Railways		5. Report Date January 31, 2025

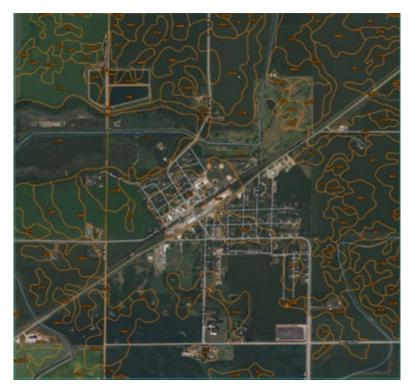
Figure 5: The soil profile map of the region in Raymond, MN

The region under investigation is located in Minnesota at latitude longitude (48.25, -101.46), about 100 miles from Minneapolis, MN. The region under observation is in a northern state with a mean annual precipitation of 24-37 inches with 140 to 180 frost-free days. The InSAR analysis can be divided into the urban area of Raymond, MN, and the rural farm area surrounding it, as seen in Figure 4 (d). The Urban area has a soil profile of clay loam in the top 0-16 inches of the soil layer, with the soil layer from 16-79 inches of loam soil. This region is classified as poorly drained, with the depth to the water table being 0 to 8 inches. The rural area has diverse soil classifications, with the largest having silt loam soil in the top layer of 28 inches of soil and loam from 28 to 79 inches below it. The water table in this region is about 47 to 59 inches, with a high capacity to transmit water (0.2 to 2in/hr). Both regions have never had problems with flooding and ponding. Soil profile map is shown in Figure 5 and complete information related to soil profile can be found in [24].
