# JOINT TRANSPORTATION RESEARCH PROGRAM

## Development of a Formalized Program for In-Service Inspection of Pedestrian Bridges

**Aedh A. Alharthi, Robert J. Connor**

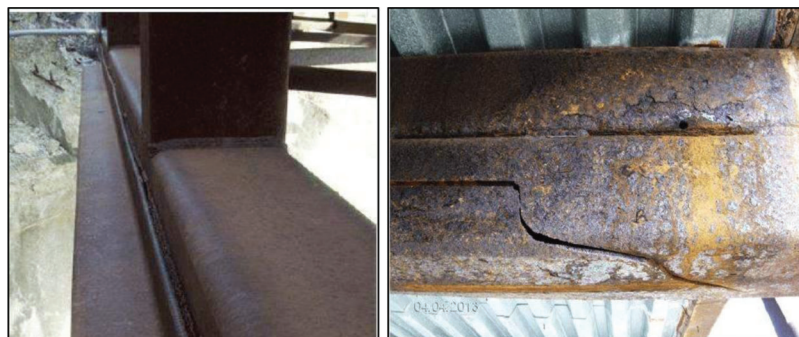
**Figure 2.3** View of fractures in the floor beam and the longitudinal attachment to the bottom chords.

Hence, based on the research findings, the research team recommended that the tubular sections be properly sealed to prevent water from seeping inside and causing expansion during freezing temperatures, which can lead to fracturing of the sections. Alternatively, drainage holes can be drilled to allow water to drain out from inside the sections. In 2015, the bridge

underwent retrofitting, which involved welding the fractures and drilling holes in the bottom of the floor beams. Additionally, the longitudinal and other attachments at the lower chords of the truss were removed. Despite these actions, the bridge continued to exhibit fractures in the floor beams, indicating inadequate execution of the retrofit, as depicted in Figure 2.3.

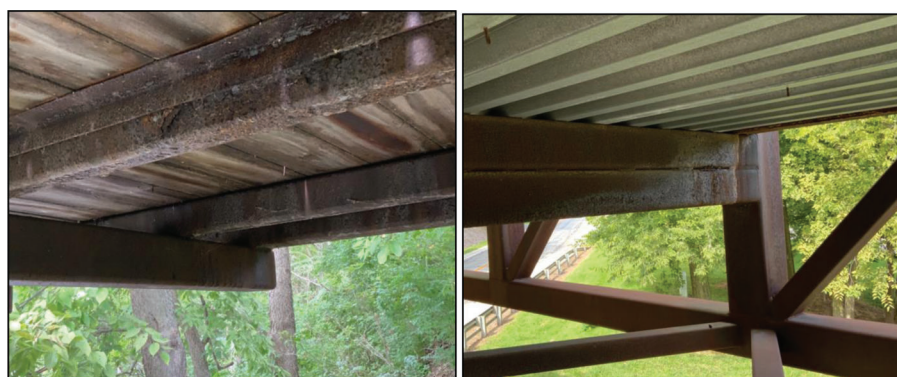
**Figure 2.4** View of the stringers and floor beam in timber and a stay-in-place concrete deck.

It was also noticed that the floor beams also experienced significant corrosion, especially at the ends of the floor beams, due to the lack of a drainage system. The rainwater drained away only from the small gap between the concrete deck and the railing. Stringers in the bridge with timber deck was severely corroded because of the direct contact between the stringers and the timber deck. Besides direct drainage onto the superstructure, the timber deck retains moisture for extended periods, continuously exposing the stringers

to moisture. As a result, stringers in timber decks are more susceptible to severe corrosion, as shown in Figure 2.4. The research team discussed the rapid corrosion of the stringers in a timber deck with the bridge fabricator. The fabricator mentioned that they usually recommend customers/owners to apply an effective coating on the stringers to prevent such issues. The use of timber decks in pedestrian bridges is ubiquitous, making it crucial to consider its effect on the corrosion development.

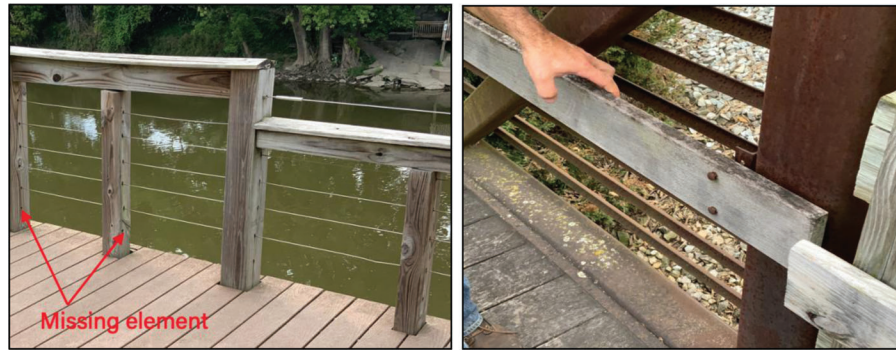
**Figure 2.5** View of missing element and inadequate anchorage of bridge railing.

The research team identified several safety criteria that could affect the bridge's serviceability, including the height of the railing, the strength of the bolts attaching the sign, and the vertical clearance. The team found that while the railing height of approximately 5 ft. was adequate for pedestrian safety, it could also increase the risk of objects being thrown from the bridge onto vehicles passing beneath it. Thus, the team recommended installing a fence to protect the service under the bridge. Moreover, the team indicated that the railing elements needed to be checked for any missing or lost elements, as shown in Figure 2.5.

The team also observed that the anchor bolts attaching the sign to the bridge were insufficient to support its self-weight and wind load, and thus suggested using larger anchor bolts to prevent the sign from falling onto passing vehicles. Finally, the vertical clearance of the bridge was 13.5 ft., which could increase impact damage likelihood. Therefore, the team recommended periodic inspections of the bridge to monitor any potential issues that may arise because of the impact.

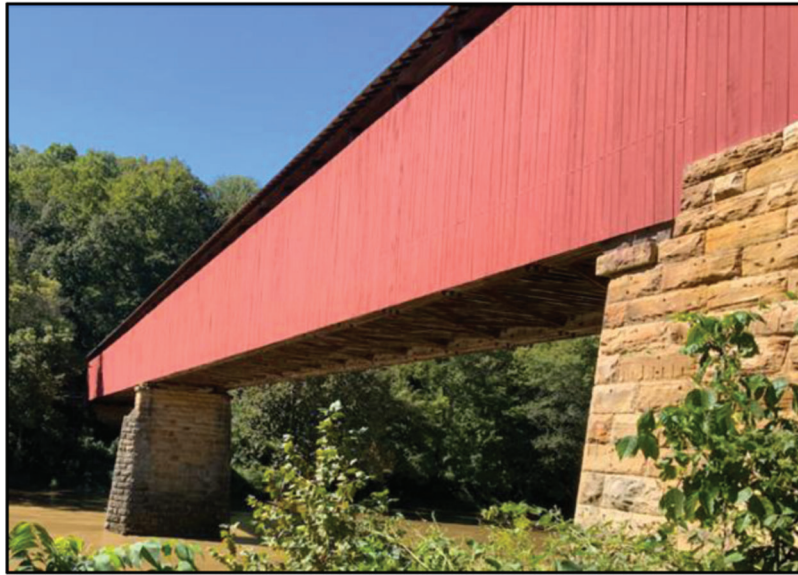
**Figure 2.6** View of the timber bridge.

The 47-00128 bridge, constructed in 1884, holds historical significance as per the National Historic Preservation Act (Eriksson et al., 2000). The bridge consists of two spans, with the maximum one measuring 184 ft. and spanning a waterway, as shown in Figure 2.6. The vertical clearance of the bridge is 16.5 ft. above the ordinary water elevation. The bridge was reconstructed in 1984, repaired in 1999 and 2012. Since the last retrofit, the bridge has been used exclusively by pedestrians.

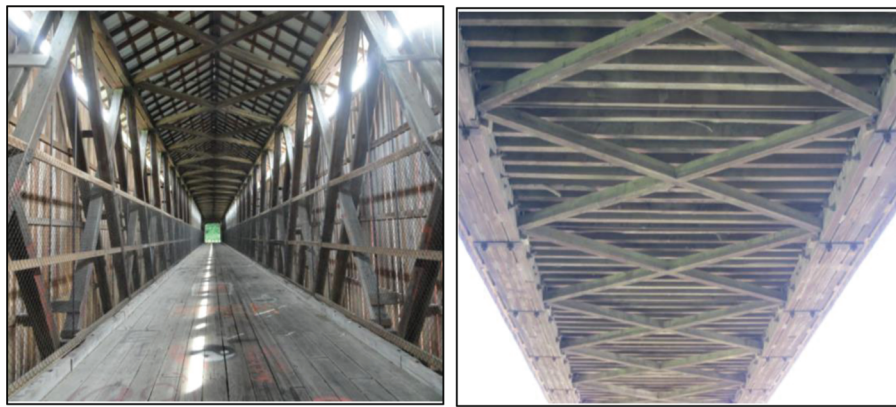
**Figure 2.8** View of the top and the bottom deck of the timber bridge.

The research team conducted a thorough inspection of both structural and non-structural components of the bridge. According to the inspection report, the structural condition rating of the bridge was evaluated satisfactory, despite the presence of splits and checks in some diagonal members of the superstructure. While enclosures can provide protection against environmental factors, the team observed that ineffective enclosures might accelerate decay development. Particularly in

scenarios where water infiltrates structural elements, the consequent lack of airflow can cause the holding of moisture for extended periods, thereby accelerating the development of decay. The team also evaluated non-structural elements and recommended that gaps between timber planks do not pose any hazard to pedestrians or cyclists, especially when the planks are placed longitudinally, as shown in Figure 2.8. Thus, the research team recommended that the gaps between timber planks should not exceed  $\frac{1}{2}$  inch in any direction to prevent any potential hazards for bridge users.

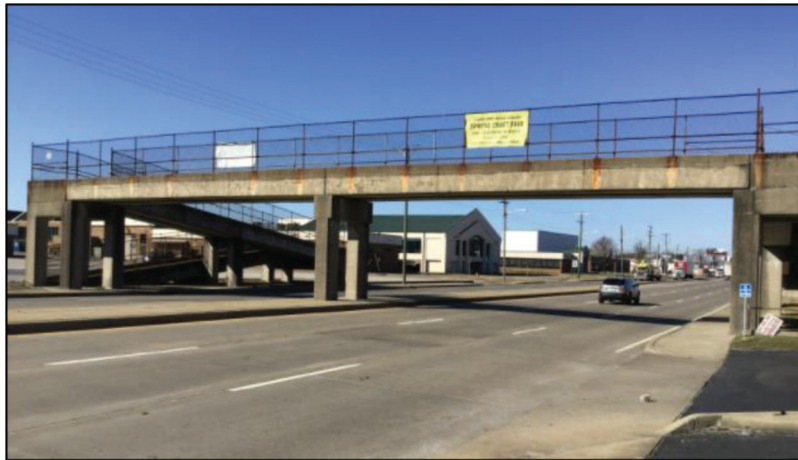
**Figure 2.9** View of the concrete bridge.

The P(66)460-82-04867 bridge is a prestressed box-girder pedestrian bridge comprising two spans that pass over State Road 66 (SR 66). The bridge was constructed in 1963, with a total length of 142 ft., and a vertical clearance of 14 ft. 9 inches, as shown in Figure 2.9. Pedestrian safety is enhanced by metal fences installed on each side of the bridge, which also serve to protect the area beneath the bridge from potential hazards,

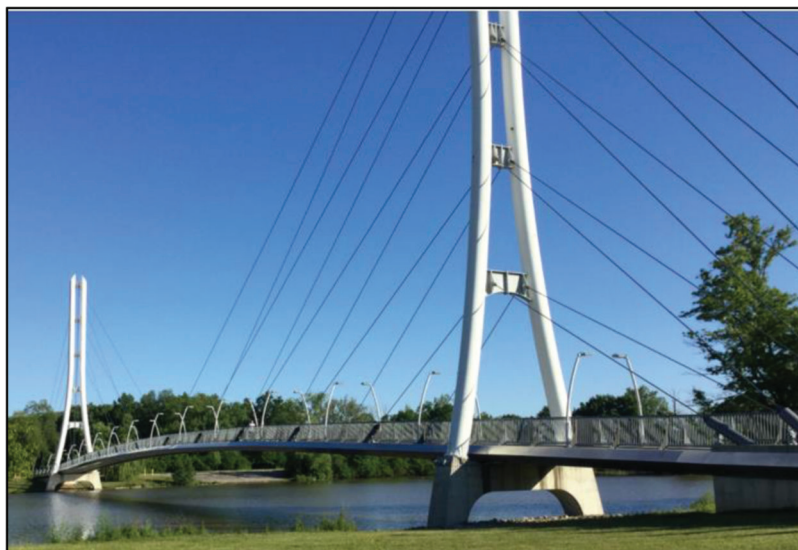
**Figure 2.11** View of the cable-stay bridge.

The P930-02-10169 bridge is a cable-stayed structure constructed in 2010 with a maximum span length of 385 ft. and a total length of 465 ft. The bridge comprises two main steel girders connected by cables to two pylons set at both ends, with floor beams and a cast-in-place concrete deck, as shown in Figure 2.11. The design drawings specify that the bridge was designed to withstand live loads of 65 pounds per square foot (psf) and dead loads of 20 psf. Additionally, the bridge was designed to carry an H5 maintenance vehicle, as per the *AASHTO LRFD Specifications for Pedestrian Bridges* (AASHTO, 2009).

Wind loads of 132 psf and a wind velocity of 100 mph were also considered during the design phase, with bent plate wind fairings installed along the longitudinal girders on both sides to minimize wind load effects. The cables comprise assemblies of ASTM A586 structural strand with zinc-filled (spelter) end socket connections, featuring stainless steel connection pins (ASTM, 2018).

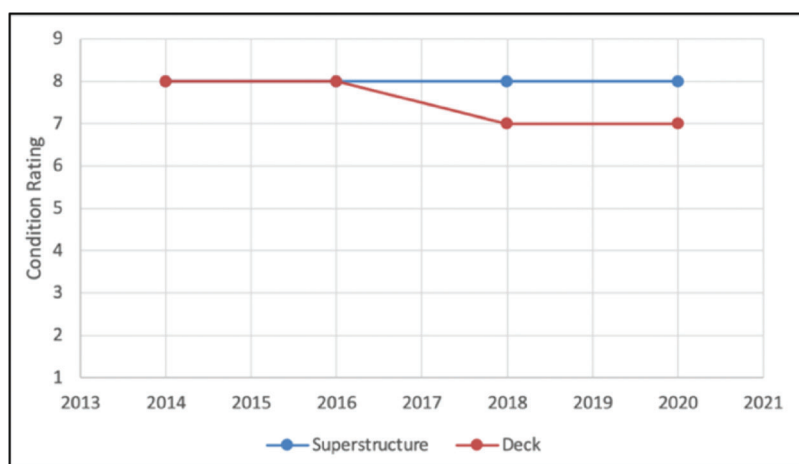
**Figure 2.12** NBI condition rating for the bridge cable stay bridge, 2012–2020.

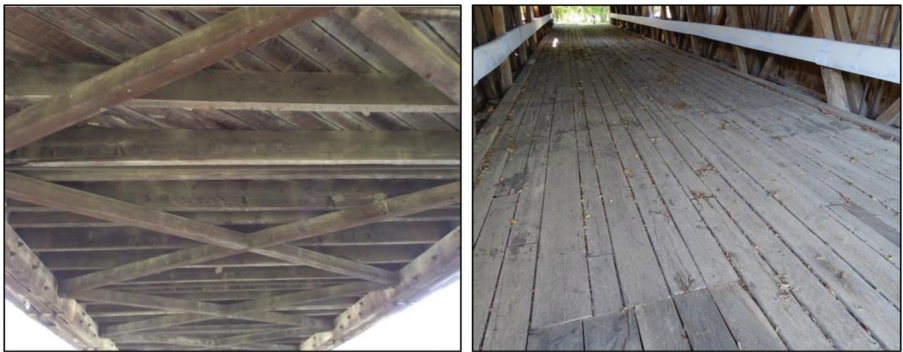
Figure 4.1 Example of timber deck with two layers planks, diagonal and longitudinal planks.

**4.4.1.1 Walkway criteria evaluation.** Pedestrian bridge surfaces are among the most crucial elements to evaluate for safety and serviceability. Unlike highway bridges, inspectors should be aware that a small defect on the surface of a pedestrian bridge may result in injuries to pedestrians or cyclists. It is essential to note that the majority of pedestrian bridge liability claims are statistically slip and fall claims. Safety and serviceability criteria for concrete and timber walkway surfaces are

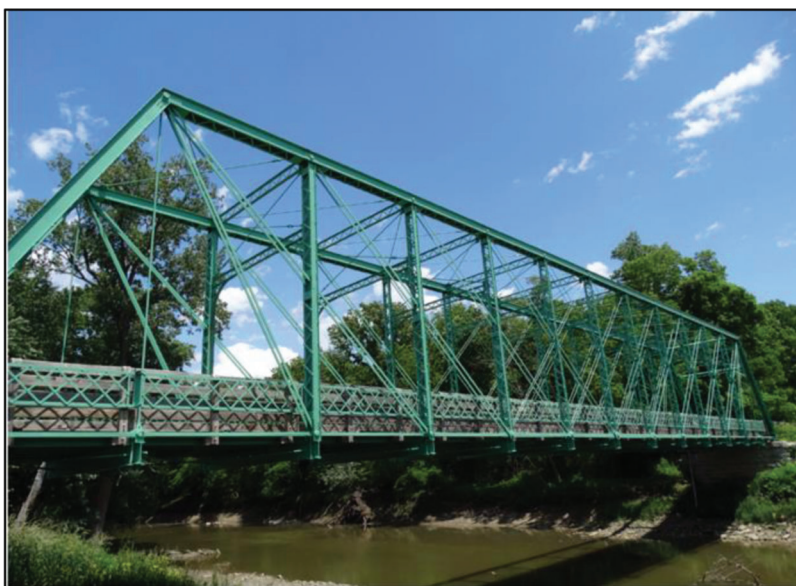
**Figure 5.1** View of the steel bridge.

This bridge, constructed in 1894, was used for vehicular traffic until 1997. Following some repairs, it was then restricted to pedestrian traffic. The bridge is a steel truss with a timber deck and passes over a non-navigable waterway as shown in Figure 5.1. According to the latest inspection report from 2020, the condition ratings were 7 for the deck, and 6 for both the superstructure and the substructure. Despite these ratings remaining unchanged since 2011, the bridge continues to undergo inspections every 24 months.

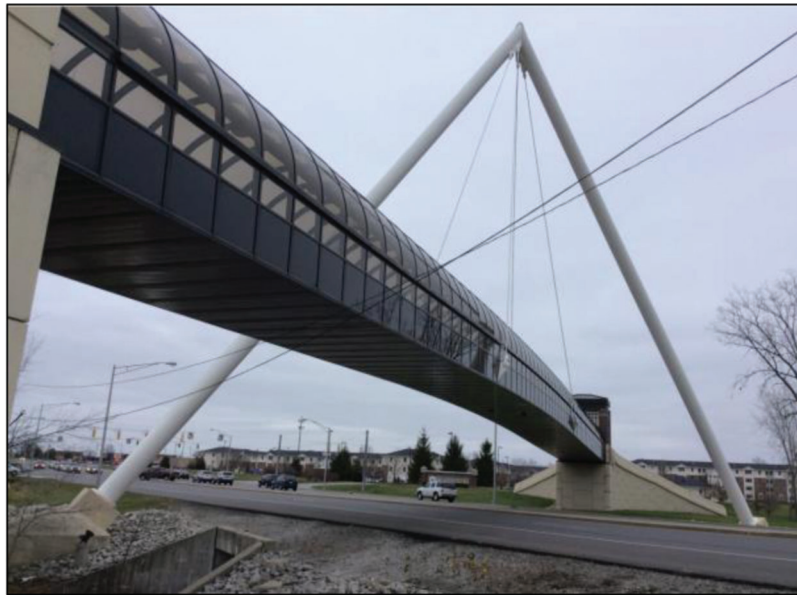
**Figure 5.3** View of the cable stay bridge.

point cable connections at the mid span. The bridge was built in 2003 with a completely covered glass enclosure and passes over a highway as shown in Figure 5.3. The latest inspection report indicates that the bridge is generally in a good condition, deck and the superstructure condition ratings are 6, and the substructure

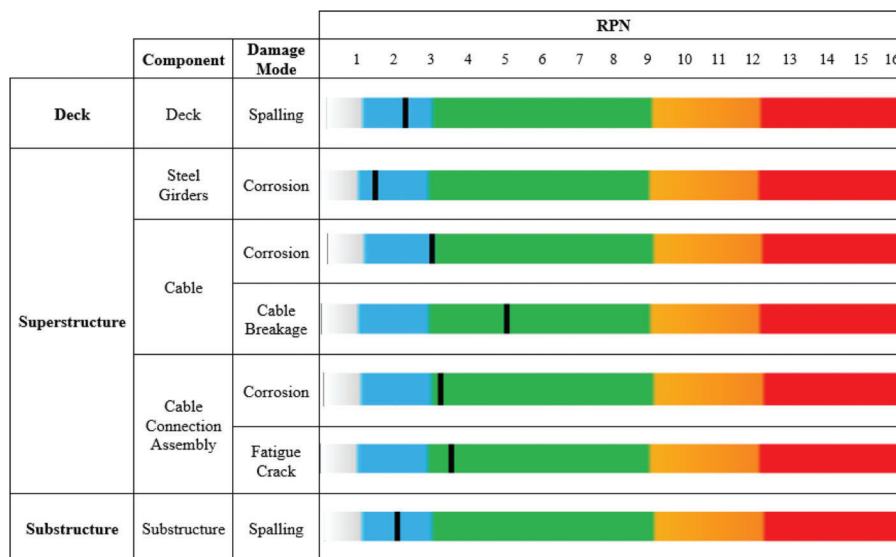
Figure 5.5 Cable-stay RPN for deck, superstructure, and substructure.

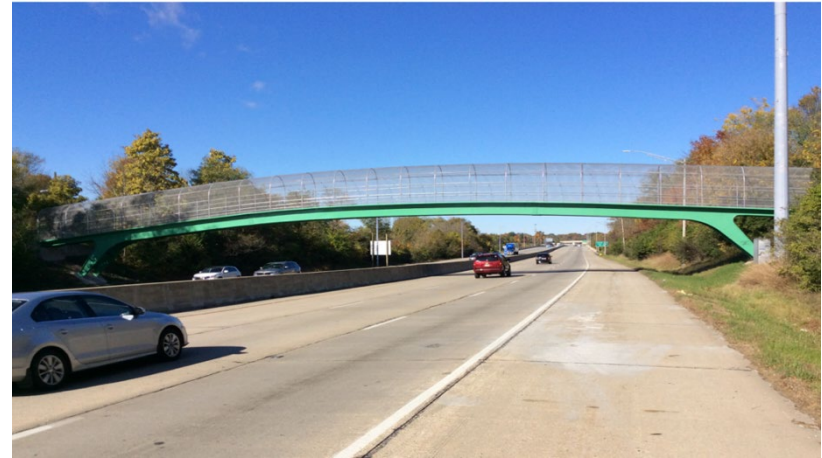
<b>Bridge #</b>	PI65-116-05940 A
<b>Deck Type</b>	Concrete
<b>Superstructure Type</b>	two girders
<b>Year of Construction</b>	1969
<b>Year of Reconstruction</b>	1996
<b>Maximum Span Length (ft)</b>	142.3
<b>Service Under the Bridge</b>	Highway
<b>Key Damage Mode</b>	Corrosion

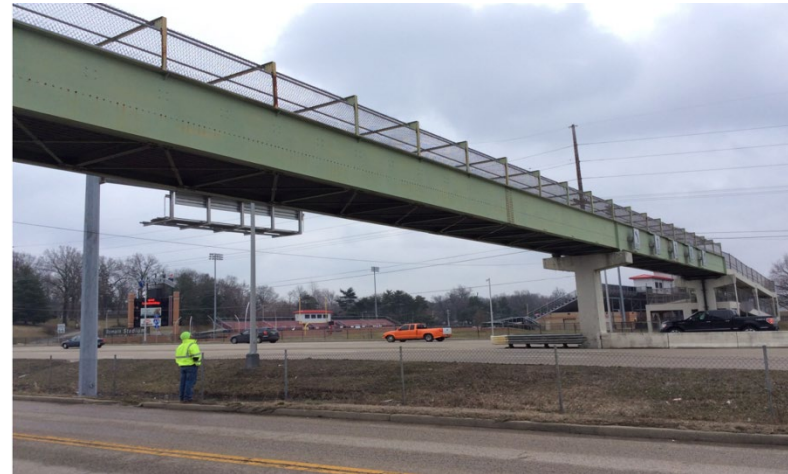
<b>Bridge #</b>	P066-82-07440
<b>Deck Type</b>	Concrete
<b>Superstructure Type</b>	Two girders
<b>Year of Construction</b>	1988
<b>Maximum Span Length (ft)</b>	117
<b>Service Under the Bridge</b>	Highway
<b>Key Damage Mode</b>	Corrosion

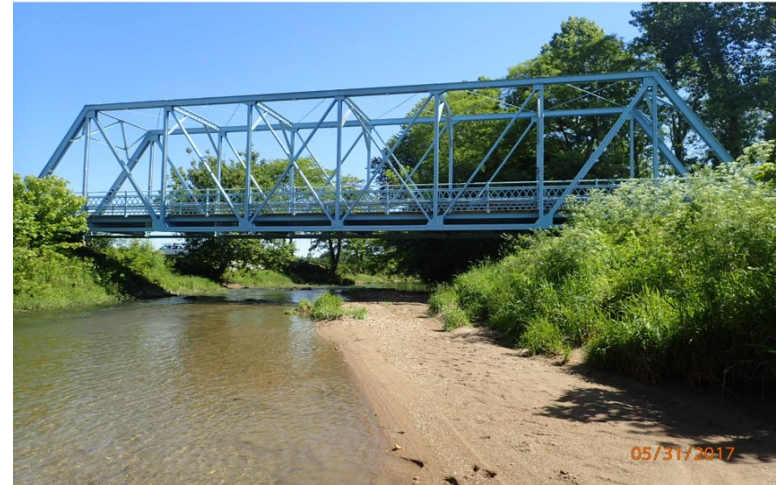
<b>Bridge #</b>	16-0115H
<b>Deck Type</b>	Concrete
<b>Superstructure Type</b>	Truss
<b>Year of Construction</b>	1915
<b>Year of Reconstruction</b>	2008
<b>Maximum Span Length (ft)</b>	119.4
<b>Service Under the Bridge</b>	Waterway
<b>Key Damage Mode</b>	Corrosion

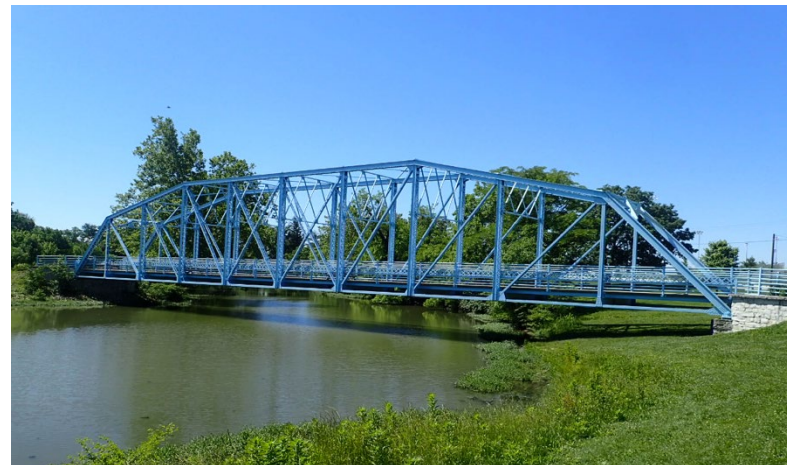
<b>Bridge #</b>	16-0140H
<b>Deck Type</b>	Concrete
<b>Superstructure Type</b>	Truss
<b>Year of Construction</b>	1915
<b>Year of Reconstruction</b>	2006
<b>Maximum Span Length (ft)</b>	177
<b>Service Under the Bridge</b>	Waterway
<b>Key Damage Mode</b>	Corrosion

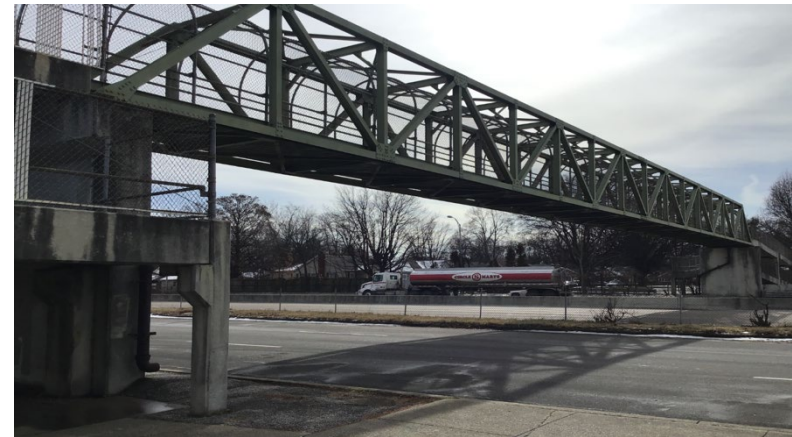
<b>Bridge #</b>	P066-82-06989
<b>Deck Type</b>	Concrete
<b>Superstructure Type</b>	Truss
<b>Year of Construction</b>	1987
<b>Year of reconstruction</b>	2006
<b>Maximum Span Length (ft)</b>	176
<b>Service Under the Bridge</b>	Highway
<b>Key Damage Mode</b>	Corrosion

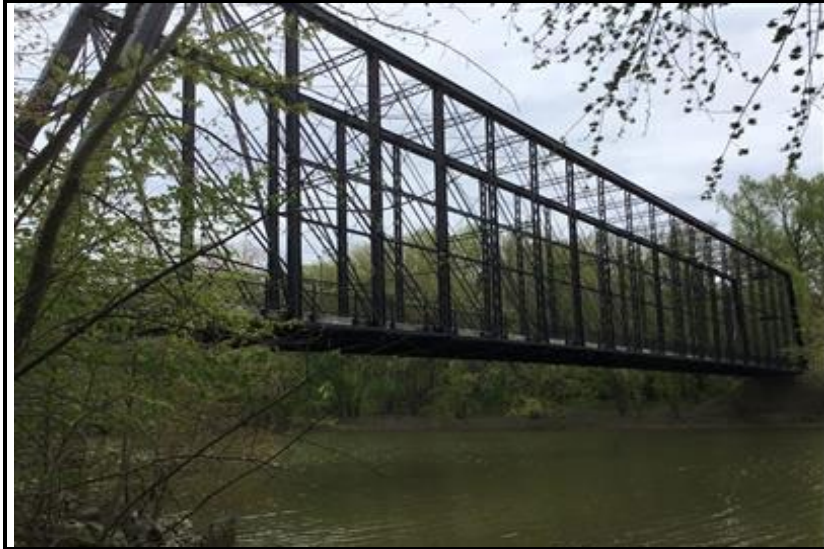
<b>Bridge #</b>	15-00095
<b>Deck Type</b>	Concrete
<b>Superstructure Type</b>	Truss
<b>Year of Construction</b>	1878
<b>Year of Reconstruction</b>	2008
<b>Maximum Span Length (ft)</b>	297.5
<b>Service Under the Bridge</b>	Waterway
<b>Key Damage Mode</b>	Corrosion

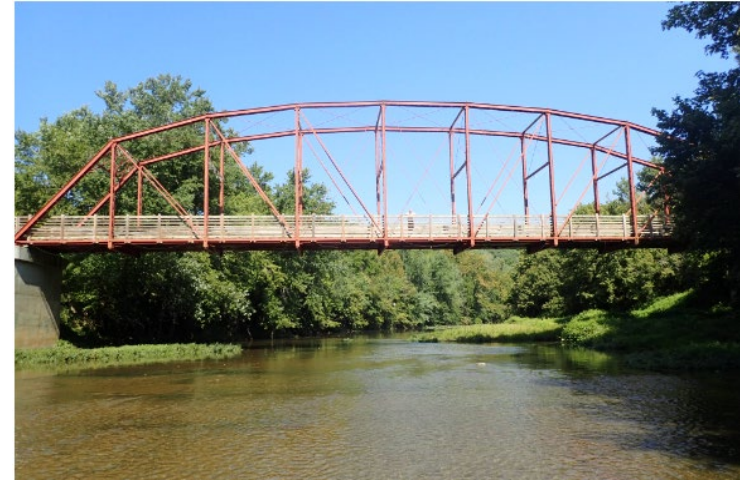
<b>Bridge #</b>	15-00095
<b>Deck Type</b>	Concrete
<b>Superstructure Type</b>	Truss
<b>Year of Construction</b>	1878
<b>Year of Reconstruction</b>	2012
<b>Maximum Span Length (ft)</b>	159.7
<b>Service Under the Bridge</b>	Waterway
<b>Key Damage Mode</b>	Corrosion

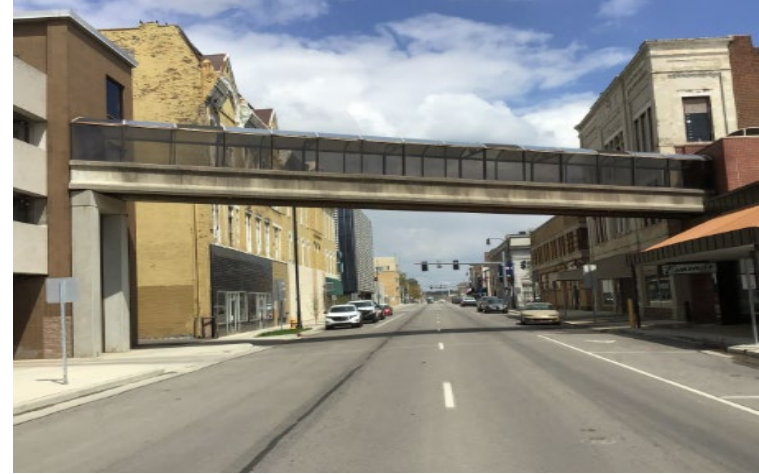
<b>Bridge #</b>	P027-89-07710 SBL
<b>Deck Type</b>	Concrete
<b>Superstructure Type</b>	Concrete
<b>Year of Construction</b>	1976
<b>Maximum Span Length (ft)</b>	74
<b>Service Under the Bridge</b>	roadway
<b>Key Damage Mode</b>	Spalling, strands corrosion
