SD94-03-F

SD Department of Transportation
Office of Research

INVESTIGATION OF ANOMALOUS ASPHALT CONCRETE ON US212

**Study SD94-03
Final Report**

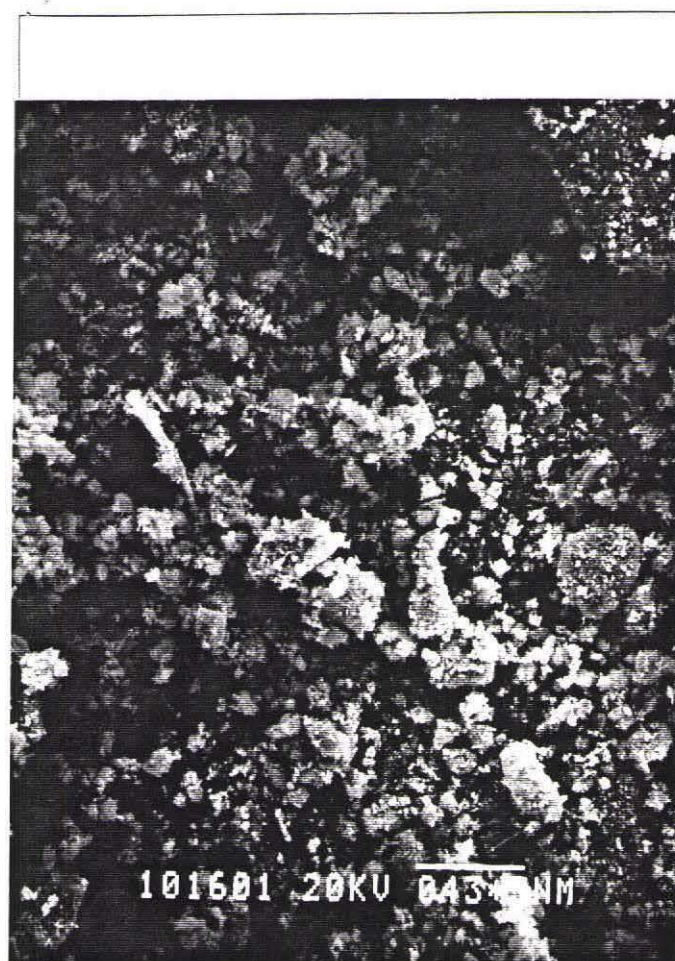
Fig A1

A-B Scanning electron photomicrograph (A) and corresponding X-ray energy spectograph (B) of centrifugation solids from a TRIAD Ltd. sample. The material consists of irregularly shaped fine particles with finer coatings and occasional fibres as seen at the I-9 position. Strong responses from silicon (Si), calcium (Ca), aluminium (Al) and iron (Fe) suggest the presence of pyrite, quartz, calcite and magnesium/aluminum silicate minerals. Weaker responses from copper (Cu), sulphur (S) and potassium (K) indicate metallic sulphides and likely other potassium rich silicates. This XES was done without a gold coating, whereas the SEM photograph was gold coated.

Photo A X350

An examination of the scanning electron photomicrographs, labelled as Figs. A1 (at x350) and B2 (at x1000) would indicate that all the particulate matter appears as "flaky, crusty" particles typical of oxide, corrosion compounds, or inorganic compounds.

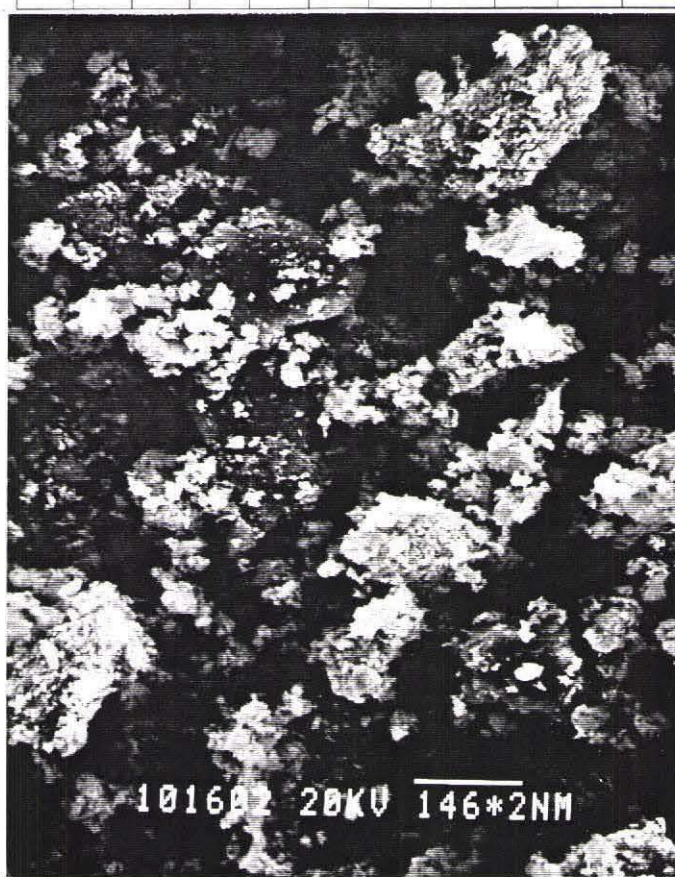
Fig B1

C-D Scanning electron photomicrograph (C) and corresponding X-ray energy spectograph (D) of centrifugation solids from a TRIAD Ltd. sample. The material consists of irregularly shaped fine particles with finer coatings. Two types of grains are apparent: a flaky type at the C-4 position and a more solid type at the F-8 position. Strong responses from silicon (Si), calcium (Ca), aluminium (Al) and iron (Fe) suggest the presence of pyrite, quartz, calcite and magnesium/aluminum silicate minerals. Weaker responses from copper (Cu), sulphur (S) and potassium (K) indicate metallic sulphides and likely other potassium rich silicates. This SEM and XES were done on a gold coated sample and the gold (Au) metal now responds. **Photo A X1000**
