HFST Review

December 2024
Final Report

Project number TR202219
MoDOT Research Report number cmr 24-023

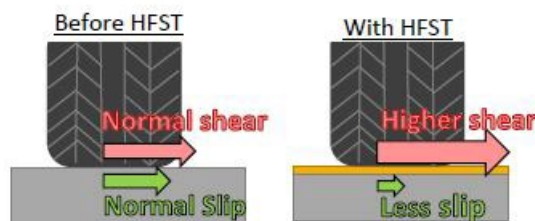
(b) Relation between shear stress and slipping

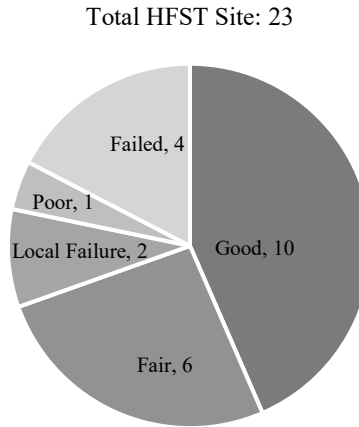
Figure 2-2: Condition of HFSTs in Florida (Wilson and Mukhopadhyay, 2016)

Wilson and Mukhopadhyay studied the performance of the 23 HFST sites in Florida (Wilson & Mukhopadhyay, 2016). A few years after construction, 16 sites were in good or fair condition, while the remaining seven sites were in poor or worse condition, as shown in Figure 2-2.

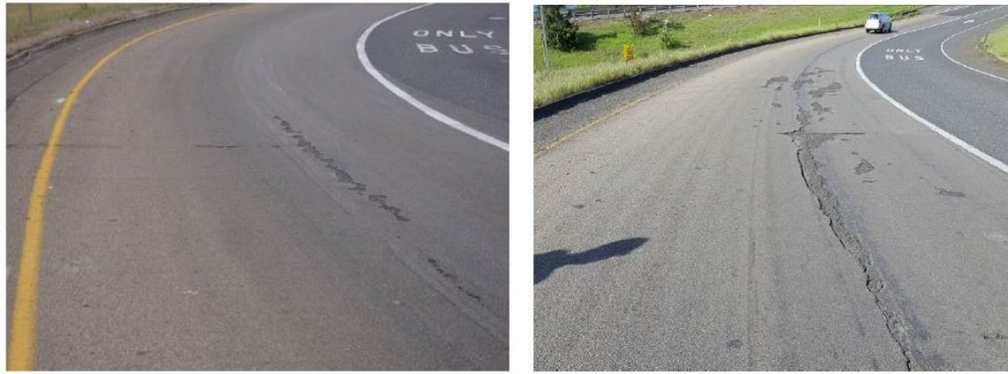
Washington State DOT performed a preliminary study on the performance of HFST by installing it on a ramp with a horizontal curve (Anderson, et al., 2017). The total installation length was 500 ft with a width of 22 feet. HFST was applied only on the outer lane and shoulder of the two-lane ramp, which allowed the comparison of friction numbers (FN40) between the pavement with and without the application of HFST. HFST was applied twice: the first application was on August 30th, 2010, and the second application was in May 2011. The untreated portion of the roadway had a friction number of approximately 44. The treated area had a friction number of between 54 and 76 after the first and second applications of HFST, respectively. The performance of the treated location was observed for 5 years. The first survey was conducted 2 years after the installation, and the second one was 5 years after construction. Distress was observed in the first survey, and the severity continued to increase with time. Delamination in the wheel path was the most prominent distress, which is shown in Figure 2-6. Transverse cracking was also observed in some locations. Several causes, such as poor existing pavement conditions, shear stress from traffic, temperature-induced stress, and thick application of HFST, were suggested as the reasons for delamination. However, as the condition of the existing pavement was not documented prior to the installation of HFST, it was difficult to identify a single reason. Despite the distresses, the friction number (FN40) of the treated location was above 70 throughout the years.

(a) Condition after 2 years

(b) Condition after 5 years

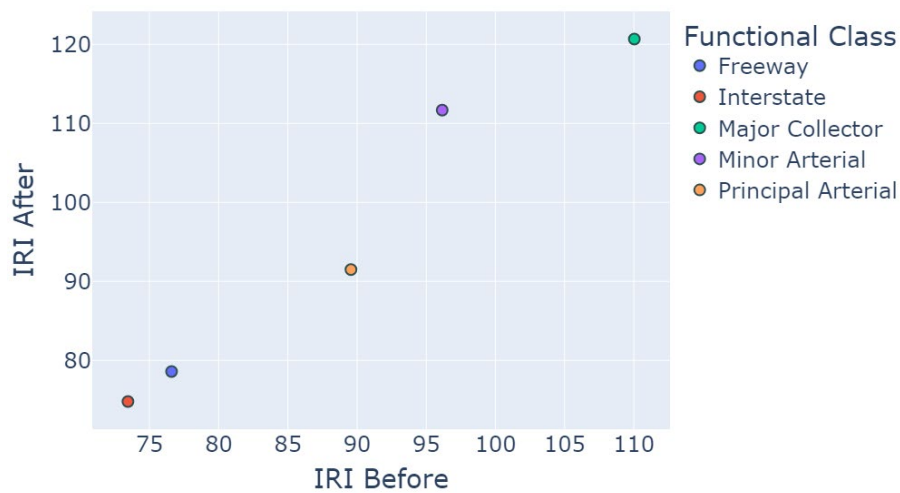
Although there are 146 HFST sections around Missouri, not all of them were constructed at the same time. Thus, the duration or length of post-HFST application pavement condition data available for sections differ. Some sections have pavement condition data available for one year, while others have up to eight years after the application of HFST. Figure 3-1 shows the variations in average distress three years after the application of HFST by functional class. Figure 3-1 (a) and Figure 3-1 (b) show that the average IRI and rutting did not increase significantly three years after the application of HFST. However, a large difference in average cracking was observed before and after the application of HFST, particularly in lower functional classes of pavements, such as arterials and collectors.

(a) IRI variations

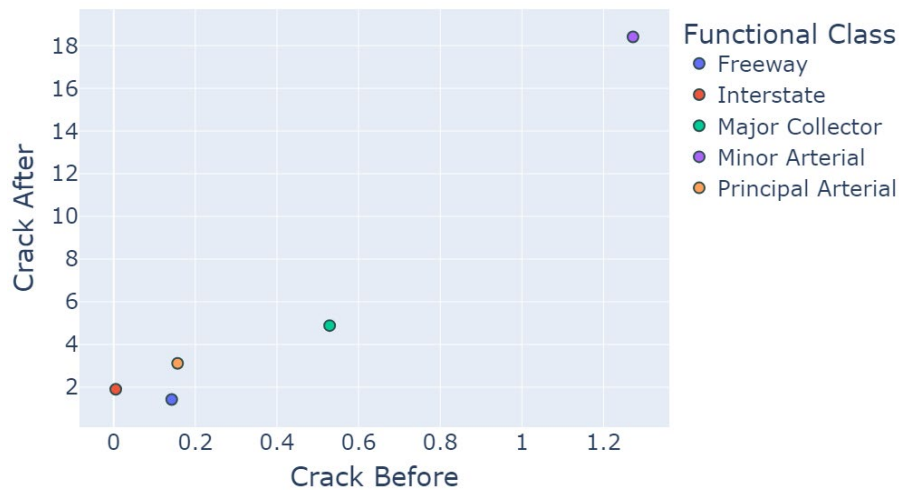
(c) Crack variations

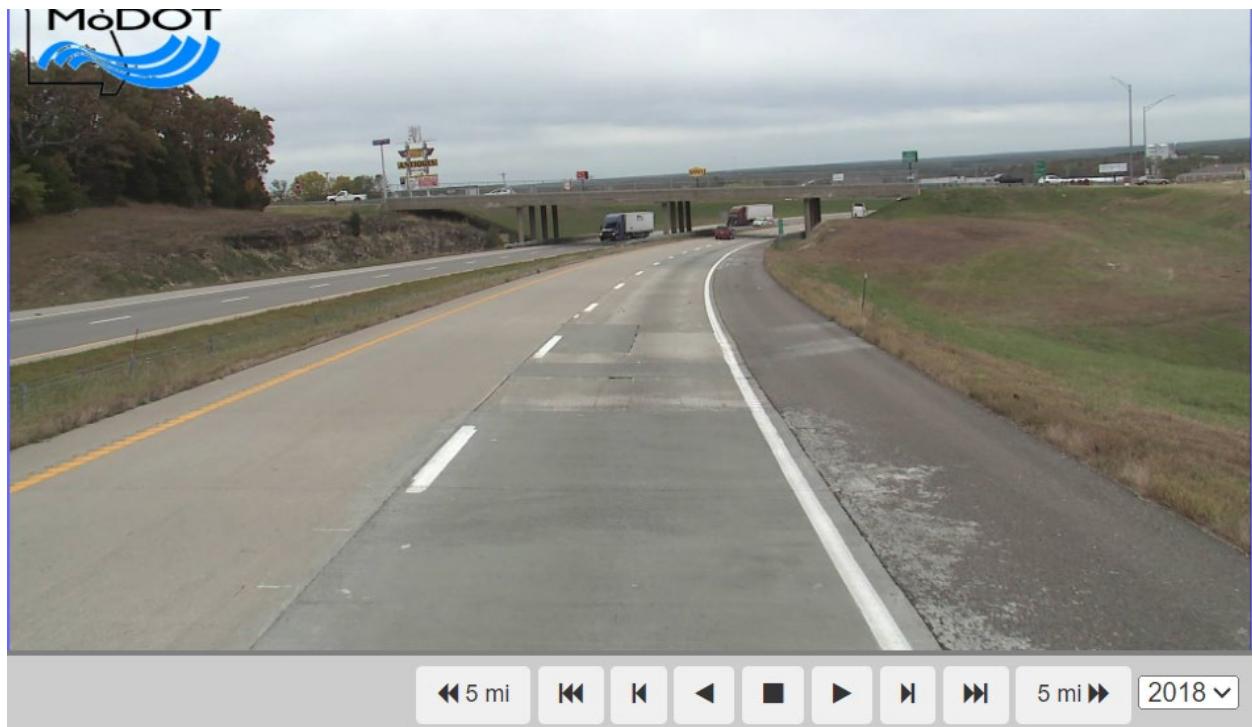
interstates with PCN have more than 5% of average cracking three years after the application of HFST. HFST section 10 is located on an interstate with PCN surface type. Three years after application of HFST, average cracking for this particular section was reported to be around 16%. ARAN image of section 10 before and after application of HFST is shown in Figure 3-3 and Figure 3-4. Compared to Figure 3-3, Figure 3-4 shows apparent white patches or polishing effects on the surface but no “failures of HFST”, such as delamination, substrate tearing, etc. HFST sections 200 and 238 are minor arterials with BM and SP surface types, respectively. Pavement surface images before and after the application of HFST for these two sections are shown in Figure 3-5 through Figure 3-8. Similar to interstate highways, even with a high percentage of reported cracks three years after the application of HFST, these sections also did not show any “failure” of HFST.

Figure 3-3: ARAN image of section 10 before HFST application (source: MoDOT)

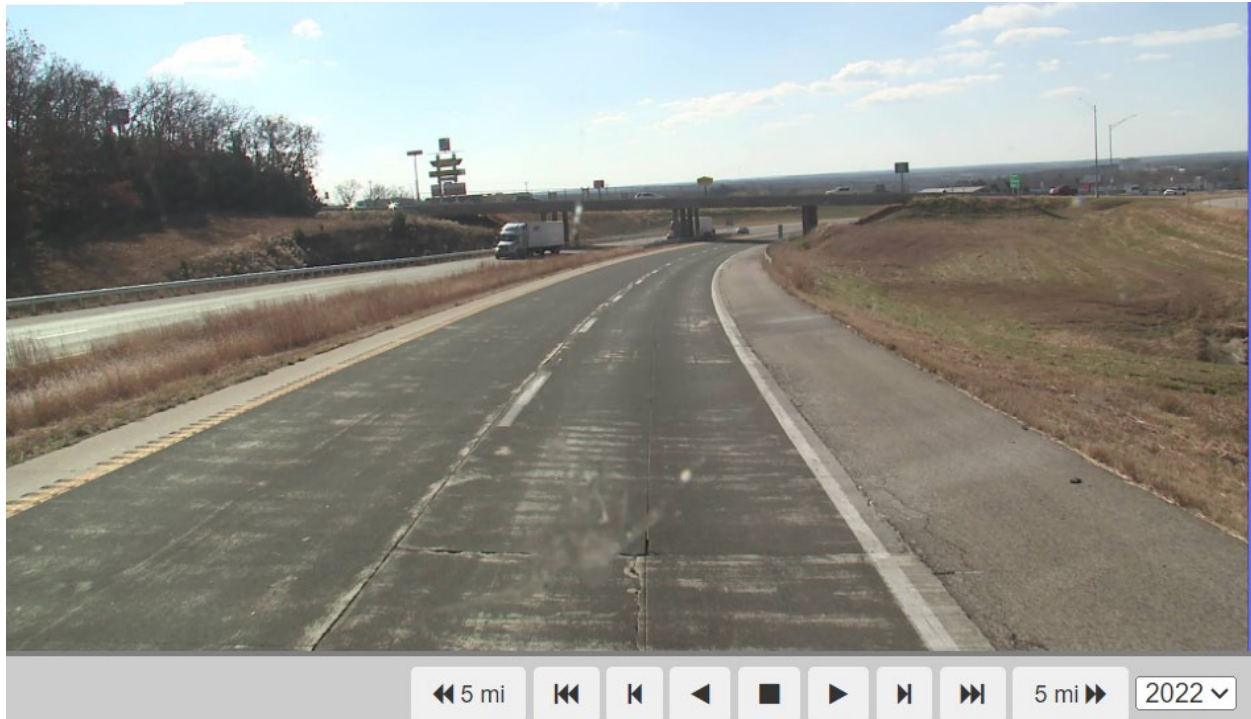
Figure 3-4: ARAN image of section 10 after HFST application (source: MoDOT)

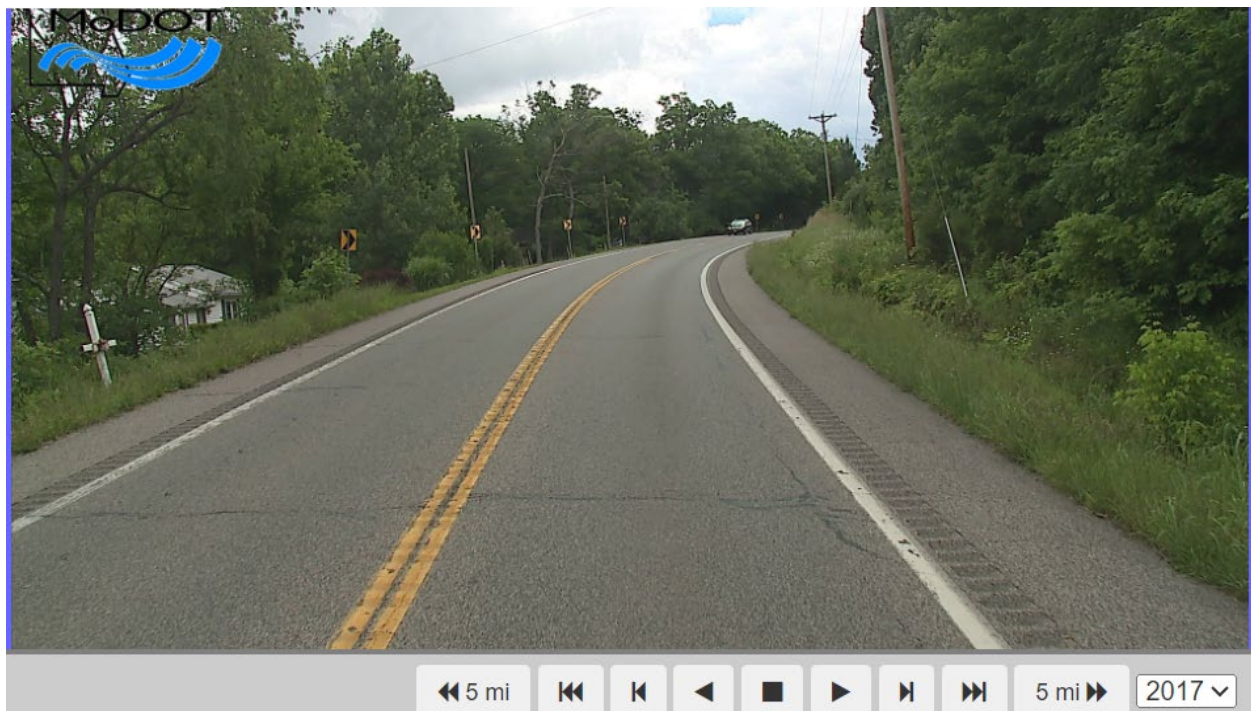
Figure 3-7: ARAN image of section 238 before HFST application (source: MoDOT)

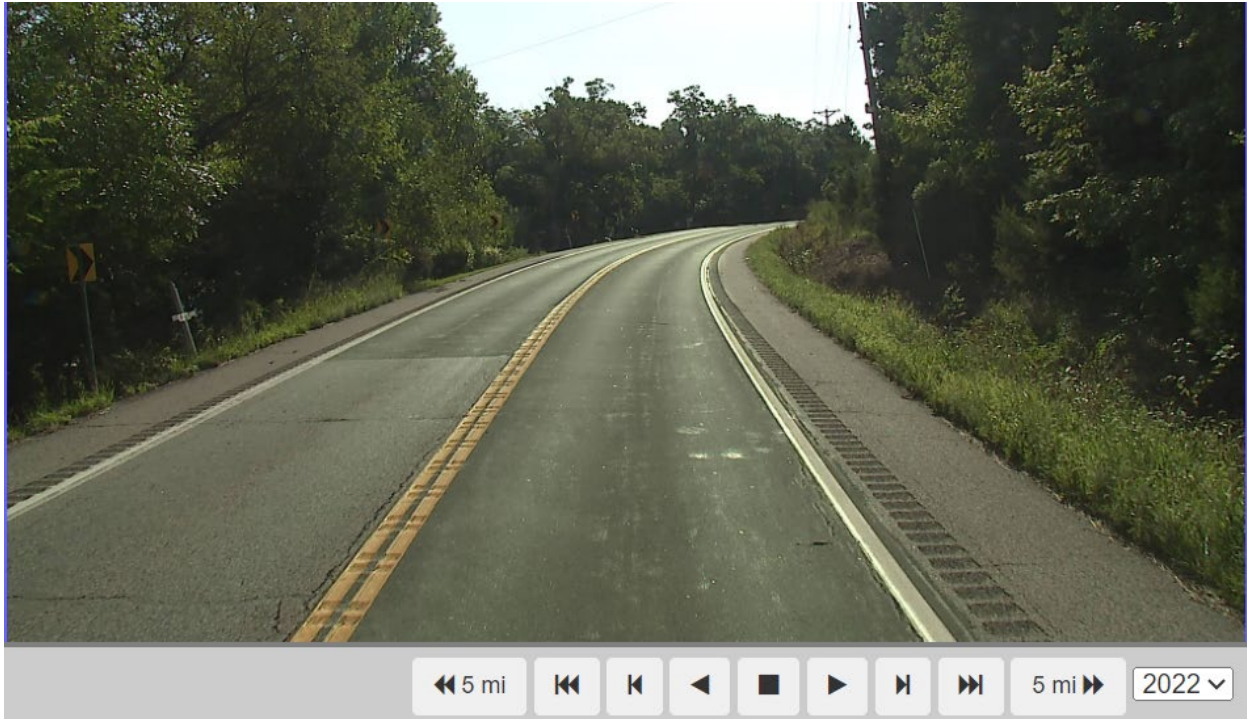
Figure 3-8: ARAN image of section 238 after HFST application (source: MoDOT)

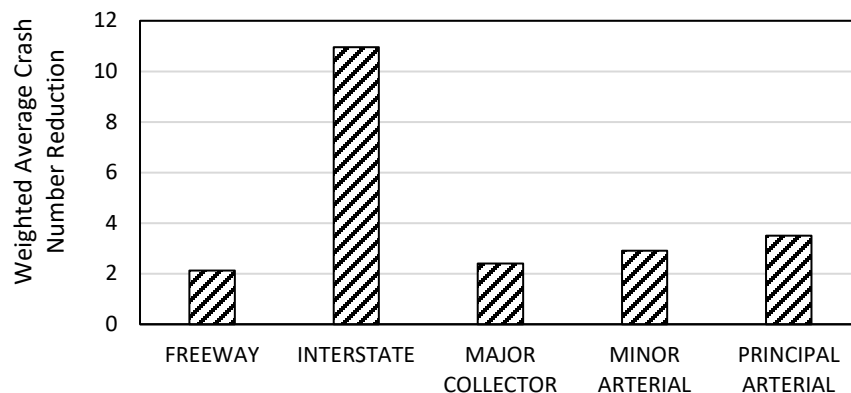
Figure 3-9 shows that the highest number of reductions in crashes after the application of HFST, around 11, was observed for the interstate class of pavements. A reduction of 3.5 and 2.9 crashes after the application of HFST was observed for the minor arterial and principal arterial classes of pavements, respectively. For other classes of pavements, a weighted average crash reduction of about two was observed after the application of HFST.

Figure 3-9: Reduction in crash numbers for different functional classes of pavements

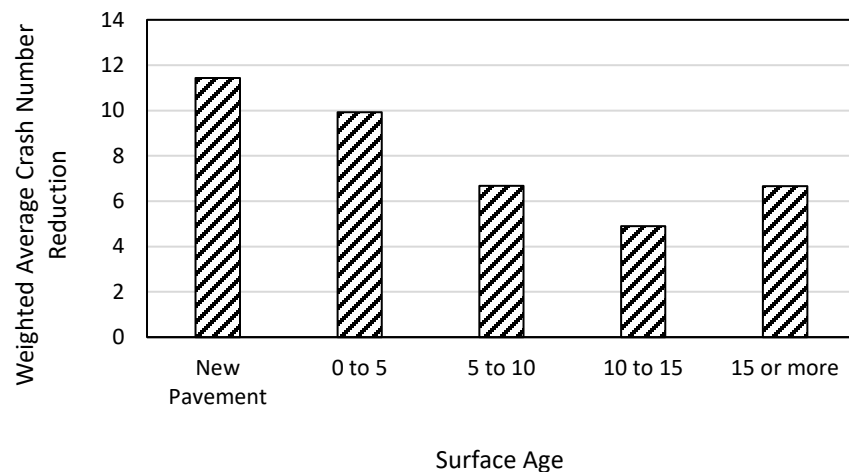
Figure 3-13 shows a positive reduction in the weighted average crash number after the application of HFST, regardless of the age of the pavement surface. At least four crash reductions were observed after the HFST application. HFST has an average service life of about five years. Figure 3-13 shows that the most benefit, in terms of positive crash number reduction, is observed for pavements of less than five years of age. Even after five years, HFST can still provide a positive reduction in crash numbers, given rehabilitative work has not been conducted on the surface, or the HFST has not been removed.

Figure 3-13: Reduction in crash number by surface age

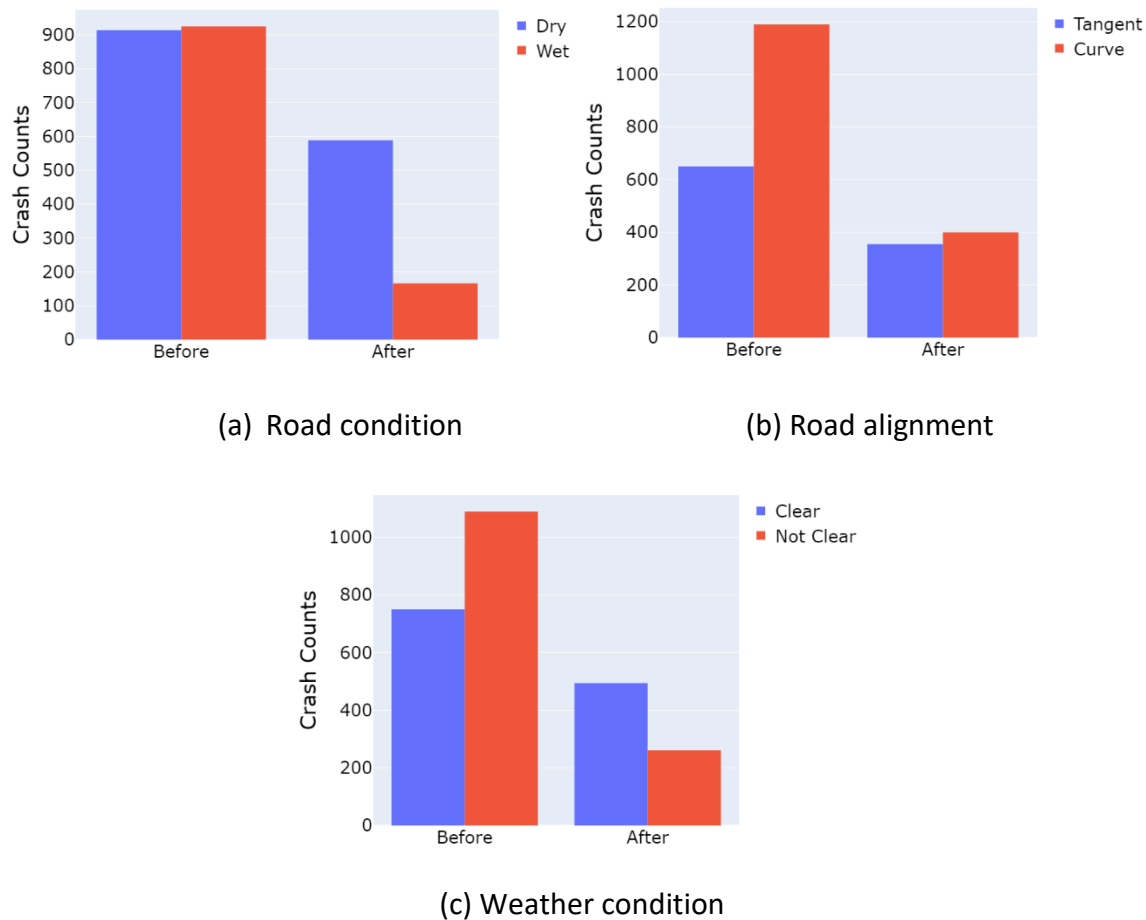
The second crash data file obtained from MoDOT had crash information divided by travel conditions, such as roadway conditions, alignment, weather conditions, etc. The file had crash data up to five years before and after the application of HFST. Figure 3-14 shows the crash counts before and after the application of HFST for various travel condition.

Figure 3-14: Crash count by travel condition

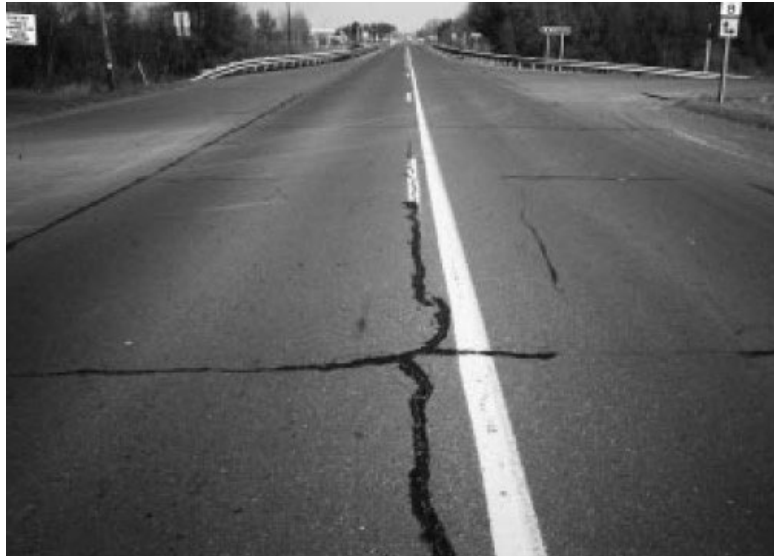
Figure 4-11: Tight and sealed transverse cracks (Source: Walker et al., 2002)

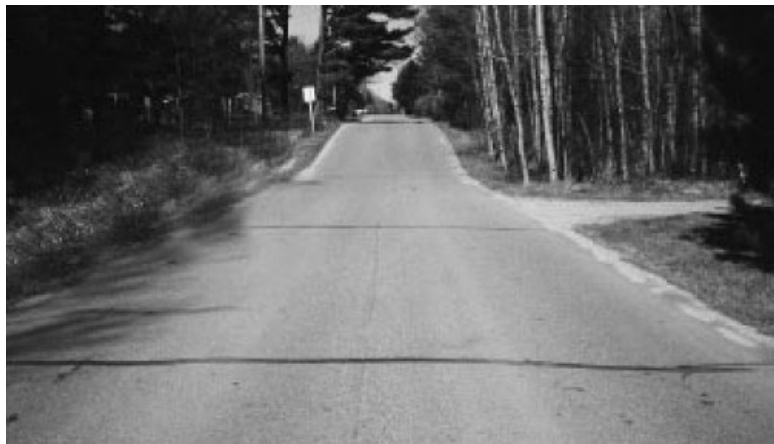
Figure 4-12: Tight and sealed transverse cracks (Source: Walker et al., 2002)

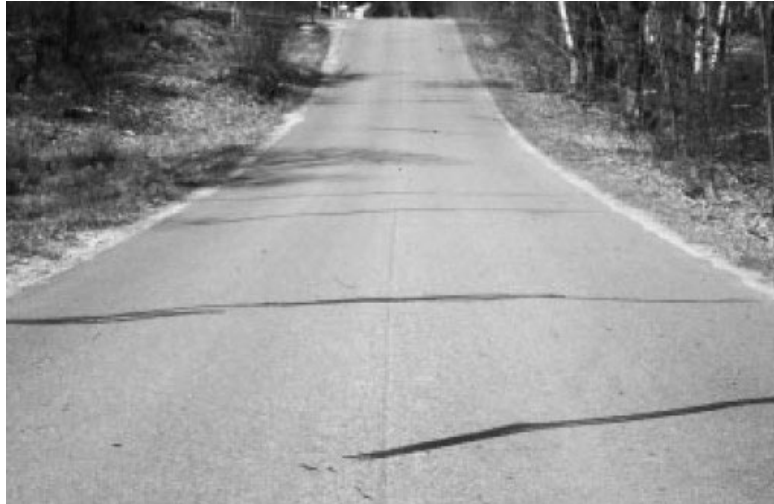
Figure 4-13: Transverse cracks about 10 feet or more apart (Source: Walker et al., 2002)

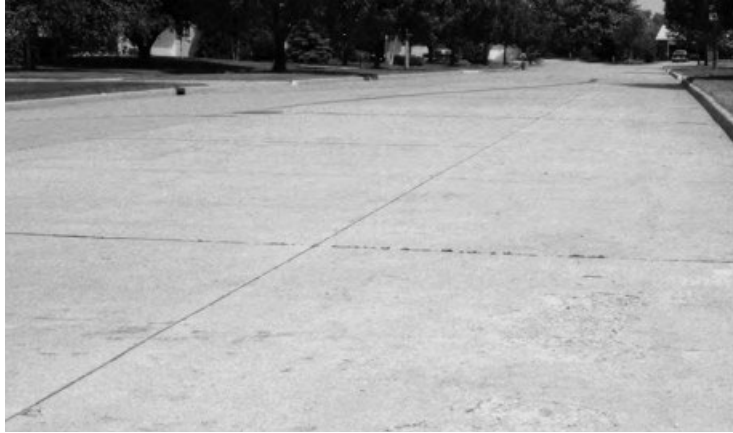
Figure 4-14: Slight scaling of concrete surface (Source: Walker et al., 2015)

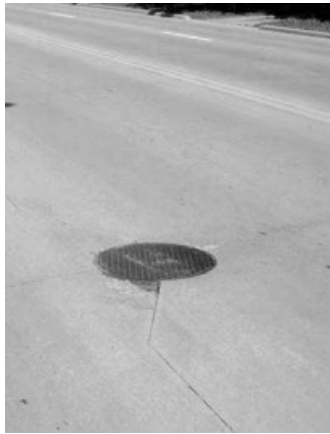
Figure 4-15: Isolated spall at manhole (Source: Walker et al., 2015)

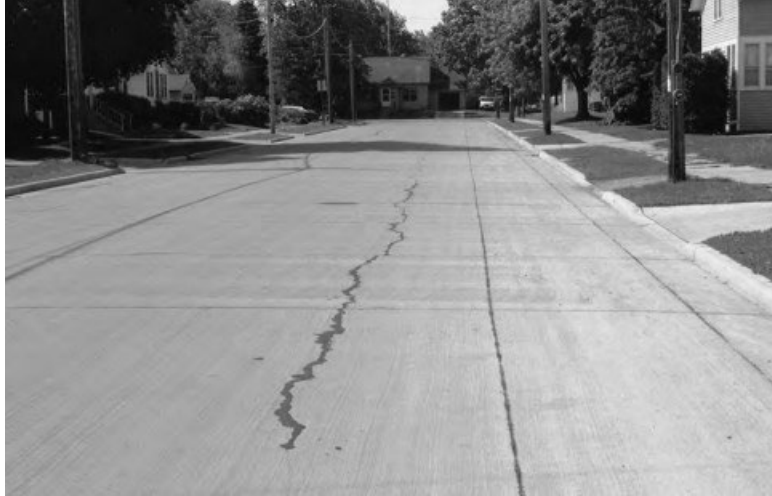
Figure 4-17: Tight and well-sealed isolated meander cracks (Source: Walker et al., 2015)
