JOINT TRANSPORTATION RESEARCH PROGRAM

New Repair Strategies for Life-Cycle Extension of Corroded Steel Girder Bridges

1. Report No. FHWA/IN/JTRP-2024/15	2. Government Accession No.		3. Recipient's Catalog No.	
4. Title and Subtitle New Repair Strategies for Life-Cycle Extension of Corroded Steel Girder Bridges			5. Report Date February 2024

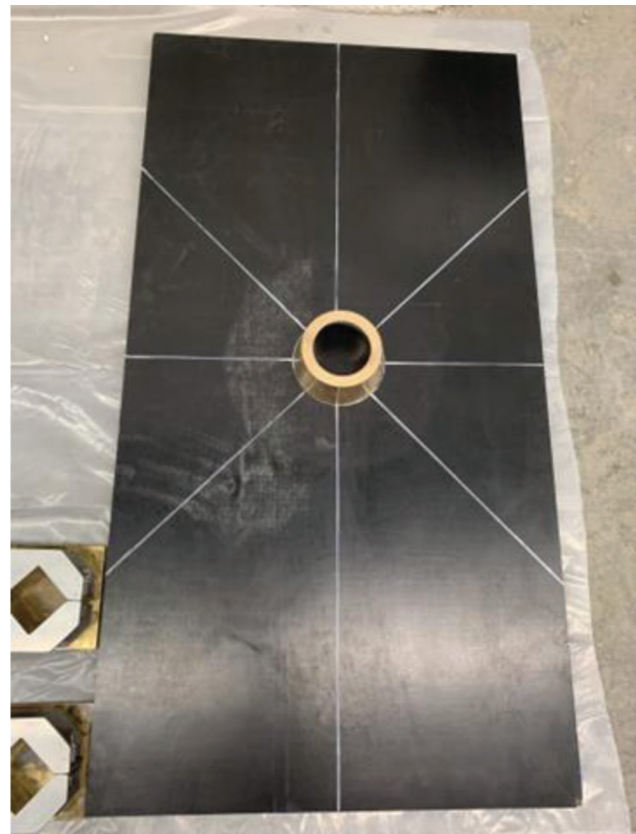
Figure 4.19 Modified flow table test setup.

The technical data sheet (TDS) states the diameter of the spread should be 8–12". The average diameter of the spread was 12.75", which exceeded the upper limit stated by TDS by 6.25% due to the increased water/cement ratio. However, the mix was accepted for casting cube (compressive strength test) and cylinder

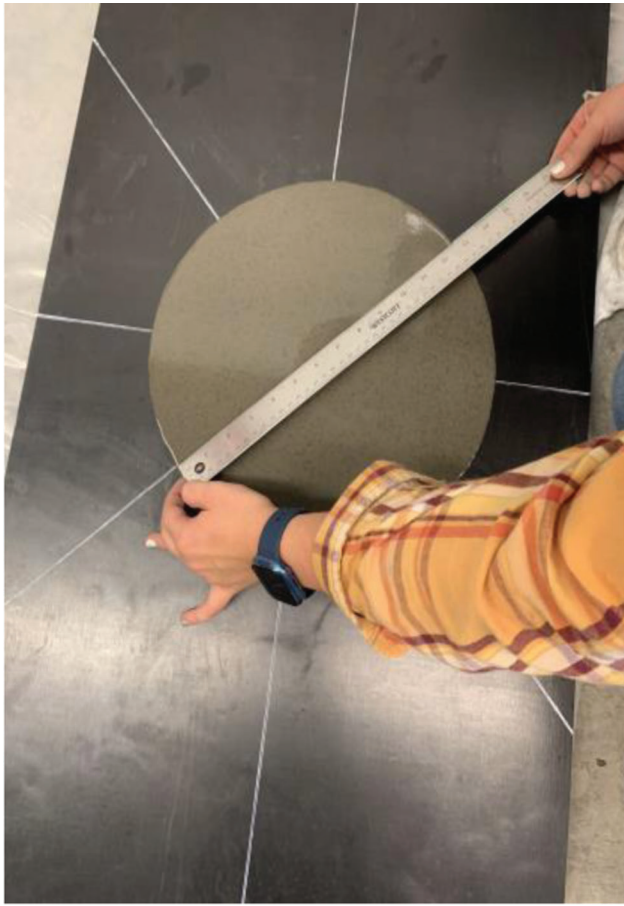
Figure 4.20 Measuring the diameter of the grout spread.

(modulus of elasticity test) specimens as reasonable deviation from TDS was observed, and no bleeding or segregation was noticed. According to ASTM C1437 (ASTM, 2020), the flow is the increase in the average base diameter of the grout, expressed as a percentage of the original base diameter. The base inside diameter of the flow mold was 4", which resulted in a flow of 219%.

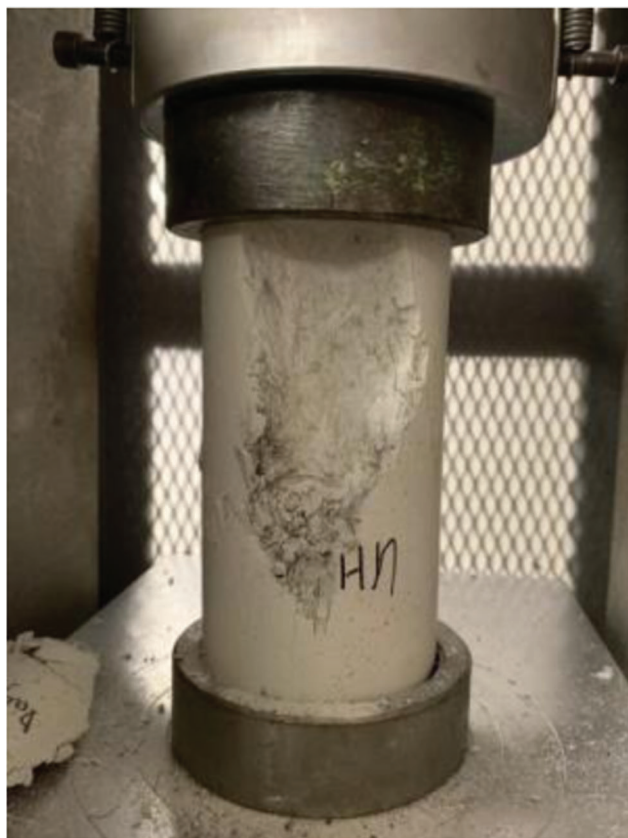
Figure 4.43 Cylinder UHPC-3.1; $f'_c = 14,936$ psi.

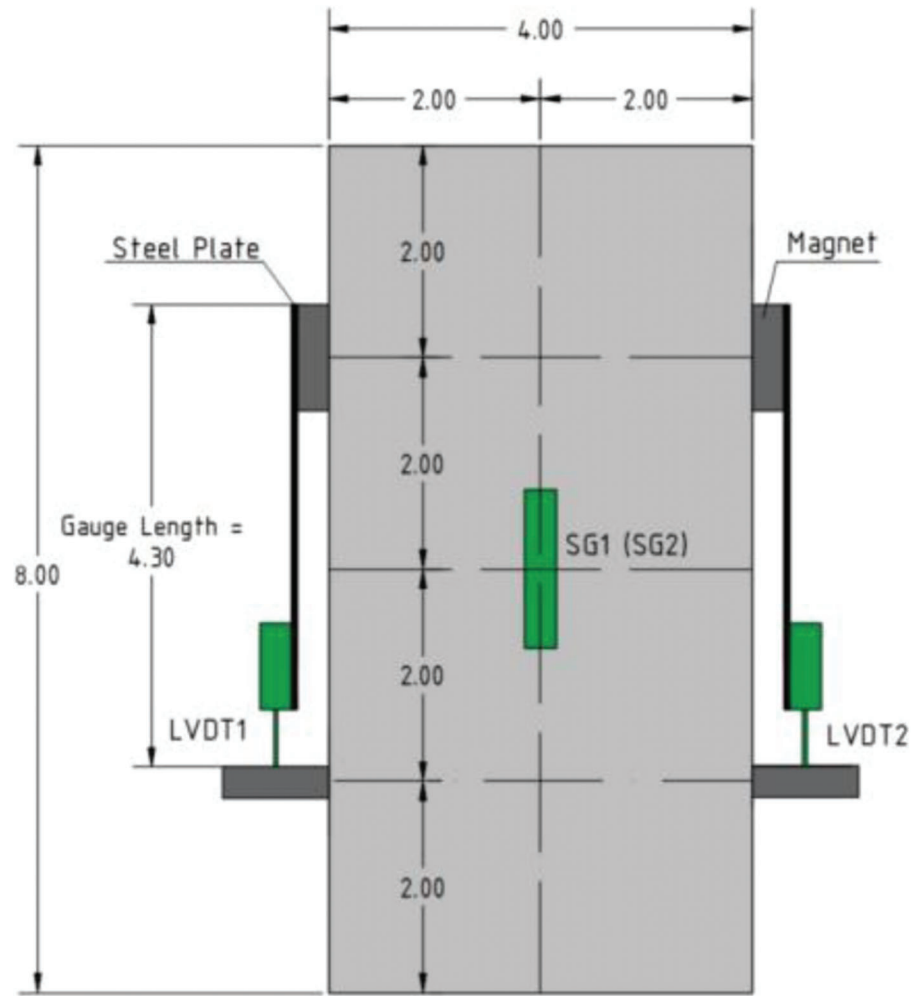
Figure 4.47 Sensor layout.

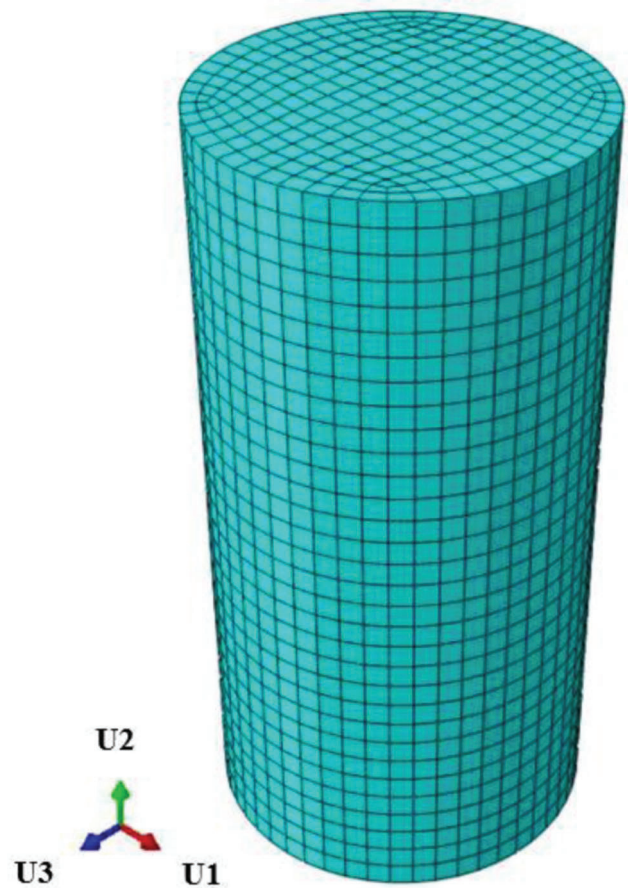
Figure 4.59 FE model: standard mesh. Mesh size = $1/4"$.

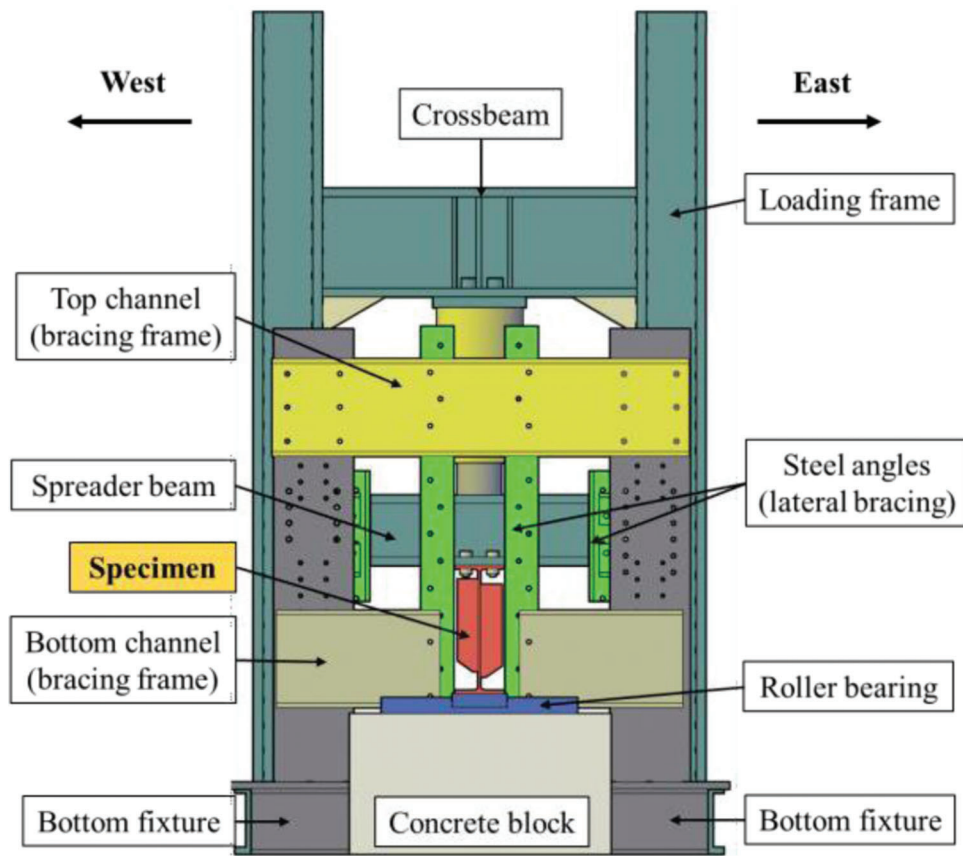
Figure 5.6 3D model of the test setup: back view.

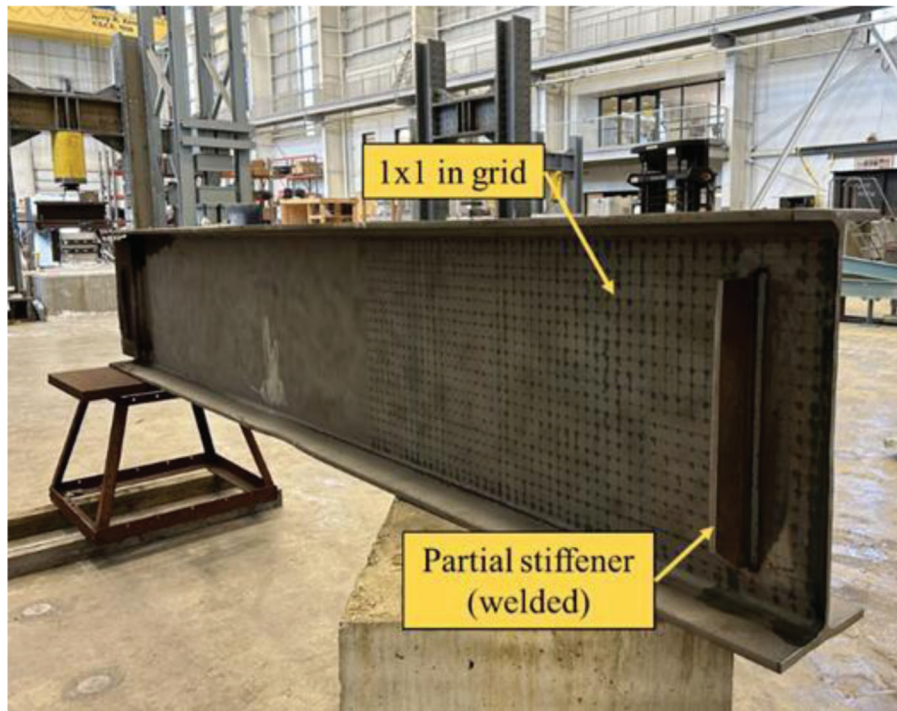
Figure 5.33 Specimen 1: isometric view.

Accurate section loss measurements were obtained using a high-precision UT gauge (R7900, 0.002 in accuracy) manufactured by REED Instruments. A detailed grid of 1×1 in. was marked over a 4-ft-long segment starting from the corroded girder end. At each grid point, measurements were meticulously obtained,

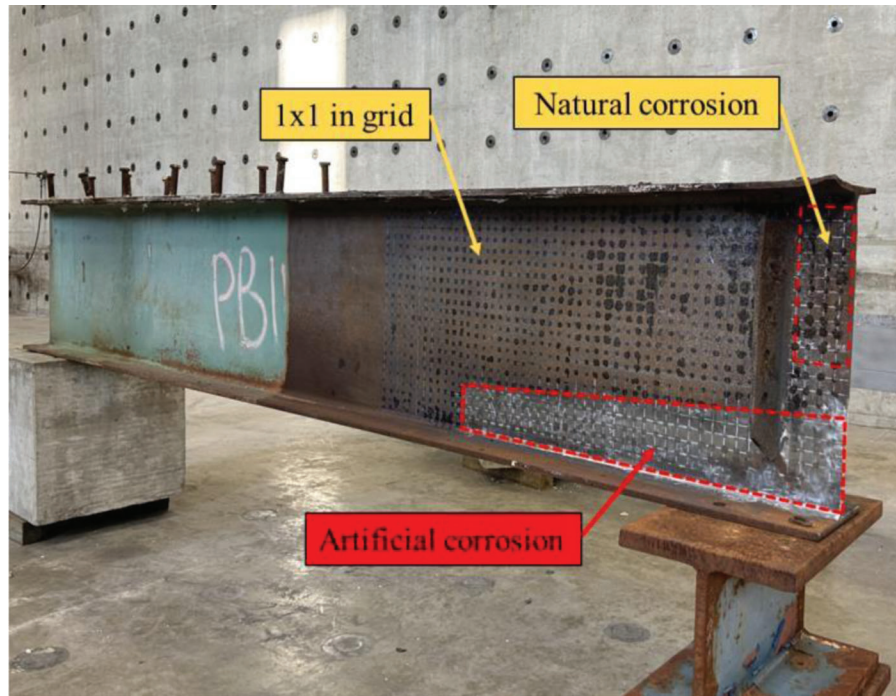
Figure 5.35 Specimen 2: isometric view.

Specimen 2 was the moderately corroded 11-ft-long steel W24×68 girder with existing partial-depth stiffeners. It could be seen from Figure 5.35 that Specimen 2 had natural (upper part of the girder web) and artificial (the bottom part of the web) corrosion. In the naturally corroded area, a patch was welded behind the partial stiffener to prevent failure as the load was applied in high proximity to this region (Figure 5.36).

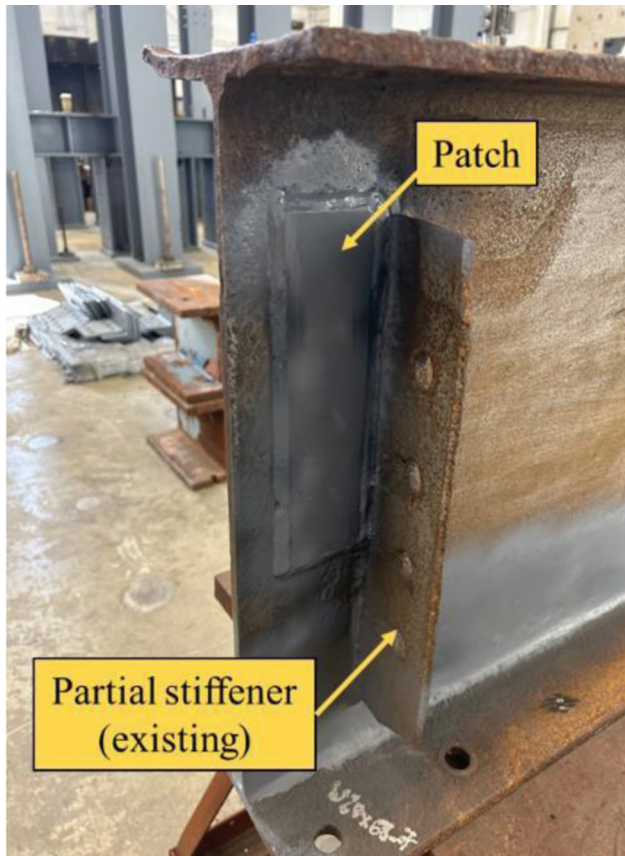
Figure 5.36 Specimen 2: side view.

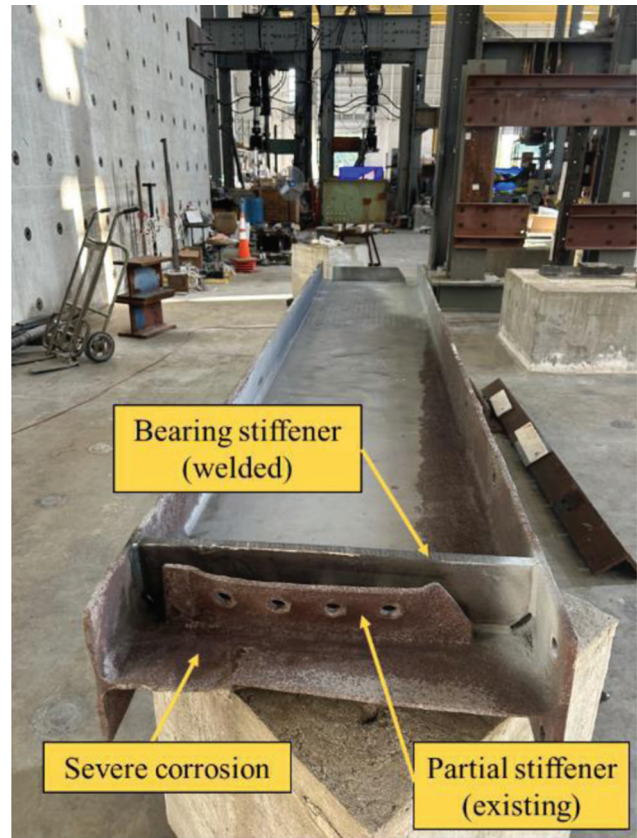
Figure 5.38 Specimen 3: bearing stiffener welded to far girder end.

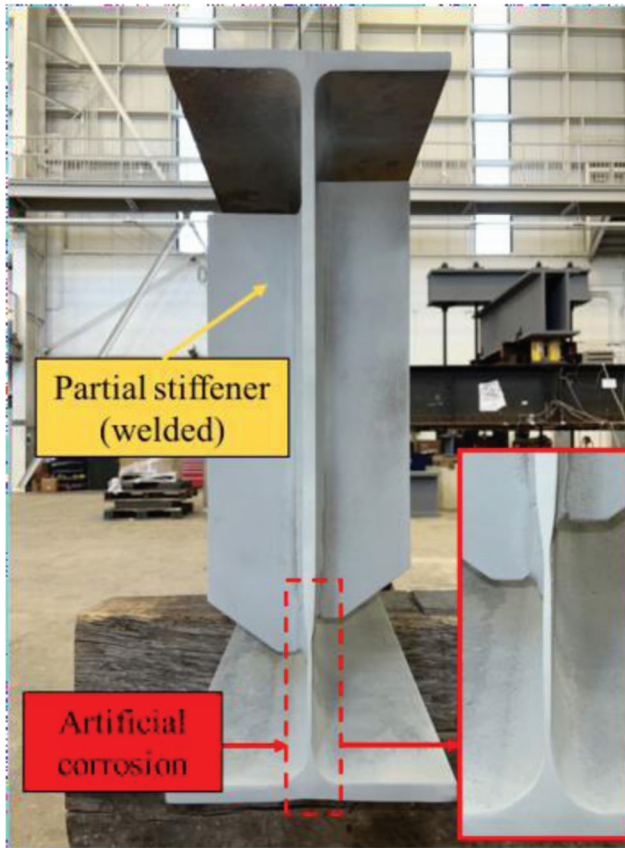
Figure 5.40 Specimen 4: front view.

regions. The final fabricated specimen after inducing section loss and welding partial depth stiffeners but before the repair is shown in Figure 5.39 and Figure 5.40.

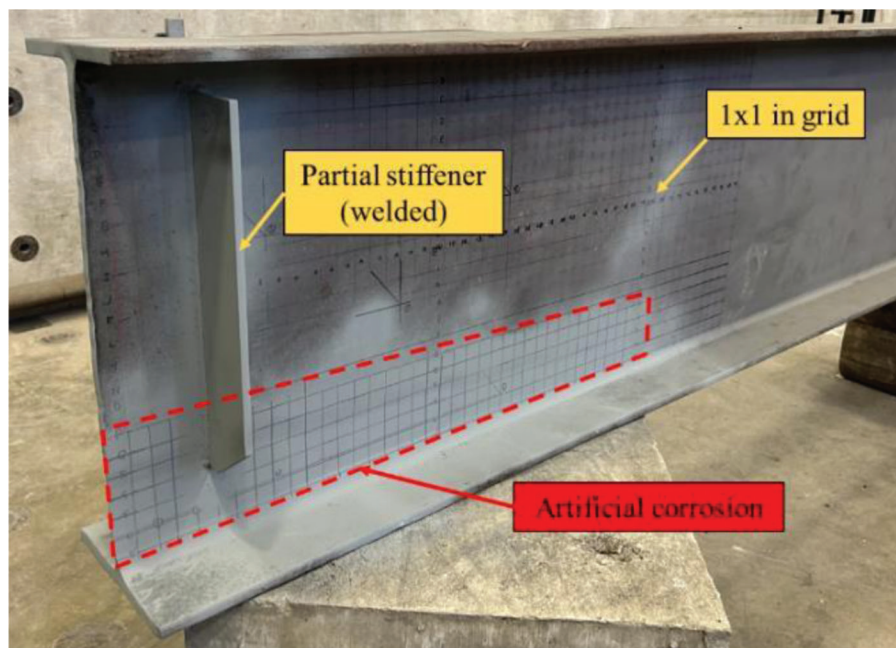
Figure 5.41 Specimen 5: isometric view.

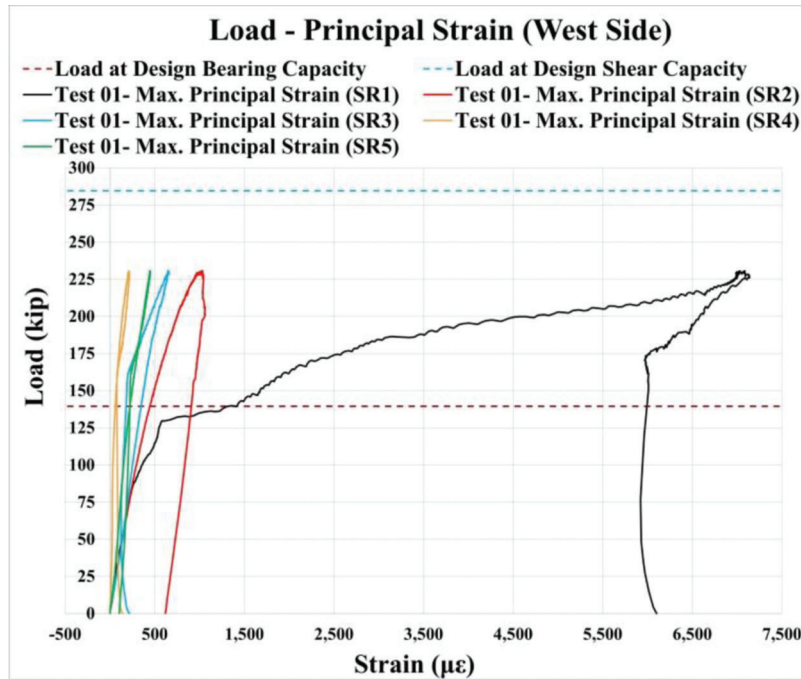
Figure 6.5 Load-maximum principal strain (west side) for Specimen 1.

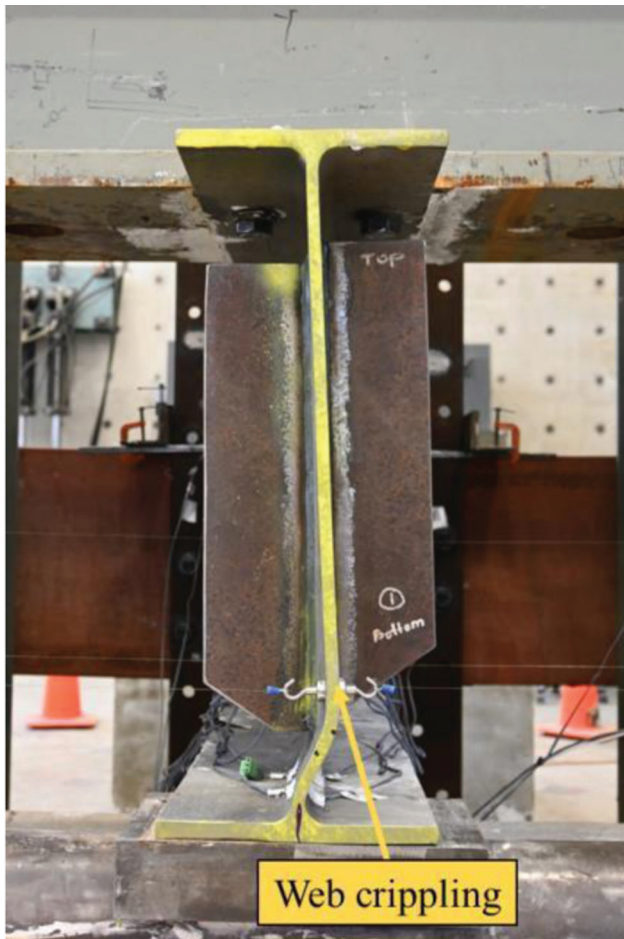
Figure 6.6 Specimen 1: deformed shape, front view.

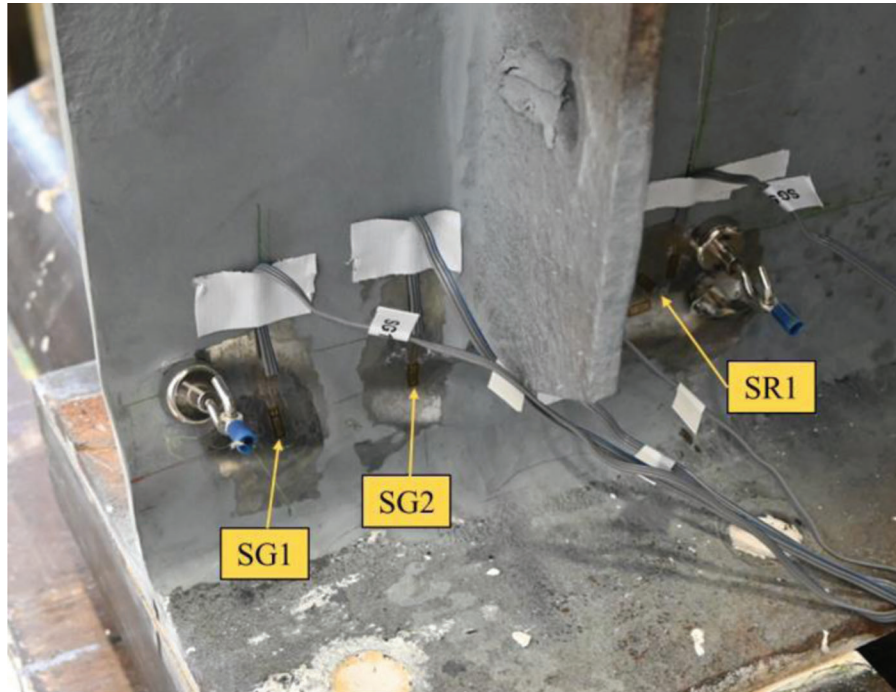
Figure 6.13 Specimen 2: deformations in the corroded region.

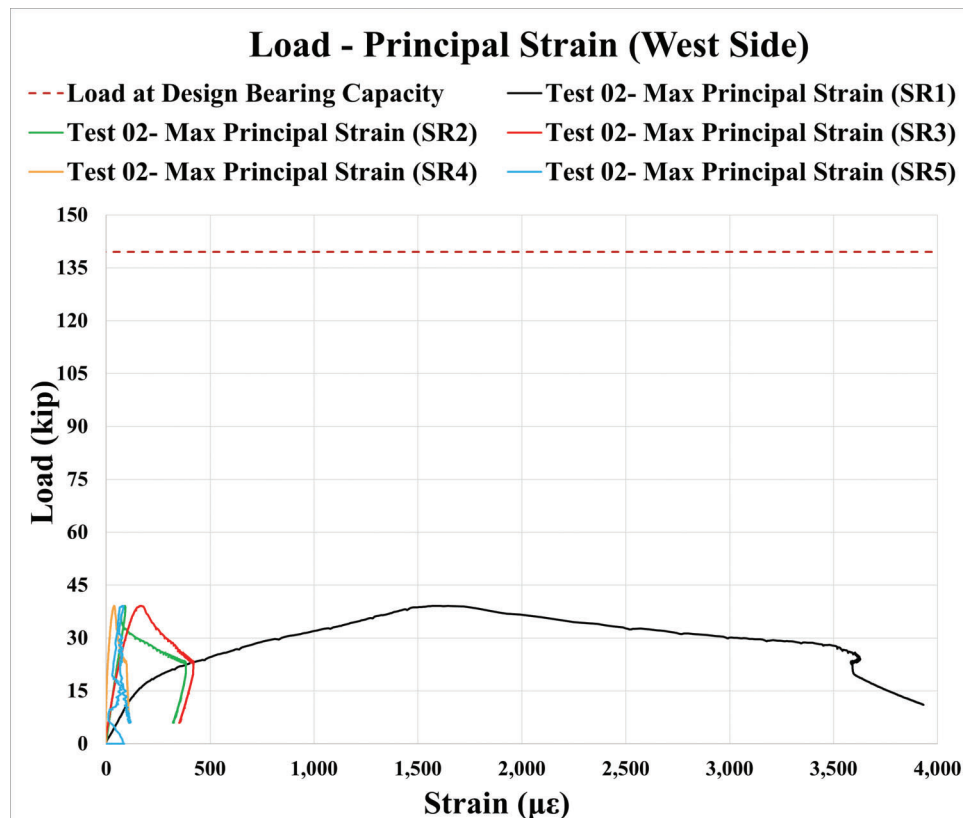
Figure 6.14 Load-maximum principal strain (west side) for Specimen 2.

Data from five strain gauge rosettes (SR) located on the west side of the girder web, revealed that SR1 yielded at 39 kips, a few time steps before Specimen 2 reached its capacity. The rest of the strain gauge rosettes (SR2–SR4, and SR10) experienced only elastic deformations (Figure 6.14). The SR5 was replaced by data from SR10 due to the strain gauges in this rosette not functioning correctly. To conclude, the yielding first was recorded by SG2, followed by the yielding of SR1, and finally SG2.

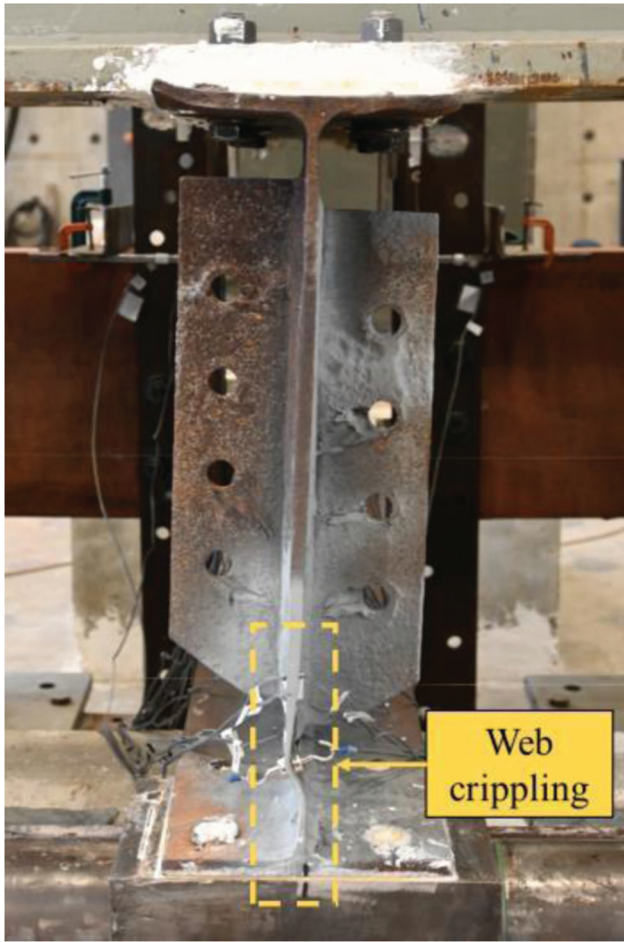
Figure 6.15 Specimen 2: deformed shape.

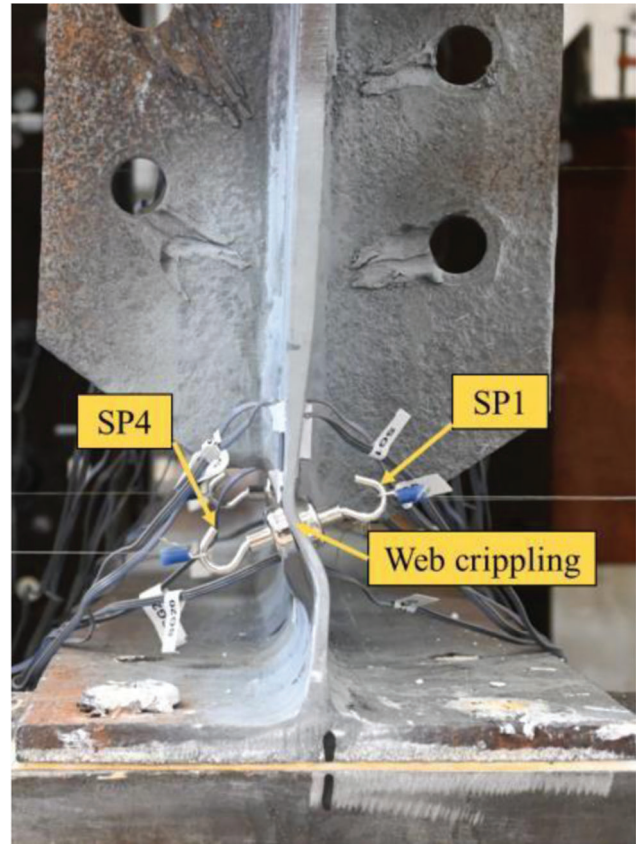
Figure 6.16 Specimen 2: deformed shape. Locations of SP1 and SP4.

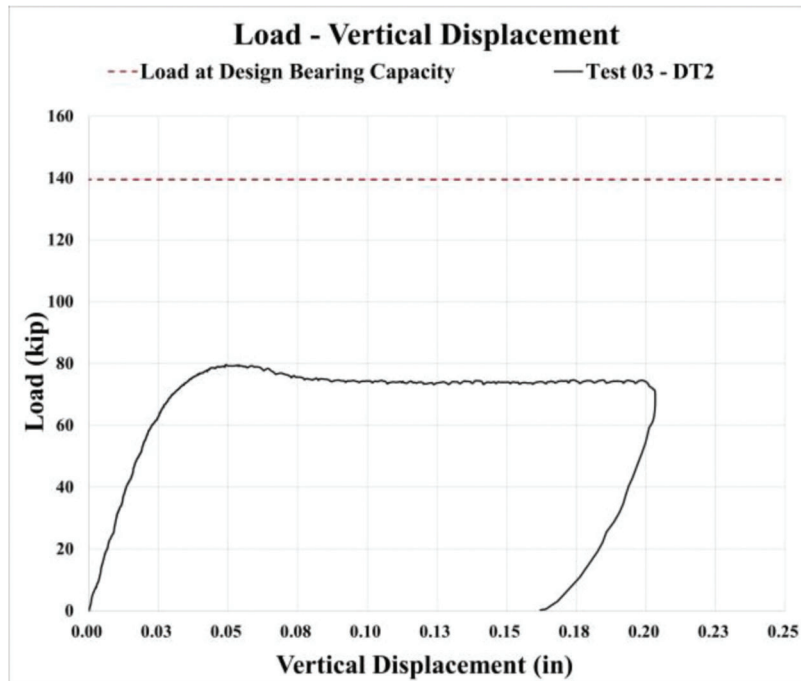
Figure 6.18 Load-vertical displacement plot for Specimen 3.

The force-vertical displacement plot is shown in Figure 6.18. The displacement transducer DT2 was positioned beneath the point of applied loading, 16" from the girder end, measuring the displacement of the bottom flange. The force-vertical displacement plot

shows that up to a load of 48 kips, the graph was linear with an initial stiffness of 3,032 kips/in. Following this loading step, softening behavior was observed. Once the load peaked, the girder underwent deformations but with negative stiffness. Subsequently, the load plateaued at 73 kips with approximately zero stiffness until the experiment was terminated.

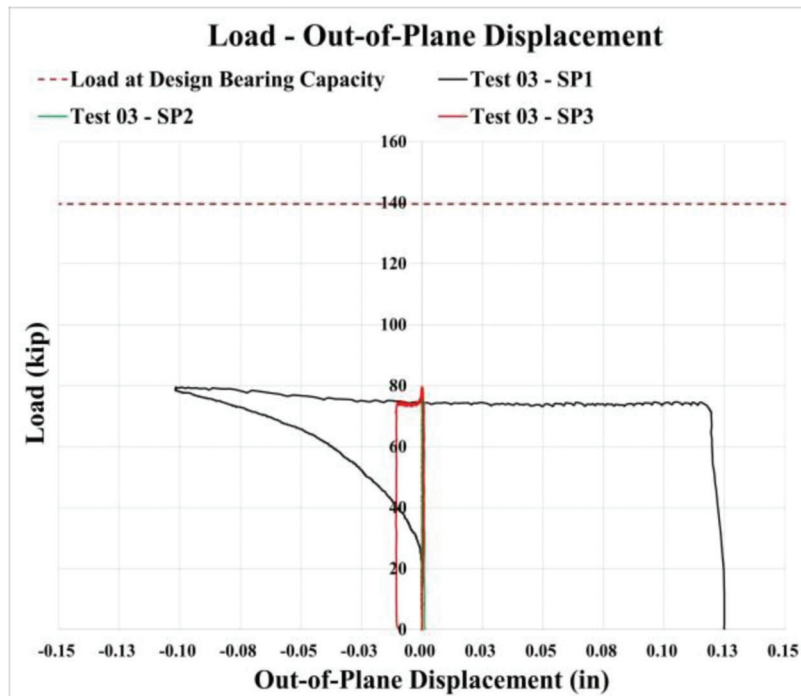
Figure 6.19 Load-OOP displacement plot for Specimen 3.

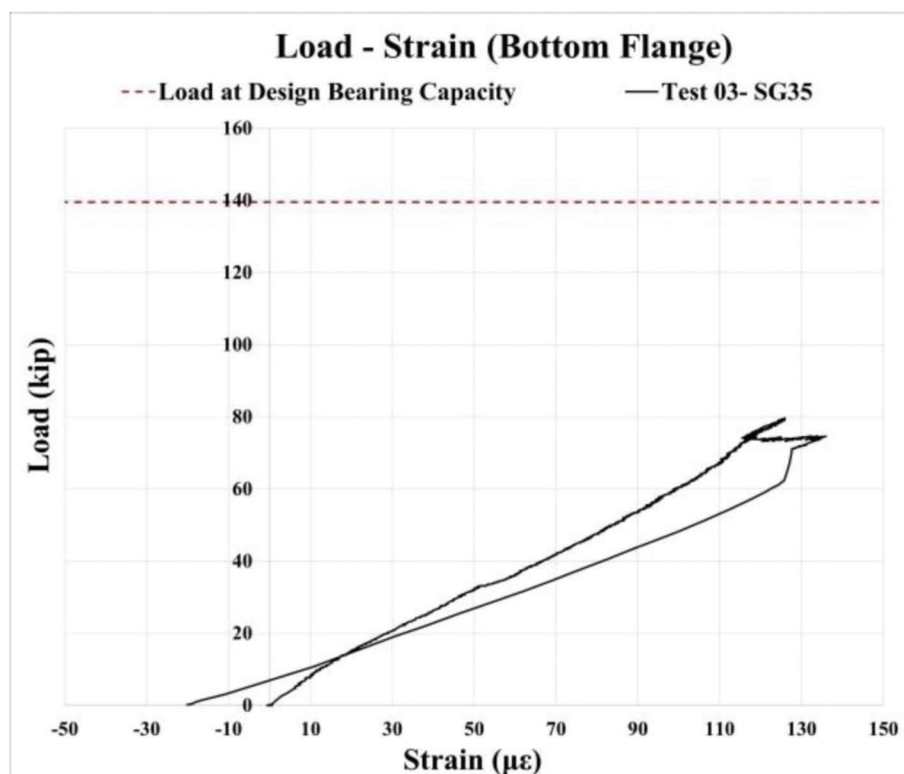
Figure 6.20 Load-strain (bottom flange) plot for Specimen 3.

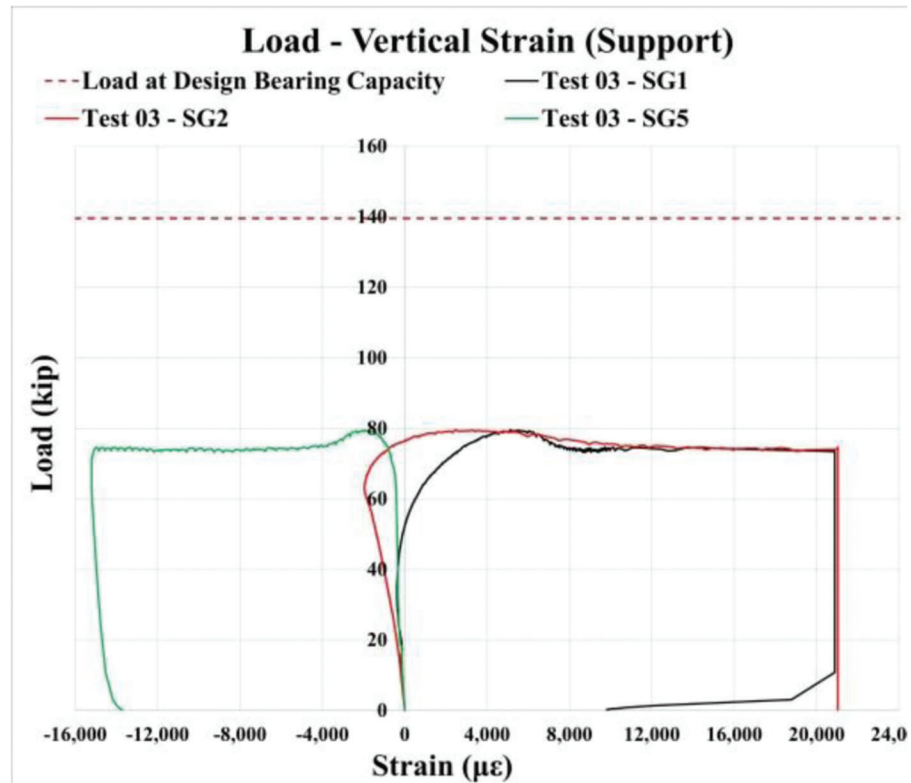
Figure 6.21 Load-vertical strain (support) plot for Specimen 3.

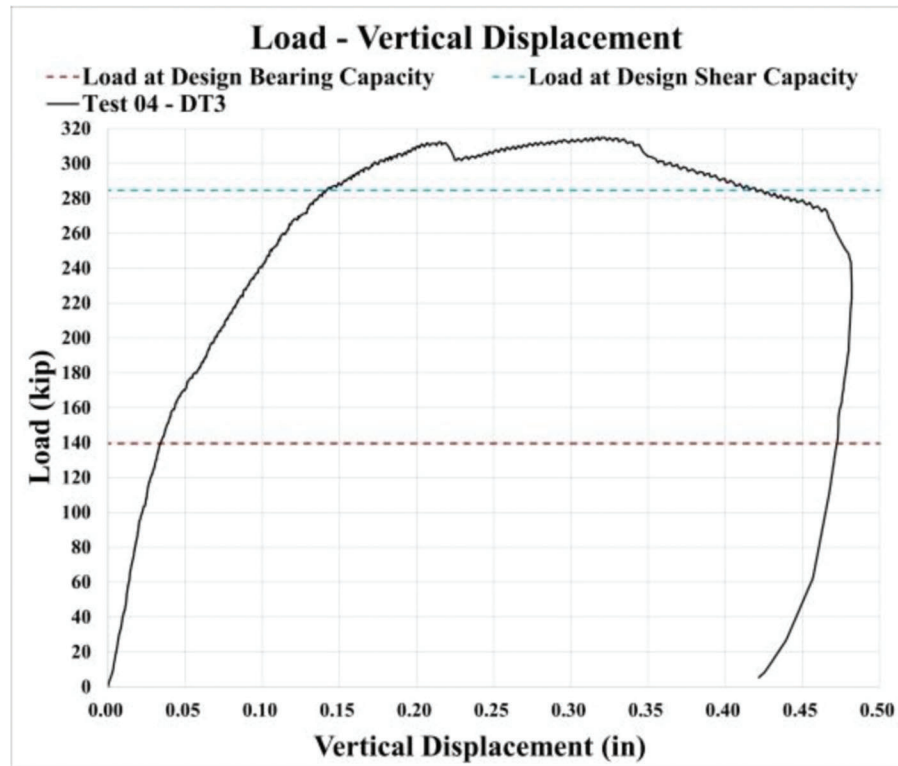
Figure 6.29 Load: vertical displacement plot for Specimen 4.

The force-vertical displacement plot is shown in Figure 6.29. The displacement transducer DT3 was installed 22 in. from the girder end, measuring the vertical displacement of the bottom flange. From the force-vertical displacement plot, it could be observed that up to a load of 131 kips, the graph was linear with an initial stiffness of 4,158 kips/in. After reaching this load level, softening behavior was observed. Once the load reached the first peak, 311 kips, the girder continued to endure deformations but with a negative

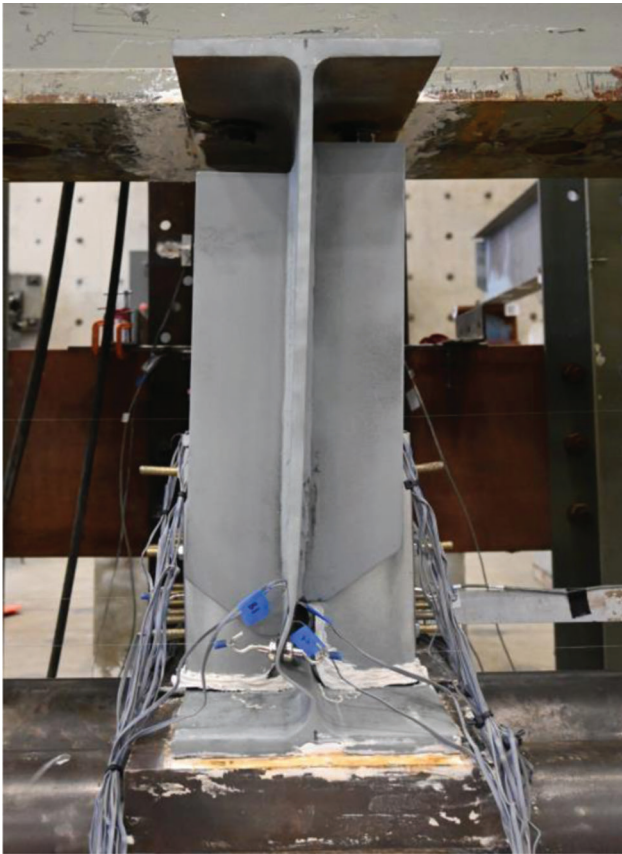
Figure 6.36 Specimen 4: deformed shape, front view.

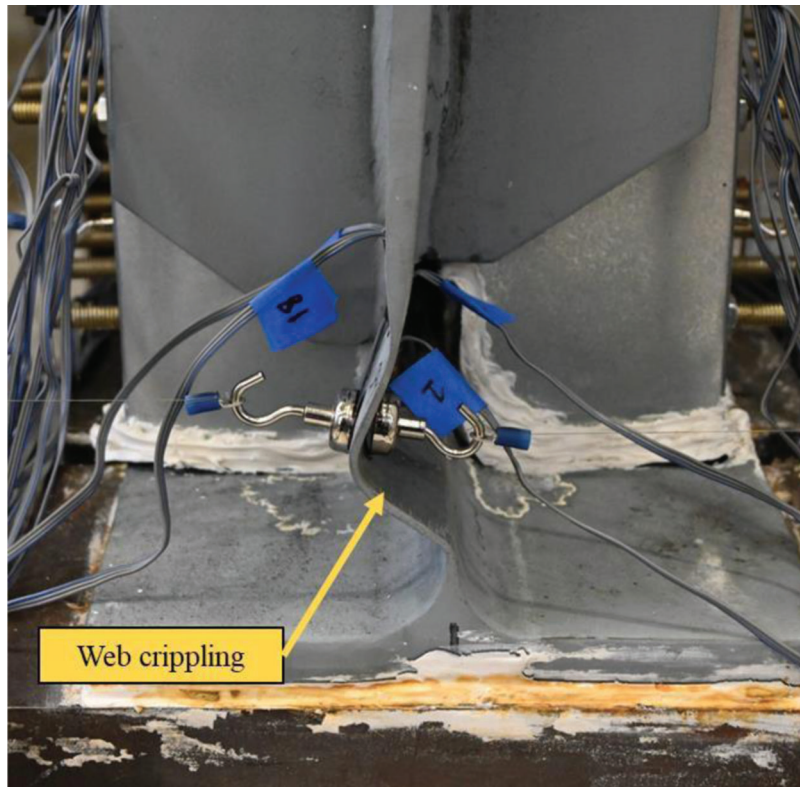
Figure 6.37 Specimen 4: deformed shape, enlarged view.

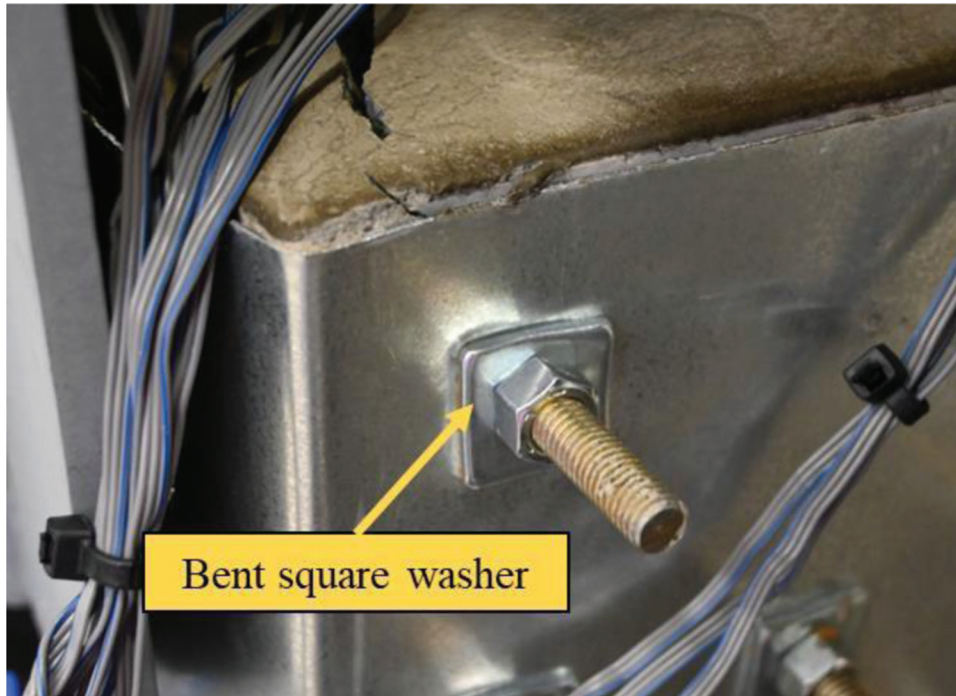
Figure 6.39 Specimen 4: deformed square washer, view from the west side.

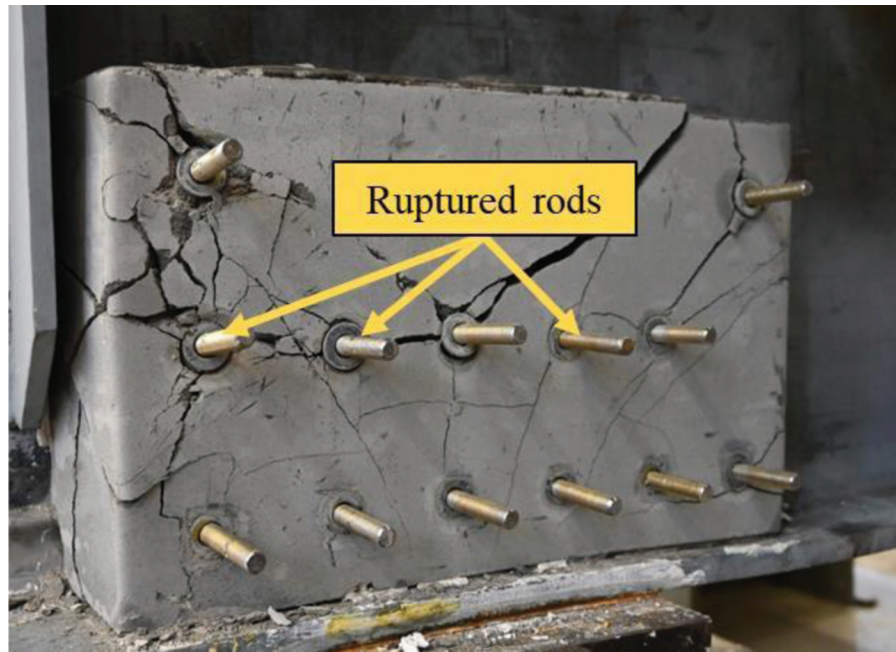
Figure 6.41 Specimen 4: cracking in west panel (elevation view).

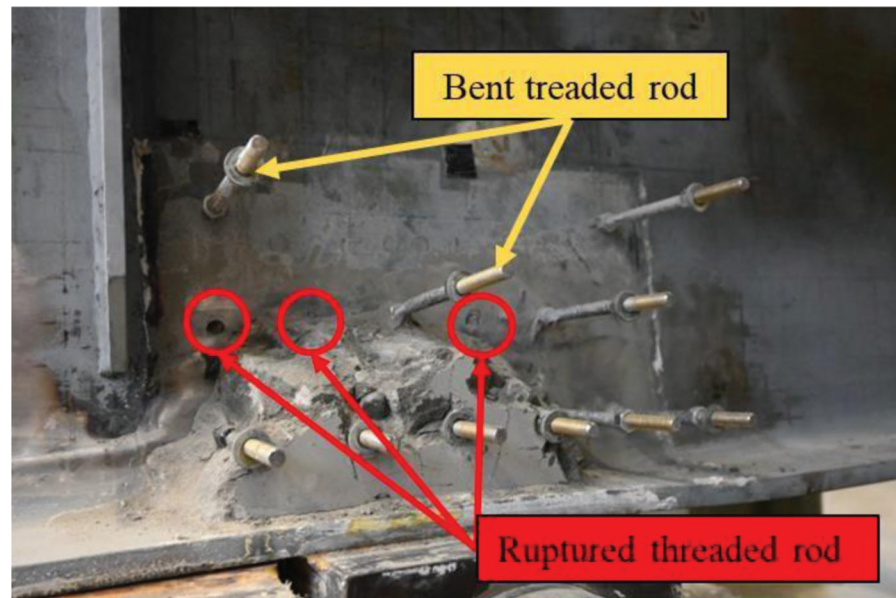
Figure 6.42 Specimen 4: threaded rod deformations (grout panel removed).

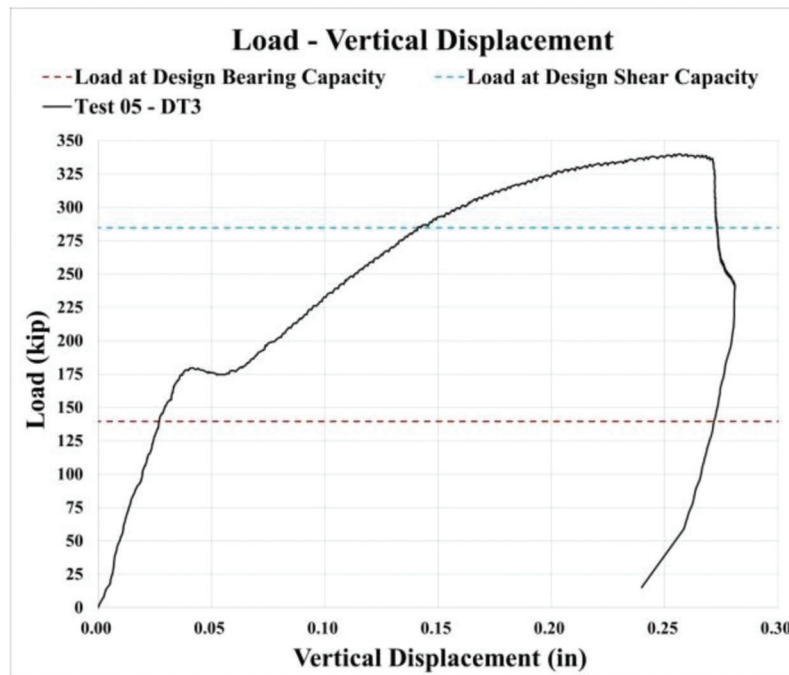
Figure 6.45 Load: vertical displacement plot for Specimen 5.

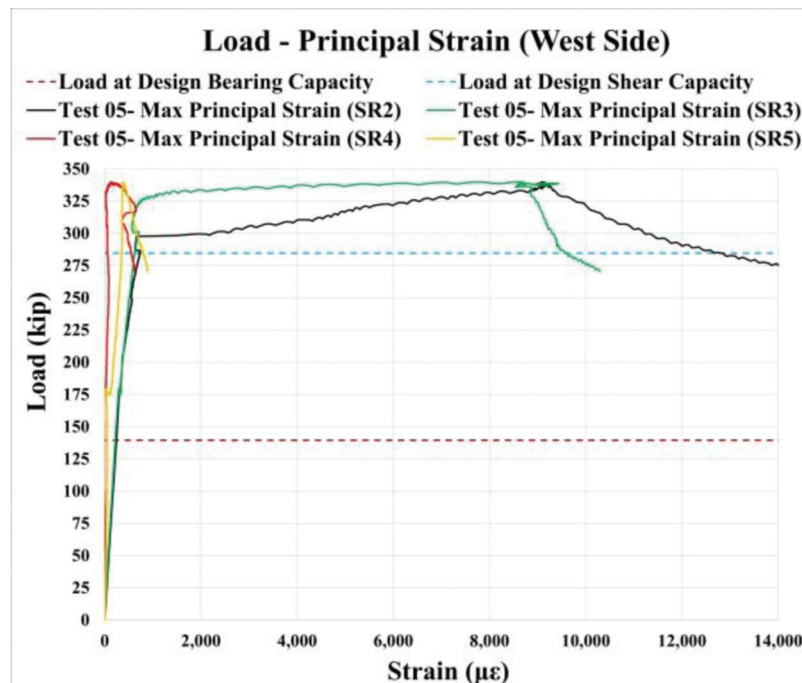
Figure 6.49 Load: maximum principal strain (west side) for Specimen 5.

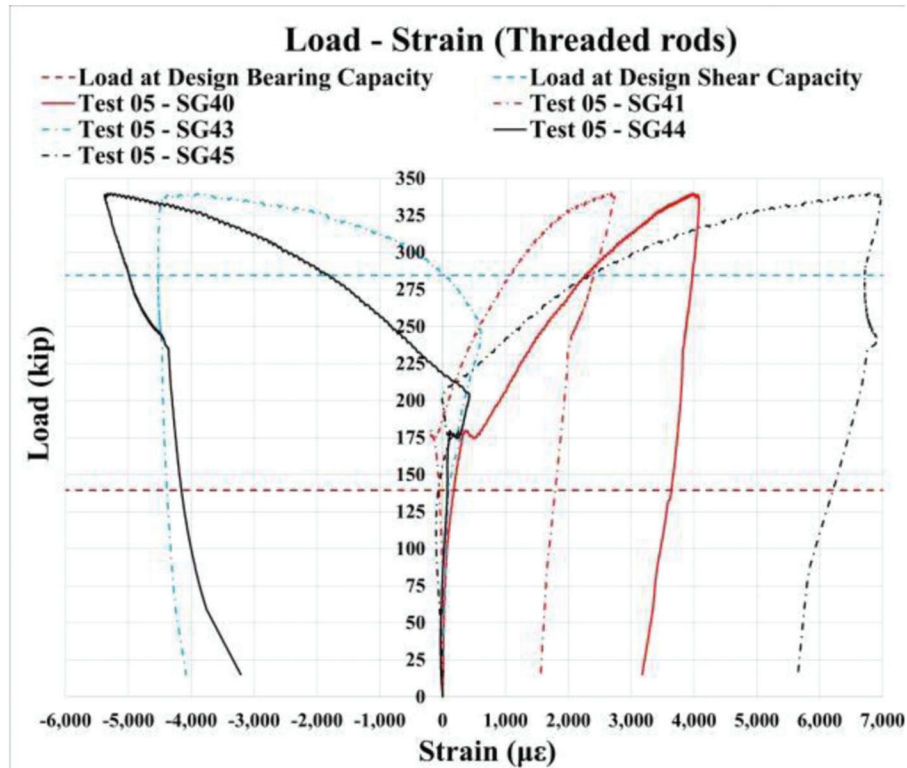
Figure 6.50 Load: strain in threaded rods for Specimen 5.

It can be seen from Figure 6.50 that up to the load of 240 kips, the top surface of threaded rod #2 was subjected to tension. However, after reaching this load threshold, deformations transitioned into bending, with the top side of a rod subjected to compression. SG42 malfunctioned during the test; therefore, its data are not presented in Figure 6.50. Finally, threaded rod #3 underwent insignificant bending deformations up to the load of 205 kips. Afterward, threaded rod #3 was subjected to reverse bending: the bottom surface was

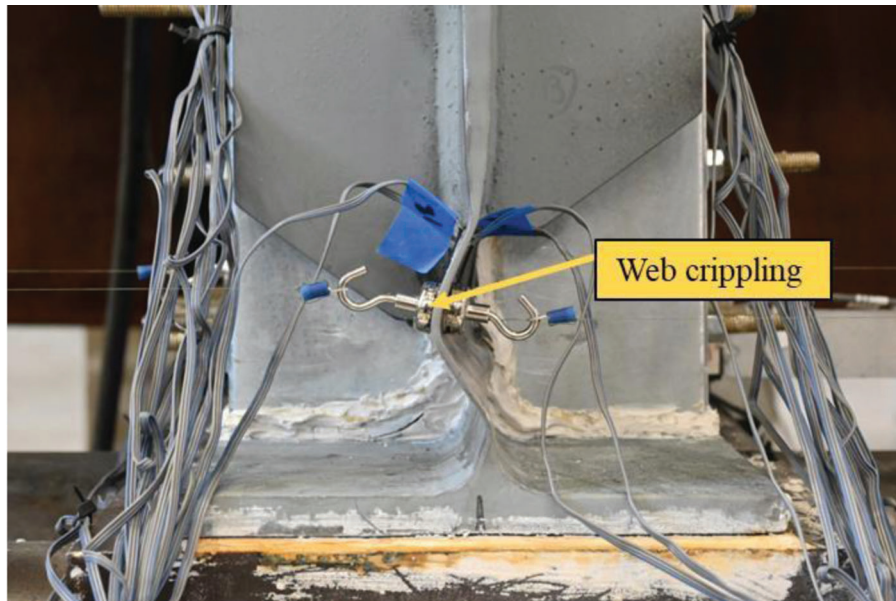
Figure 6.52 Specimen 5: deformed shape, enlarged front view.

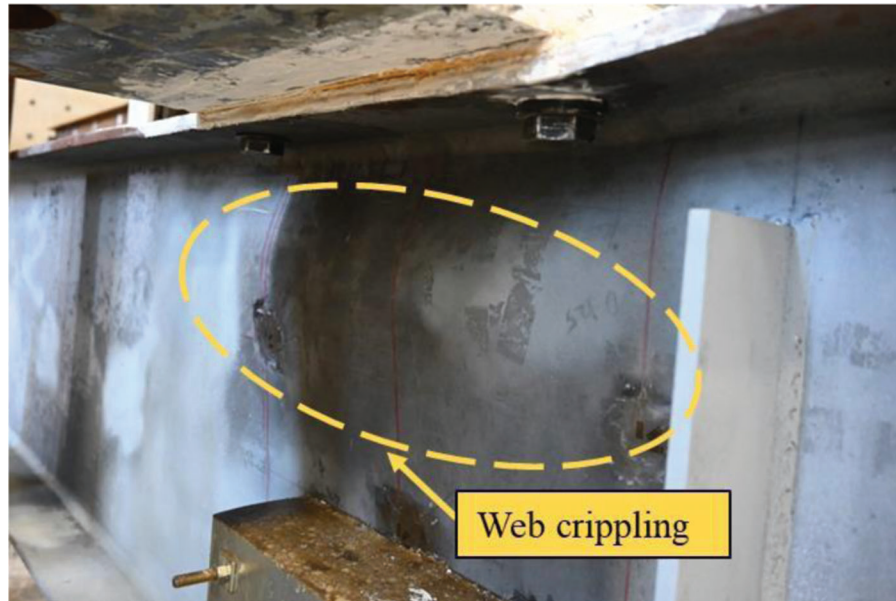
Figure 6.54 Specimen 5: deformed shape, view from the east side.

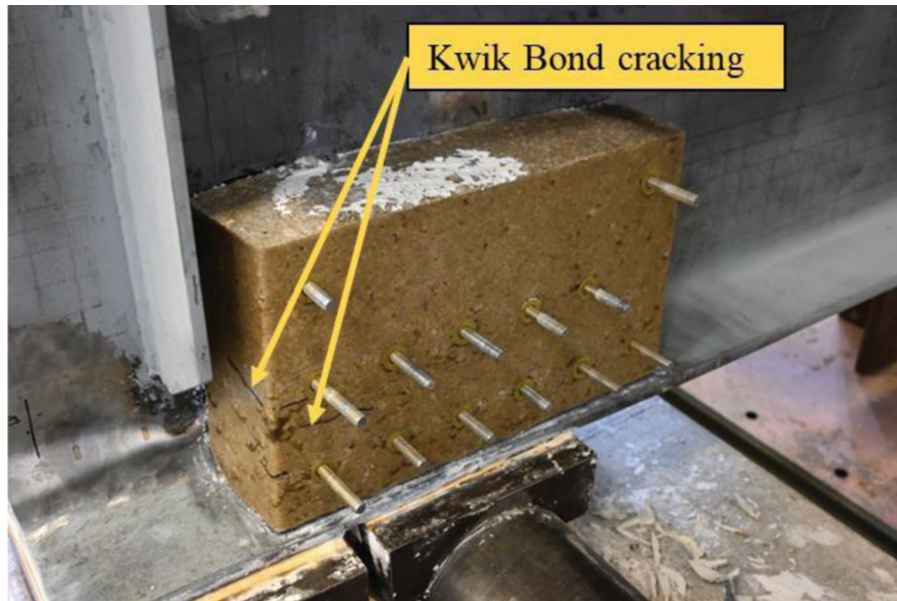
Figure 6.56 Specimen 5: cracking in the west Kwik Bond panel.

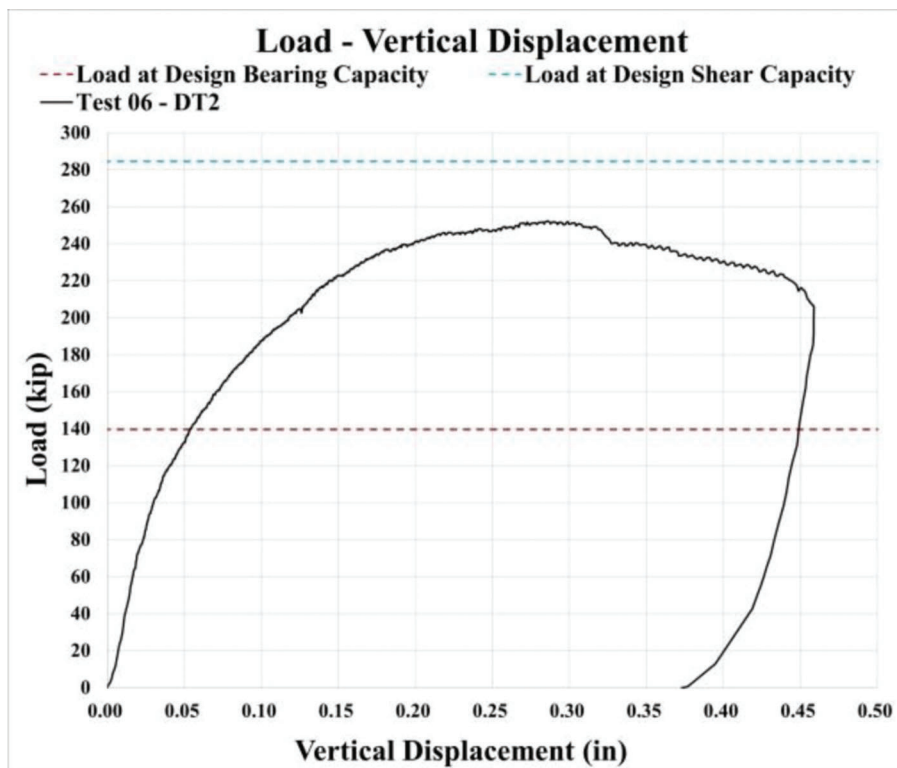
Figure 6.57 Load: vertical displacement plot for Specimen 6.
