JOINT TRANSPORTATION RESEARCH PROGRAM

New Repair Strategies for Life-Cycle Extension of Corroded Steel Girder Bridges

1. Report No. FHWA/IN/JTRP-2024/15	2. Government Accession No.		3. Recipient's Catalog No.	
4. Title and Subtitle New Repair Strategies for Life-Cycle Extension of Corroded Steel Girder Bridges			5. Report Date February 2024

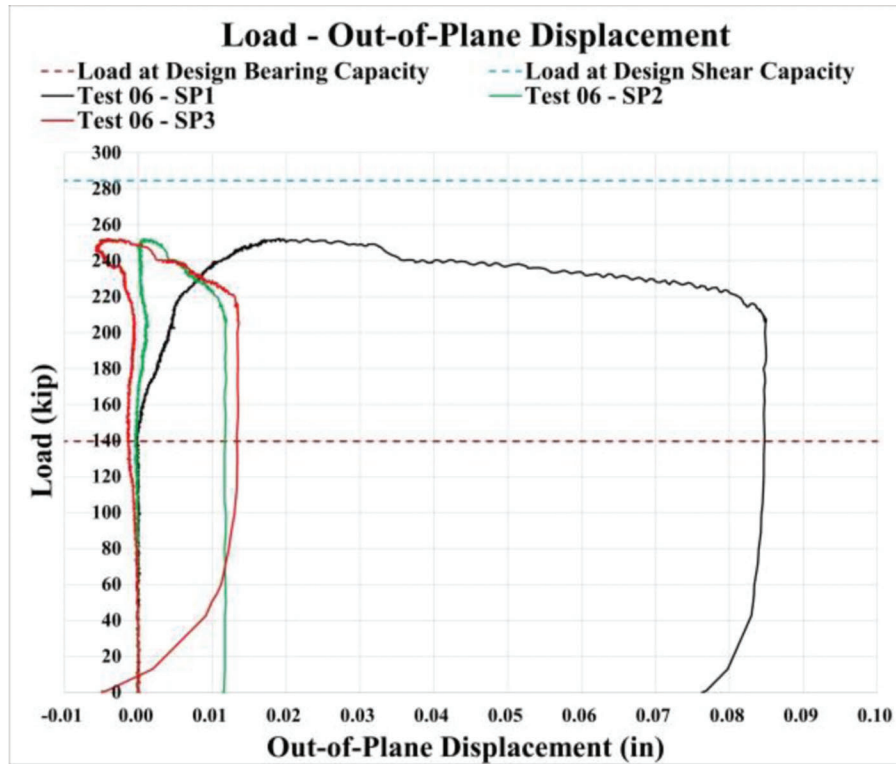
Figure 6.58 Load: OOP displacement plot for Specimen 6.

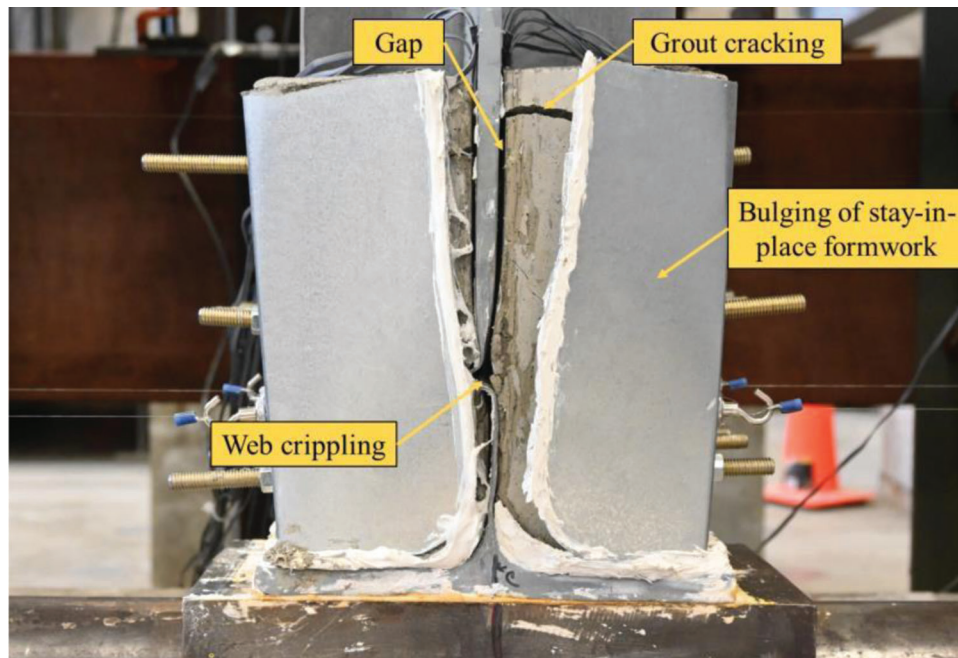
Figure 6.64 Specimen 6: deformed shape, enlarged front view.

The deformed shape of Specimen 6 is shown in Figure 6.63 through Figure 6.68. Specimen 6 failed in web local crippling, followed by threaded rod yielding

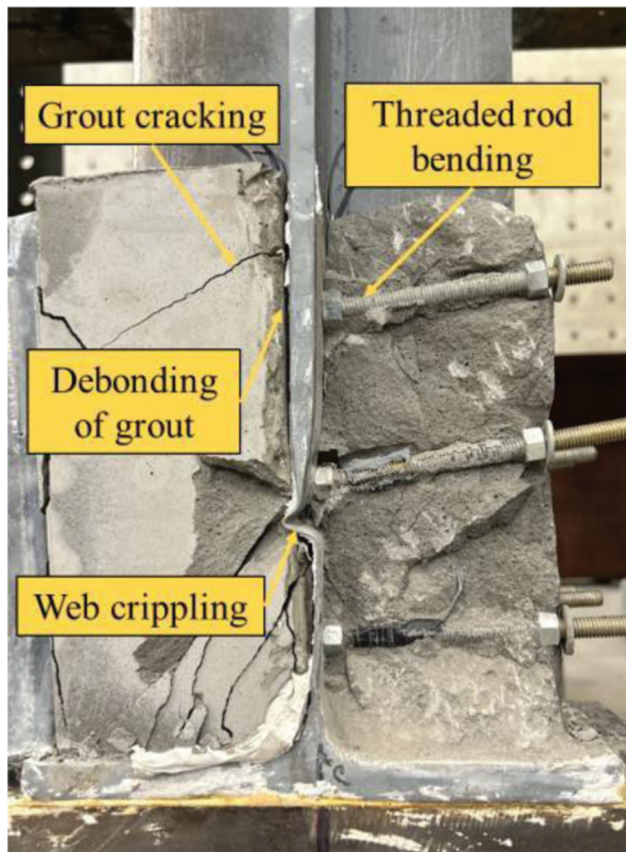
Figure 6.65 Specimen 6: deformed shape and failure

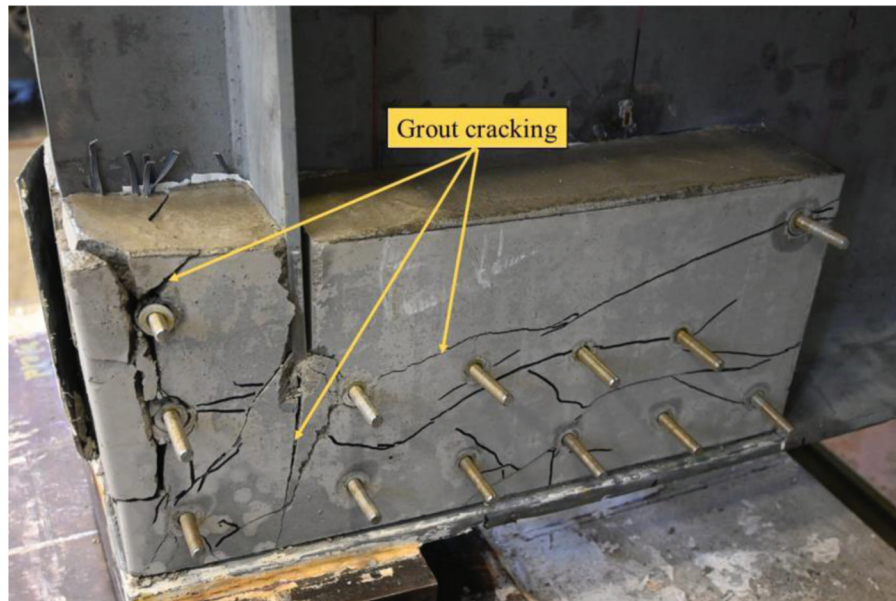
Figure 6.66 Specimen 6: cracking in the west panel.

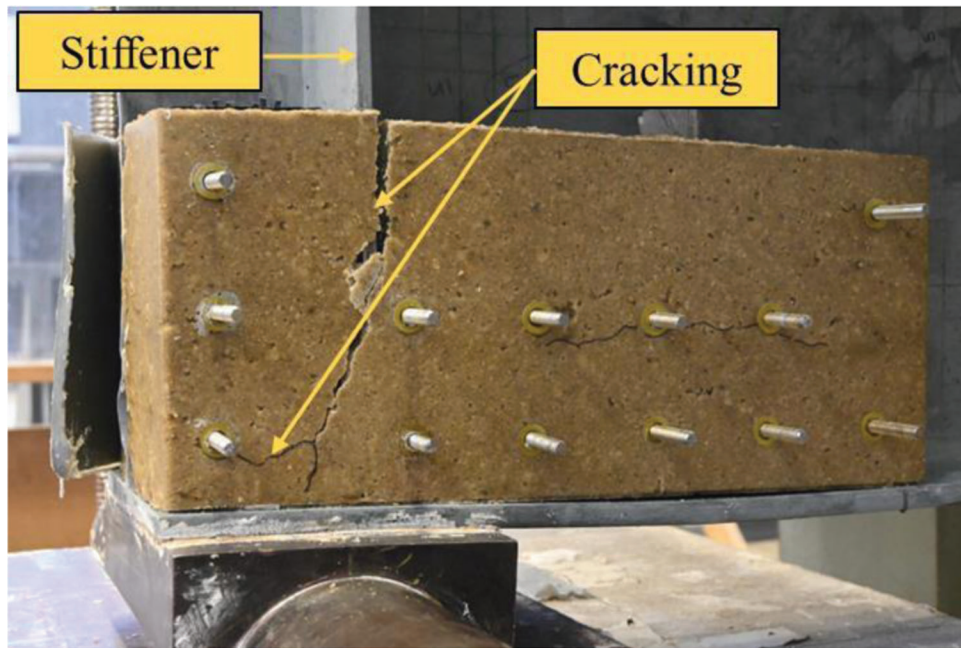
Figure 6.78 Specimen 7: cracking in a west panel.

The deformed shape of Specimen 7 is shown in Figure 6.75 through Figure 6.81. Specimen 7 failed in web local crippling, followed by threaded rod rupturing and polyester polymer concrete panel cracking. After the experiment, one of the steel sheets was removed to observe the cracking pattern in the Kwik Bond PPC-1121 panel. Only one major crack was found that propagated from the partial stiffener. Besides that, the panel was not significantly cracked when the experiment was terminated, as shown in Figure 6.78, due to a considerably higher tensile strength of the polymer concrete compared to conventional cementitious grout. In summary, it was found that the infill material can

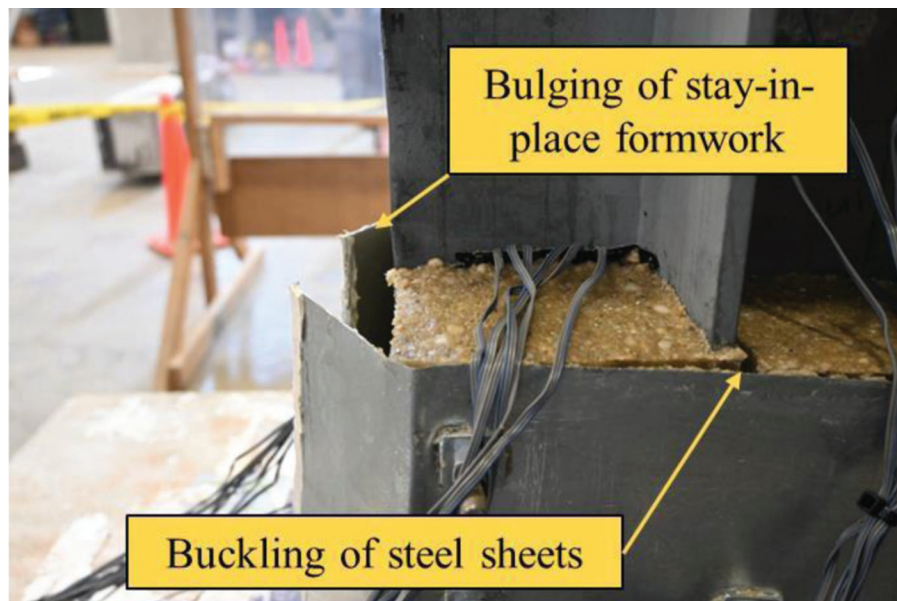
Figure 6.79 Specimen 7: buckling and bulging of steel sheets.

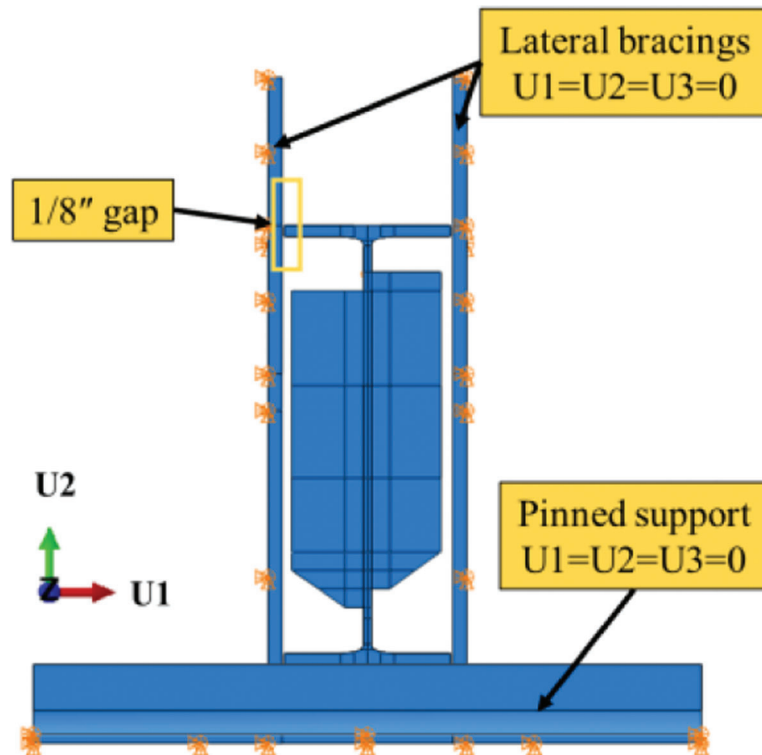
Figure 7.4 BC of the FE model, front view.

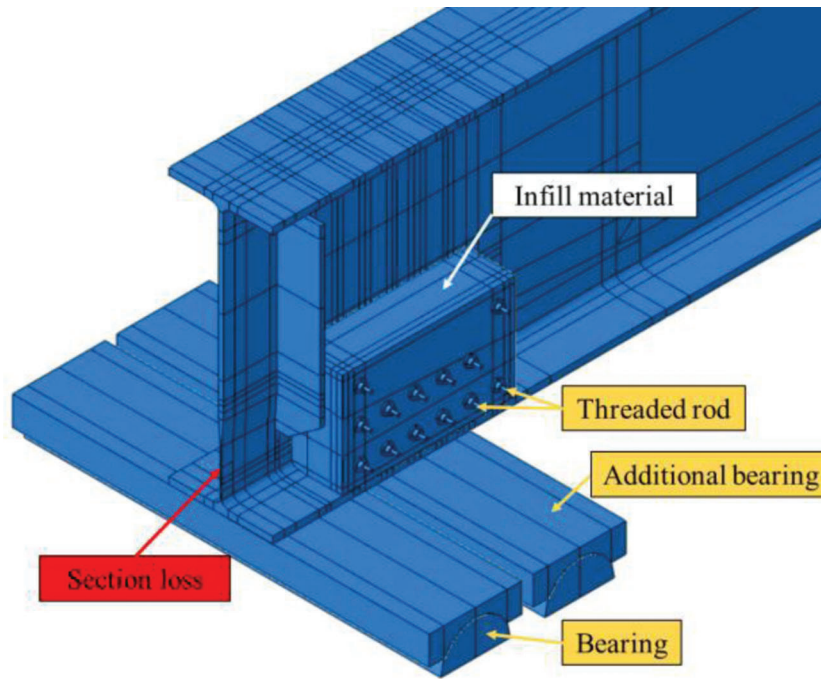
Figure 7.12 Specimen 4 and 5 assemblies.

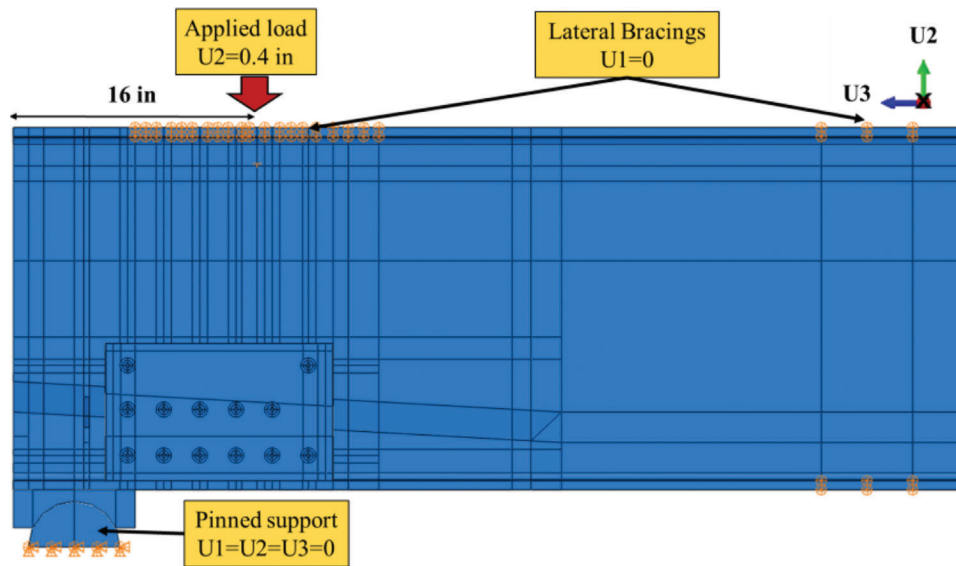
Figure 7.14 Specimen 3–Specimen 7: boundary conditions.

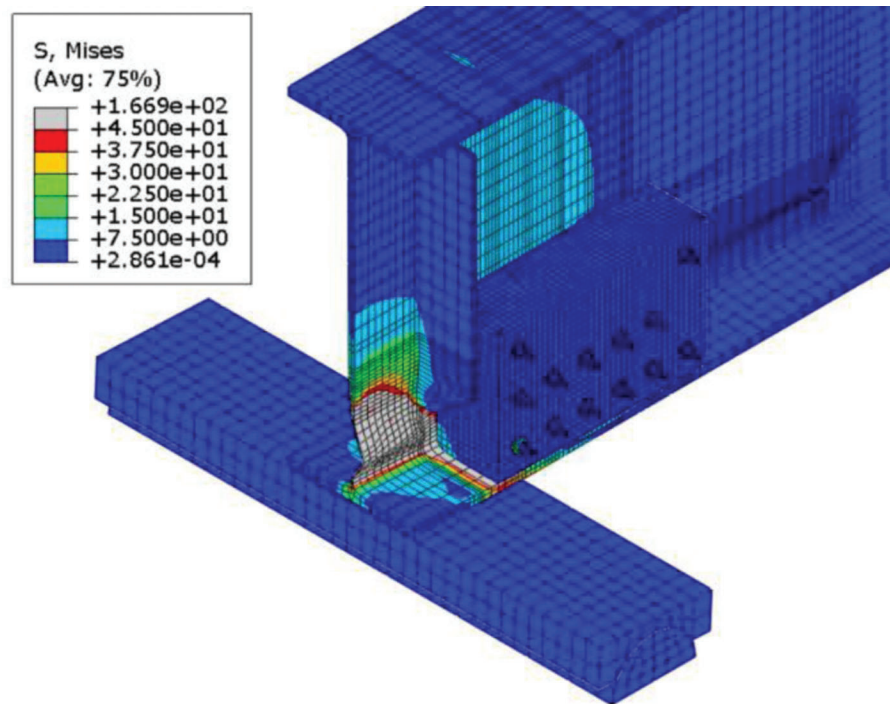
Figure 7.23 Deformed shape of Specimen 3 (FE model, post-peak load = 55.6 kips).

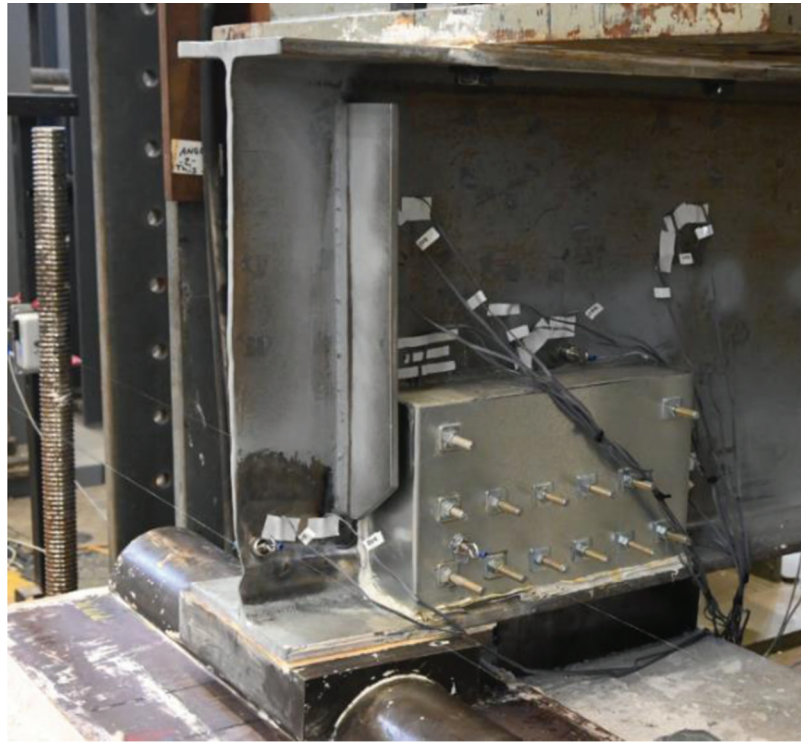
Figure 7.24 Deformed shape of Specimen 3 (experiment).

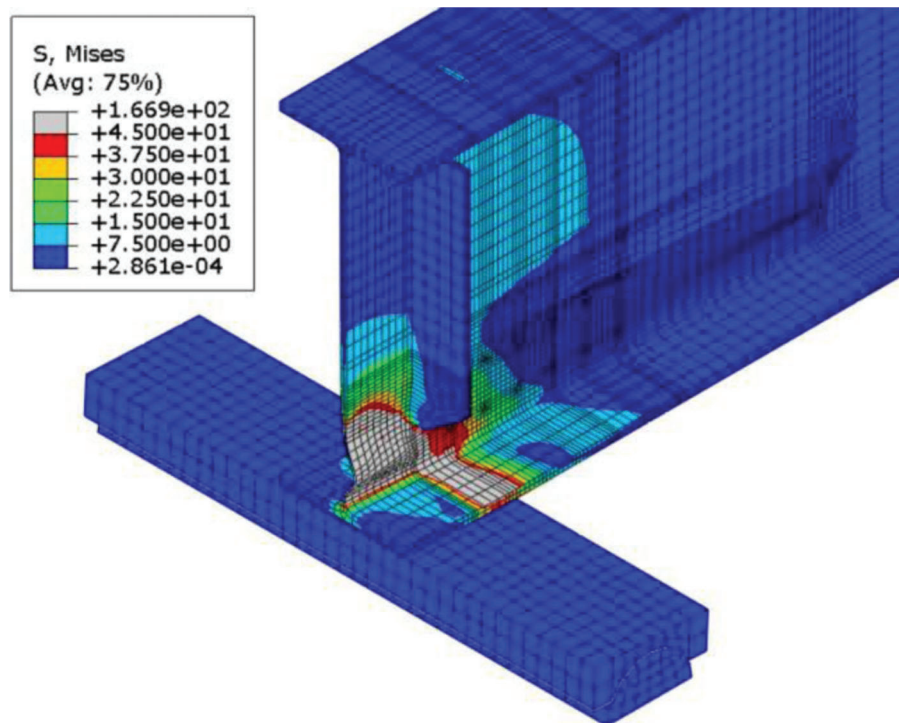
Figure 7.25 Specimen 3: corroded web yielding (FE model, post-peak load = 55.6 kips).

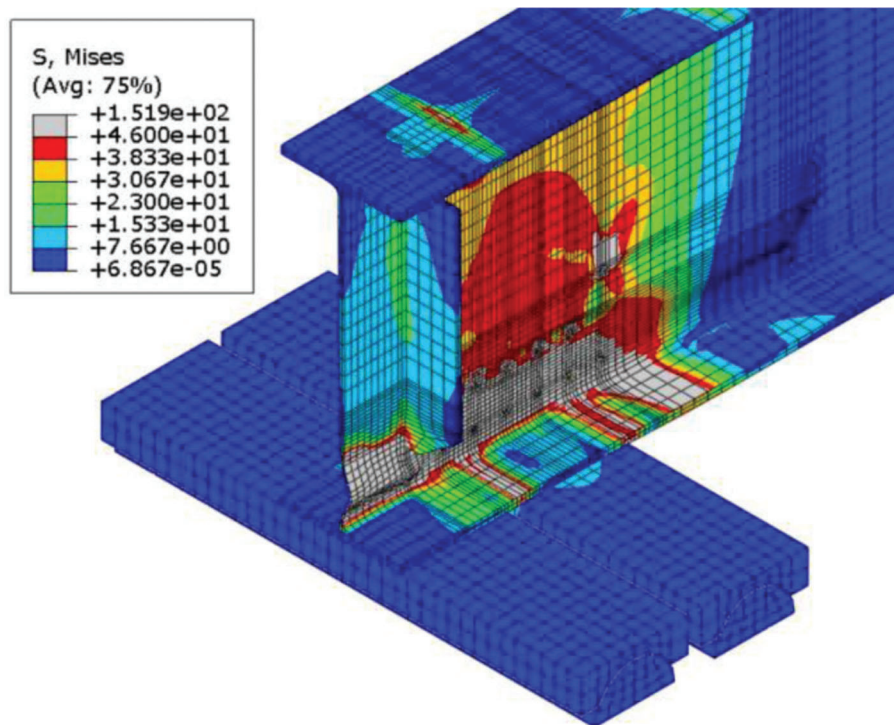
Figure 7.30 Specimen 4: corroded web yielding (FE model, peak load = 310.2 kips).

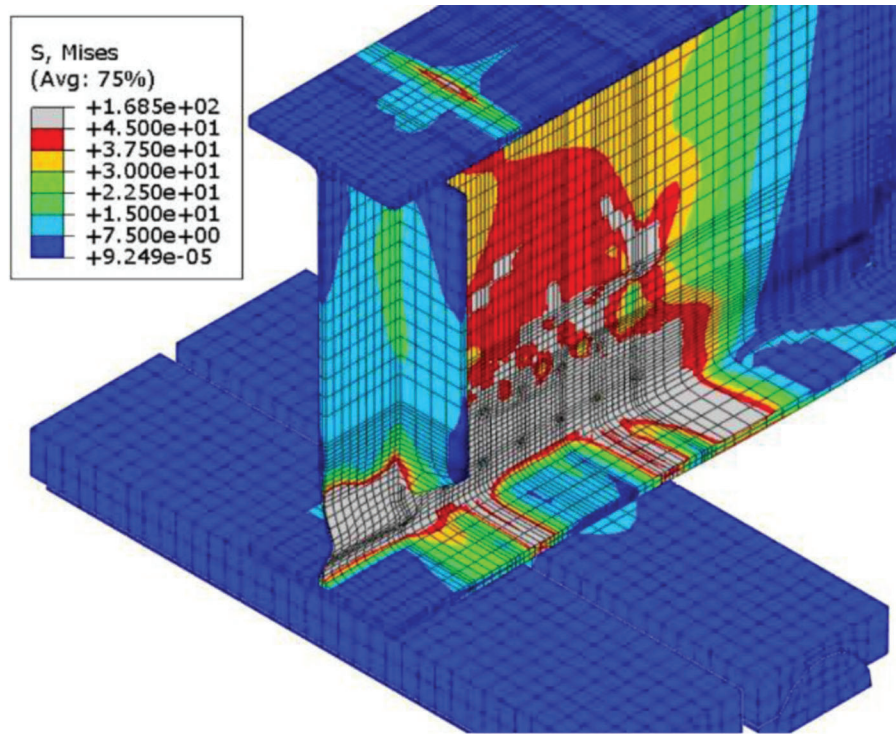
Figure 7.35 Specimen 5: corroded web yielding (FE model, peak load = 307.3 kips).

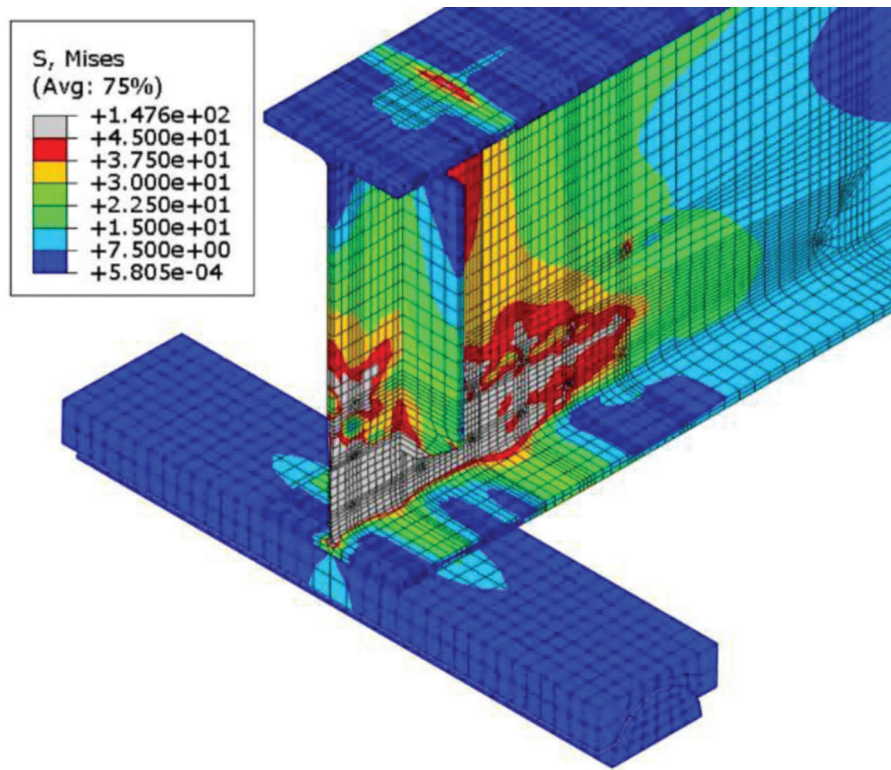
Figure 7.39 Specimen 6: corroded web yielding (FE model, peak load = 228.7 kips).

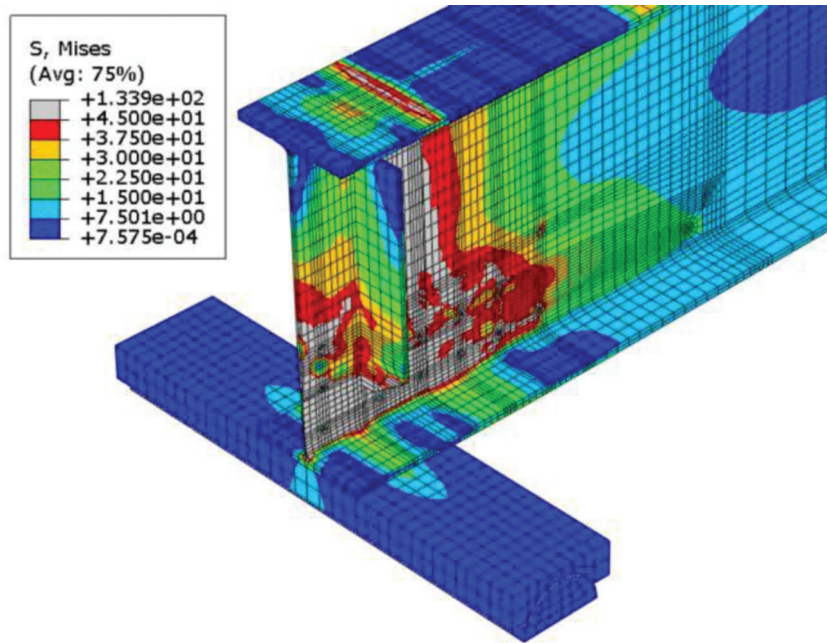
Figure 7.43 Specimen 7: corroded web yielding (FE model, peak load = 271.4 kips).

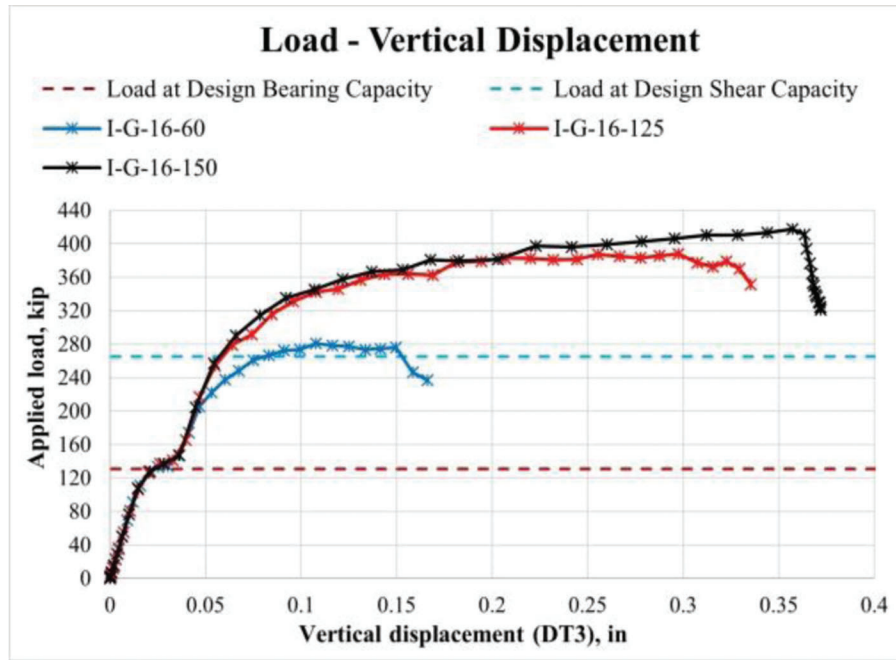
Figure 8.5 Impact of threaded rod material on the repair capacity (Case I: 16 effective threaded rods).

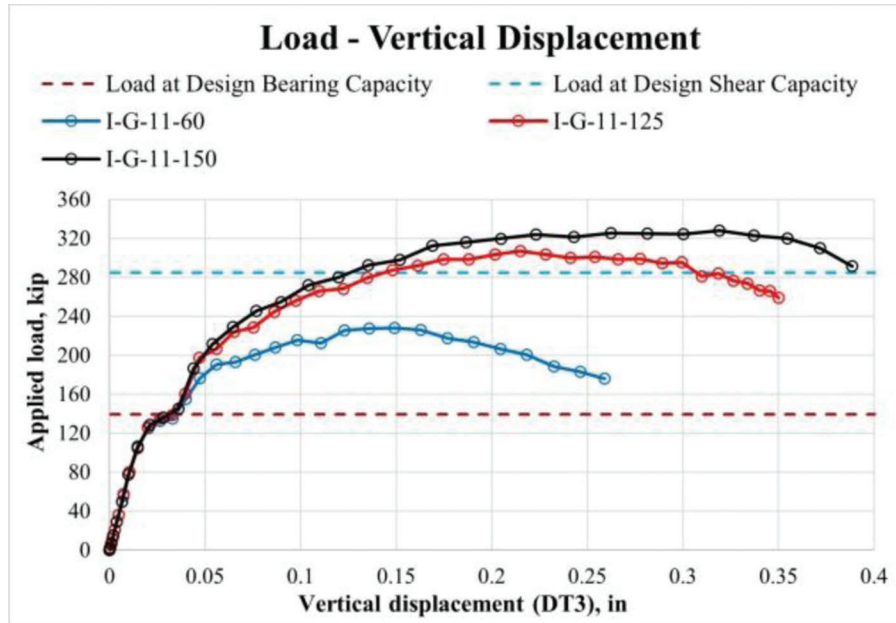
Figure 8.6 Impact of threaded rod material on the repair capacity (Case I: 11 effective threaded rods).

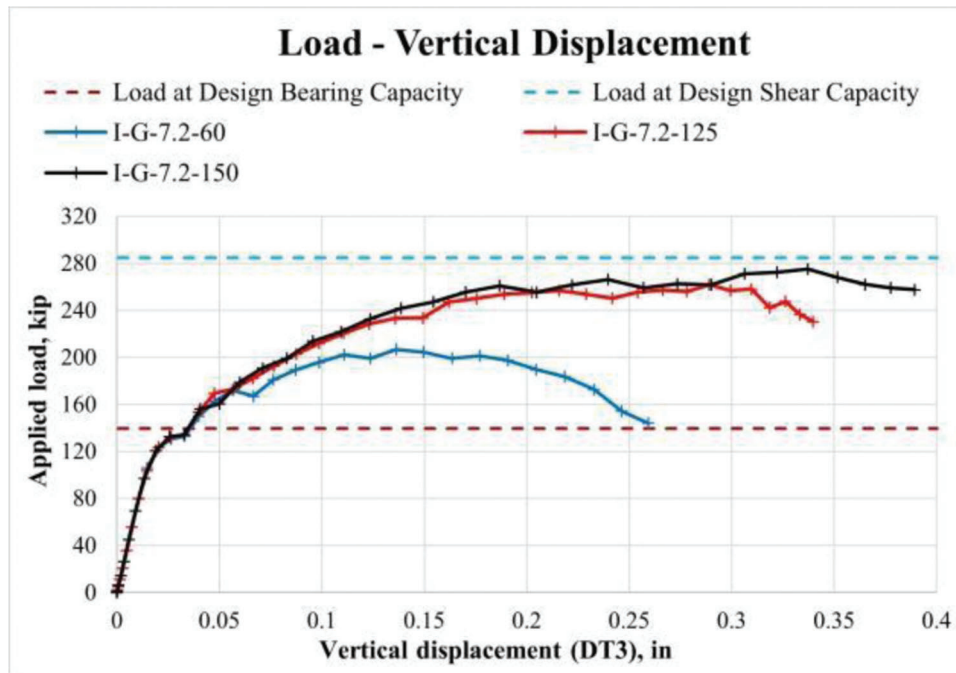
Figure 8.8 Impact of threaded rod material on the repair capacity (Case I: 7 effective threaded rods, Option 7: bottom).

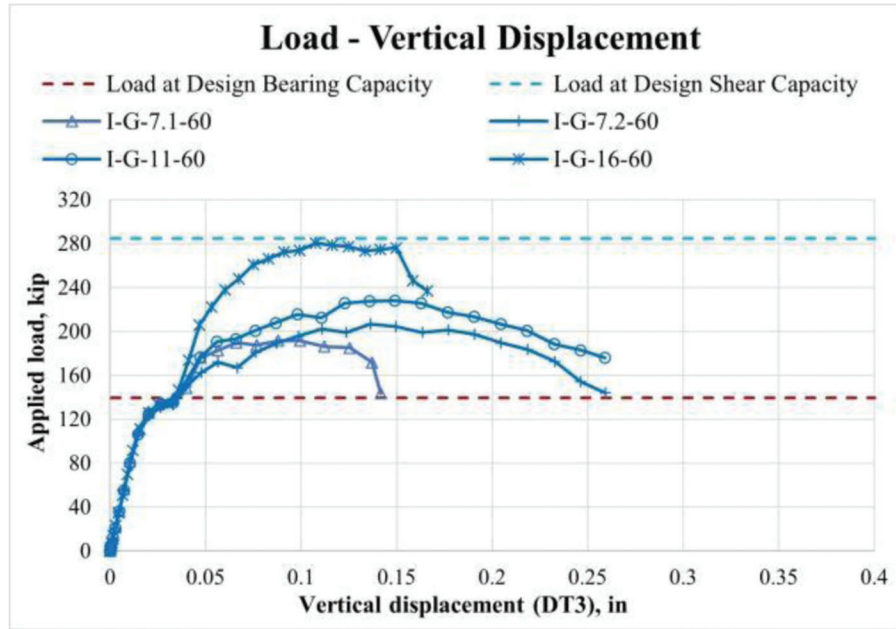
Figure 8.9 Impact of the number of threaded rods on the repair capacity (Case I: $F_u = 60$ ksi).

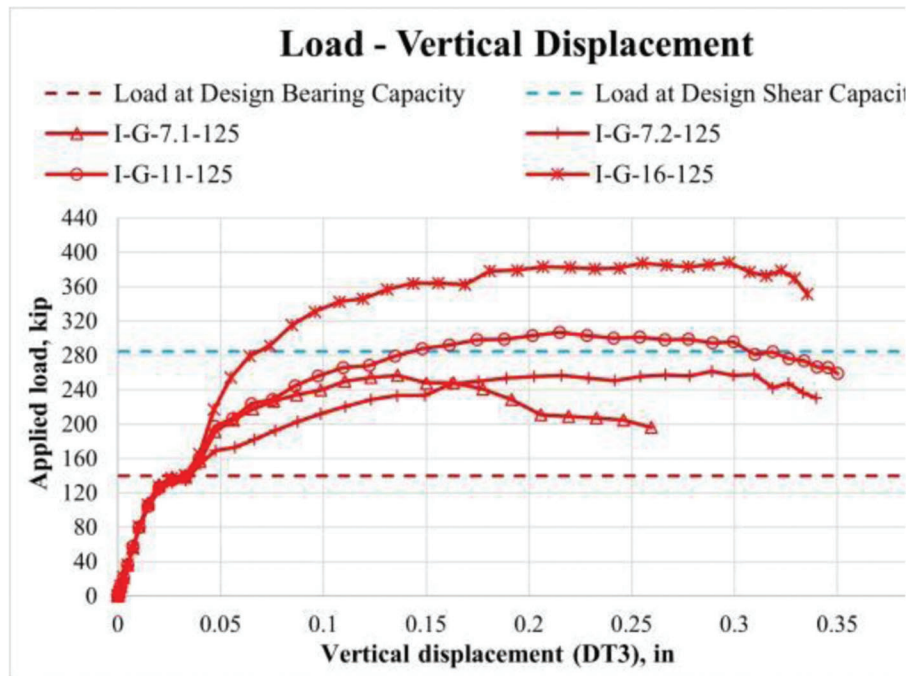
Figure 8.10 Impact of the number of threaded rods on the repair capacity (Case I: $F_u = 125$ ksi).

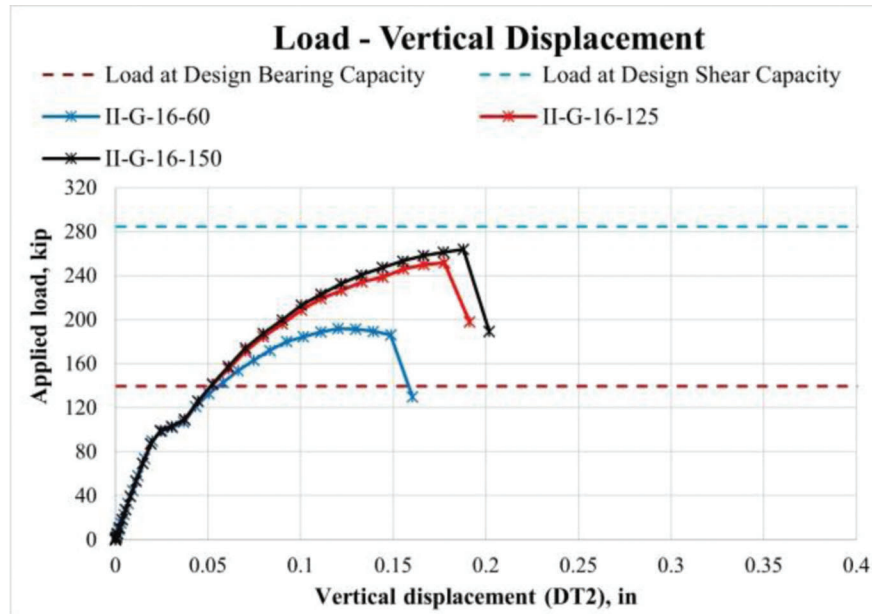
Figure 8.16 Impact of threaded rod material on the repair capacity (Case II: 16 effective threaded rods).

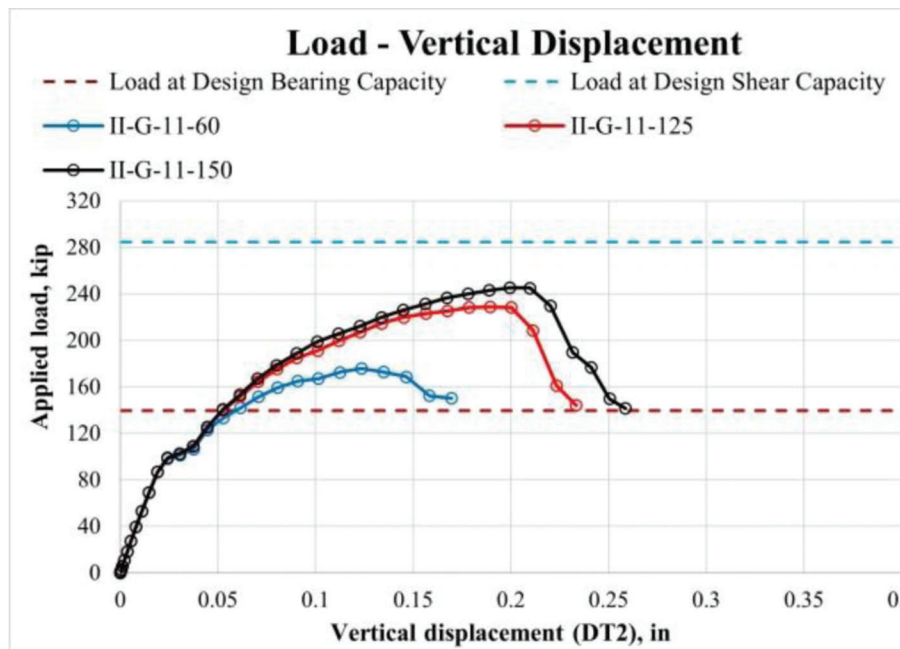
Figure 8.17 Impact of threaded rod material on the repair capacity (Case II: 11 effective threaded rods).

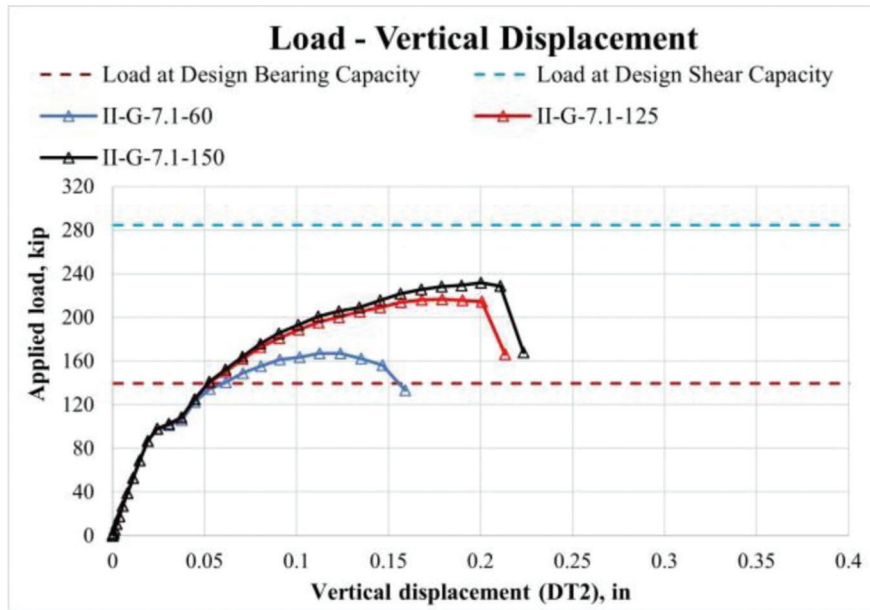
Figure 8.18 Impact of threaded rod material on the repair capacity (Case II: 7 effective threaded rods. Option 7: middle).

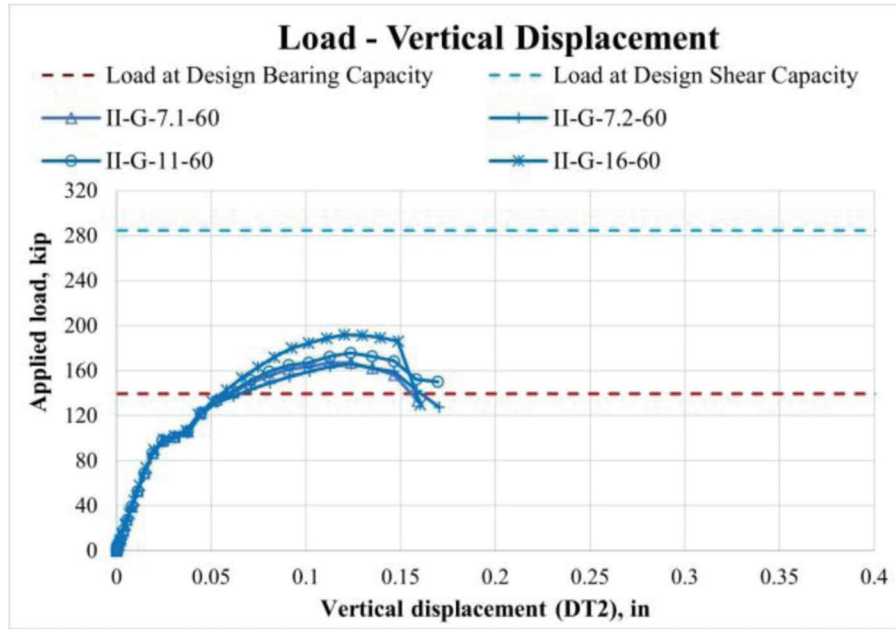
Figure 8.20 Impact of the number of threaded rods on the repair capacity (Case II: $F_u = 60$ ksi).

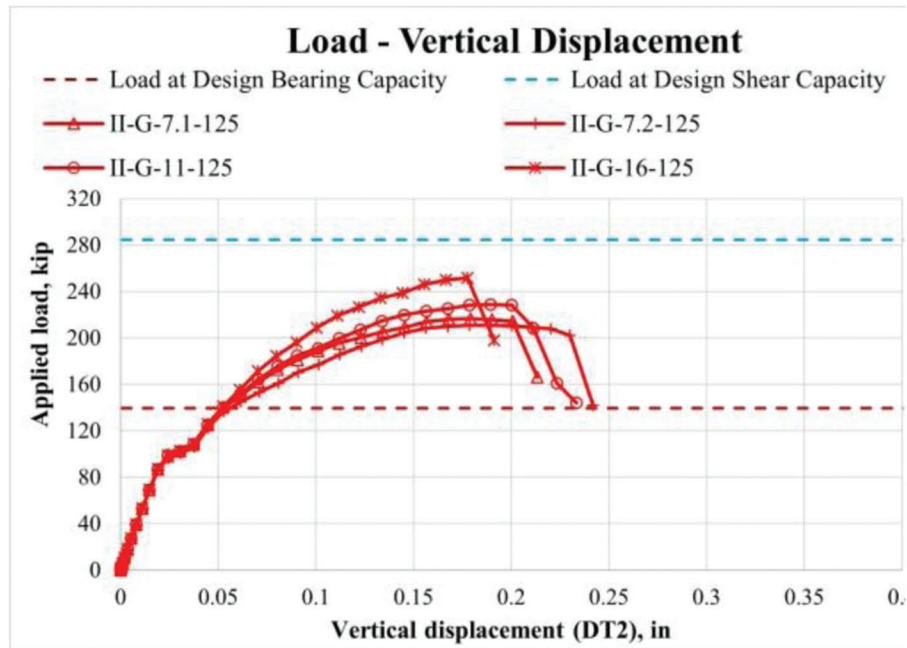
Figure 8.21 Impact of the number of threaded rods on the repair capacity (Case II: $F_u = 125$ ksi).

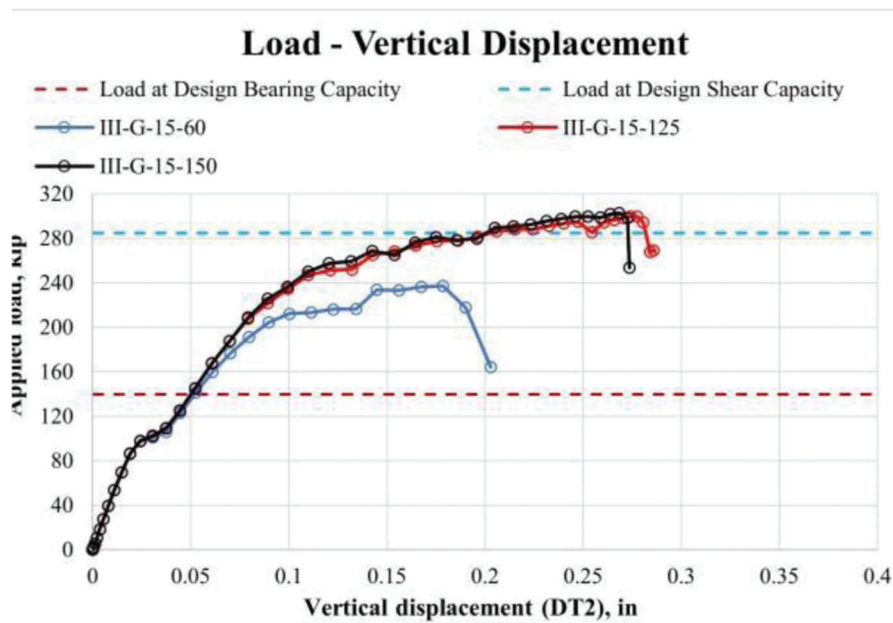
Figure 8.26 Impact of threaded rod material on the repair capacity (Case III: 15 effective threaded rods).

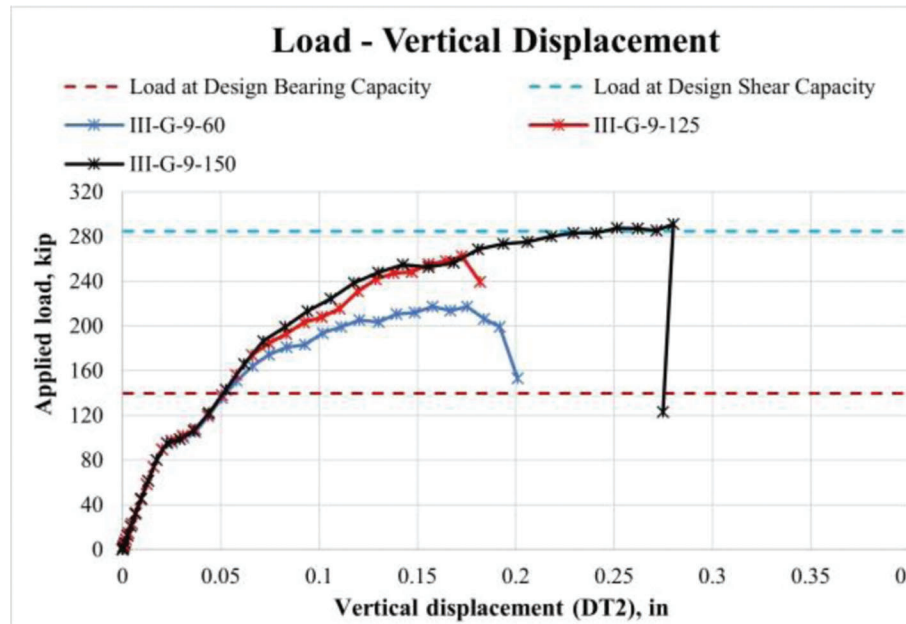
Figure 8.27 Impact of threaded rod material on the repair capacity (Case III: 9 effective threaded rods).

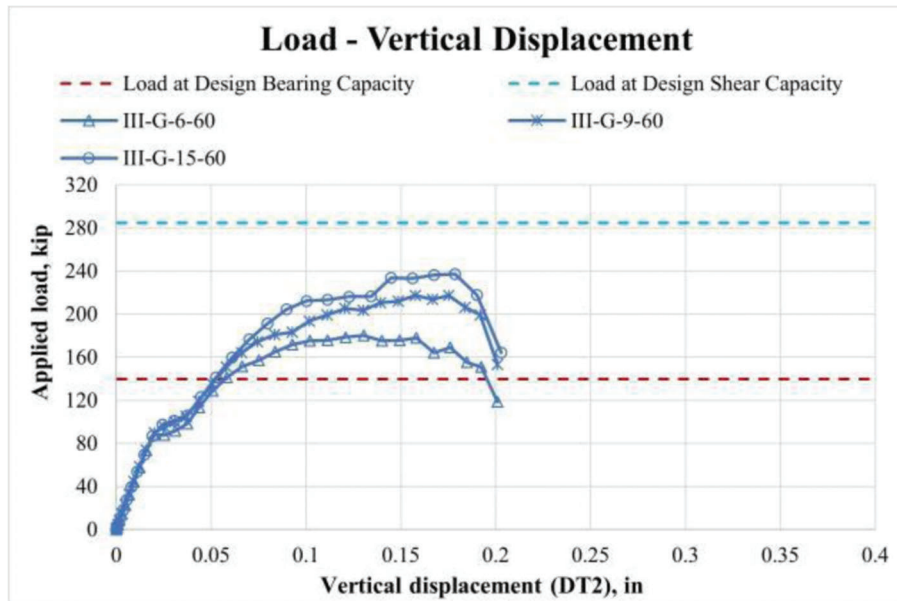
Figure 8.29 Impact of the number of threaded rods on the repair capacity (Case II; $F_u=60$ ksi).

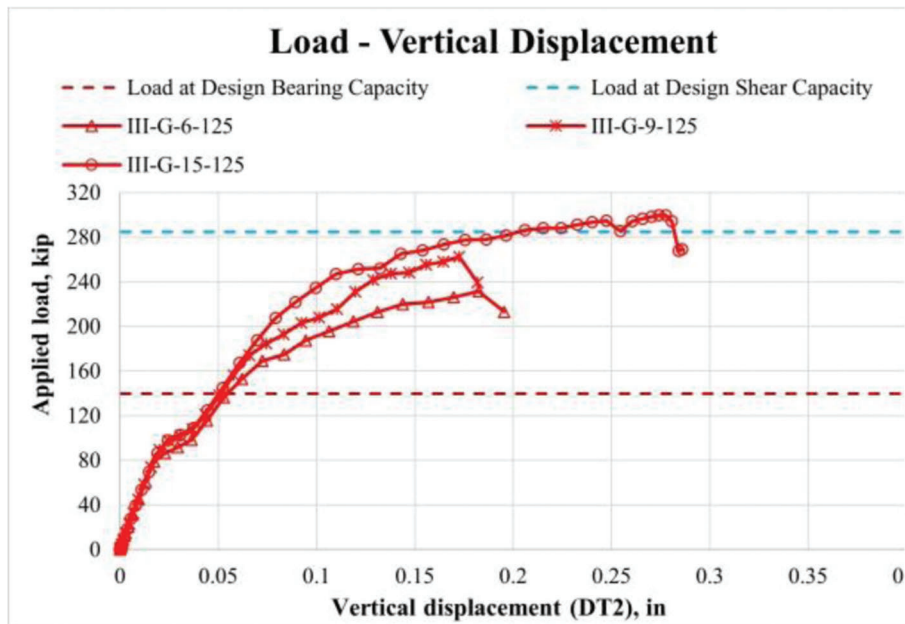
Figure 8.30 Impact of the number of threaded rods on the repair capacity (Case II; $F_u=125$ ksi).

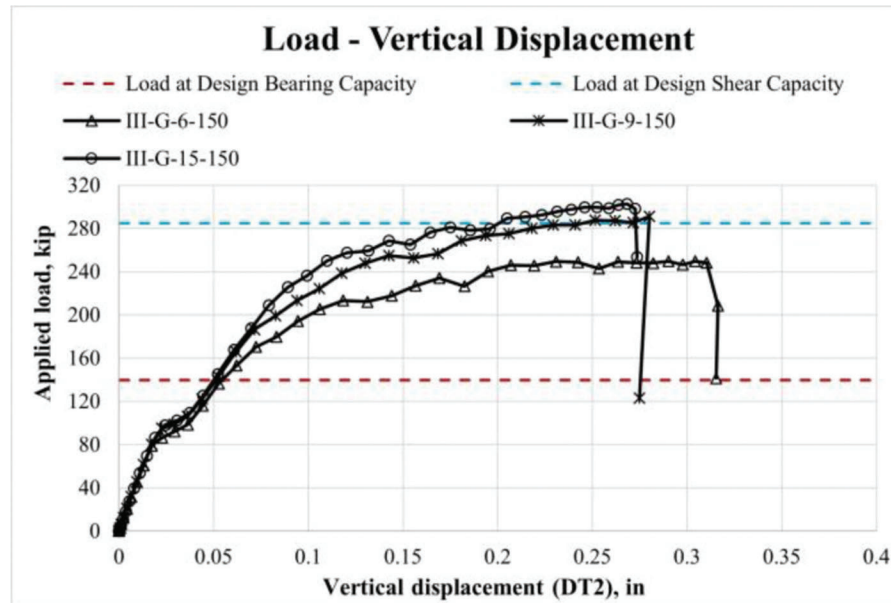
Figure 8.31 Impact of the number of threaded rods on the repair capacity (Case III: $F_u = 150$ ksi).

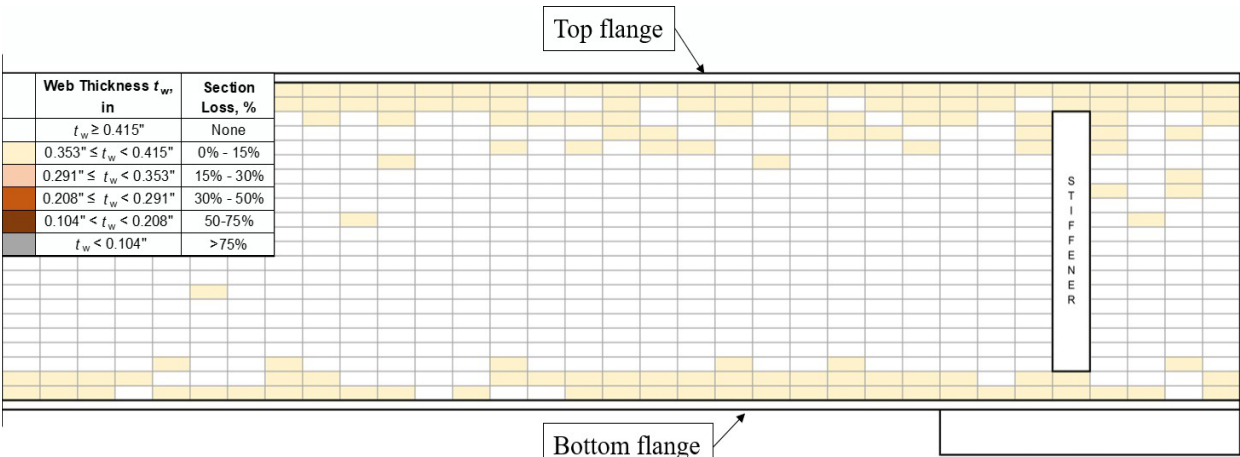
Figure B.1 Section loss measurements for Specimen 1.
