| 4. Title and Subtitle<br>Non-Contact Acoustic Emission Approach for Rail Health Monitoring | | 5. Report Date<br>July 2024 | |
| 9. Performing Organization Name and Address<br>Department of Civil and Environmental Engineering<br>University of Nevada, Las Vegas<br>4505 S. Maryland Pkwy.<br>Las Vegas, NV 89154 | | 10. Work Unit No. | |

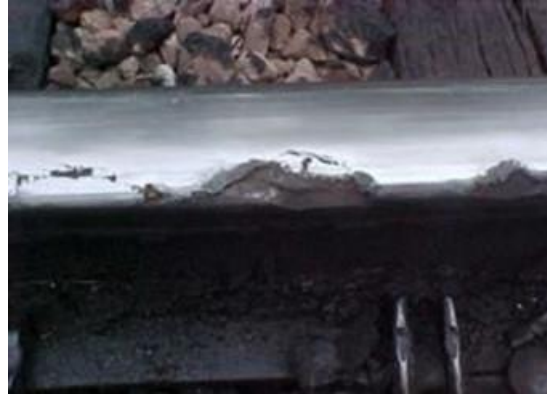
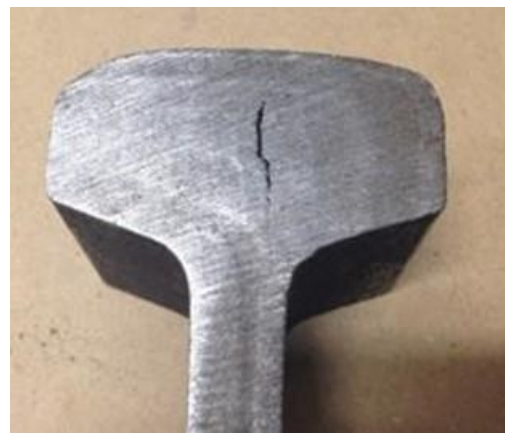
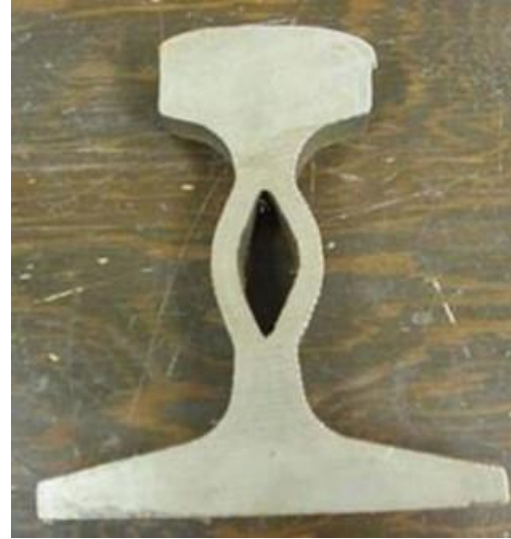
**Figure 2 Rail Surface Defects (Office of Railroad Safety, 2015)**

**Figure 3 Rail Internal Defects (Office of Railroad Safety, 2015)**

presents external defects such as head checks at the higher side, side shell corrosion, flaking caused by centralized loading, and thermal cracks on burned stock railheads. Internal defects include transverse fissure, vertical split head, defective weld with slag entrapment, and piped rail as shown in

Figure 3. Internal defects are invisible from the exterior.

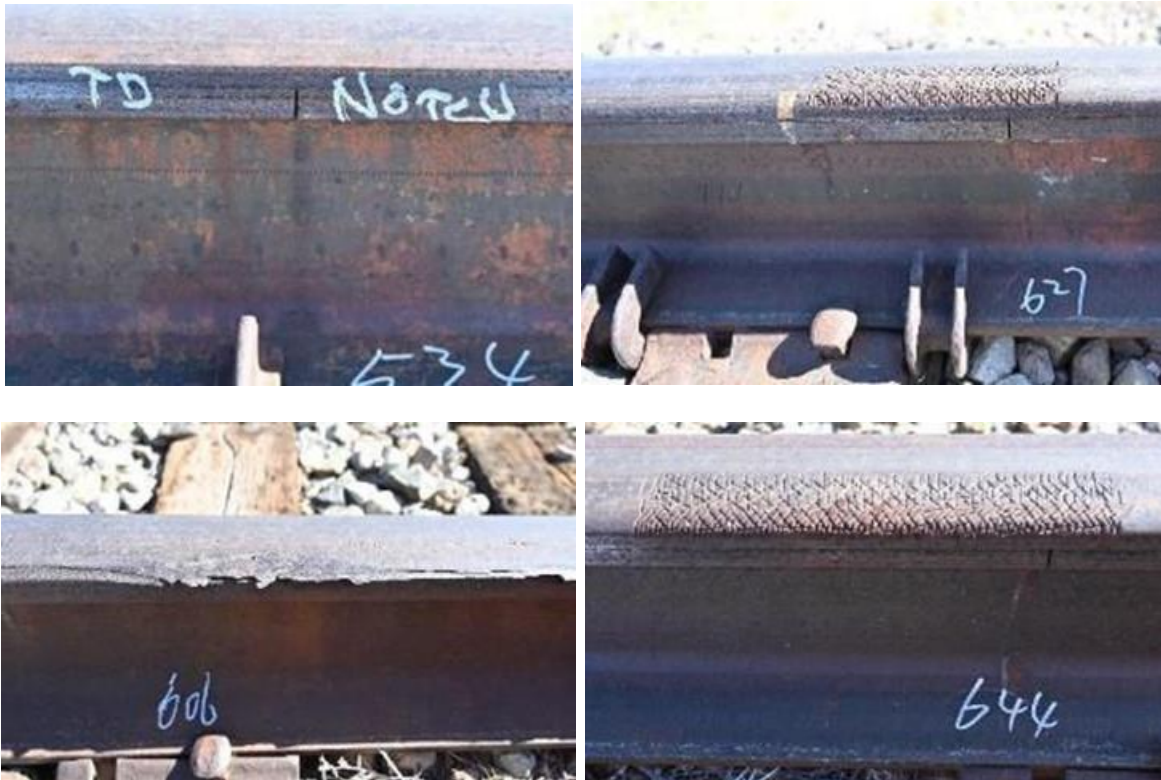
**Figure 19 Defects in RDTF loop**

Acoustic signals were collected as the Hi-rail vehicle traversed the defects. A hammer hit was used at the beginning of each test to synchronize the cameras with the DAQ equipment. The Hi-rail vehicle, weighing approximately 5 tons, had an axial load significantly lower than that of a commercial hopper. Field tests were conducted at four different speeds—5 mph, 10 mph, 15 mph, and 20 mph. The 20-mph setup included 10 runs (each run consisting of a back-and-forth motion), while the other setups had 5 runs each. This ensured sufficient rail-wheel impacts to generate AE events. The primary goal was to collect AE signals at various speeds, enabling a comprehensive evaluation of AE features based on different defect types and vehicle speeds.

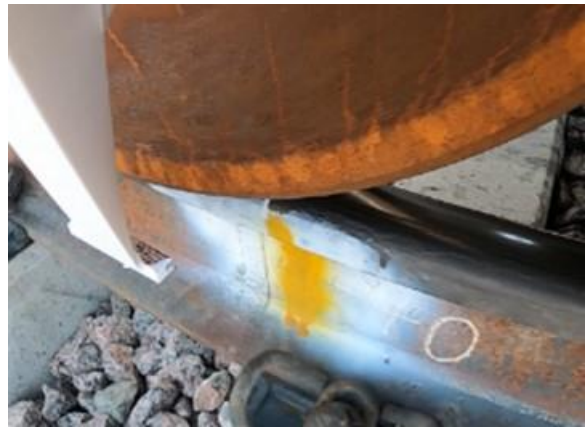
**Welding defect 1: 0.8 in x 0.6 in. Location:  
0.7 inches below the surface**

**Welding defect 2: 0.3 in x 0.3 in.**  
**Location: 0.6 inches below the surface**

### Figure 46 The internal defects

The rail-mounted field test used two naturally generated internal defects shown in Figure 46. Their detailed information as to the defect size and location were provided by MxVRail. The larger defect measured 0.8 inches by 0.6 inches and was situated 0.7 inches below the top surface, indicating that it was in the late stage of development. In contrast, the smaller defect, measuring 0.3 inches by 0.3 inches and located 0.6 inches below the top surface, was still in the early stage of development.

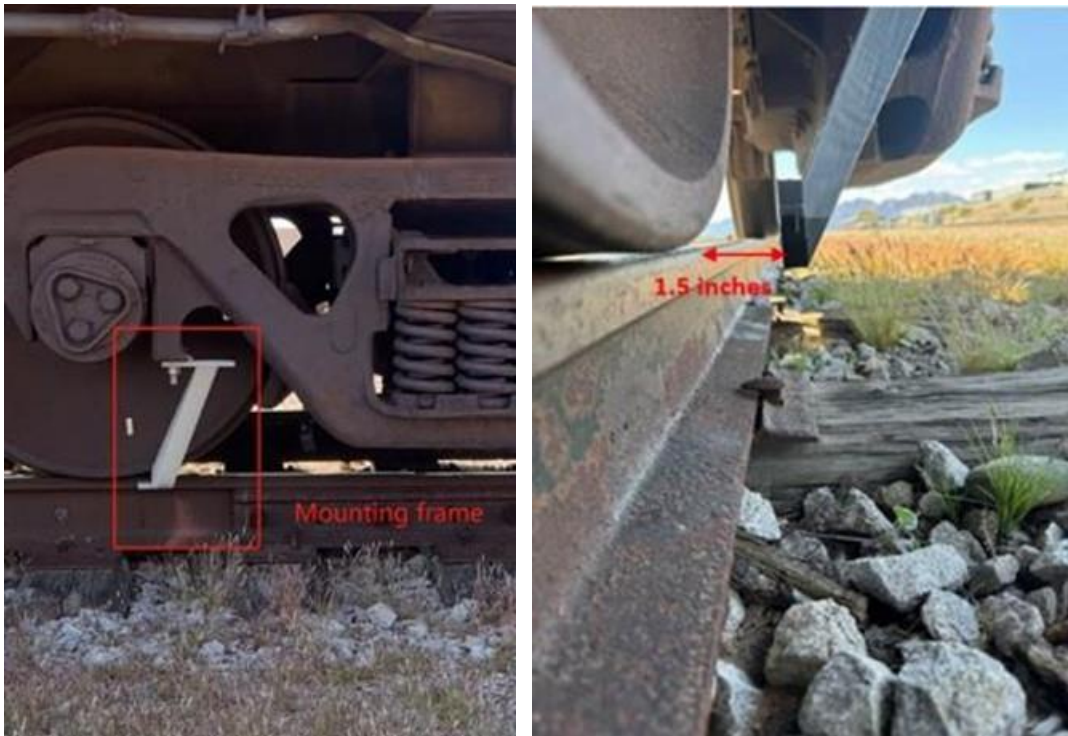
Figure 48 Mounting frame (front and side views)

In this testing scenario, the sensor was installed the same way as in the museum test. It was installed on the train's mounting frame, and the acoustic signals were recorded when the train was running over defects (Figure 48). The sensor was designated to be safely placed 1.5 inches away from the rail head side. As in previous tests, the sensor was relocated from its original position to the far side of the defect by moving it from 0 to 4 inches at two inches increment (Figure 49).
