1. Report No. PU-23-RP-04	2. Government Accession No. N/A	3. Recipient's Catalog No. N/A	
4. Title and Subtitle Photogrammetry and LiDAR-Based Precast Railroad Crossties Abrasion Damage Detections		5. Report Date December 2024

*Photogrammetry and LiDAR-Based Precast Railroad Crossties Abrasion
Damage Detections
PU-23-RP-04*

FINAL REPORT

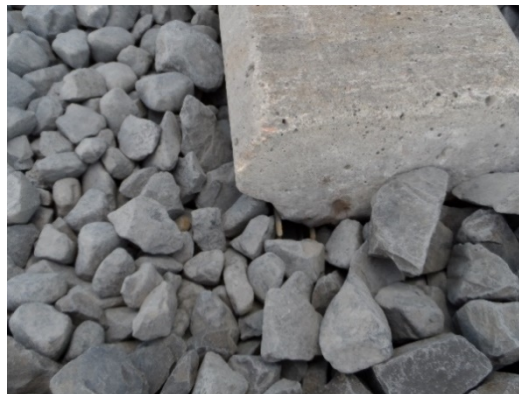
Figure 2 Concrete crosstie that experienced undercutting abrasion damage, including the exposure of some wires in a section of track in Washington State. (Picture courtesy of BNSF)

The US railroad industry has been struggling with precast concrete crossties abrasion damage for a long time. Our research team has communicated with multiple class I railroads and all have responded that some of their crossties are facing the abrasion issue. Figure 2 shows abrasion damage on concrete crossties. According to BNSF Railway, crossties abrasion at the ballast interface is a problem of concern for BNSF Railways that often occurs at locations with high moisture and soft subgrades. The Alaska Railroad saw section loss typically at higher speed areas where pumping is a concern. CSX indicated that they had seen this deterioration in locations with and without freezing conditions. To extend the precast concrete crossties service life and ensure railroad safety, there is a strong demand to mitigate the crossties abrasion damage. As it is not practical for the railroad industry to inspect thousands of miles of track to find concrete crosstie abrasion loss manually, an automated, low-cost, mobile, and accurate monitoring approach is urgently needed for the crossties' maintenance and repair.

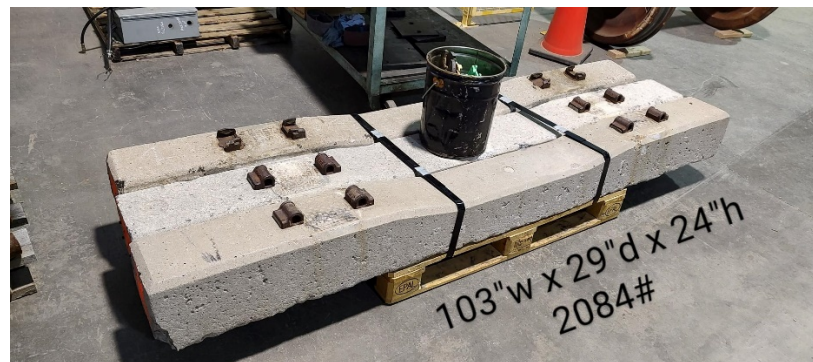
Figure 3 Precast concrete crossties donated by MxV Rail

Our team works closely with MxV Rail and Rocla Concrete Tie to understand their demands and experience with abrasion damage of the precast concrete crossties. We visited MxV Rail and discussed with their railroad crossties group to understand the damage pattern of precast concrete crossties and learn their technologies detecting concrete crossties conditions. This trip helps our team understand the damage mechanism and develop an effective system to detect the damages. It provides an excellent sampling of ties from the field to aid in the determination of the prevalence of severe abrasion loss. Our team received three precast concrete crossties donated by MxV Rail. These precast concrete ties shown in Figure 3 will be used as test specimens for our project. We requested three different types of precast concrete ties to represent more real world scenarios.

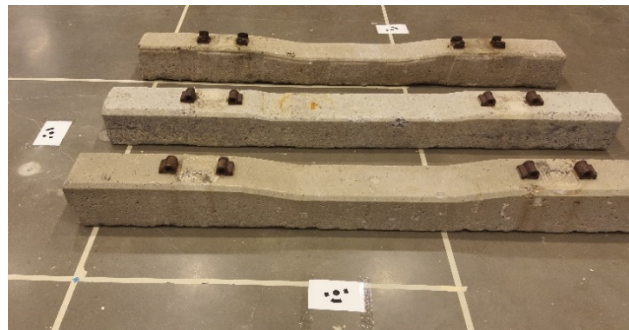
Figure 3 A drone captured concrete crossties image.

Our team has conducted a series of laboratory experiments using a drone-based photogrammetry approach to conduct 3D scanning to sense the concrete crossties conditions. As shown in Figure 3, three concrete ties are stationed on the ground with a 2-foot interval to simulate the practical concrete crossties distribution. The DJI Mavic 3 flew over the concrete crossties along pre-defined paths to take high-resolution video footage and images, which took 15 to 20 minutes. Then the images and videos were imported to Agisoft Metashape to create a high-resolution 3D model (Figure 4). After the 3D model is created, it is analyzed using Cloudcompare software to understand

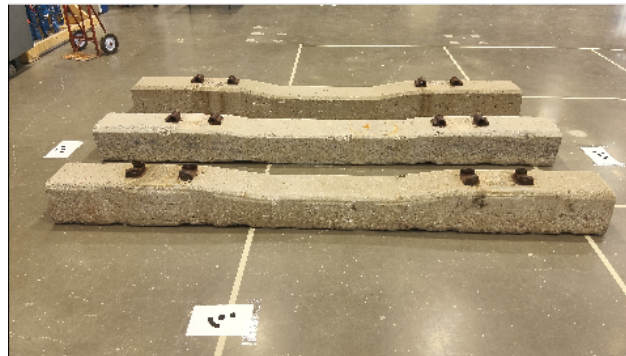
Figure 4 3D model created by AgiSoft Metashape via the drone-based photogrammetry.

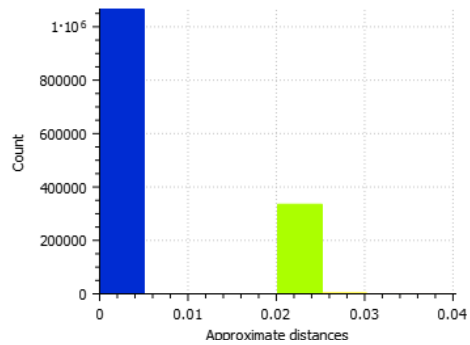
Figure 6 Crossties alignments.

the concrete crossties conditions (Figure 5). We measured the geometry of the concrete crossties and calculated the volume of the concrete crossties to determine their volume loss. We adopted a reference target with all known dimensions to quantify our measurement errors. The discrepancy between the reference target and our 3D model measurements is minimal (Table 1). Then we compared our model results with the actual dimensions of the concrete crossties (Table 2) and the errors are less than 3.33%, which is promising for real application in railroad industry. In addition to the volume loss measurements, our team also quantified the alignments of the crossties which is another critical factor of the railroad safety. The crossties demonstrate good alignments based on the distance between each individual crosstie (Figure 6). In addition to laboratory experiments, our team also conducted a site visit to Madison Railroad company in Indiana to validate our system performance (Figure 7).

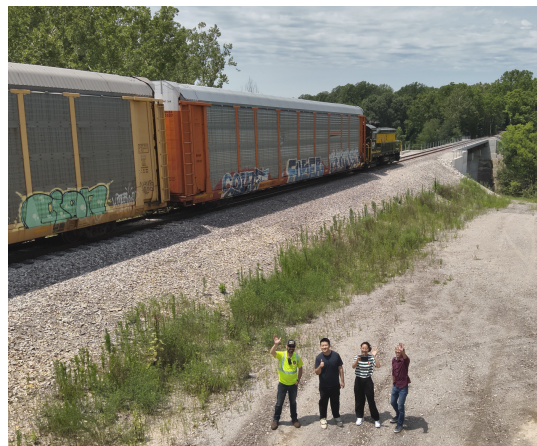
Figure 7 Madison Railroad site visit.
