Final Report SPR-FY23(019)

# Minimizing Take of Threatened Rattlesnakes and Optimizing Project Review in SE Nebraska

### Nebraska Department of Transportation Research

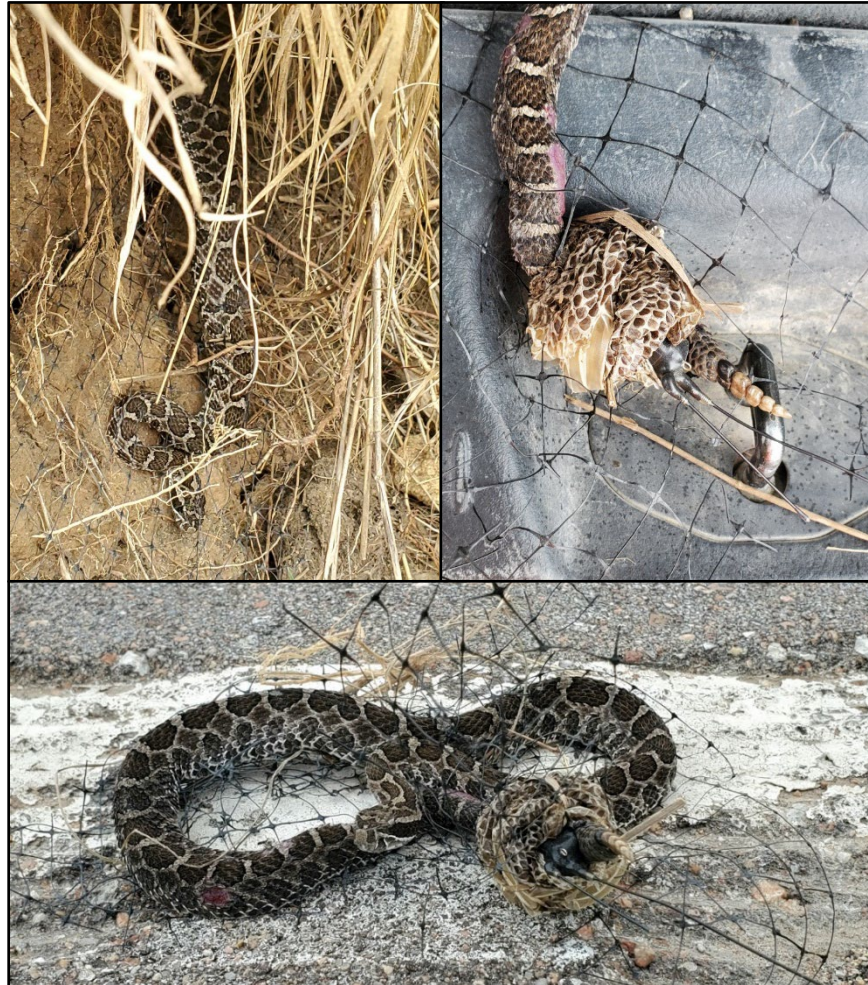
Figure 3.3 [top left]: a western massasauga caught in plastic erosion control netting in Pawnee County. [top right]: close up of erosion control netting caught around transmitter on snake's tail.

Little information was gathered on this Objective because the massasaugas did not move as much as anticipated and individual snakes were rarely near project materials (e.g., culverts, riprap, bridges, etc.). However, in July of 2023 a single massasauga was found tangled in a plastic erosion control net around a culvert along Highway 8 in Pawnee County (see Figure 3.3 below). The specimen was removed from the netting but had sustained acute scale damage and was taken back to a laboratory setting to clean his wounds and recuperate for several weeks to ensure his survival. This specimen was likely using the culvert or the surrounding substrate to initiate ecdysis and got caught in the netting. The presence of the transmitter attached to the tail likely exacerbated the entanglement and made the injuries worse.

Erosion control netting and its negative impacts to snakes are well documented (Stuart et al. 2001, Kapfer and Paloski 2011, Ebert et al. 2019) and has been discouraged for decades in any environment where snakes, especially threatened or endangered species, are likely to move

through the area. This was an unfortunate incident but a good case study illustrating how detrimental plastic erosion control netting can be for snakes and its longevity in the environment.

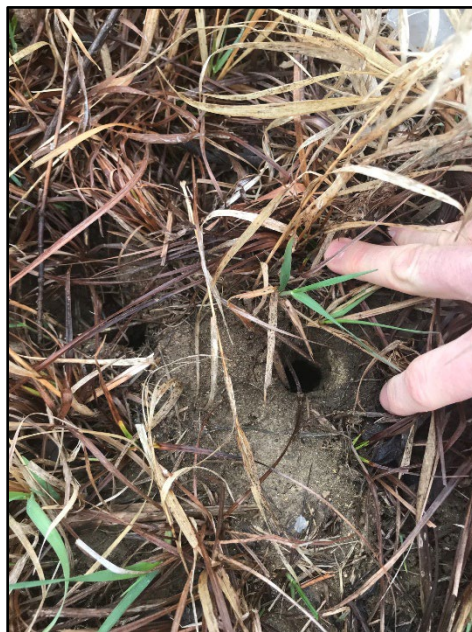
Figure A.4 A crayfish burrow in the ROW in Pawnee County

vegetation (e.g., cordgrass [*Spartina spp.*], cattails [*Typha spp.*], smartweed [*Persicaria bicornis*], ironweed [*Vernonia spp.*], etc.) are likely to have crayfish burrows. Even if no massasaugas are located, the presence of crayfish burrows should be documented (see Figure A.4 for an example).

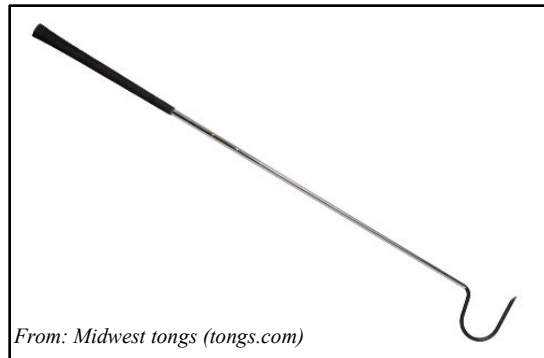
Figure A.6 Example of a snake stick with a hooked end.

**A note of caution:** timber rattlesnakes and western massasaugas are venomous and a bite from either species is a serious injury that requires immediate medical attention. While surveying areas, do NOT pick up cover boards, logs, or other debris with your hand; use a snake stick with a hook on the end (Figure A.6) to lift objects. Boots and pants are required safety gear when looking for venomous snakes and snake chaps/gaiters can also be worn if desired.
