**TWO POST DRIVABLE SIGN SUPPORTS**

Study No. 2-5-91-1219

TEXAS TRANSPORTATION INSTITUTE  
TEXAS A&M UNIVERSITY SYSTEM  
COLLEGE STATION, TEXAS 77843

August 1991

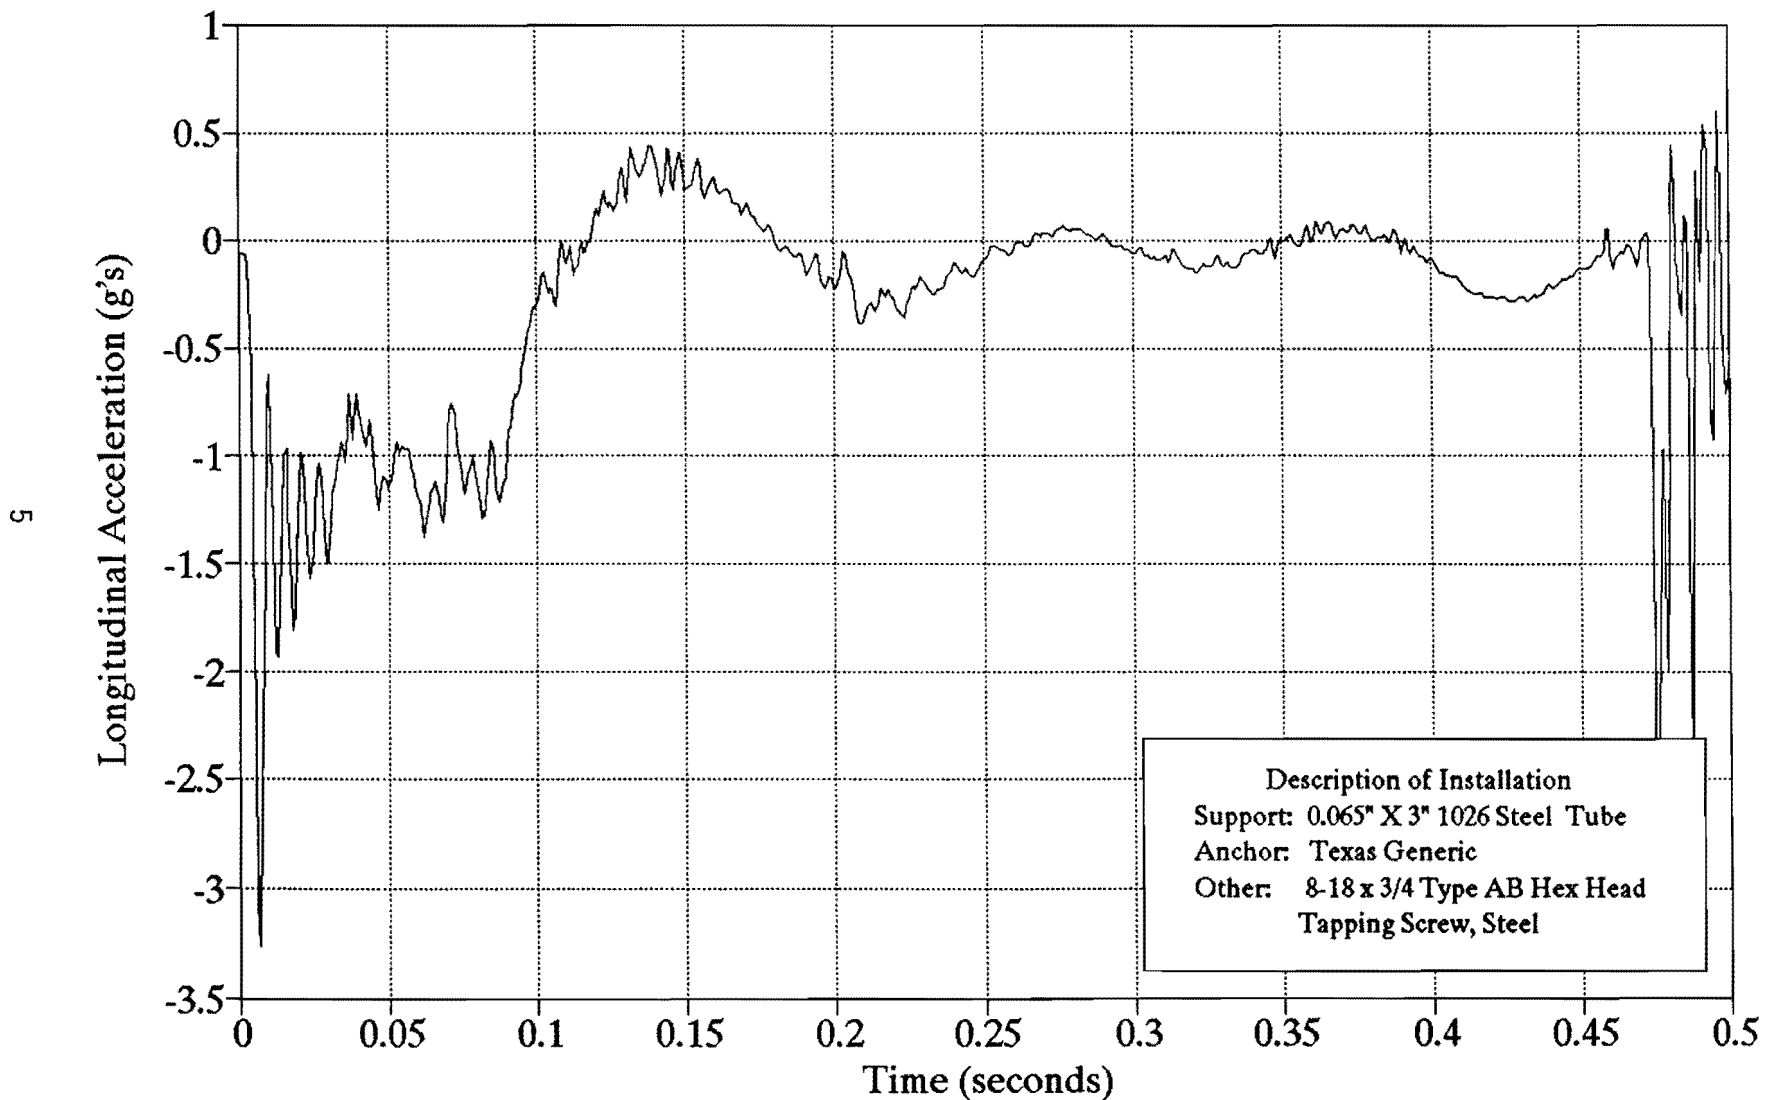
Figure 1. Pendulum longitudinal accelerometer trace (1219-P1).

A total of seven pendulum tests were conducted during the developmental effort. A performance evaluation summary of the pendulum tests is shown in Table 1. In addition, longitudinal accelerometer traces are shown in Figures 1 through 7. Tests were conducted by inserting the sign post into the modified generic anchor (with 6 inch insertion for all but test P3 which used a 12 inch insertion and a 2-1/2 in x 6 in pipe sleeve between the anchor and the post). It should be noted that in all pendulum tests, except P5 and P6, the sign post pulled out of the anchor. Comparison of the results shown clearly indicate that pullout of the sign post from the anchor is required for satisfactory impact performance.

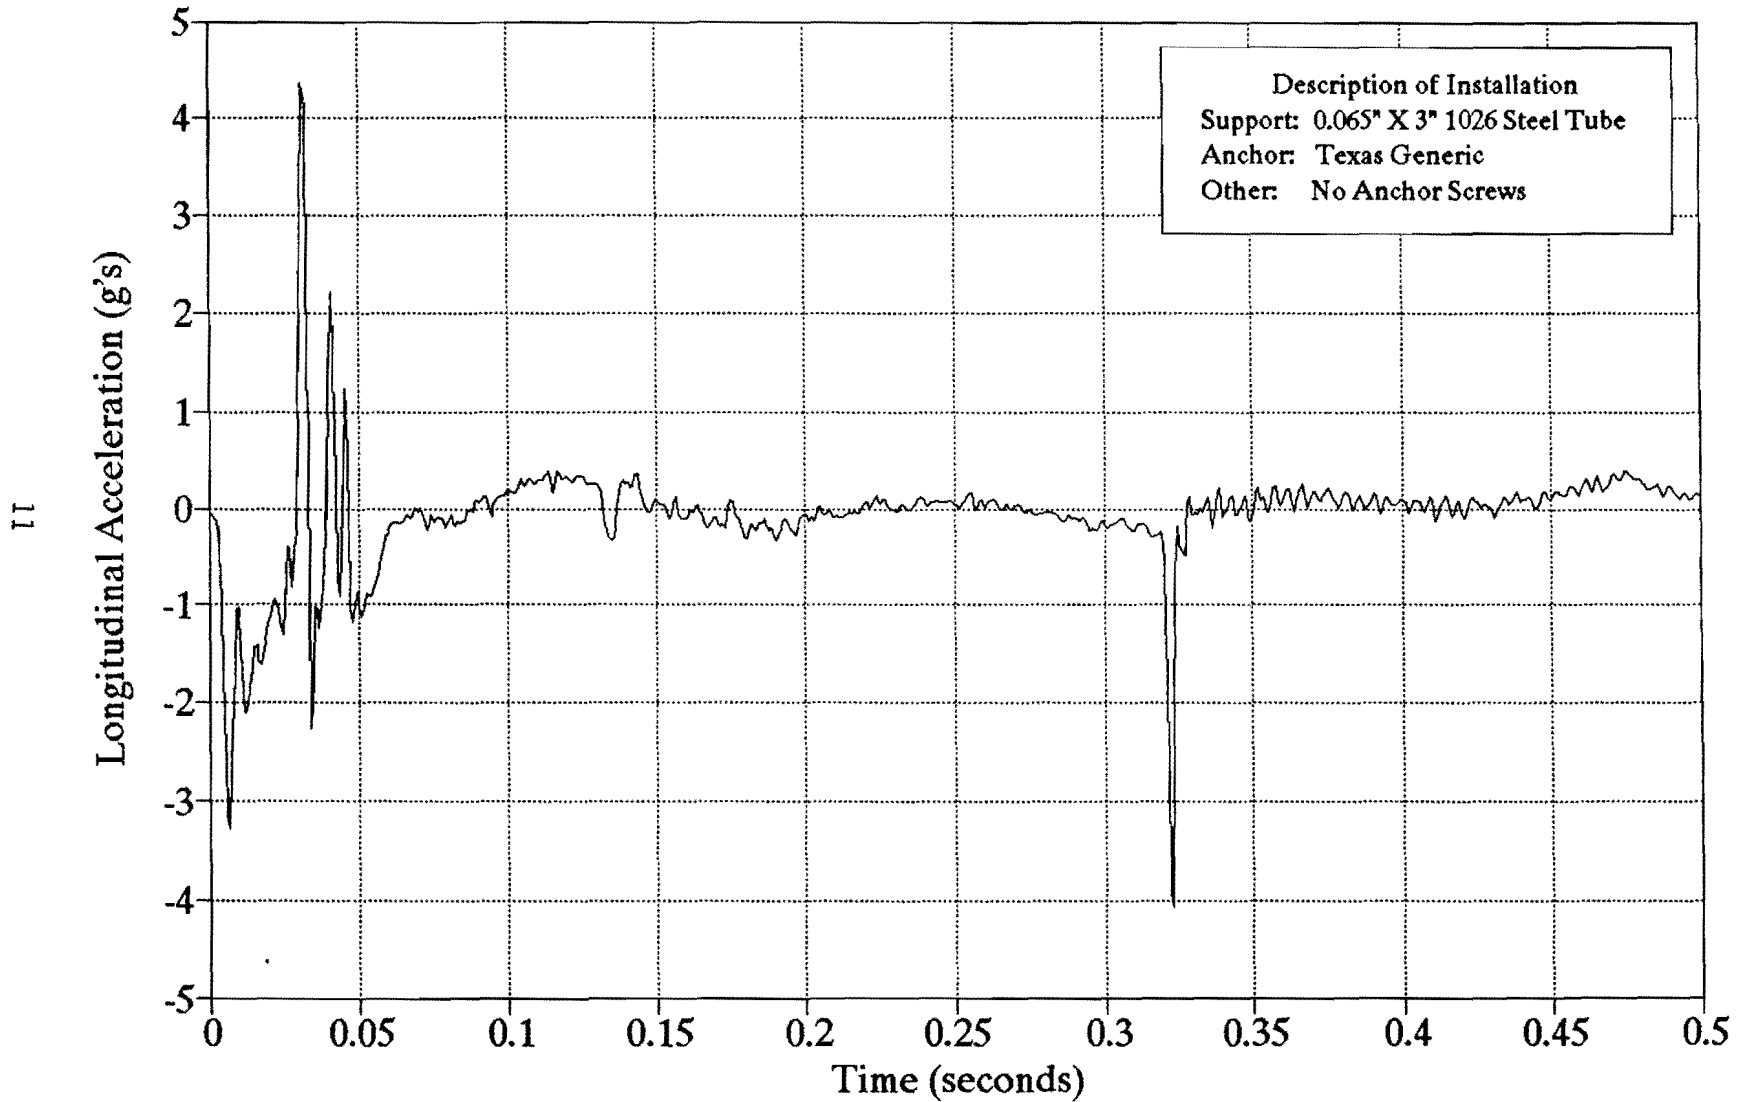
Figure 7. Pendulum longitudinal accelerometer trace (1219-P7).

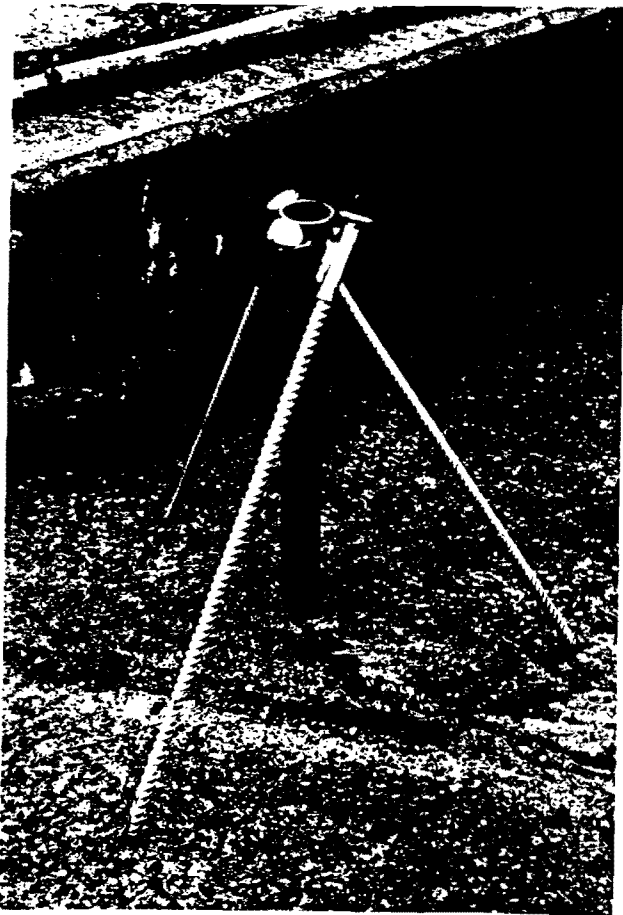
Figure 8. 1122 Generic anchor system

Figure 8. 1122 Generic anchor system (continued)

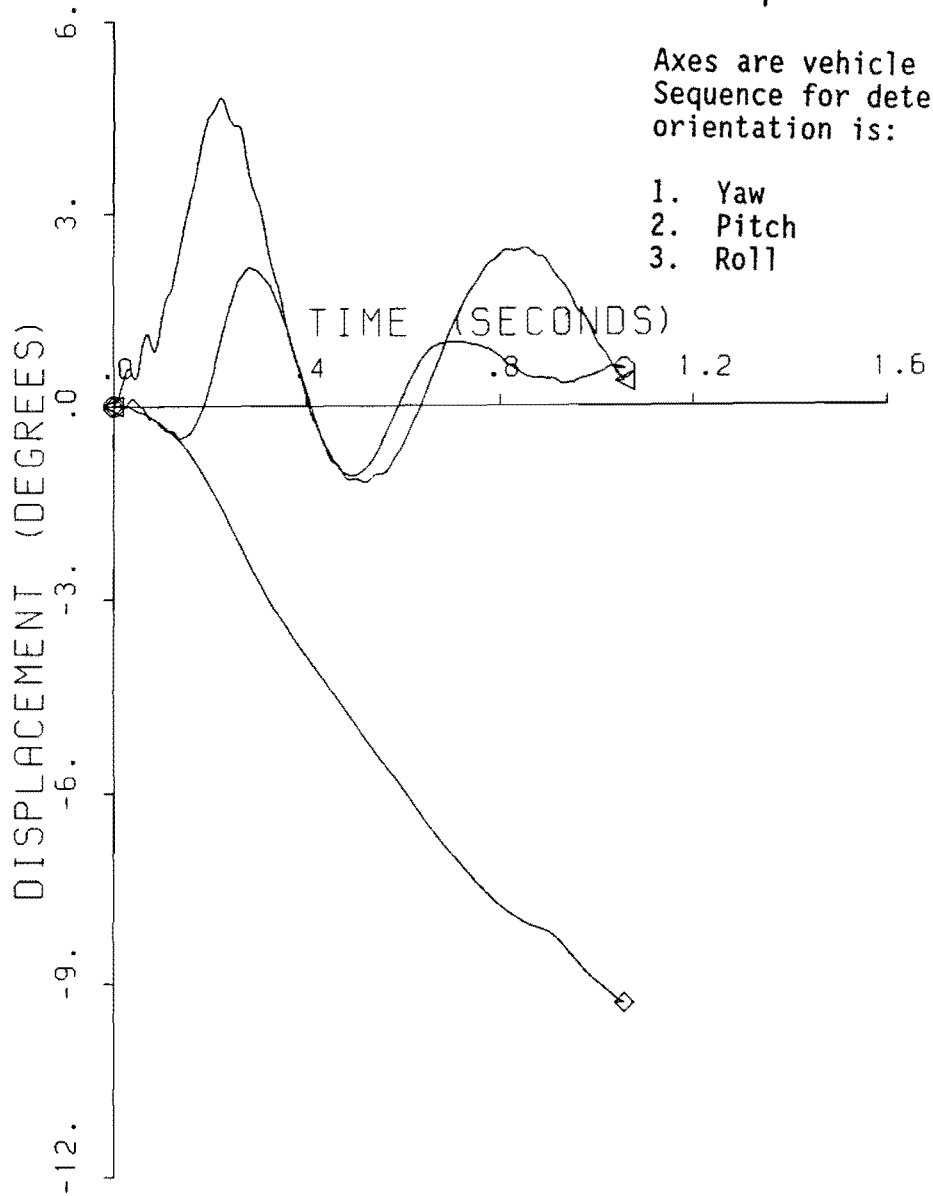
Figure 17. Vehicle angular displacement for test 1219-1.

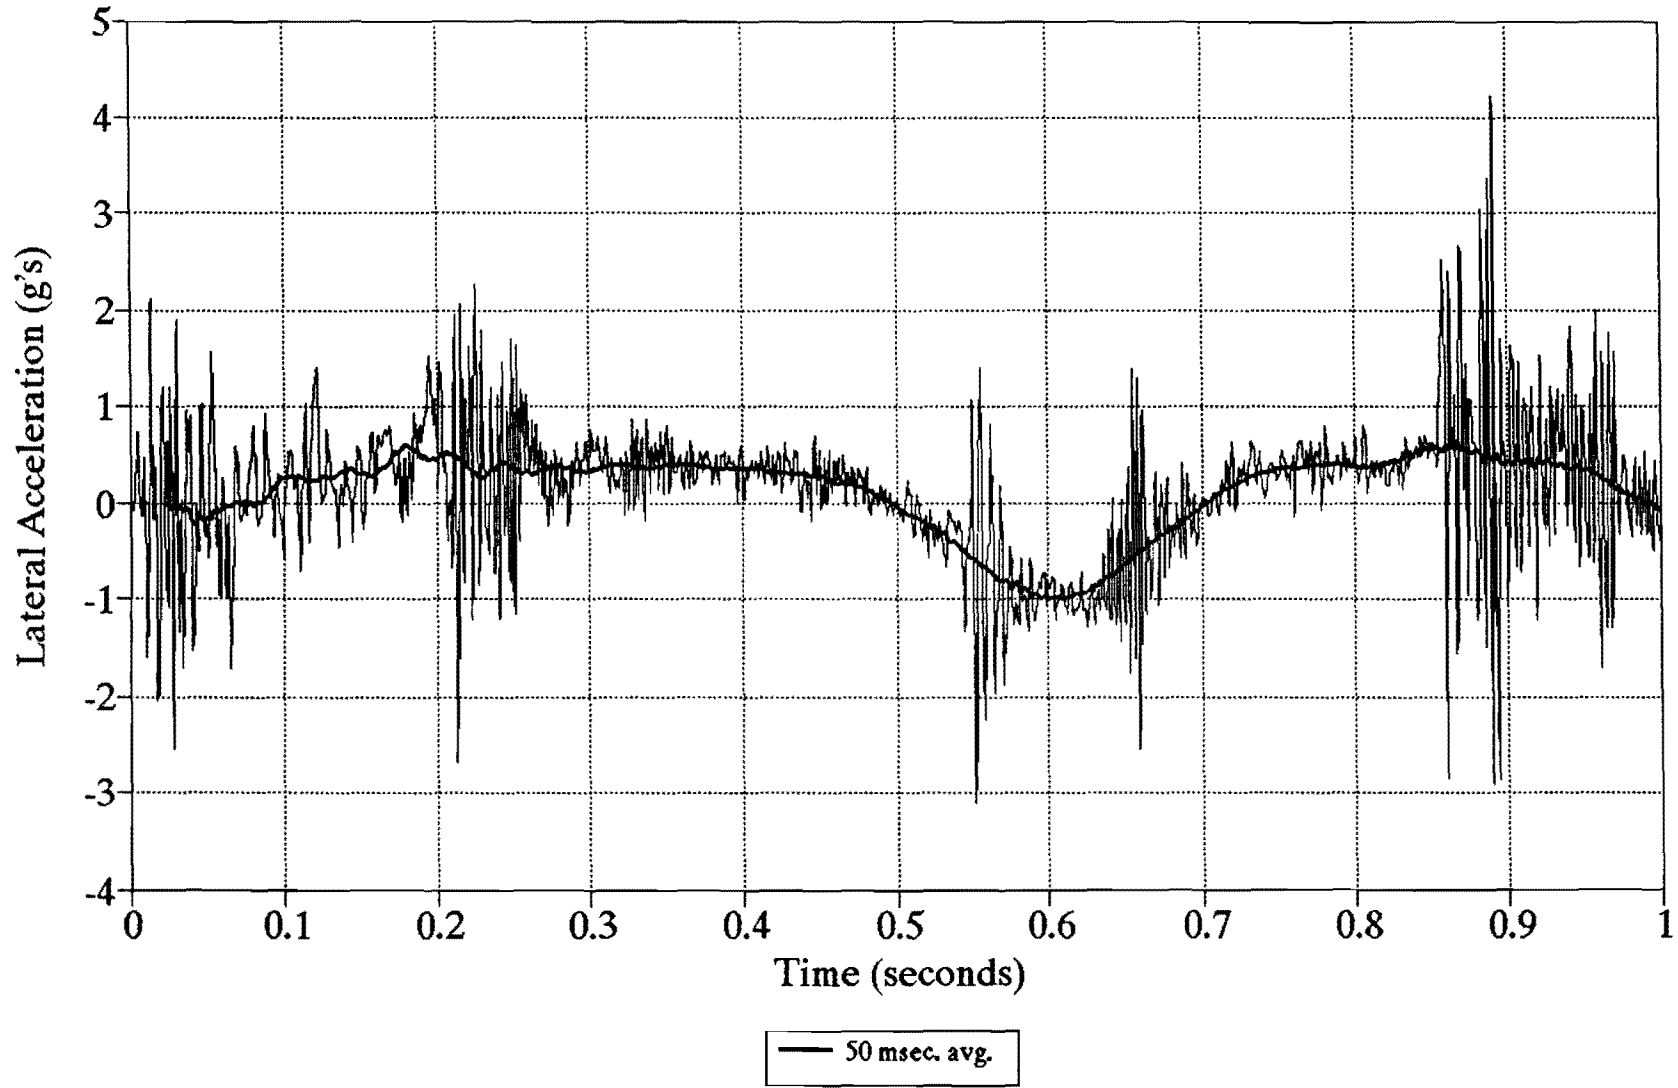
Figure 19. Lateral accelerometer trace (1219-1).

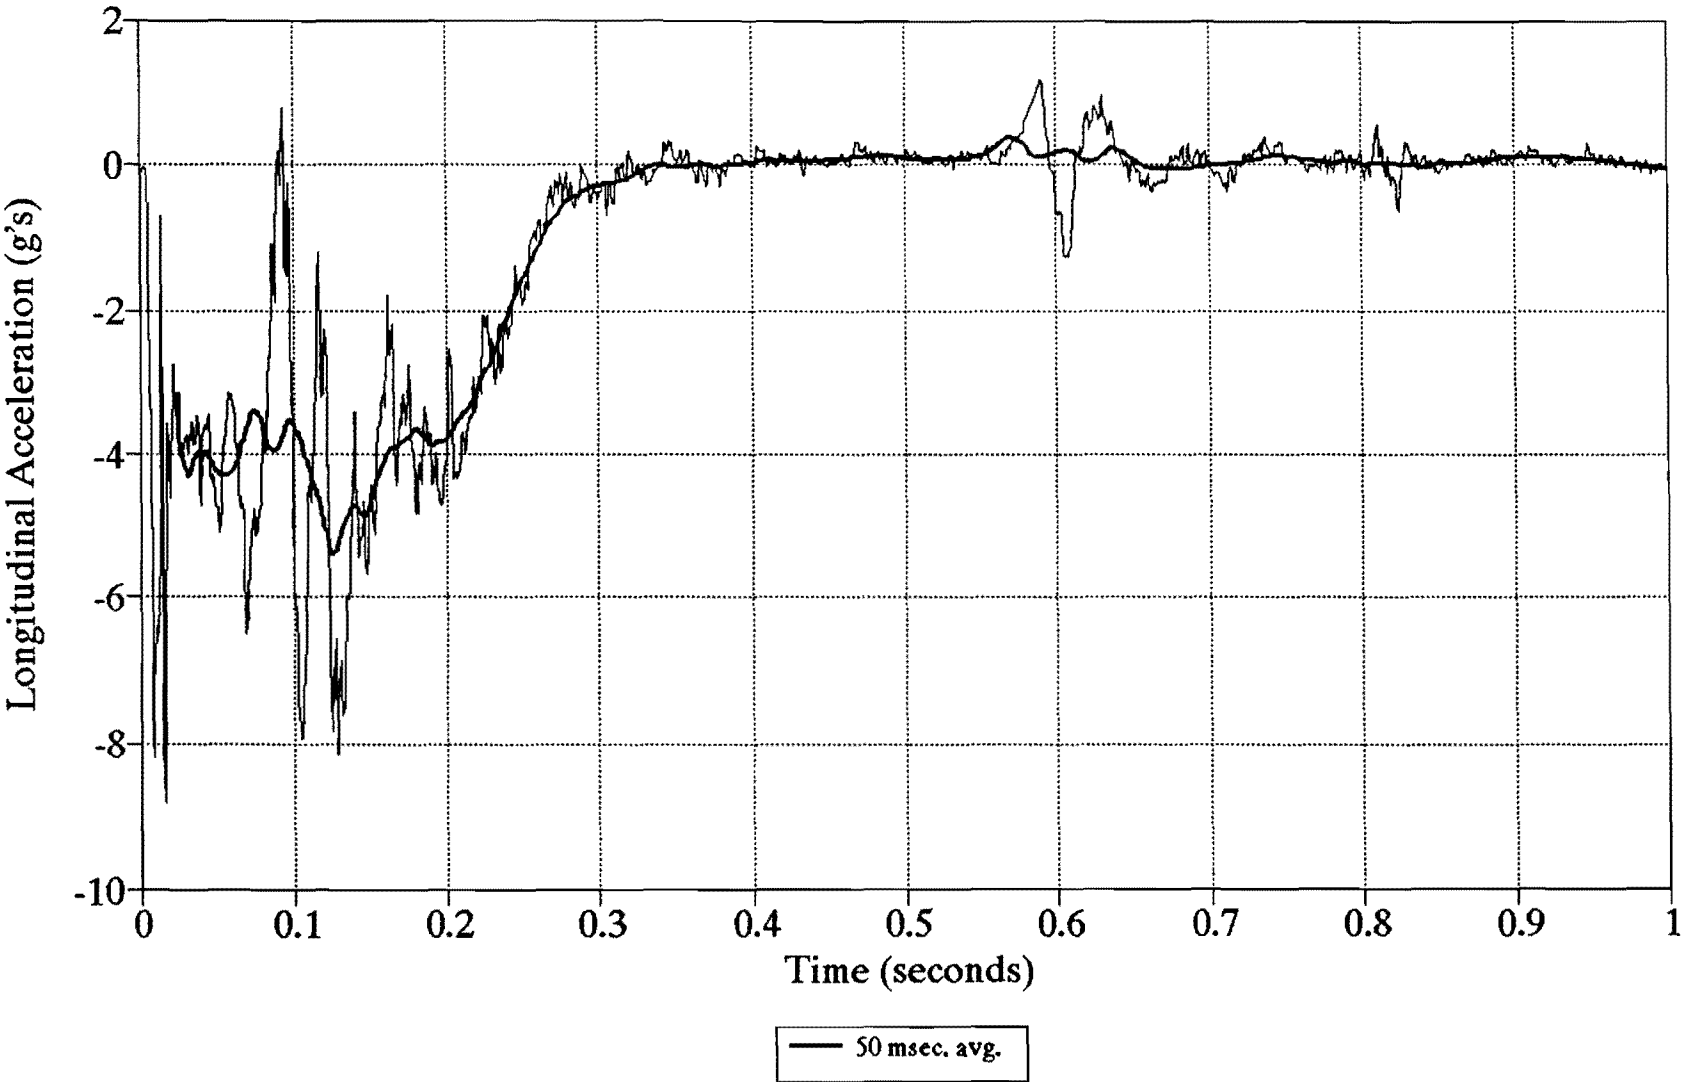
Figure 40. Longitudinal accelerometer trace (1219-5).

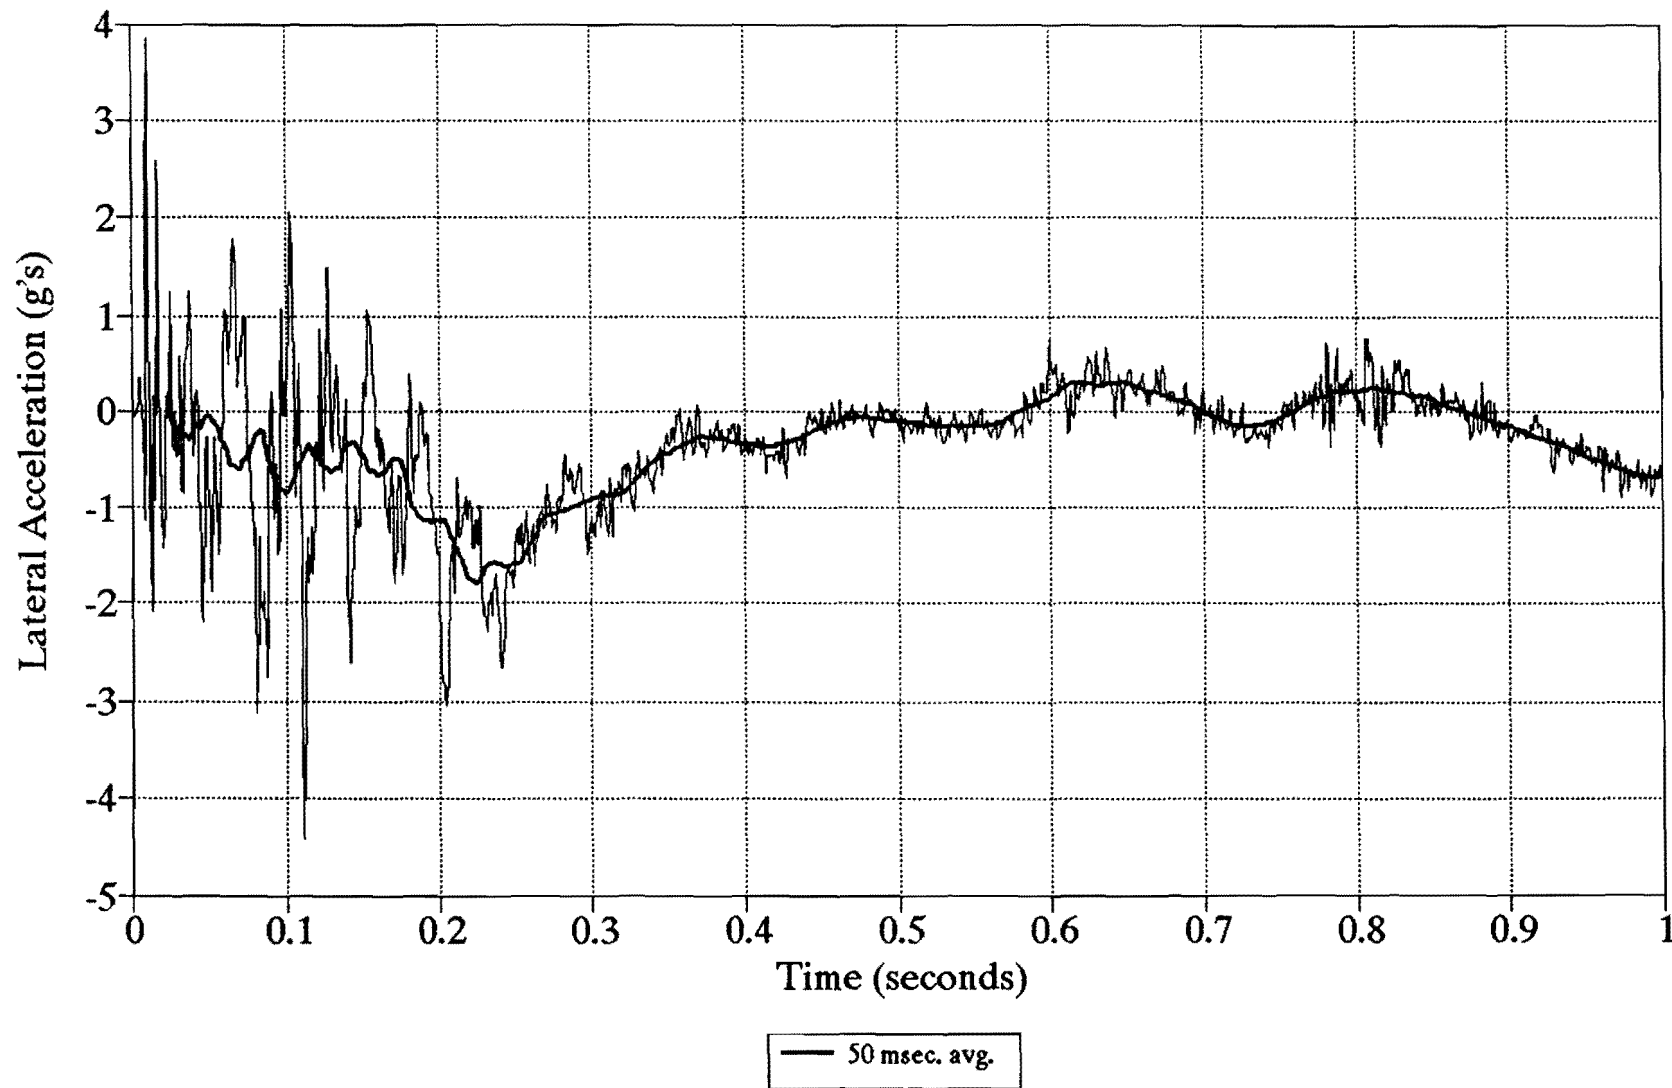
Figure 41. Lateral accelerometer trace (1219-5).

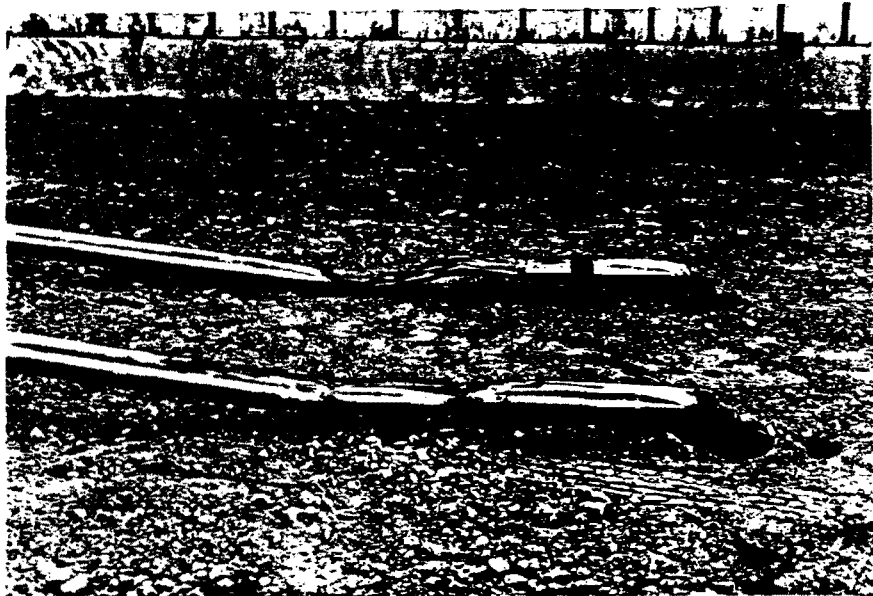
Figure 48. Sign installation after test 1219-6.

The installation did not allow the vehicle to pass safely through . The support tubes yielded, but remained attached to the ground anchors. The sign installation came to rest at the point of impact on the roadway (Figure 48). The vehicle sustained damage to the bumper, grill, hood and right front strut shown in Figure 49.

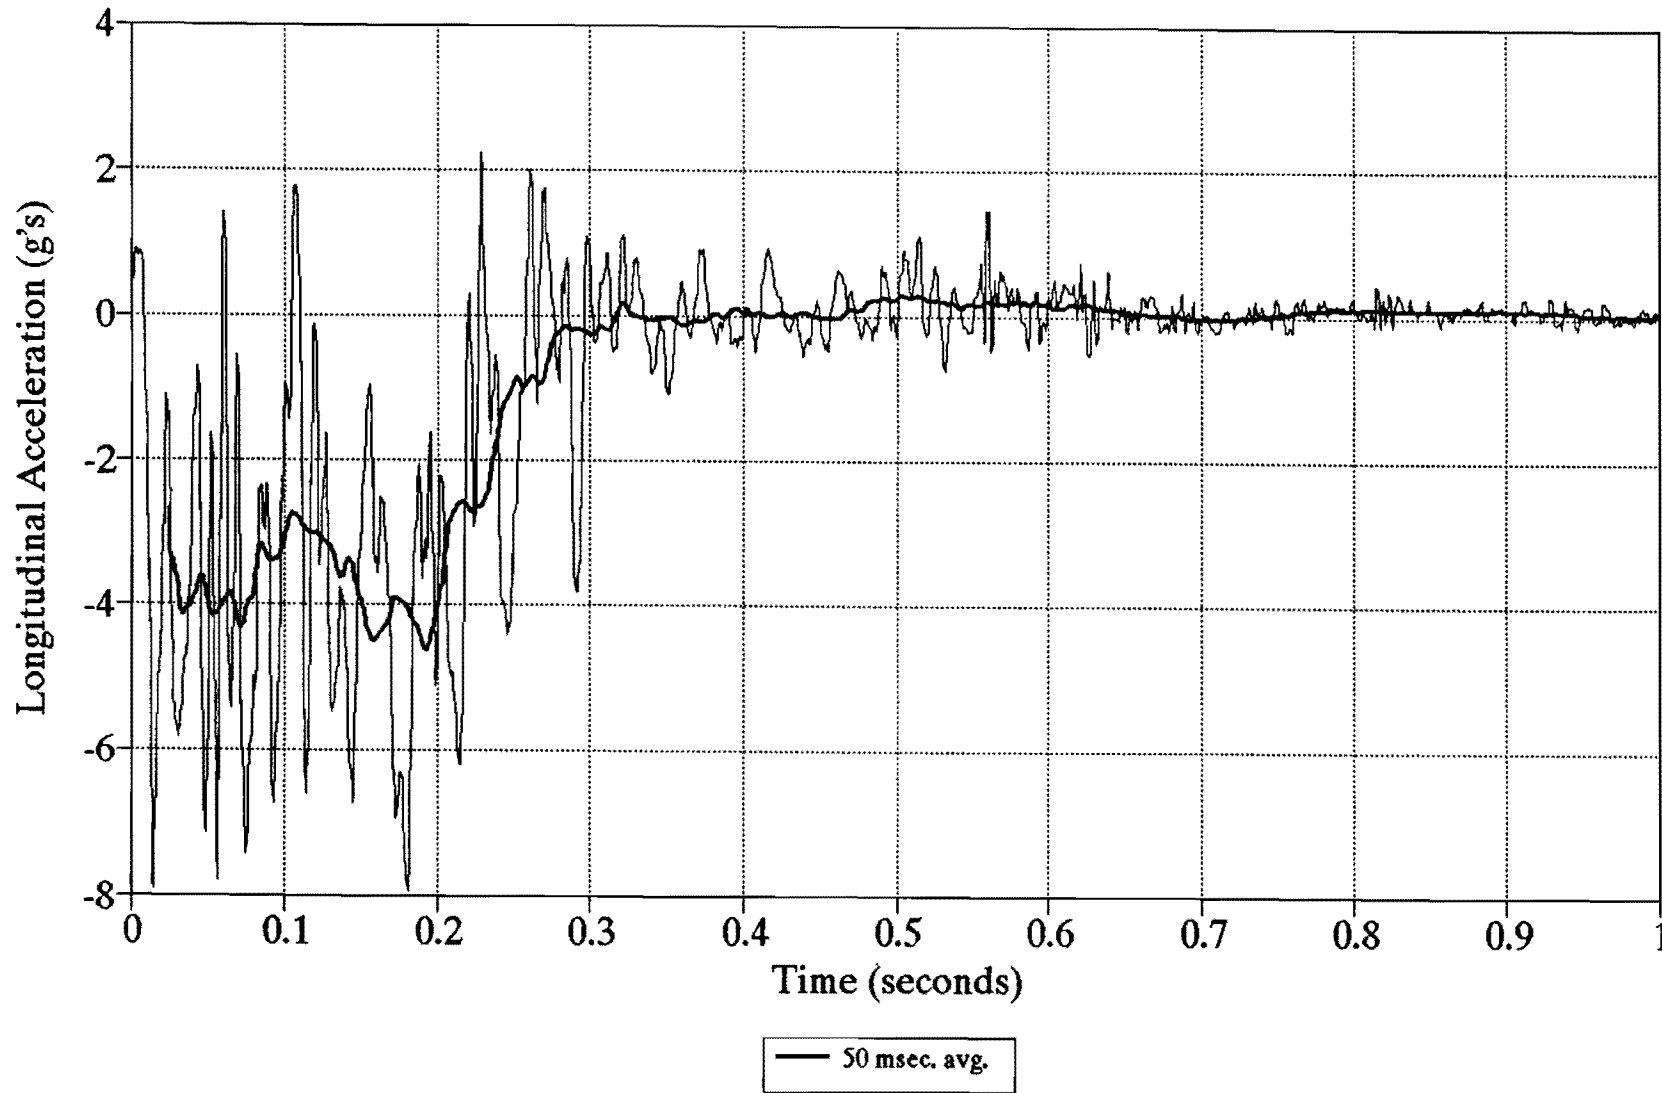
Figure 52. Longitudinal accelerometer trace (1219-6).

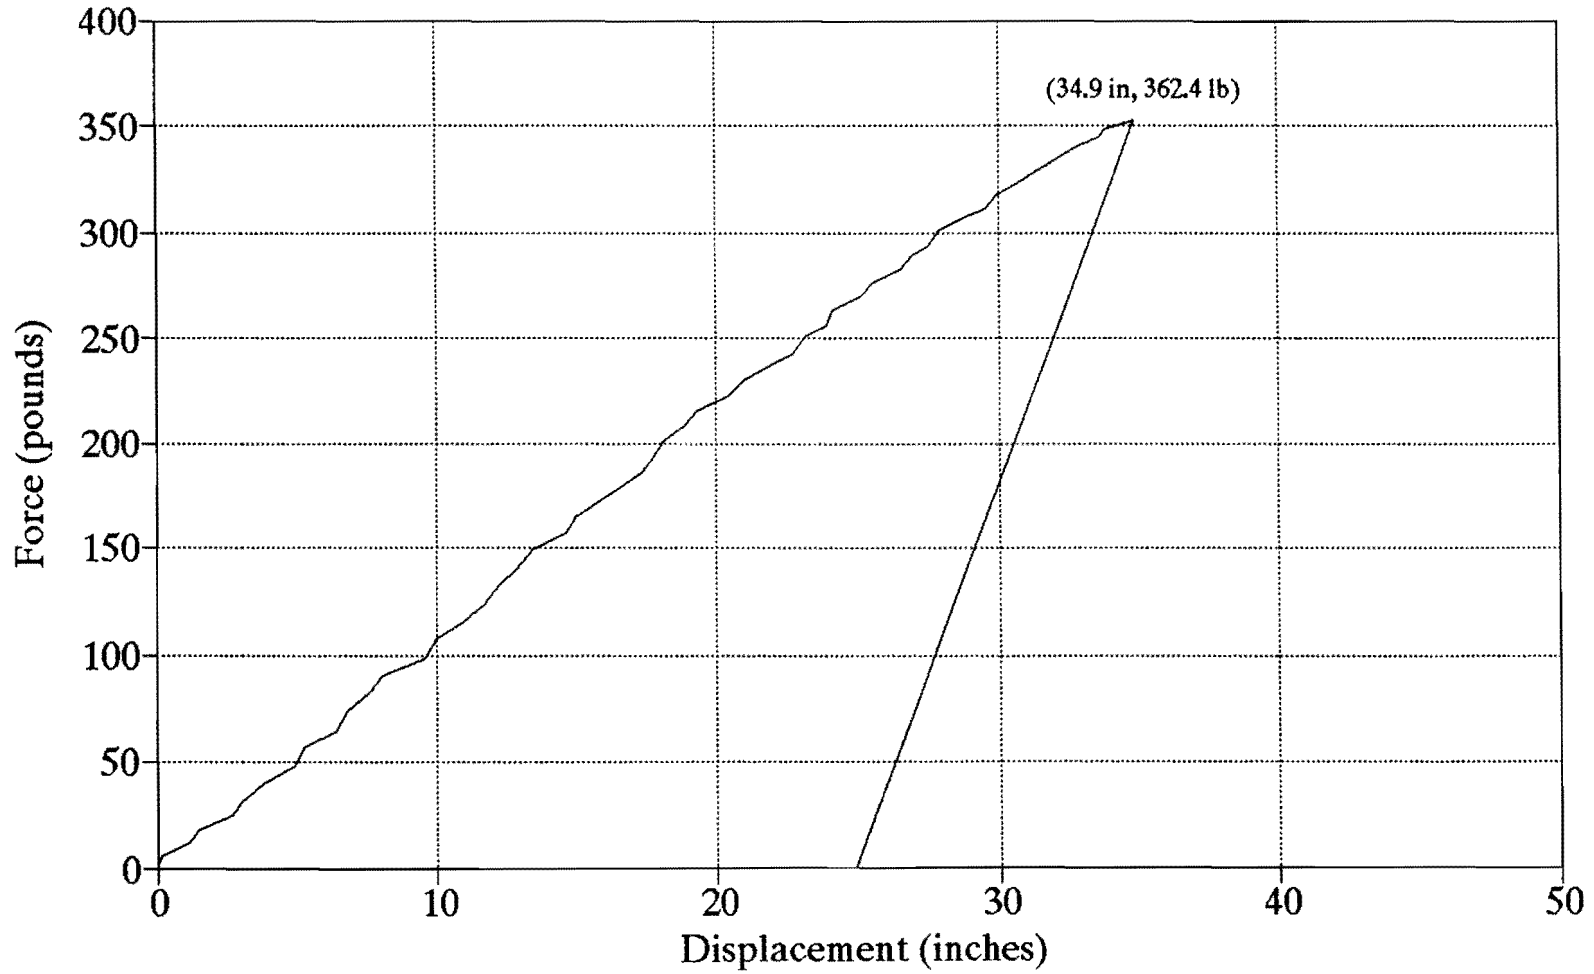
# PROJECT 1219 STATIC LOAD TEST HWYCOM SYSTEM

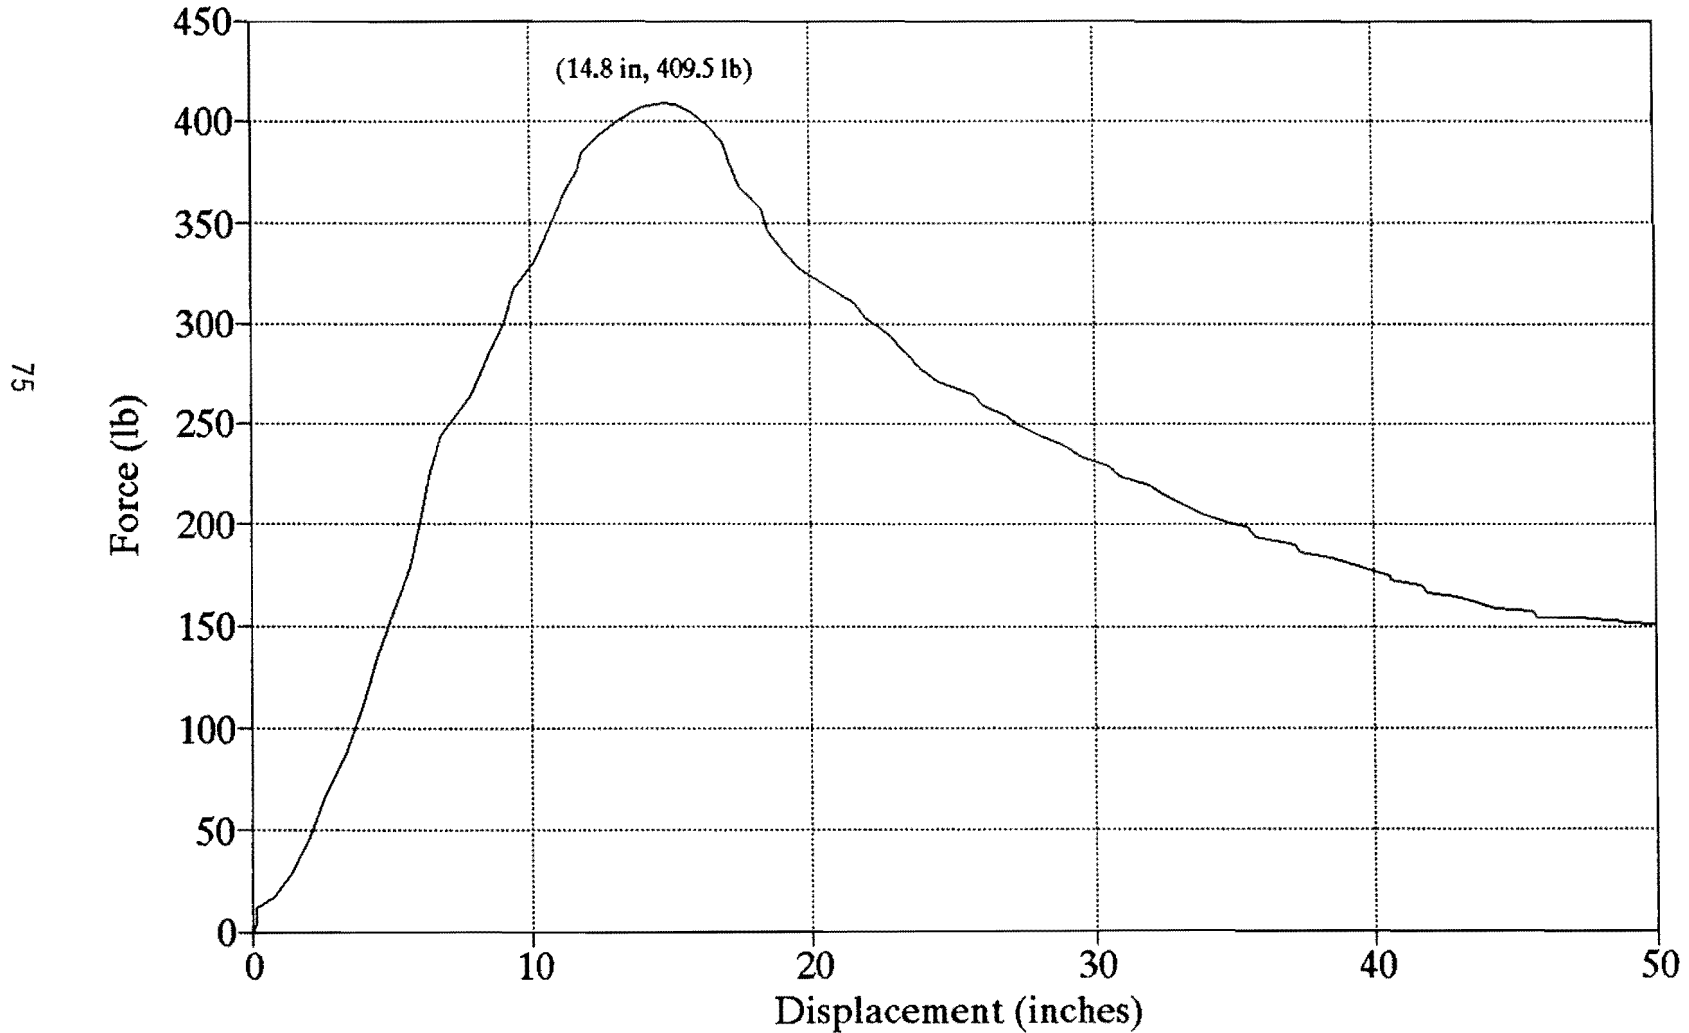
**PROJECT 1219 STATIC LOAD TEST  
STEEL TUBE W/ GENERIC ANCHOR (6" DEPTH)**

**0.065" x 3.0" 1026 ROUND STEEL TUBE  
W/O CHAMFER ON ANCHOR**

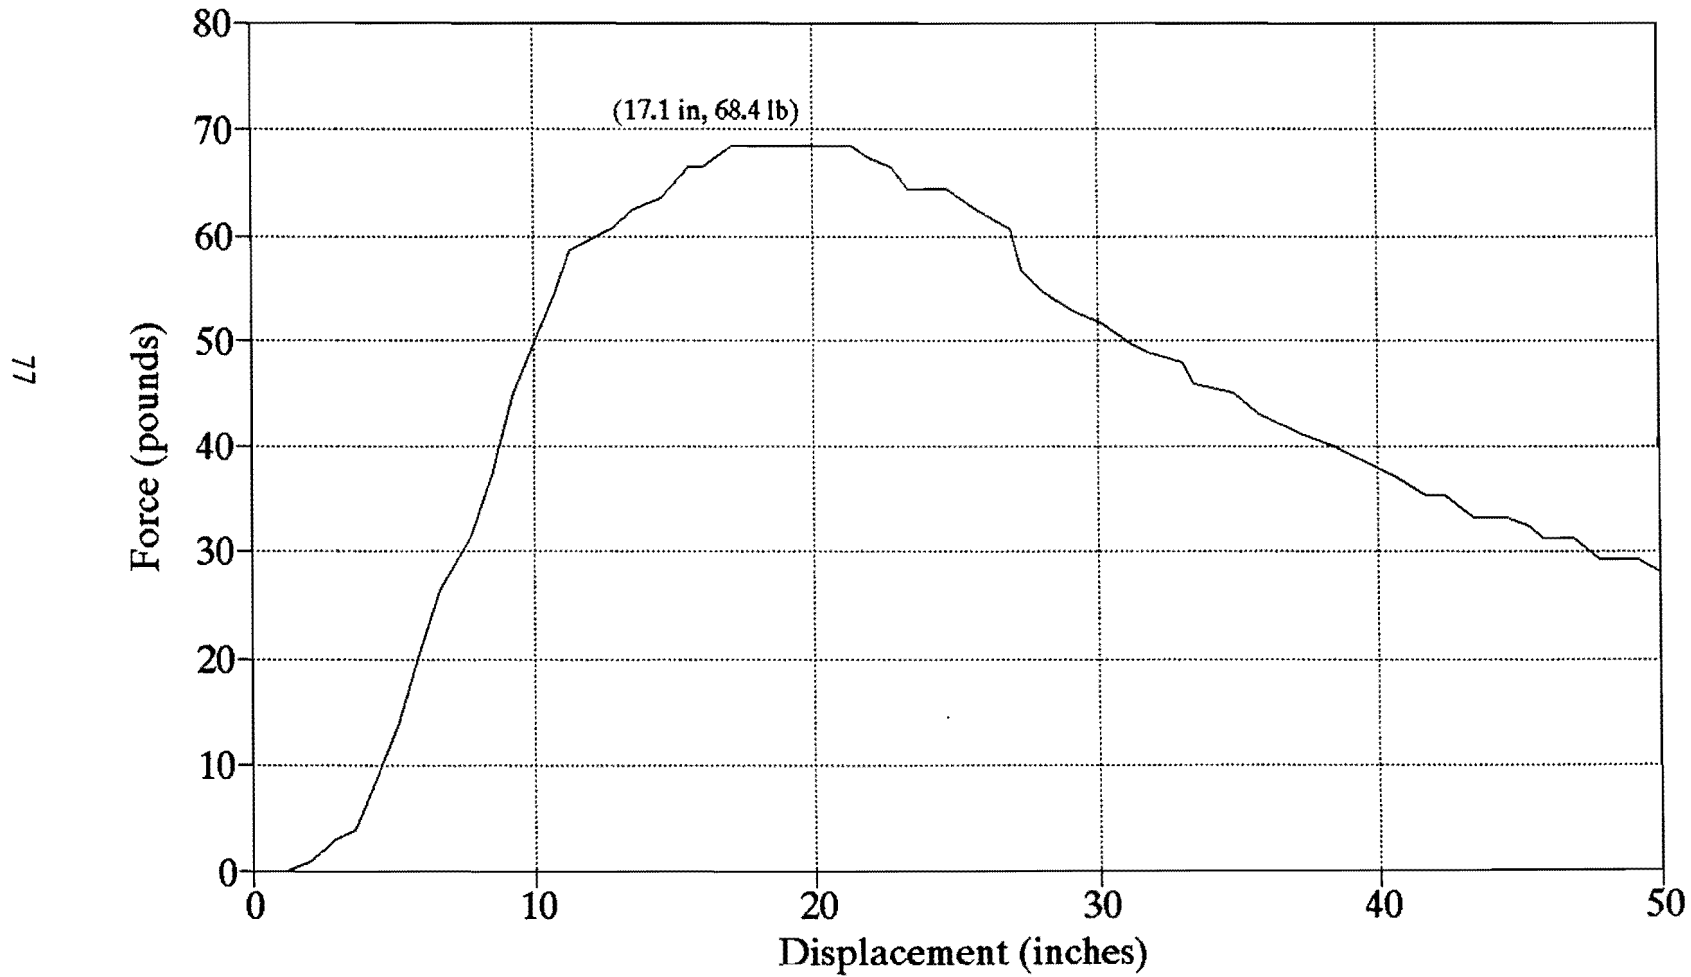
**PROJECT 1219 STATIC LOAD TEST**  
**STEEL TUBE W/ GENERIC ANCHOR (2" DEPTH)**  
**0.049" x 3.0" 1010 ROUND STEEL TUBE**

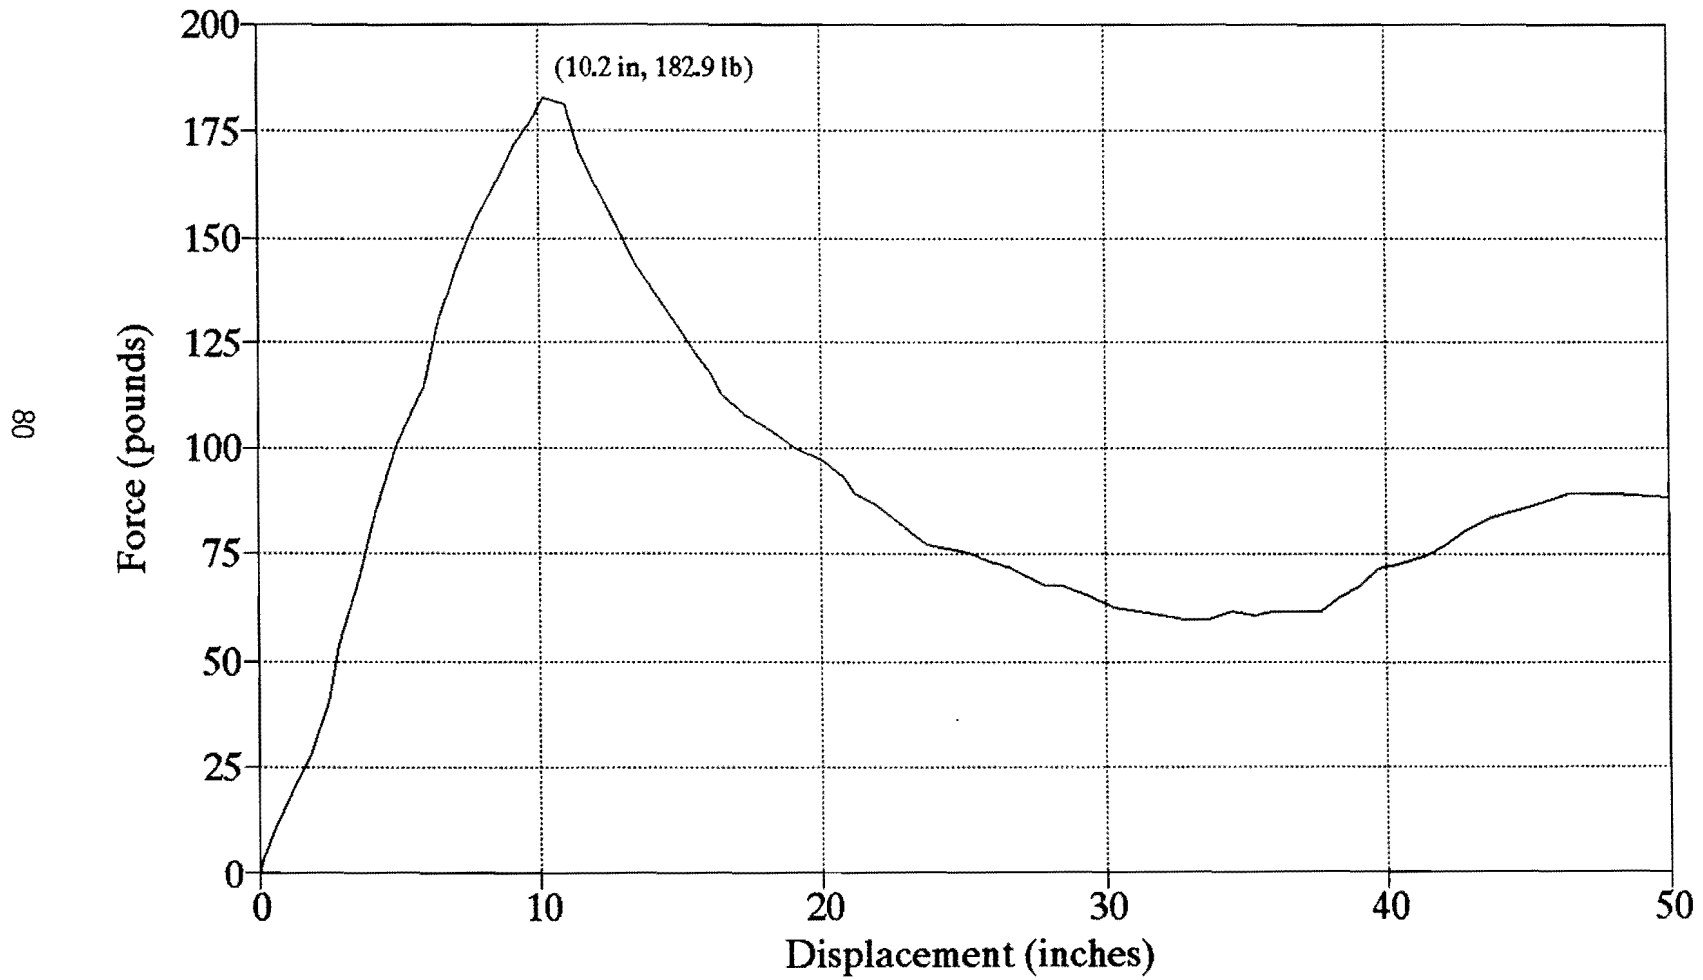
**PROJECT 1219 STATIC LOAD TEST**  
**STEEL TUBE W/ GENERIC ANCHOR (6" DEPTH)**  
**0.049" x 3.0" 1010 ROUND STEEL TUBE**

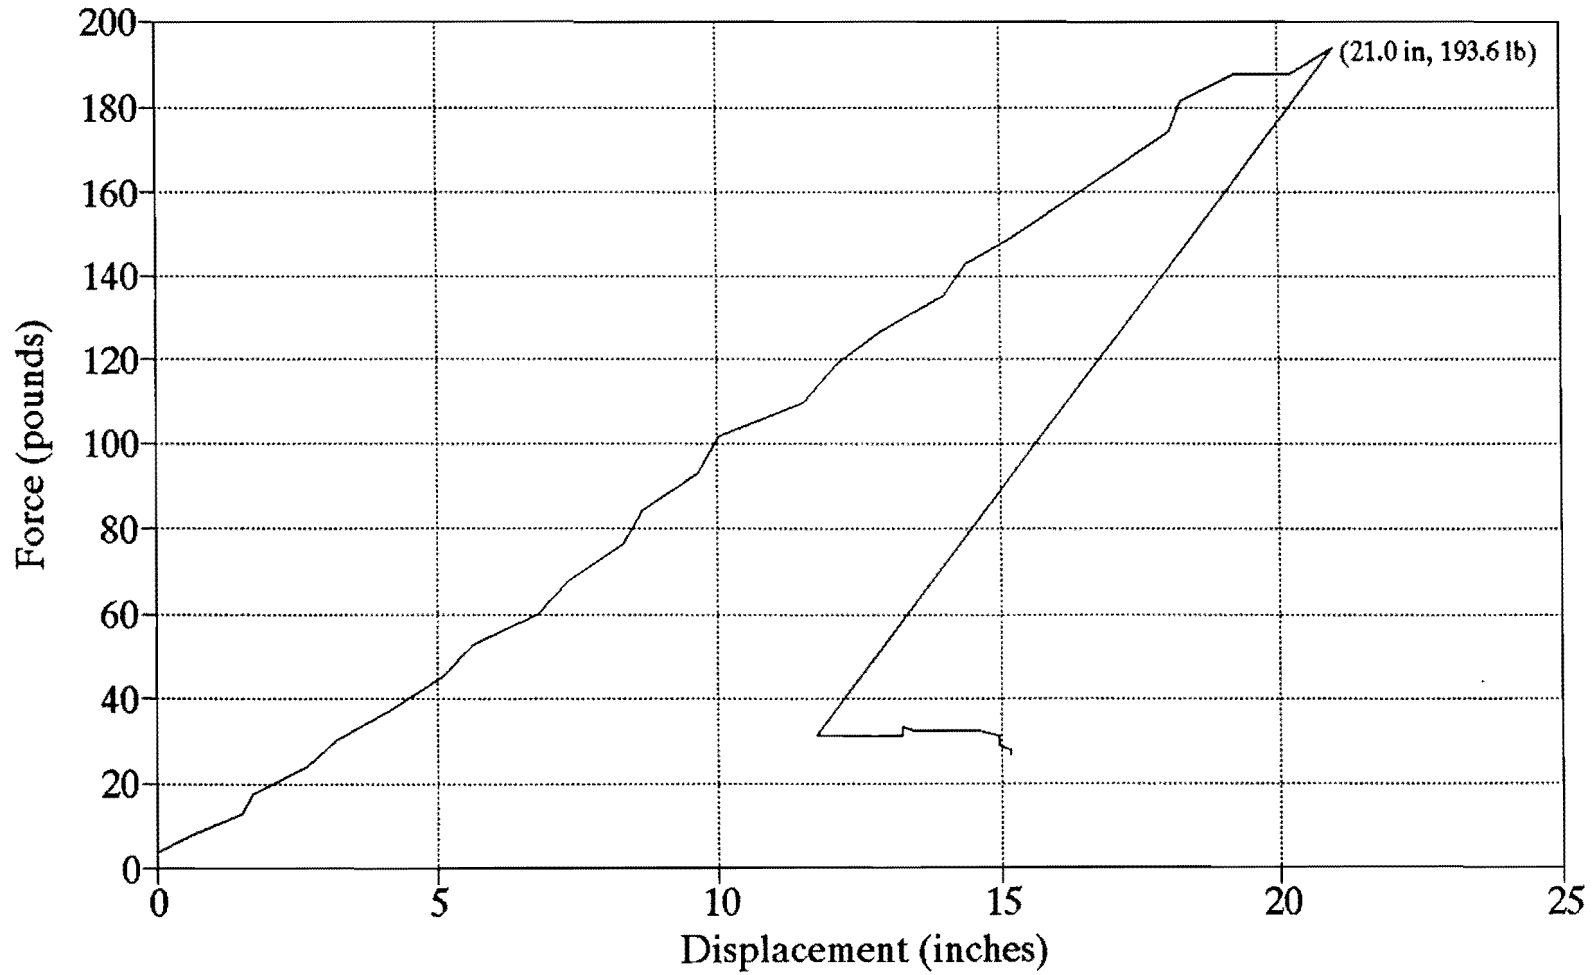
# PROJECT 1219 STATIC LOAD TEST HWYCOM POST W/GENERIC ANCHOR (6" DEPTH)
