**TWO POST DRIVABLE SIGN SUPPORTS**

Study No. 2-5-91-1219

TEXAS TRANSPORTATION INSTITUTE  
TEXAS A&M UNIVERSITY SYSTEM  
COLLEGE STATION, TEXAS 77843

August 1991

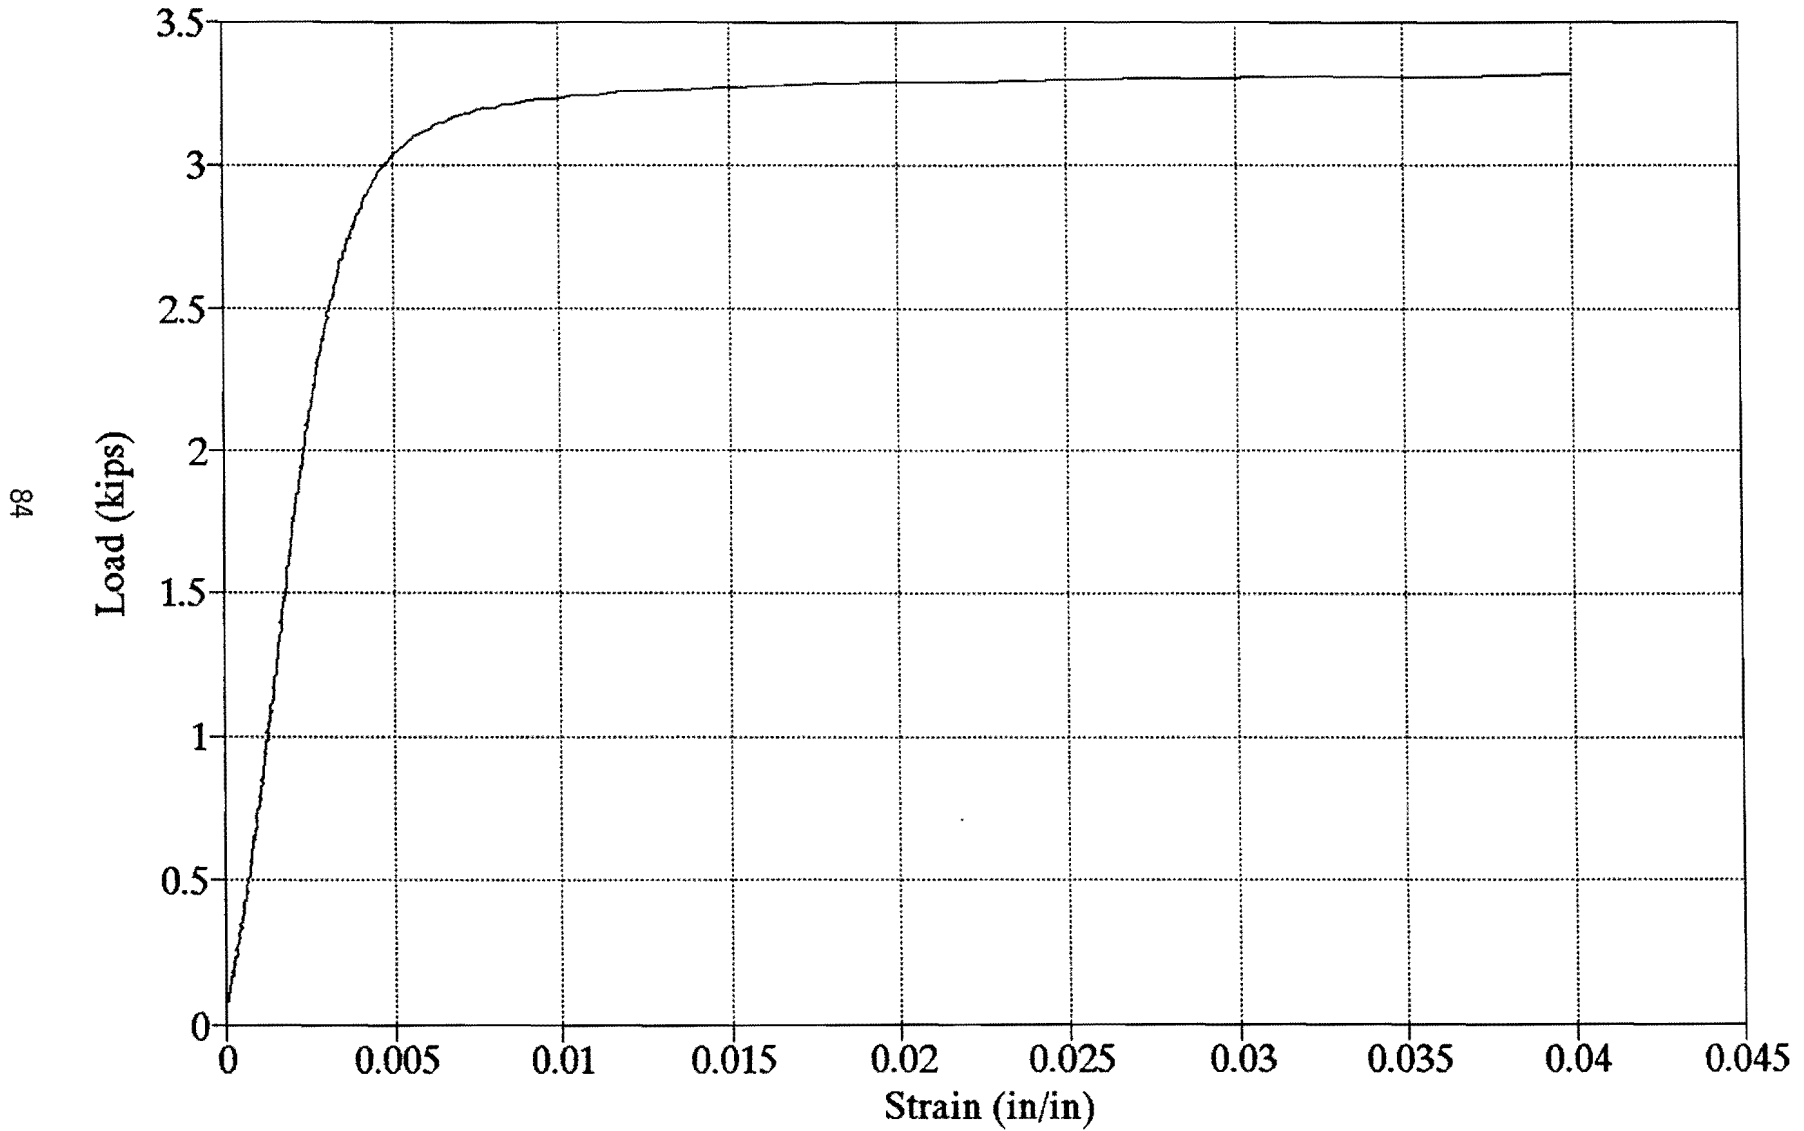
TENSILE COUPON TEST 1219-1A  
0.085" x 3.0" 1026 DOM Steel Tube

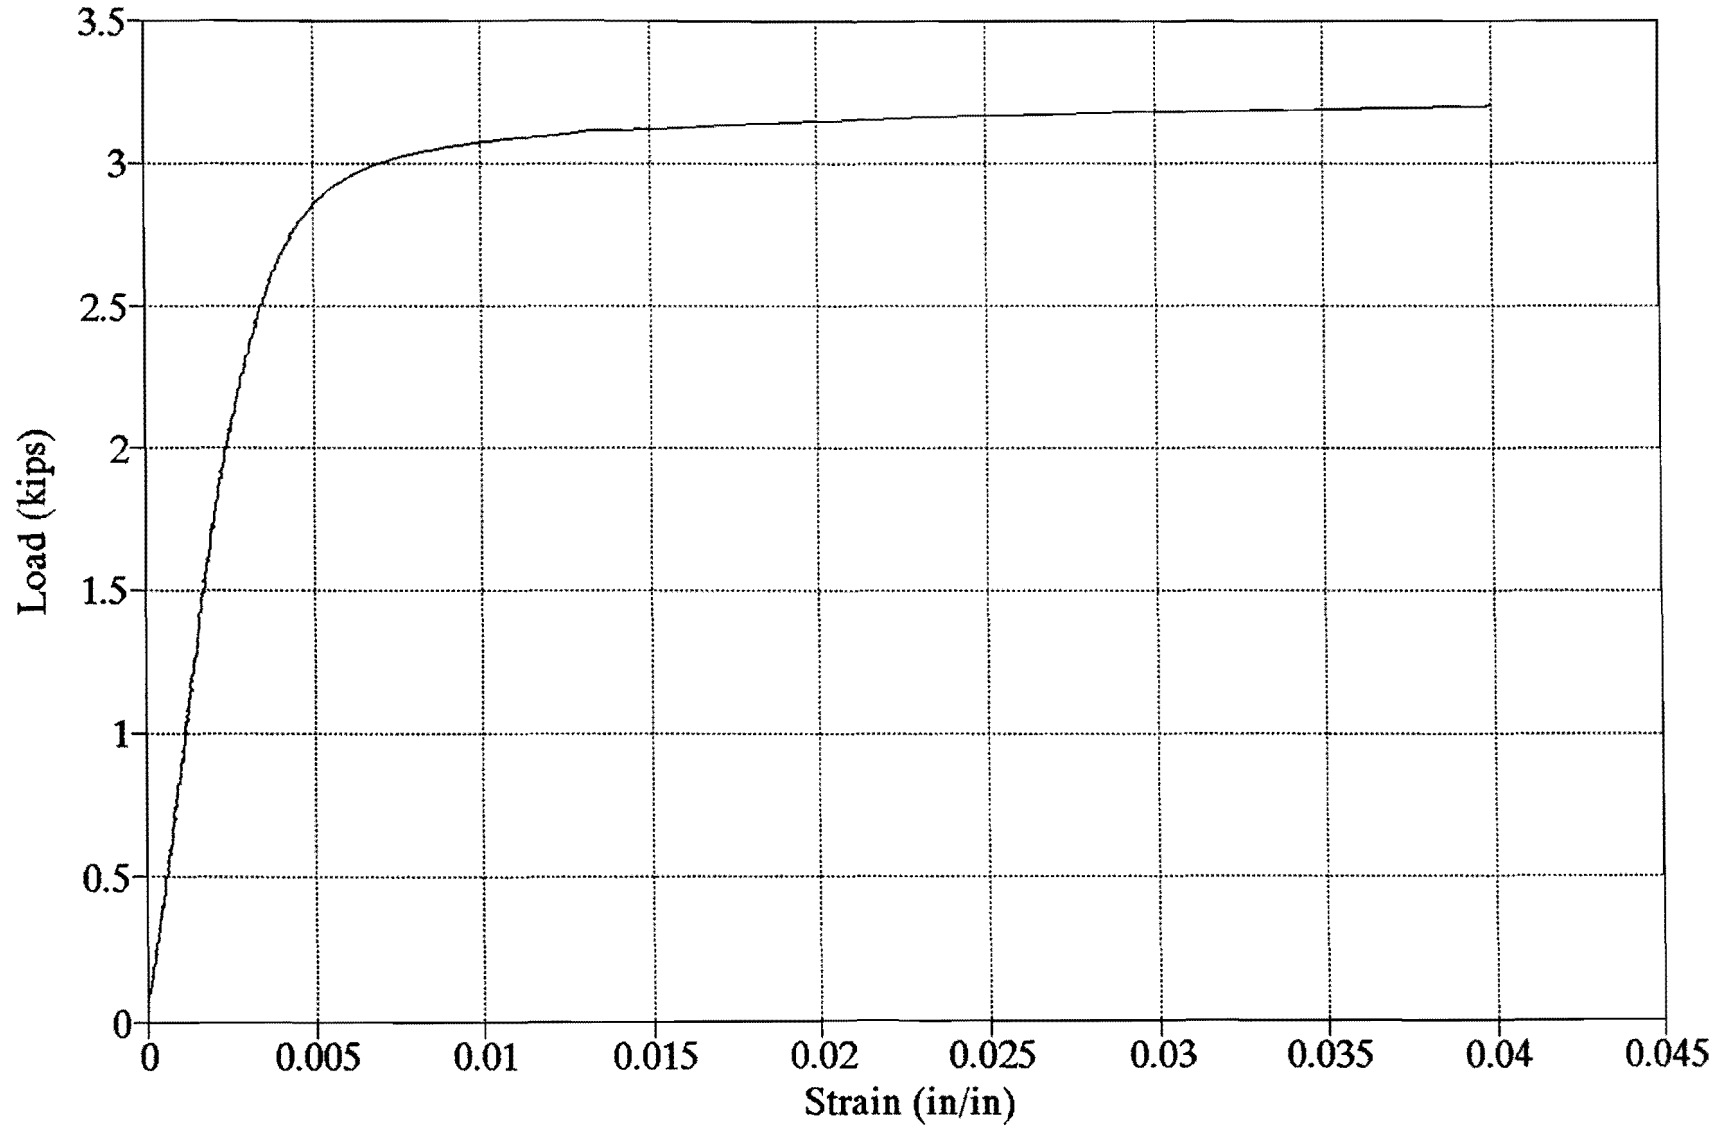
TENSILE COUPON TEST 1219-1B  
0.085" x 3.0" 1026 DOM Steel Tube

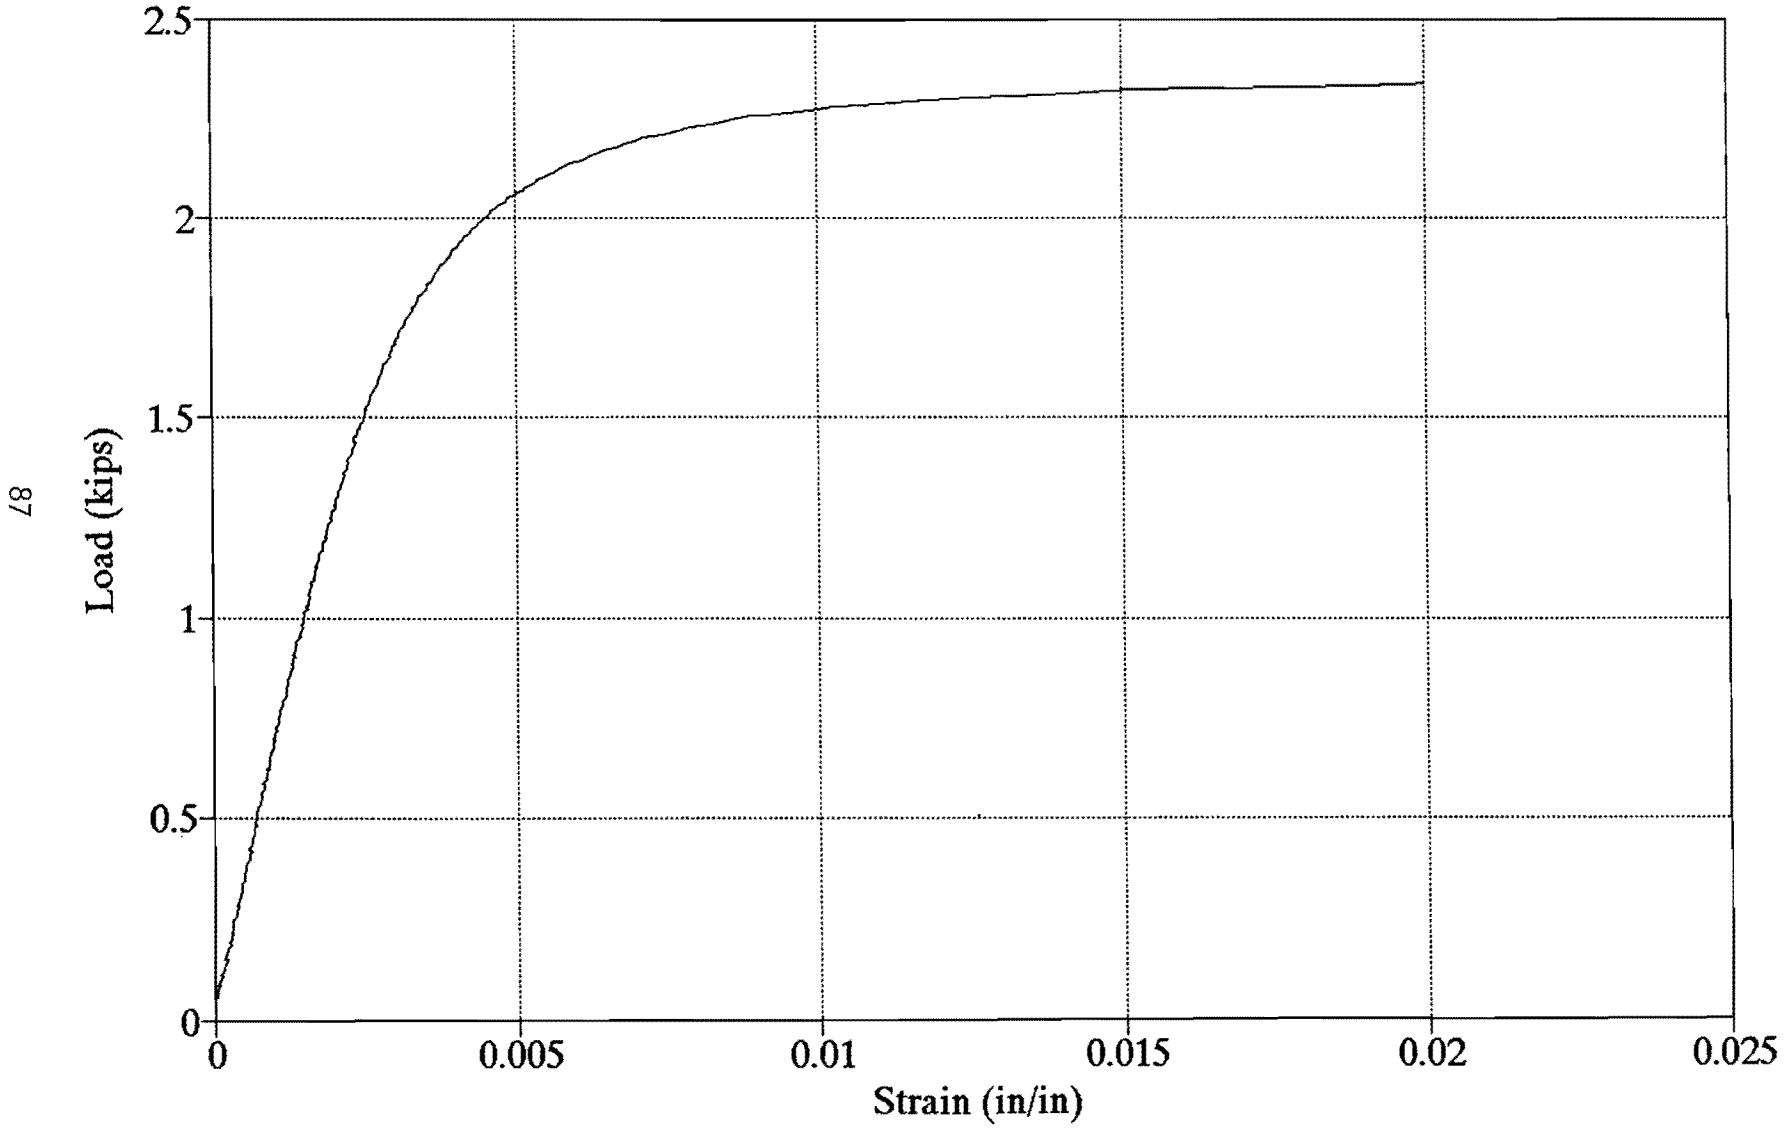
TENSILE COUPON TEST 1219-2B  
0.065" x 3.0" 1026 DOM Steel Tube

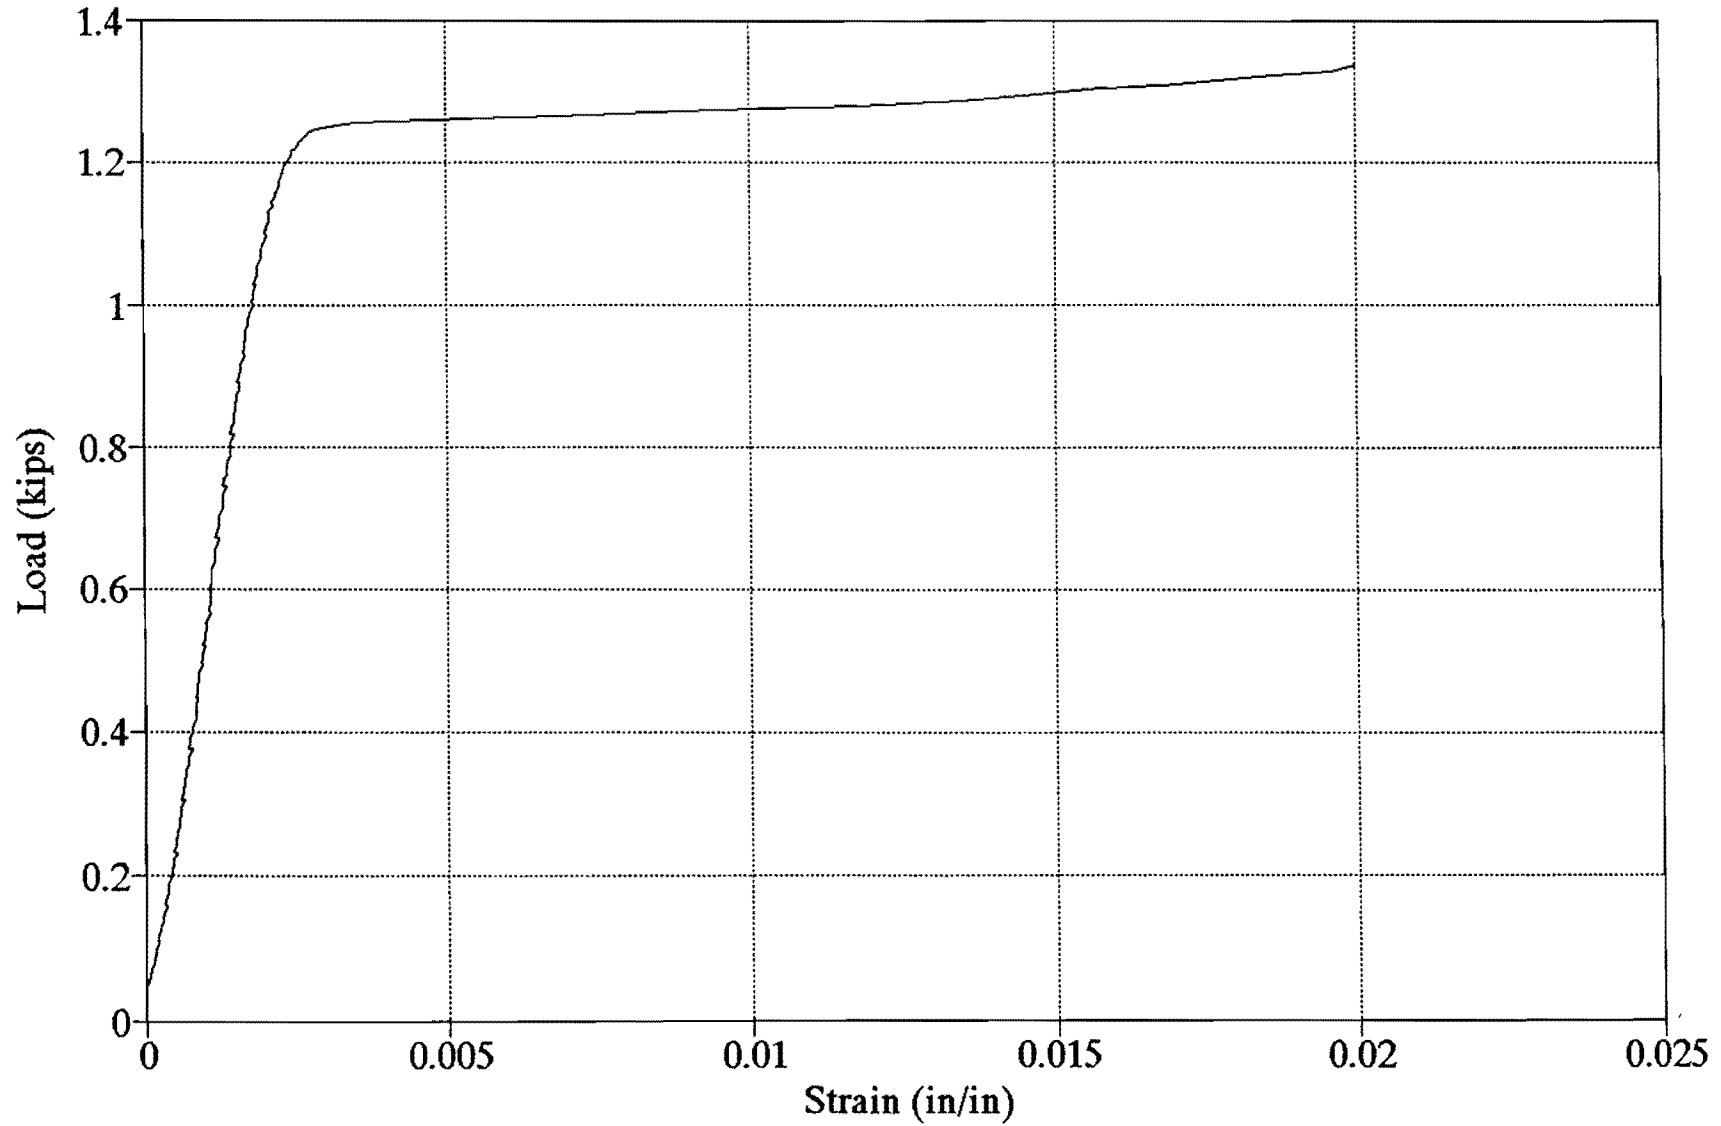
TENSILE COUPON TEST 1219-3B  
0.049" x 3.0" 1018 Steel Tube

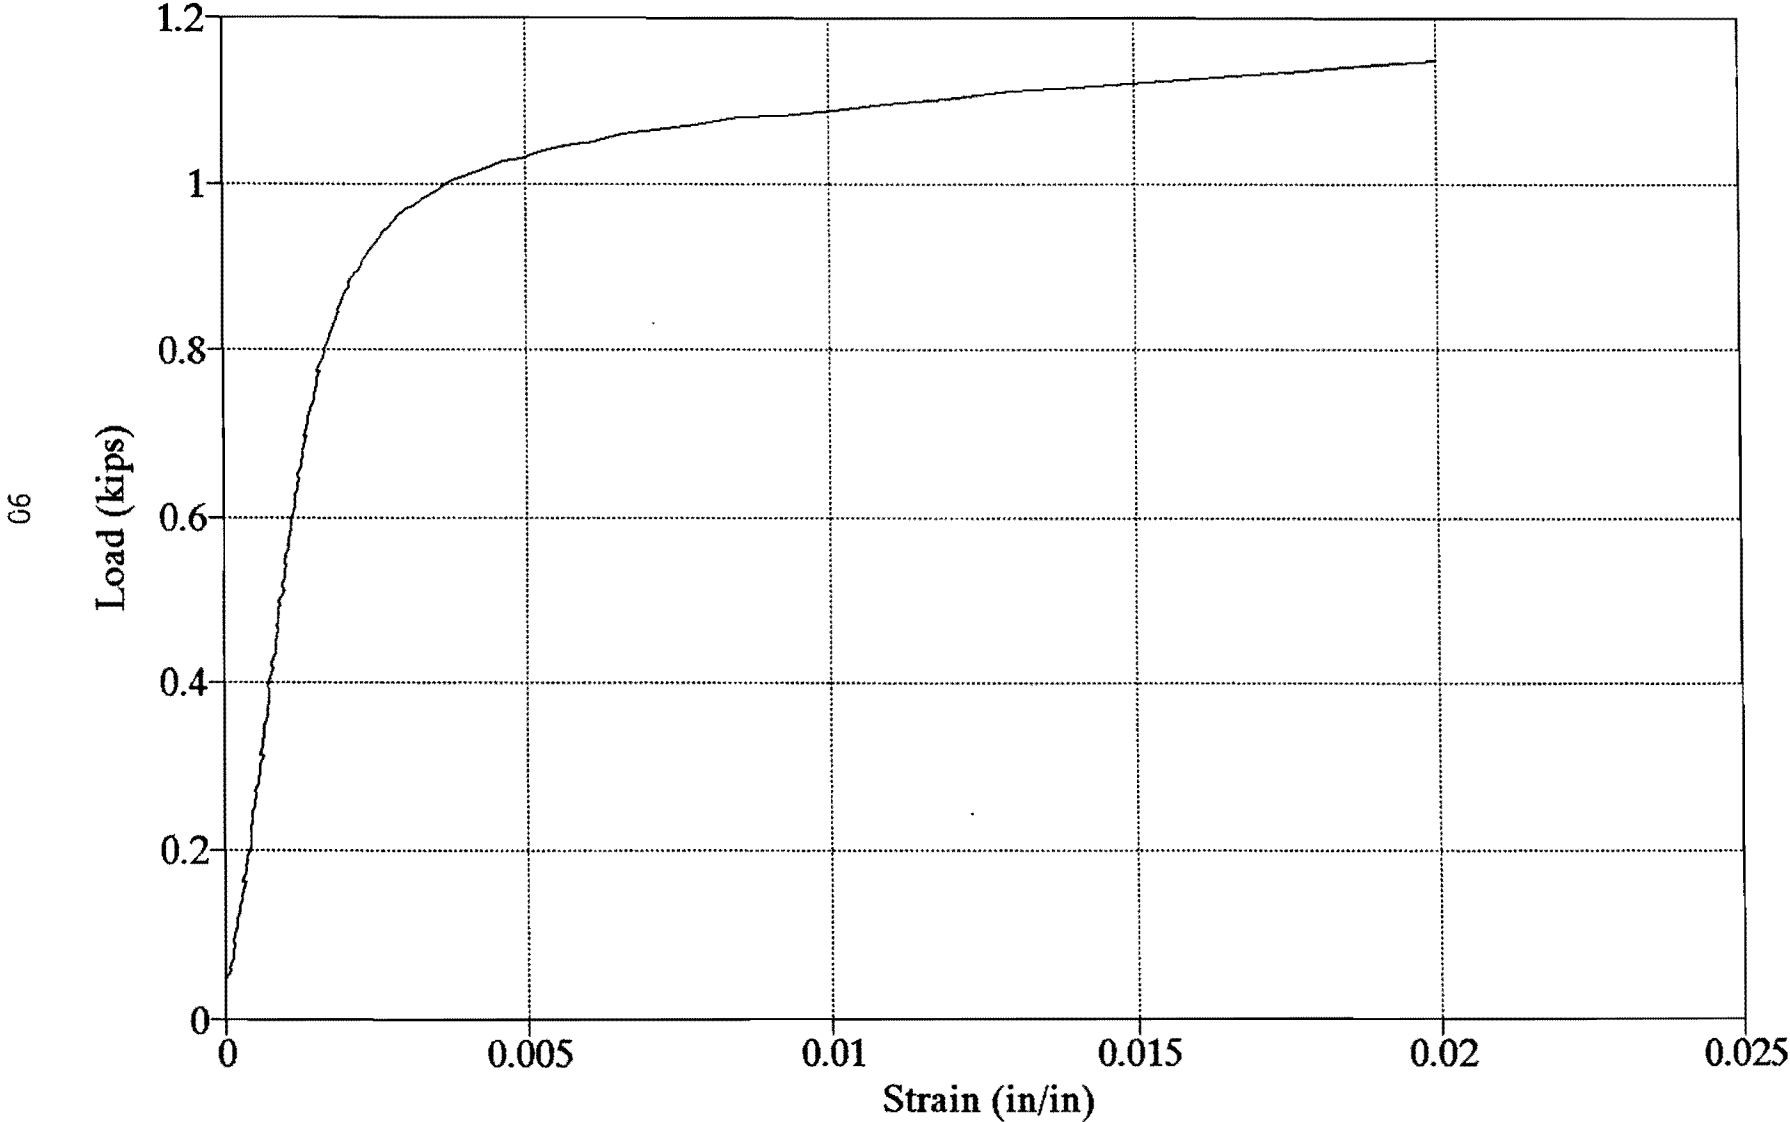
TENSILE COUPON TEST 1219-4A  
0.065" x 3.0" 1018 Steel Tube

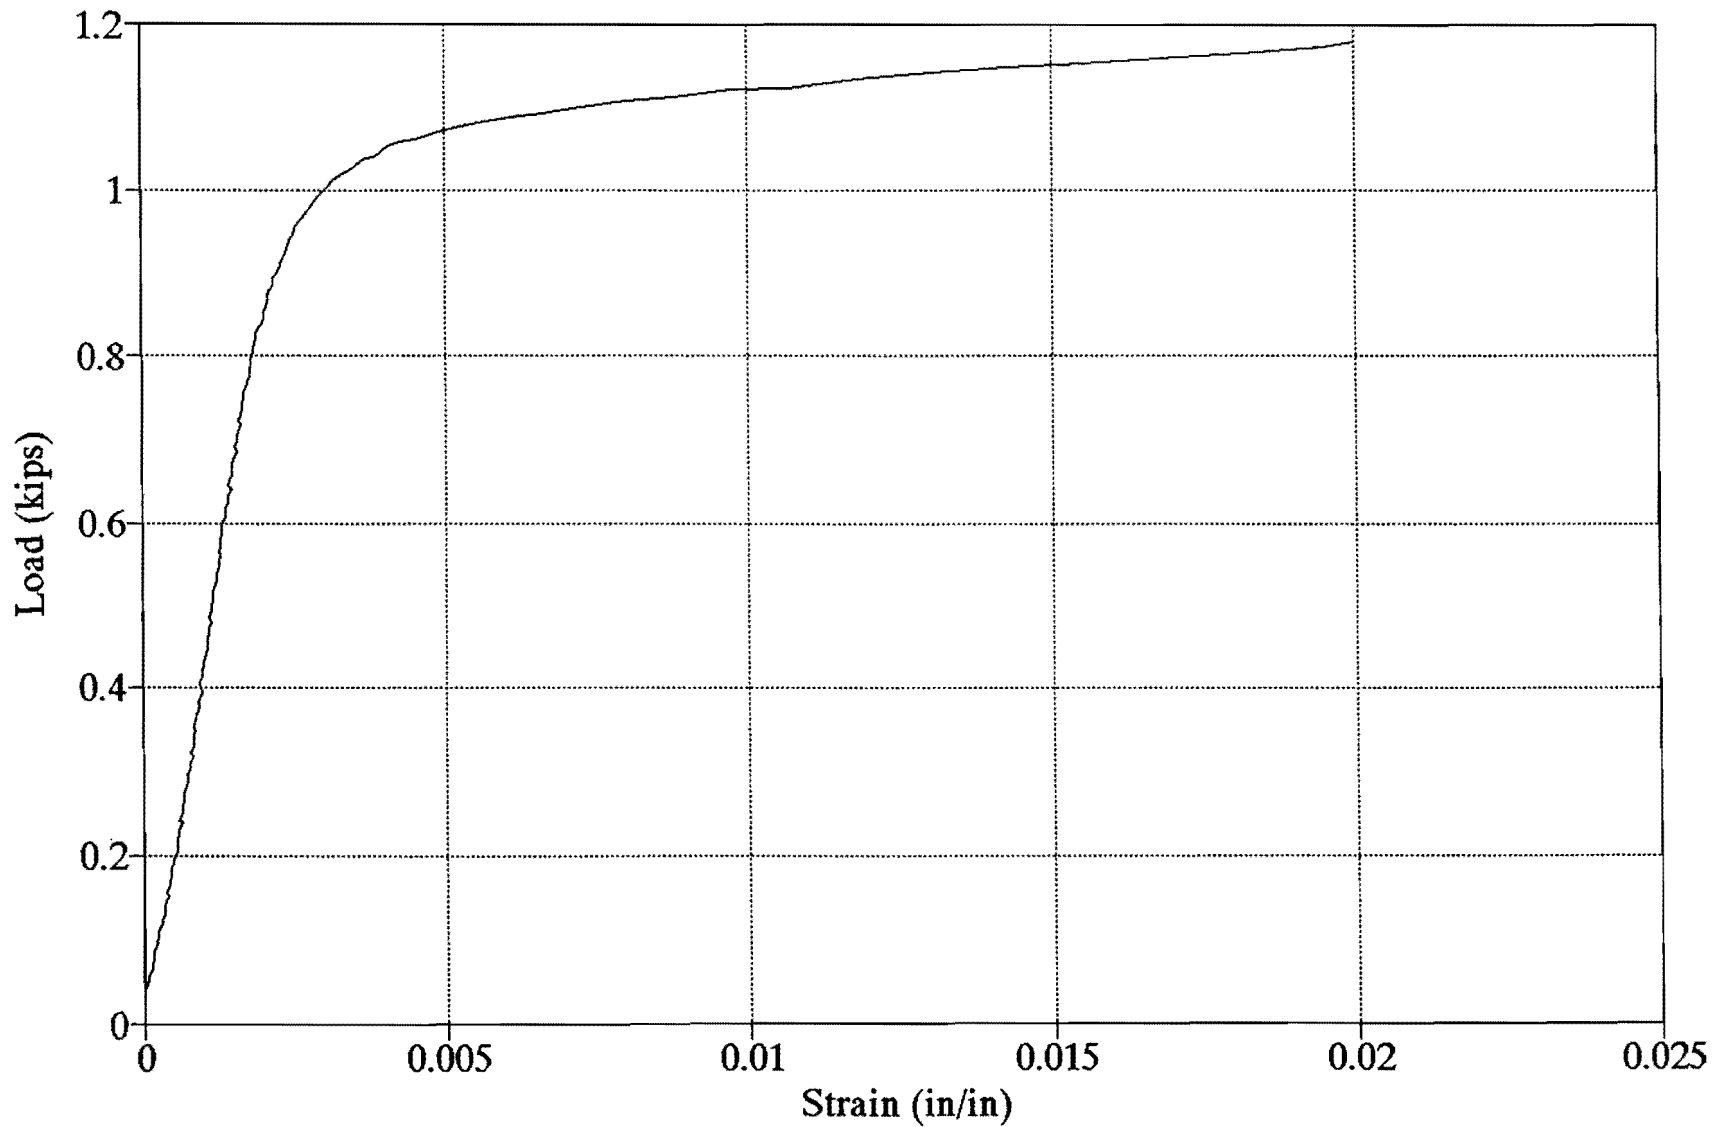
TENSILE COUPON TEST 1219-4B  
0.065" x 3.0" 1018 Steel Tube

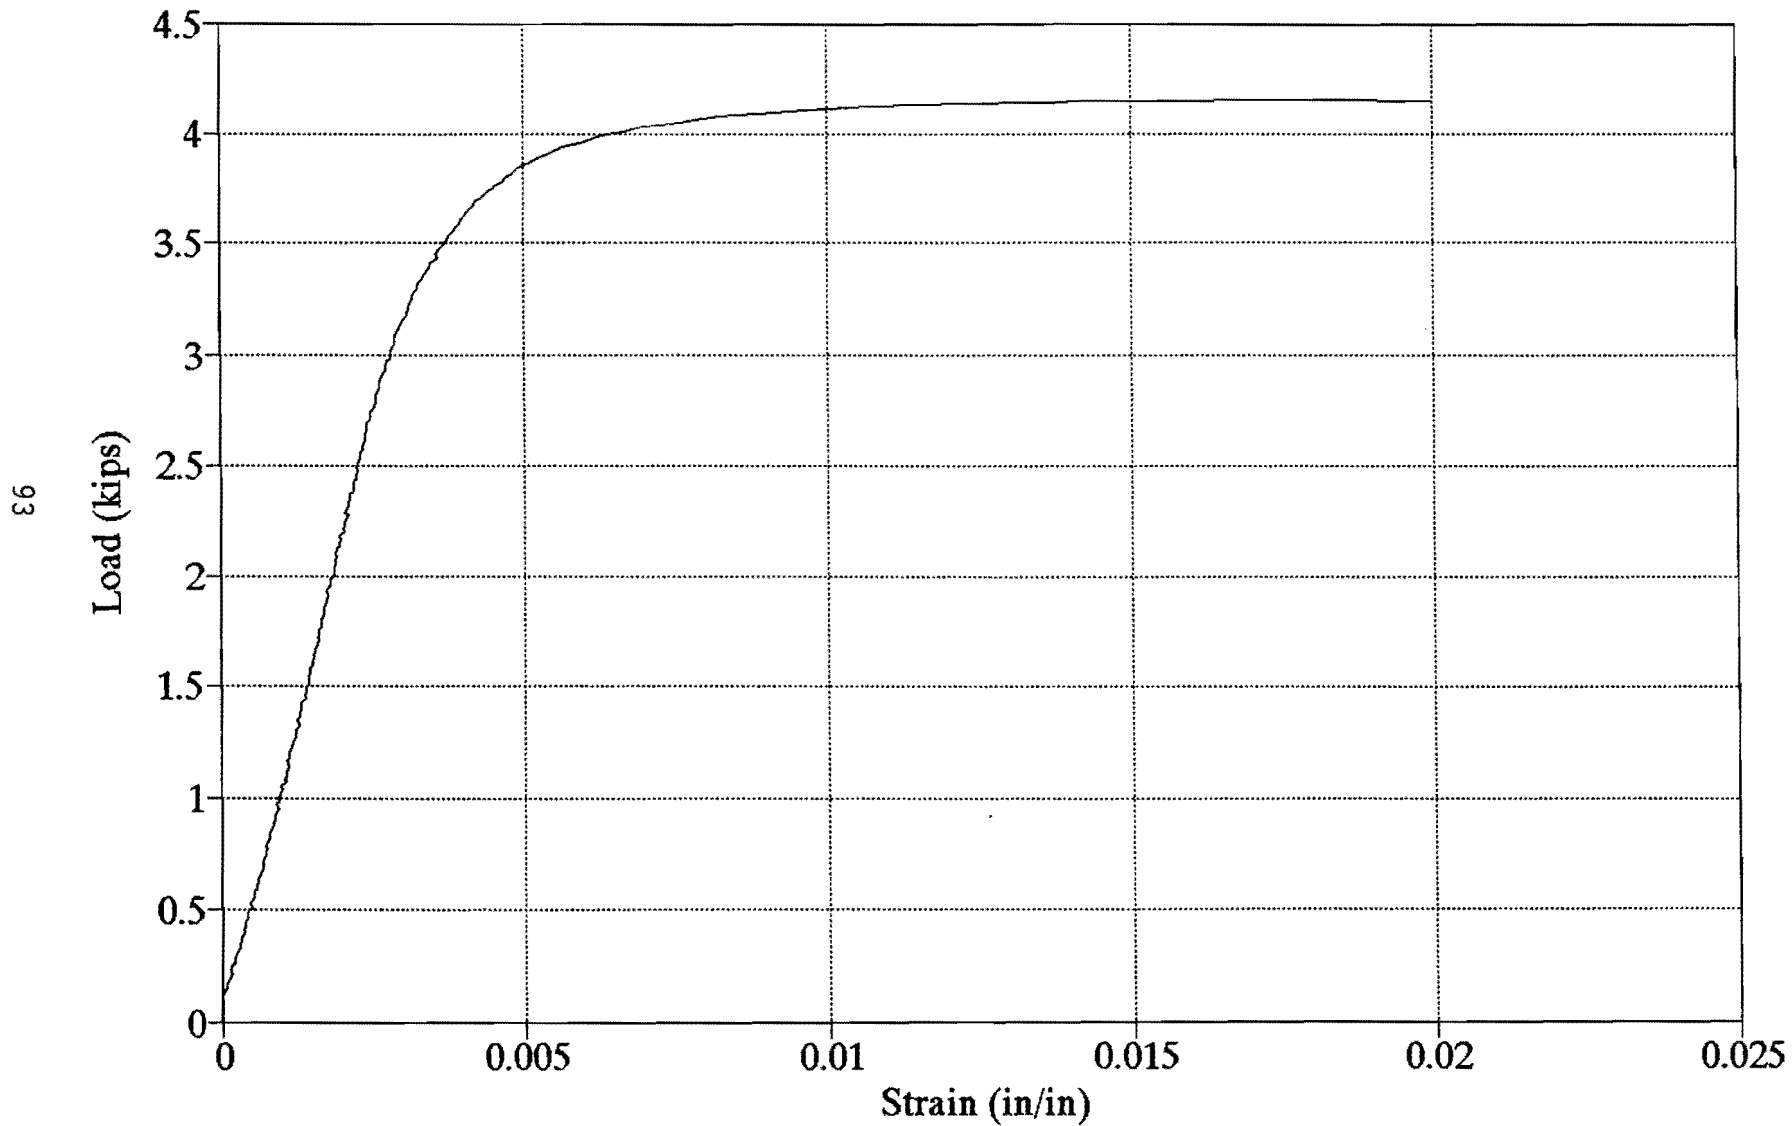
TENSILE COUPON TEST 1219-5B  
0.095" x 3.0" 1026 DOM Steel Tube

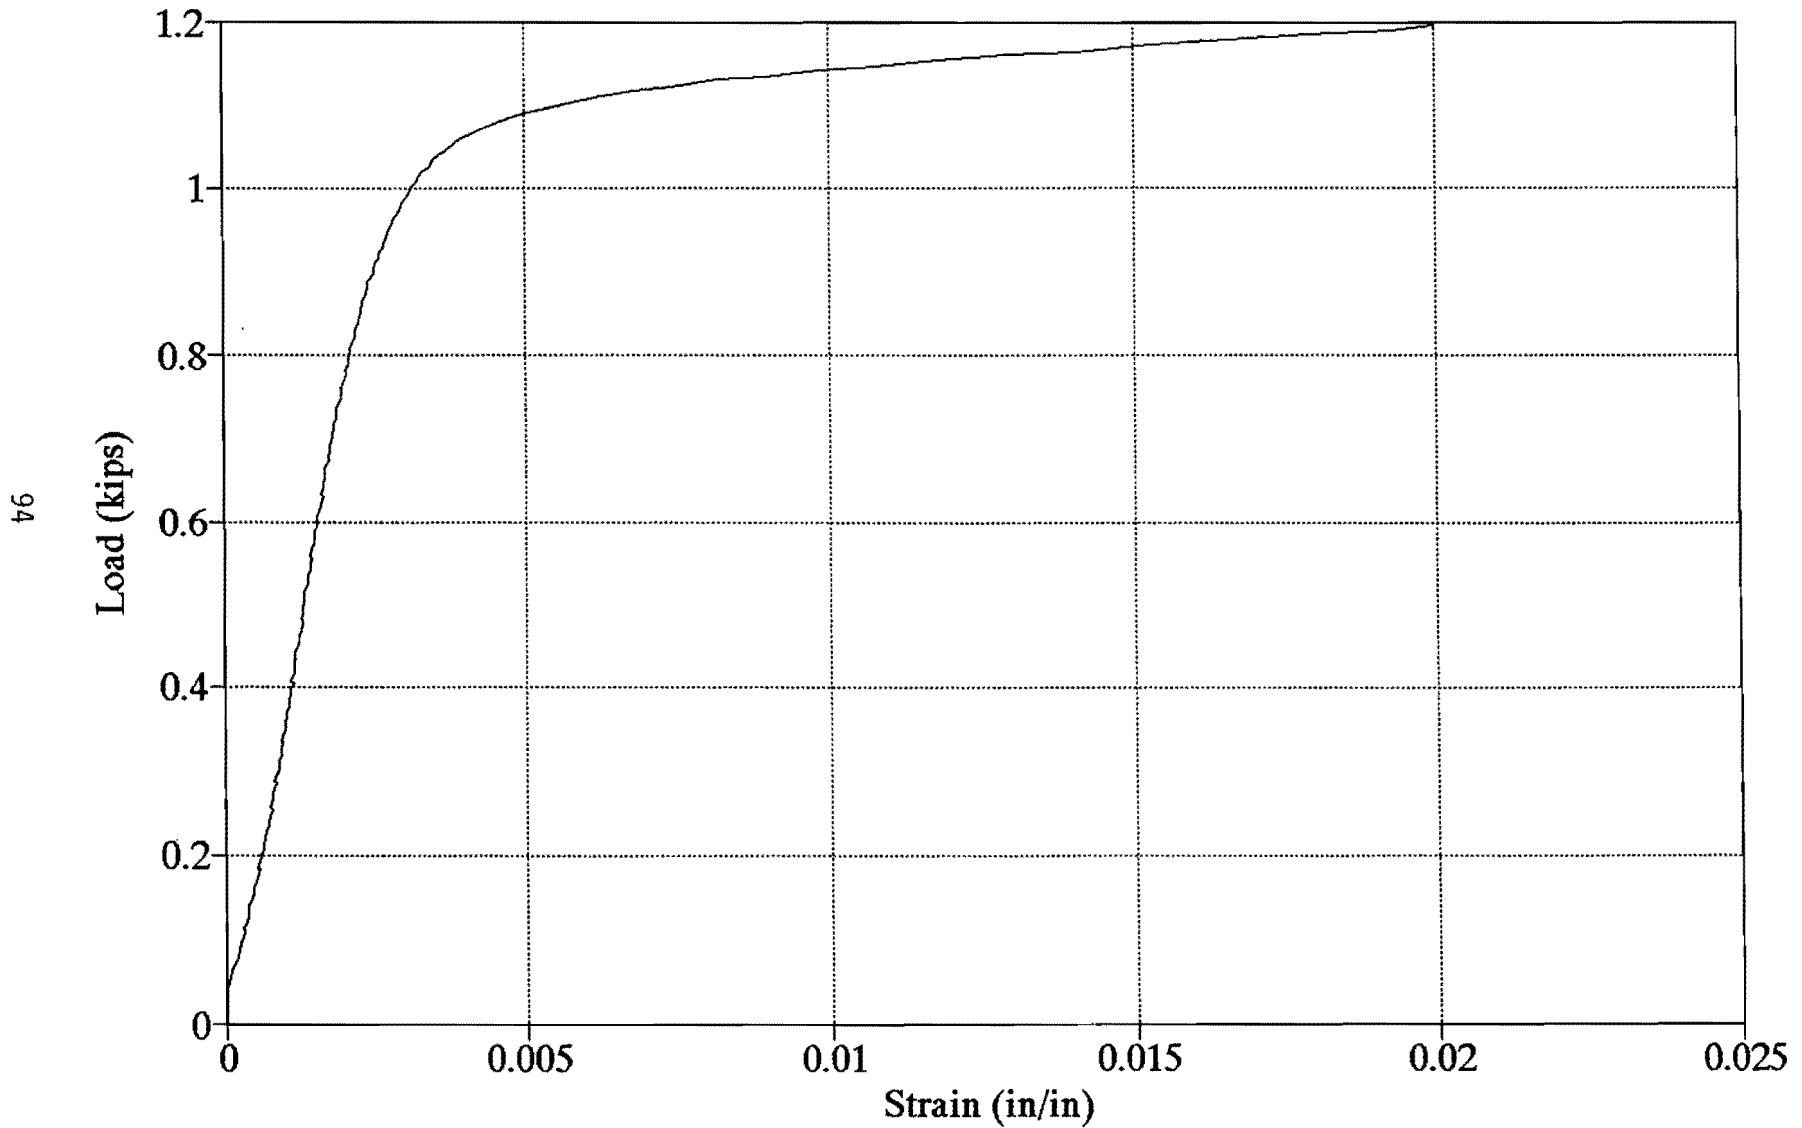
TENSILE COUPON TEST 1219-6A  
0.065" x 3.0" 1018 Steel Tube
