USDOT Tier 1  
University Transportation Center  
on Improving Rail Transportation  
Infrastructure Sustainability and Durability

Final Report VT-6

**METHODS FOR QUALITATIVE AND QUANTITATIVE MEASUREMENT OF TOP  
OF RAIL FRICTION MODIFIERS (TORFM) IN REVENUE SERVICE**

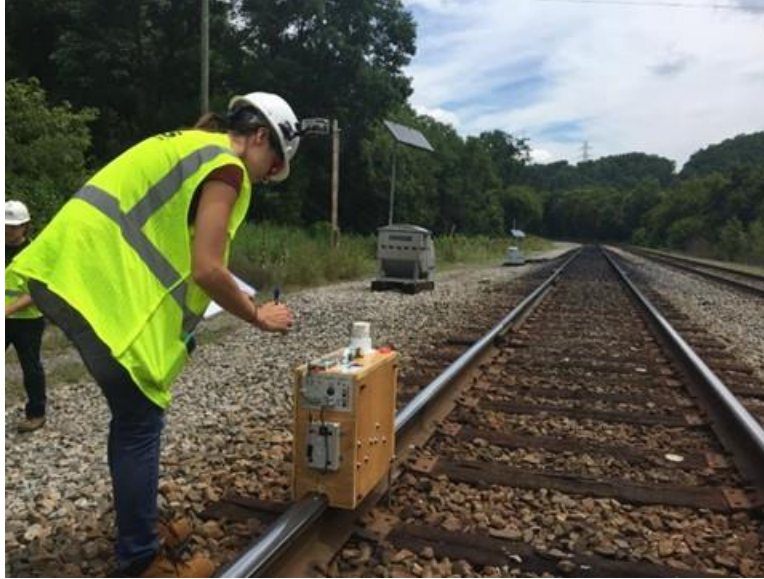
Figure 3-2: Second Generation Rail Lubricity Sensor in operation during field testing [31]

The results of this indicated that optical detection methods were successful but a more advanced and custom sensor would significantly aid in creating metrics for evaluating rail lubricity. In response, the second generation Rail Lubricity Sensor was constructed with multiple optical detectors at different angles. At the time of its design and construction, the instrument was designed to be used for hand held spot checks at intervals down track from a wayside applicator. The user would approach the track and place the unit on the tracks. The box would be rotated around the rail head while monitoring a readout of the specular refraction channel. When the signal maximum was found, this orientation was assumed to be normal to the rail surface normal as the specular reflection would be maximum when perfectly aligned. At this point an optical reading would be captured, the box would then be switched off and moved to the next check point. For this phase of testing, it was also possible to clean the rail surface to get and compare a clean and field condition for that section of rail [31].

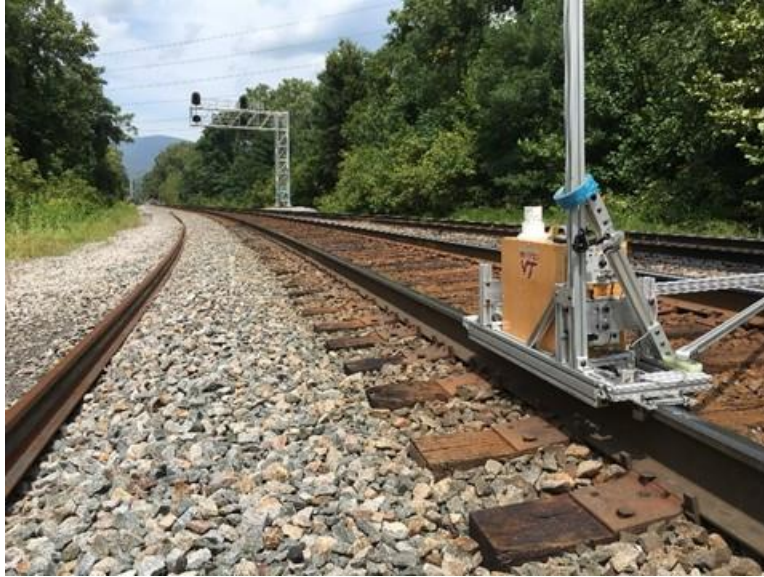
Figure 3-3: Second Generation Lubricity Assessment System in operation during moving field testing [4]

It was decided that continuous moving data along the track would provide more detailed information and a much higher resolution to the actual lubricity content and carry distance down track. To this end, the second generation Rail Lubricity Sensor was mounted onto a rail push cart. The push cart featured wheels designed to clamp to the rail head to remove lateral variation from the sensor position. The wheels were also located such that they minimized their contact with the point of interest on the running band of the rail head. This was to avoid disturbing the track condition while taking measurements to the greatest extent possible. A tachometer was added to the cart and connected to the data acquisition unit (DAQ) on the Rail Lubricity Sensor. It is worth noting that while the moving data is sometimes referred to as “continuous” this is somewhat of a misnomer since the data is sampled at a discrete frequency by the DAQ and then further delineated by each tachometer pulse, or tach, of the wheel to determine distance. This cart was used for two field tests in the summer of 2018 and began the basis for all of the dynamic field testing moving forward [4].

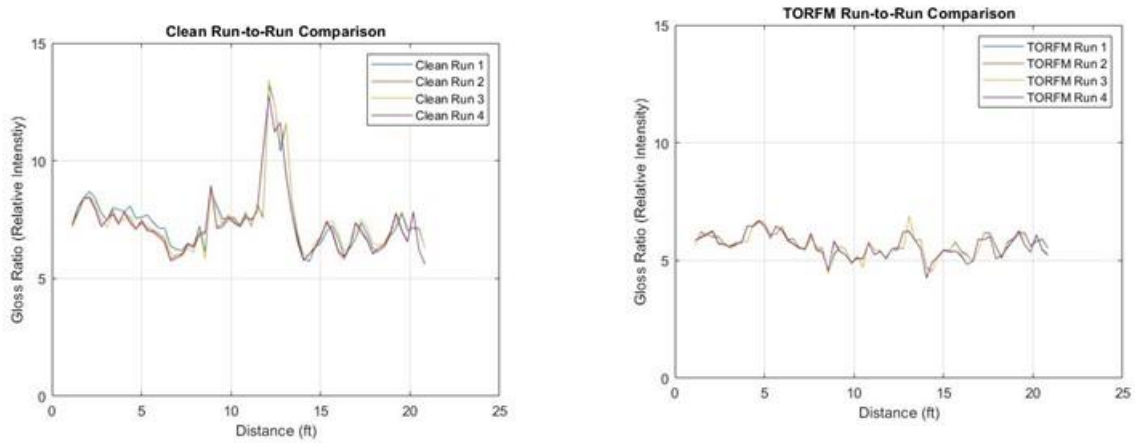
Figure 3-15: Run-to-run repeatability evaluation for clean and lubricated condition

from one clean condition to the next. This shows that the cleaning process is consistent and repeatable and the sensor is likewise repeatable.

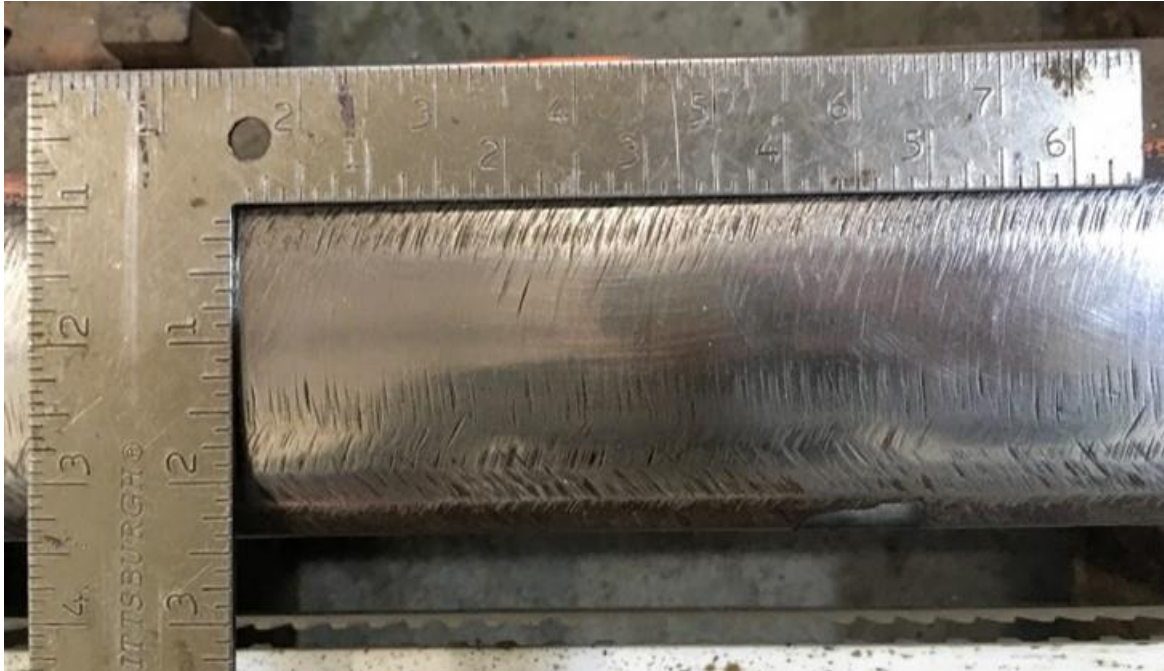
Figure 5-2: Top-of-Rail Surface roughness of RTL track panel

Small localized spikes in the optical channels are prevalent as the rail surface is not a uniform, smooth surface. The rail surface is very stochastic with a high amount of surface imperfections. Different angled cracks in the rail surface can sharply change the scattered power for a single sample and surface glints are common during measurements on rail surfaces. Some of these surface features can be easily visible by the human eye and some of the cracks and facets will require a microscopic view of the specimen. Because all of these features are far below the -20 dB cutoff period of 3.73 feet, the majority of the effects of these high frequency, low period effects should be strongly attenuated by the moving average filter.

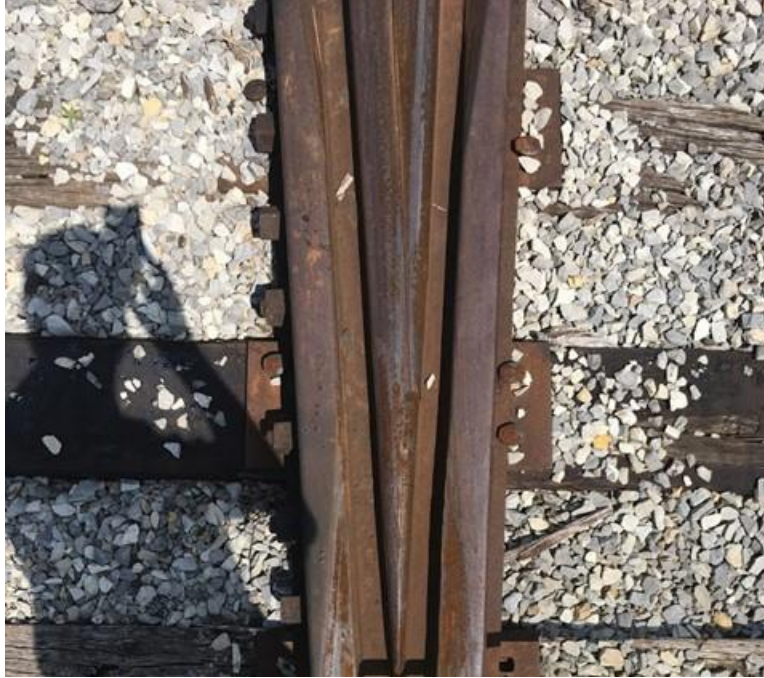
Figure 5-8: Example of a switch frog

Near MP 1.2, there are a few dips in the gloss ratio on the right hand rail. At this spot there is a signal and a switch to the passing siding at Riverside. The right hand rail passes through a switch frog which allows for the diverging rails to cross and the trains to navigate from one track to the other. When the sensor goes over the switch frog, it is exposed to the rough oxidized steel surface of the frog and the gloss ratio drops for a short distance. With access to track data, it is easy to identify these anomalies and disregard the local effects caused by them.

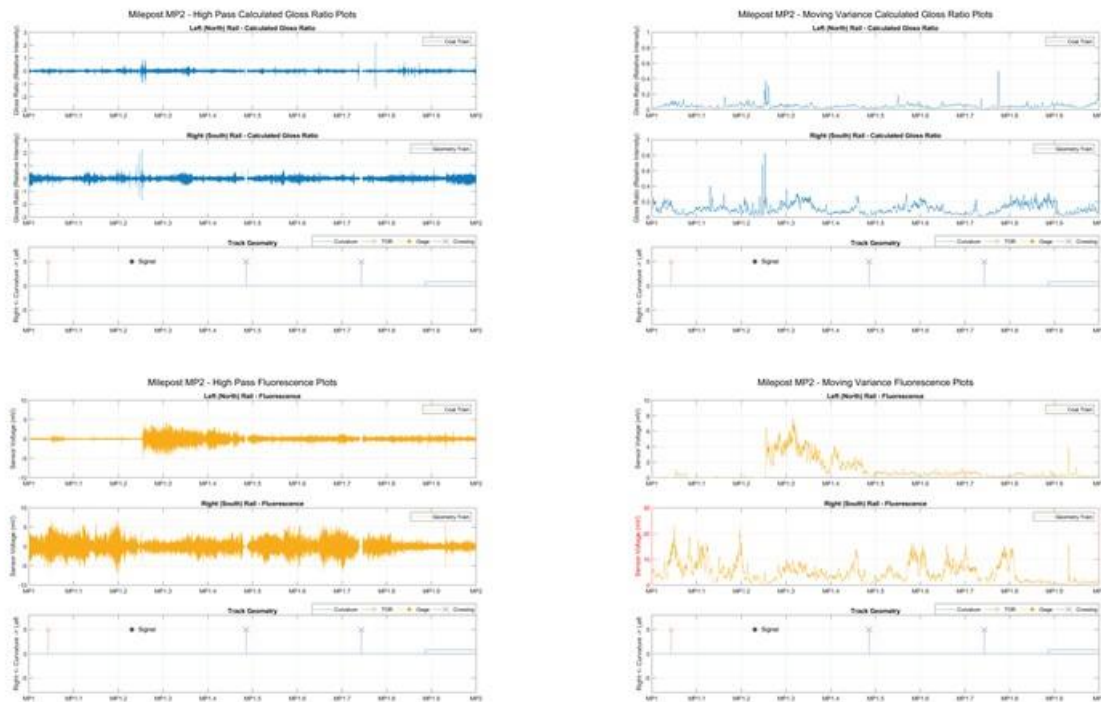
Figure 5-34: High Pass Filtered and Moving Variance Plots for Milepost 2

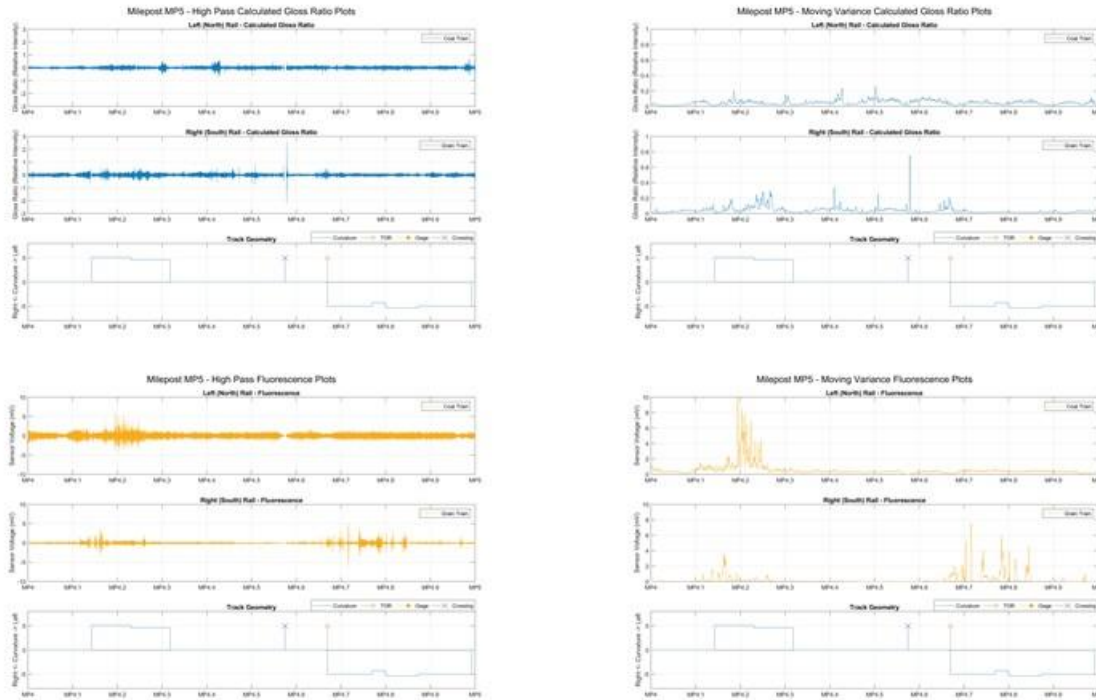
Figure 5-37: High Pass Filtered and Moving Variance Plots for Milepost 5
