# **Friction Restoration of Pavements with Polished Aggregates**

**Study SD90-16  
Final Report**

**Prepared by  
South Dakota Department of Transportation  
Office of Research  
700 East Broadway Avenue  
Pierre, SD 57501-2586**

**January, 1996**

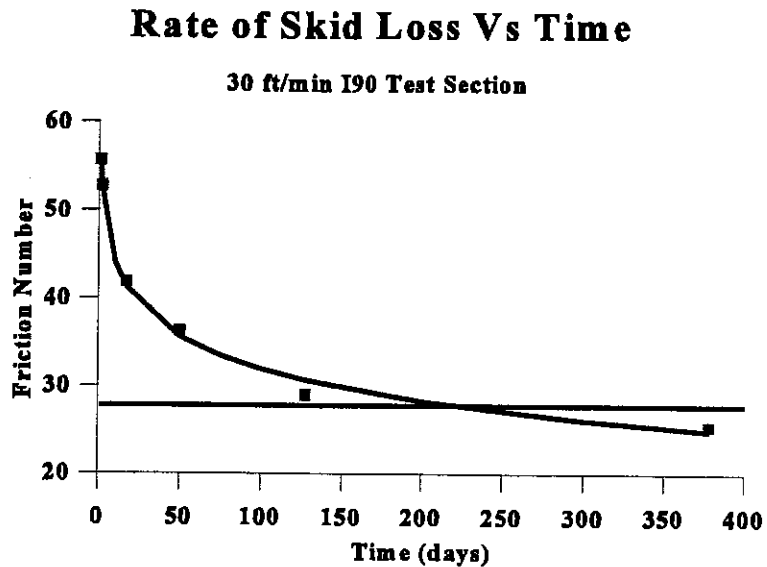
Figure 3: Rate of Skid Loss

occurrence and the pavement was unable to retain the microtexture necessary for adequate skid resistance. Friction values decayed exponentially with respect to time. Table II shows the fairly rapid loss in skid resistance over the first year after treatment and Figure 3 illustrates a typical friction decay curve for the test section treated at 30 feet/minute. All of the test sections lost skid resistance in a similar way but at varying rates. The general equation used to fit these curves was:

$$\text{Friction Number} = \alpha + \beta \ln(\text{Time})$$
