Design and Operational Assessment of a Railroad Track Robot for Railcar Undercarriage Condition Inspection

James Kasch and Mehdi Ahmadian *

Railway Technologies Laboratory (RTL), Center for Vehicle Systems and Safety (CVeSS), Virginia Polytechnic Institute and State University, Blacksburg, VA 24060, USA; jamesk18@vt.edu

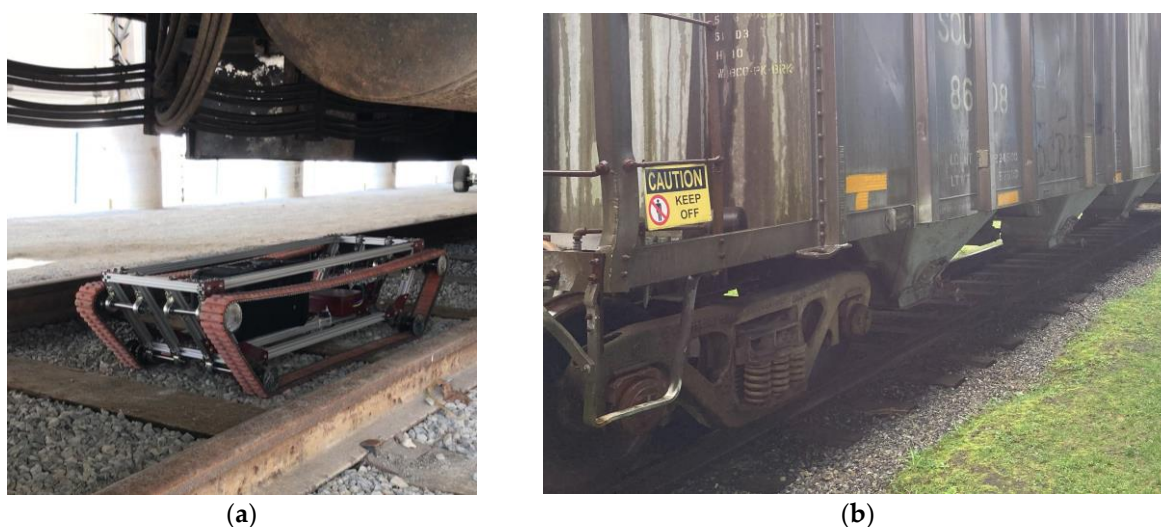
Figure 2. (a) The TCR operating on the track bed beneath a railcar; (b) A hopper railcar illustrating the low height of the gates above the track bed.

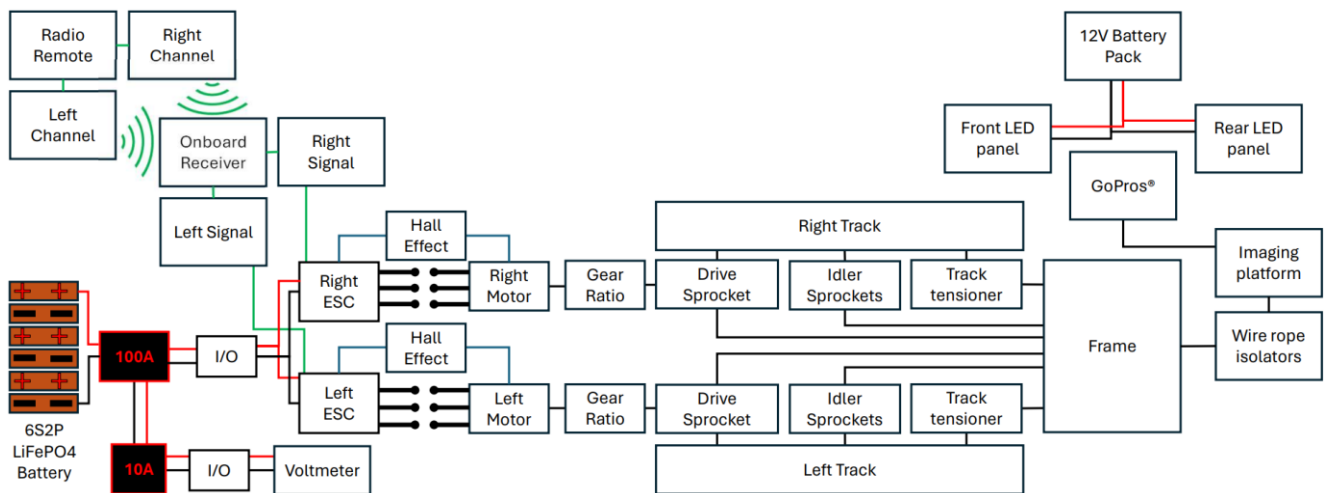
Figure 3. Box diagram showing the major components of the TCR and their relations.

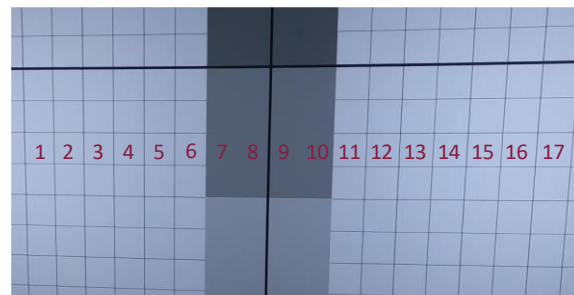
Figure 7 demonstrates that a maximum of 17 grids (430 mm) could be imaged at this height, representing only 30% of the required 1435 mm width to image the full undercarriage.

Figure 7. Existing field of view (FOV) evaluation image demonstrating an ability to image only 17 grids (430 mm) at the minimum height.

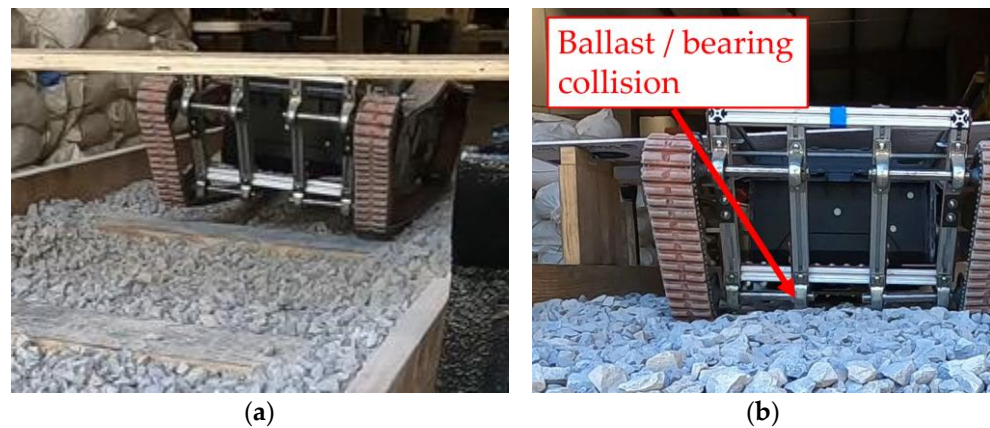
The TCR was driven across the Test Bed at different speeds. Its performance was evaluated using video footage. At speeds below 4.8 km/h, the TCR was observed colliding with the edges of the ties, but the collisions did not appear significant, with a few causing the front end of the TCR to become slightly airborne. However, at 6.8 km/h, the TCR was violently jolted by collisions with ties, and the front end became significantly airborne. A frame from the video is shown in Figure 9a. The difficulty of controlling the TCR through feedforward methods was also revealed during the testing, as the varied terrain made maintaining the speed very difficult. Lastly, video from a camera placed at the end of the Test Bed showed that the undercarriage bearing housings were exposed to impacts from the ballast, Figure 9b. Inspection revealed that these components all had signs of being

impacted, and a few of the bearing housings had become deformed and no longer fixed the bearings and axles in place.

Figure 9. Test Bed evaluation results: (a) Sharp collision during the 6.8 km/h test, causing the front end of the TCR to become airborne; (b) Impact between the ballast and bearing housing.

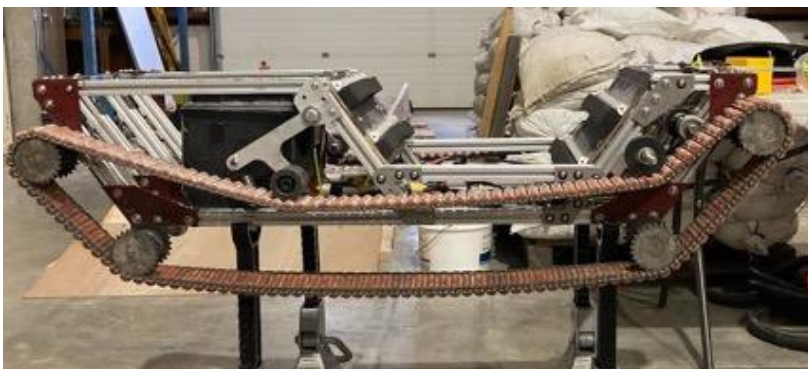
To modify the frame according to this redesign, the topmost frame members were cut into two pieces, and the new frame members were installed using custom-cut aluminum brackets, Figure 16a. The light strip panels were installed onto the surface of the transverse frame members to locate them in a similar position. Lastly, one of the vertically oriented cameras was removed and replaced by two additional cameras, angled toward the left and right sides, Figure 16b.

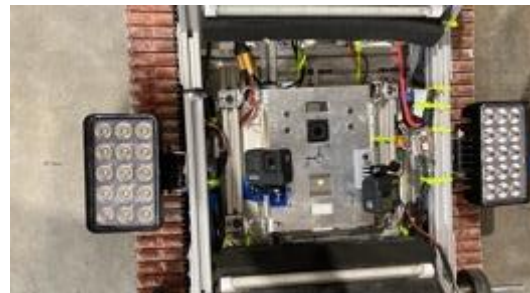
Figure 17. Initial configuration of the additional light bars.

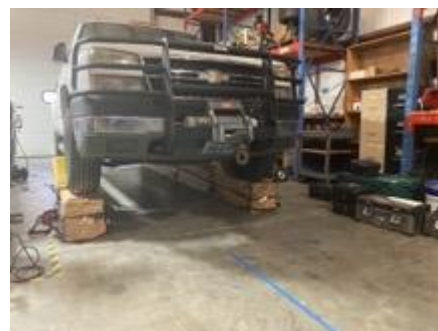
To complete this test, a pickup truck undercarriage was used to approximate the railcar undercarriage. The pickup truck was driven onto 30.5 cm (1 ft.) blocks over an indoor concrete floor to simulate the approximate height and width of typical rolling stock undercarriage components, Figure 23a. Imaging data was taken from all three cameras while the TCR traveled at 4 km/h, and the diffusive coverings were placed over the light bars as shown in Figure 23b. The resulting images were analyzed for adverse lighting effects such as dim areas and glare to draw conclusions about the effectiveness of each diffusive covering.

Figure 23. Under-truck testing setup: (a) Pickup truck placed on 30.5 cm high blocks; (b) A sample diffusive covering, two layers of wax paper.

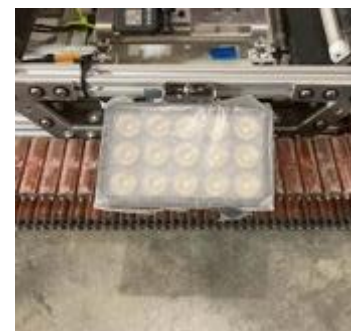
(b)

Control	N/A
Covering 1	2 layers of wax paper
Covering 2	Frosted plexiglass
Covering 3	Combination of wax paper and plexiglass

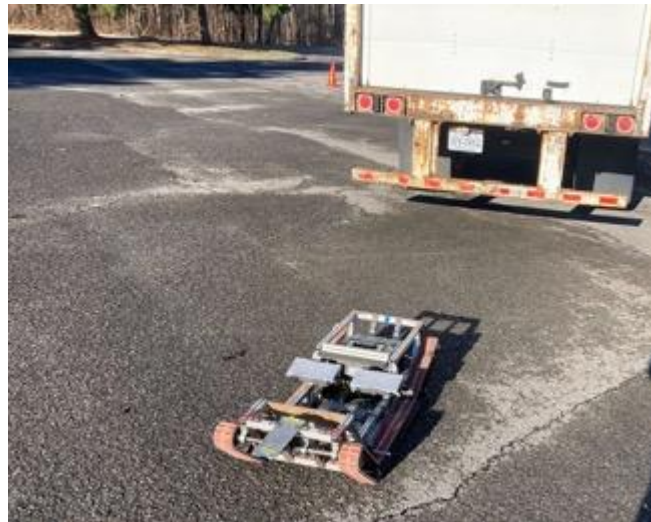
speed. The combination of wax paper and plexiglass was used for diffusion. Additionally, before this testing, the light bars were relocated to be mounted to the frame’s interior just forward of the imaging platform. This was performed to mount the light bars in a location where they were shielded by the frame of the TCR rather than exposed on the sides. For these tests, they were oriented vertically, Figure 24. The TCR was placed a short distance behind the trailer. This allowed the TCR to reach testing speed before traversing beneath the trailer. A step input was applied to command the testing speed, and manual steering inputs were applied by the operator to account for any deviations from the desired course. Videos were recorded from all three onboard cameras.

Figure 24. The setup for under-trailer testing. The light bars were relocated to the front transverse frame member and oriented vertically.

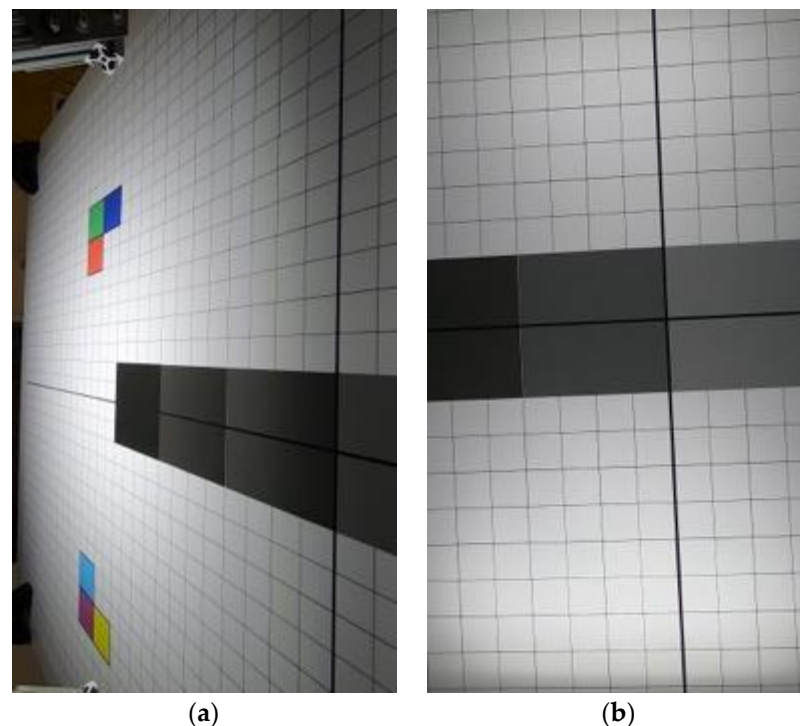
After the modifications to the frame, track routing, and camera configuration, the tests indicate that the TCR is capable of imaging a full rolling stock undercarriage in a single pass. Figure 25 shows that the left camera angle can image the far edge of the 1520 mm wide poster mounted at 380 mm while also overlapping with the FOV of the vertically oriented camera. This result demonstrates that the FOV now spans the entire 1435 mm width at 380 mm, and the TCR's FOV has been increased from just 30% of the required to 100% while still using the linear digital lens. Therefore, without any image distortion, the TCR will be able to provide an image of the entire railcar undercarriage. This capability is crucial to the development of the TCR, as the risk of not imaging a defect that should be visible from the undercarriage is greatly reduced.

Figure 25. FOV validation results show the ability to image from the center to the far edge of the 1520 mm poster: (a) Left view; (b) Vertical view.

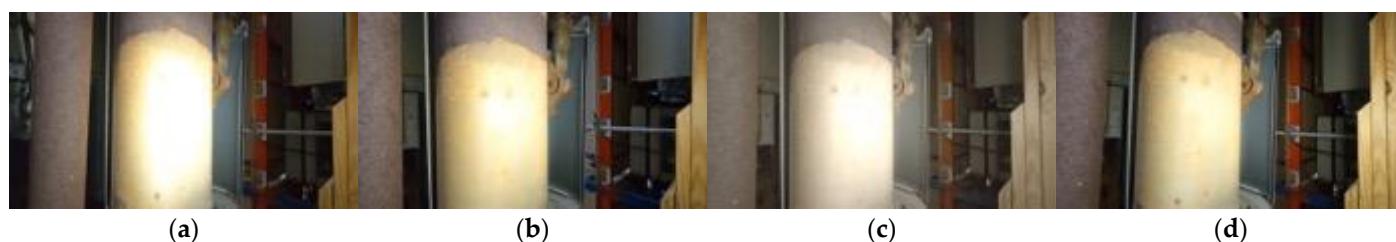
Results from diffusion method testing under the pickup truck show that diffusers aid in reducing the intensity and presence of harsh reflections, Figure 26. The combination of frosted plexiglass with two layers of wax paper does so most effectively and nearly eliminates pixel saturation in the case of the muffler, Figure 26d. The added diffusion provides more light to the outer reaches of the FOV and helps to prevent the camera from reducing its sensitivity in response to bright reflections, causing a two-fold increase in image quality. Additionally, the overall intensity of the light is not significantly reduced by the diffusive coverings, Figure 27. Therefore, diffusers were included in the TCR design, and for the remainder of the imaging tests, a combination of frosted plexiglass and two layers of wax paper was installed. Areas of glare are still possible in this configuration; however, the effect is mostly limited to close-up, reflective objects, such as the axle in Figure 28a.

Figure 26. Comparison of diffusion methods on glare reduction from mufflers: (a) No diffusers; (b) Wax paper; (c) Plexiglass only*; (d) Plexiglass and wax paper. * Different color settings were used in other tests.

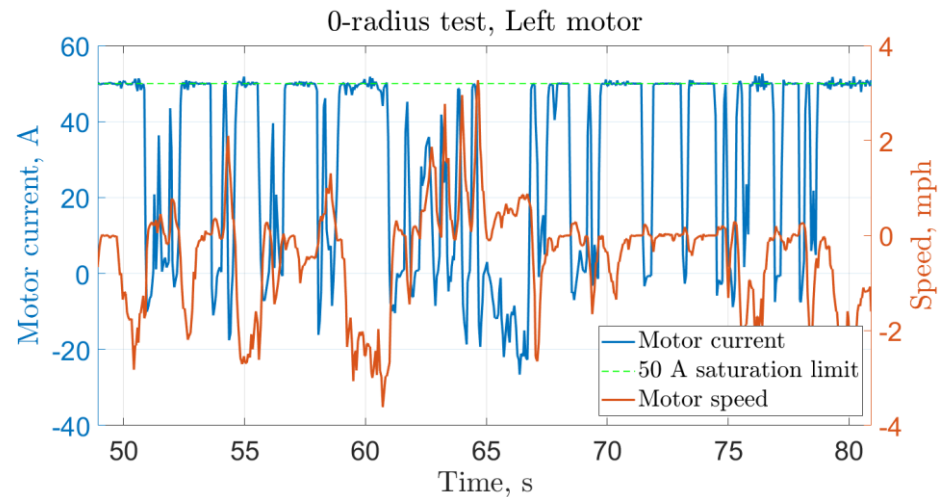
torque [45], and the limiting factor for maximum continuous current is the ESC itself, which recommends a maximum value of 50 A while the motors are capable of 80 A each. This maximum current could potentially be increased if it can be shown that operation at a higher value does not cause overheating within the ESC. The ESCs' operating conditions, being exposed to ambient air and mounted onto a moving platform, create the potential for effective convective heat transfer, allowing for operation at higher current values. Future work could include temperature data collection at currents higher than 50 A in normal operating conditions to investigate the thermal response and determine if more power can be safely applied.

Figure 29. Current and speed data collected from the left motor during the 0-radius test showed periods of stalling and spikes in speed, indicating slippage.

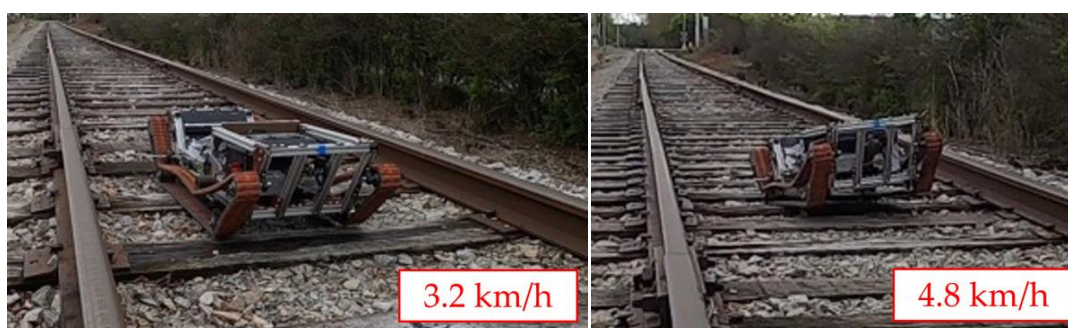
The footage from the constant speed tests shows that the TCR traverses smoothly over the ties at 1.6 km/h while the front was occasionally knocked slightly airborne during the 3.2 km/h test; however, the TCR was consistently and violently knocked airborne during the 4.8 km/h test, Figure 30. The conditions in the track bed appear slightly rougher than those in the Test Bed, as significant collisions were not observed until 6.8 km/h over the Test Bed. With the TCR's rigid construction, these collisions impart large shock loads to the TCR, which could be detrimental to its reliability over time. The TCR remains uncontrollable while it is airborne.

Figure 30. Track bed testing results compare the impacts experienced at 3.2 km/h (left) and 4.8 km/h (right).

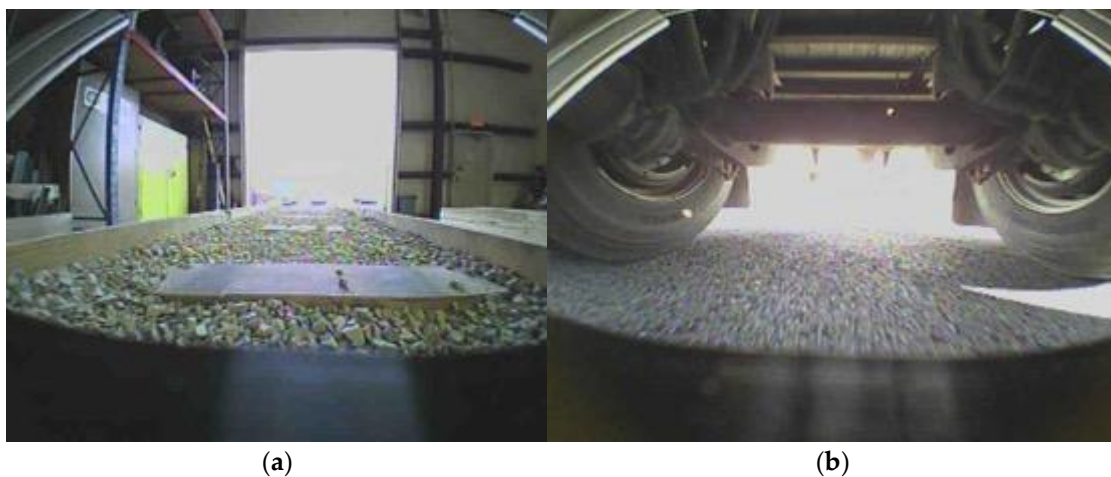
Feedback from the FPV system was used to control the TCR on the Test Bed without contacting the sides of the bed at speeds up to 4.8 km/h, Figure 32a. This test qualitatively demonstrates that the FPV system operates with low enough latency to be sufficient for feedback even when large disturbances are present. Additionally, it shows that high vibrations do not degrade imaging performance to the point of becoming uncontrollable.

Tests conducted up to 9.6 km/h beneath the trailer indicate the FPV system’s ability to operate in similar lighting conditions as seen beneath the railcars. The FPV camera effectively altered its sensitivity to provide a clear image while both beneath the trailer and the sky; although, as expected, periods of saturation or dimness occurred when transitioning from dim to bright (Figure 32b) and vice versa, respectively. However, the length of these transitions was relatively short, and the TCR was still able to be controlled at twice the speed that will be seen in the track bed, effectively showing that lighting conditions will not significantly hinder controllability beneath the railcar and that the latency inherent to the system is sufficiently low not to be a limiting factor. Therefore, the FPV system is adequate for supplying an operator with constant feedback sufficient for control of the TCR in the track bed.

Figure 32. FPV testing results: (a) 4.8 km/h test over Test Bed showing the ability to operate in high vibratory conditions; (b) 9.6 km/h under the trailer showing a dark to light transition.
