Final Report

# Inspection of Flexible Filler Tendons

Embry-Riddle Aeronautical University

Florida Department of Transportation

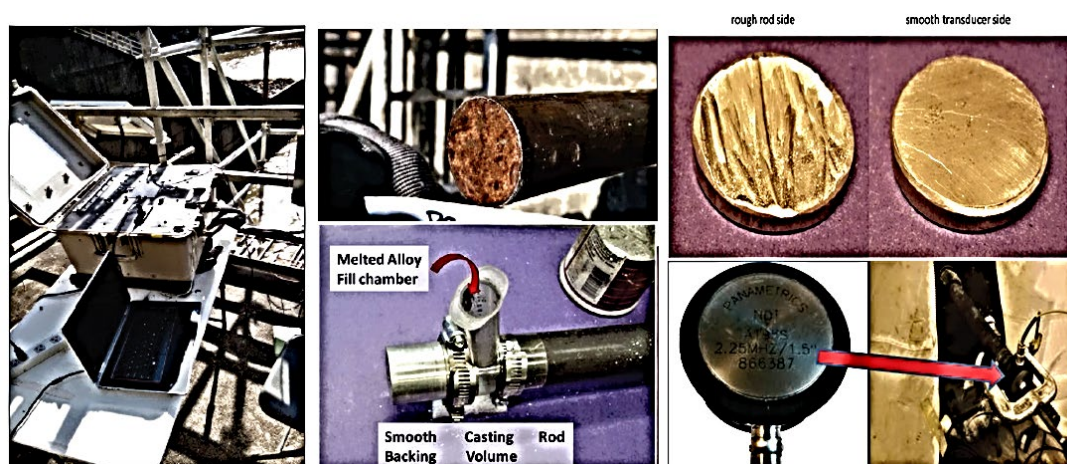
Figure 22. Data acquisition and transducer setup for GWUT of post-tensioned trunnion rods.<sup>13</sup>

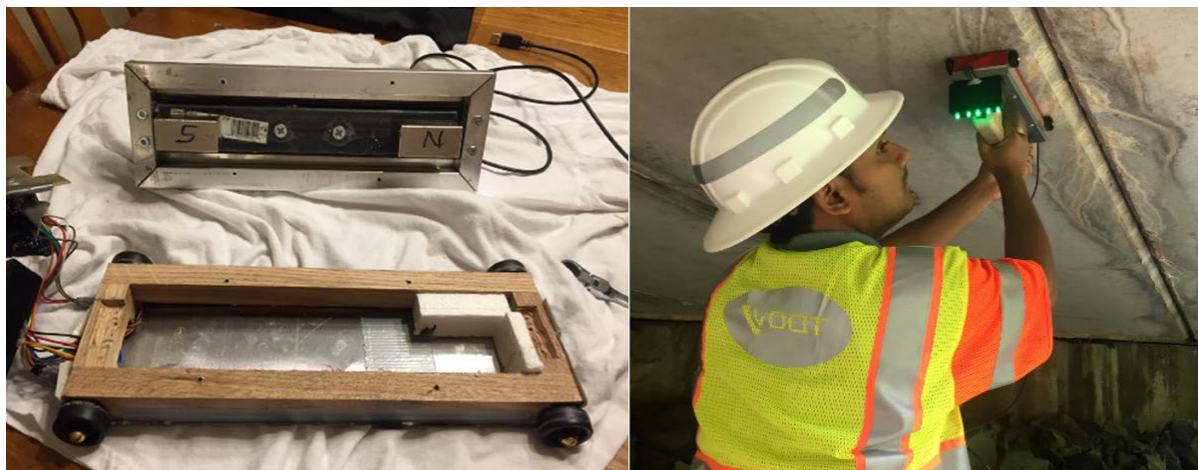
*Figure 28. MFL device for corrosion detection in traditional prestressed (pre-tensioned) concrete box girders<sup>28</sup>*

concrete Figure 28. The device operates using a color-coded LED system where green lights indicate sound prestressing strands and yellow lights indicate potential areas of concern.

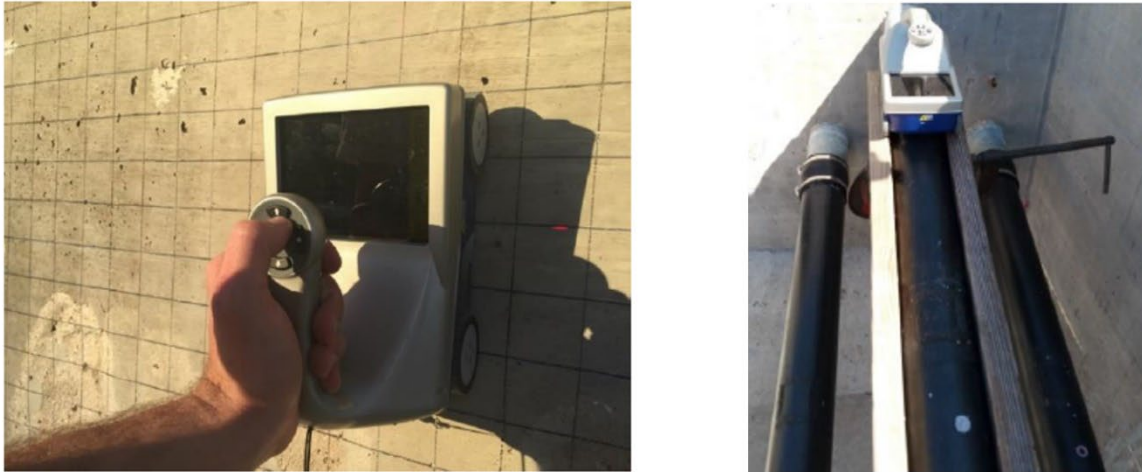
*Figure 29. StructureScan Mini HR GPR unit inspecting concrete and the external tendons (Hurlebaus et al. <sup>15</sup>)*

depth up to 16". This set up can be seen below (Figure 29). Due to the size of the PT girder specimen, it was divided up into several sections to allow for full coverage. To scan the external duct, wooden supports were added along the side to account for the circular shape to ensure the results were accurate (which can also be seen below).

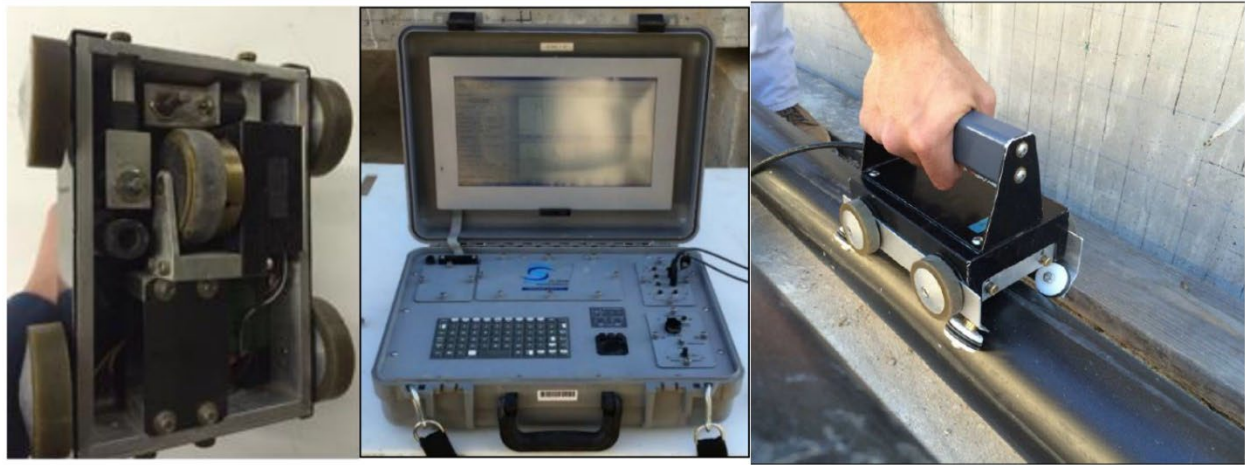
Figure 40. IE scanner test head, the PC data acquisition platform, and the IE device in use on an external duct (Hurlebaus et al. <sup>15</sup>)

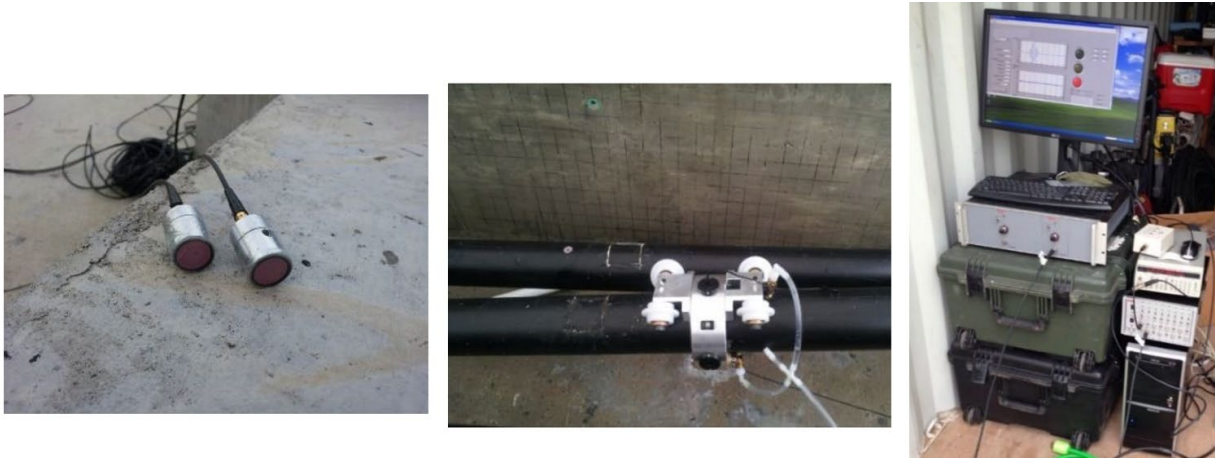
*Figure 44. Pulse transmitter and receiver, prototype scanning head with encoder and data acquisition system*

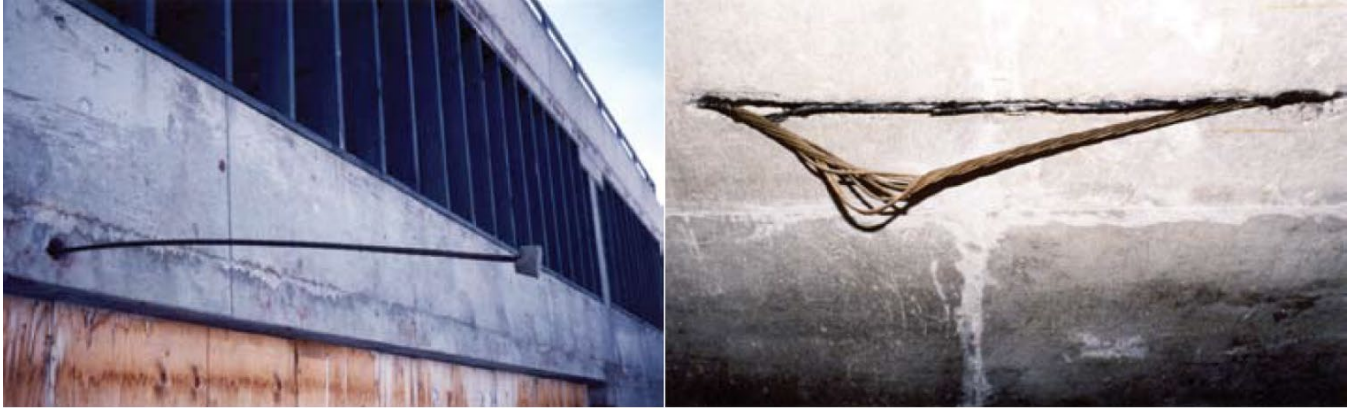
Figure 58. Erupted or ejected tendons from anchorage and slab soffit (Fallis et al. <sup>45</sup>)

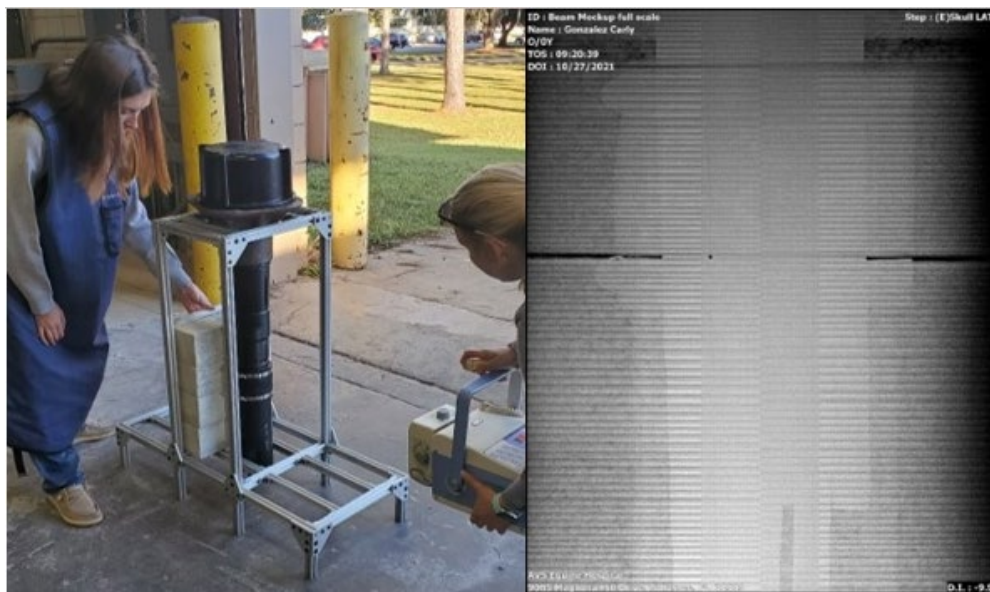
Figure 87. Anchorage mockup: duct results
