1. Report No. RailTEAM UD-4	2. Government Accession No.	3. Recipient's Catalog No.	
4. Title and Subtitle Analysis of Wheel Wear and Forecasting of Wheel Life for Transit Rail Operations		5. Report Date March 27, 2019

Final Report UD-4

**ANALYSIS OF WHEEL WEAR AND FORECASTING OF WHEEL LIFE FOR
TRANSIT RAIL OPERATIONS**

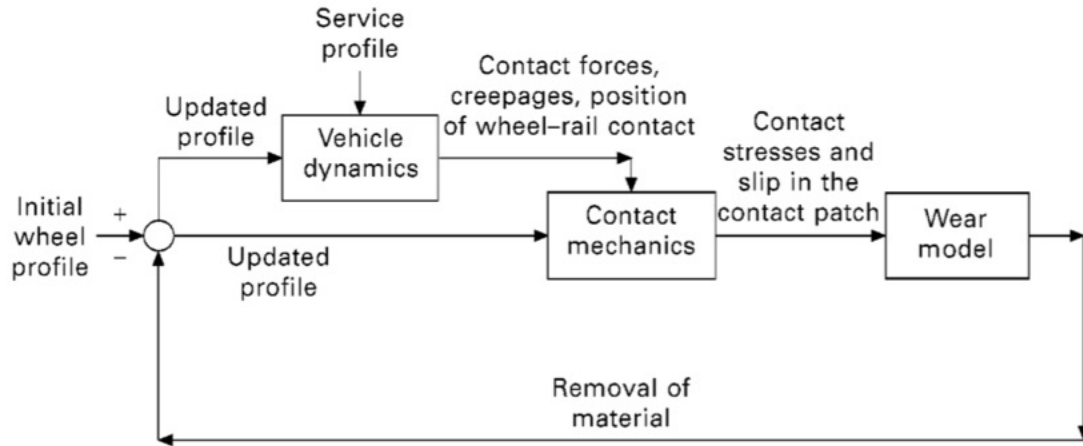
Figure 4 Wheel Wear Flowchart (Braghin, et al., 2009).

The flowchart presented in Figure 4 provides a general idea as to how wheels wear over time. It begins with an initial wheel profile, and considers how vehicle dynamics cause dynamic variations of wheel loads. Next, the effects of the various creepage and frictional forces, as well as the

migration and slipping of the contact patch, are considered. This information gives way to the determination of the shape, location, and size of the contact patch, as well as the distribution of the normal and tangential stresses within that patch. Finally, the normal and tangential stresses cause metal to be worn away in the tread and flange, and ultimately cause the aforementioned modification of wheel profile and causes maintenance process to form a natural loop. Unfortunately, the components that make up the loop are non-linear. This makes it difficult to predict how the process will evolve with time, and how the change of a single parameter, such as initial wheel profile, will impact the progression of wear (Braghin, et al., 2009).

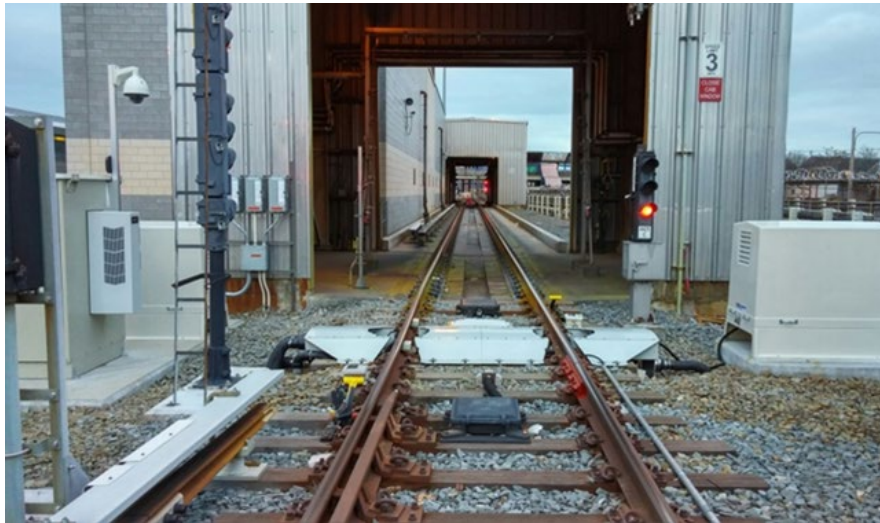
Figure 9 KLD automatic WheelScan located at the Corona Yard Car Wash (NYCTA).

One of the key new wayside instrumentation packages installed for this project was the Automatic WheelScan, provided by KLD Labs at the NYCTA car wash at Corona Yard, Queens, NY. The WheelScan is designed to monitor wheel profile and record digitized wheel condition data for each wheel that passes over it. For every wheel in the NYCTA 7 Line Fleet, the flange thickness, flange angle, flange height, rim thickness, wheel diameter, back of flange reading, and back to back gauge are measured. This, in turn, allows for accurate and timely monitoring of wheel profile conditions, based on NYCTA standards for wheel safety, maintenance, and replacement. In addition, this data allows for calculation of wheel wear rates and forecasting of projected wheel lives. This in turn allows for a more in-depth understanding and evaluation of current wheel maintenance procedures. The KLD Automatic WheelScan is shown in Figure 9.

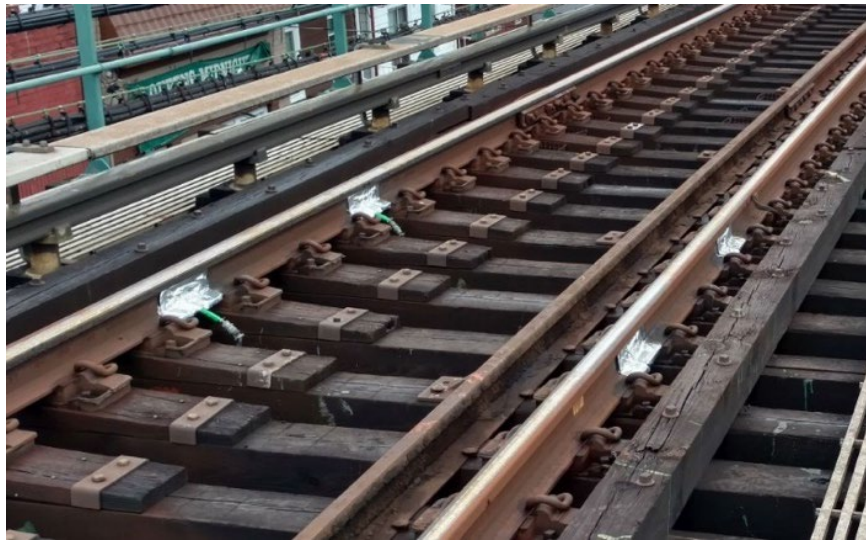
Figure 10 ISI L/V measurement system located north of 103rd street station (NYCTA).

lateral and vertical wheel/rail forces and calculated associated L/V ratios for every vehicle that passed over it, which included the entire 7 Line fleet. Excessively high L/V ratios are a cause for concern, as wheel climb derailments could occur. Thus, using the L/V system allows for better monitoring of wheel and rail performance, and identifies specific axles or bogies that may be at risk of derailment. In addition, the system allows for better monitoring of truck performance, and how it is affected by track maintenance activities like re-profiling, grinding, and lubrication. The ISI L/V Measurement System is shown in Figure 10.

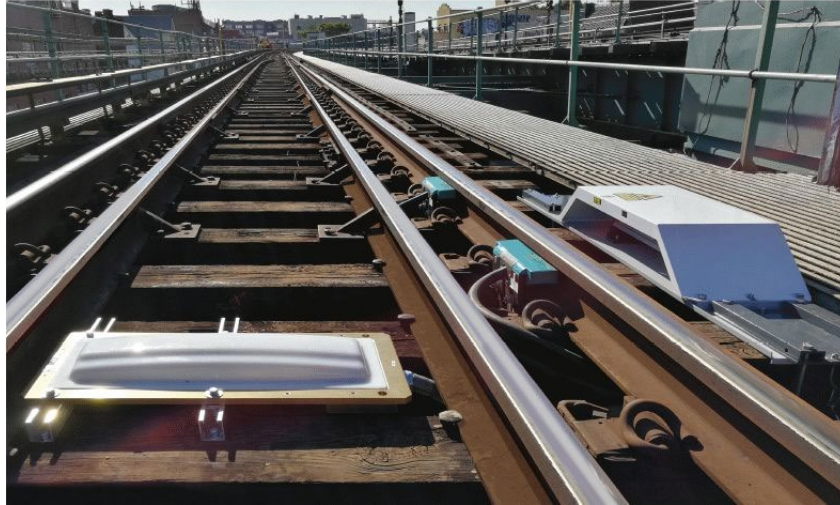
Figure 11 WID TBOGI site located north of 103rd Street station (NYCTA).

A companion wayside measurement system, also installed as part of this project was the TBOGI, as provided by WID, and located at the exit of a 3.2-degree curve just north of 103rd Street station. This wayside device was designed to measure key truck (bogie) characteristics and performance. Thus, for every truck that passes over the TBOGI, a set of key truck performance parameters are measured or calculated; most notably angle of attack and tracking position, but also inter-axle misalignment, rotation, shift, and tracking error. These parameters are used to help to identify bad acting trucks, to include any truck with curving performance issues, such as skewed axles, misaligned axles, or improper tracking. If left unattended, these issues can result in unsafe lateral load or L/V levels, as well as accelerated wheel and rail wear. In addition, these measurements can help characterize the wheel/rail interface, wheel and rail wear rates, and rolling resistance. The WID TBOGI is shown in Figure 11.

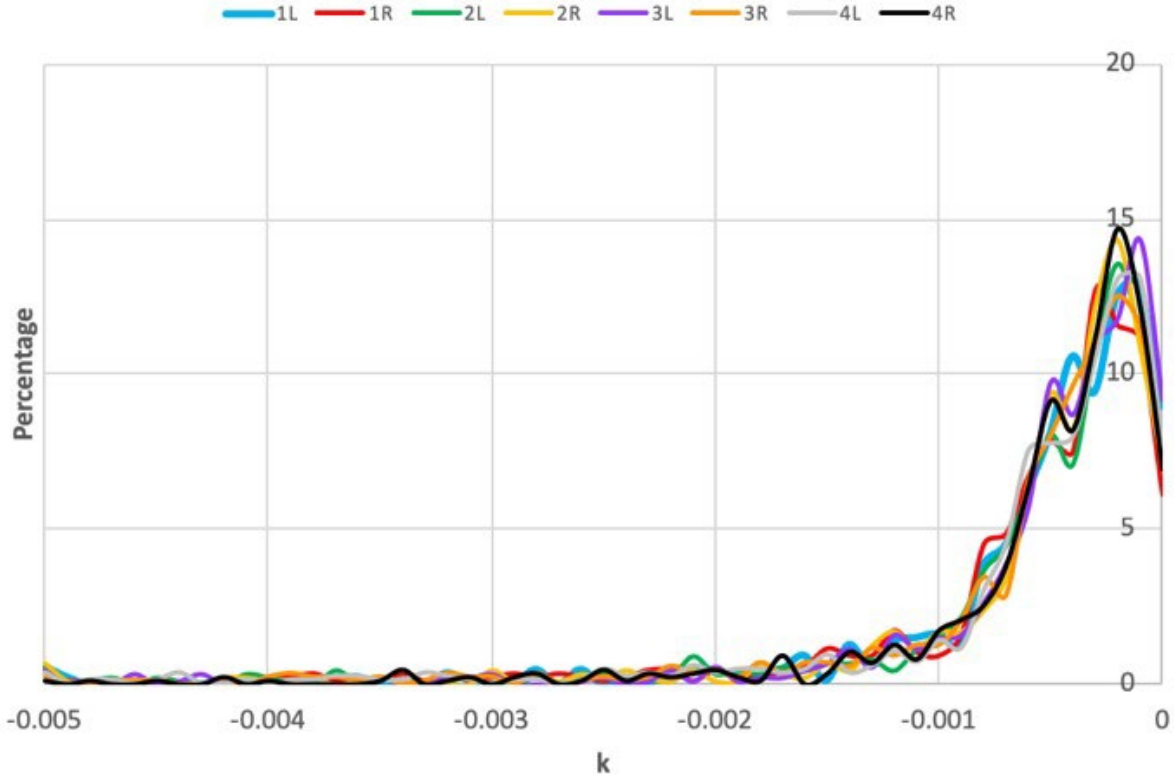
Figure 32 Histogram of k parameter by wheel position.

Since the focus of this study was wheel wear rates, a histogram of k sorted by wheel position was created, and can be seen in Figure 32. In addition, Table 3 presents descriptive statistics of the k parameter by wheel position. As can be seen, the wheel wear rate is not dependent upon wheel position. The distributions of all eight wheels are nearly identical, as too are the descriptive statistics. This is because the 7 Line is nearly symmetrical. Therefore, throughout a wheel's lifetime, it will experience an equal amount of left-hand and right-hand curves, meaning each wheel should wear similarly.
