DEPARTMENT OF COMMERCE
BUREAU OF AIR COMMERCE
SAFETY AND PLANNING DIVISION

REPORT NO. 16

THE DEVELOPMENT, ADJUSTMENT, AND APPLICATION
OF THE Z MARKER

By
W. E. Jackson
and
H. I. Metz
Radio Development Section

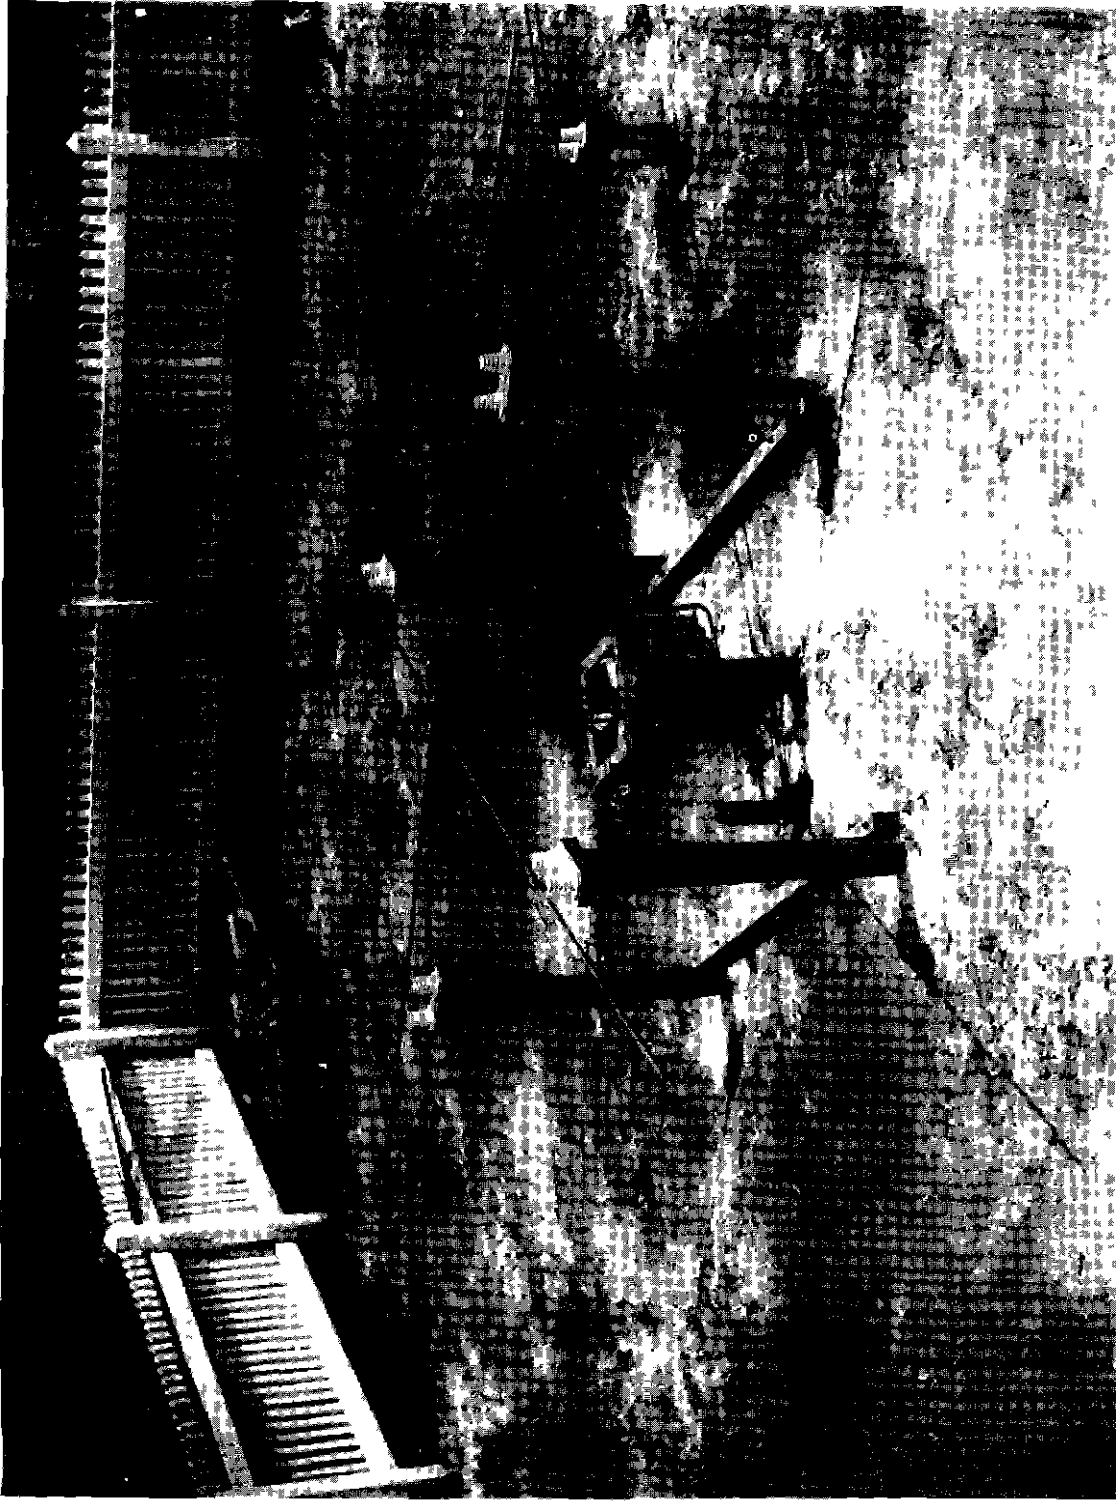
FIG. 15b
VIEW OF THE ANTENNA OF FIGURE 15a AFTER BEING INSTALLED AND
ADJUSTED AT THE WASHINGTON RADIO RANGE STATION

A new arrangement of the antenna system, shown in Figs. 5c and 15, was set up and adjusted. It was found possible to support the antenna and download system rigidly, and to perform all tuning adjustments on the system, by variation of the straps on the downloads and the position of the transmission line along the downloads. The former adjustment directly affects the balance of currents in the adjacent antenna rods, while the position of the transmission line along the downloads determines the relative phasing of currents. The actual operation of performing this adjustment is outlined later in the test and installation procedure. The adjustment is relatively simple, in that the links on the downloads are moved until the currents, as measured in adjacent antennas, are equal; then the transmission line position is varied until the current in an elevated pick-up antenna is constant, regardless of its orientation.

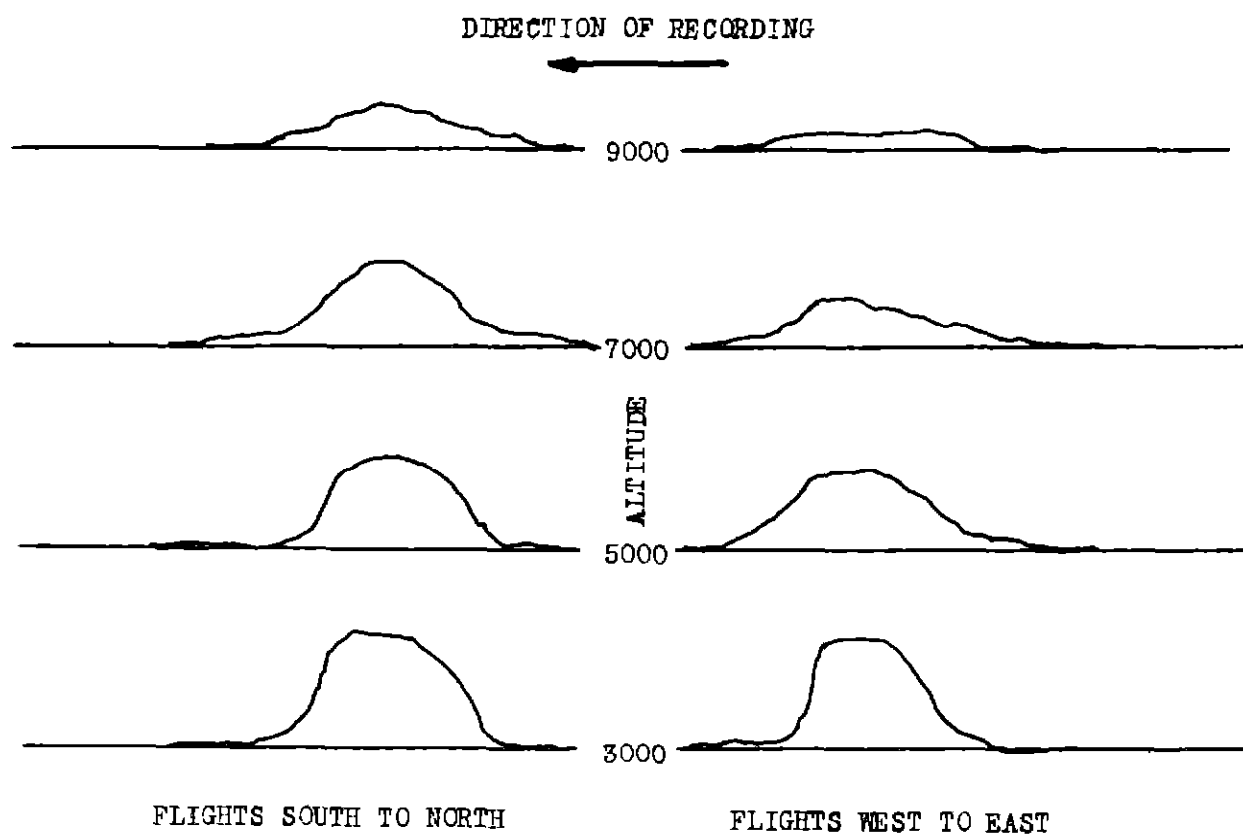
FIG. 18 COPIES OF GRAPHIC RECORDS/
MADE ON FLIGHT TESTS OF ARRAY SHOWN IN FIG. 15 AND USED IN PRE-
PARING THE PATTERN CURVES OF FIGS. 16 AND 17. WASHINGTON, D.C.

Many flight checks were made of this final antenna system. The general results obtained are as indicated in Figs. 16 and 17. The graphic records made on one group of flights are shown in Fig. 18. It will be observed from these curves that the signal is relatively uniform, and contains no observable lobes that might cause erratic operation of the marker signal lamp in the airplane. Three experimental installations (Chicago, Kansas City, and Newark) of this type of marker were made in November and December, 1936, and comparable results were obtained in each case. All use 3000-cycle motor alternators for plate supply. Reliability of the transmitters has been demonstrated by satisfactory operation of

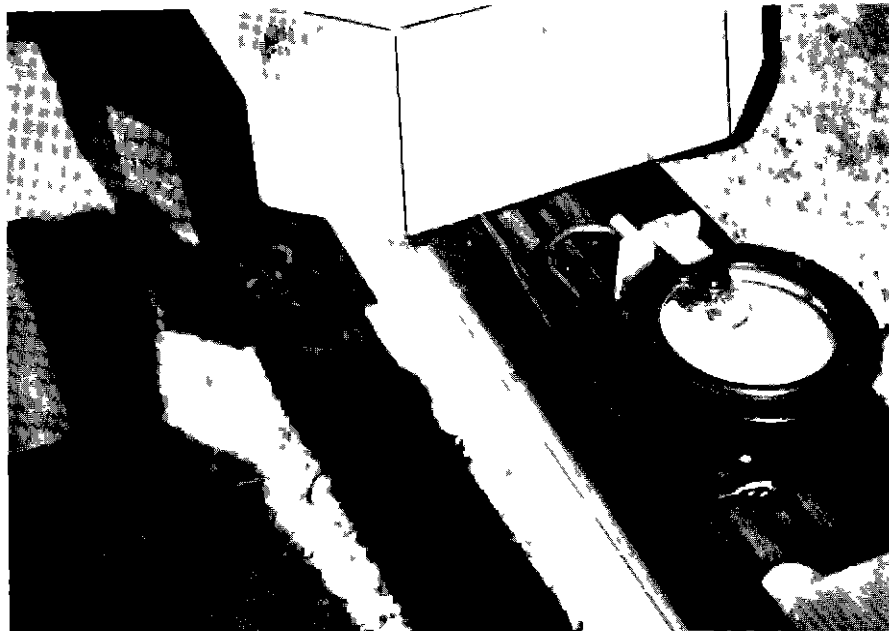
FIG 43 ALLENTOWN "Z" MARKER INSTALLATION

A close-up view of the spacing block used to hold duct sidewall spacing accurate during transmission line measurements.

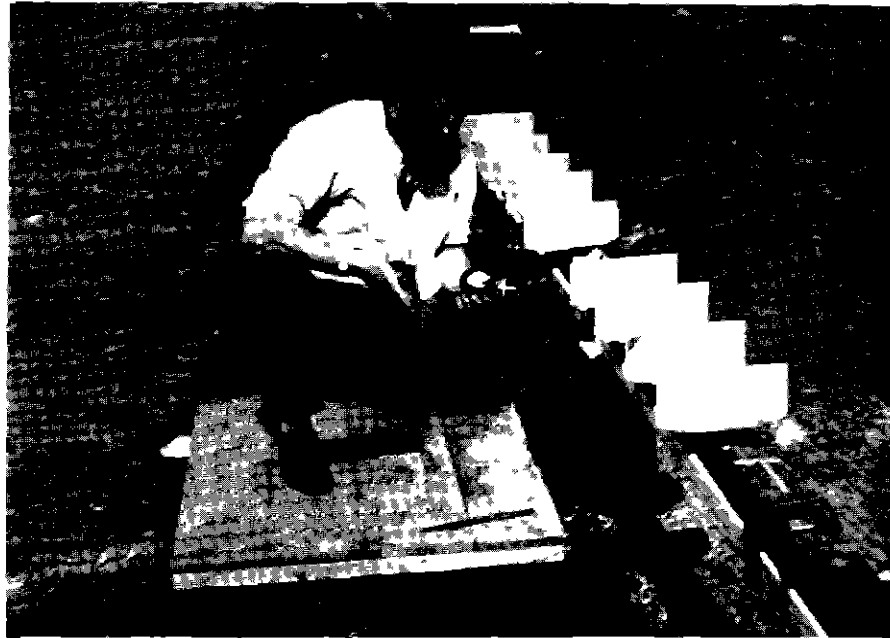
FIG. 44 ALLENTOWN "Z" MARKER INSTALLATION

Showing the complete assembly of slotted blocks to hold duct sidewall spacing accurate during line current measurements.
