THE CAA-RTCA INSTRUMENT LANDING SYSTEM TESTS AND MODIFICATIONS

PART II

Preliminary
Technical Development Report No. 36

October 1943

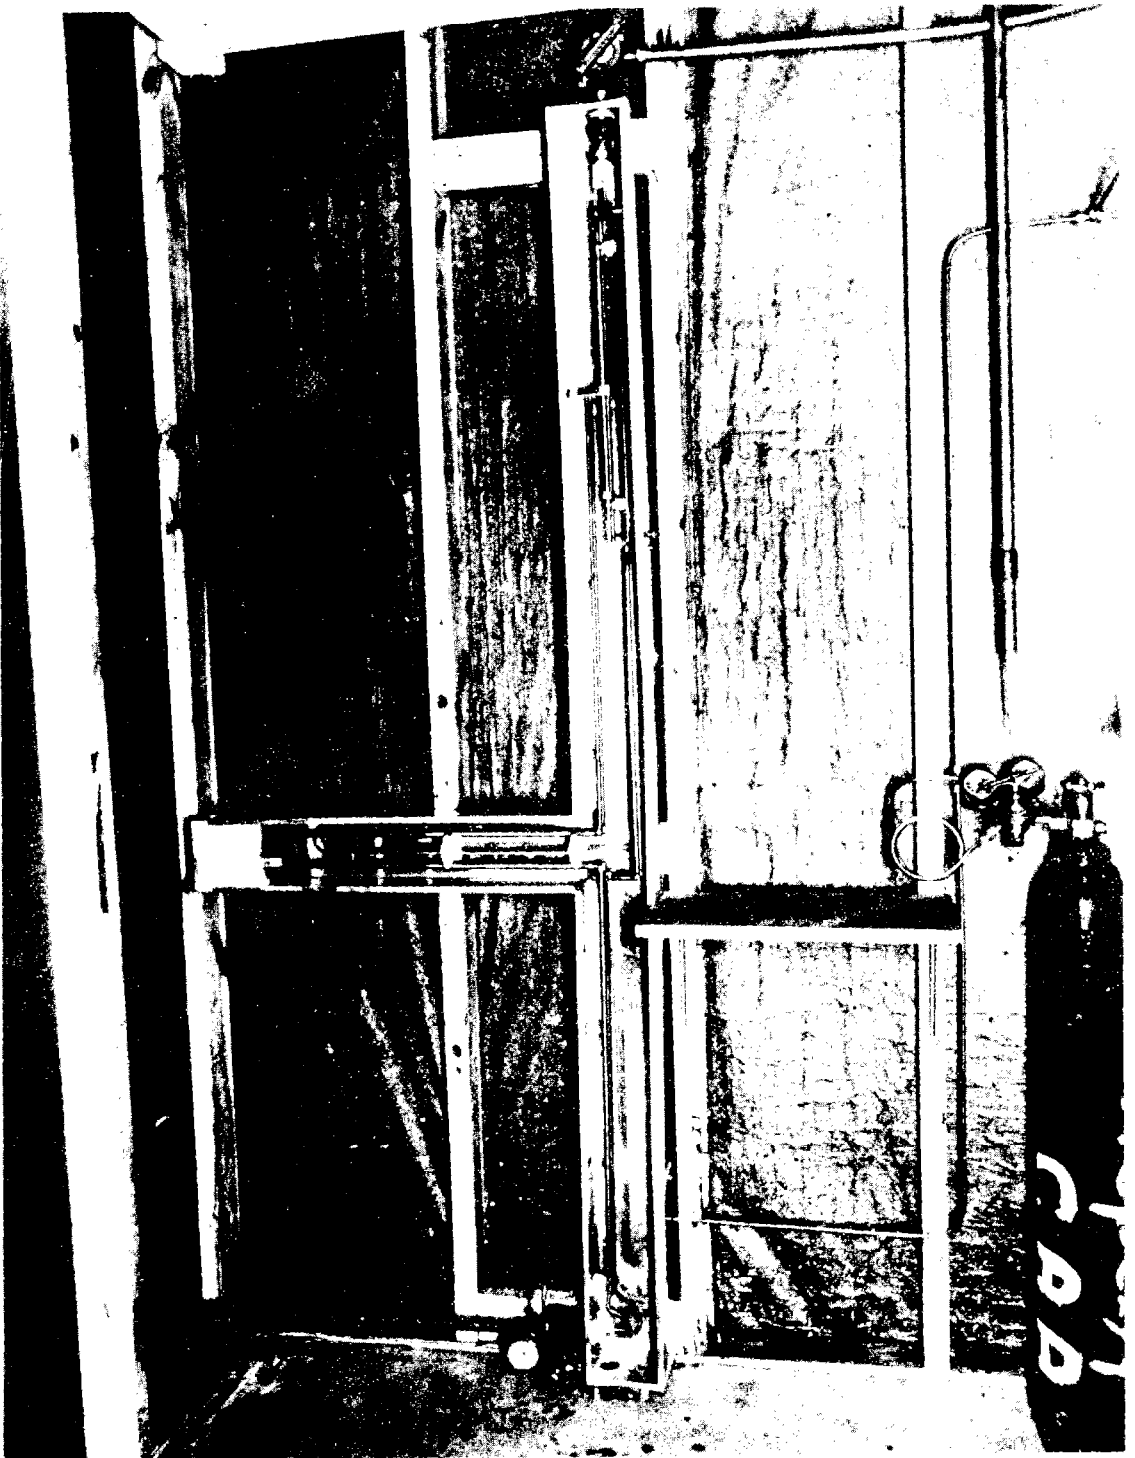
FIGURE 4. Phase and Current Control Unit for Auxiliary Antenna.

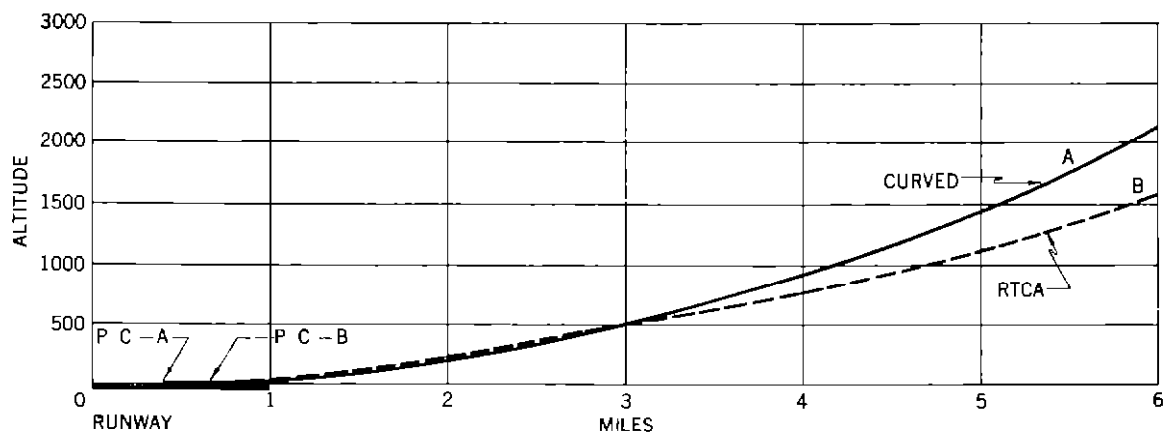
FIGURE 12 Comparison of Glide Paths

The shape of path produced by the radiation pattern of figure 8 is shown in curve B of figure 12. Curve A of figure 12 shows the conventional parabolic path. An advantageous characteristic of the CAA-PTCA glide path, curve B, is the low altitude at the 6-mile point. This permits orientation at the safe altitude of 1,600 to 1,700 feet and entrance into the actual approach farther from the field without excessive or rapidly changing rate of descent.

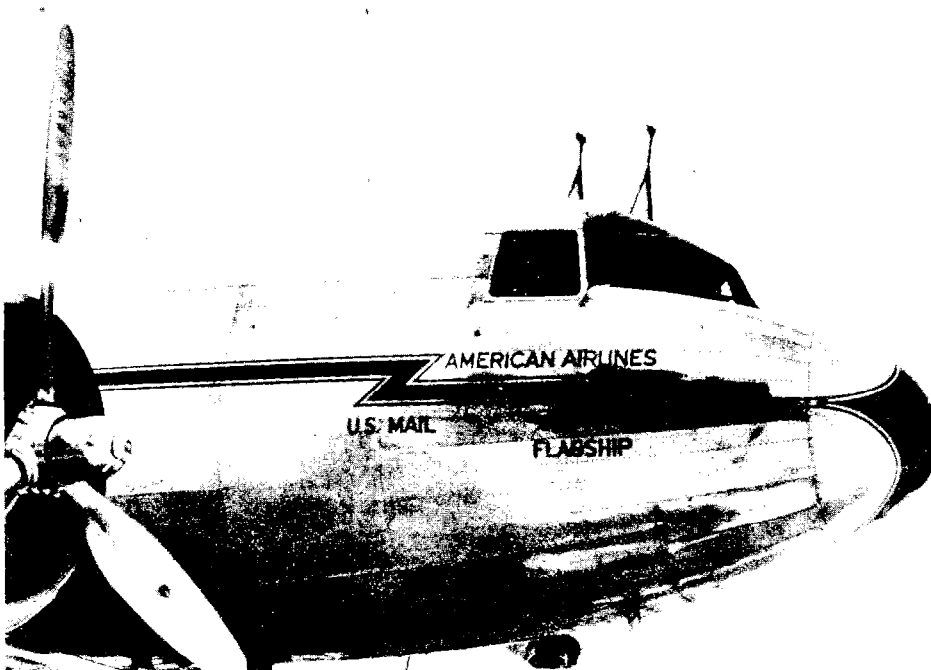
FIGURE 16. DC-3 Airliner with New Receiving Loop.

An improvement in the receiving antenna for localizer and glide path signal reception is illustrated in figures 16, 17, and 18. These are views of a DC-3 type hatch cover equipped with a receiving loop hermetically sealed in lucite tubing. There is no observable variation in the glide path receiver output when this antenna is subjected to direct water spray. The previously used exposed loop antennas were unstable in rain or spray, the glide path in one instance changing from 600 feet to 1,000 feet at the outer marker. The antenna became detuned in rain but not in heavy icing conditions. The new antenna gave no change in path when flown in heavy rain. The type of enclosed loop shown was constructed and mounted on hatch covers for DC-3 and DC-2 Douglas aircraft and for 247-D Boeings for experimental use.

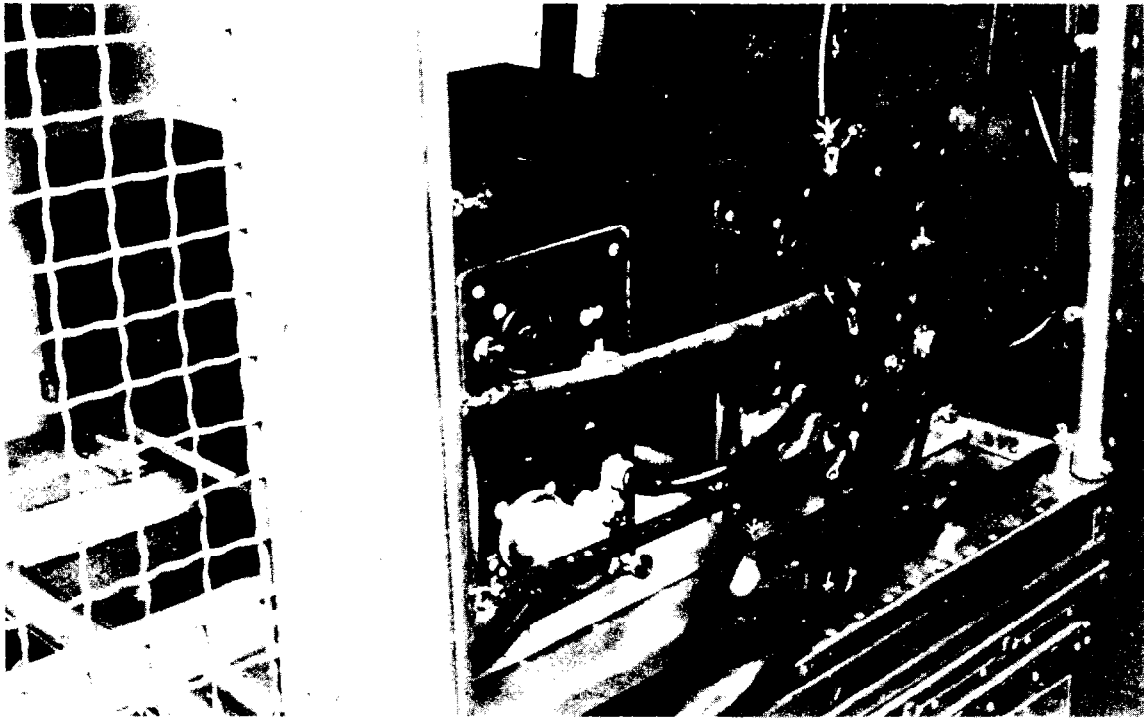
FIGURE 23. Receiver Installation in DC-3 Airliner.

Figure 22 shows the installation of the cross pointer instrument and marker signal lamps in an American Airlines Douglas DC-3 airplane. The associated receiver installation was made in a baggage compartment, as shown in figure 23.
