AIRPHOTOS
ILLUSTRATING
THE ORIGIN, DISTRIBUTION, AND AIRPHOTO IDENTIFICATION
OF UNITED STATES SOILS

Appendix B
of
Preliminary Technical Development Report No. 52
1946

U. S. DEPARTMENT OF COMMERCE
CIVIL AERONAUTICS ADMINISTRATION
WASHINGTON, D. C

APPENDIX B

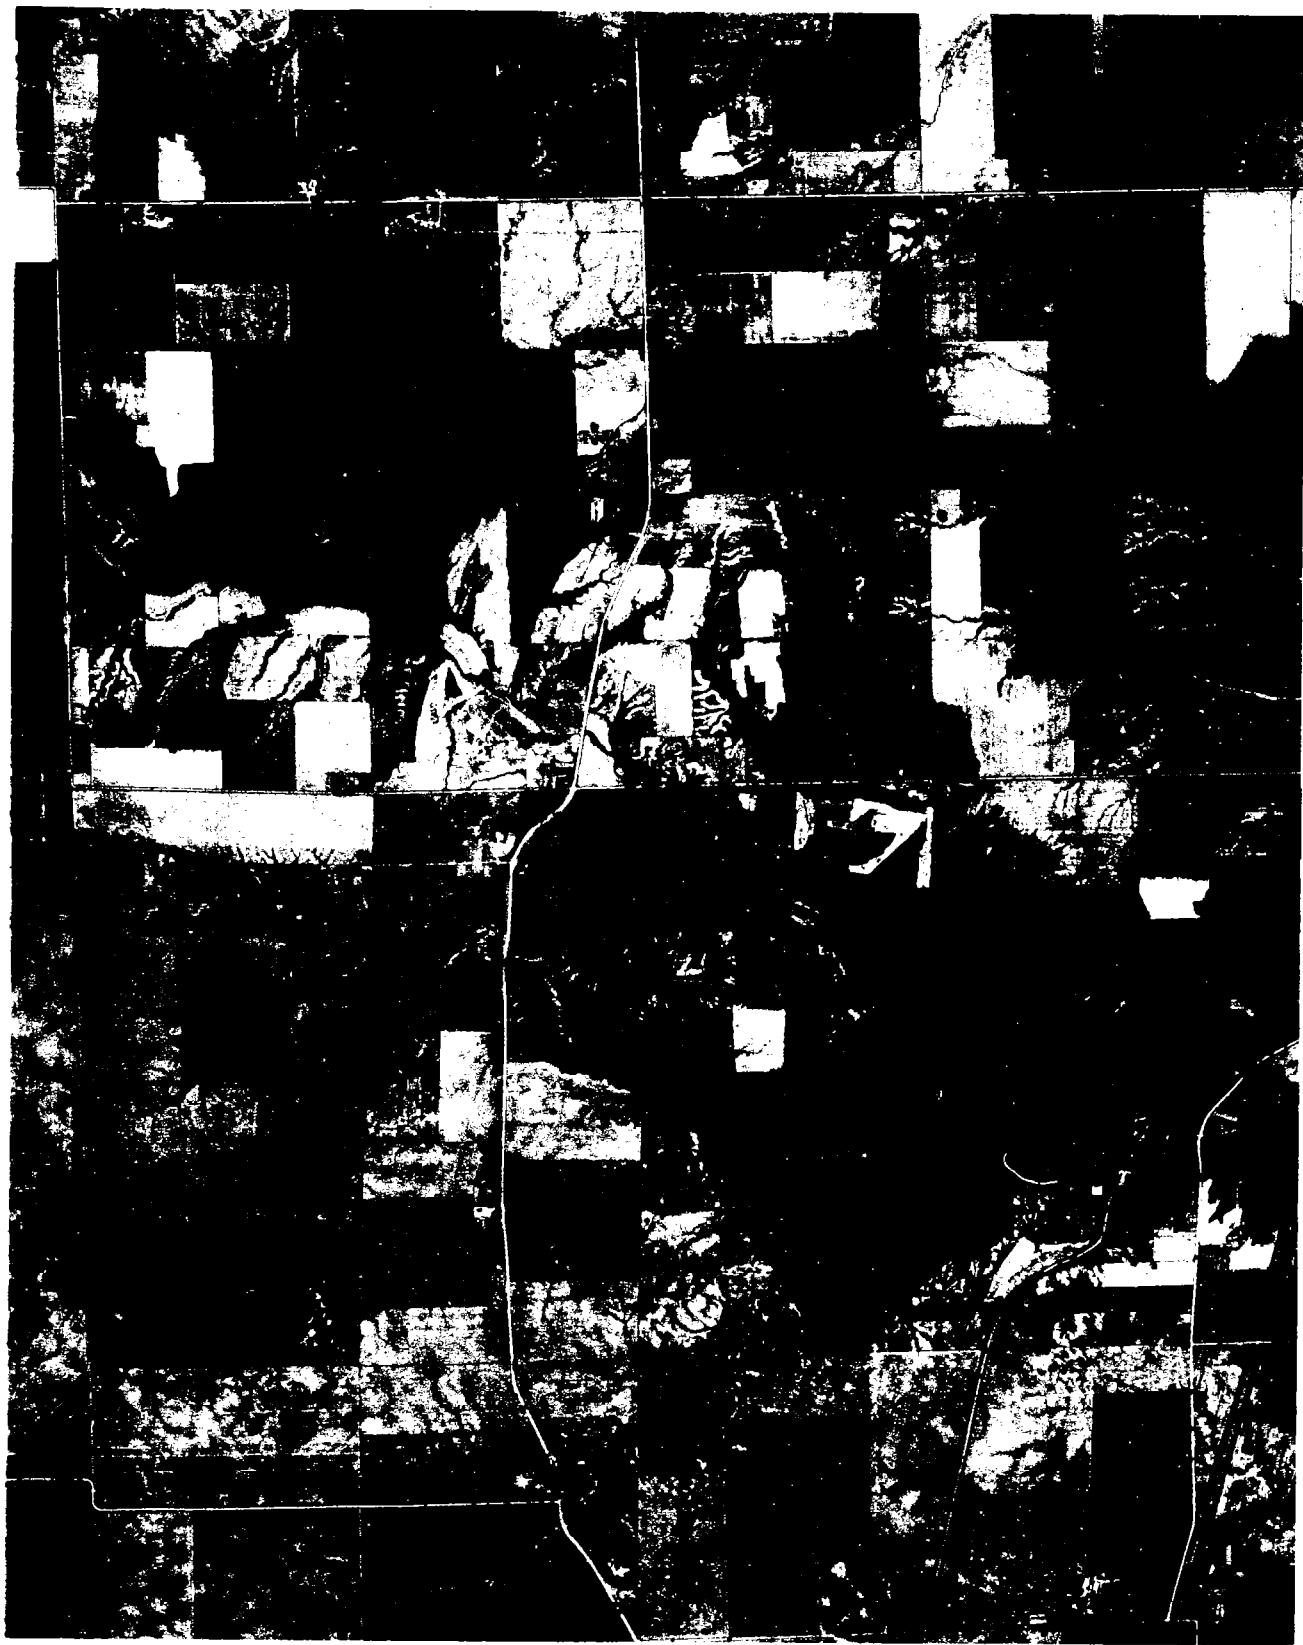
Plate 4. An airphoto of an area of moderate relief showing the contrasting soil patterns in adjacent young and old drift.

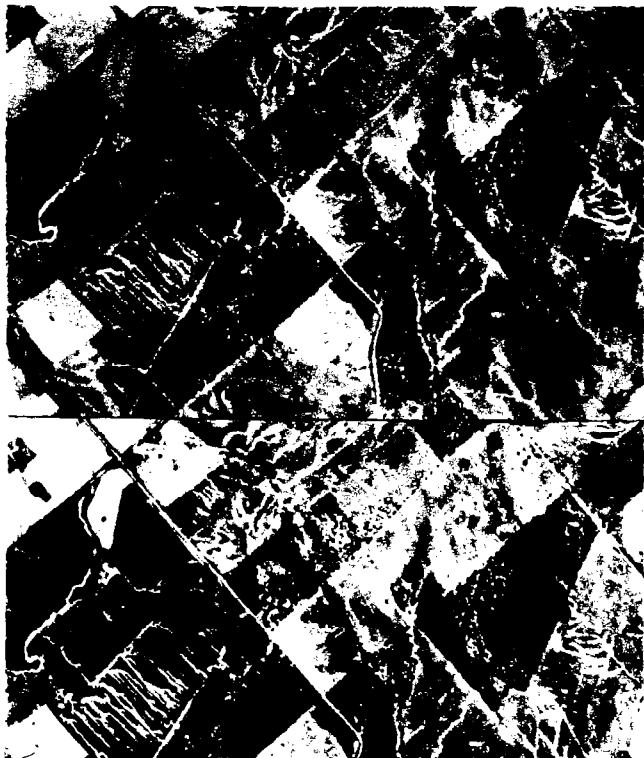
Plate 6. Erosion typical of sandy silts and sandy clays having a high percentage of sand. These long narrow gullies have a U-shape, and are cutting through the weathered profile. Angularity in their courses is a result of farm practices rather than of soil or parent rock.

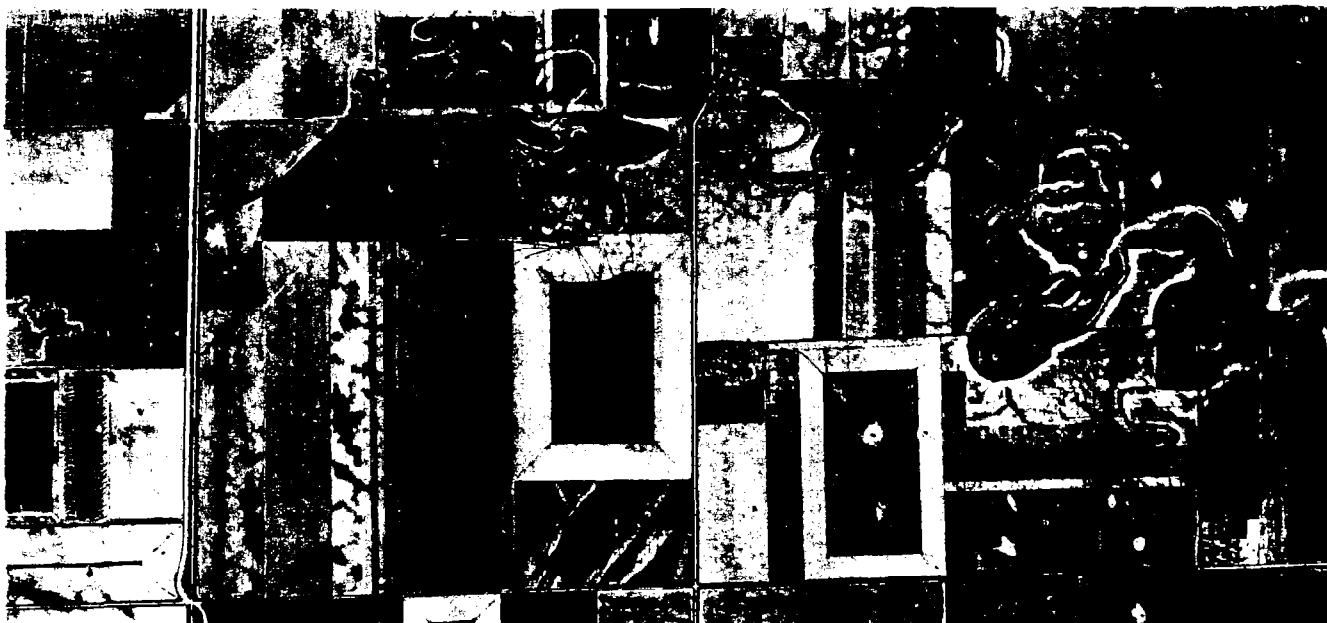
Plate 8. A gully form occurring in a plastic lakebed (lacustrine) soil showing the uncontrolled meanders and the extensive channel.

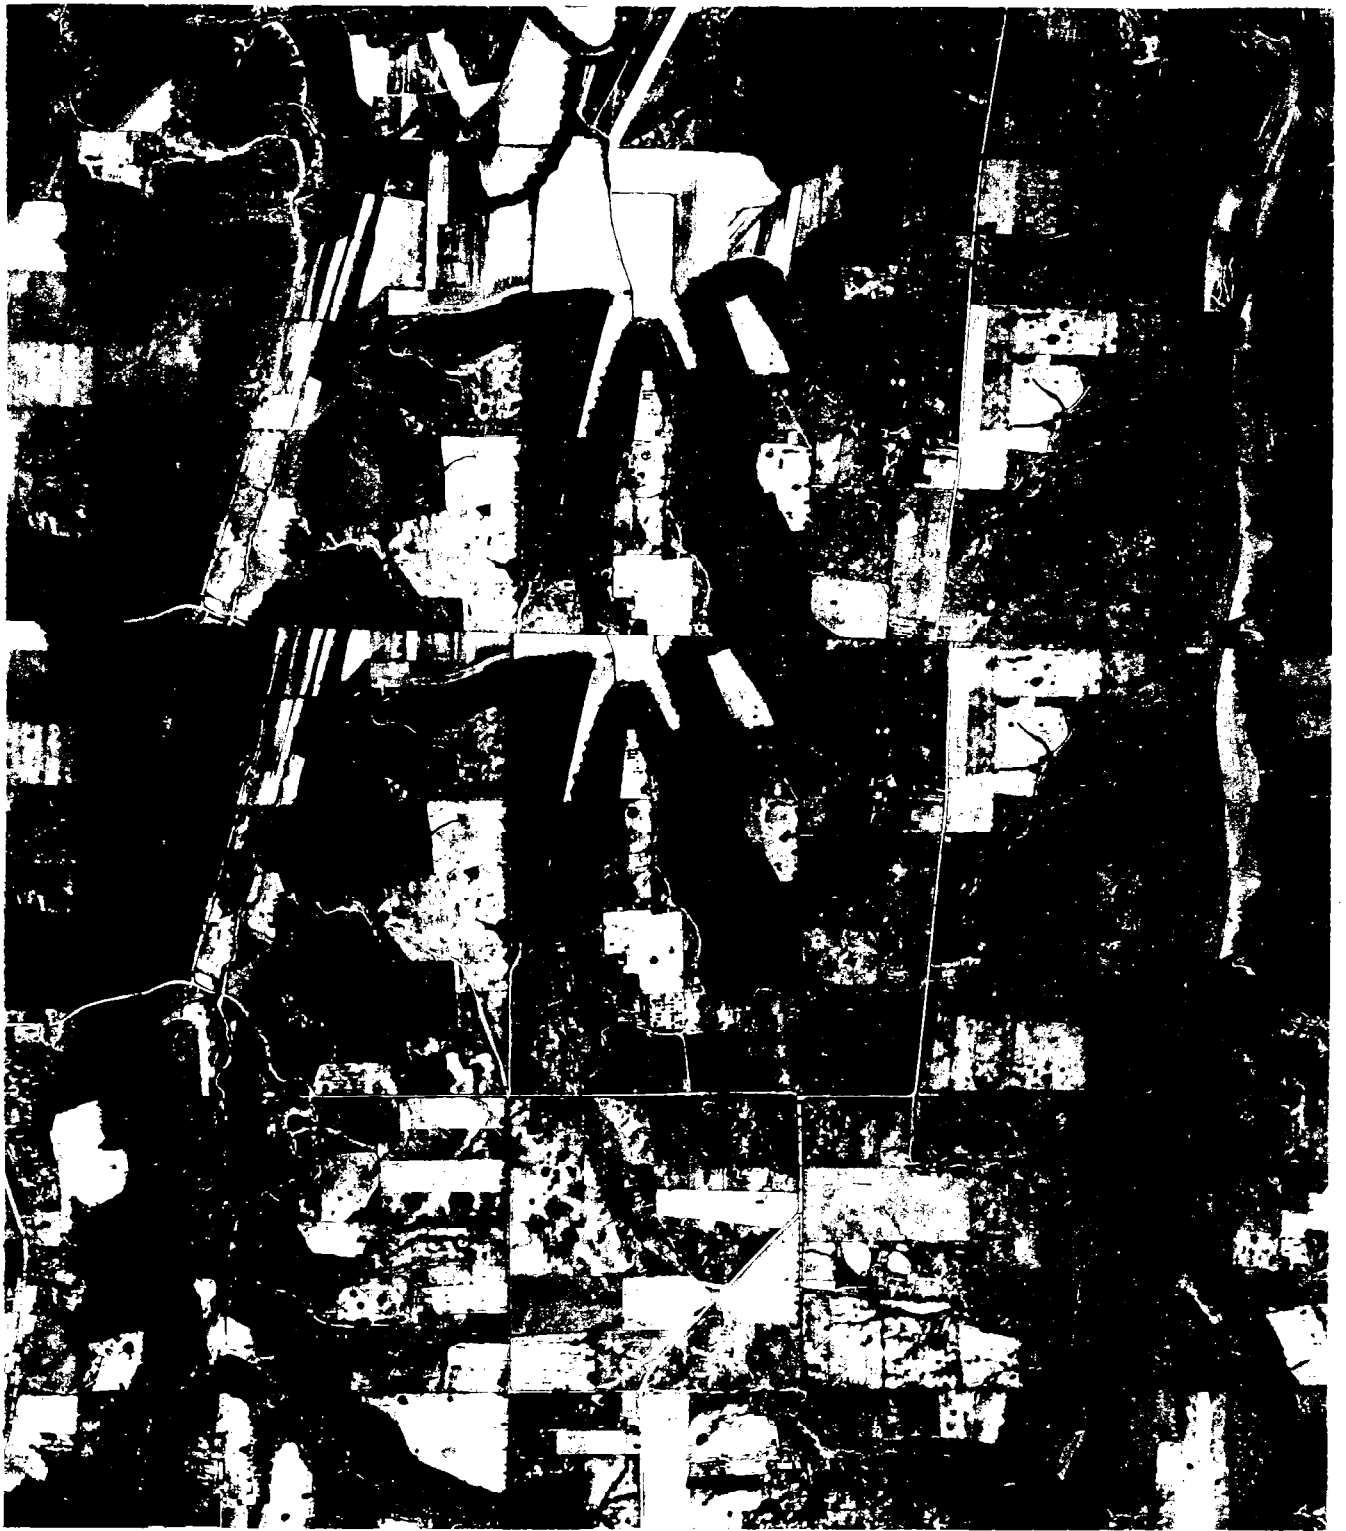
Plate 13. This stereopair illustrating the topographic drainage and sinkhole characteristics of a moderately dissected limestone area also shows the typical valley shapes and sections. In comparing this with Plate 10 the sharp intersection angles of valley walls and the lack of modification of valley walls by surface runoff present a sharp contrast to the rounded slopes and intersections observable in sandstone and shale mixtures.

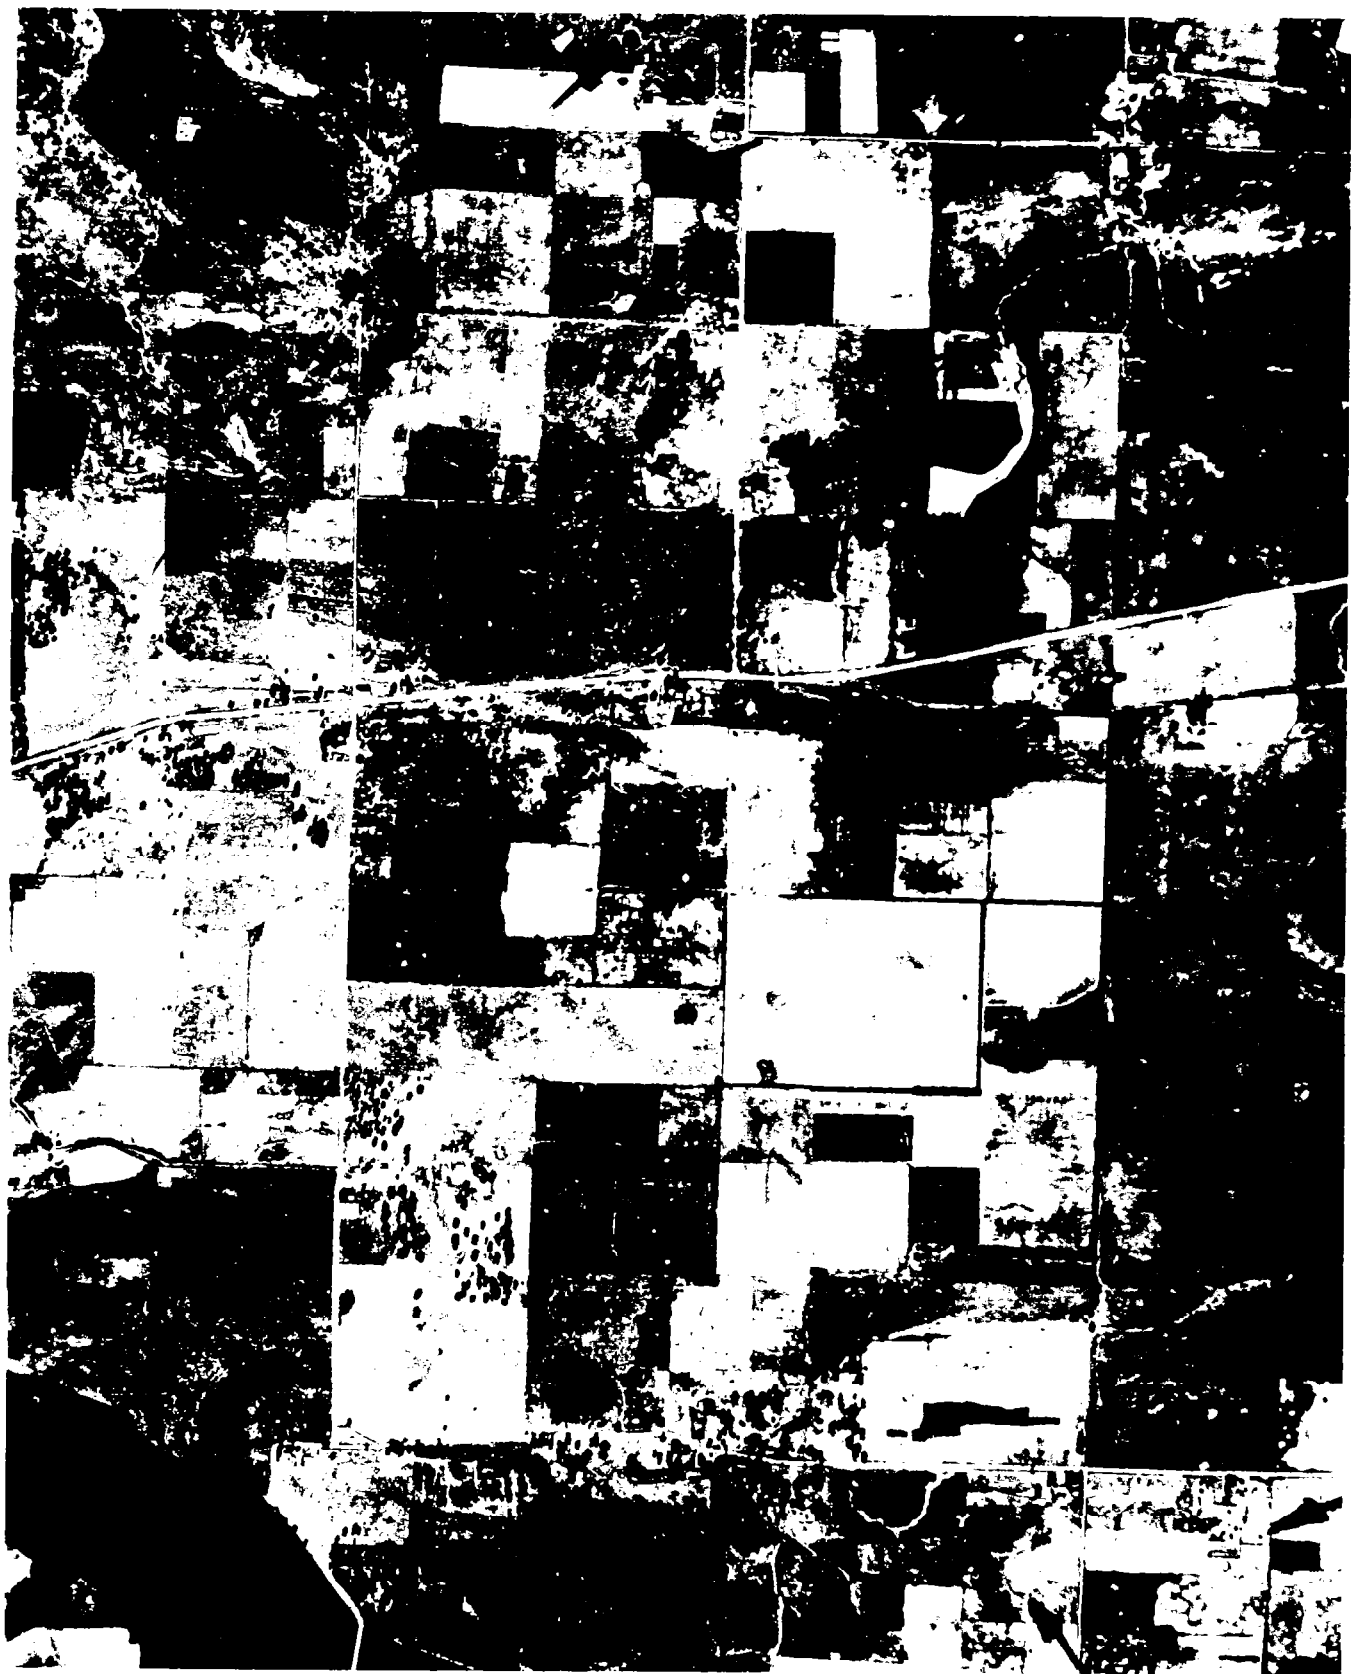
Plate 16. An air view of a cherty limestone region. The presence of scattered sinkholes and the obvious "limestone valley" identify this as an area of residual soils developed from limestone. In further detail the numerous circular white dots that appear in many fields indicate the presence of a high percentage of chert fragments in the soil profile.

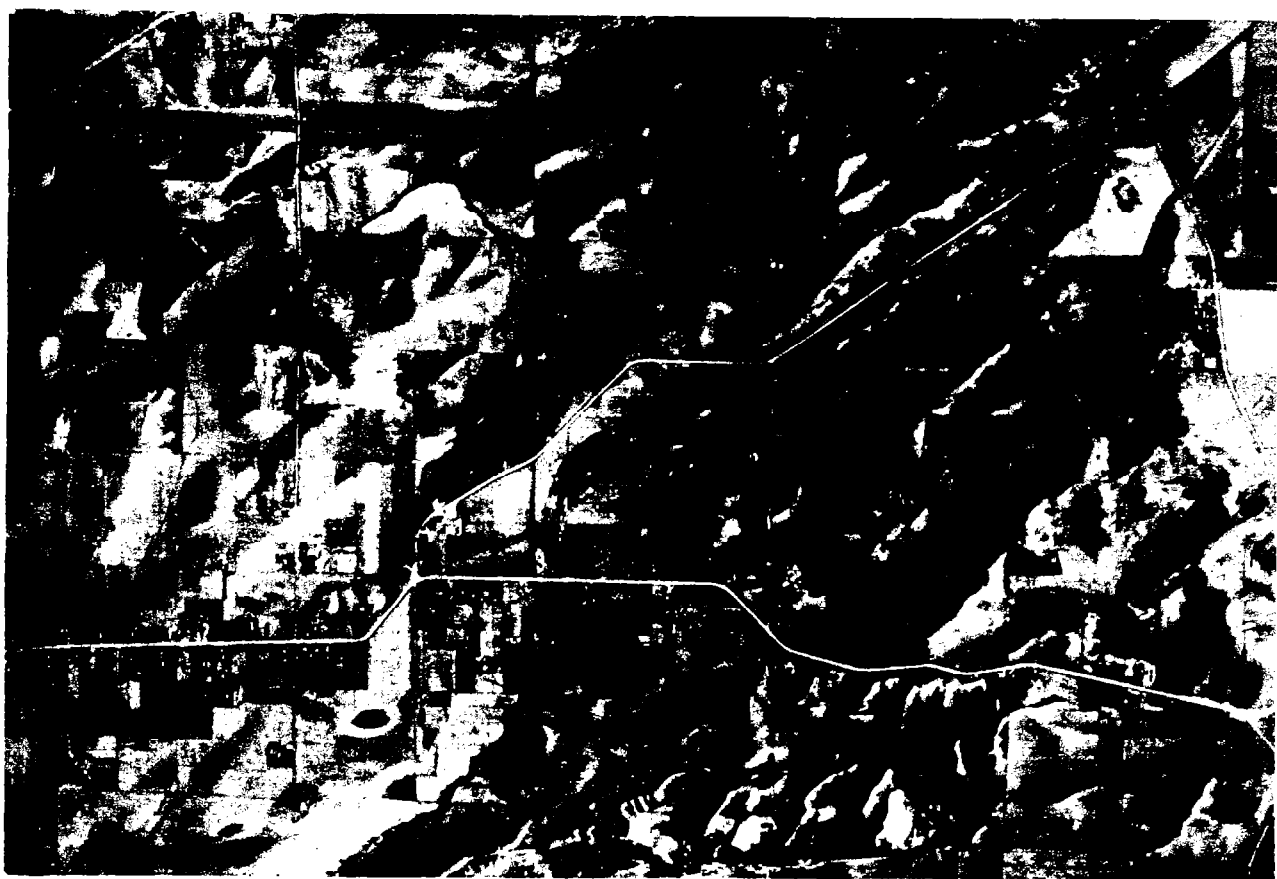
Plate 27. The two sections of this plate illustrate the land form pattern of other loess areas in the Mississippi-Missouri River belts. In each there can be seen the alluvial areas that furnished the materials picked up by the wind and deposited nearby. The parallel hills oriented cross-wind again produce the related drainage pattern. A few instances of the outline of gullies in the loess can be seen along the face of the hills bordering the alluvial plains.

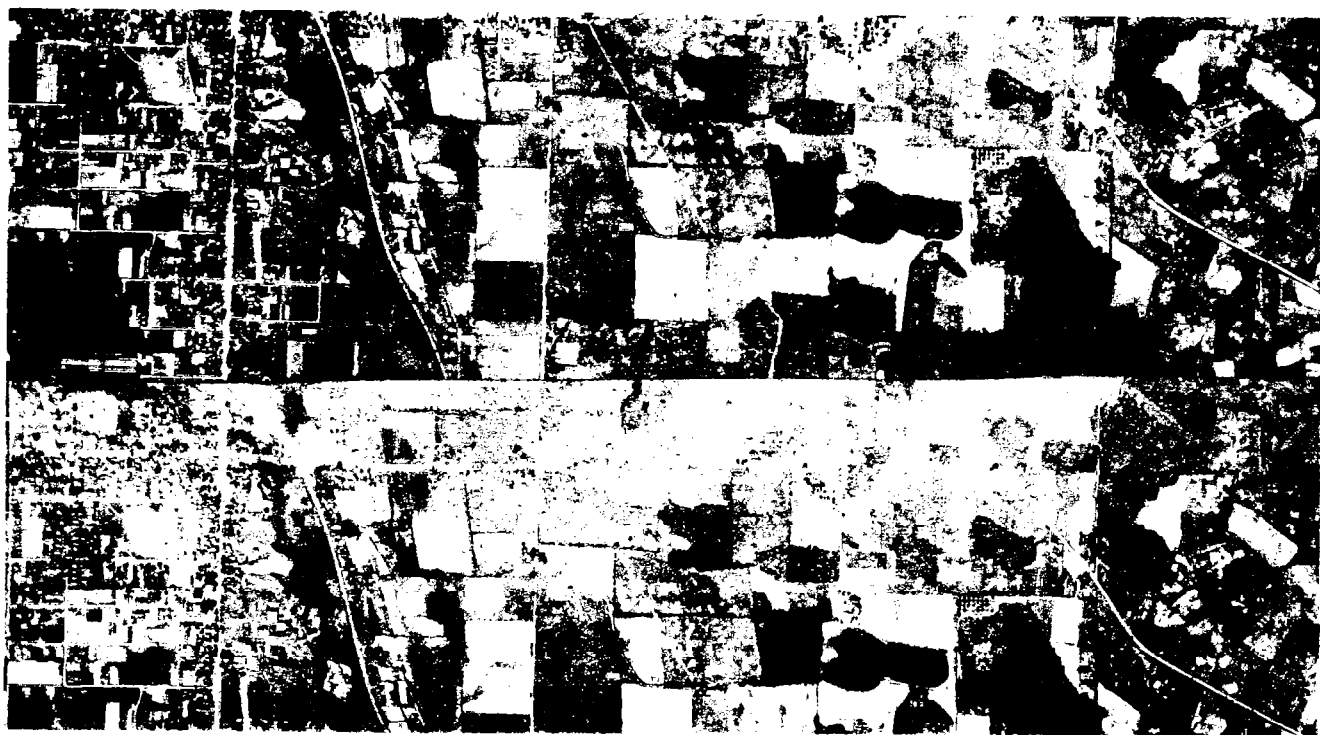
Plate 35b

(b) An Ohio moraine of Wooster soil which was found also to have a parent material of silt with sand and clay. Included in this area are mucks, (a), in depressions, an esker lying parallel to the railroad, and the generally light soil colors associated with rolling topography.

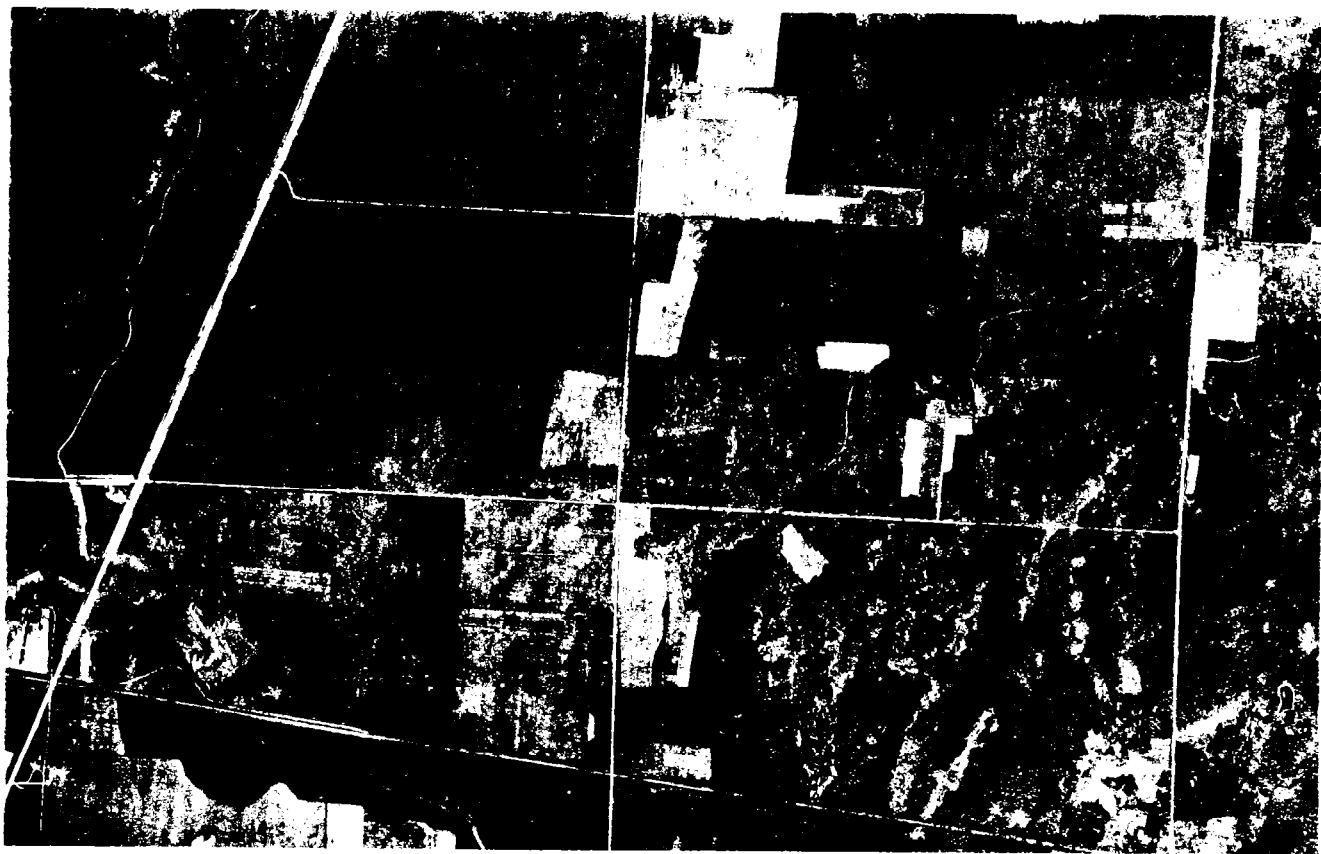
Plate 42. This outwash plain in a glaciated region illustrated the level land form that significantly includes numerous abandoned channels. The forested section covers a very slightly depressed trough that contains many faint channel scars. There a high ground-water condition exists that is not found on the sandy plain that is largely cultivated. Except for a muck-filled abandoned channel striking across the center of the sand plain, there is no evidence of surface drainage. This indicates a deep sand. Shallow sands on impervious material show faint markings of ground-water movement. A large area of muck occurs in the upper left

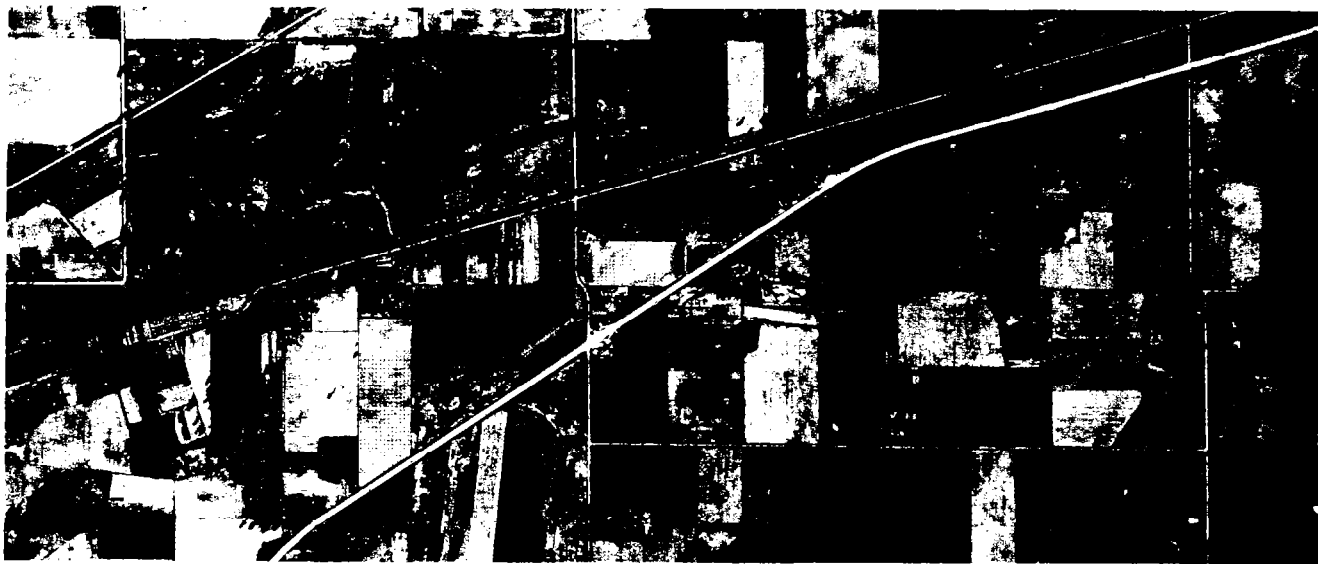
Plate 43. The flat expanses that are so impressive in lacustrine deposits are well represented by this area that was once the glacial Lake Chicago. The fine-textured sediments and the flat relief create both ponding and slow internal drainage. Dead furrows (fine parallel lines in fields) and excavated ditches provide some artificial drainage. The wide meanders of the channel also indicate poor natural surface drainage. Large areas of mottled black soil, often coincident with wood lots and swamp growth, are slight depressions where water stands on the surface. Field inspection showed that the principal highway, which is the white diagonal line, suffered from unstable soil conditions except where sand was used to construct a light fill.

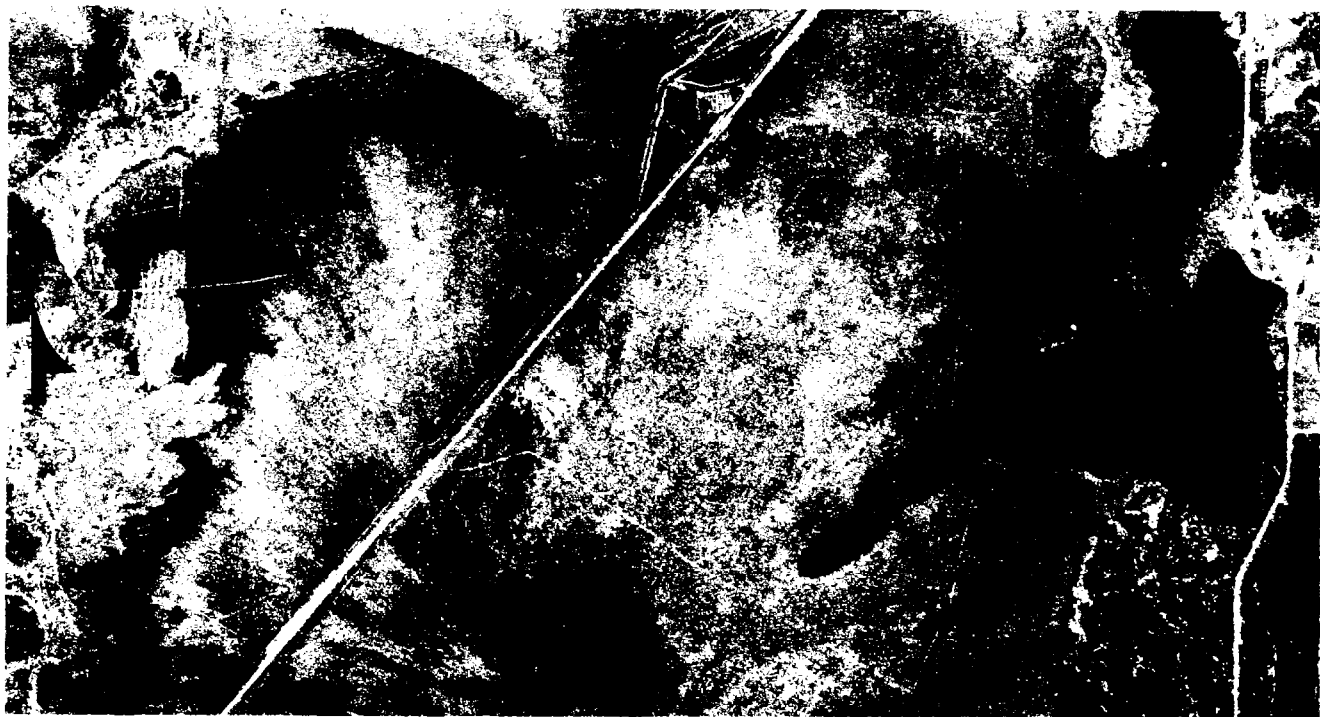
Plate 44. The striking contrast between a peat swamp and the surrounding area is well illustrated here by the relief, color, vegetation, and land form. Underground springs may account for the local body of open water. The white line running diagonally across this peat swamp is a railroad. A moss farm is shown, adjacent to the railroad.

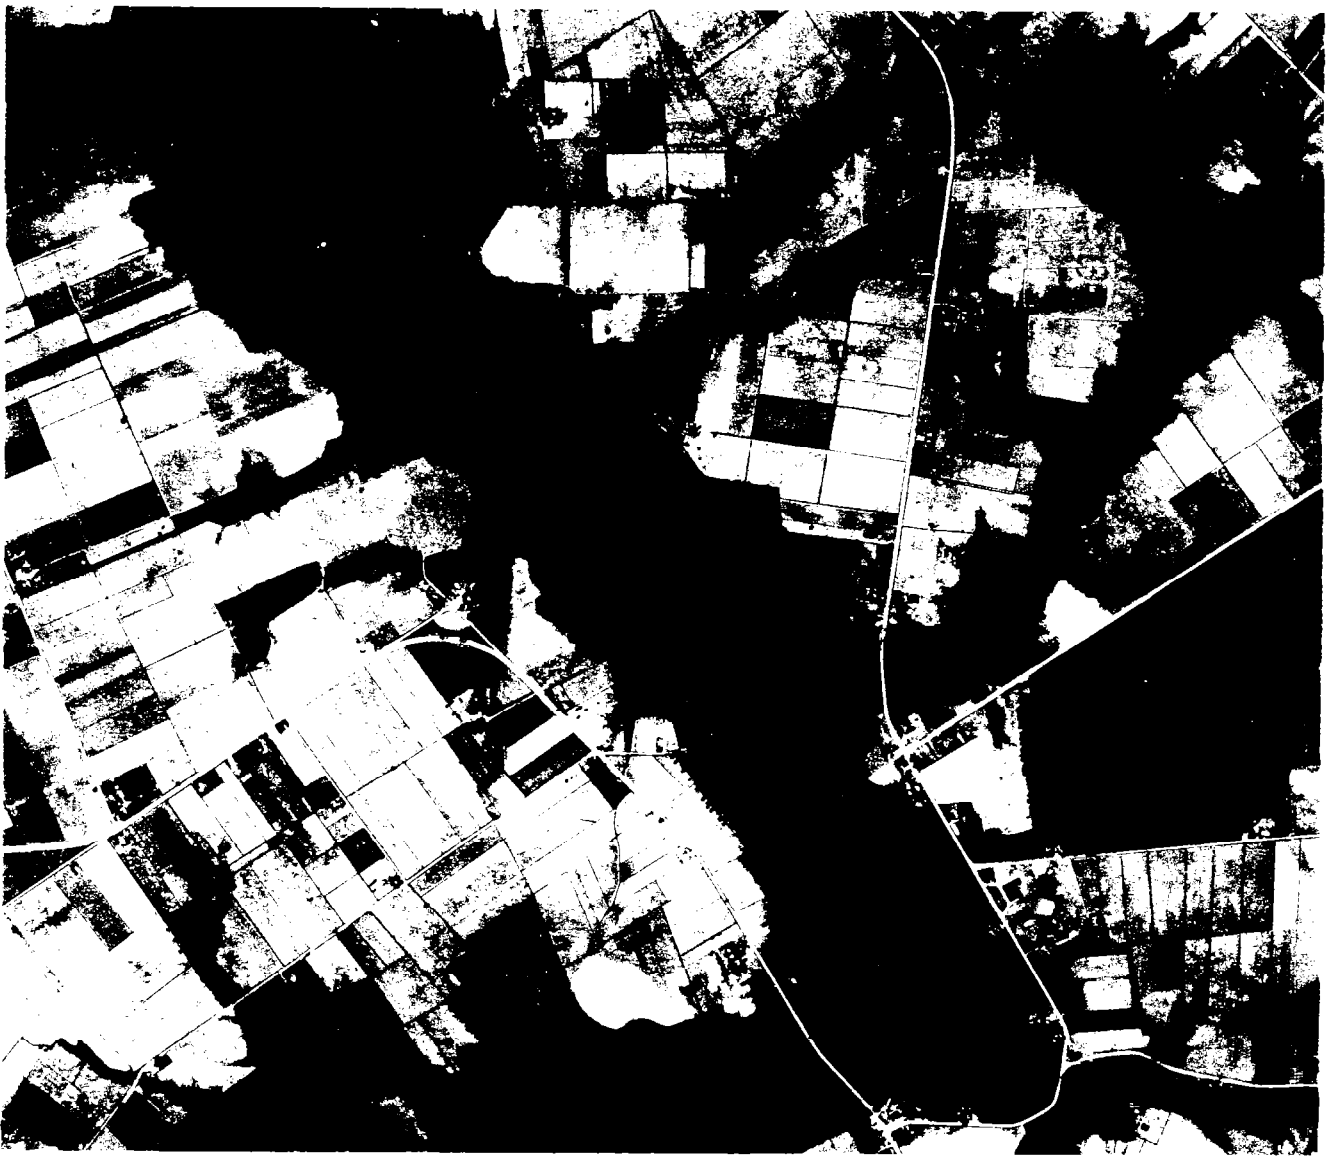
Plate 46. Silty clay of the lower Atlantic Coastal Plain. This view contains most of the elements needed for airphoto analysis in this geographic location. The primary feature is the very flat, low terrain. The absence of relief indicates alluvial origin. The present stream possesses the two typical features associated with tidal streams. These are the short length and rapid decrease in width from mouth to source, and the stubby appearance of tributaries shaped as though opened by tidal pressure. The adjacent swamps and the intricate pattern of artificial drainage in all of the fields indicate a high ground water table.

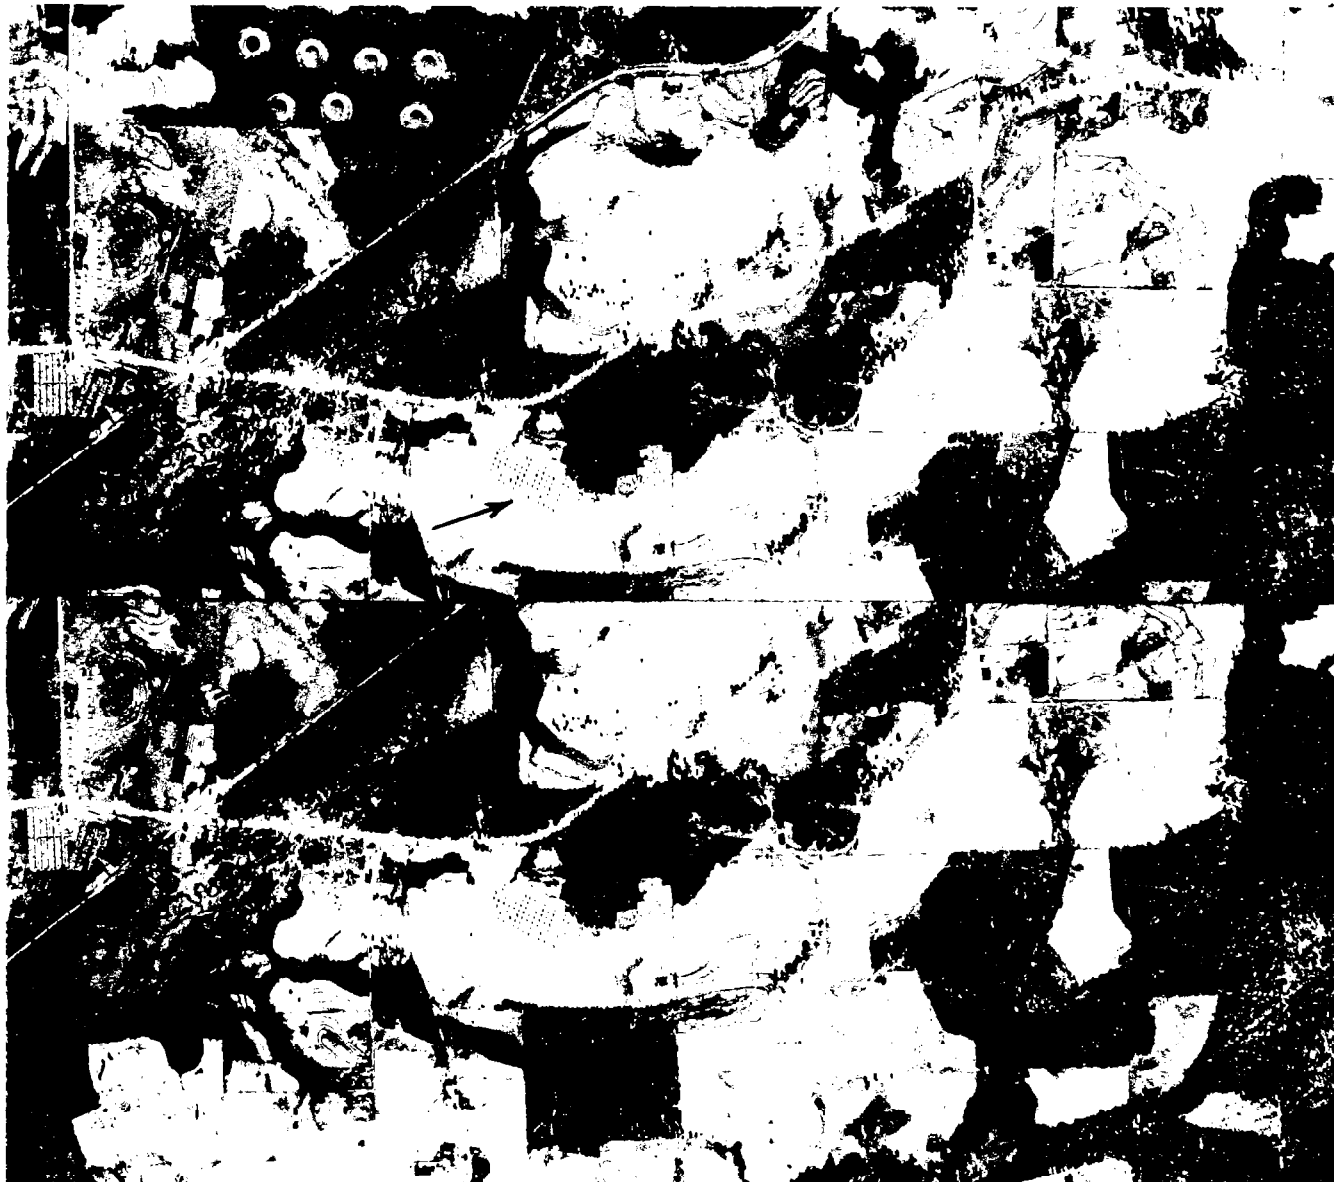
Plate 48. Highly dissected upper Coastal Plain. Stereoscopic observation indicates the drainage-ways are not controlled by any form of bedrock as they are in Plates 9 and 15. In contrasting the color and erosion patterns with those of the accompanying illustration, it will be seen that the cultivated fields have an extremely light color indicative of sandy texture, and the several gullies are the type associated with friable materials. The land-use pattern as well as the vegetation are typical of the Coastal Plain. The terracing and contour plowing indicate that slope and texture promote runoff, causing sheet erosion if otherwise cultivated. In one of the very lightest areas, occupied by an orchard and indicated with an arrow, sampling showed the soil profile to consist of at least six feet of relatively loose sand. Some areas in adjacent fields show various degrees of color (red); there increased quantities of silt are found mixed with the sand.

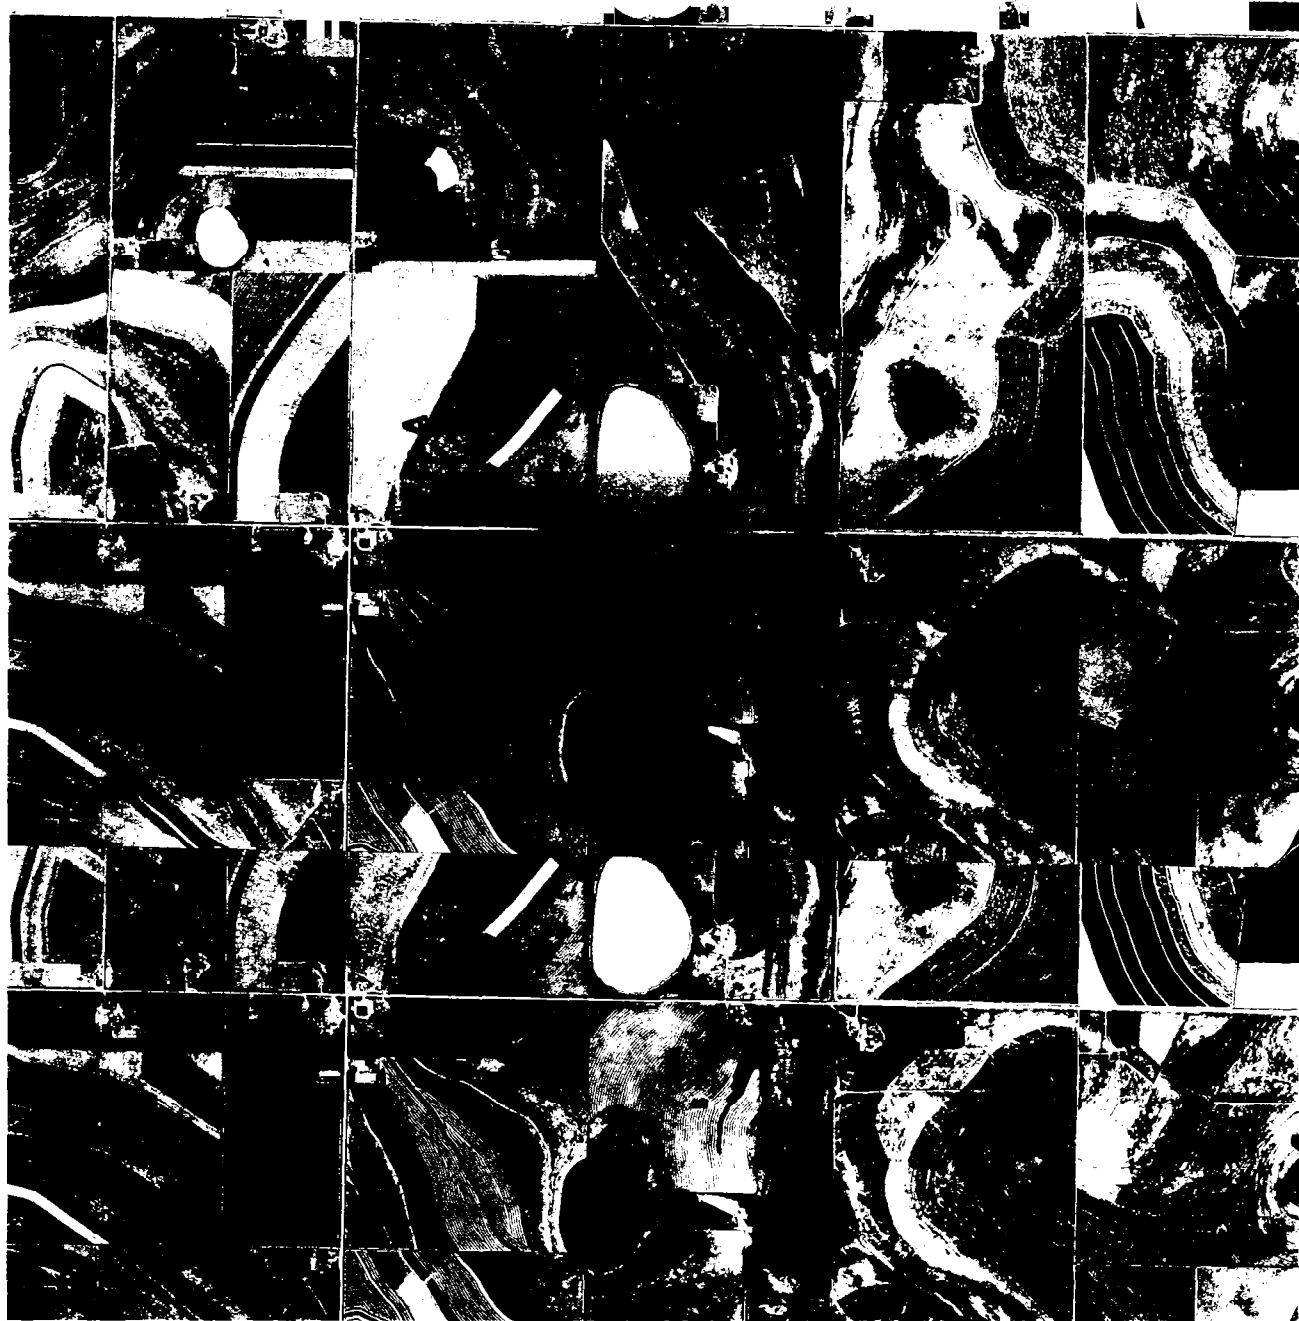
Plate 51. This stereopair shows one of several soil patterns found in that formation of the Great Plains Outwash Mantle mapped geologically as Ogallala. The most outstanding feature is the presence of large circular depressions which contain water for days or weeks following wet weather. Depression "A" has dried to some extent.

The striped appearance is the result of contour plowing and terracing to control sheet erosion. A stereoscopic examination shows that the relief is gently undulating, so that the occurrence of sheet erosion indicates that the subsoil may be impervious. The soil conditions in these areas are exceptionally uniform in comparable positions. The clay content and depth of the soil profile increases toward the center of the depression. On the higher inter-depression areas the soil profile contains relatively large proportions of silt and fine sand. Consequently, soil surveys made with aerial photographs in this area are accurate as to depth, texture, plasticity, and water conditions.

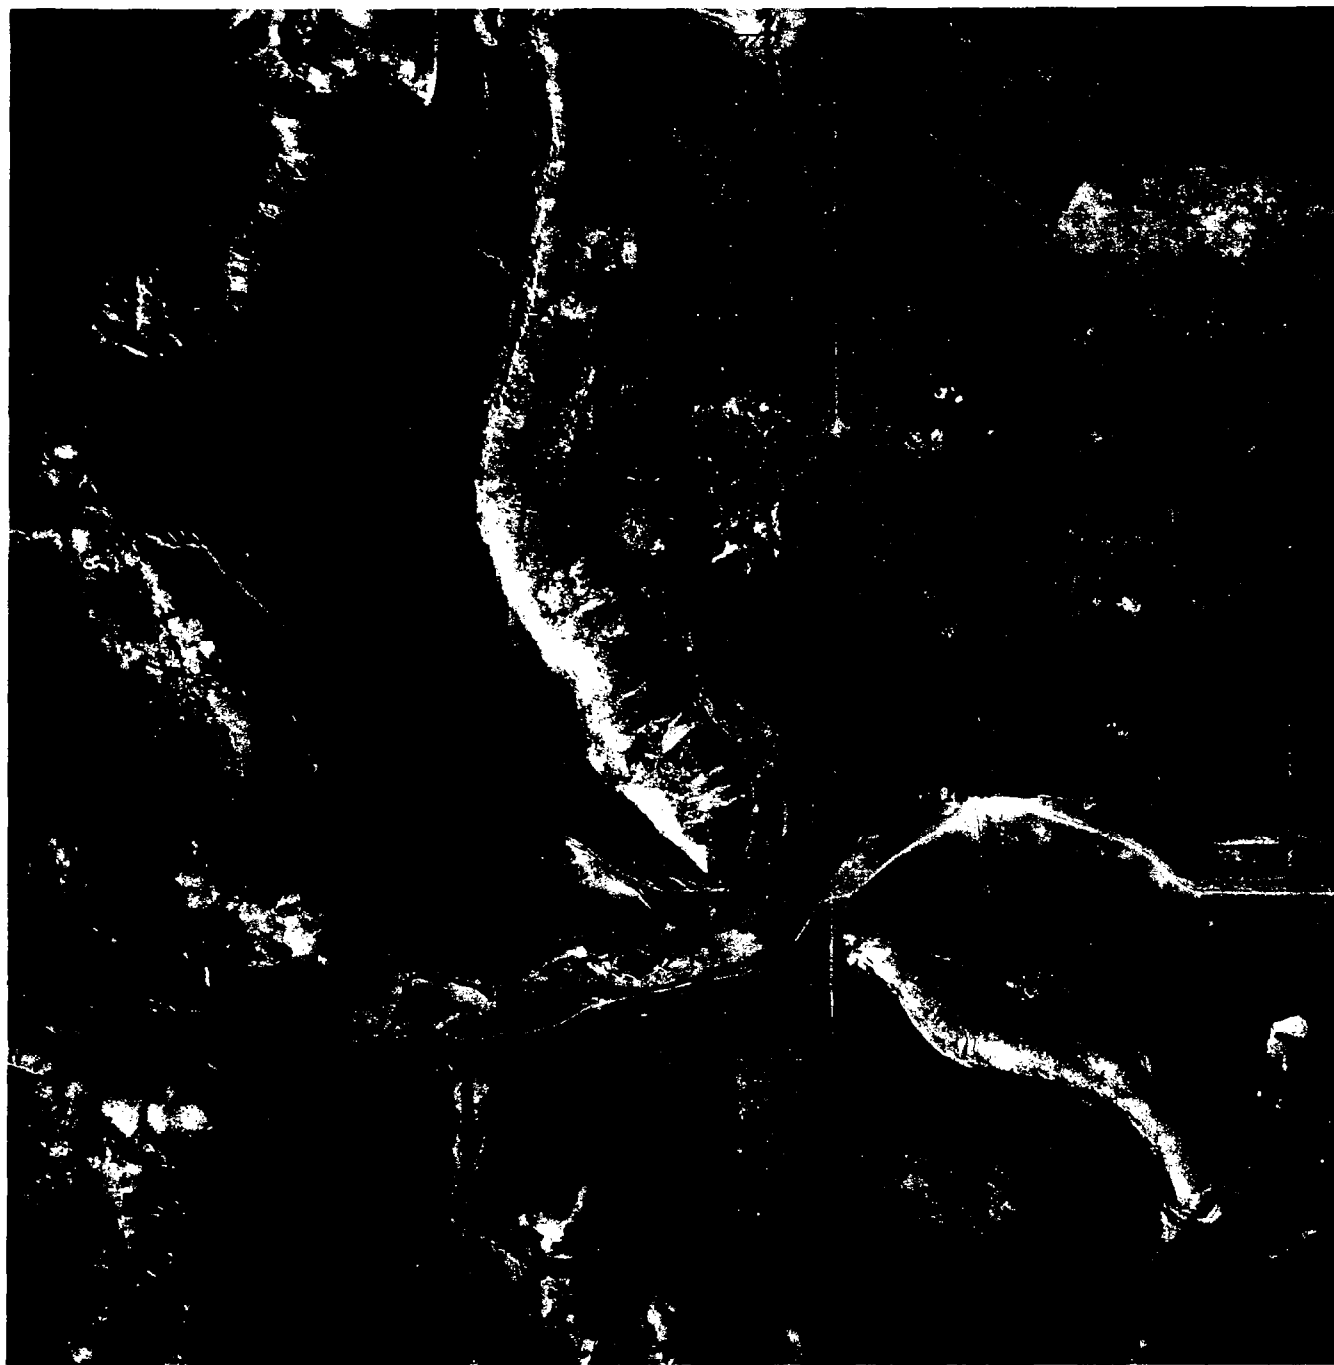
Plate 54. This illustration shows only one of the unrelated land forms exposed by removal of the Tertiary mantle. The area on the left is a more or less level upland that once extended entirely across the area covered by the picture. At the present time headward erosion is progressing toward the upper left corner and is carrying the sediments away in a small valley developed in the lower center. This process of removal has exposed the sharp ridge crossing the center of the photograph. In all probability, this rock ridge was formed long before the temporary burial by the outwash sediments. Subsequent erosion and removal of the sediments may expose a much more complete pattern of this ridge. Gradual lowering of the surrounding plain will also heighten the relief now existing between the lowest part of the picture and the top of the ridge.
