AIRPHOTOS
ILLUSTRATING
THE ORIGIN, DISTRIBUTION, AND AIRPHOTO IDENTIFICATION
OF UNITED STATES SOILS

Appendix B
of
Preliminary Technical Development Report No. 52
1946

U. S. DEPARTMENT OF COMMERCE
CIVIL AERONAUTICS ADMINISTRATION
WASHINGTON, D. C

APPENDIX B

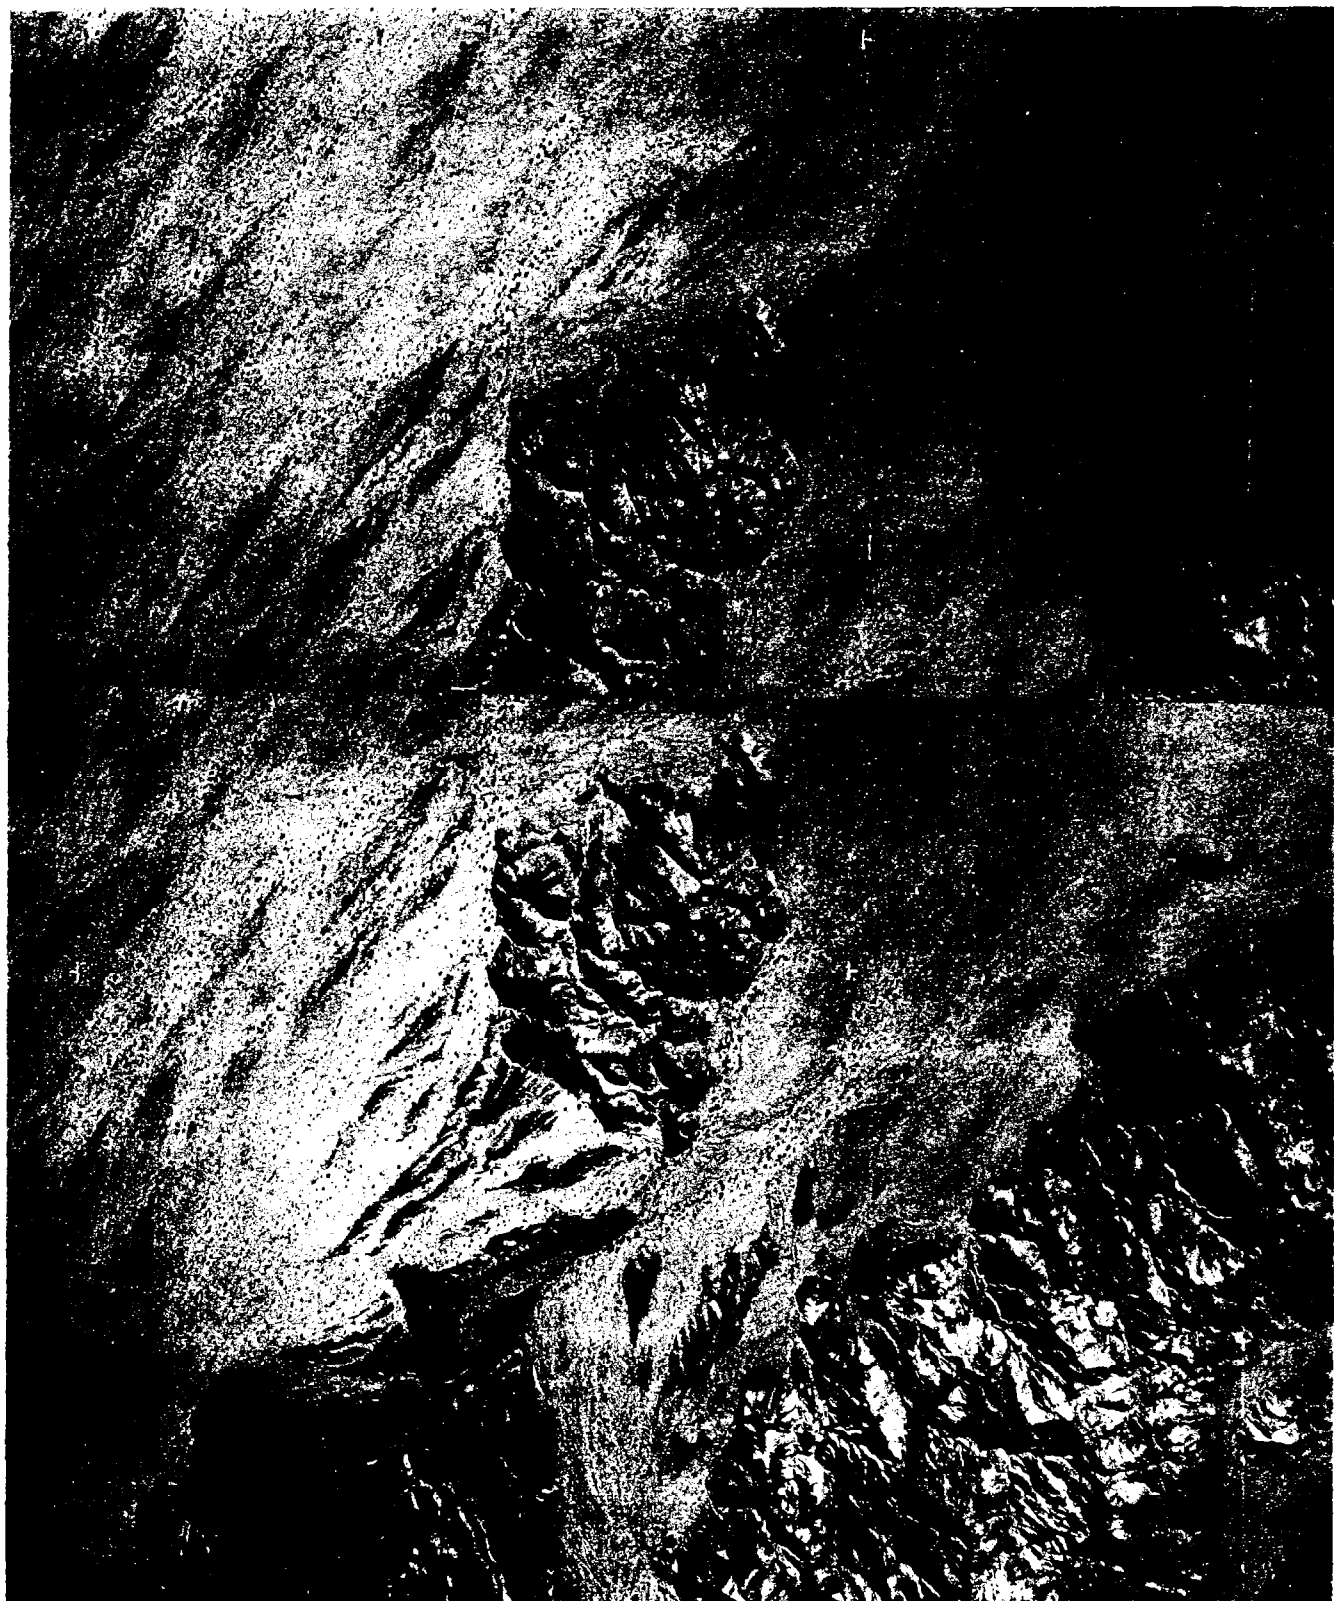
Plate 55. (a) This stereopair shows the zone of destruction and transportation in a filled valley area. The bare rock mountains and remnants are severely eroded while the vast sweep of debris is being transported downhill toward the center of the valley. The black spots that seem to form definite paths are desert shrubs that are growing in the shallow channels where subsurface water conditions are more favorable to growth. Here the texture of the material is predominantly coarse and little segregation has taken place.

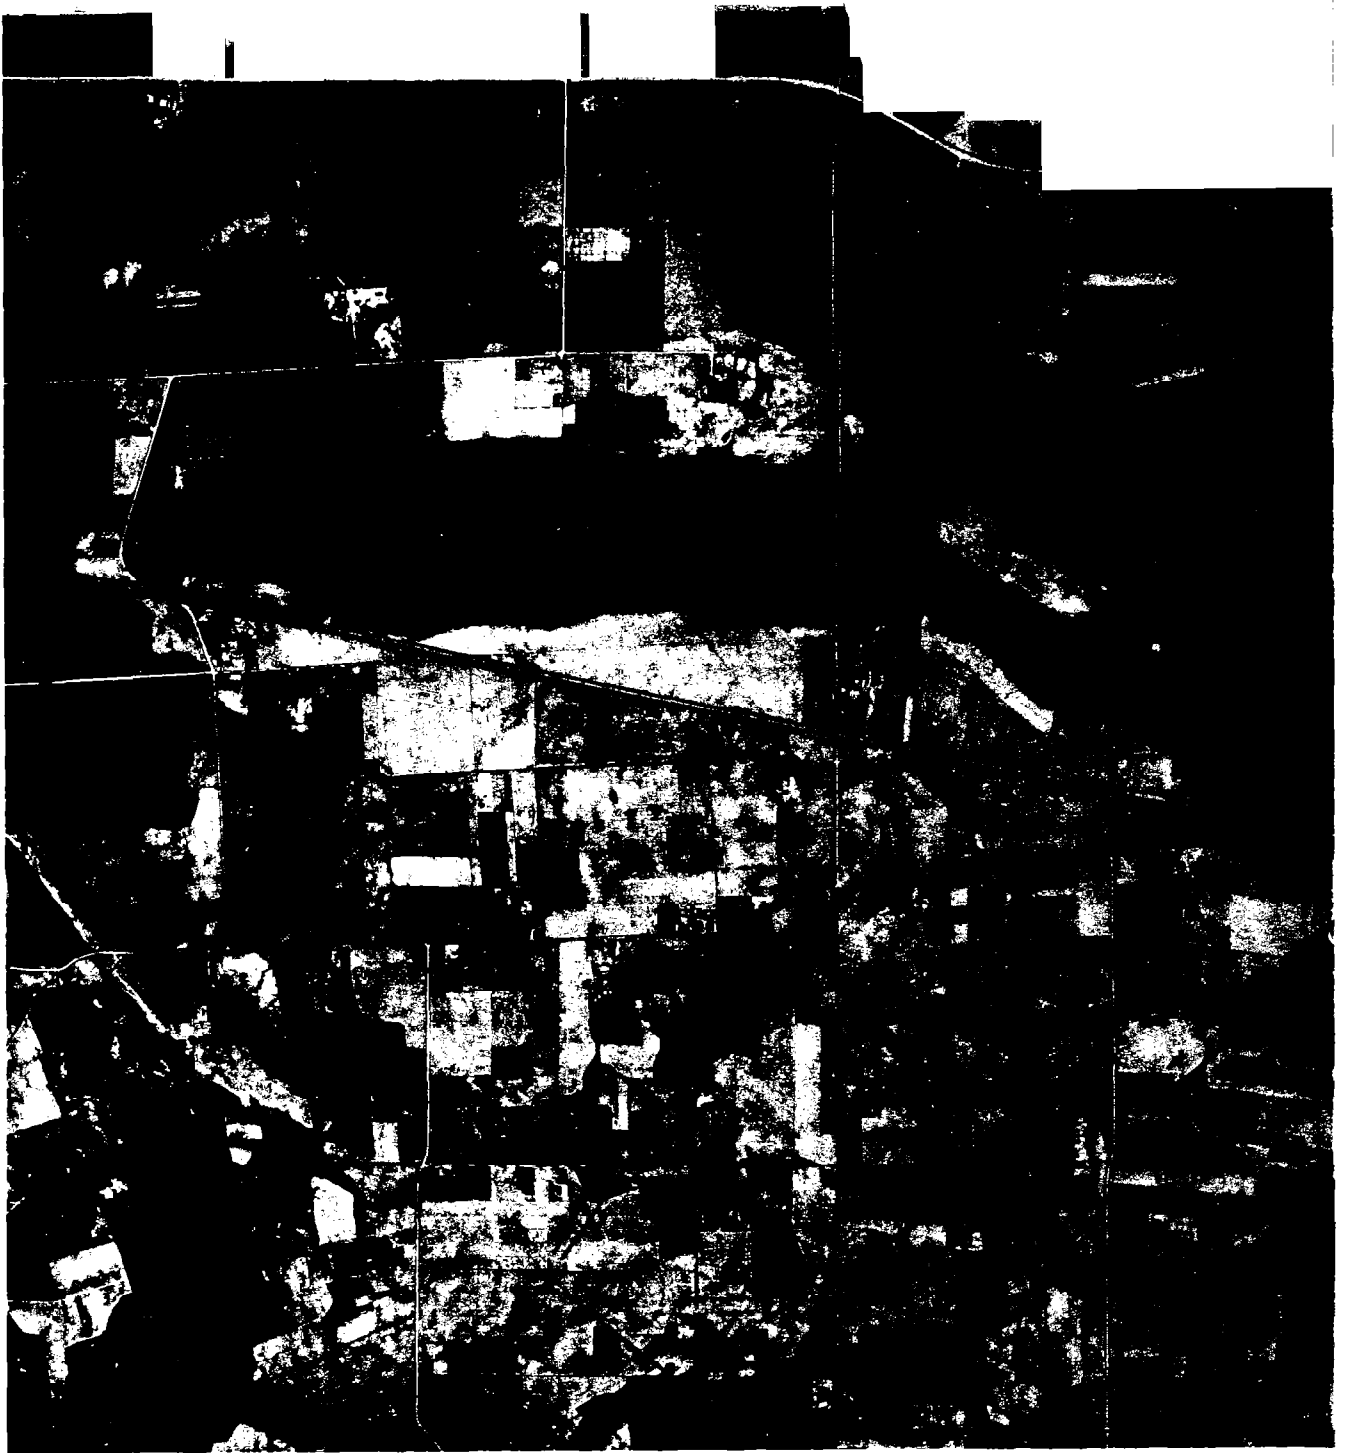
Plate 57. In the selection of sites in alluvial soil areas such as this a wide variation in subgrade conditions may be avoided by selecting well drained terraces for the general location as well as by shifting and adjusting the alignment of runways. The light-colored areas are coarse sand and fine gravel while the dark areas (channels) are wet silty clays. The mottled color pattern (M) on the major terrace indicates local occurrences of silty clay soil as the terrace tapers toward an impervious soil area. Orchards, (o), often an indication of well drained materials, are seen to be located on the light colored areas.

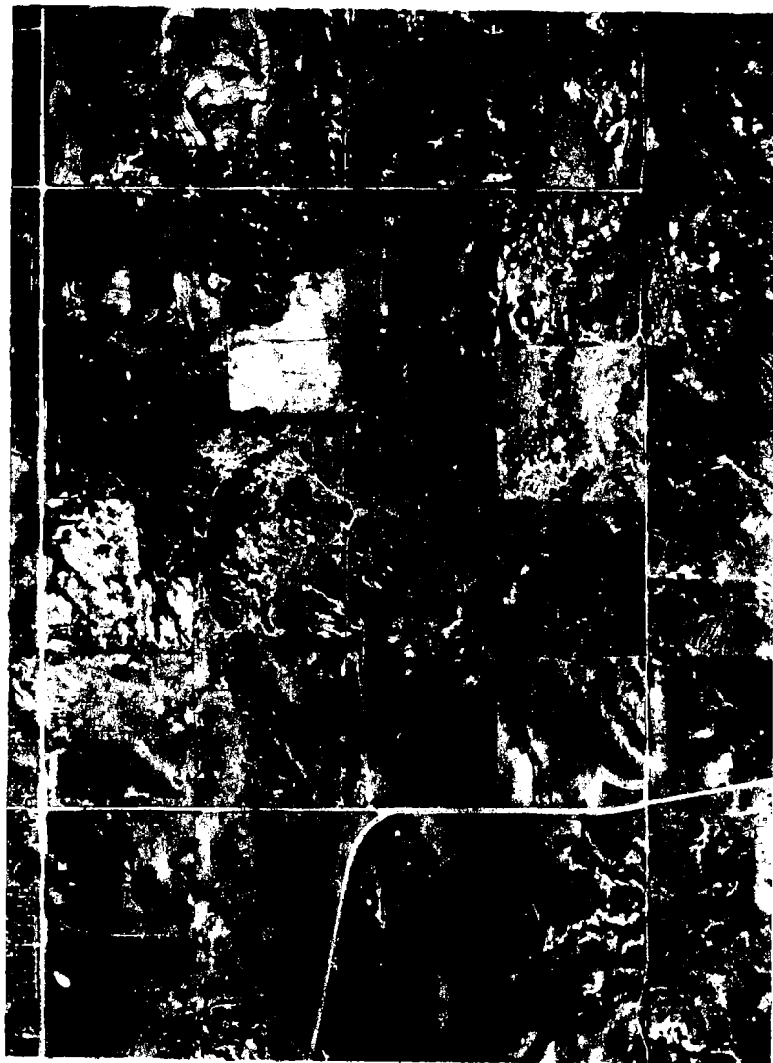
Plate 62. (a) Existing airport and vicinity illustrating the two types of erosion observed in the sandy clay and plastic clay soils. As the two dark V-shaped gullies progress through the sandy clays their shape changes to broad flat sections in the underlying clay soil farther down the slope. (See Figs. 70 and 71.)
