TECHNICAL DEVELOPMENT REPORT NO. 78

REPORT ON COMPARATIVE TESTS OF EXISTING  
TERRAIN CLEARANCE INDICATORS

March 1948

CIVIL AERONAUTICS ADMINISTRATION  
TECHNICAL DEVELOPMENT  
INDIANAPOLIS, INDIANA

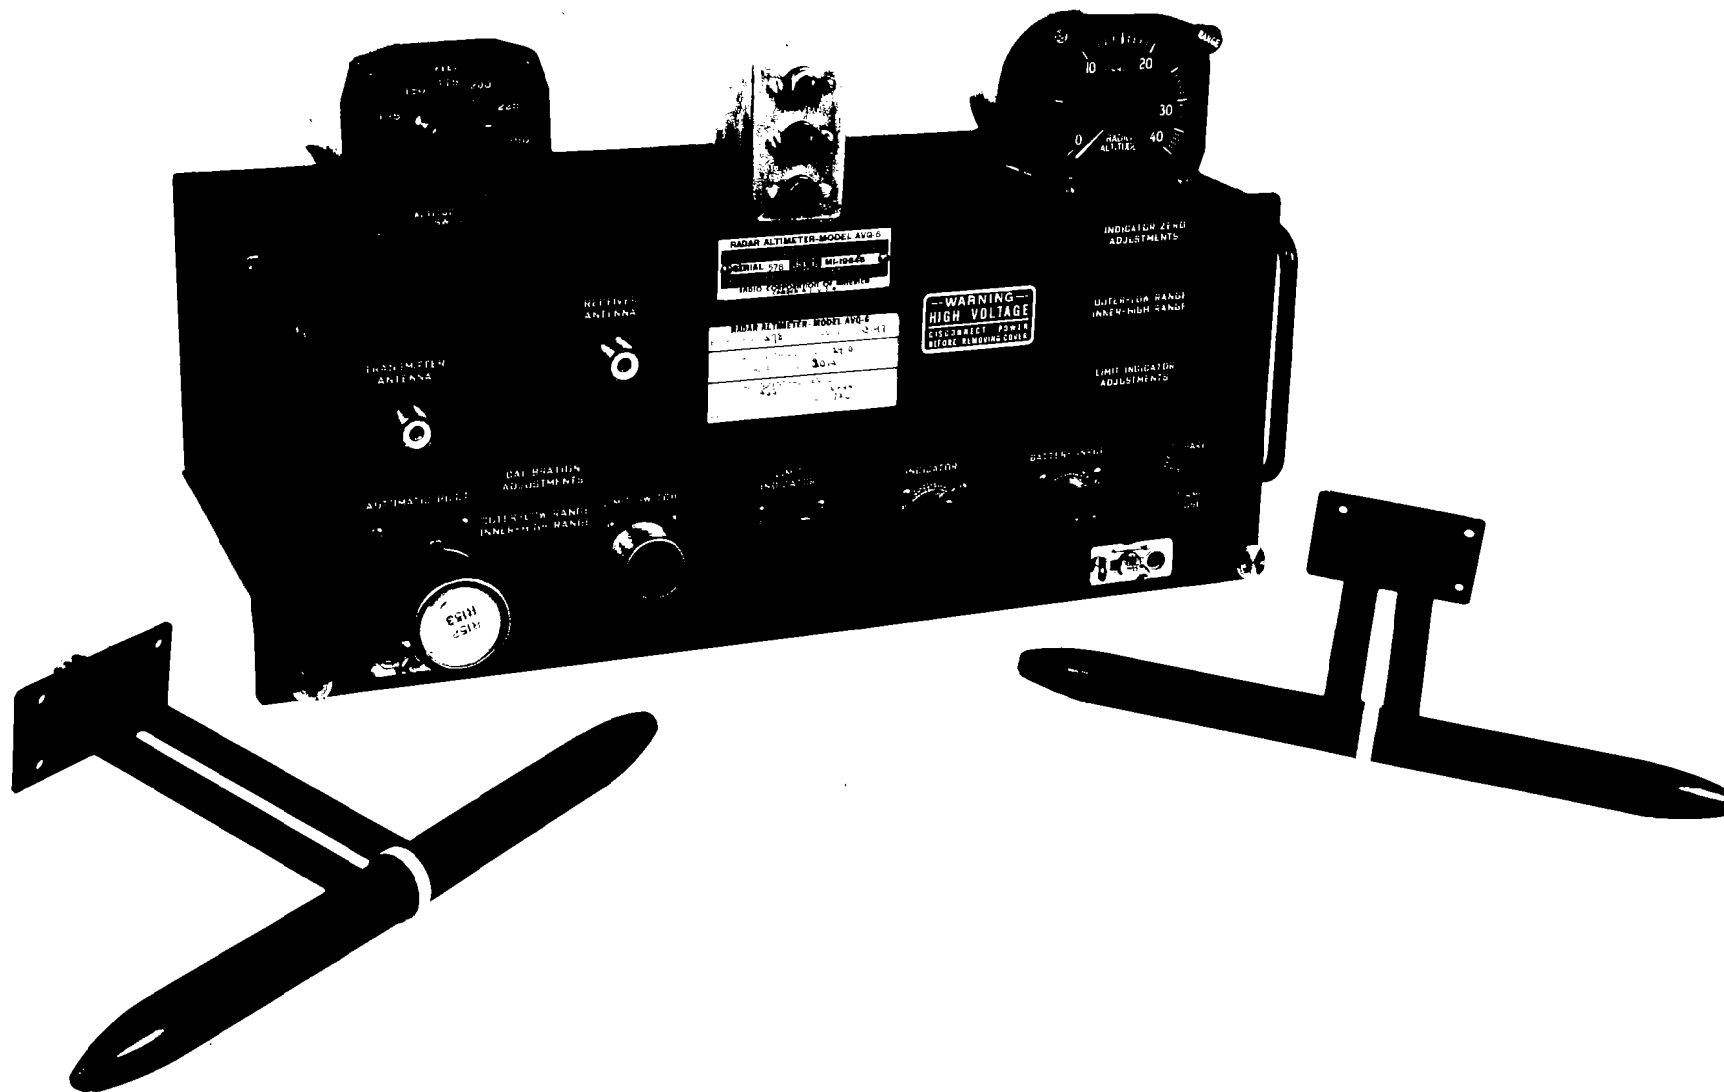
FIGURE 1. RADIO ALTIMETER, UNINSTALLED

The AVQ-6 radio altimeter which was used during these tests is manufactured by the Radio Corporation of America and is very nearly the same equipment as the APN-1 radio altimeter which was employed extensively by the armed services during the war. This device supplies continuous altitude information to the pilot through means of a d-c meter mounted on the instrument panel. Two altitude ranges are available, 0-400 feet and 400-4000 feet. Altitude measurement is accomplished by transmitting a frequency modulated carrier which varies between 420 and 460 megacycles. A portion of the energy striking the ground is reflected back to the airplane where it is received by a separate antenna. Since a finite time is required for this energy to travel to the ground and return, the return signal will be at a slightly different frequency than that of the transmitted carrier at the time of arrival of the return signal. The difference between these two frequencies is a measure of the distance to the reflecting surface and is in the audio range. A suitable detector is used to measure this frequency difference, and following detection, this audio wave form is shaped into a limited square wave for counting by conventional circuits, which in turn drive the indicating meter. The AVQ-6 radio altimeter weighs approximately 30 pounds including all accessories. It is contained in one box 19 1/16 x 7 9/64 x 7 1/16 inches and is shock mounted. There are 14 tubes in the equipment, and the power consumption is 70 watts at 27 volts d-c. Space is required on the aircraft instrument panel for a three-inch indicator, a three-inch limit switch, and three indicator lights. The complete equipment is shown in Fig. 1. Fig. 2 shows the indicator, limit switch, and indicator lights as mounted on the instrument panel, and Fig 3 shows the location of the two antennas.

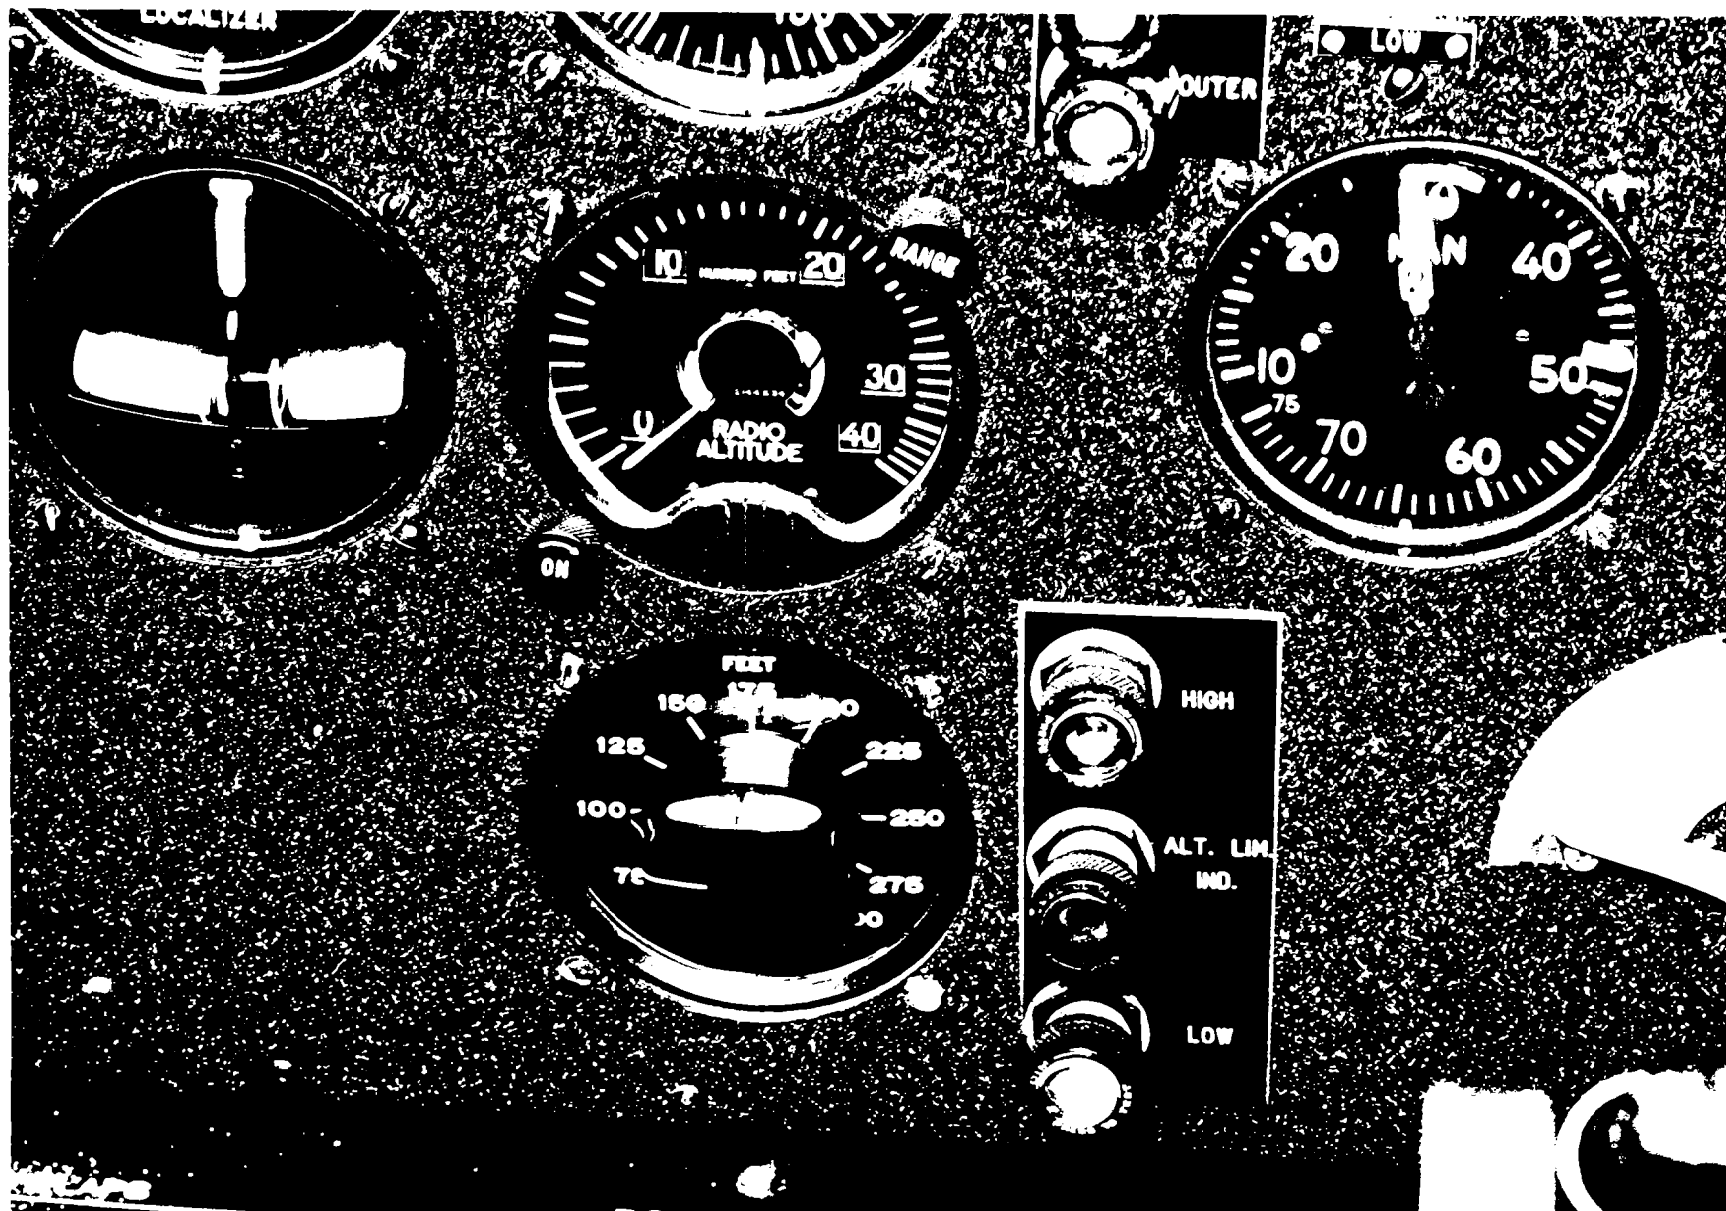
FIGURE 2. RADIO ALTIMETER COCKPIT INSTRUMENTATION
