RADAR IGNITION OF PHOTOFLASH LAMPS

Technical Development Report No 87

November 1948

**CIVIL AERONAUTICS ADMINISTRATION
TECHNICAL DEVELOPMENT
INDIANAPOLIS, INDIANA**

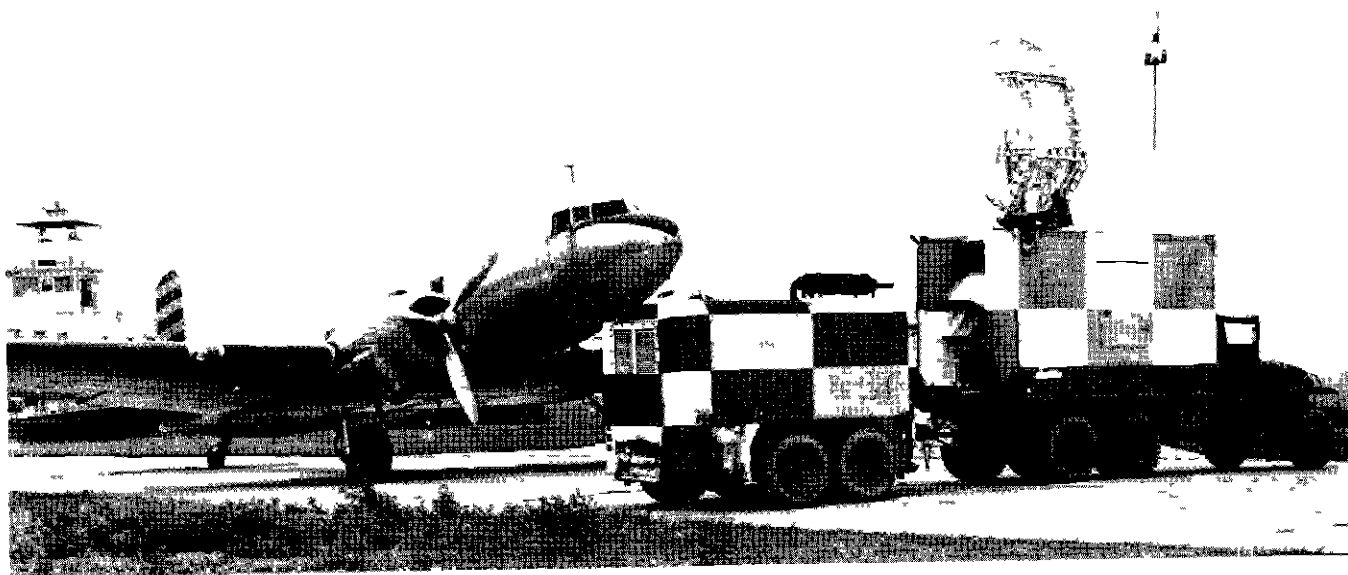
Fig 1 Relative Position of Aircraft and Ten Centimeter Radar

The ground tests were made with the same quantities of flash lamps in the forward and rear baggage compartments. An A/N-GPN-2 ten centimeter radar was positioned in front of the aircraft and the antenna oriented to direct energy through the windshield of the aircraft. The radar was turned on and left running for a 20-minute period. After the first 15 minutes had elapsed, the flashlamp cartons in both compartments were shaken and oriented through all conceivable positions in an attempt to ignite the lamps. The radar antenna was approximately 20 feet from the nose of the aircraft. See Fig. 1

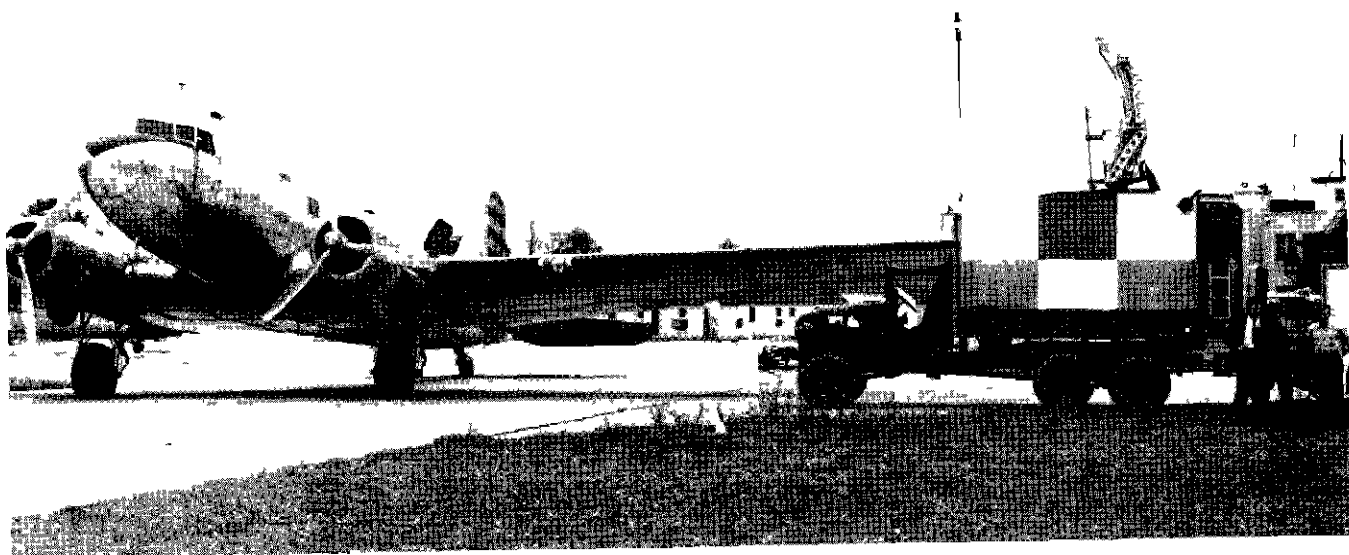
Fig. 2 Radar Directed at Forward Baggage Compartment of C-47

It is interesting to note that during one of the ground tests one carton of flash lamps was positioned directly in front of a plexiglass window in the forward baggage compartment. The radar antenna was at a wing-tip position. Figs. 2 and 5 show the relative positions of radar and flash lamps during this test. Figs. 1 through 4 show the relative positions of the aircraft and radar during the ground tests. Figs. 8, 9, and 10 show the positions of cartons in the forward compartment as they were placed for both the flight and ground tests. Figs. 6 and 7 indicate the carton positions in the rear compartment

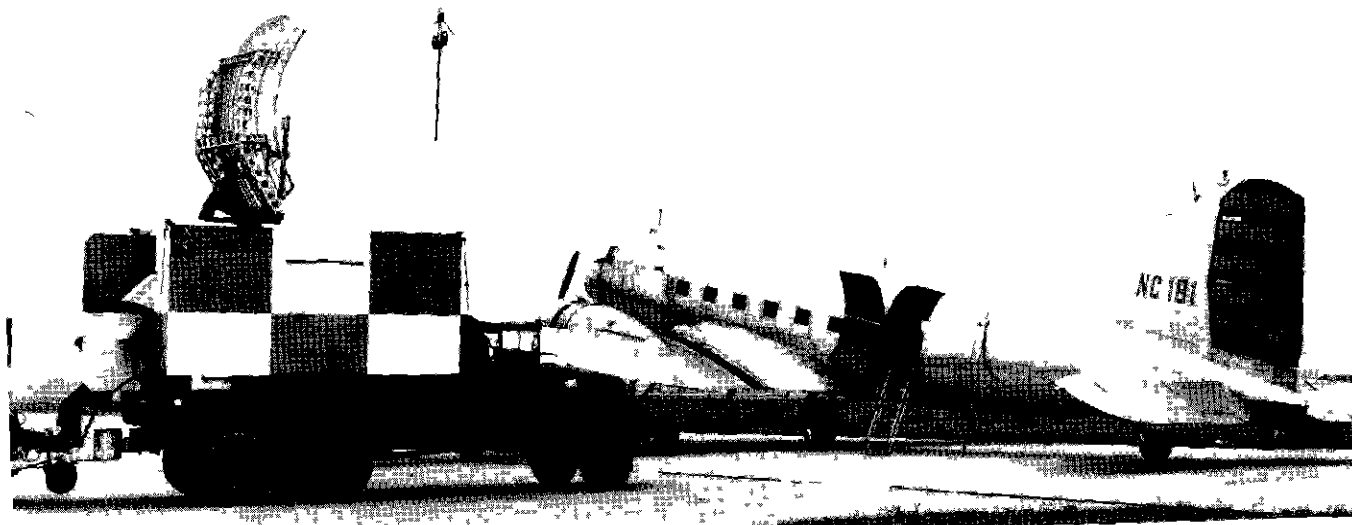
Fig 3 Radar Directed at Rear Compartment of C-47

In the successive ground tests, the radar was repositioned at the side and tail sections of the aircraft as shown in the photographs. The distance from the radar antenna to the cabin wall was approximately 35 feet. Twenty-minute exposures were made at each position

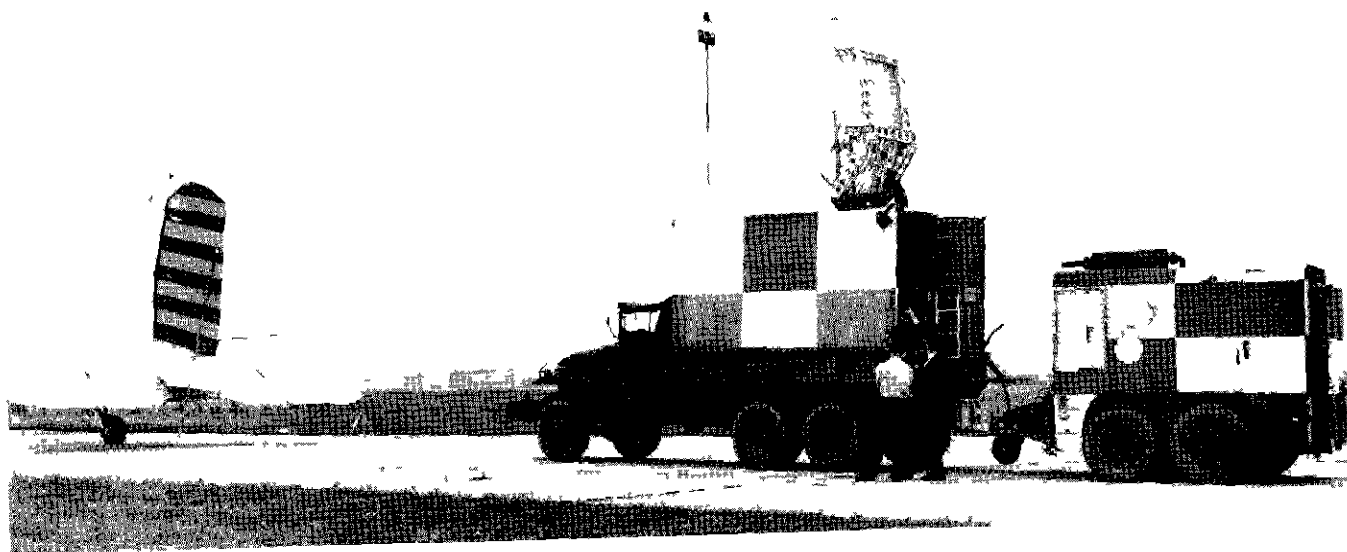
Fig 4 Radar Directed at Tail Section of C-47

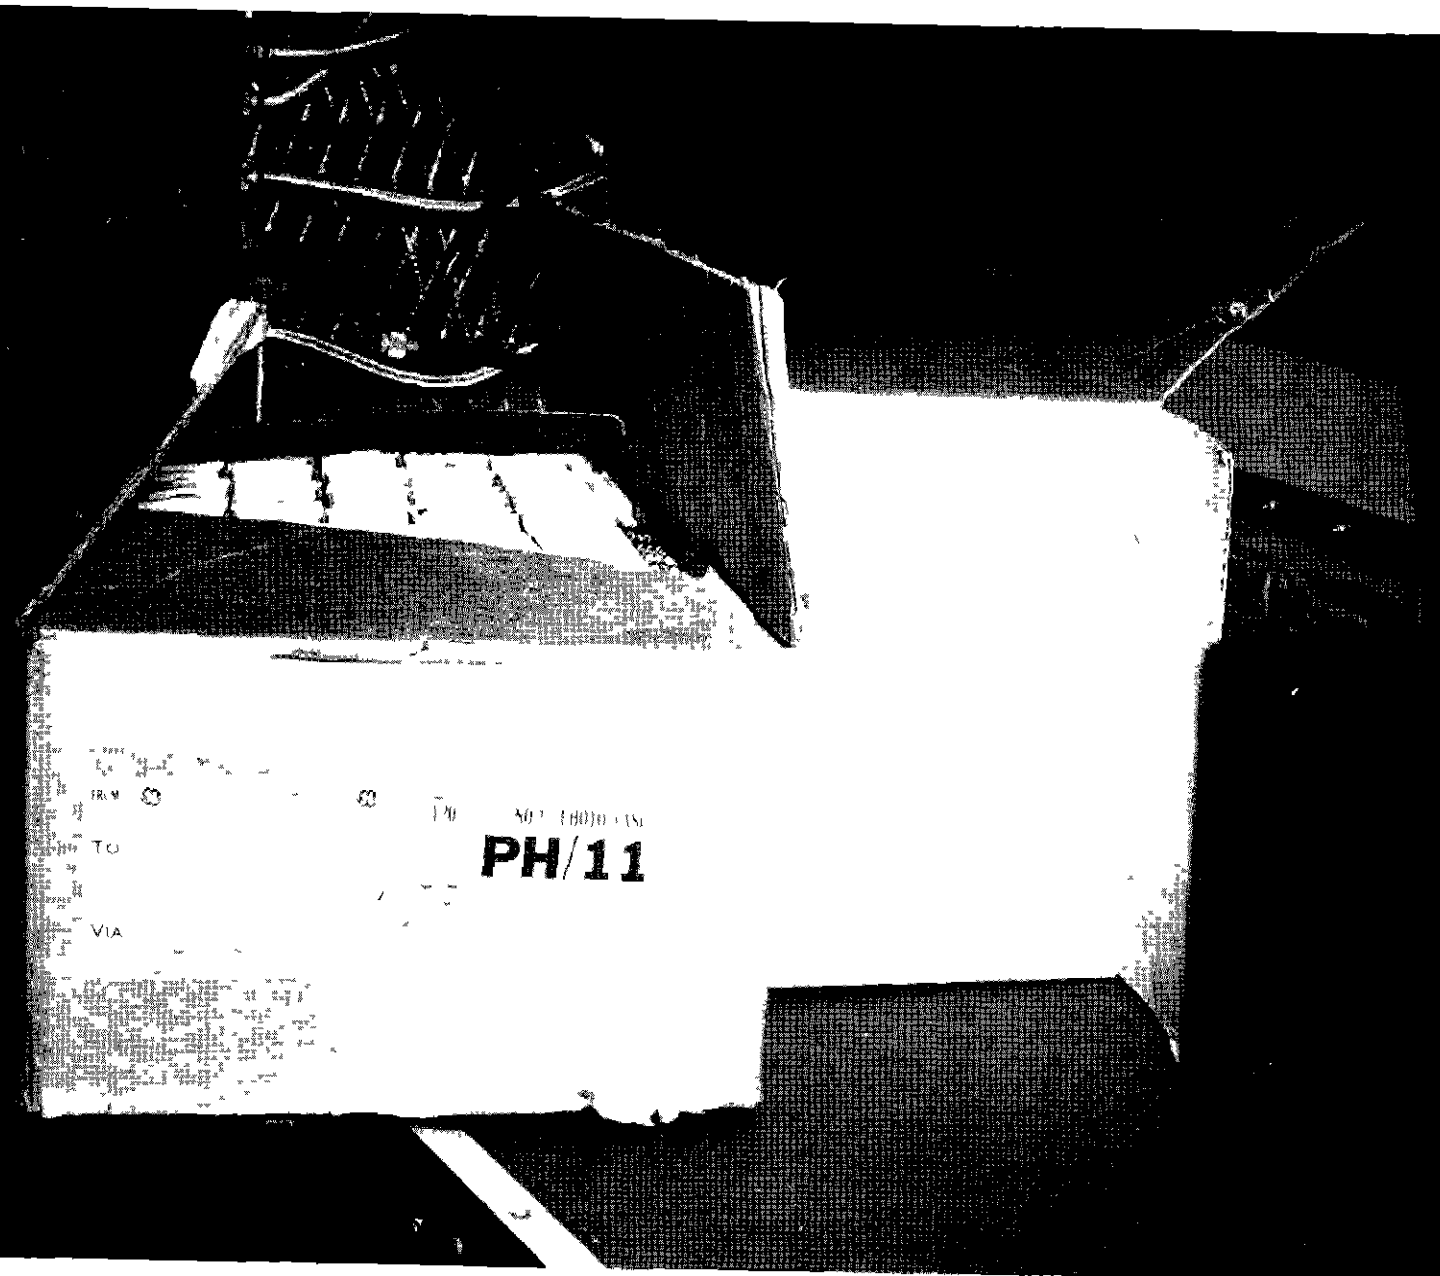
Fig 5 Radar Directed at Flash Lamps Through Plexiglass Window

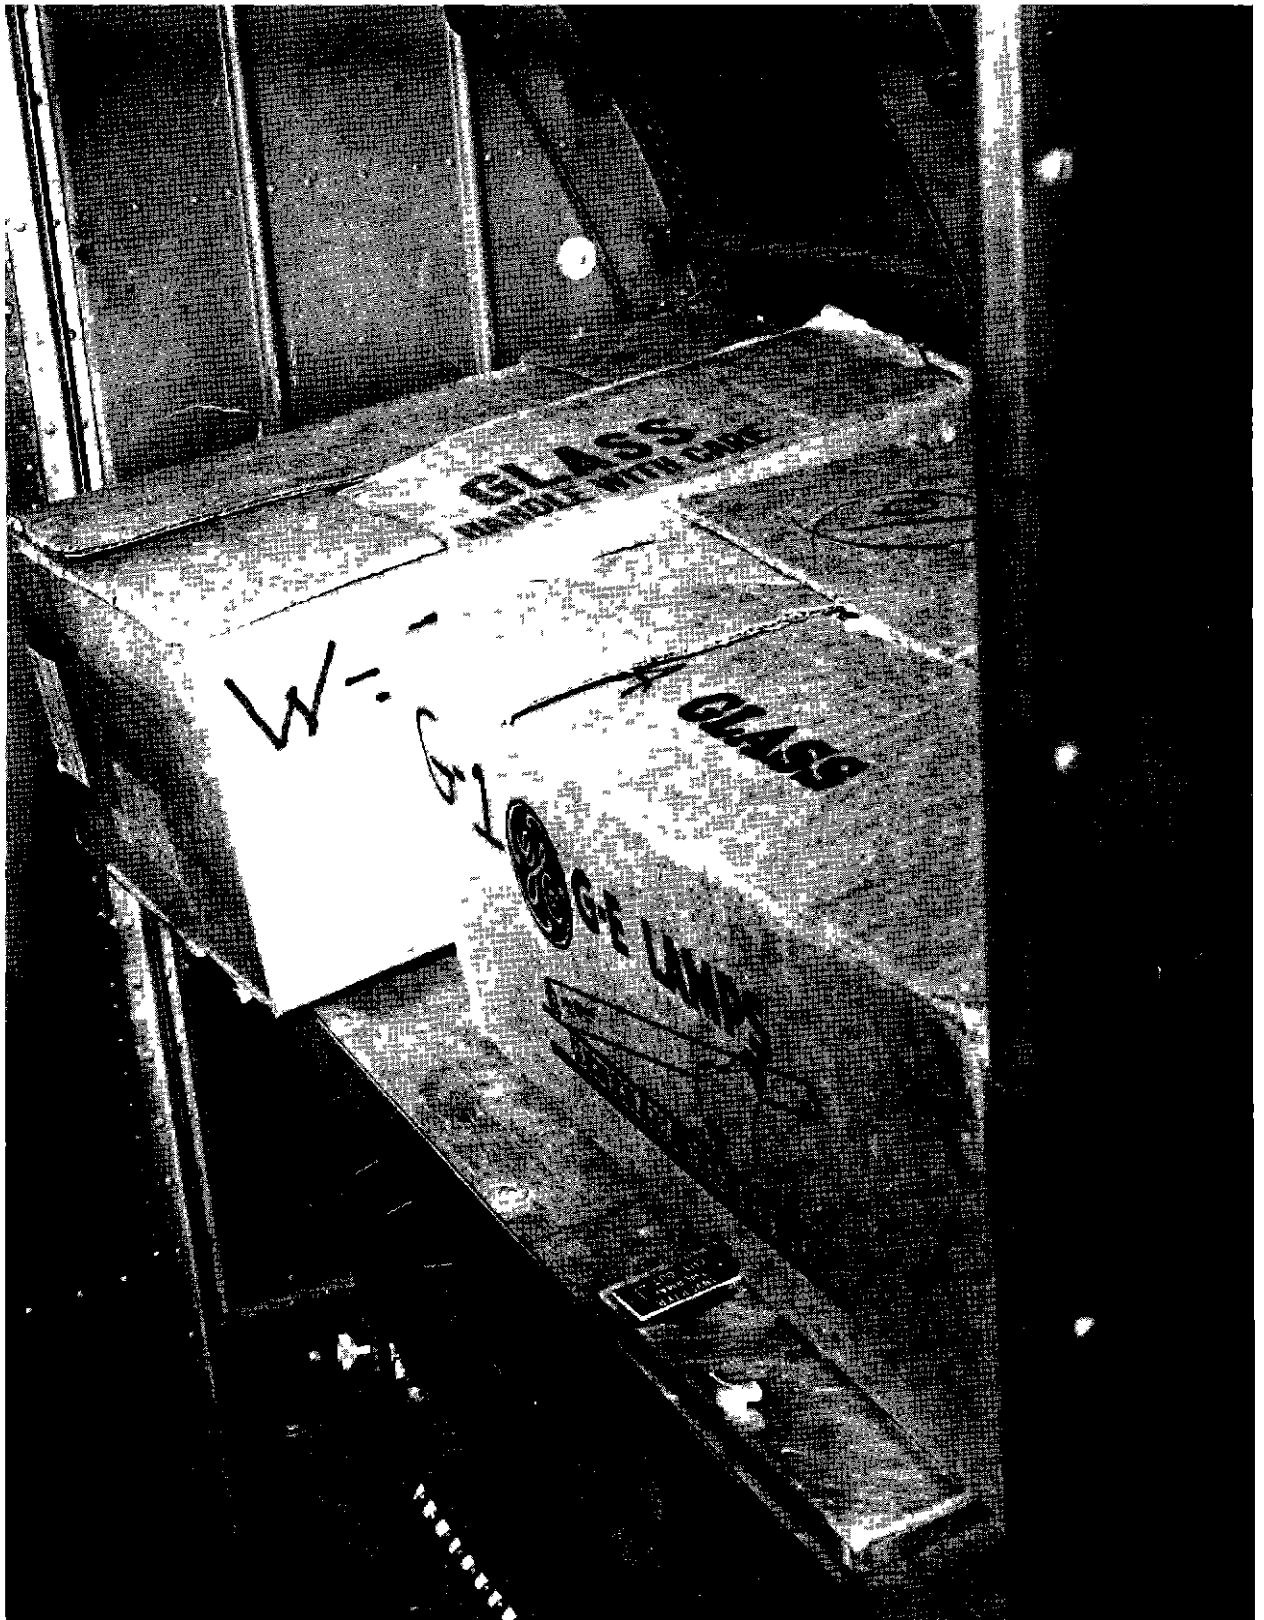
Fig 6 Position of Flash Lamp Cartons in Rear Compartment

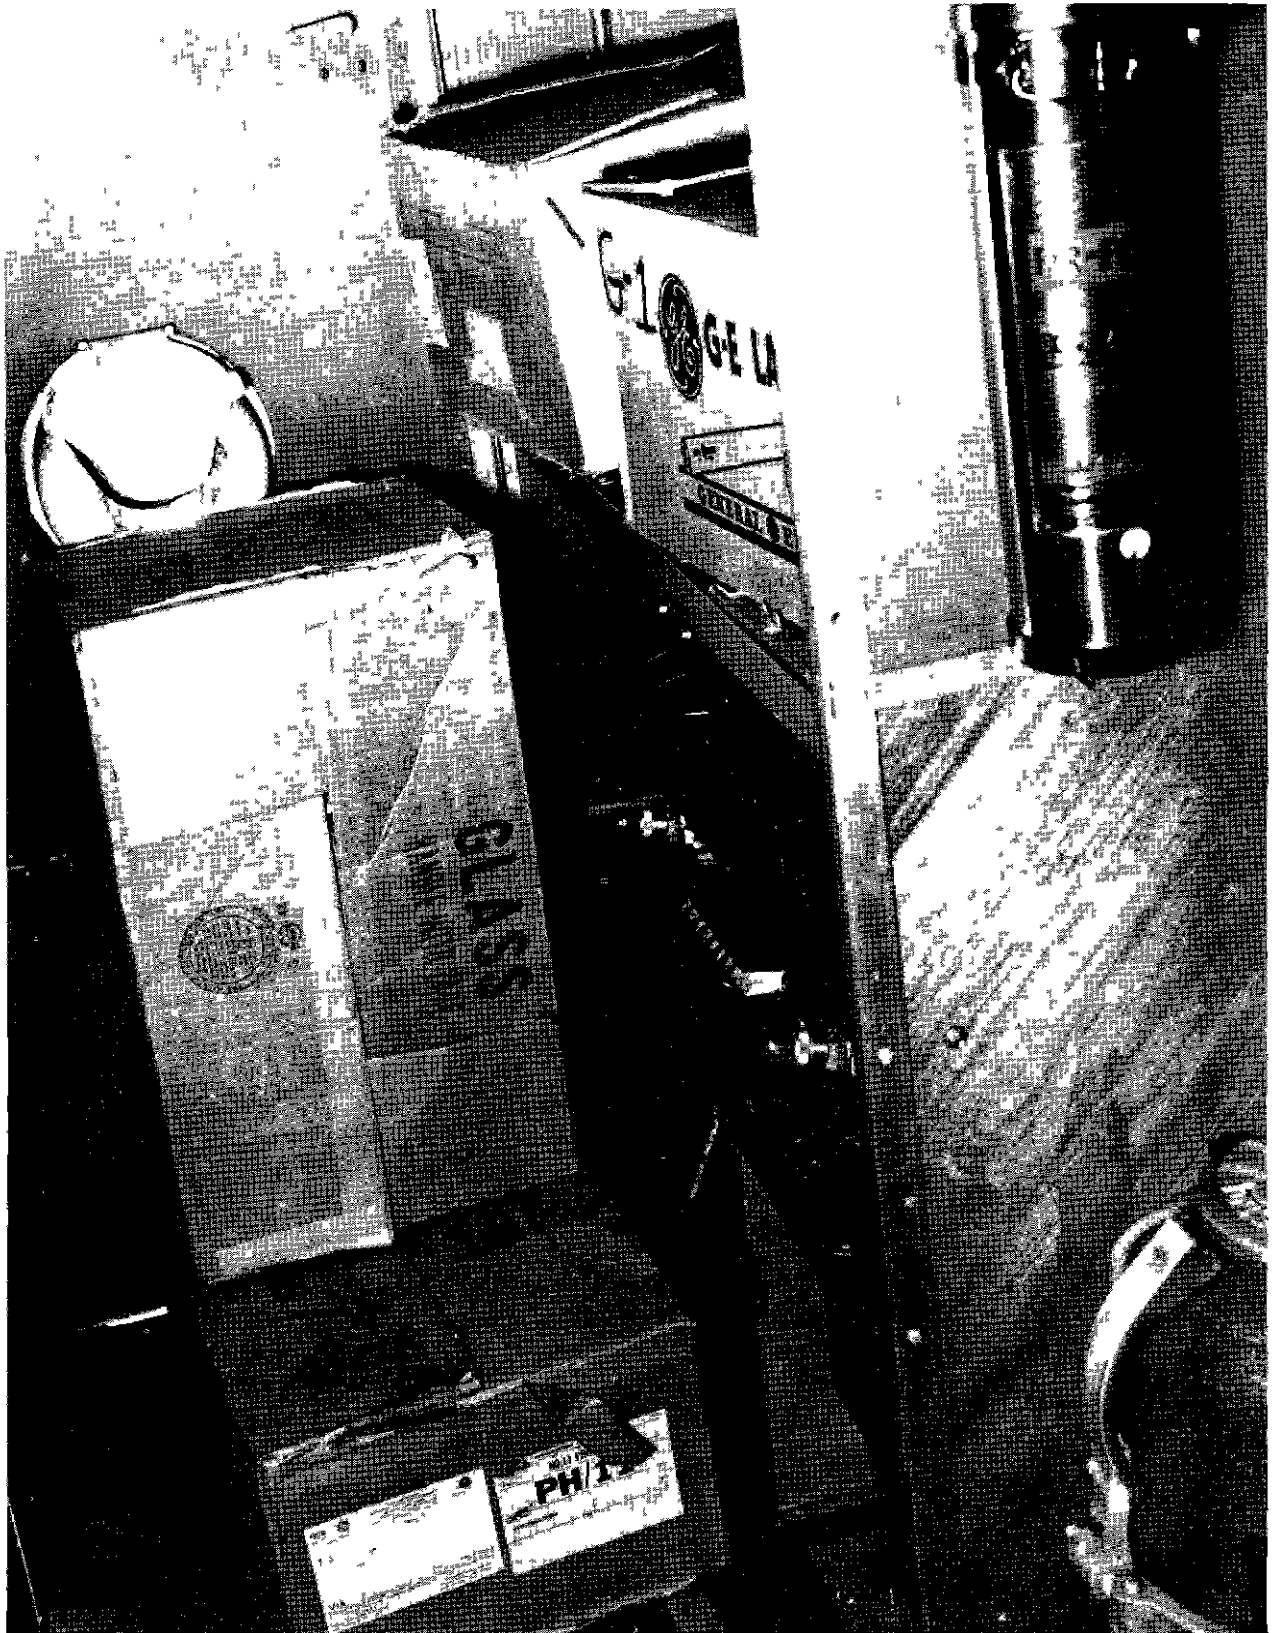
Fig 7 Position of Flash Lamps in Rear Compartment

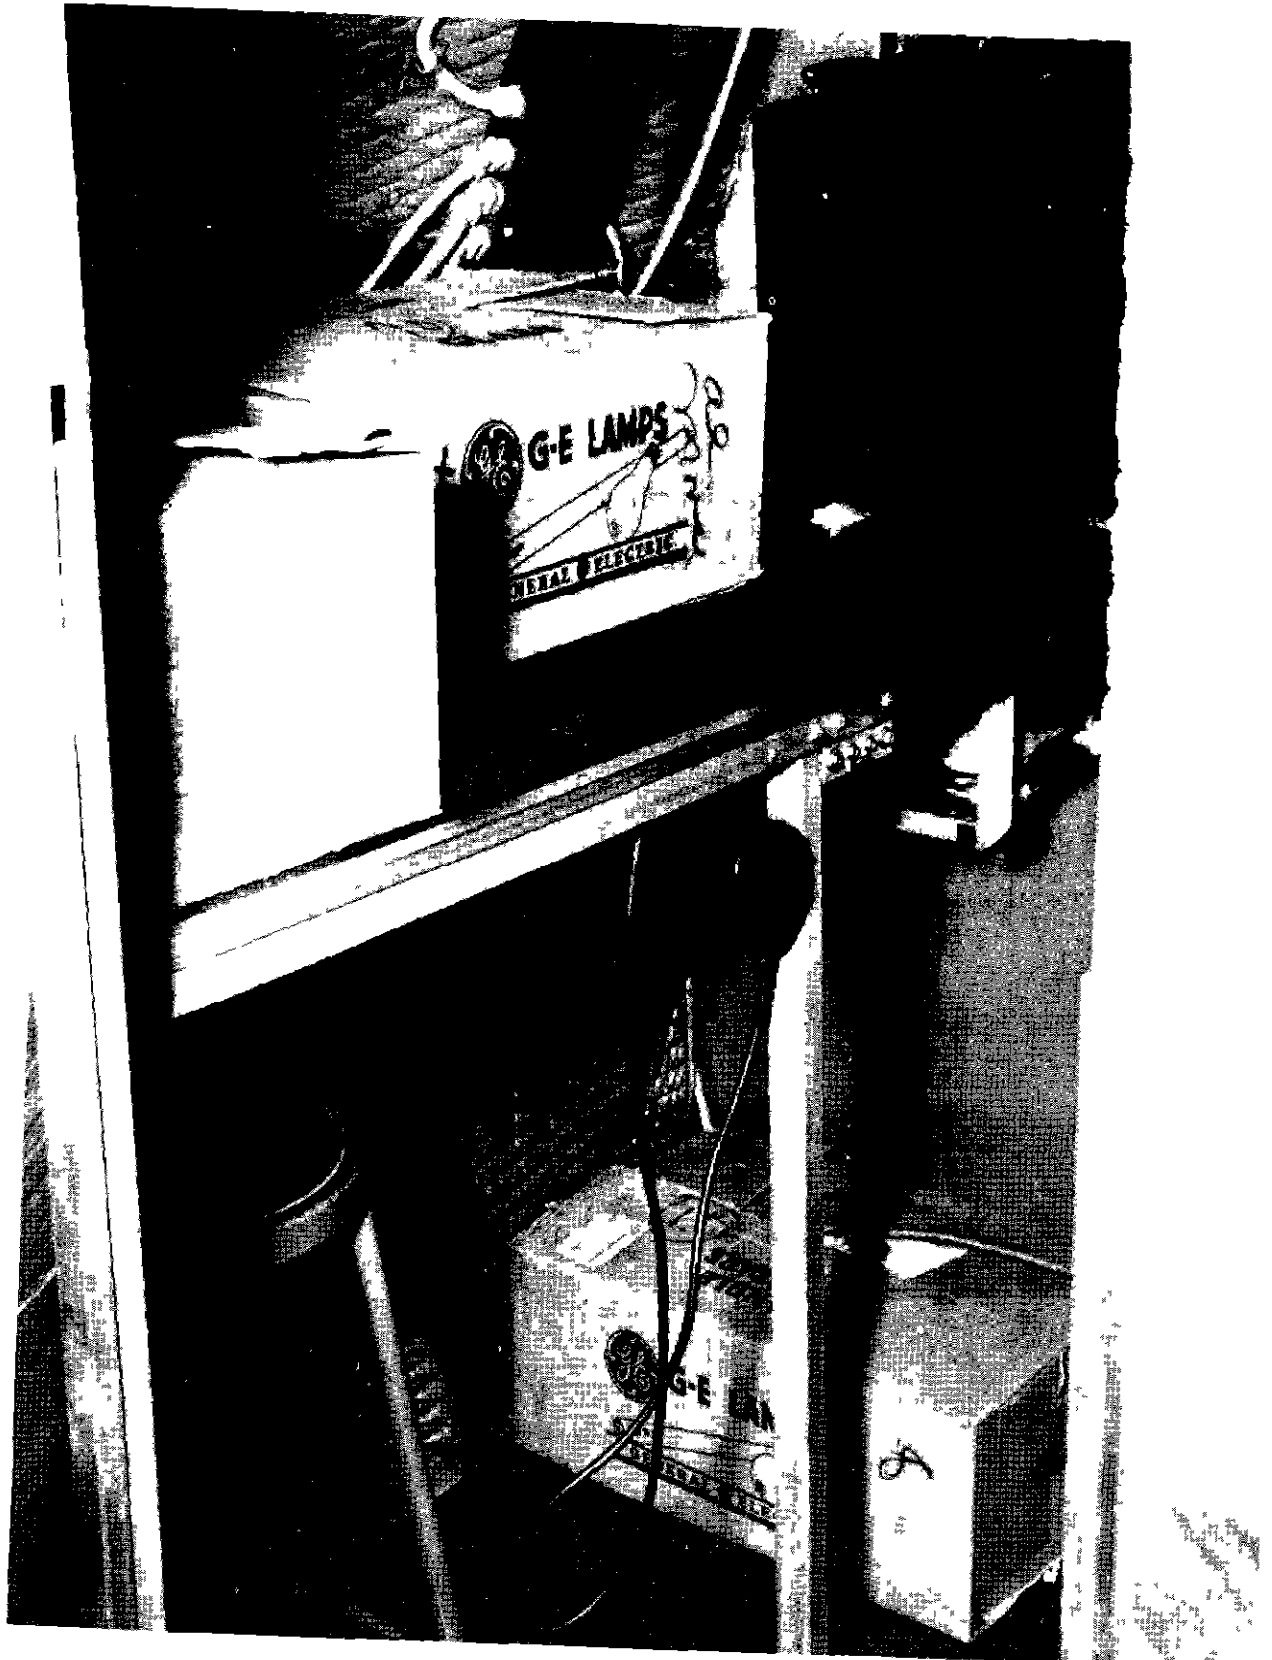
Fig. 8 Position of Flash Lamp Cartons in Forward Compartment

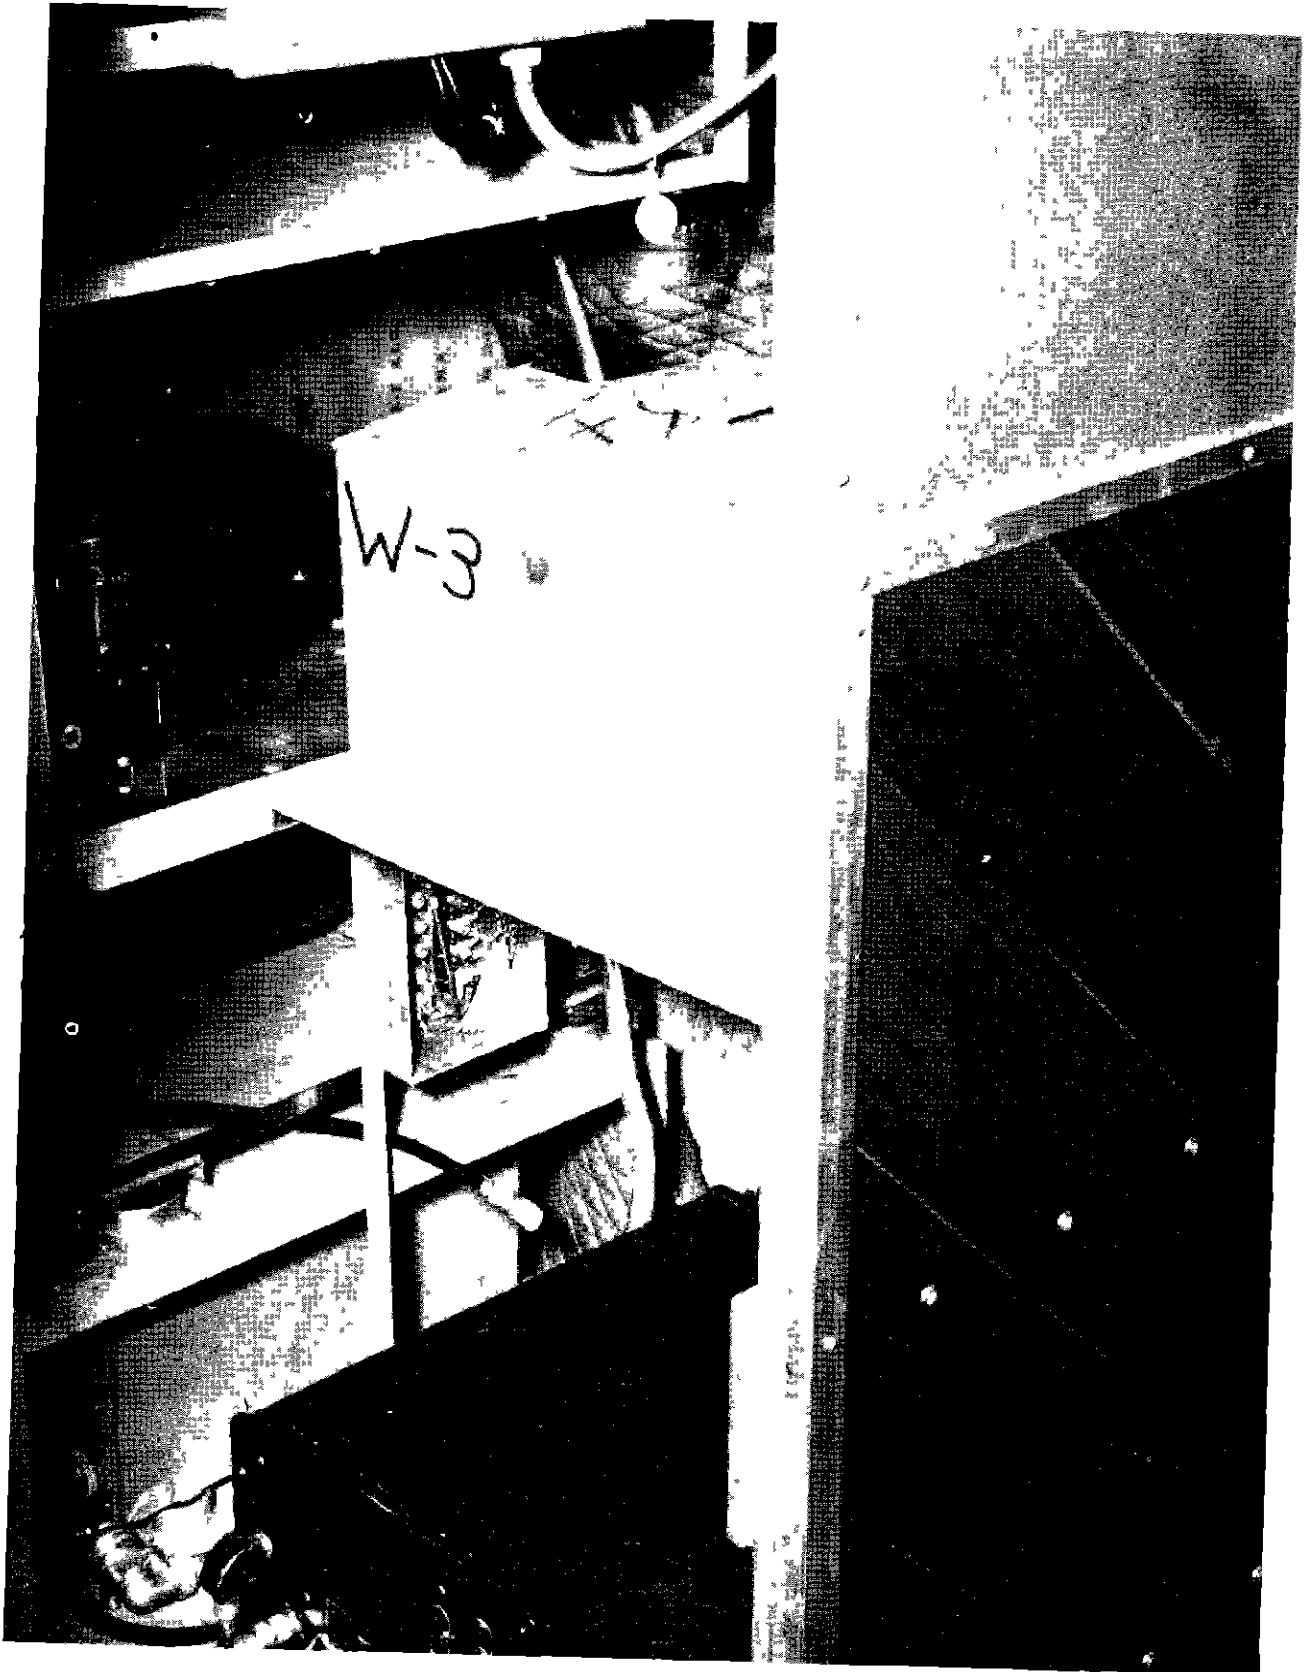
Fig. 10 Position of Flash Lamp Cartons in Forward Compartment
