THE DEVELOPMENT OF TECHNIQUES FOR THE UTILIZATION OF VHF RADIO IN LIGHT AIRCRAFT

Technical Development Report No 116

CIVIL AERONAUTICS ADMINISTRATION
TECHNICAL DEVELOPMENT AND
EVALUATION CENTER
INDIANAPOLIS, INDIANA
June 1950

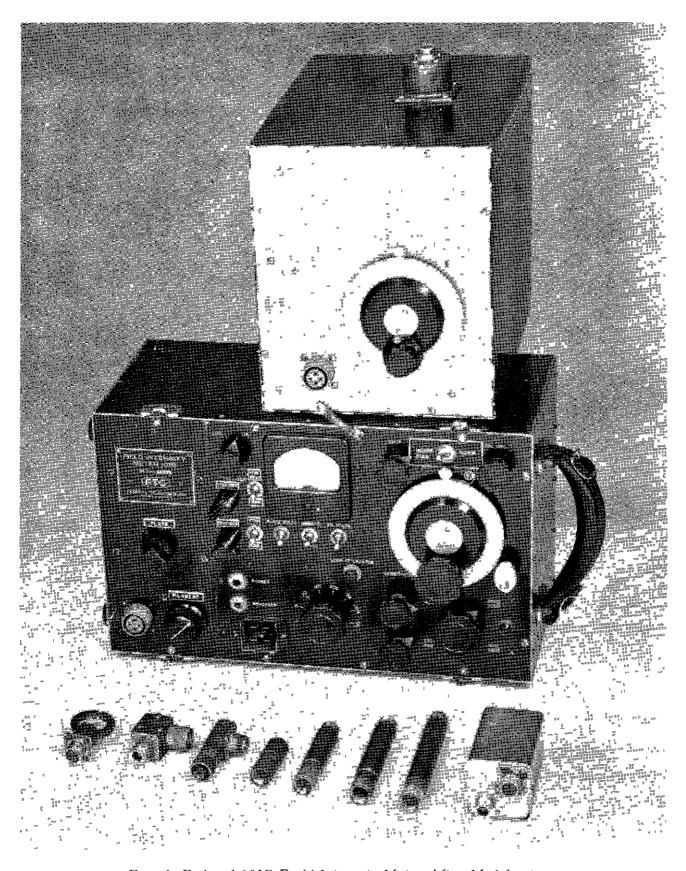
Fig. 1 Federal 101B Field Intensity Meter After Modification

The following changes were made in this instrument to adapt it for use in making noise intensity measurements in the frequency range 108-126 Mc See Figs 1, 2 and 3

was constructed. This converter uses a pair of 6J4 tubes in a push-pull grounded-grid input circuit to provide a good termination for a 100-ohm balanced transmission line. These 6J4's feed a 6J6 first mixer stage having an intermediate frequency output of 30 Mc. A 6C4 is used as local oscillator for the first mixer. A stage of 30 Mc intermediate frequency amplification using a 6AK5 tube, and 6BE6 second mixer-oscillator with an intermediate frequency output of 3.5 Mc for the field intensity meter are provided.

- 2 The power supply in the field intensity meter was replaced by a Mallory Type VP-G 556 Vibrapack to permit operation from a 12-v aircraft battery
- 3 A vacuum-tube voltmeter weighing circuit was incorporated in the basic field intensity meter with provision for switching it into the output of the detector to measure peak noise. Voltmeter time constants of 10 milliseconds on charge and 600 milliseconds on discharge were provided.

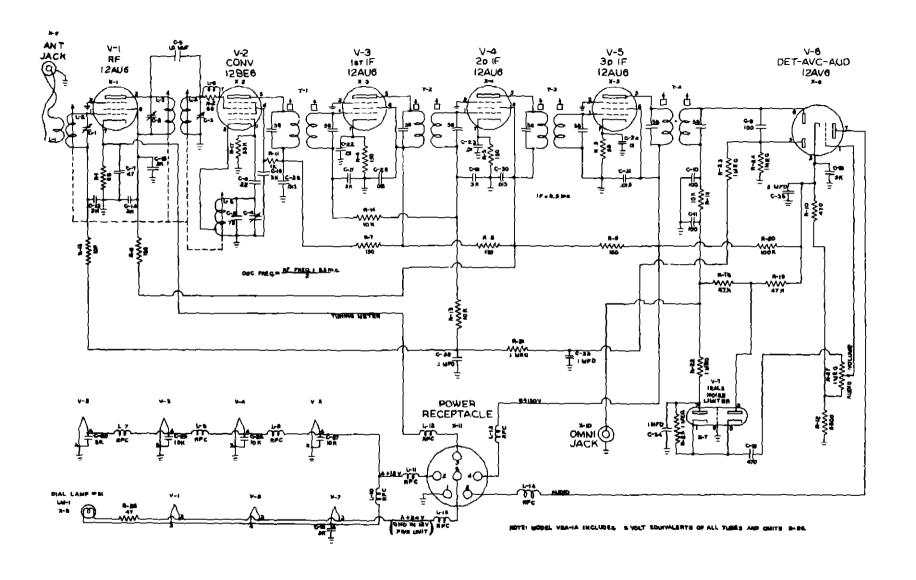
Fig 4 NARCO VRA-1 Receiver

Little difficulty was experienced in modifying a NARCO (National Aeronautical Corporation) Model VRA-1 VHF Receiver to function as a VHF noise intensity meter. However, it was found that satisfactory results could not be obtained by simply connecting an audio noise voltmeter across the receiver audio

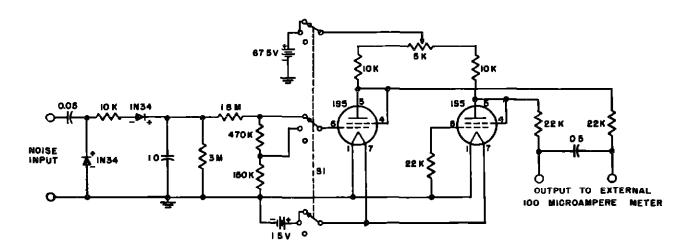
Fig 5 Audio Noise Meters

Any high-impedance audio frequency voltmeter having the proper damping and frequency characteristics is satisfactory for employment with the NARCO Receiver as outlined previously. The meter damping required in a study of aircraft ignition noise is related to the speed of the aircraft engine involved, the noise consisting essentially of sharp pulses produced by the magneto. Suitable damping constants are a 10 millisecond rise and 600 millisecond decay time for the indicating meter.

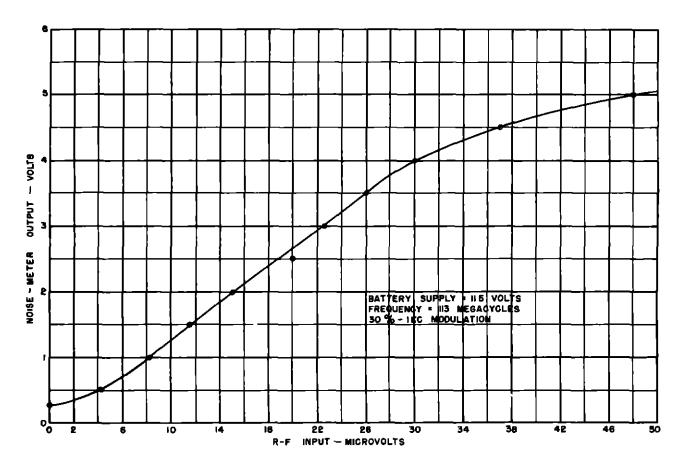
Fig 7 ERI-NARCO VHF Noise Meter Linearity Curve

as 1 0 v, corresponding to the audio output obtained with 30 per cent modulated receiver inputs of less than 8 microvolts (Fig. 7), were considered good

^{*} Volts at output of ERI-NARCO VHF noise meter See Fig 7

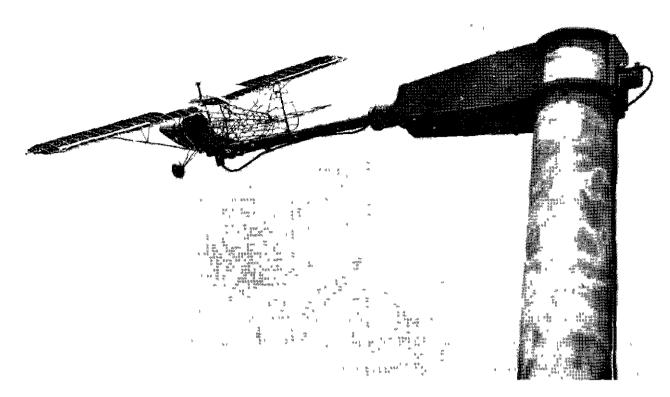
Fig 8 Piper Cruiser Model Test

models of the aircraft and proportional scaling of the wavelengths associated with the antennas involved. In order that the most advantageous location for the CAA V-109 antenna on the Piper Cruiser aircraft might be ascertained, a 1/12 size scale model of the aircraft and antenna was made. A model of this size was suitable for use on the model range of Electronics Research, Inc. since the pattern measurements could be made at 12 times the normal operating frequency of 118 Mc or approximately 1,420 Mc. See Fig. 8. This

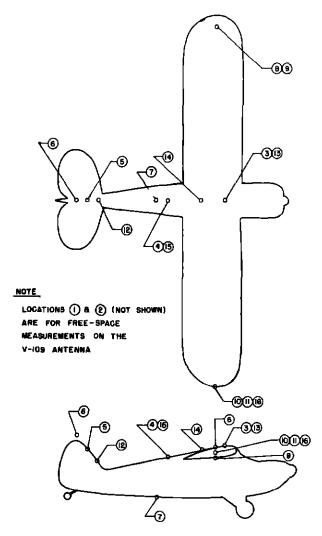
Fig 9 Antenna Test Locations on Piper Cruiser Model

model technique made it relatively easy to check the performance of a large number of antenna arrangements (Fig. 9) on the Piper Cruiser

Pattern measurements were made with the 1/12 scale model of the Piper Cruiser and V-109 antenna with the antenna at a point above the forward part of the cabin (Location 3, Fig 9) The patterns obtained are given in Fig. 13 for comparison with the free-space patterns for the same antenna (Fig. 11) Pattern 3 for Plane 1 is similar to the free-space pattern and is satisfactory. While the patterns show large upward lobes, there still is appreciable reception in useful directions Pattern 3D, with deep downward nulls, again indicates shielding by the fuselage. The crosspolarization patterns, 3A, 3C and 3E, are satisfactory Patterns 3F and 3G were taken with the aircraft in a position simulating flight directly toward and away from the illuminating antenna with the aircraft rotating on its fore-and-aft axis (Axis 4, Fig. 10) simulating a 360° roll of flight These two patterns are not of great significance, the nulls being due to cross polarization

The patterns of Fig. 13 indicate that this antenna location (Location 3, Fig. 9) is satisfactory. There is considerable shielding by the metal structure of the aircraft, causing appreciable useless upward antenna sensi-

The V-109 antenna was mounted at a position on the upper side of the port wing of the Piper Cruiser (Location 8 Fig 9) Again the antenna elements were flush with the fabric Fig 18 gives the results obtained at this installation

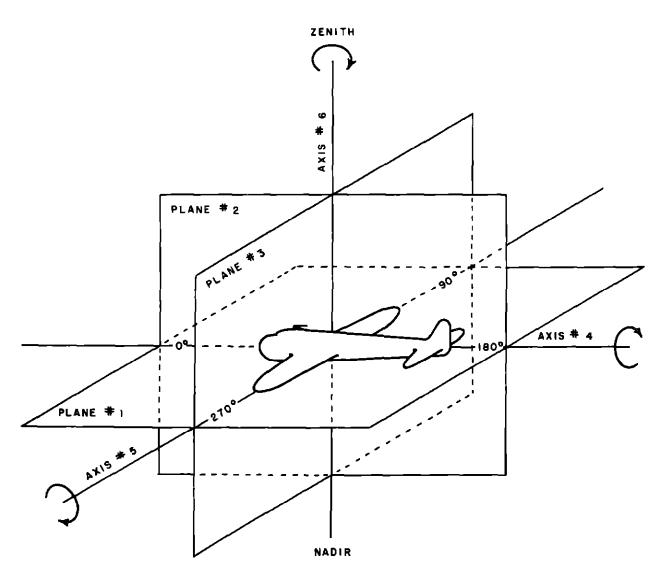
Fig. 10 Plane And Axis Terminology for Aircraft Antenna Field Patterns

Fig. 11 showing the patterns obtained on the V-109 antenna confirms that it has acceptable characteristics. Pattern 1 for the horizontal plane (Plane 1, Fig. 10) shows that the response is concentrated fore and aft as desired. Pattern 1B for the fore-and-aft vertical plane (Plane 2, Fig. 10) shows the desired freedom from downward nulls, but that about half of the antenna pickup is directed uselessly in an upward direction. Pattern 1D for the vertical plane athwartship (Plane 3,

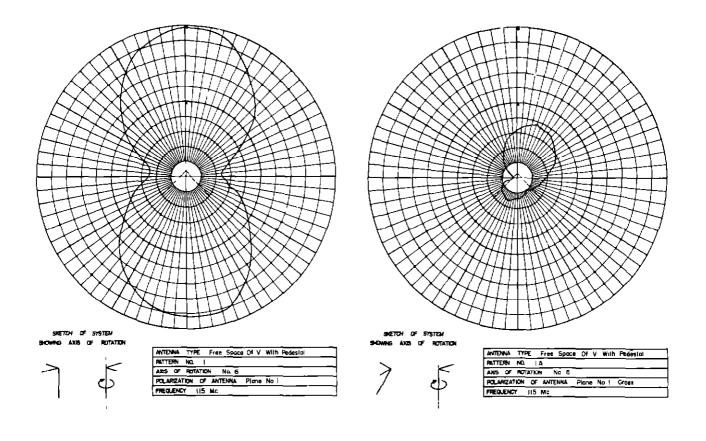
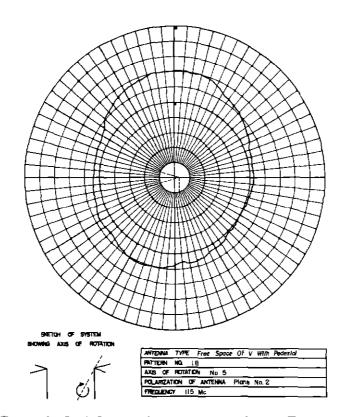
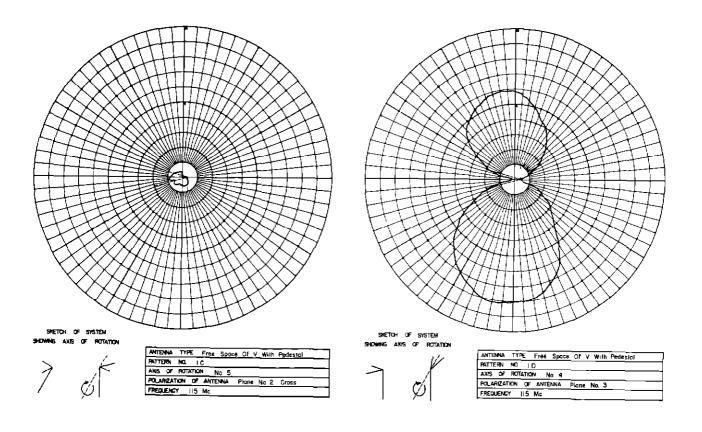
Fig 11 CAA V-109 Antenna Free-Space Patterns

The first pattern tests made were on a full-scale model of the CAA Type V-109 antenna at 115 Mc These tests were made to determine the free-space characteristics of this conventional type of antenna

Fig 10) shows most of the received energy is from below the aircraft with nulls to the side which are somewhat deeper than desired Cross-polarization measurements for the three planes, Patterns 1A, 1C and 1E indicate that cross-polarized radiation is negligibly small

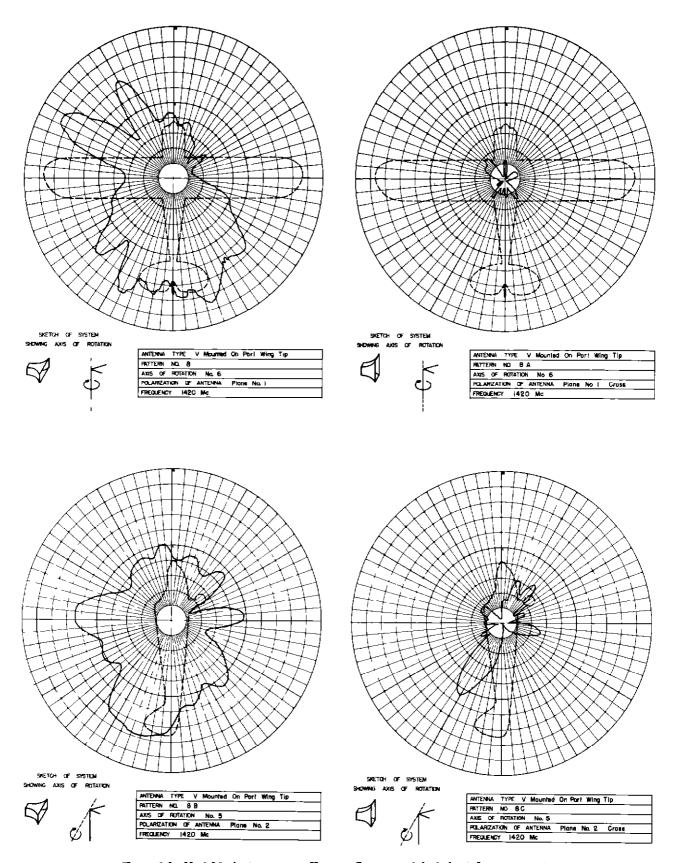
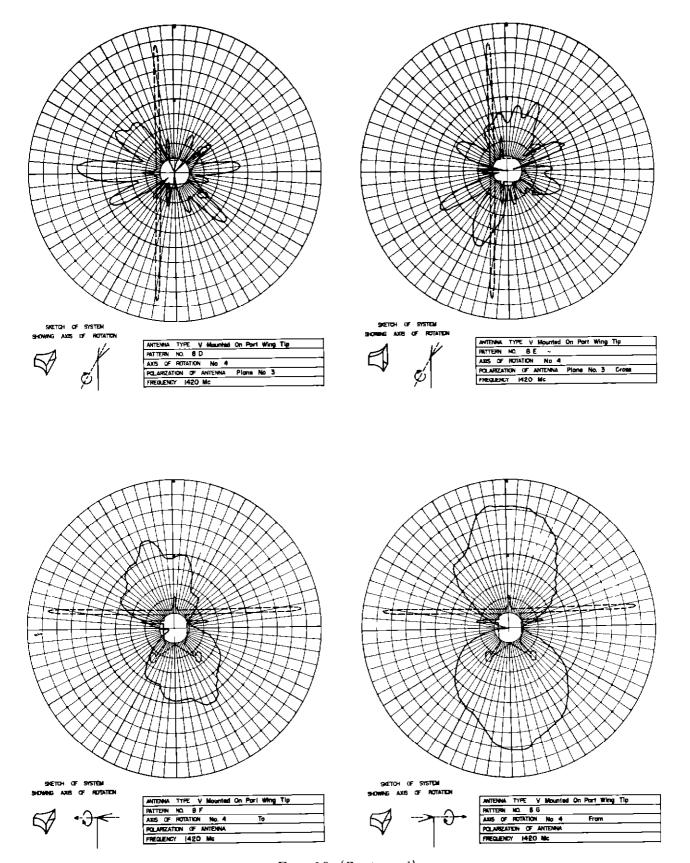
Fig. 18 V-109 Antenna on Piper Cruiser Model at Location 8

The patterns show that this location has some acceptable qualities Patterns 8 and 8A show that most of the pickup is directed rearward, and there are appreciable maxima in other directions. The cross-polarization patterns are objectionably large. The deep nulls in Pattern 8D are undesirable.

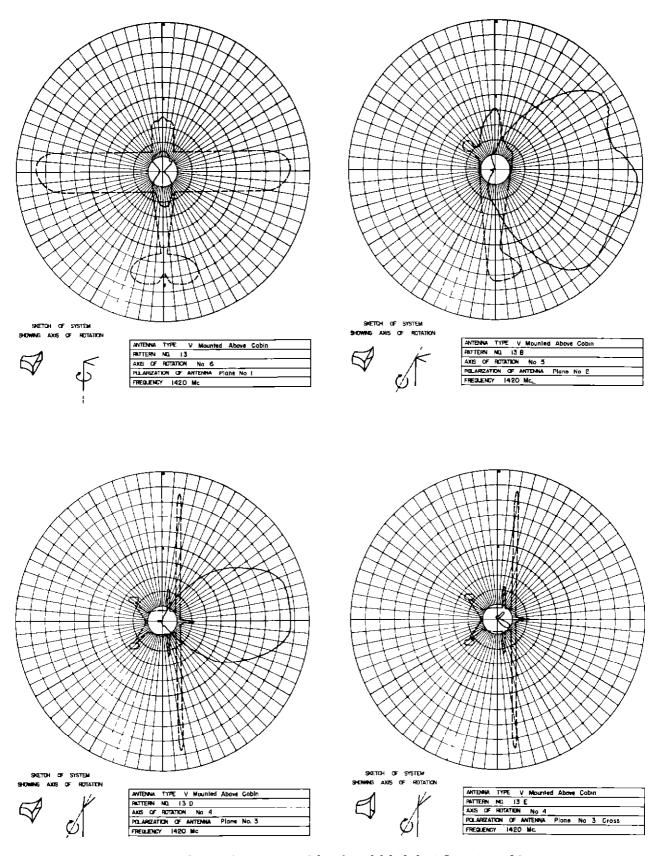
Fig 24 V-109 Antenna on Metalized Model at Location 13

Pattern 13 shows satisfactory signal pickup fore and aftalthough the greater sensitivity toward the rear is undesirable. The pattern is not quite as good as that obtained with the fabric-covered model (Fig. 13, Pattern 3).

Pattern 13B, while satisfactory, indicates that most of the signal pickup is in an upward direction as in Pattern 13D. Compared to the fabric-covered model, Fig. 13, Patterns 13B and 13D show the more complete shielding effect of the metal covering. Cross-polarized components were negligible and for this reason Patterns 13A and 13C are not included

From the results of the metallized model tests it appears that there are few significant differences in the patterns obtained with the metallized and fabric-covered models of the Piper Cruiser Where a shielding effect was observed with the fabric-covered model, similar, but usually more complete shielding was obtained with the metallized model these model tests no consideration was given to antenna impedance characteristics actual practice it is very important that the input impedance of the VHF receiver, the output impedance of the antenna and the characteristic impedance of the transmission line between the two be similar over the frequency range employed In the case of a V-type VHF antenna, it is necessary to use the antenna with a balanced-feed system or to employ a balun where unbalanced transmission lines are involved

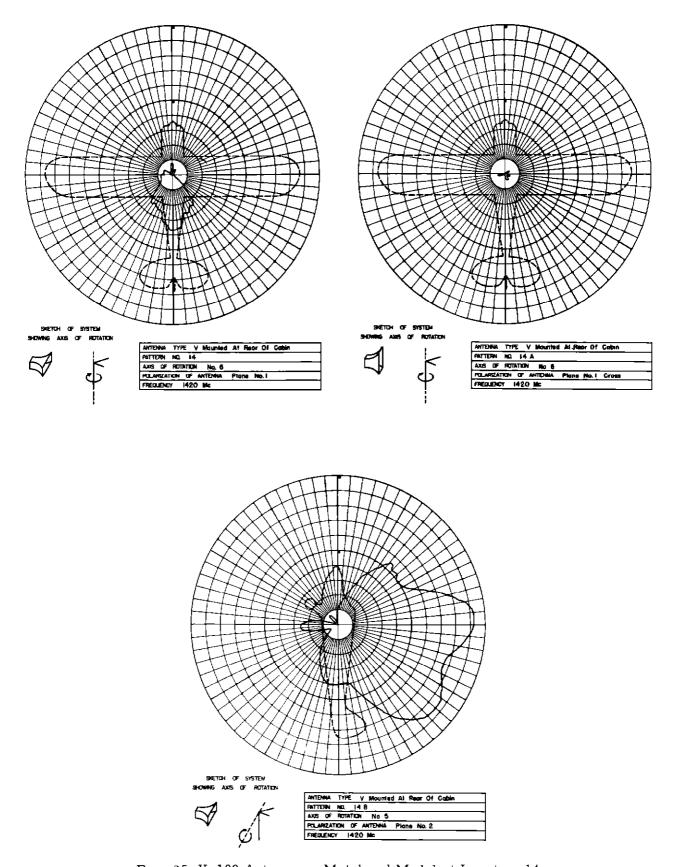
$F_{1g} \ 25 \ V\text{--}109$ Antenna on Metalized Model at Location 14

Pattern 14 shows unsatisfactory characteristics in the forward direction, as does Pattern 14B Cross-polarized components are negligible. The results are interesting, in that they show a considerable deterioration in performance with a relatively small change in antenna location.

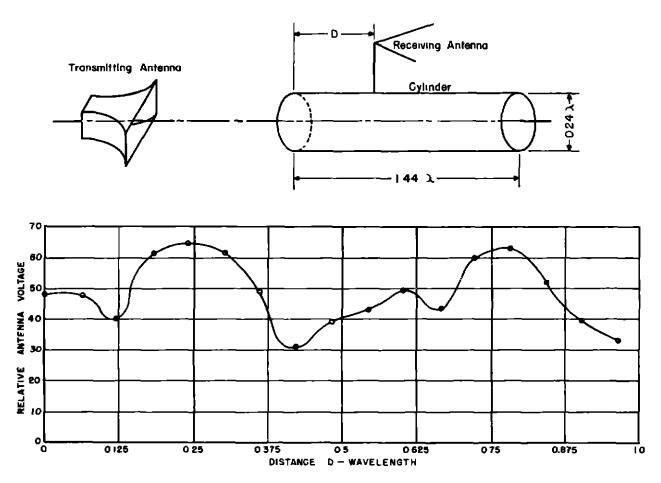
Fig 28 Metal Cylinder Test Effect of Antenna Position on Cylinder

During preliminary experiments with the Piper Cruiser model and V-109 antenna it was observed that the forward sensitivity went through successive minima and maxima as the antenna was moved progressively backward on the center line of the aircraft To investigate this effect further, a model range experiment was set up in which the 1/12 size scale model of the V-109 antenna was used with a cylinder instead of the aircraft model The signal received by the antenna from the direction of the axis of the cylinder was measured as the position of the antenna was changed along that axis The diameter of the cylinder was 3.1/2 inches and the length 12 inches, corresponding to 0 24 and 1 44 wavelength respectively at the operating frequency of 1,420 Мc

The results obtained are shown in the curve of Fig. 28, which shows the received signal voltage as a function of antenna position along the longitudinal axis of the cylinder Examination of the curve reveals that similar points occur at intervals of multiples of a quarter wave, and that the first maximum is approximately a quarter wave from the end of the cylinder facing the signal source. It probably can be concluded that, in the case of an antenna mounted on an actual aircraft,

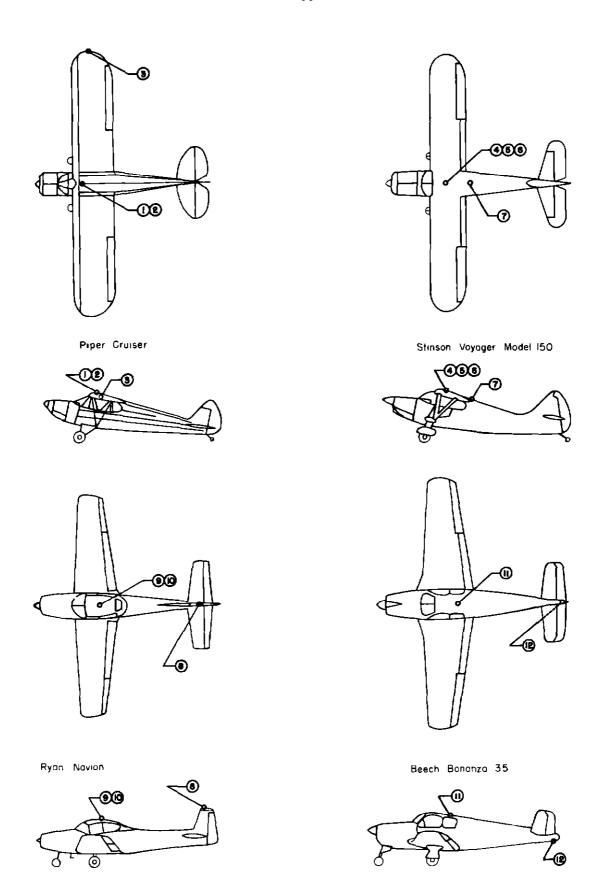
Fig 29 Antenna Locations for Stage II Flight Tests

The most critical factor involved in the placement of VHF receiving antennas on small aircraft is the location effect on the antenna pattern. It is necessary to locate the antenna in a position which will give a good horizontal pattern on the horizon and a few degrees below, if optimum performance is to be obtained with the VHF navigation equipment. The best locations found on the tested aircraft were, over the cabins of the Piper Cruiser (Point 1, Fig. 29) and Stinson Voyager (Point 6, Fig. 29), above the vertical stabilizer of the Navion (Point 8, Fig. 29), and over the cabin on the Beechcraft Bonanza (Point 11, Fig. 29)

A NARCO V antenna was mounted on the Navion cabin in the same location as that for the V-109 antenna in Flight 9 See Figs 29 and 34 Results obtained with this in-

The only noise-suppression system tested on the Navion airplane was the shielded ignition system with which the aircraft was already equipped. The antenna installation on this aircraft was that given in Fig. 29 for Flight 9, of Stage II of this report. The VHF noise level was found to be of no consequence, as indicated in Table VI

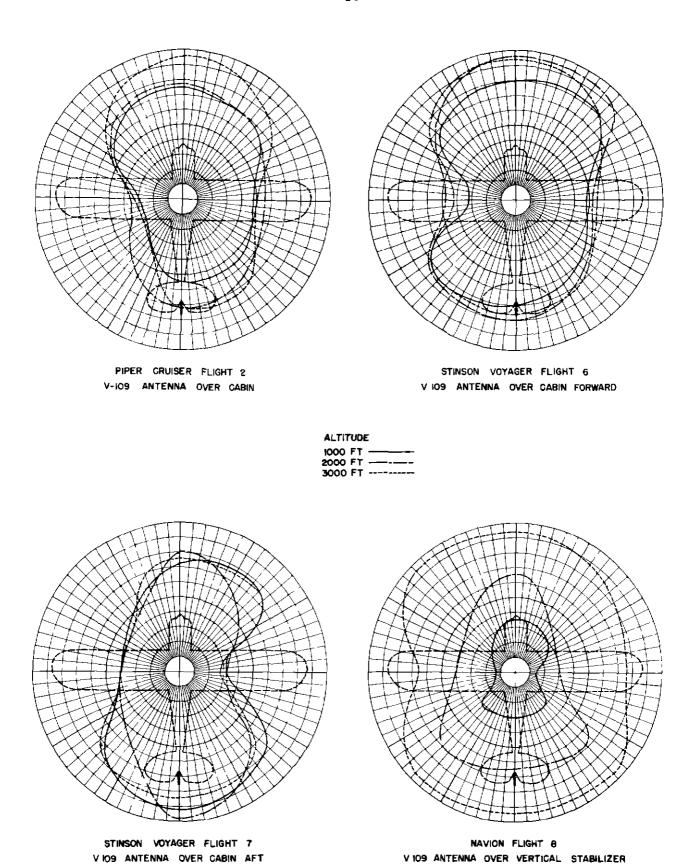
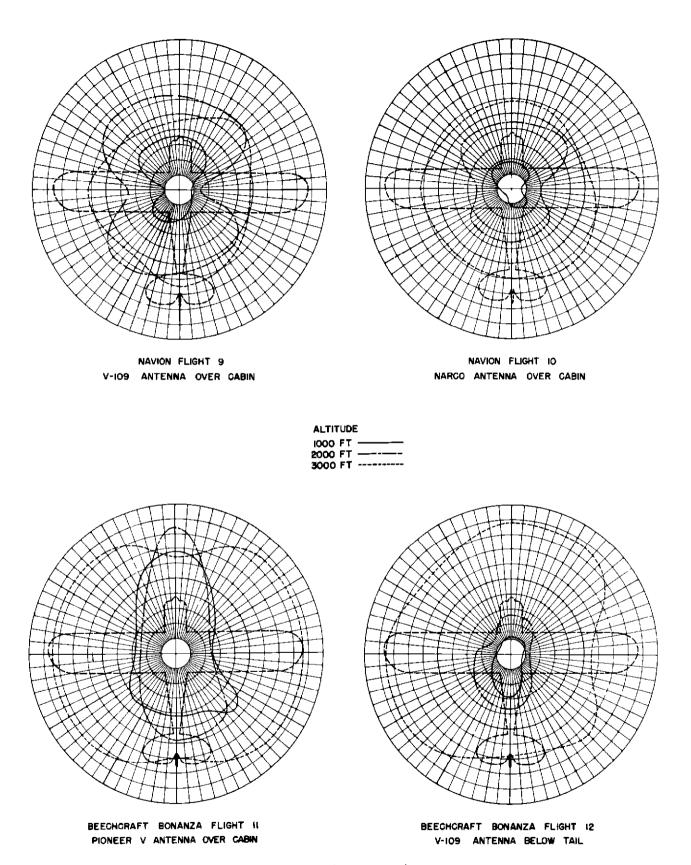
Fig 31 Stage II Flight Patterns

The antenna patterns, Fig 31, show unsatisfactory forward sensitivity, the coursewidth doubled well before the desired mini-

mum of 45 miles, and performance was generally unsatisfactory

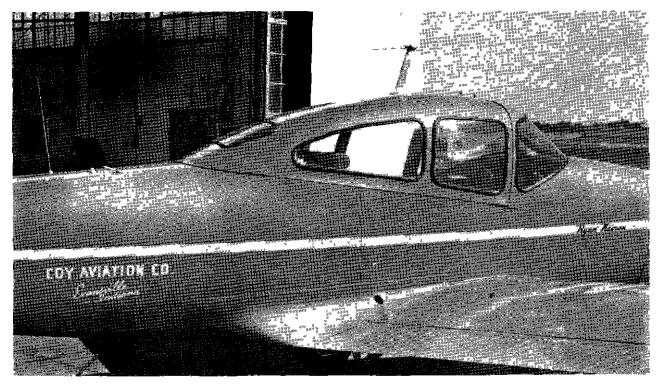
Fig 34 NARCO Antenna on Navion Cabin

stallation were generally inferior to those obtained with the V-109 antenna at the same location and the performance was vastly inferior to that obtained at the vertical stabilizer location in Flight 8 See Tables I and II and Fig 31 The sensitivity of the NARCO antenna appears to be considerably less than that of the CAA V-109 antenna See Appendix II

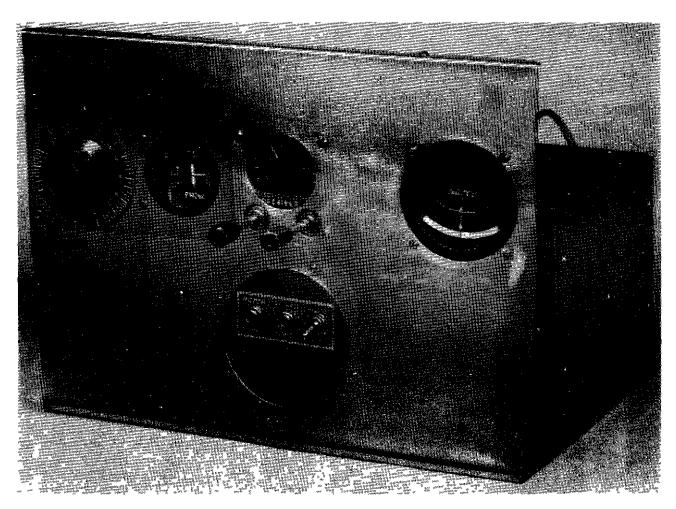
Fig 38 Portable NARCO VHF Receiver Assembly

The NARCO VHF receiver installation shown in Fig. 39 was tested on a Stinson Voyager. The receiver is seen in the photograph just to the right of center on the instrument panel, and the omniconverter and power supply, mounted above the rudder pedals, are not visible. Tests were also made with the portable receiver assembly of Fig. 38 in the front and rear seats.

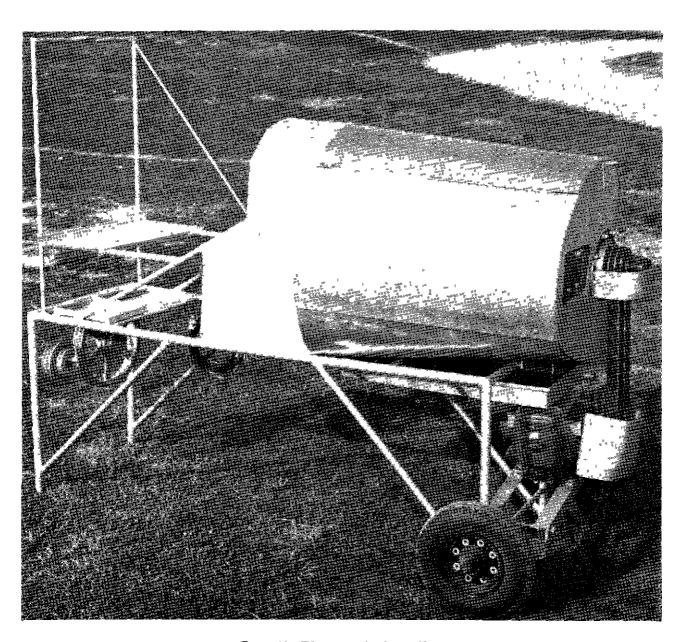
Fig 41 Electrical Mock-Up

The aircraft engine used on the mockup is a Lycoming 0-435-2 six-cylinder engine, enclosed by a conventional metal cowling

and firewall A 3-hp 3-phase, 220 v, 1,800 rpm electric motor is provided for driving the aircraft engine. The Lycoming engine was modified by removing certain parts to reduce driving-power requirements. The propeller reduction gears were replaced by a three-fourths inch shaft, to be driven by the electric motor. The pistons, connecting rods, cam followers and push rods were removed. The valves were sealed, cylinder bases welded closed, and all cylinders connected with tubing to a central point for connection with a pres-

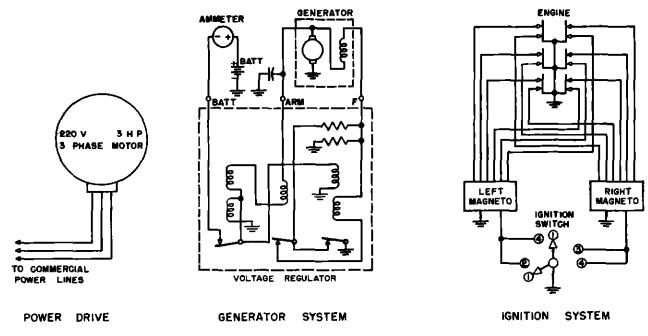
Fig 42 Mock-Up Electrical System

A schematic diagram of the mock-up electrical system is given in Fig 42 Mechanical arrangements are such that electrical components such as generators, voltage regulators, ignition harness, spark plugs

and magnetos can be replaced easily and quickly. The following replaceable accessories are provided unshielded, shielded, and resistance-wire ignition harness, unshielded, shielded, and resistance spark plugs, Delco 1101876 and Eclipse 310 generators, Delco-Remy Voltage regulator, Autolite 23,742 Ammeter, 12 v storage battery, AC 7 ignition switch, and Bendix Scintilla SF6LN8, Eiseman LA4 and Eiseman LM4 magnetos

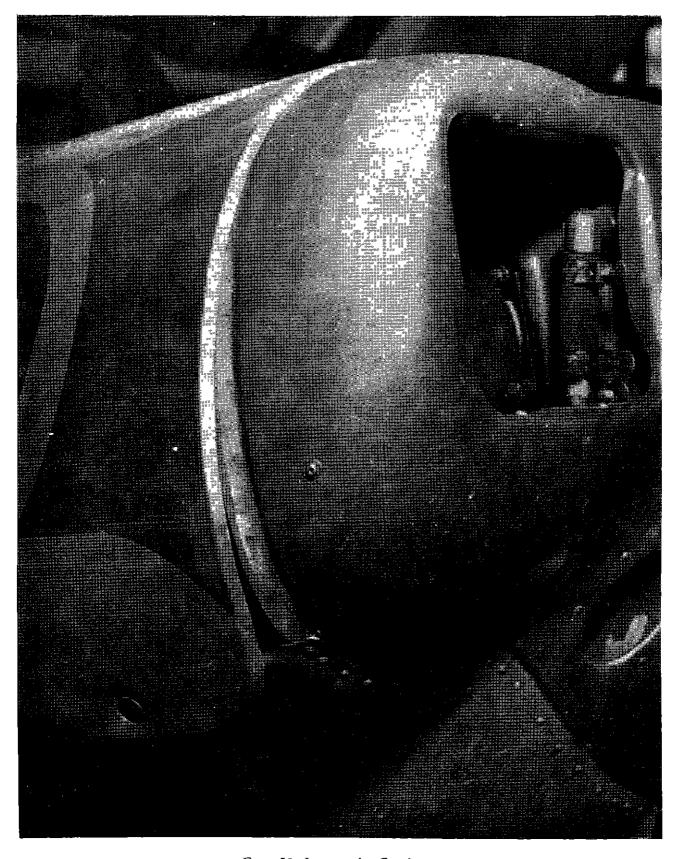
Fig 53 Luscombe Cowling

Mention was made of near-acceptable performance being obtained on the Luscombe without any noise-suppressing accessories. This was undoubtedly due to such details as the good overlapping contact made along the edges of the cowling cover (Fig. 53)
