817537
EVALUATION OF
AIRPORT SURFACE DETECTION EQUIPMENT
MODEL AN/MPN-7 (XW-1)

PART I
TECHNICAL EVALUATION

Technical Development Report No 175

CIVIL AERONAUTICS ADMINISTRATION
TECHNICAL DEVELOPMENT AND
EVALUATION CENTER
INDIANAPOLIS, INDIANA

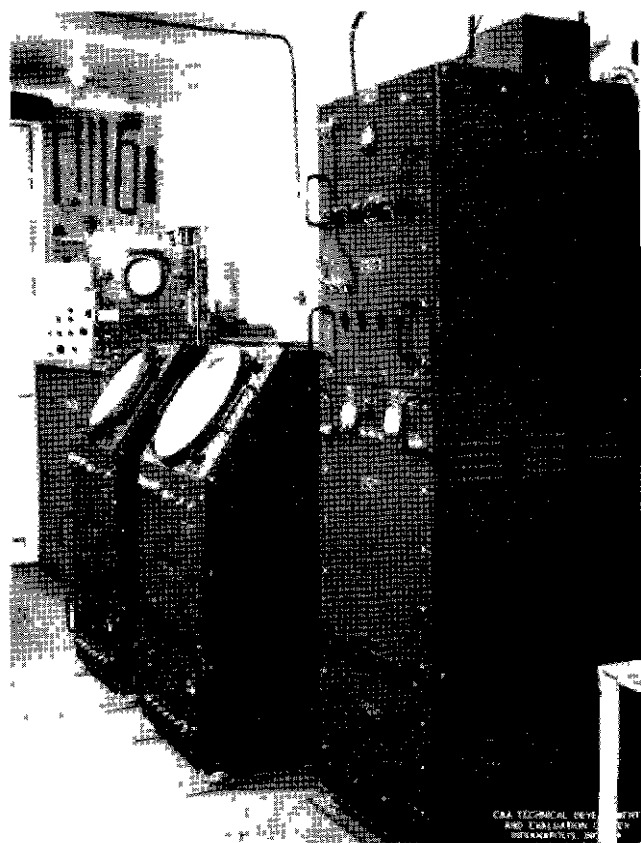
Fig 2 Transmitter, Receiver, and Indicator Cabinets
