**DETERMINATION OF MEANS
TO SAFEGUARD AIRCRAFT
FROM POWER PLANT FIRES IN FLIGHT**

**PART V
THE LOCKHEED CONSTITUTION
(NAVY XR60-1)**

Technical Development Report No 198

**CIVIL AERONAUTICS ADMINISTRATION
TECHNICAL DEVELOPMENT AND
EVALUATION CENTER
INDIANAPOLIS, INDIANA**

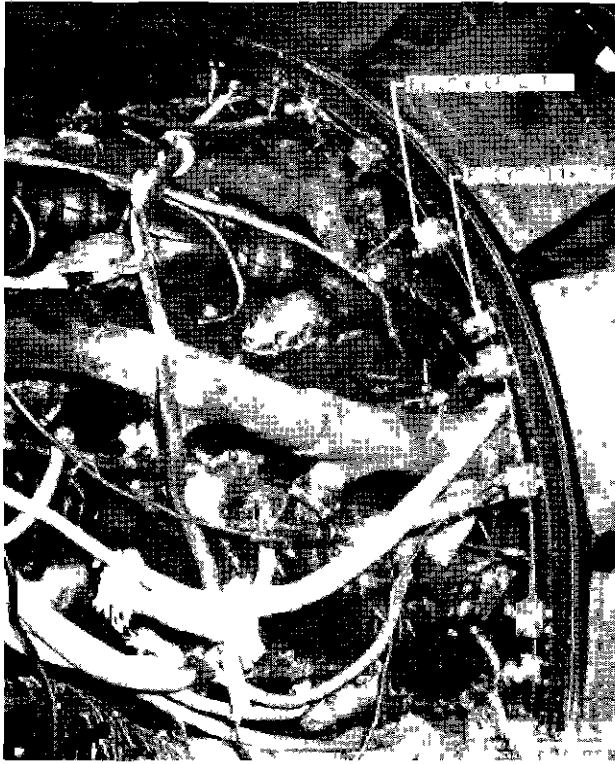
Fig 16 View of Fireye and Edison Detectors Mounted on Cowl Ring

Occasional false alarms were produced during 27 simulated rain tests using early arrangements of the FD-2 detector units. Apparently the water droplets passing between the unshrouded exhaust manifolds and the units produced modulated infrared radiation of the critical frequency. No false alarms resulted from this source with the configuration that is shown in Fig 16.

1 Units of the system should be mounted on the cowl support ring and oriented to view 45° from a radial line toward the center of the engine, as shown in Fig 16

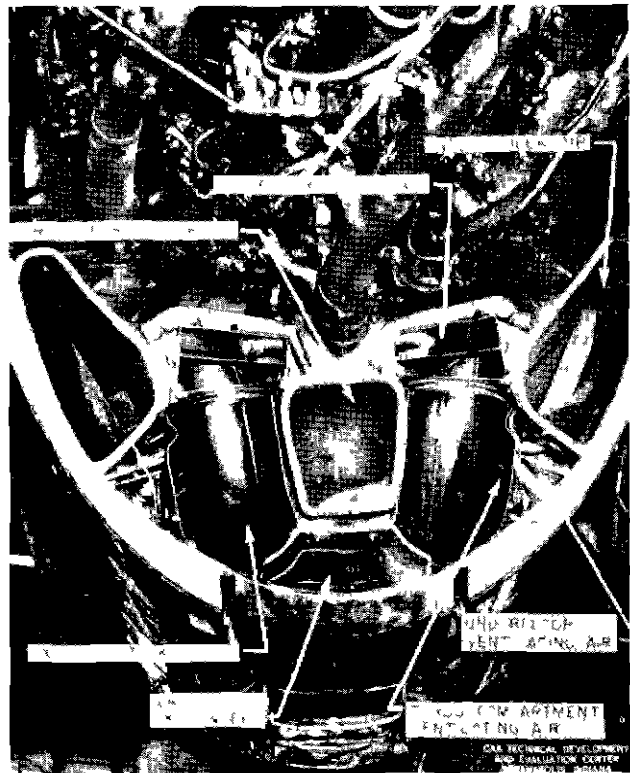
Fig. 26 Zone 4 Ducts

The first method tried for extinguishing Zone 4 fires was to introduce extinguishing fluid into the front scoop. However, the fluid supplied in this manner tended to enter those ducts where the air flow was the greatest, and since the air flow through the underfloor and the ventilating ducts to the turbosupercharger compartment was of comparatively small magnitude (approximately one or two pounds per second), these latter ducts were not adequately purged. See Fig 26.

Other possible hazards in the same general region were studied by spraying gasoline and hydraulic fluid into the heat-exchanger duct and into the underfloor ventilating air ducts. See Fig. 26 for location of these ducts. No fires were ignited even when a spark-plug ignitor was arcing inside the accessory section. The engine was operated at 1800 rpm with and without added air from the wind tunnel, and the cylinder-head temperature was above 450° F. Even shutting down the engine quickly from a heated condition did not cause the fluids to ignite.
