TECHNICAL DEVELOPMENT REPORT NO. 219
EVALUATION OF THE ALFORD SLOTTED-CYLINDER VOR ANTENNA
FOR LIMITED DISTRIBUTION

Navigation Aids Evaluation Division

August 1954

EVALUATION OF THE ALFORD SLOTTED-CYLINDER VOR ANTENNA

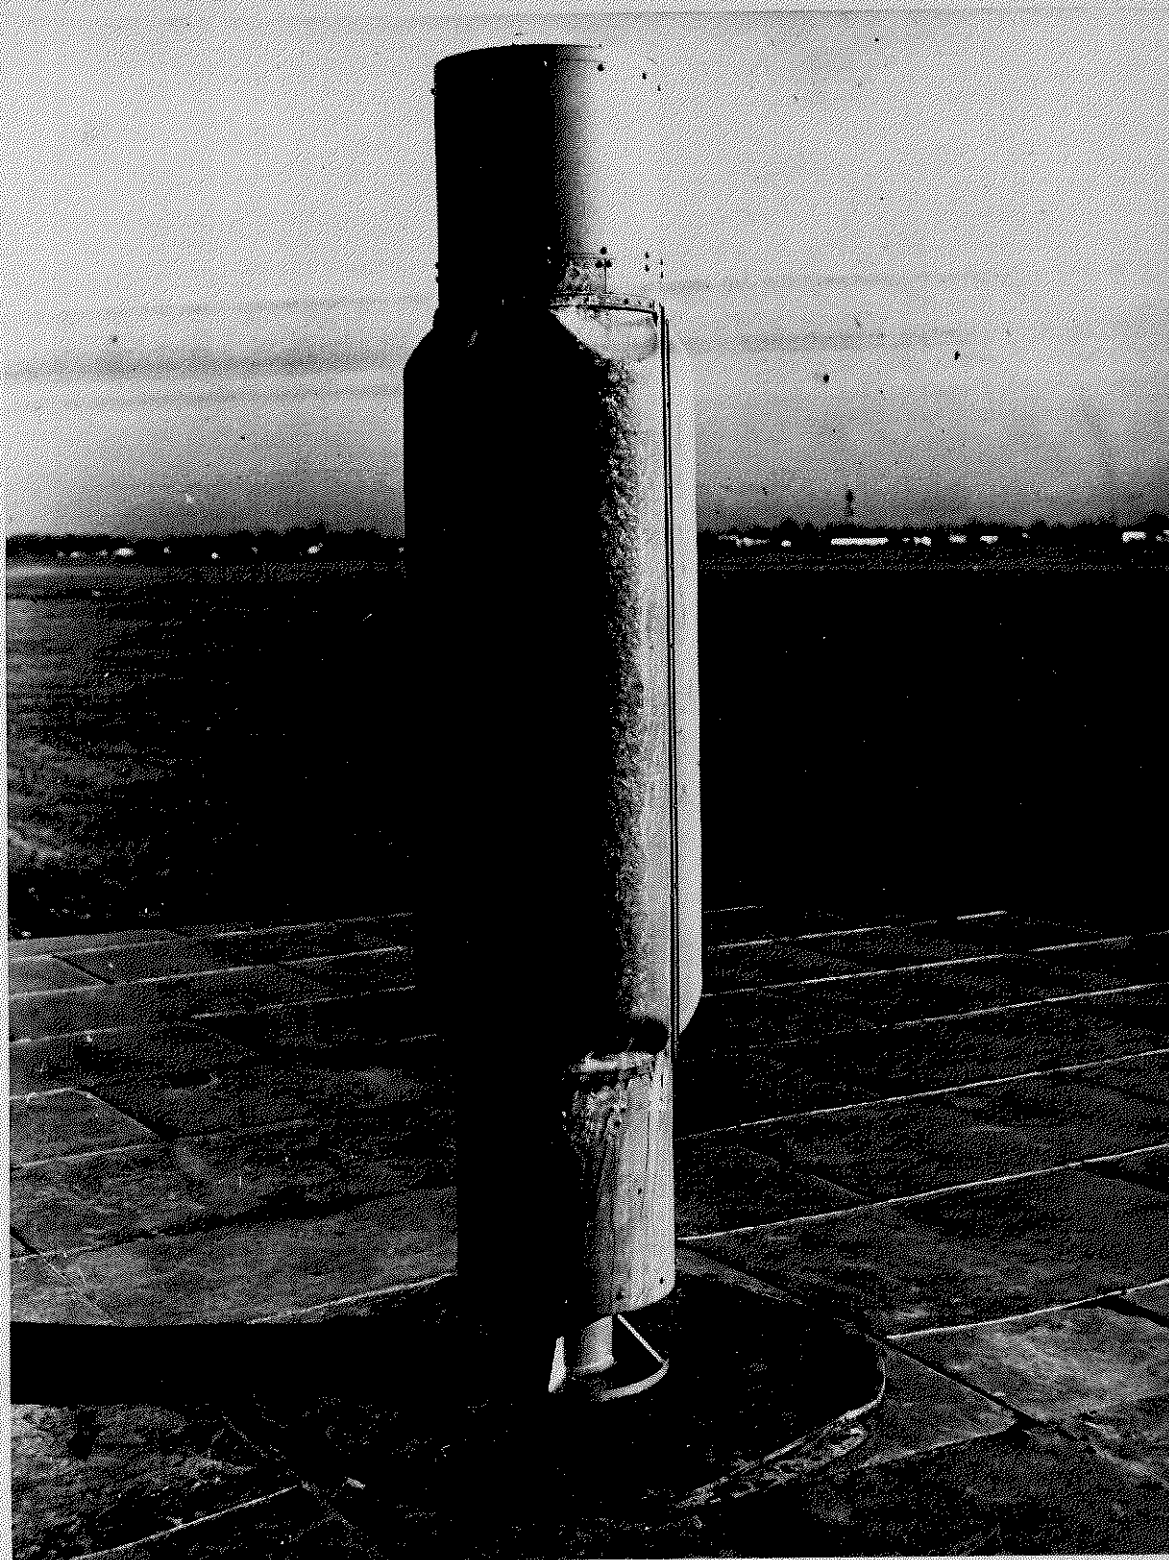
An ice coat $3/8$ inch thick was next applied to the No. 4 slot and bearing errors were observed. Figure 8 is a photograph of this ice coating. A bearing-error curve, plotted with a normal curve is shown in Fig. 9. As in the case with the snow coating, the ice had little or no effect on the bearings transmitted. The total difference between the normal curve and the curve with an ice-coated slot is only 0.4° .

FIG. 8 ICE COATING ON ALFORD SLOTTED ANTENNA
