An Investigation of Some Parameters Related to Midair Collisions of Aircraft

TECHNICAL DEVELOPMENT REPORT NO. 322

**CIVIL AERONAUTICS ADMINISTRATION
TECHNICAL DEVELOPMENT CENTER
INDIANAPOLIS, INDIANA**

October 1957

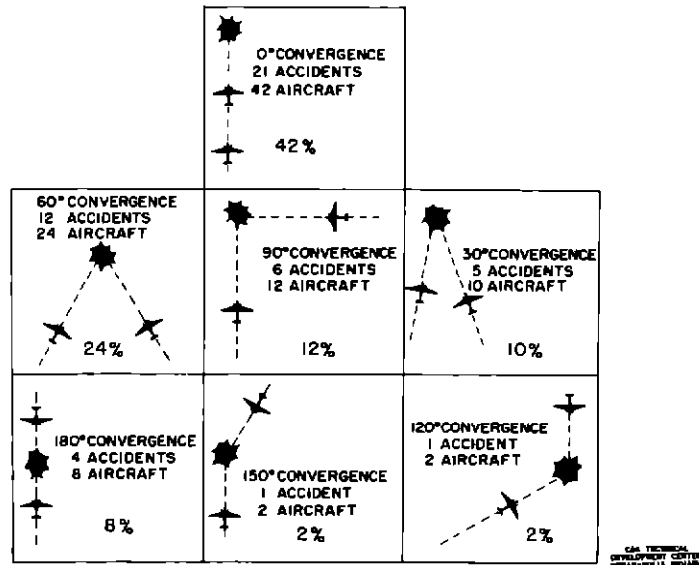
Fig. 2 Summary of 50 Midair Accident Investigation Reports for Years 1949 Through 1954

The accident reports first were analyzed to determine the angle of convergence that was the most predominant. A summary of separation angles indicates that the greatest danger of midair collisions between two aircraft does not involve the head-on situation but shows, rather, that the overtaking situation predominates. See Fig 2. Dividing the spherical space about an aircraft into forward and rearward hemispheres, and designating the forward convergence angles as head-on and the rearward angles as overtaking, about 80 per cent of the accidents then can be classified as overtaking accidents. All of the accidents in this analysis occurred under visual flight rule (VFR) conditions. Only one of the 50 accidents occurred in minimum VFR conditions, and 92 per cent occurred in ceiling and visibility unlimited (CAVU) weather.
