15  
TECHNICAL DEVELOPMENT REPORT NO. 371

**Some Methods for Inspecting  
Adhesive-Bonded Joints in  
Helicopter Rotor Blades**

Aircraft Division

# SOME METHODS FOR INSPECTING ADHESIVE-BONDED JOINTS IN HELICOPTER ROTOR BLADES

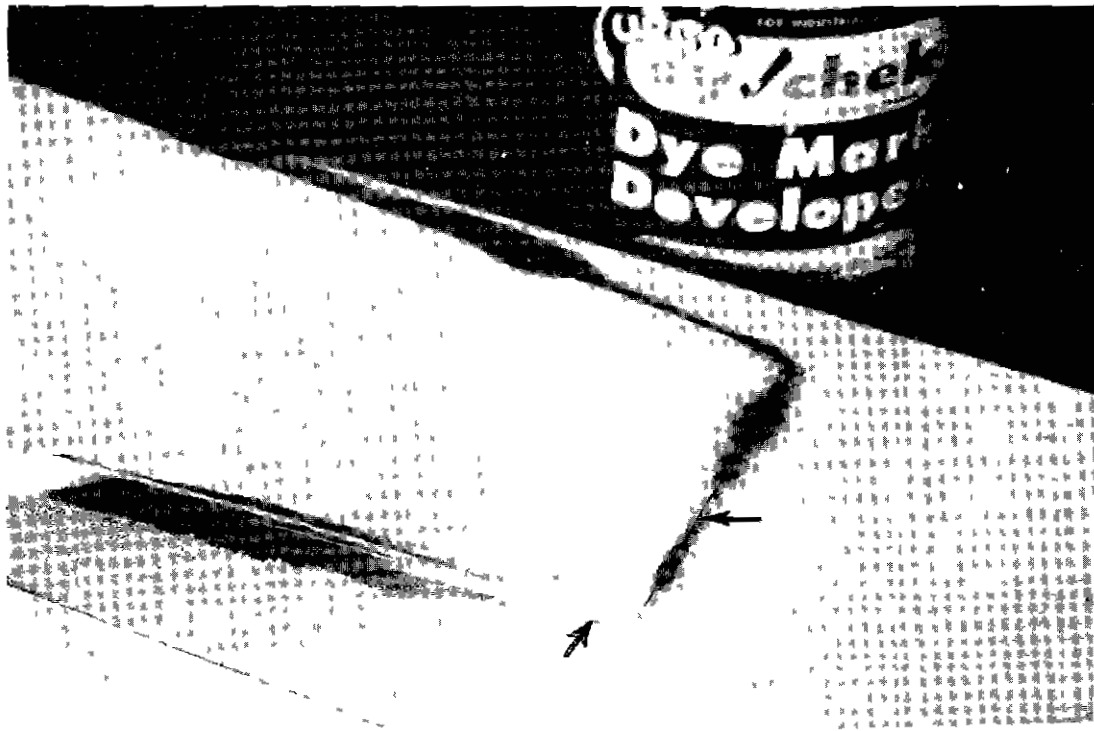
FIG 24A PHOTOGRAPH OF HELICOPTER BLADE SECTION 1 SHOWING RESULTS OF DYE PENETRANT TEST

A void beneath the thin end of the cuff plate, which had been detected previously by tapping, was detected also by the dye penetrant inspection method. See Fig. 24. In a multilaminate leading edge section, several voids were noted at either end of the sample in the thin glue line of FM-47 tape. Sample panel No. 3, a bilaminate panel, showed evidence of bond failure at several places along the exposed edge of the joint. Two additional panels, Nos. 1 and 2, demonstrated similar results as shown in Figs. 25A, 25B, and 25C.
