FINAL REPORT

## DEVELOPMENT OF GENERAL SPECIFICATIONS FOR A DEVICE FOR INSPECTING HELICOPTER BLADE BONDING

NOVEMBER 1959

TEST AND EXPERIMENTATION DIVISION

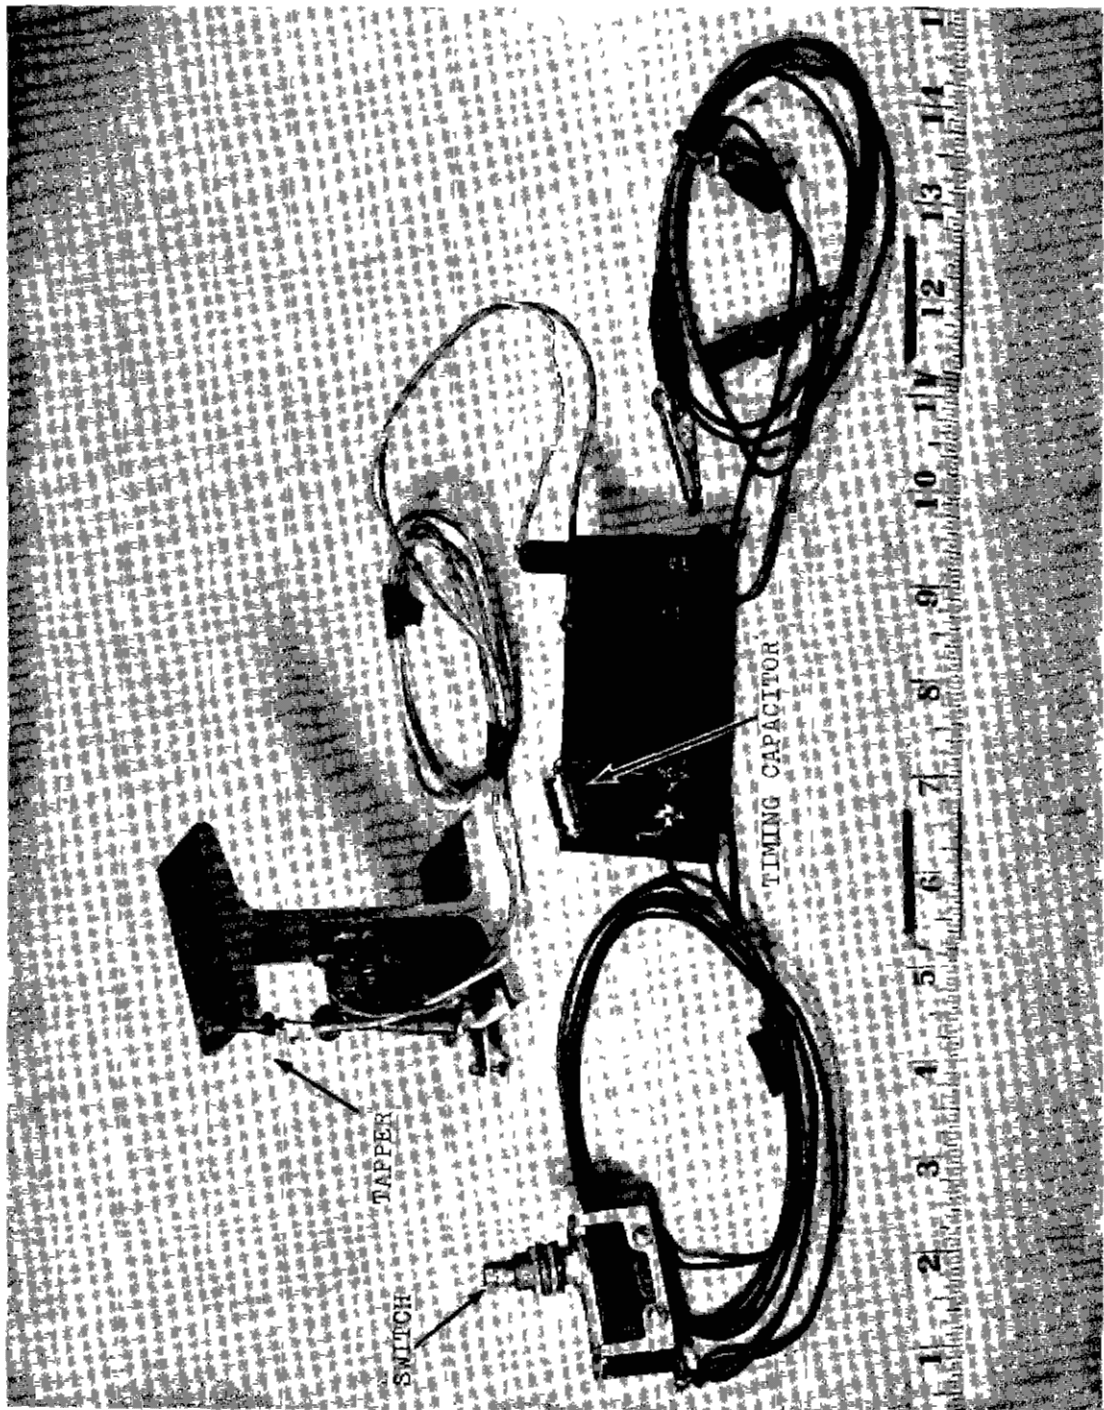
An electronically controlled, single-tap device was designed and built. See Fig. 2. With this device, the tap force and the duration of tap dwell could be controlled by adjustment of the timing capacitor, as shown in Fig. 3. A tap was produced for each push on the control-switch button. In operation, the button was released to discharge the

SINGLE TAPPER

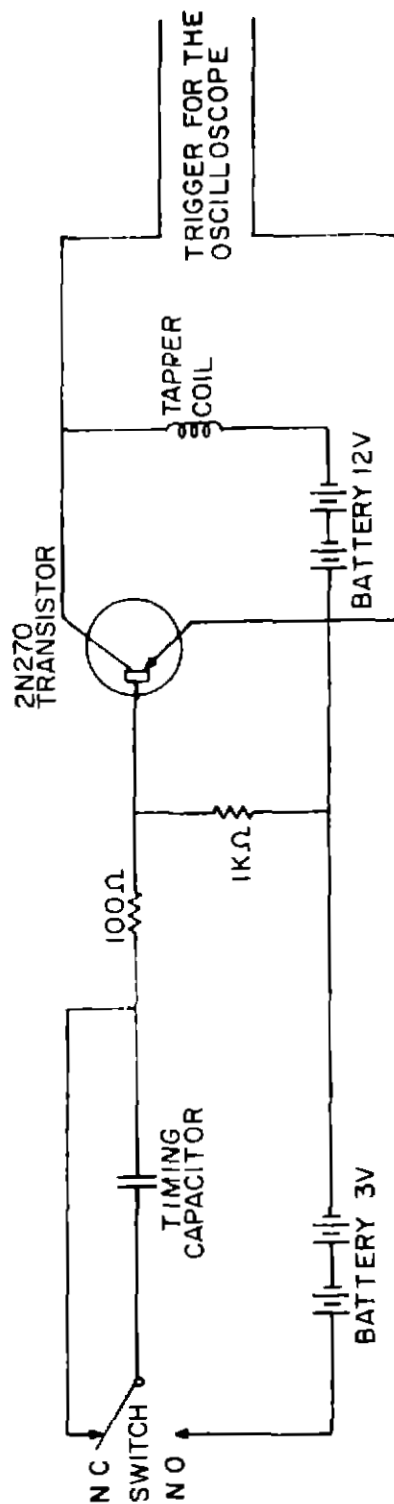
capacitor before another tap was produced. Starting with the 54-millisecond value, it was found that the tapper dwell time should be as short as practicable. The sound of the single taps of the device was picked up by a microphone and fed to an oscilloscope. The oscilloscope trace was triggered by the tapper control switch, so that pressing the switch button started both the trace and the tap simultaneously.

WIRING DIAGRAM FOR THE ELECTRONICALLY CONTROLLED SINGLE-TAP DEVICE

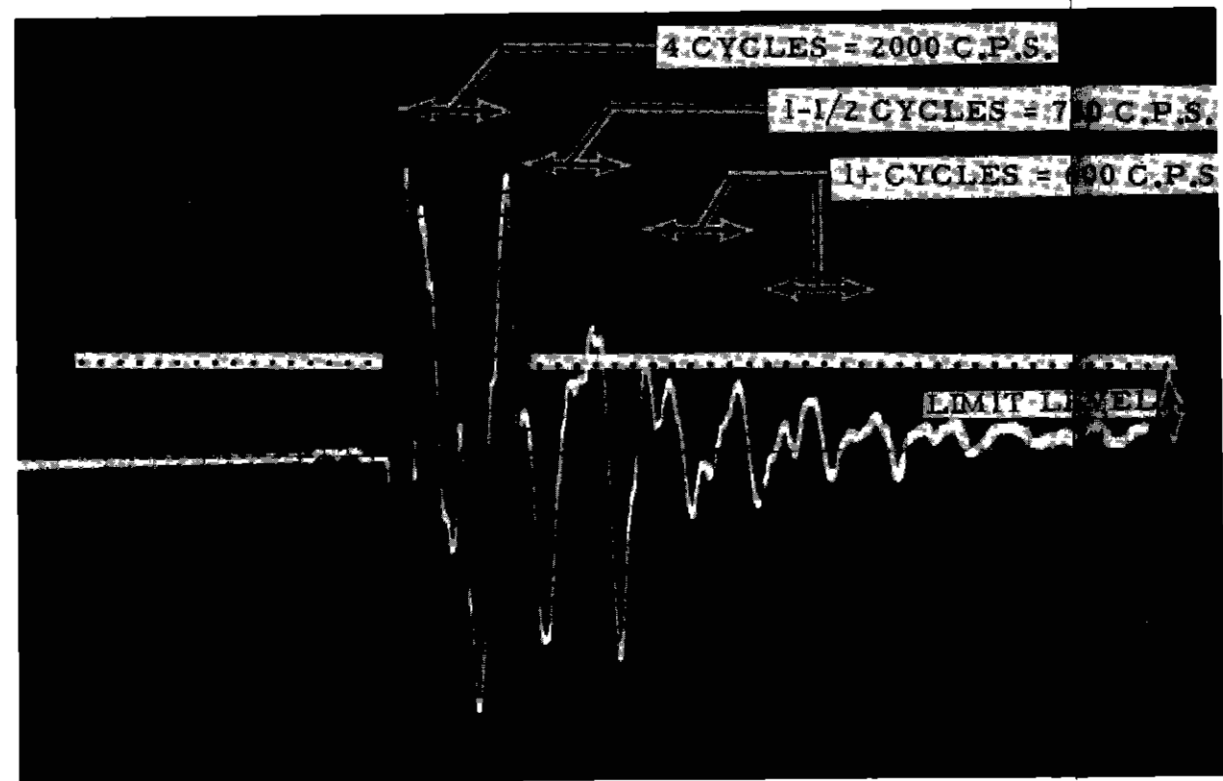
NATIONAL BUREAU OF STANDARDS WASHINGTON, D. C. 20540 ATLANTA, GEORGIA	
<b>SOUND DIFFERENCE          GOOD AND POOR BOND</b>	
Task No 59 - 214 I	<b>FIG. 4</b>

The oscilloscope displays of typical sound waves as shown in Fig. 4A and 4B illustrate tap sounds over good bonding, Fig. 4A, and over poor bonding, Fig. 4B. It will be noted that the trace in Fig. 4A shows an essentially constant frequency of 2,500 cycles per second (cps), whereas the frequency of the trace in Fig. 4B decreases as the wave dies away. The trace pattern over a void area, as shown in Fig. 4B, indicates a beat between a low frequency and the higher impact frequency, thereby producing the notched appearance to the sound wave. The readily measurable amplitudes of the sound wave of a nondestructive tap are seen to have a duration of approximately 8 milliseconds. The difference in sound between the waves in Fig. 4A and 4B, as heard by the human ear, is that the sound caused by poorly bonded or void areas causes an admixture of lower tones to follow the initial impact sound. The resulting damped sound waves were reproduced precisely with each tap. It was apparent that a tapper driven to strike at the end of the decay of each preceding tap sound wave, that is, every 8 milliseconds (125 taps per second), would produce a periodic train of damped waves which could be analyzed, and with suitable circuitry, indicate the difference between good and poor bonds or void areas.

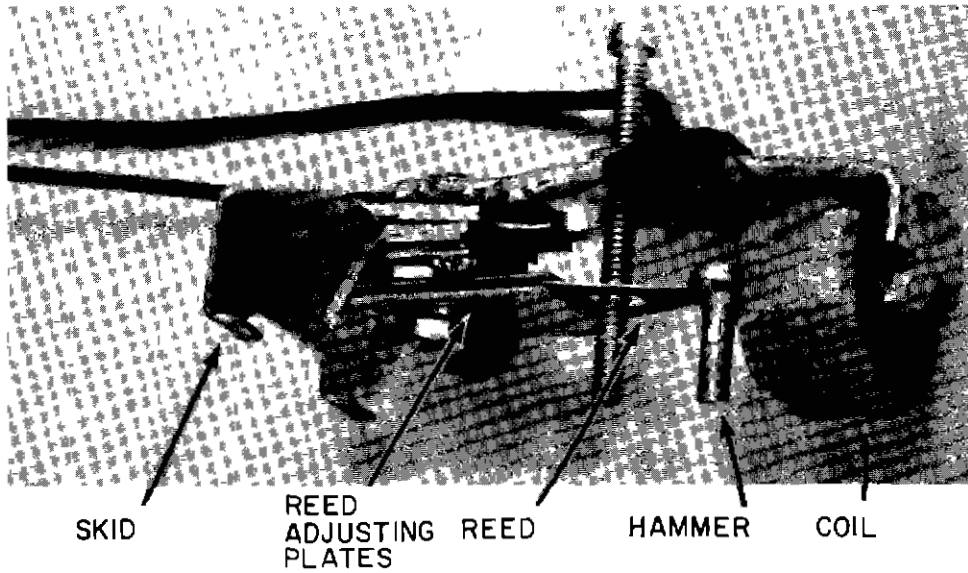
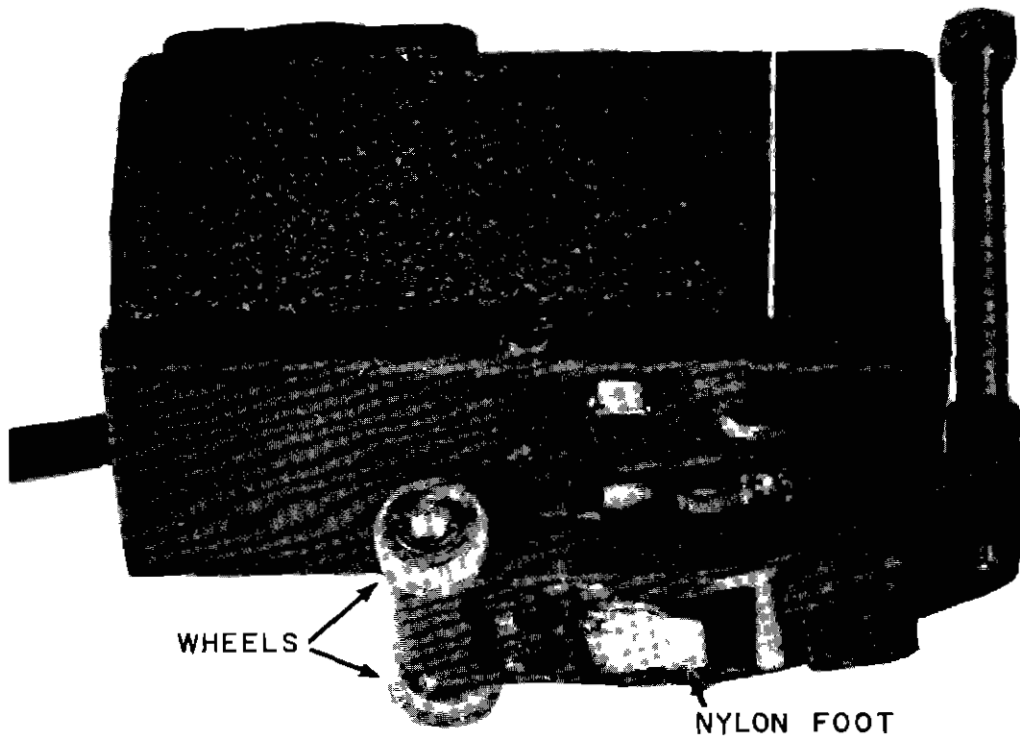
a. Reed-Type Tapper: The original reed-type tapper, shown in Fig. 5A, was evolved from a Mallory autoradio vibrator, which is designed to vibrate at 115 cycles or 115 taps per second. The vibrator was dismantled, the contacts removed, and the drive coil was rewound with the coil insulated from the frame, using Mallory specifications of 2,788 turns of No. 35 enameled copper wire. The insulating reed support stack was replaced with steel to give a better magnetic circuit. A clamping plate was used on both sides of the reed, as a crude adjustment for the active reed length, to tune the reed for the best swing. A flathead, 1/8-inch by 1/2-inch, anodized, aluminum rivet was bonded to the center of the reed weight, and the small end of the rivet slightly rounded off as a hammer face. A hole was punched in the reed to allow the tap sound to impinge directly on the microphone.

A-ORIGINAL REED TAPPER

B-IMPROVED REED TAPPER

REED-TYPE TAPPING DEVICE

The original three-skid-type supports gave squeaks which were eliminated by using wheels at the rear and a Teflon skid 1/2-inch behind the hammer. The skid being so near the hammer slightly damps the higher frequency impact sound of the hammer but does not interfere seriously with the total sound. The close location of the skid to the hammer was found to be necessary to allow the hammer to follow concave surfaces.

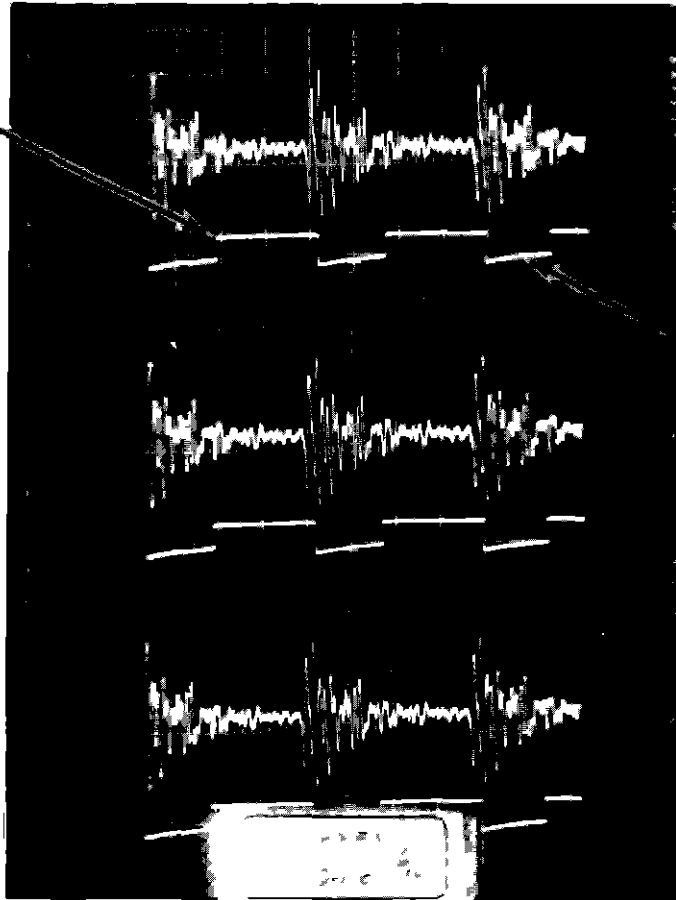
An experimental tapping device suitable for operation at the desired frequency of 125 taps per second was designed and built using a tuned steel reed carrying a hammer. A rectangular wave driver was used to provide a sudden application and release of the hammer. The rectangular wave for the driver was derived from a transistor multivibrator, amplified, and applied to the coil of the reed-type tapper. See Fig. 5A. This tapper was improved by substituting wheels for the back skids, and a nylon foot in place of the screw, as shown in Fig. 5B. The precise drive and resulting exact duplication of the sound waves, obtained with the electronically driven tapper, are shown in the three separate exposures, taken 1 minute apart, in Fig. 6. The pulse that drives the reed is applied after the reed hammer has struck the surface. This phase shift gives the most vigorous reed swing. The exact time of each wave train is

7.8 milliseconds, with power on for 3.5 milliseconds. Each division in Fig. 6 represents 2 milliseconds.

PRECISION DRIVE AND SOUND REPRODUCTION

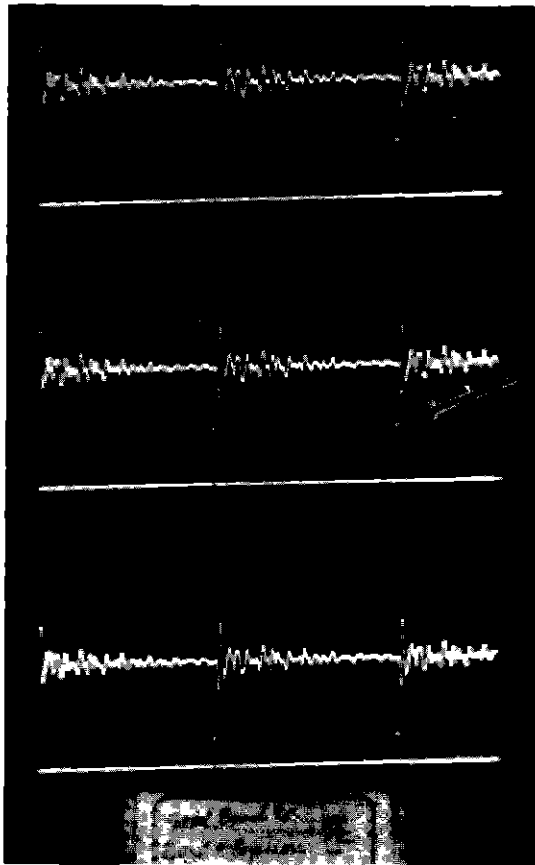
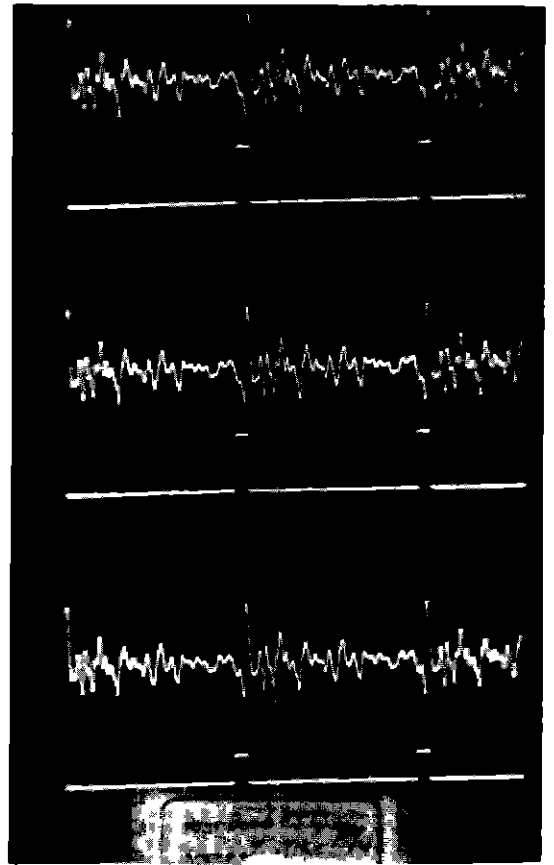
The hammer dwell time for the reed-type tapper is shown in Fig. 7A and 7B. Fig. 7A illustrates the short dwell over a firm structure (No. 5 panel), the dwell time being approximately 0.8 millisecond. Fig. 7B illustrates the dwell time over a loose surface facing within the square area of the No. 5 panel. The hammer dwell time increased, due to yielding of the metal, to approximately 3 milliseconds.

HAMMER DWELL TIME

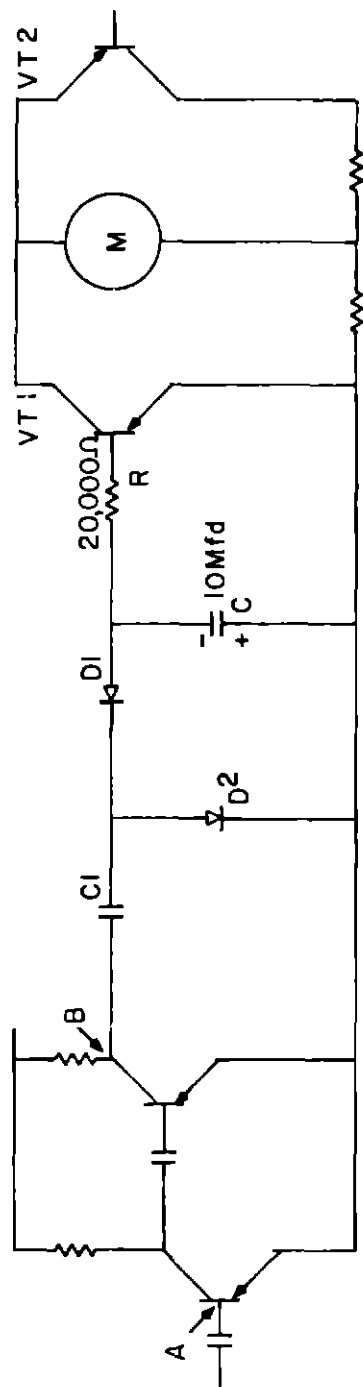
The circuit used in the experimental Flawmeter is illustrated in Fig. 8, where C and R form an integrating circuit. The diodes, D1 and D2, serve as an automatic switch, sending the plus polarity half-pulses to ground through D2 and the negative polarity half-pulses charge capacitor C through D1. Capacitor C can discharge only through the resistance R and the small resistance of the base-to-emitter of the transistor VT1, thus causing the meter M to deflect in accordance with the average charge and discharge current of C. Hence, over a good bond, when

the sound waves are composed of pulses separated by about 6 milliseconds, the meter will read low, whereas over a poor bond with almost continuous sound pulses, the meter will read full scale.

# INTEGRATING CIRCUITRY

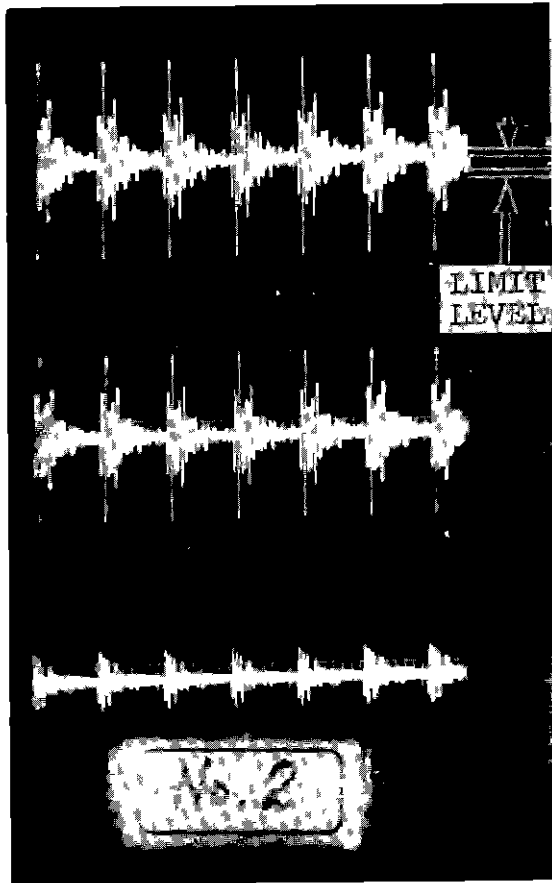
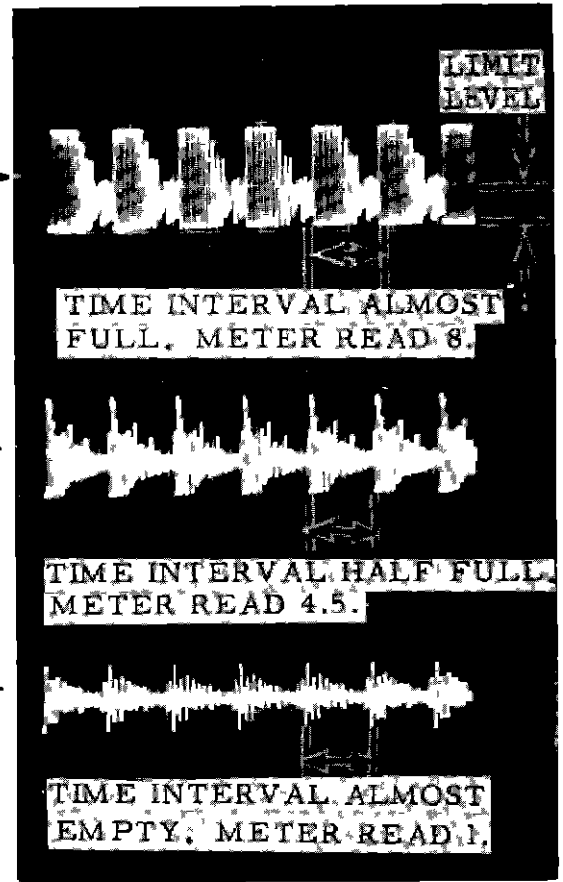
The requisite for use of the integrating circuit is that the amplitude, or volume, variation of the sound must be eliminated as much as possible so that only the frequency or pulse difference remains. The sound received at point A of Fig. 8 is shown amplified in Fig. 9A, however, the amplification is not as great for Fig. 9A as it is in Fig. 9B, as will be noted by the difference in the indicated limiting levels. The sound is both amplified and limited, in amplitude, in the transistor amplifier of Fig. 8, as shown in Fig. 9B. The sweep rate for the oscilloscope writing beam for the pictures of Fig. 9 was 5 milliseconds per centimeter, which is the distance between the grid lines.

SOUND WAVE AT POINT A, FIG 8

SOUND WAVE AT POINT B, FIG 8

## ACTION OF THE CIRCUIT ON THE SOUND WAVE

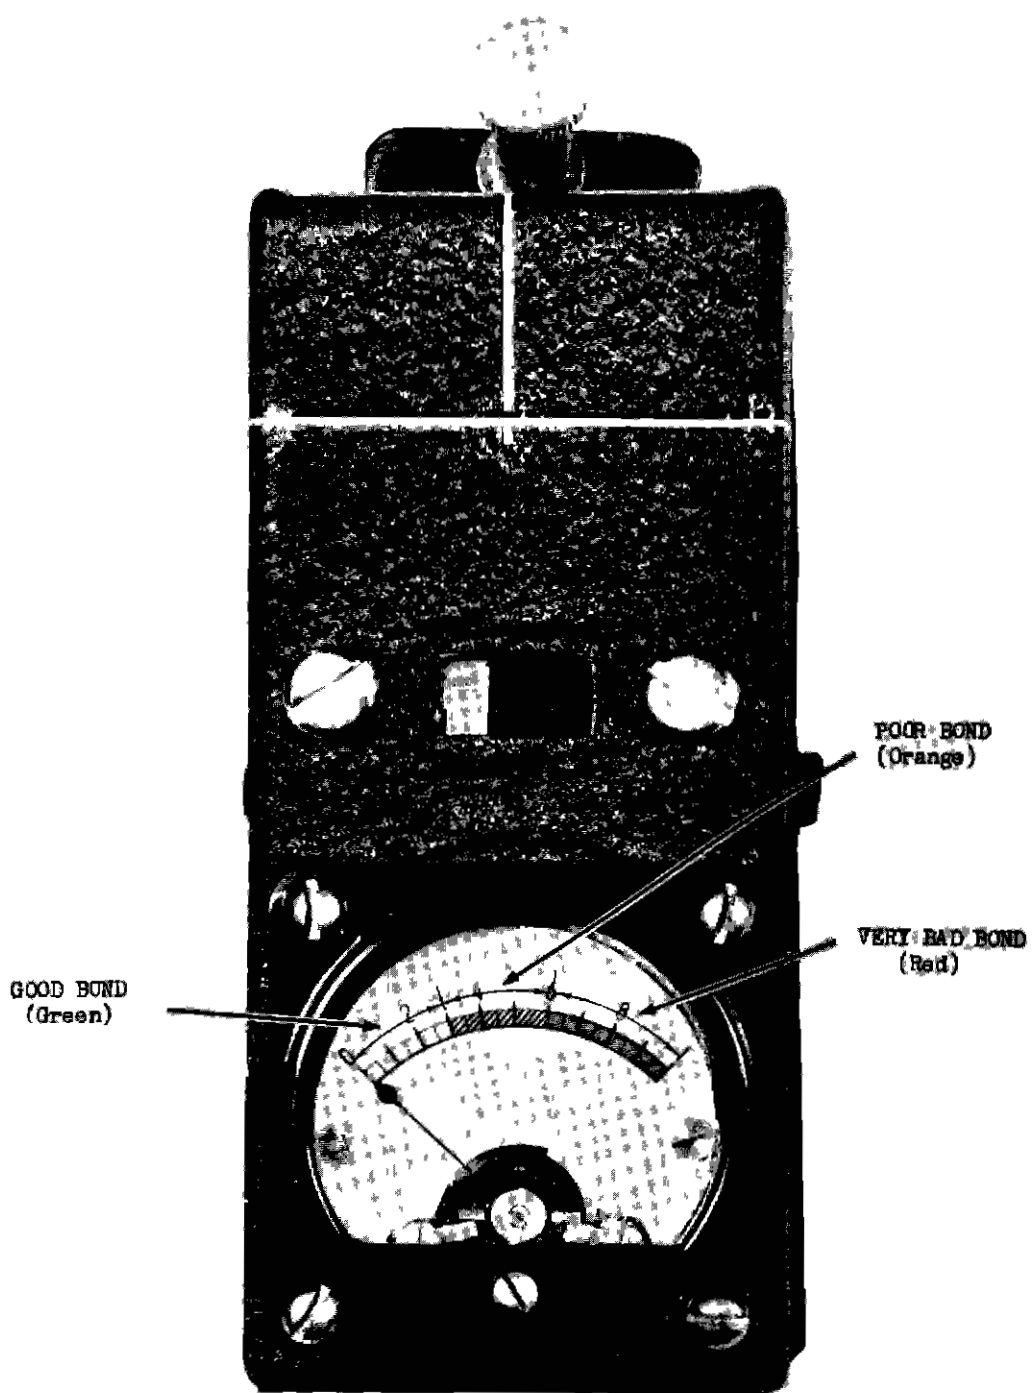
Fig. 10 illustrates the meter used to indicate the conditions of the bonding. Sector 0 - 3 of the meter is colored green for good, sector 3 - 6 is colored orange for poor, and the final sector, 6 - 10, is colored red for very bad. The larger the reading, the poorer the bonding. Any upscale movement of the meter needle indicates a decrease in bond quality. Over box-type structures, the needle reads higher because of the open or void condition of the box; however, the meter will indicate a poor bond over such a box section by a slight rise above the basic reading for the good box section.

GOOD, POOR AND BAD  
BOND SCALE READINGS

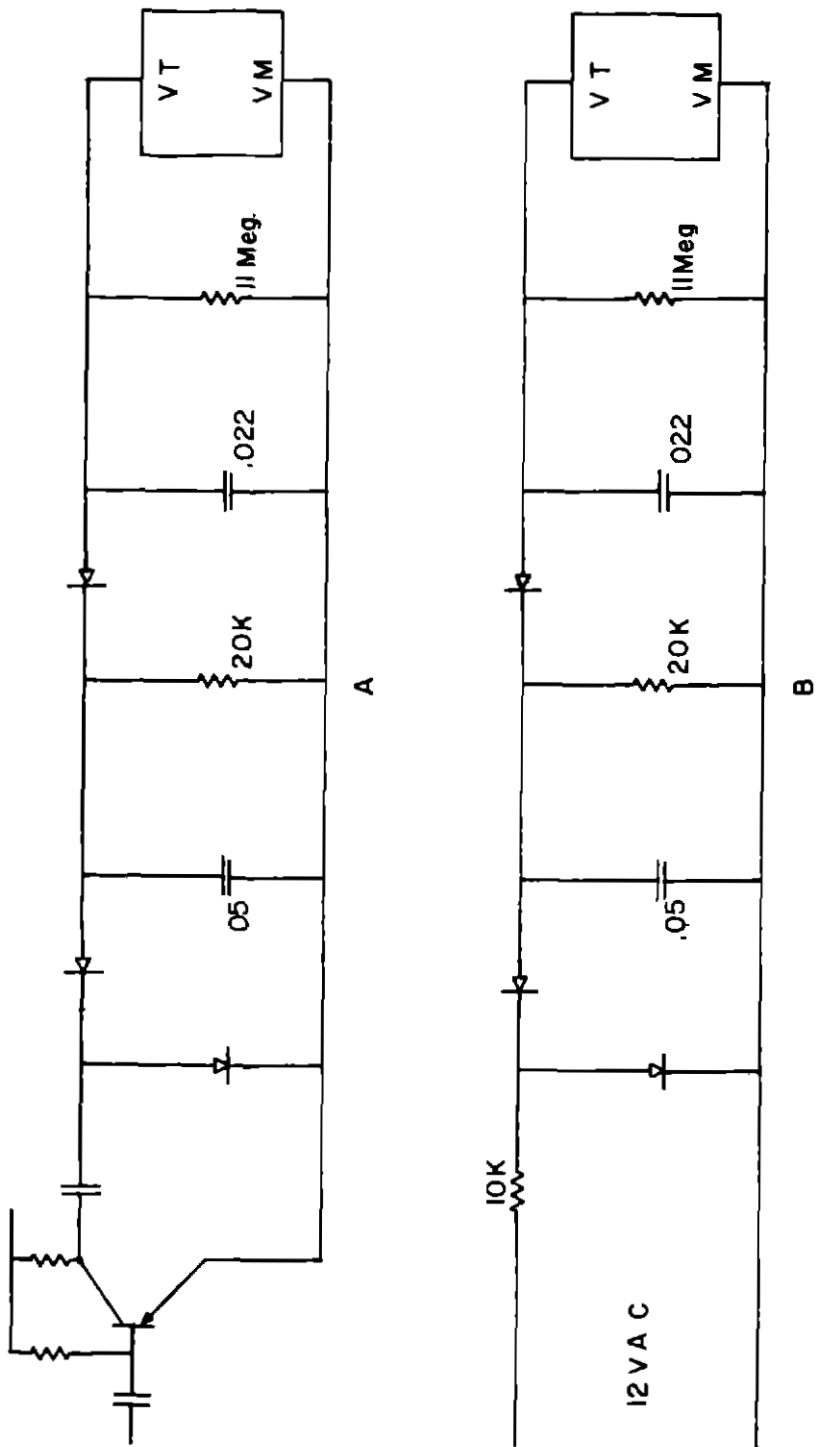
An investigation of a direct frequency comparison circuit also was made. The circuit is shown in Fig. 11A. The component values were assigned for a frequency difference of 2,000 to 500 cycles per tap sound. The test setup for the circuit is shown in Fig. 11B.

A level of 12 volts was maintained at the input, and the frequency was varied from 4,000 cycles down to 200 cycles, and the output voltage read on the vacuum tube voltmeter

<u>Frequency</u> (cps)	<u>Volts Output</u>
4,000	2.8
2,000	2.9
1,000	3.35
500	3.95
400	4.1
200	4.95

CIRCUITRY FOR DIRECT  
FREQUENCY COMPARISON

The results obtained with the circuit of Fig. 11A, as compared to the counting type of indicator circuit actually used in the Flawmeter, produced a more sharply defined indication on test panel No. 5 (Fig. 1) but not as good an indication when used on the heavy steel test panel, No. 2. It has been noted that both the impact and lower following frequencies over poor bonding on test panel No. 2 were higher in frequency than those obtained on test panel No. 5. The direct frequency comparison circuit should be investigated further.

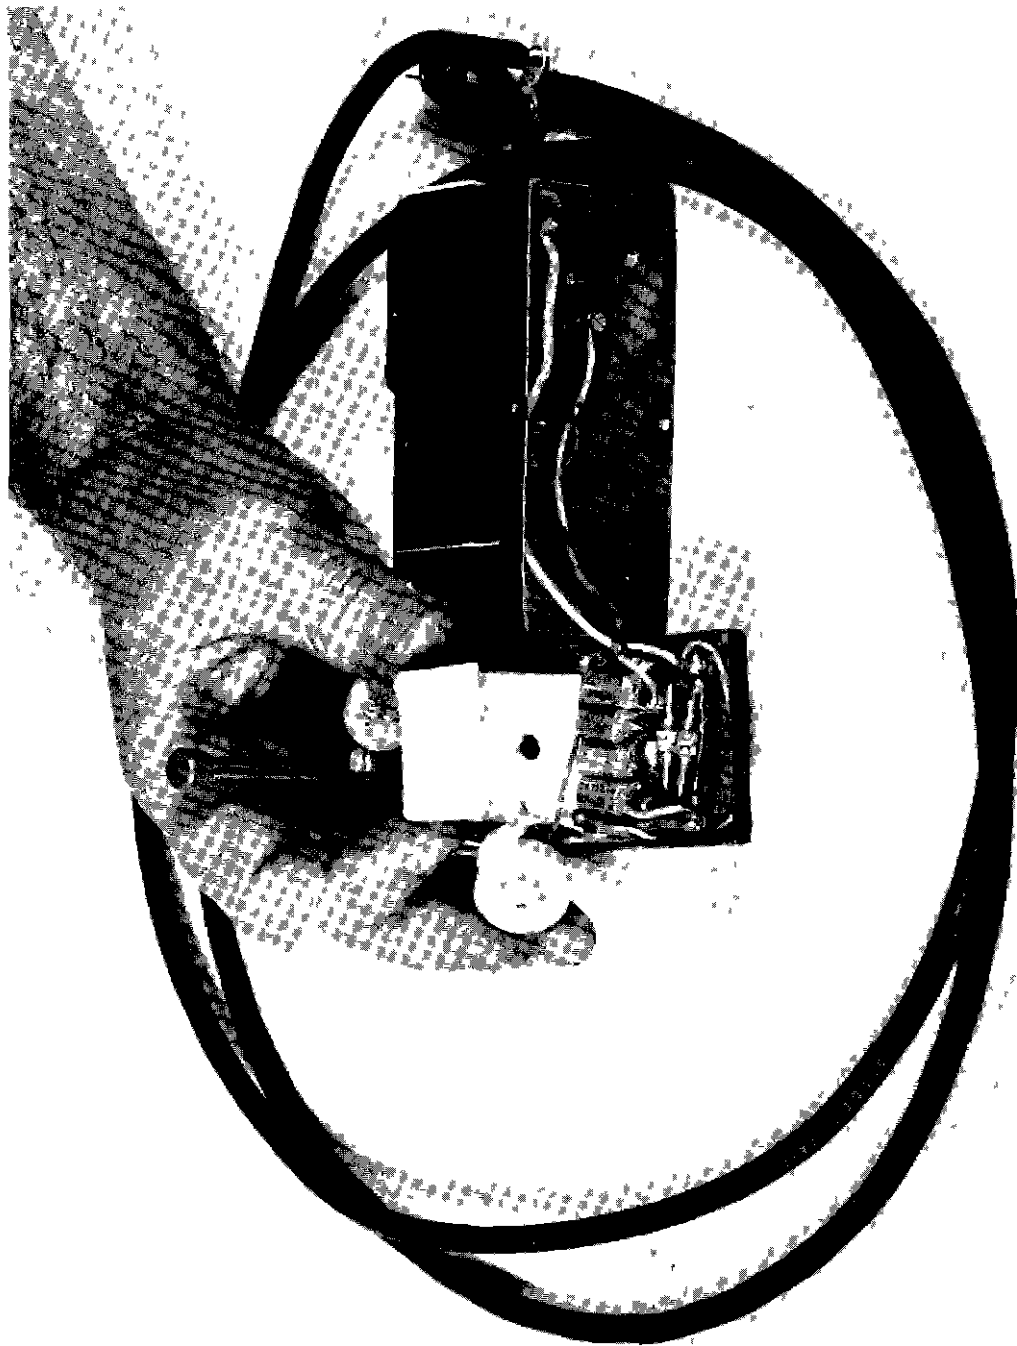
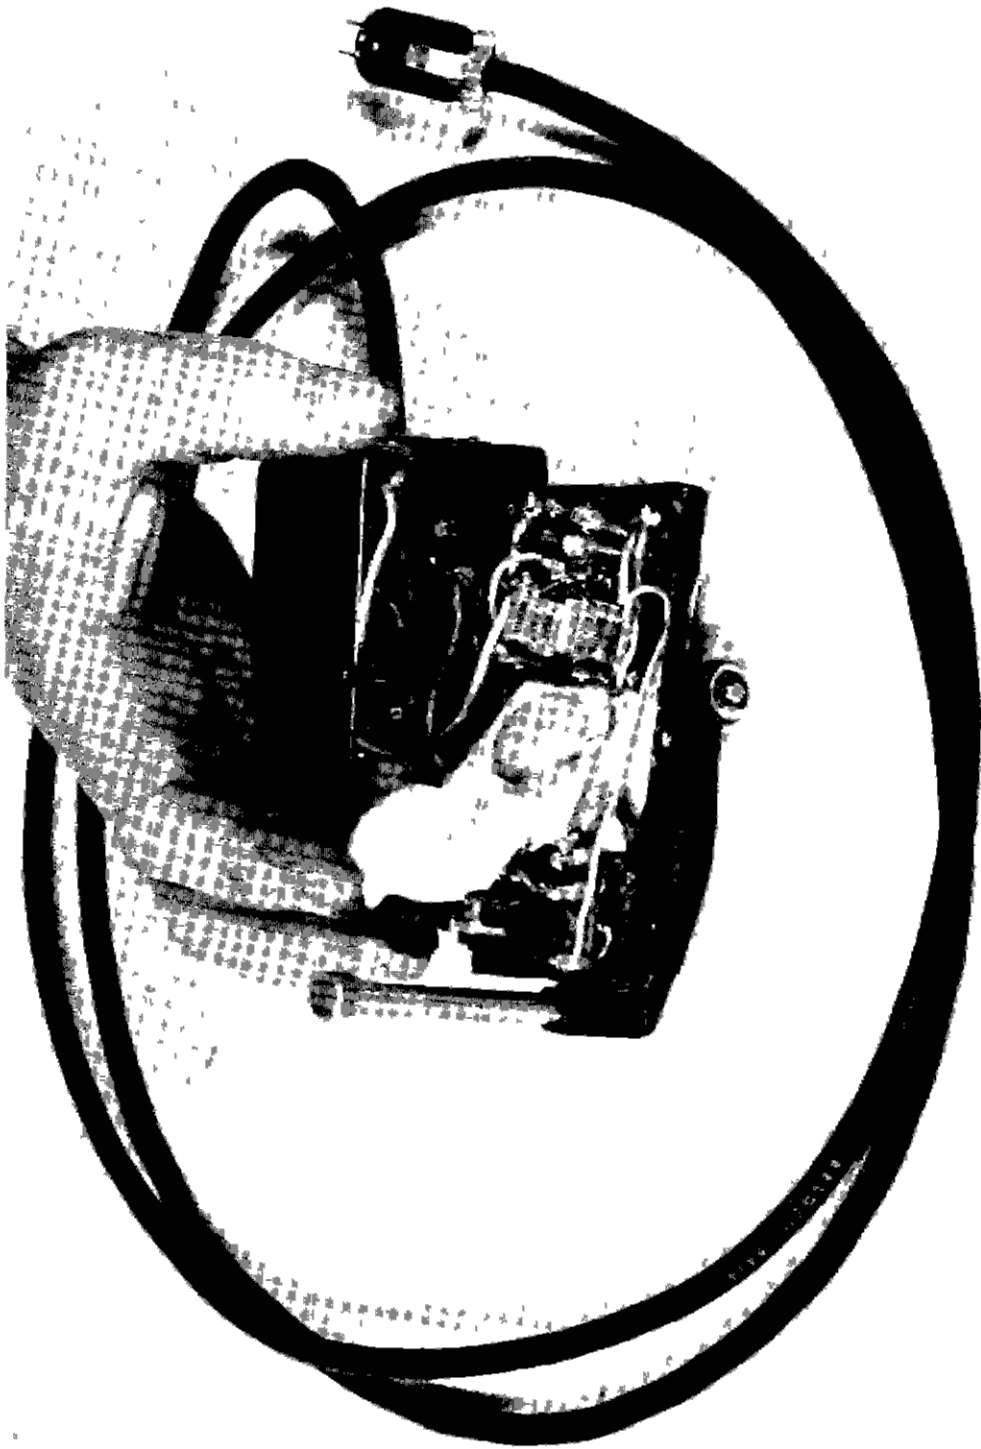
The magnetic field of the driver coil affected the microphone, until it was mounted above a steel plate over the frame of the vibrator. See Figs. 12 and 13. The dynamic-type microphone is preferred to a crystal, as it is much more weatherproof.

MICROPHONE AND MOUNTING

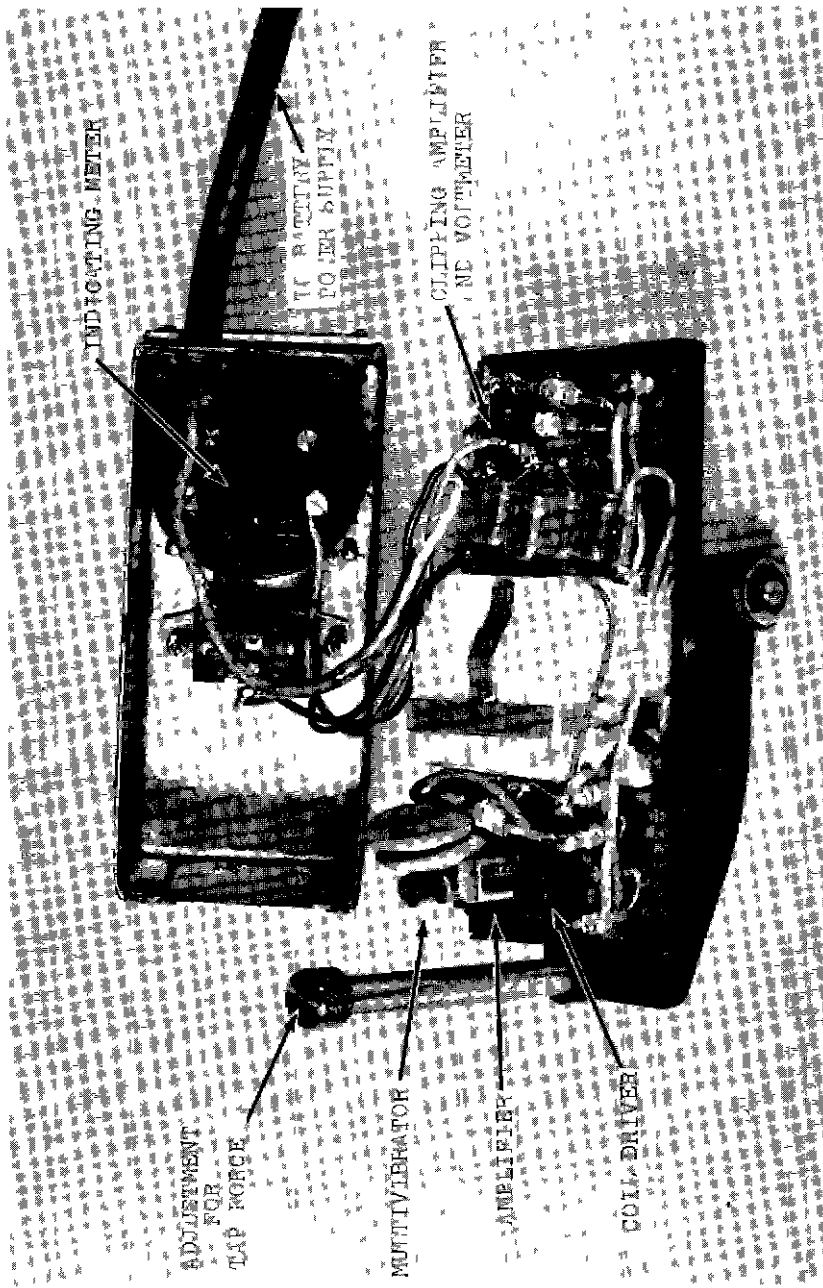
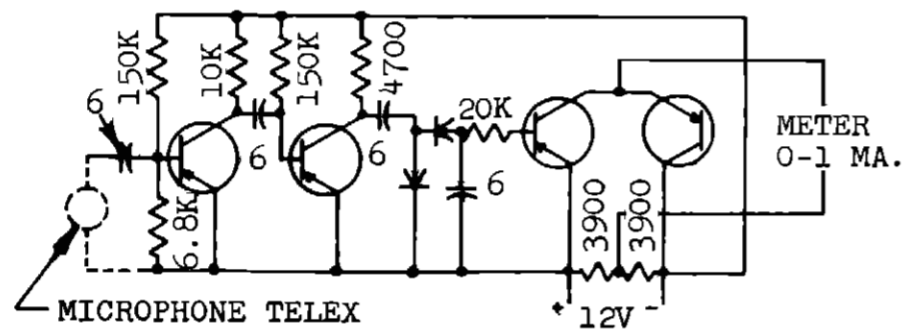
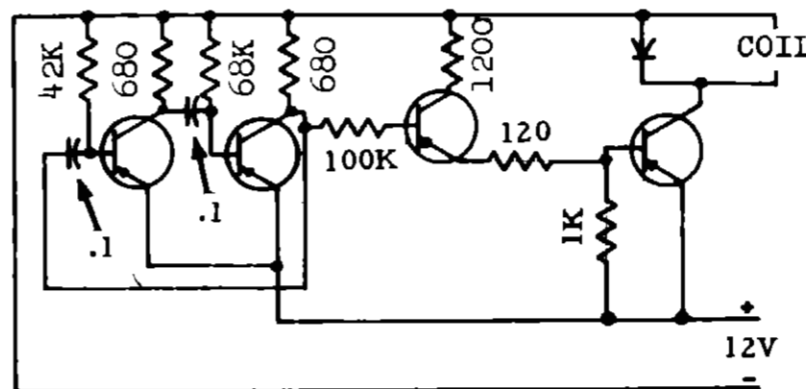
FIG. 15

d. Amplifier It was decided to build a compact hand-held device for the test work. This limited the space available for the amplifier-voltmeter. Only half-watt size resistors and 1N38A diodes were available for the initial work. The rather large size of these units further restricted the space and necessitated the most simple form of circuitry. A suitable limiting transistor amplifier was empirically designed, using an oscilloscope to determine the resistance values required to give the necessary amplification and limiting. The values chosen gave the required action, but operated the transistors at such low current and voltage values as to give trouble. Some investigative work had been done on properly stabilized transistor circuits but the required limiting action was difficult. The output of a simple transistor-balanced voltmeter circuit was used to drive the indicating meter. Details of the experimental assembly are shown in Figs. 14 and 15.

ELECTRONIC ASSEMBLIES  
OF THE FLAWMETER

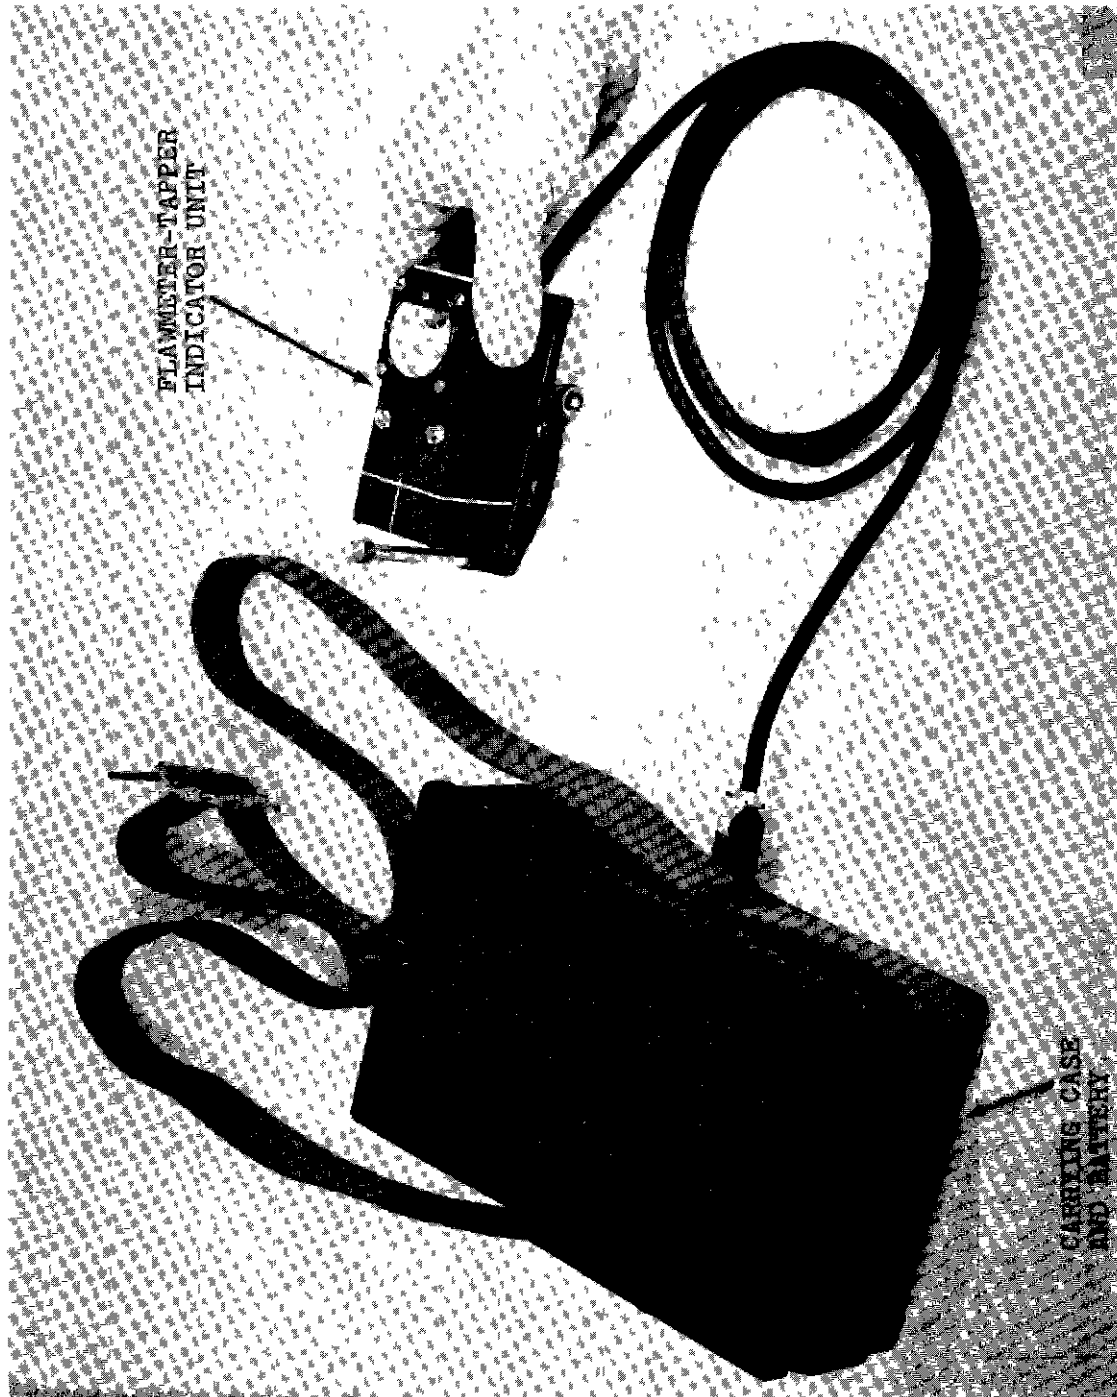
One amplifier may not cover the range of light to heavy panels without some form of volume or sensitivity control. The amplifier might be placed in the carrying case, but this requires a multiwire cable with the microphone wires shielded. Therefore, all of the circuitry was built into the tapper-indicator unit and only batteries are located in the carrying case. The complete experimental Flawmeter including the carrying case is shown in Fig. 16.

COMBINATION BATTERY  
AND CARRYING CASE

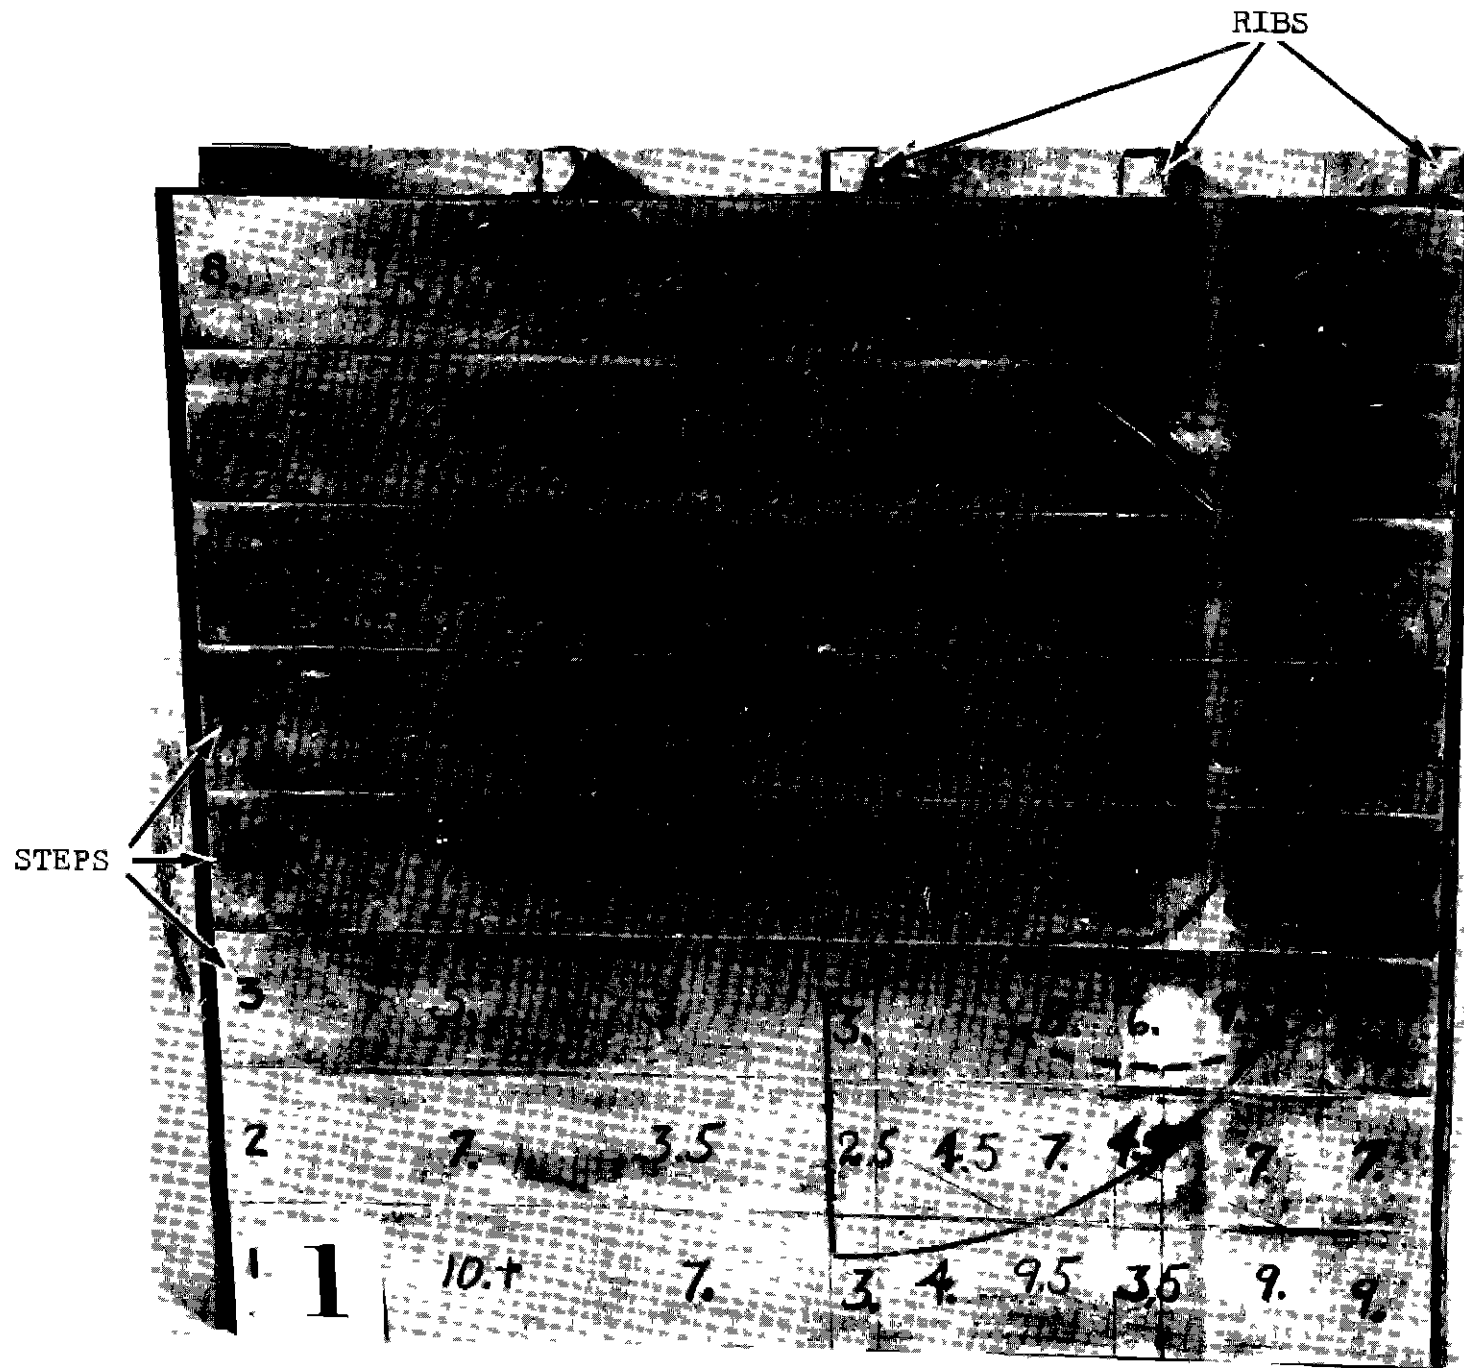
FIG. 17

a. Panel No. 1. Panel No. 1, Fig. 17, was prepared to determine the depth of penetration of any test device. It is constructed of alclad aluminum alloy. In constructing panel No. 1, the two facing sheets first were assembled to the ribs. Bonding material was applied to all the surface of the top facing sheet except in the void areas, then a sheet covering the entire area of the facing sheet was laid down. On panel No. 1, the visible part of the first covering sheet is marked step 1. Succeeding sheets, each 1 1/2 inches shorter than its predecessor, were well bonded to the next lower sheet so as to form a series of steps or increments of .018-inch thickness of metal plus the thickness of the bonding material.

The numbers on panel No 1 in Fig. 17 are the Flawmeter readings. The higher the reading, the poorer the bonding or solidity of the structure. Note the horizontal row of figures on step 1. The readings over the hollow structure are much higher than the two readings over the ribs. The upper horizontal row of figures on step 8 shows that the meter indicates a lack of solidity caused by the edge of the structure. The dotted outlines clearly indicate actual void areas in the bonding beneath step 1.

Undoubtedly, the bonding material flowed under pressure, departing from the planned positions shown by the solid outlines. The results shown on Fig. 17 indicate that the light tapping experimental Flawmeter is limited to a thickness of six or seven layers of .018-inch aluminum and bonding material.

SPAR: 2" X 1" X 1/8" X 12"  
 WT. 1.59 LB.  
 AISI C1015 - 20 CHANNEL  
 1 - REQUIRED

RIBS: 2" X 1/2" X .050" X 12"  
 24S-T3 ALCLAD FORMED CHANNEL  
 4 - REQUIRED

FACING: .032" 24S-T3 ALCLAD SHEET  
 NO. REQUIRED:  
 3 - 12" X 12"  
 1 - 10.5" X 12"  
 1 - 9" X 12"  
 1 - 7.5" X 12"  
 1 - 6" X 12"  
 1 - 4.5" X 12"  
 1 - 3" X 12"  
 1 - 1.5" X 12"

ADHESIVE: PLASTOLOCK 601
