FINAL REPORT

## DEVELOPMENT OF GENERAL SPECIFICATIONS FOR A DEVICE FOR INSPECTING HELICOPTER BLADE BONDING

NOVEMBER 1959

TEST AND EXPERIMENTATION DIVISION

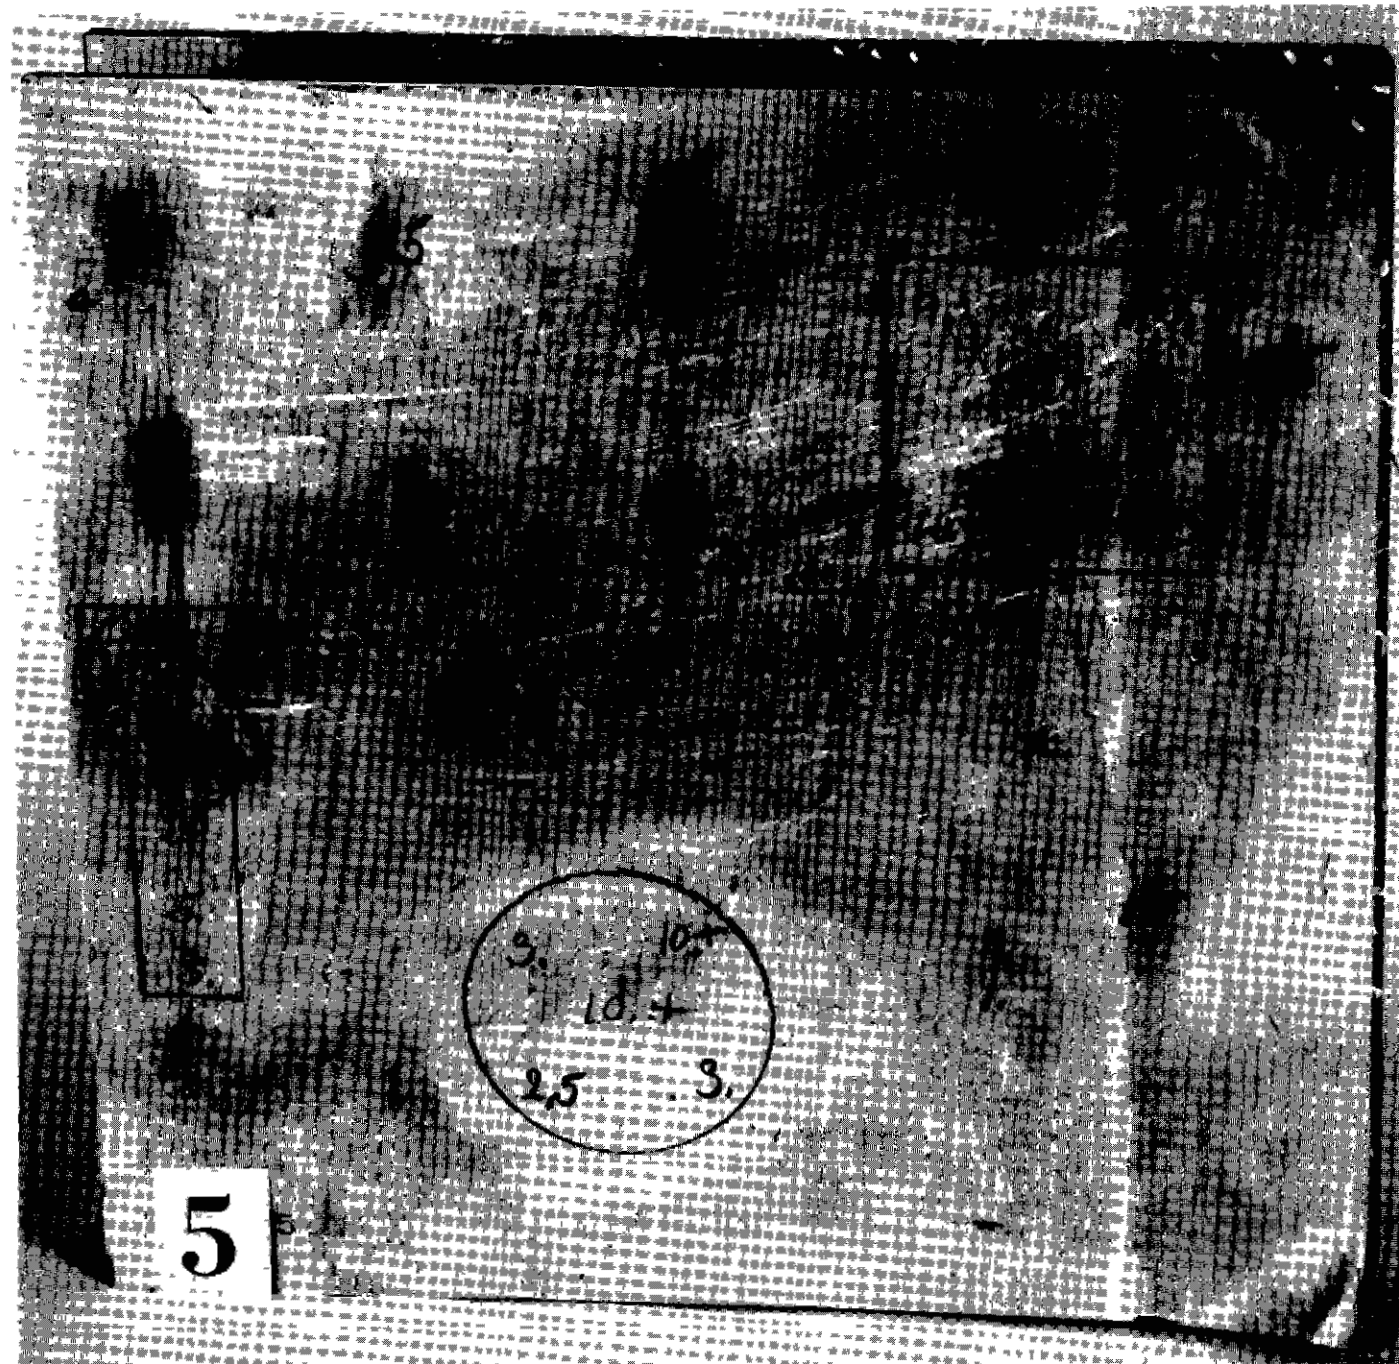
FIG. 21

e. Panel No. 5 (Fig. 21). This 24S-T3 aluminum, honeycomb sandwich panel was used more than the other panels in developing the Flawmeter. The intended void areas of circle, square, and tee were determined easily by coin tapping. The single tap sound pictures A and B of Fig. 4 were taken with the tapper striking the spot marked X below the square and the plus in the square, respectively.

The intended void in the tee-shape suffered from flowing of the bonding material. The actual void is in the dotted area. This area was probed from the left edge with a very thin and narrow piece of metal. A small blister in the bonding is noted at the reading 5 near the bottom of the tee.

The circular area was badly dented by some of the earlier mechanical tappers so that the facing metal has been driven down against the core material. The dotted extension of the lower left corner of the square area is an unintended void.

SPAR: 2" X 2" X 1/4" X 12"  
62S-T6 ALCOA NO. 892  
WT. 1.667 LB.  
1 - REQUIRED

RIBS: 10" X 12" X 2"  
ALUMINUM HONEYCOMB 3/8" CELL  
1 - REQUIRED

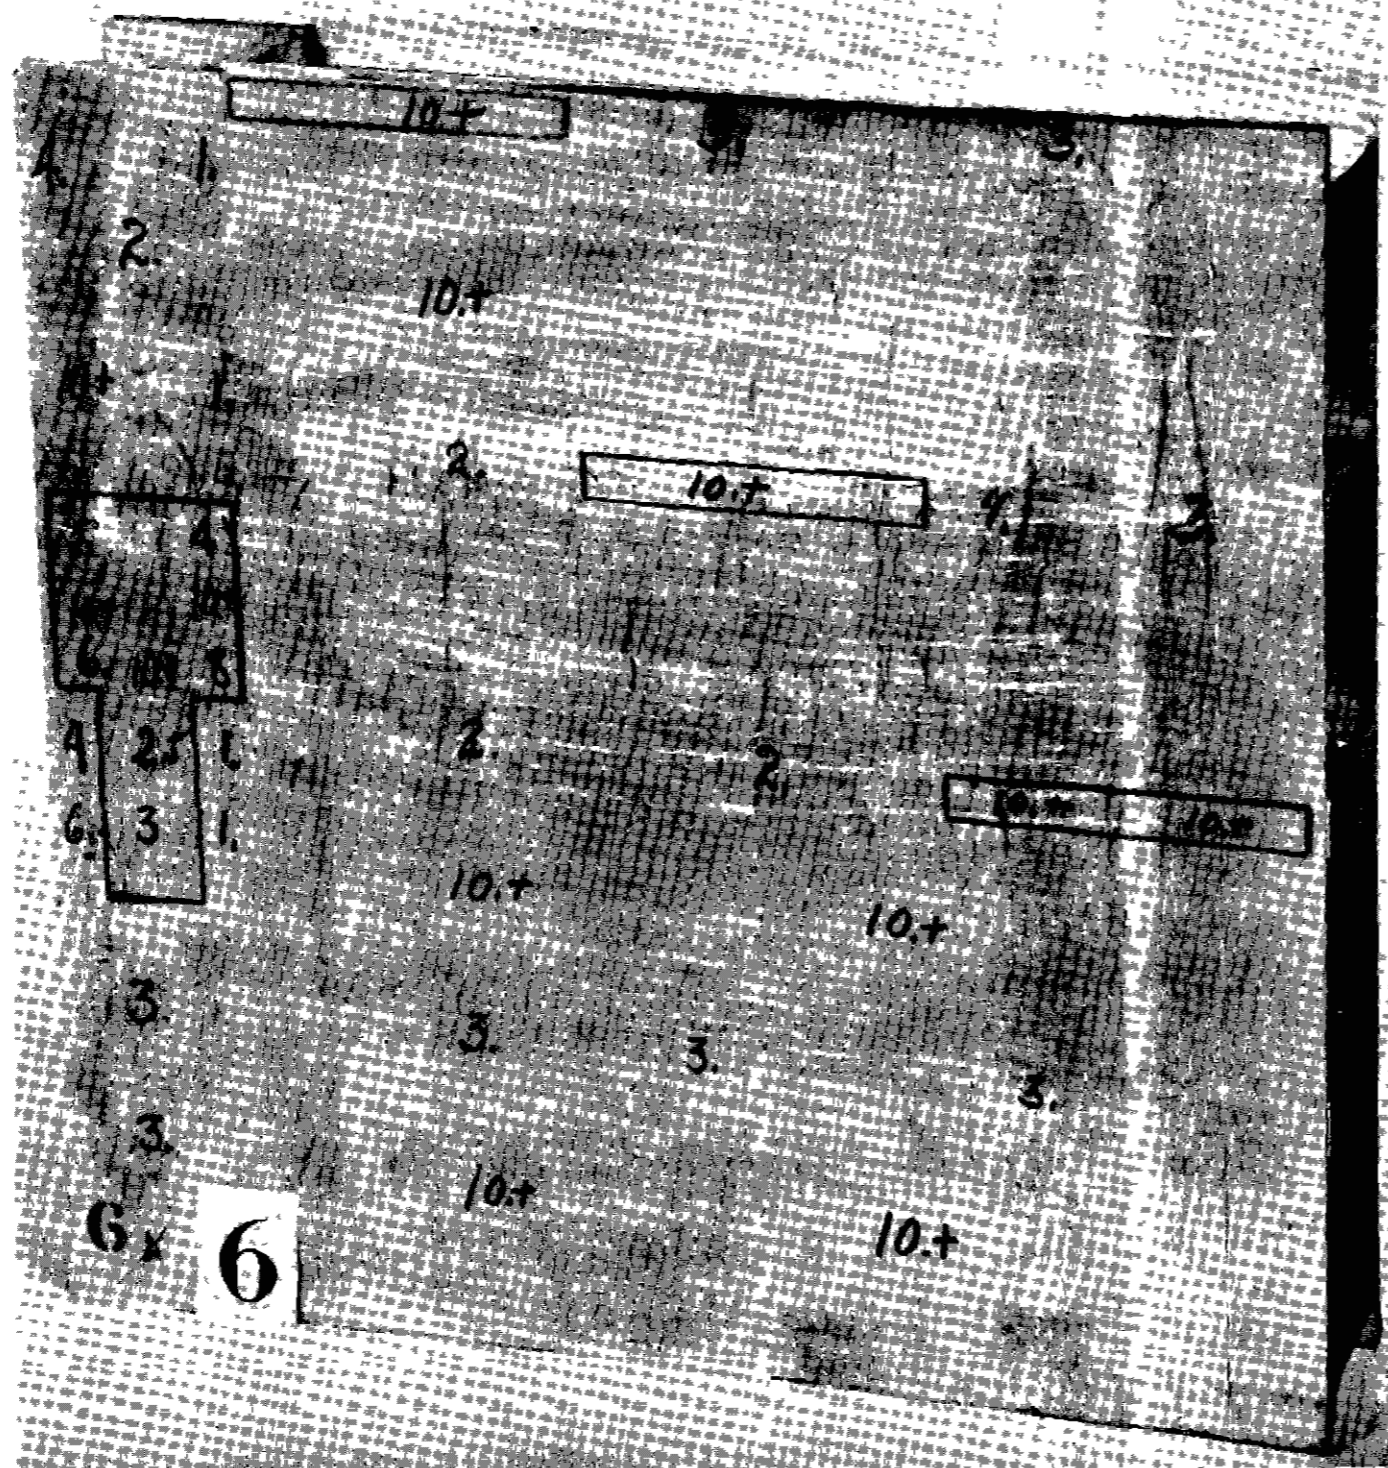
NAT LAB  
 TESTS ON PANEL NO. 6  
 Task No 59-214 I  
 FIG. 22

f. Panel No. 6 (Fig. 22): Panel No. 6 is a 24S-T3 aluminum box structure bonded to a heavy 24S-T3 aluminum spar. Flawmeter readings over the open box structure are 10 plus as are the void areas over the ribs. The extreme left vertical column of readings show an edge effect, except for the 10 plus, over a blister above the tee-shaped void. The tee-shaped intended void shows flowing of the bonding material. Compare the edge readings with the readings of 1 over the web of the spar.

SPAR: 2" X 2" X 1/4" X 12"  
 62S-T6 ALCOA NO. 892  
 WT. 1.667 LB.  
 1 - REQUIRED

RIBS: 2" X 1/2" X .016" X 10"  
 24S-T3 ALCLAD FORMED CHANNEL  
 5 - REQUIRED

ADHESIVE: 2 OR 3 LAYERS SCOTCHWELD 585

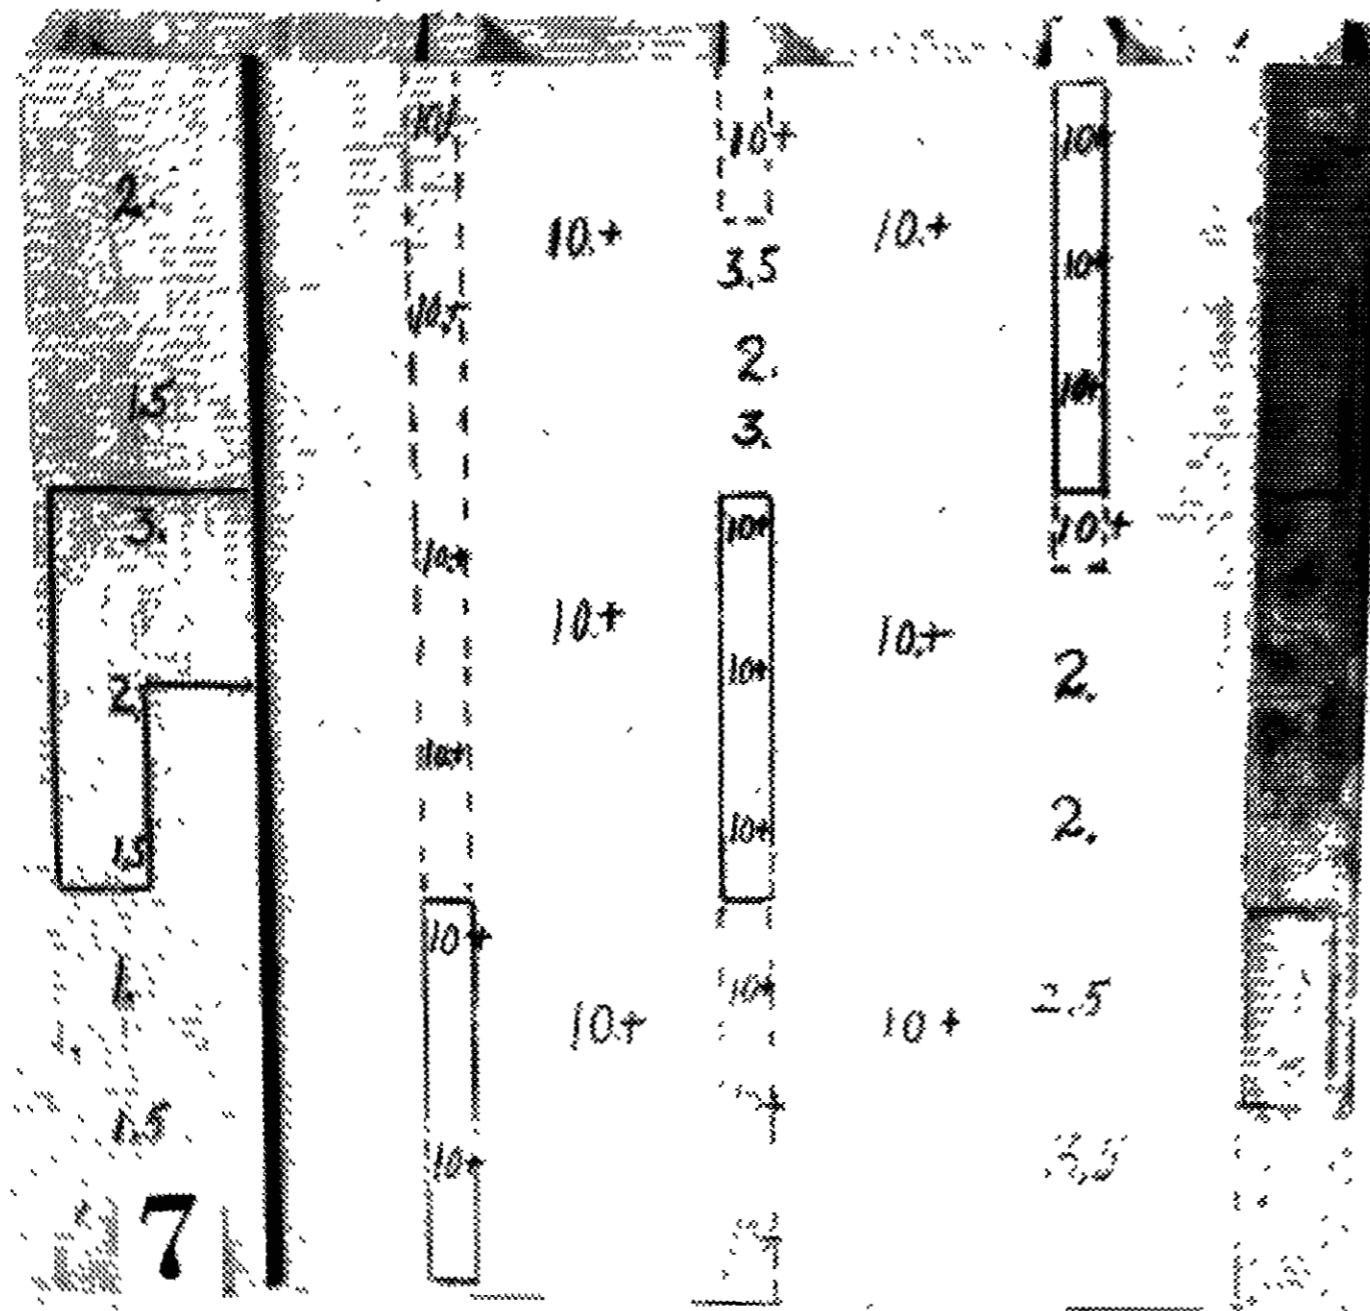
NATIONAL AVIATION	
TESTS ON PANEL NO. 7	
Task No 59-214 I	FIG. 23

g. Panel No. 7 (Fig. 23): Panel No. 7 is a 24S-T3 aluminum box structure with the 24S-T3 aluminum face plates bonded to the inside of the spar flanges. The left-hand spar is 1/4-inch-thick 24S-T3 aluminum and the right-hand spar is 1/16-inch-thick steel. Void areas were intended

under both spars, however, the configuration of the Flawmeter, involving the relation of wheel track to wheel-foot spacing, would not permit readings to be obtained over the narrow steel spar. The readings of 2 and 3 over the planned void area under the aluminum spar seem to indicate the existence of a void area though this indication should be classed properly as doubtful. The bonding of the ribs to the upper face sheet is much worse than was intended.

SPAR: 2" X 2" X 1/4" X 12"  
 62S-T6 ALCOA NO. 892  
 WT. 1.667 LB. CHANNEL  
 1 - REQUIRED  
 SEE SPEC.  
 2" X 1" X 1/8" X 12"  
 AISI C1015 - 20 CHANNEL  
 WT. 1.59 LB.  
 1 - REQUIRED

RIBS: 2" X 1/2" X .050" X 12"  
 24S-T3 ALCLAD FORMED CHANNEL  
 3 - REQUIRED

ADHESIVE: PLASTOLOCK 601

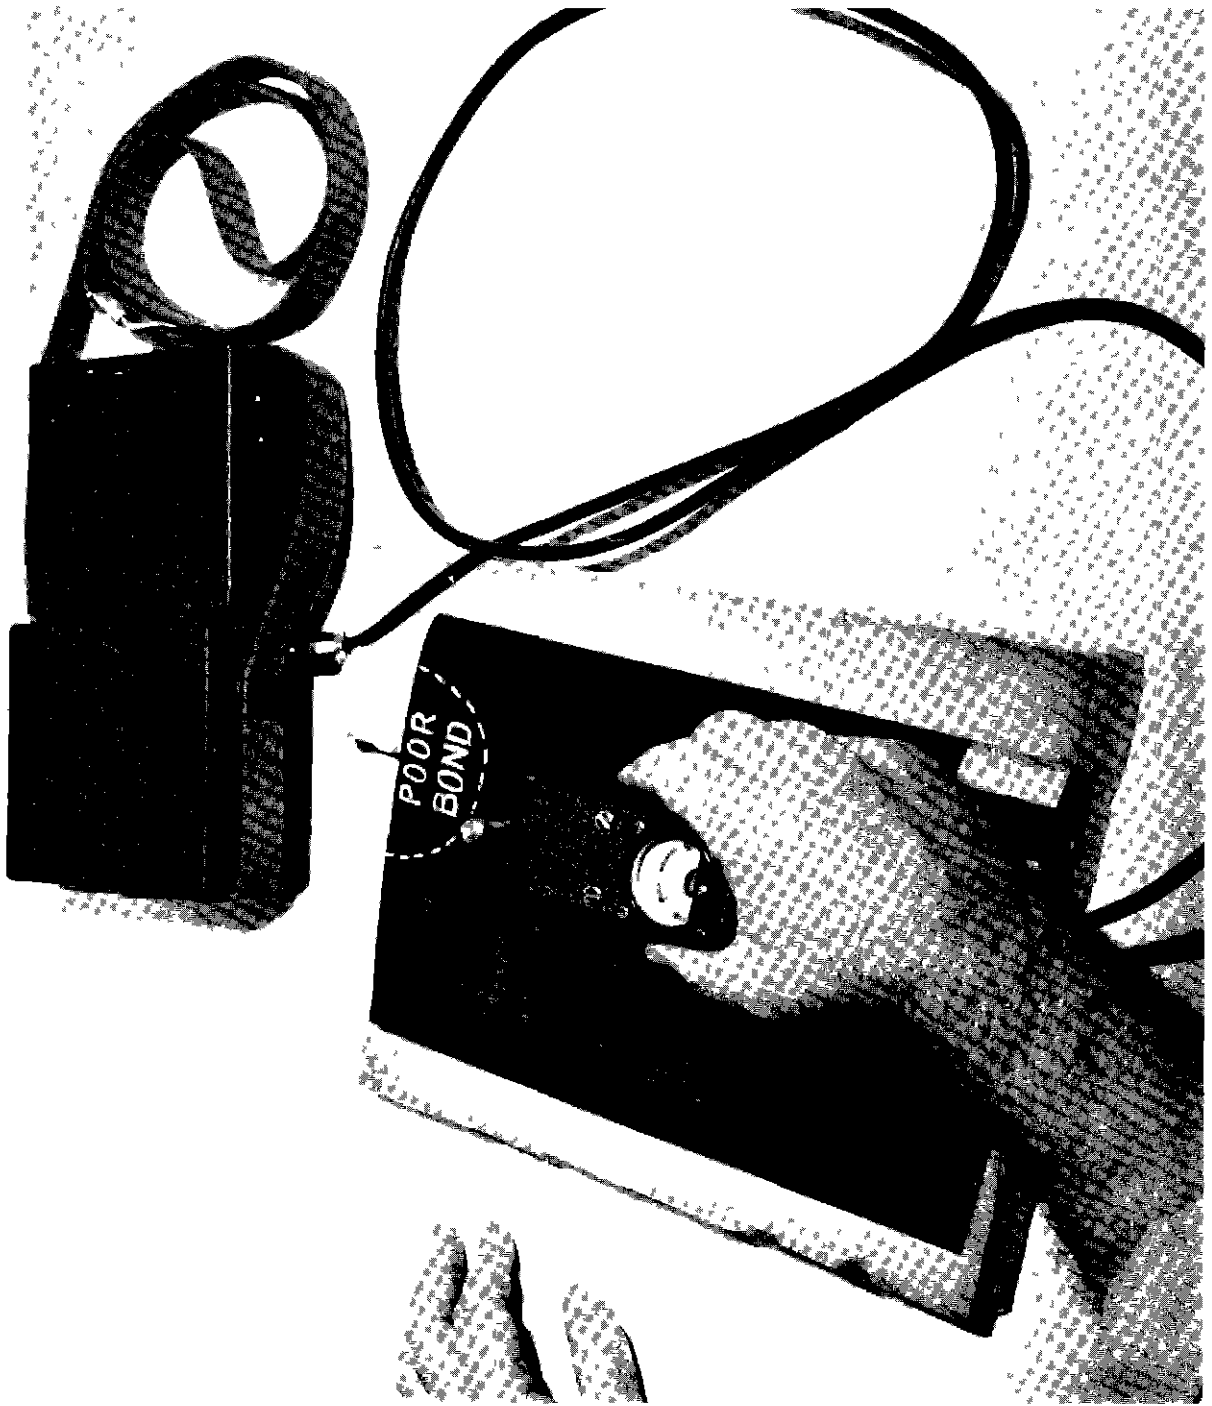
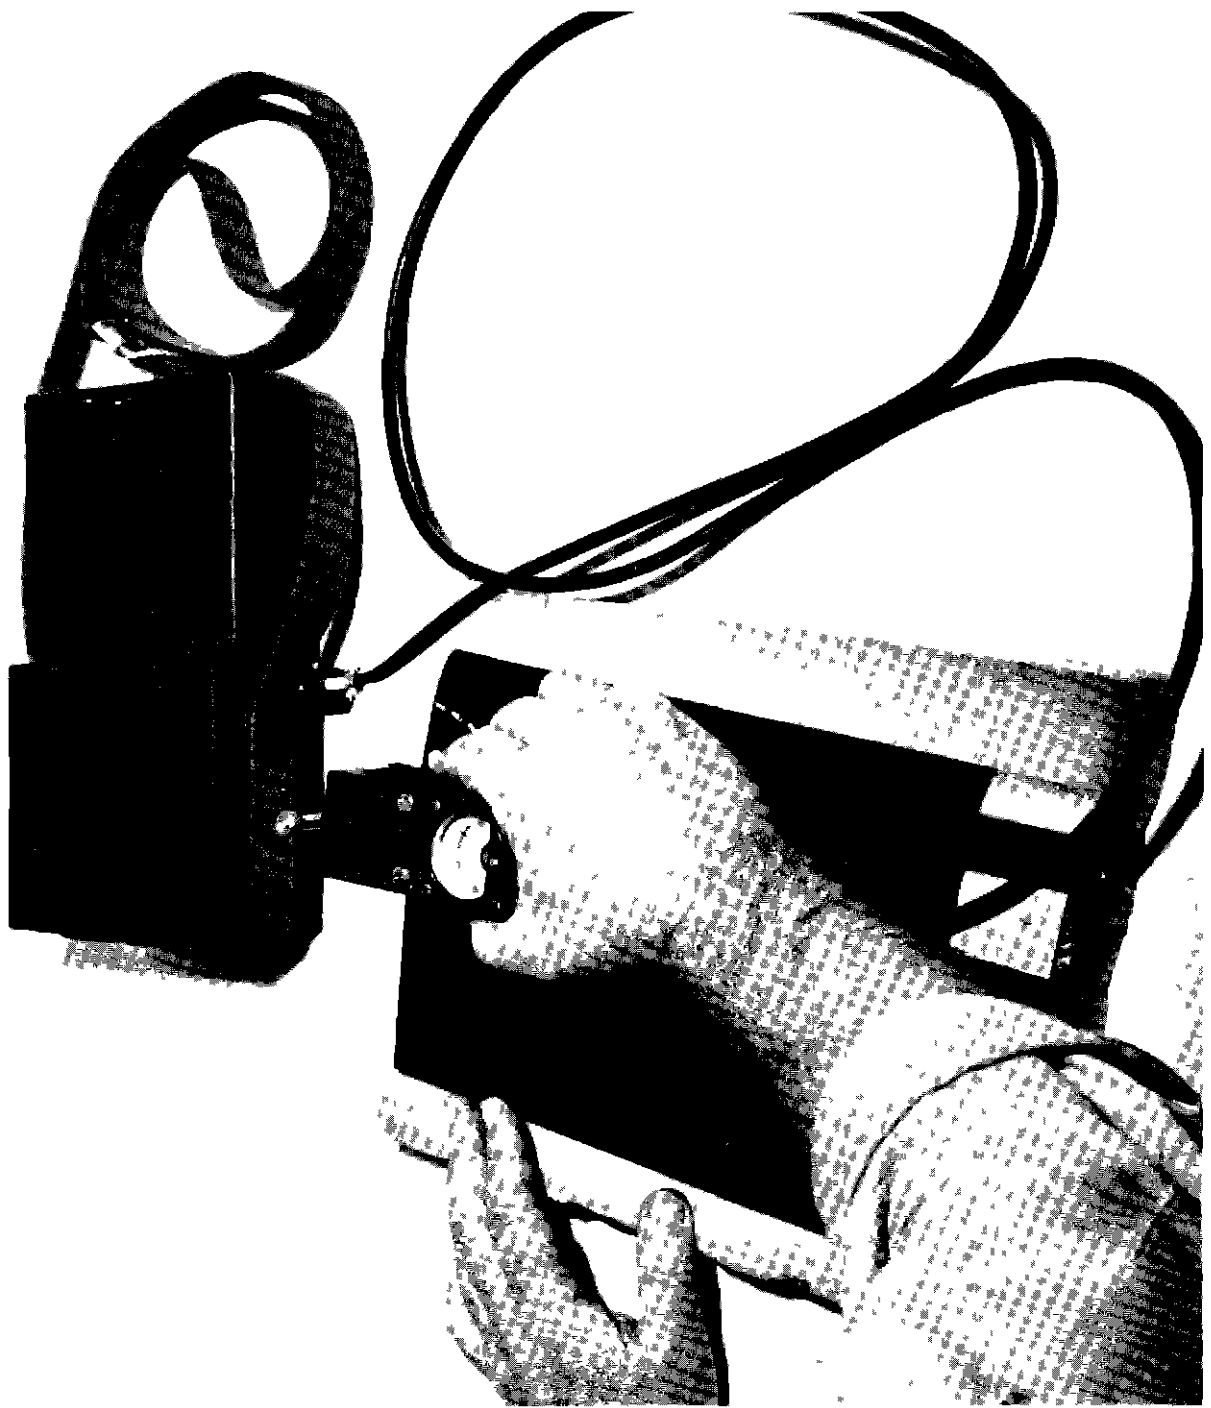
h. Tail Rotor Test (Figs. 24 and 25). The section of aluminum honeycomb sandwich tail rotor shown in Figs 24 and 25 was found to have a poor bond or void condition where it is marked. Note the reading of the meter over the good bonding shown in Fig. 24. Figure 25 illustrates the increased reading on the Flawmeter obtained over the void or poor bond area. Figure 26 shows the appearance and lack of bonding between the face sheet and the aluminum honeycomb. The edge was slotted with a jeweler's saw and the face sheet turned back

ACTUAL GOOD BOND READING

ACTUAL BAD BOND READING

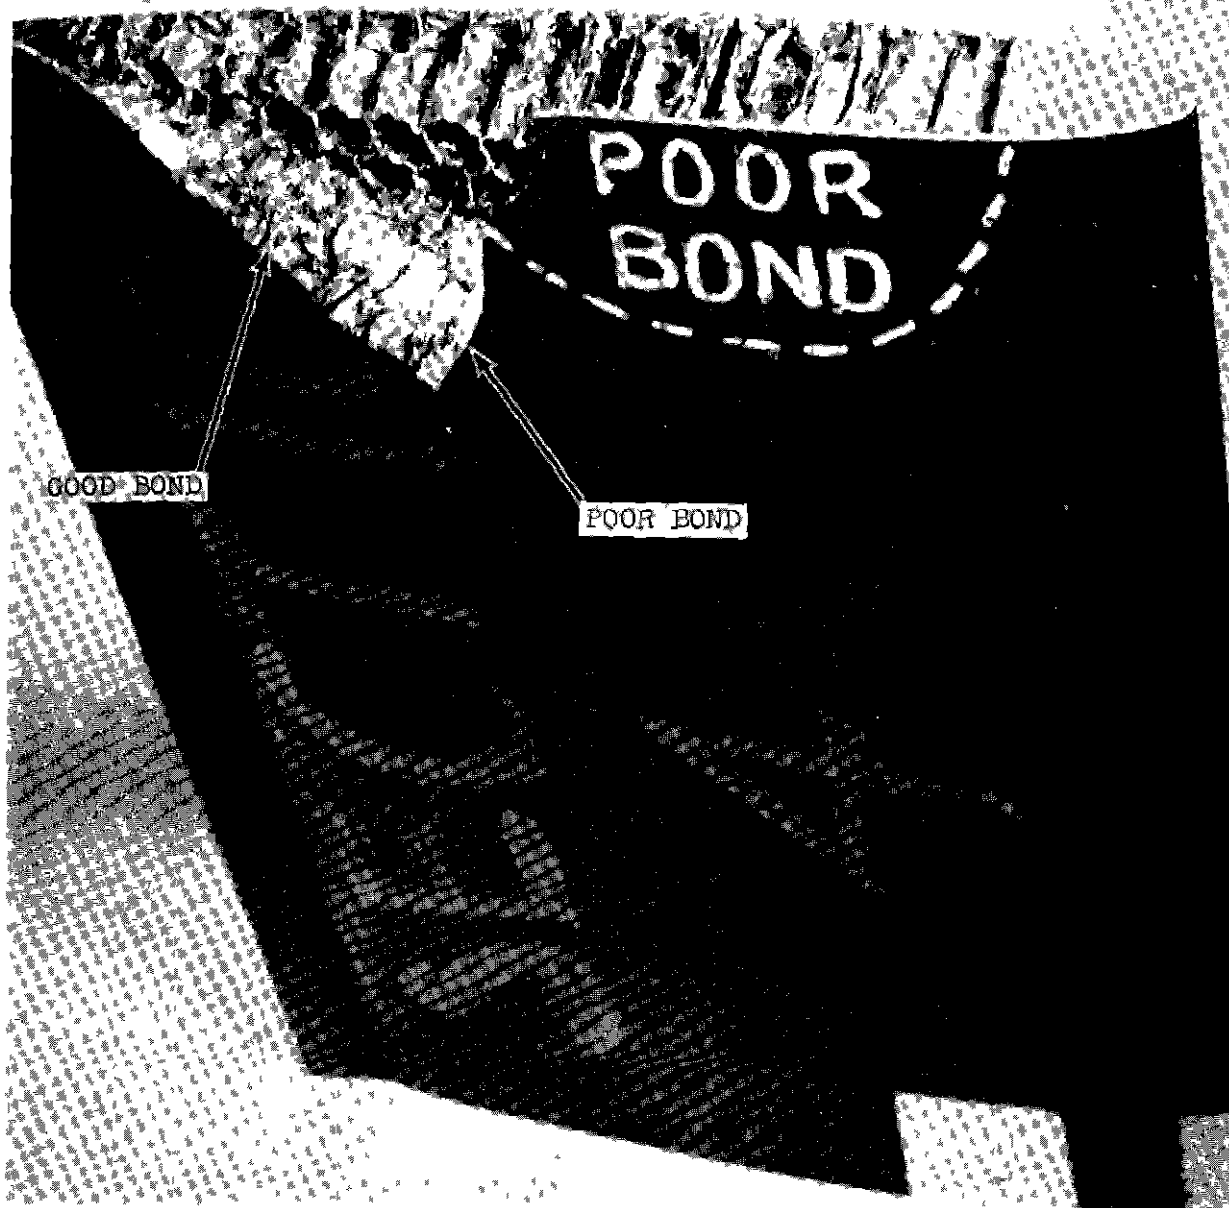
PROOF OF FLAWMETER READING
