1. Report No. FHWA/TX-93/1232-21	2. Government Accession No.	3. Recipient's Catalog No.	
4. Title and Subtitle EVALUATION OF SENSORS FOR MONITORING TRUCK SPEEDS		5. Report Date November 1993

EVALUATION OF SENSORS FOR MONITORING TRUCK SPEEDS

Research Report 1232-21
Research Study Number 0-1232
Research Study Title: Evaluation of Sensors for Monitoring Truck Speeds

TEXAS TRANSPORTATION INSTITUTE
The Texas A&M University System
College Station, Texas 77843-3135

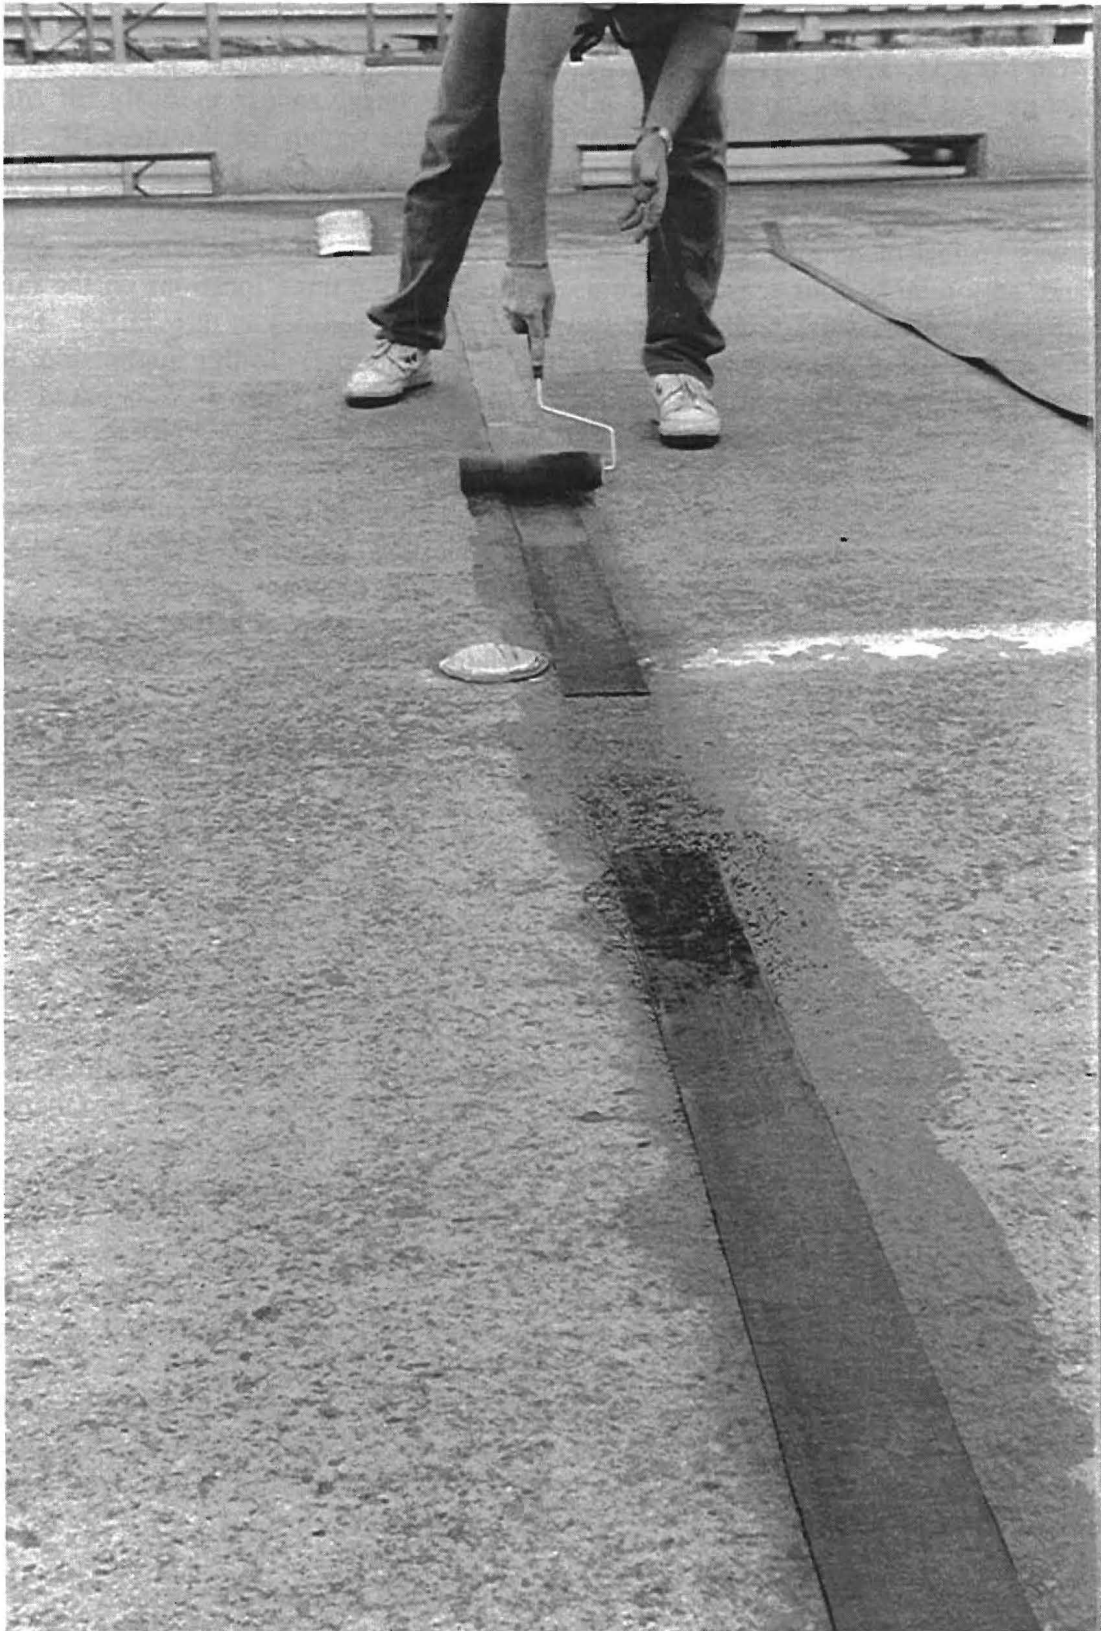
Figure 2-1. Applying Polygard and Primer for Piezo Sensors

To keep these TP sensors in position, TTI initially used a primer painted directly on the pavement surface, followed by one layer of a scale tape material called Polygard across the entire lane width. After a few minutes of curing time (depends on ambient temperature), TTI then placed a new piezo sensor directly on top of and in the center of the Polygard, being careful to maintain its position relative to the other sensor in the same lane. At least one layer (preferably two layers) of Polygard covered the sensor in an overlapping fashion to maintain its position relative to the other sensor and to protect it from traffic. Six-inch (152 mm) widths of Polygard were typically used, although 4-inch (102 mm) widths were also occasionally used. Figures 2-1 through 2-4 show the initial process of placing these sensors on the pavement. Efforts used to protect sensors and coaxial cables from damage included placement of raised pavement markers adjacent to the terminal block of each sensor and placing coaxial cables behind (downstream) shoulder tiles.

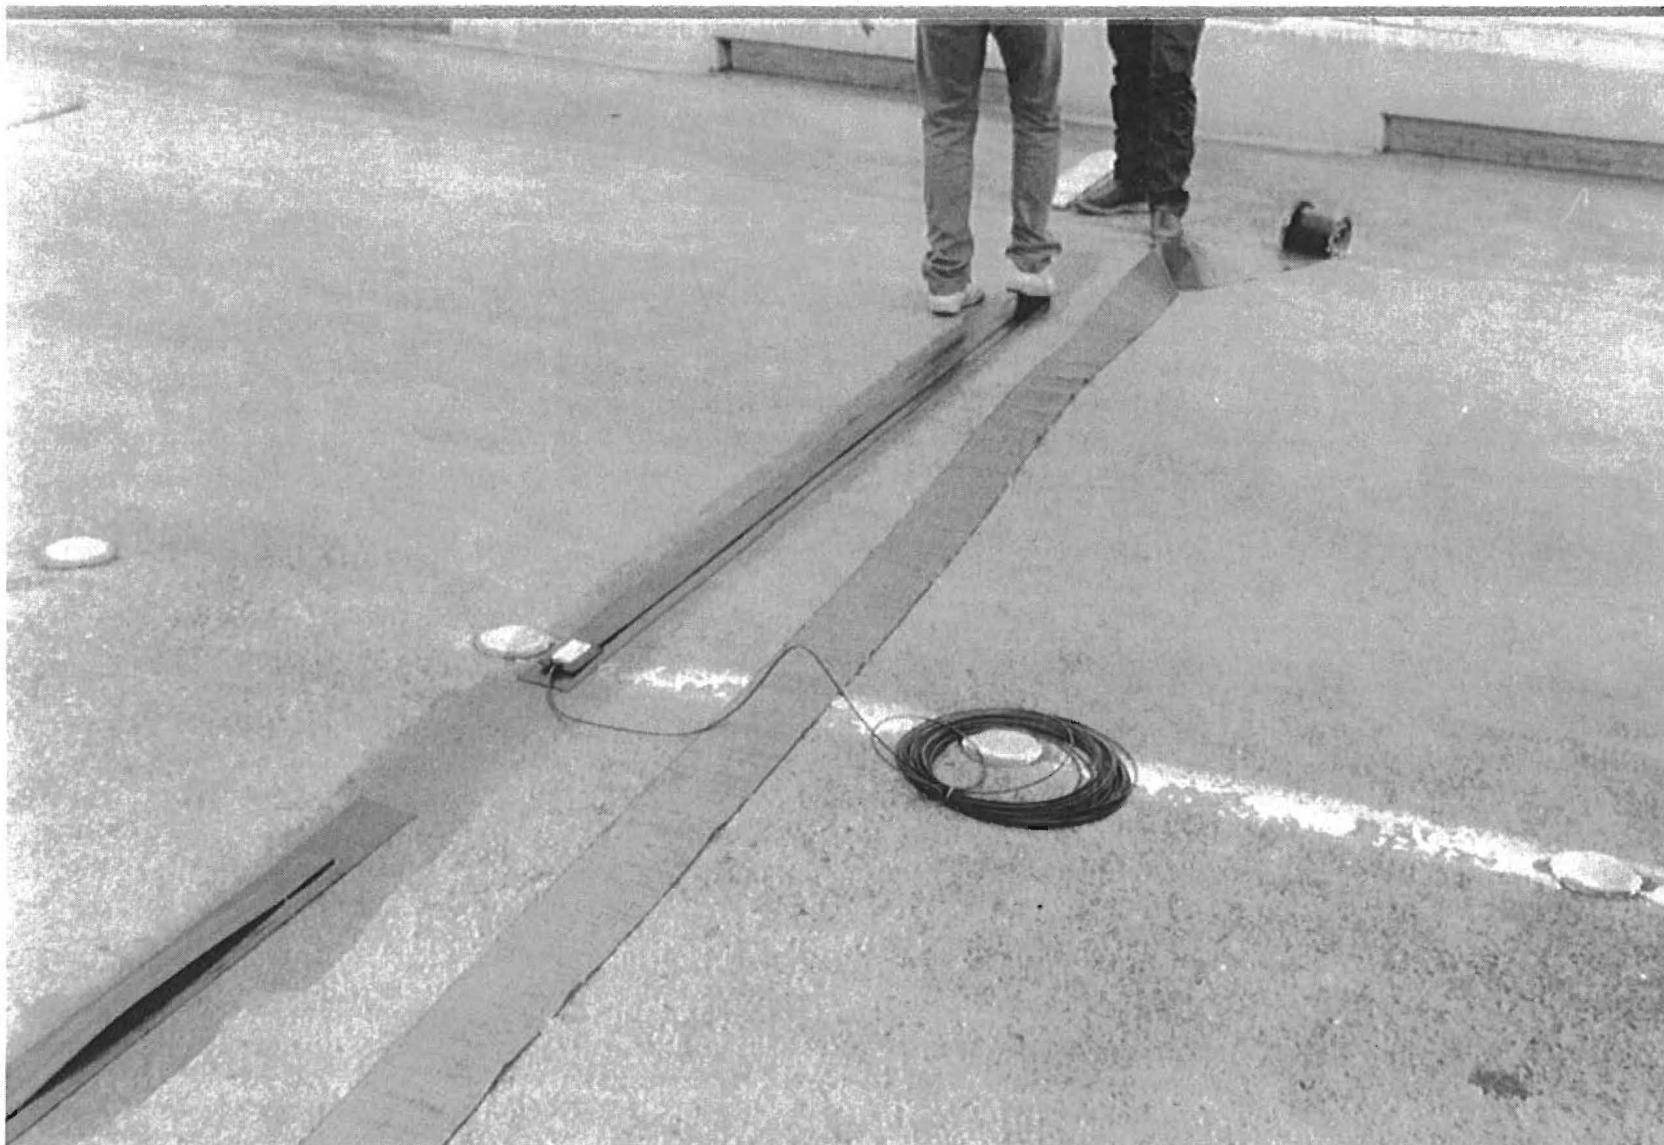
Figure 2-2. Lane 2 Piezo Sensor Prior to Covering with Polygard

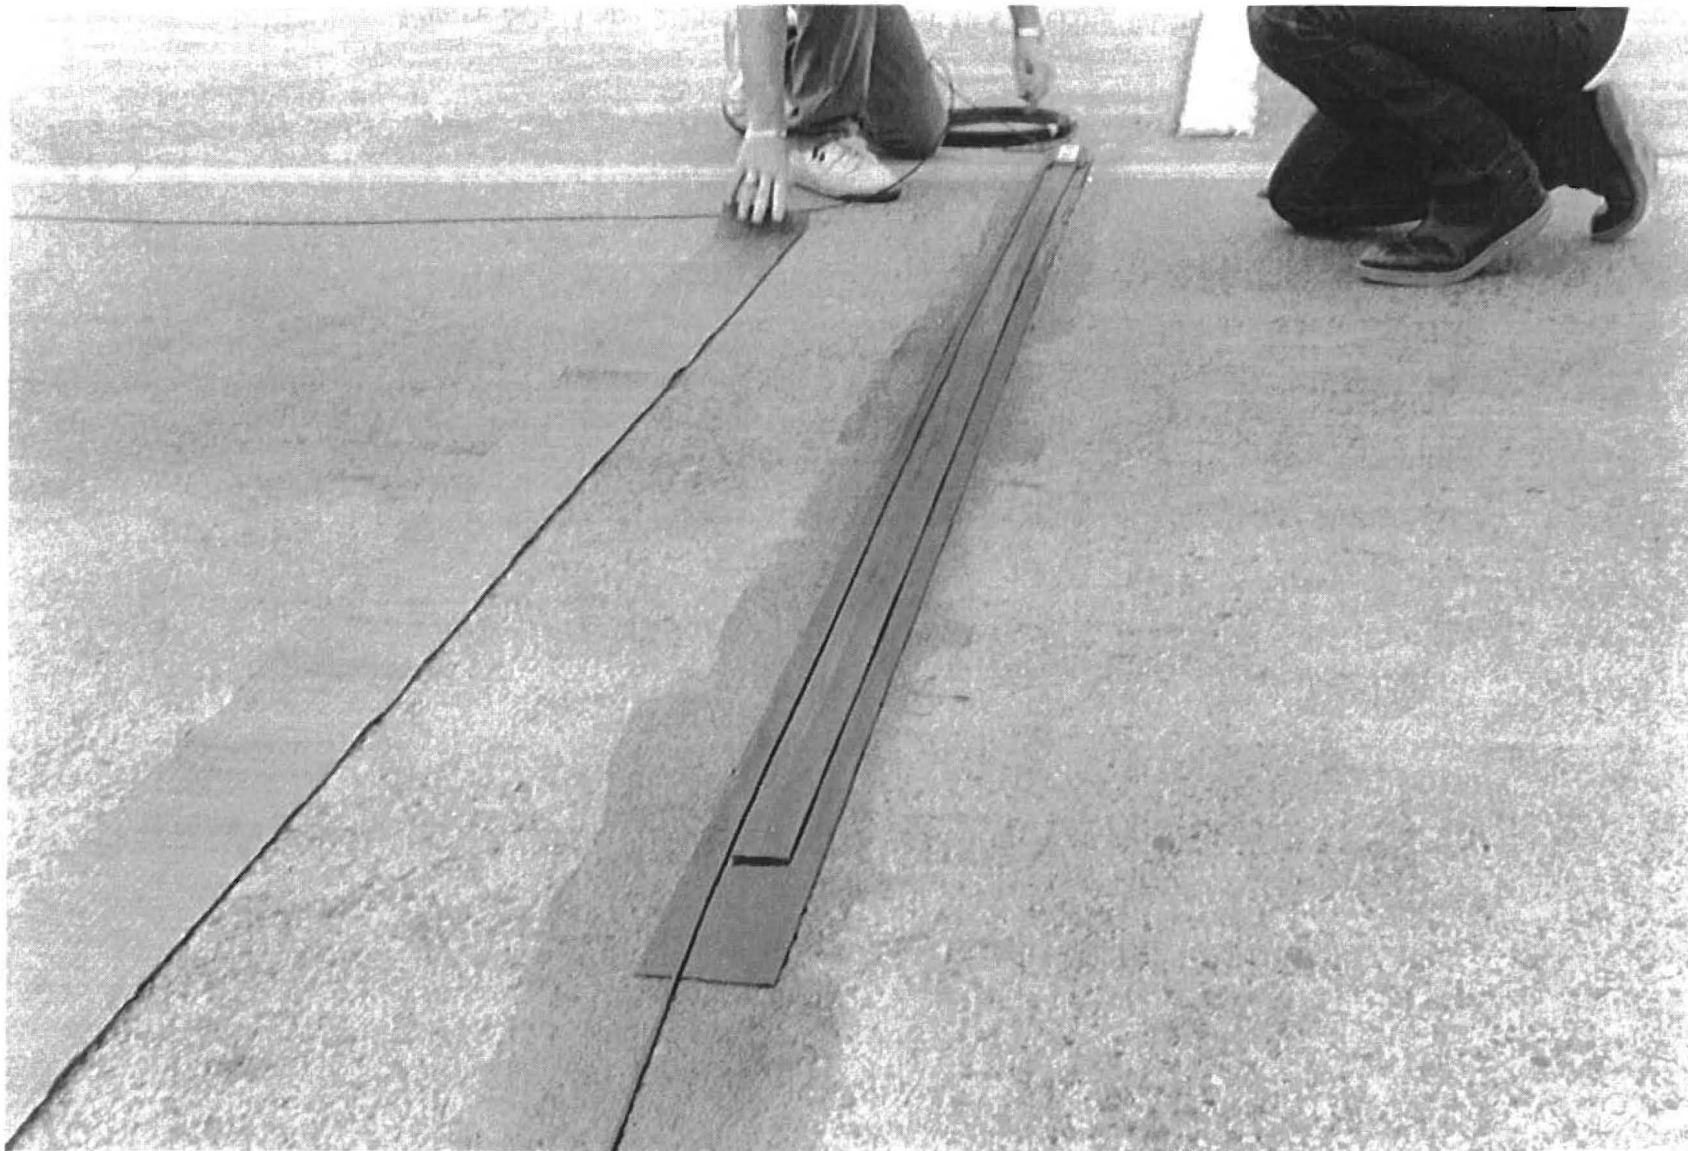
Figure 2-3. Lane 1 Piezo Sensor Showing Placement of Coaxial Cable from Lane 2 Sensor

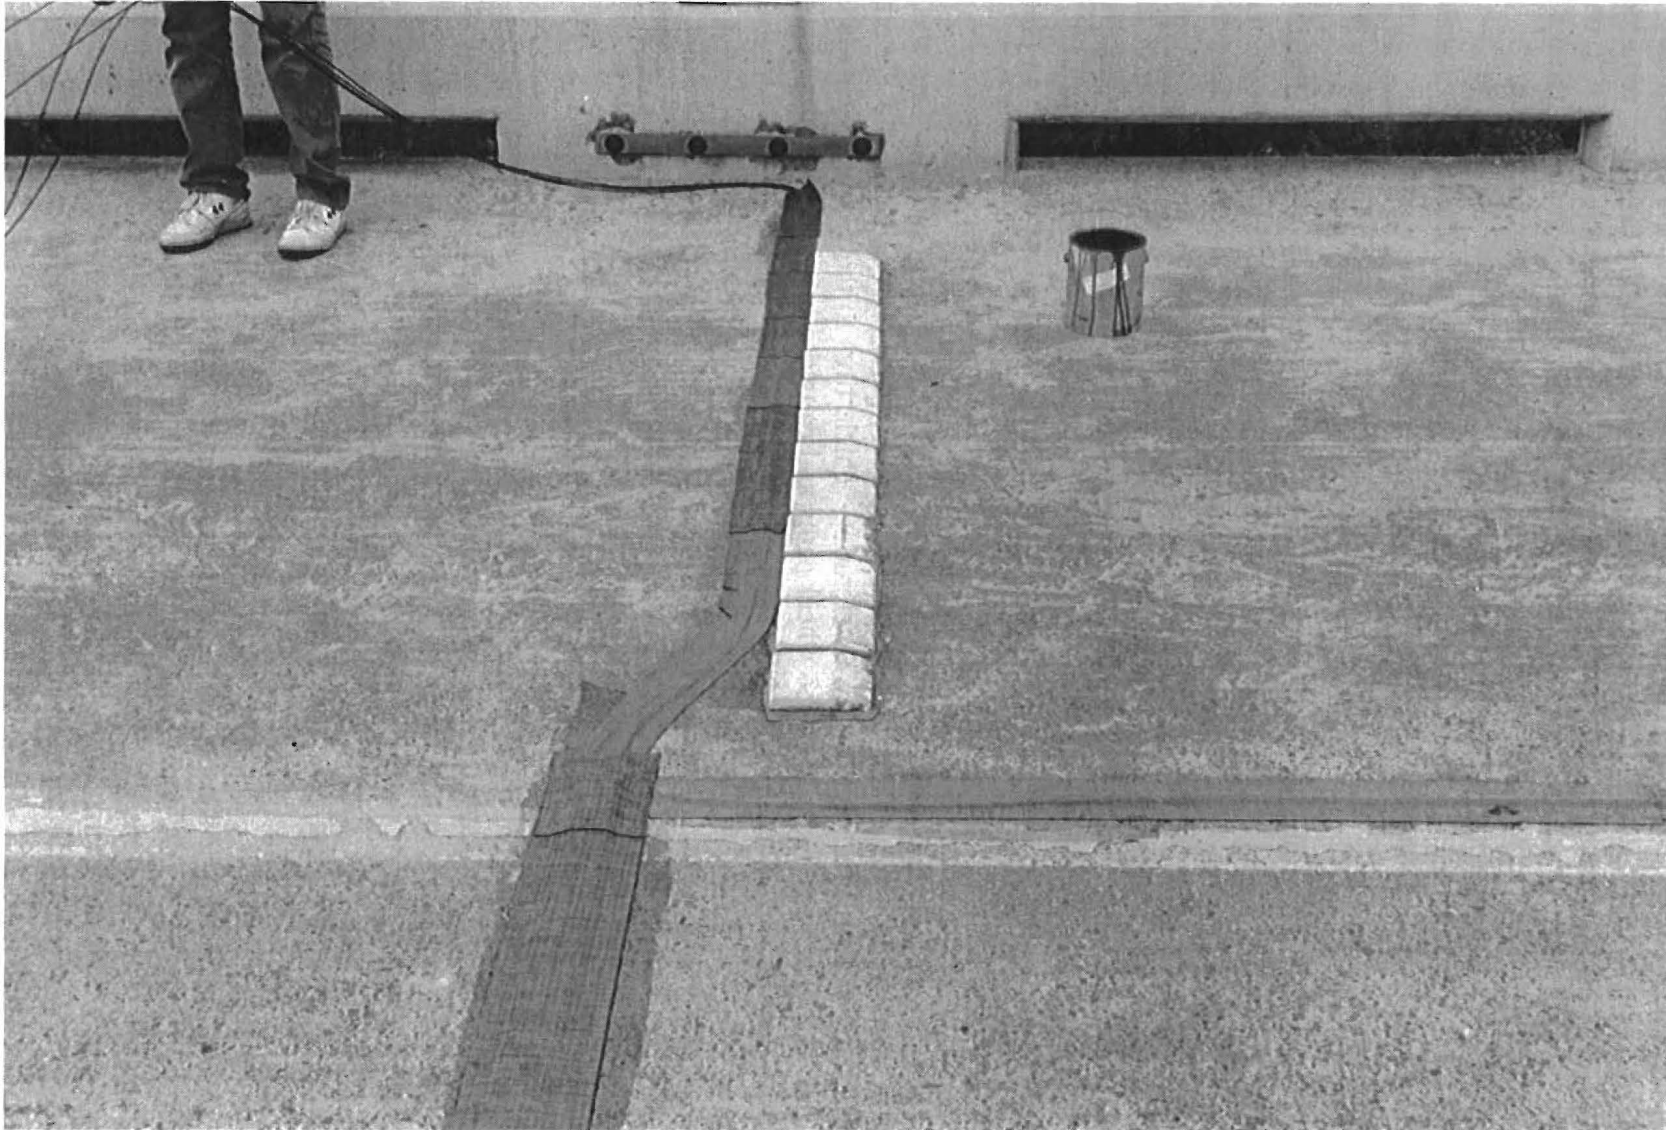
Figure 2-4. Shoulder Treatment of Coaxial Cables

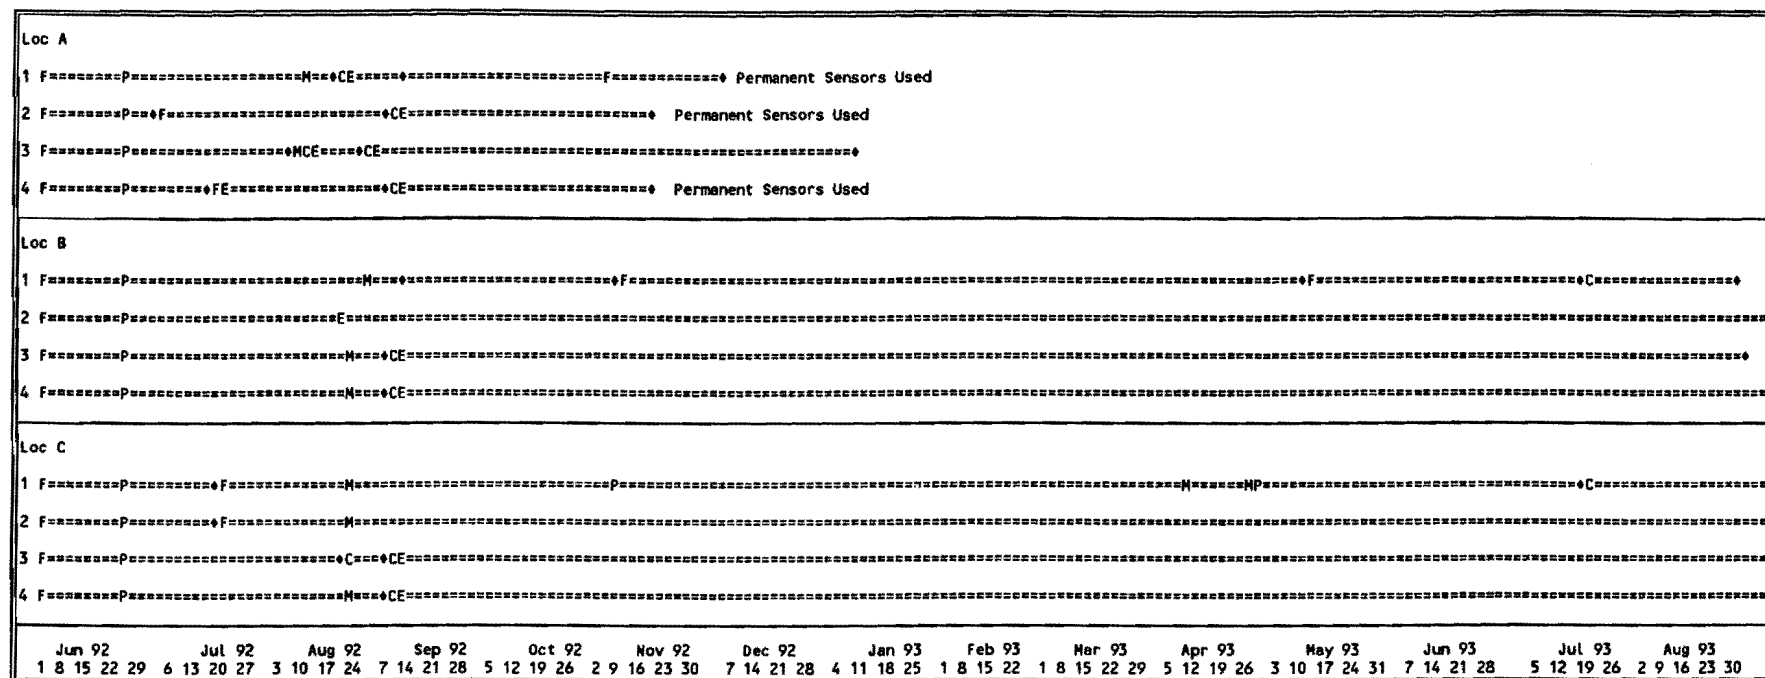
F = Film Sensor Installed
 C = Cable Sensor Installed
 M = Maintenance to include Straightening Sensor
 P = Polygard added
 E = Epoxy used
 ♦ = Failure
 1,2,3,4 = Sensor Number

Lane 2 →	3	4
-----	-----	-----
Lane 1 →	1	2

Figure 2-5. TP Sensor Replacement and Repair History

The use of these temporary sensors produced at least two failure modes. One was simply from repeated loadings from heavy traffic volumes, particularly trucks, and the other was due to the lateral forces applied by decelerating vehicle tires to the sensors. This latter effect shoved the sensors forward in the wheel paths and caused a breakdown in the bond between the adhesive material and the pavement. After an extended period of time of this shoving action in hot weather, the adhesive bond was so weak or even nonexistent that a passing vehicle would cause visible movement in the sensor. It should be noted that the slippage of the sensors in the wheelpaths was not apparent during the cooler winter months of January, February, and part of March, as depicted by Figure 2-5. This figure is a summary of repairs and/or failures of both film and cable piezoelectric sensors.

A total of thirty-one sensors were required during the 65 weeks of the test period beginning on May 31, 1992, and ending August 30, 1993. Temporary sensors were used for the entire period at Locations B and C, but only through January 8, 1993, for Location A. Because of the high failure rate of TP sensors at Location A and after discovering that the permanent sensors were still operational, TTI resumed the use of the permanent sensors. Table 2-1 is a summary of sensor durability at each of the three stations on the ramp. Location A required twelve sensors over a time period of 32 weeks; Locations B and C

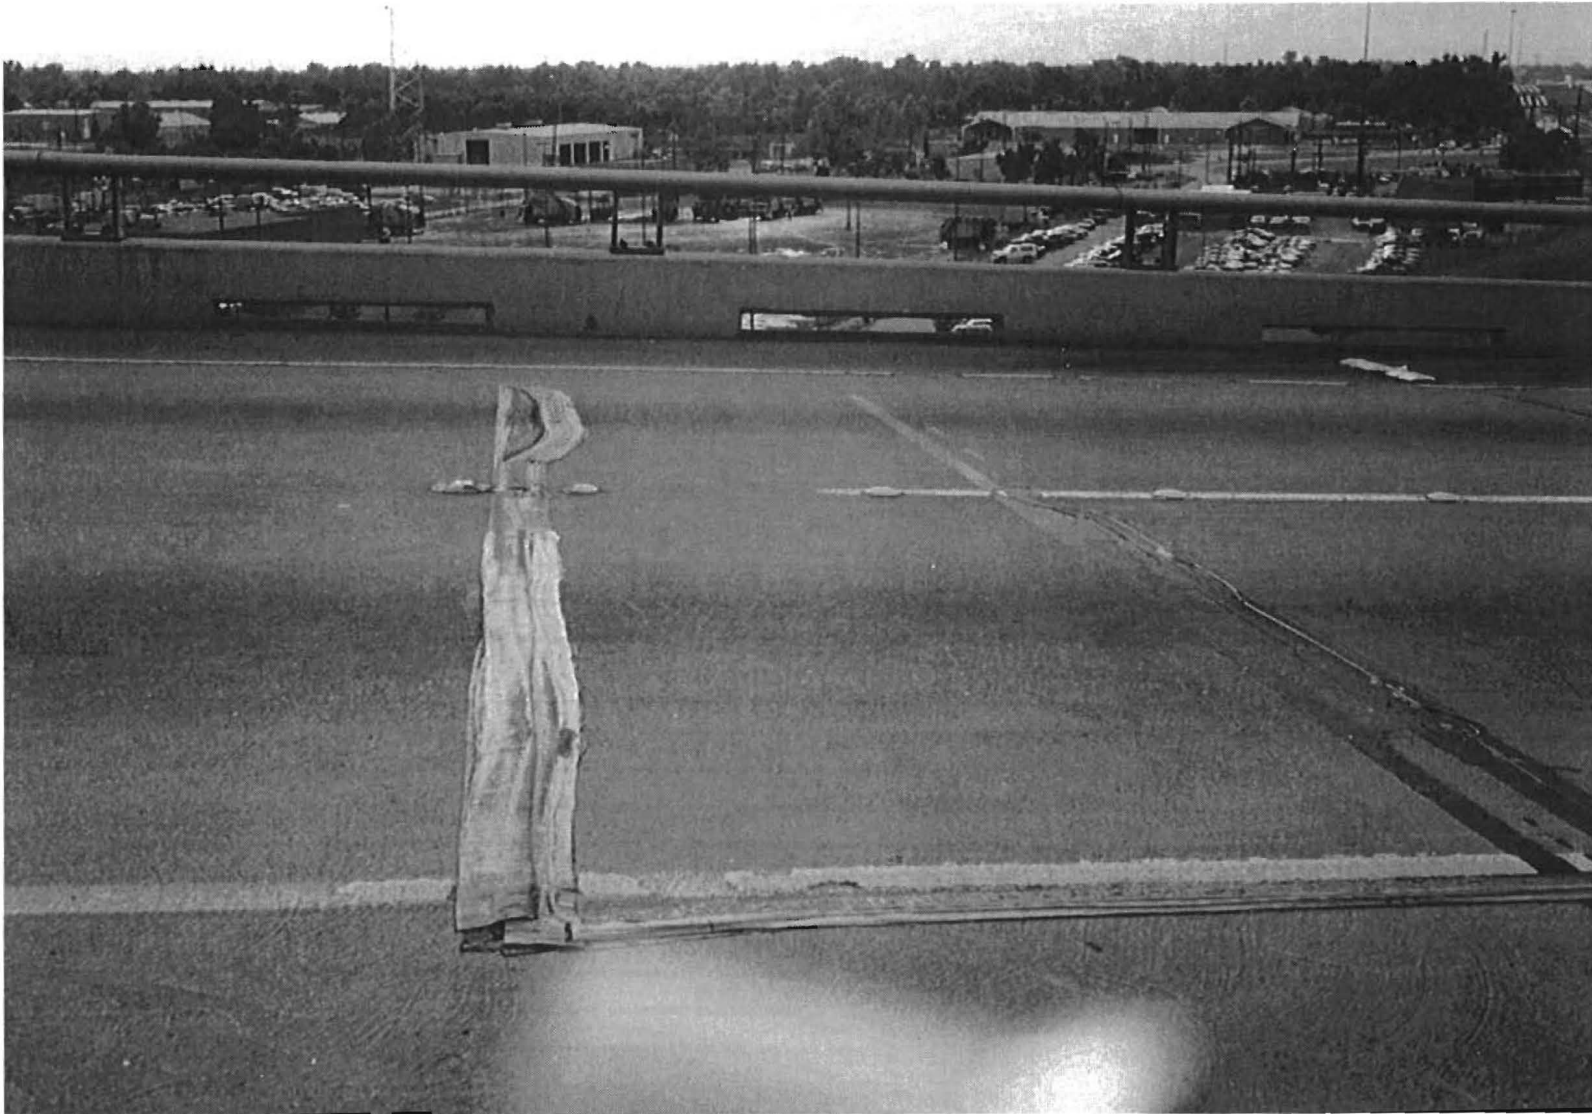
Figure 2-6. Deformed Piezo Sensors at Location C

Attempts to straighten these deformed sensors were not always successful. Stress created by the removal process sometimes caused failure, and at other times the sensor or its coaxial cable were inadvertently cut during the repair. The coaxial cable was always protected underneath one or more layers of scale tape and was difficult to locate before cutting away old material. Figure 2-6 illustrates sensor deformation in lane 2; Figure 2-7 illustrates a later view of the lane 2 replacement sensor and the lane 1 sensor beginning to shift.

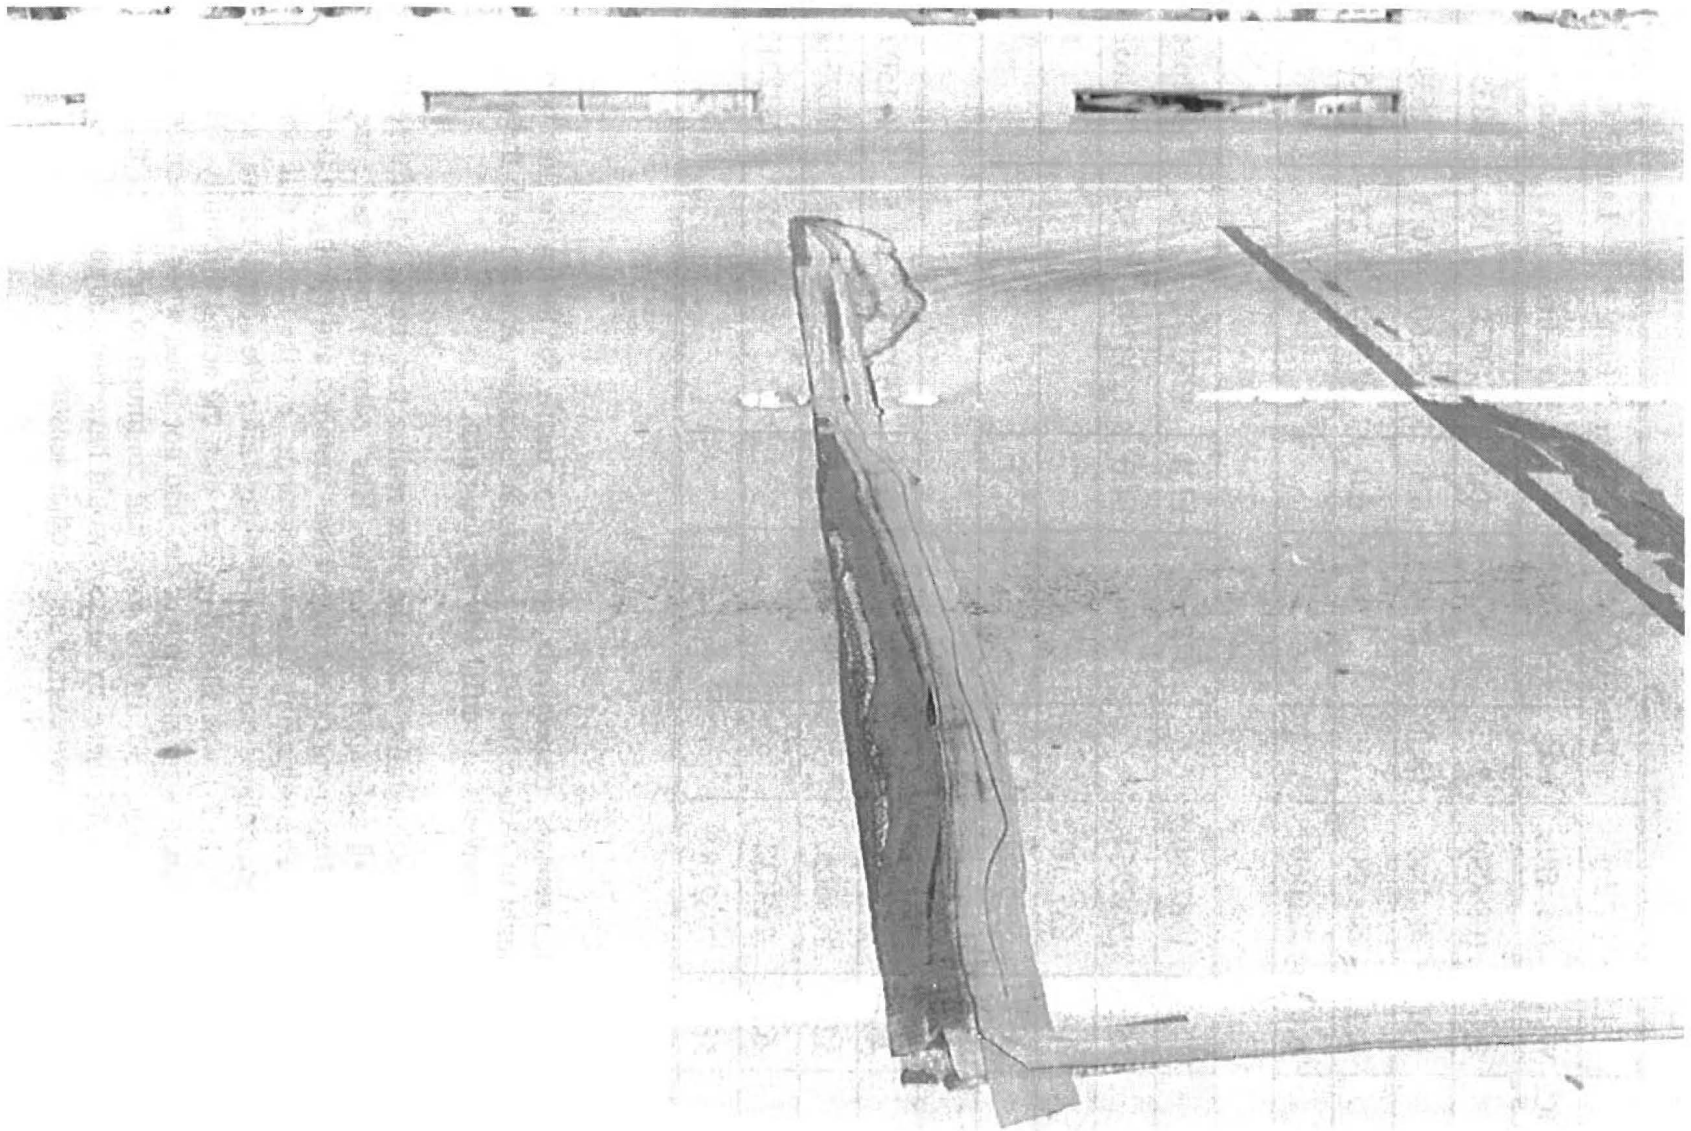
Figure 2-7. Location C Following Replacement of Lane 2 Piezo Sensor
