Strengthening of Deteriorated Concrete Bridge Girders Using an External Posttensioning System

Soliman Khudeira, Ph.D., P.E., S.E., M.ASCE

Case Study: Lake Shore Drive Bridge over LaSalle Drive

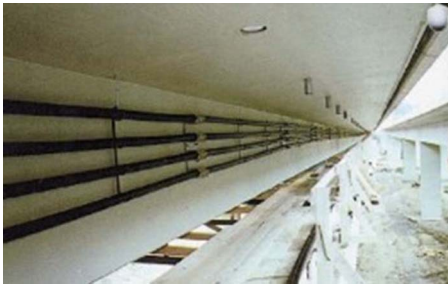
Fig. 1. External posttensioning using straight profile cables

External posttensioning cables could be either straight tendons (Figs. 1 and 2) or draped tendons using deviators (Figs. 3 and 4). The cable profile and anchor locations are based on the required combination of axial load, bending, and shear strength (Macoveo-Benczur and Rogowsky 2002)

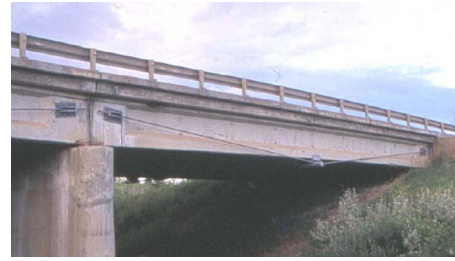
Fig. 3. External posttensioning using draped profile cables

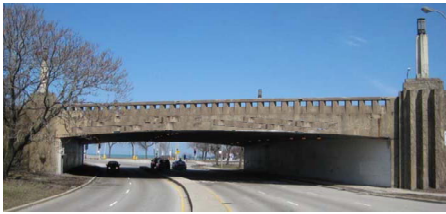
Fig. 6. Profile of Lake Shore Drive Bridge over LaSalle Drive

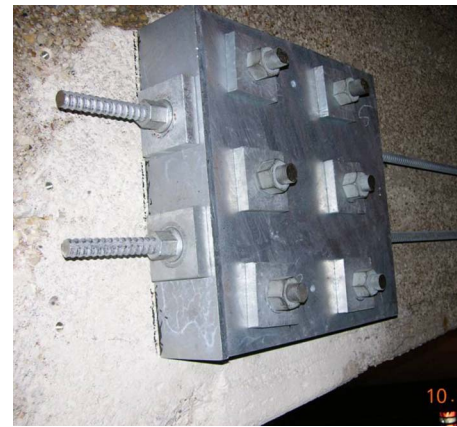
Fig. 13. Transverse pretensioned rods (six rods per bracket)

Six 38.1 mm (1.5 in.) diameter pretensioned transverse rods (per bracket) were used (Fig. 13). The final pretensioned load per bolt was 444.8 kN (100 kips). The transverse pretensioned rods were threaded ASTM A193 (AISI 4140) Grade B7 steel rods with a minimum yield strength of 724 MPa (105 ksi) and an ultimate strength of 862 MPa (125 ksi).

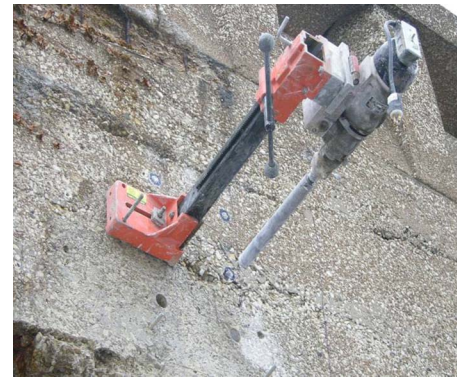
Fig. 14. Drilling holes through the exterior girder in the transverse direction

1. Drilled 44.45 mm (1.75 in.) holes in the transverse direction (Figs. 14 and 15).
2. Installed the interior and exterior brackets with 12.7 mm (0.5 in.) expansion anchors.
3. Pretensioned the 38.1 mm (1.5 in.) transverse bolts. Each bolt was pretensioned to a 50% increment of the final load.
4. Attached the interior and exterior support angle with 12.7 mm (0.5 in.) expansion anchors (Fig. 16).
5. Posttensioned the 25.4 mm (1 in.) diameter longitudinal rods in pairs, one at each face of the girder (Fig. 17). A 25% increment was used to posttension the top and bottom rods.

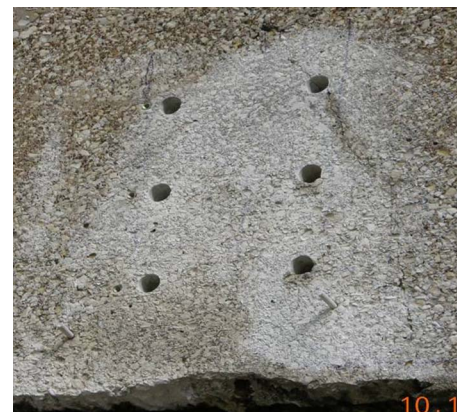
Fig. 15. Six holes drilled through the exterior girder in the transverse direction

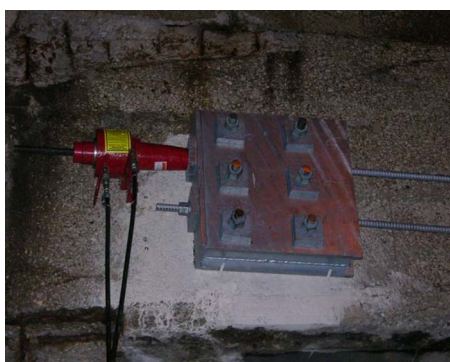
Fig. 17. Posttensioning the longitudinal rods

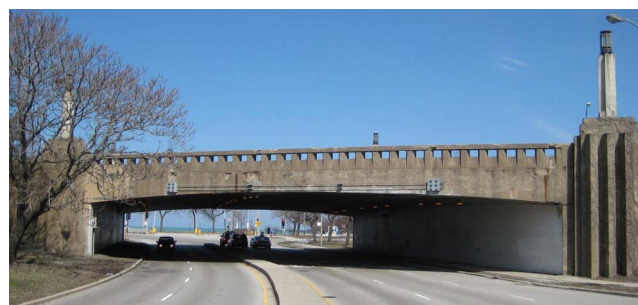
Fig. 18. Completed exterior posttensioned rods, brackets, and support angles

The completed exterior posttensioned rods, brackets, and sup-

port angles are shown in Fig. 18. Repair of the exterior girders and installation of the PT system were completed while the bridge was open to traffic.
