Experimental monitoring of the strengthening construction of a segmental box girder bridge and field testing of external prestressing tendons anchorage

The Sanguxian viaduct prestressed concrete bridge is a continuous segmental box girder T-shape rigid frame bridge that is located in the Mudanjiang-Harbin Highway within the Heilongjiang Province of north-east China. The bridge is 280-m long and 12-m wide. It has a slope of 2.2% along the length of the spans. The bridge was constructed using the cast-in-place cantilever method. There are two separate T-shaped cantilever beams. Each side of the T structure consists of 10 segments. The length of segment No. 0, which is on the top of the pier, is 7.0 m. Segment Nos. 1 and 2 are cast in situ. The 8 remaining cantilever segments are cast in place. The bridge was open to traffic in 1997. Figure 1 shows the longitudinal layout of the bridge structure, Fig. 2

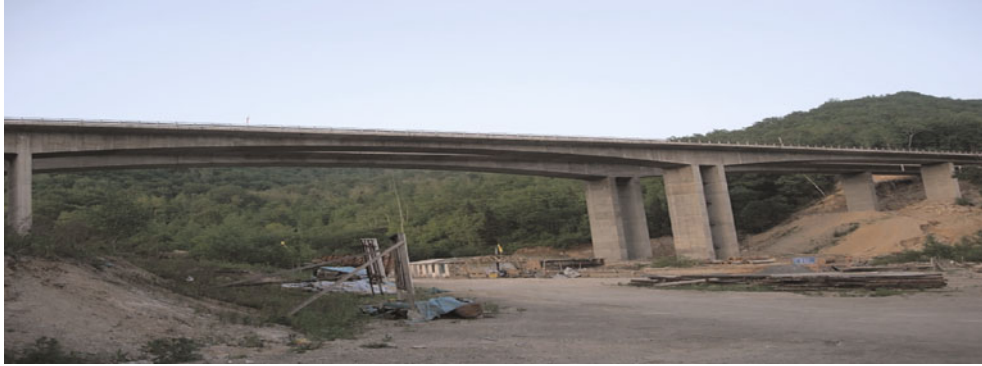
Fig. 2 View of the Sanguxian Bridge

shows the general view of the bridge, and Fig. 3 shows the pier and the span of the prestressed box girder.

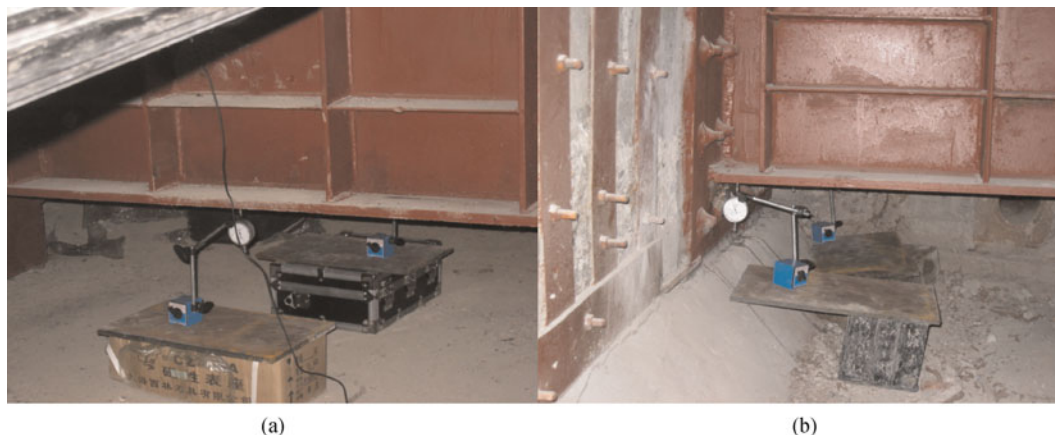
Fig. 6 Locations of the deformation dial gauges on the cross beam. (a) At mid-span; (b) at end-span

As different levels of tension forces are applied to the external prestressing tendons, the deformation of the steel deviation cross beam is measured at six points. As shown in Fig. 6, six dial gauges are installed at these locations, which have maximum vertical reactions. Table 1 lists the steel deviation cross beam deformations for the different levels of tension forces. As shown in the table, the

maximum deformation is 2.18 mm at measuring point No. 4, which is located at the mid-span of the steel deviation cross beam. This value is less than the allowable limit value of 6.15 mm. Therefore, the safety factor is high, and the carrying capacity meets the requirements. The end anchorage of the steel deviation cross beam of the B4 and the Z4 tendons deforms when tension forces are applied to the B2 tendon. Figure 7 shows the deformation of the end anchorage of the steel deviation cross beam, and Table 2 provides the deformations of the end anchorage of the steel deviation cross beam. As shown in the table, the maximum and minimum vertical deformations, which occurred simultaneously, are 15 mm and 4 mm, respectively, and the deformation appears in the same time in the end anchorage.

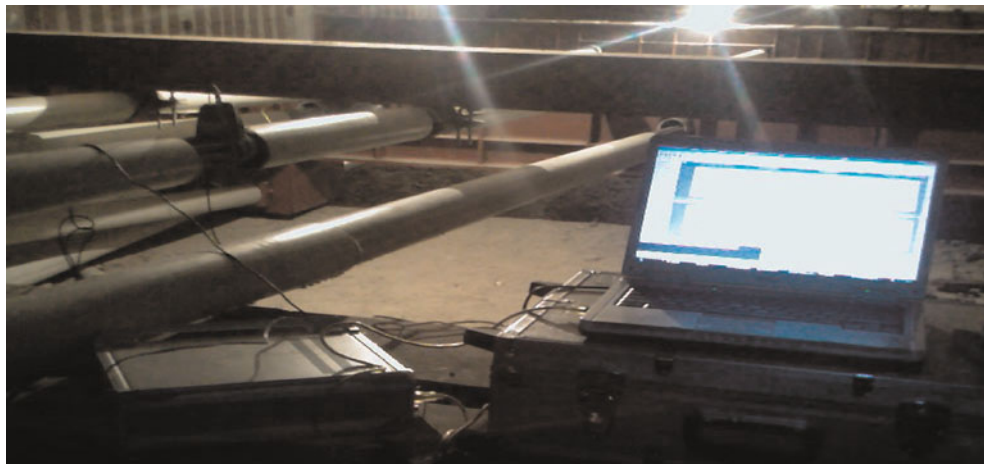
Fig. 9 DH5922 dynamic data collection system

calculated and compared with the measured natural frequency. Figure 9 shows the DH5922 dynamic data collection system, and Fig. 10 shows the measured frequency and the measured acceleration of the external tendons. Table 5 provides the theoretical frequency and the measured natural frequency of the external tendons. As shown in this Table, the measured frequency is 1.66 Hz for all of the external prestressing tendons. This value is less than the theoretical value, which ranges from 1.871 to 1.891 Hz. Therefore, the external prestressing tendons are in a good working state.

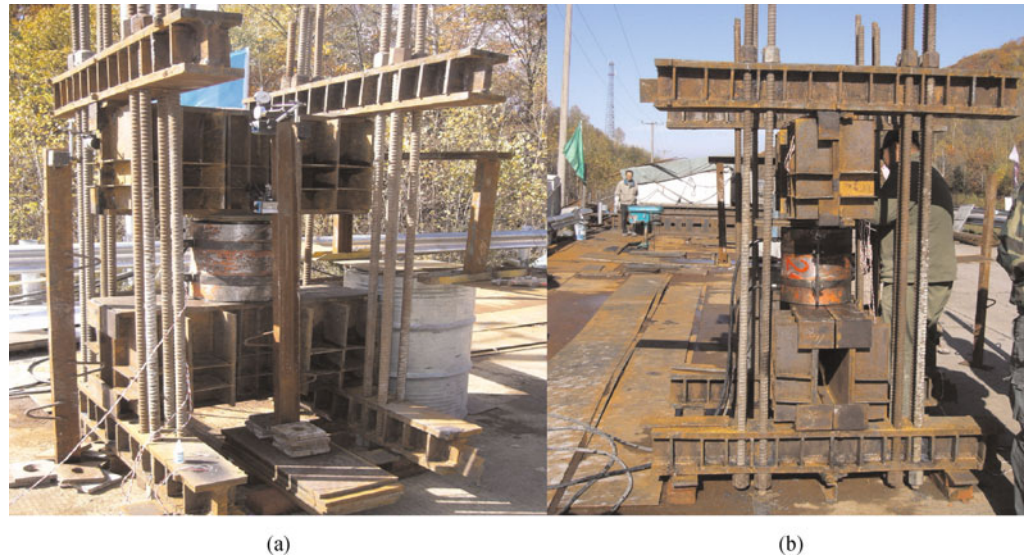
Fig. 12 Load test devices, including the strain and the deflection dial gauges. (a) Isometric view; (b) side view

Two side I-shaped steel beams are used in opposing directions. The load is performed using two jacks, which apply an increasing force until it reaches 120% of the maximum tension force of the external tendon ($187.5 \times 1.2 = 225$ T). Figure 12 shows the load test devices, including the strain and the deflection dial gauges. Figure 13 shows the dimensions of the I-shaped steel beam. In this test, the horizontal strain and the vertical deflection are measured under the applied load and compared with the respective allowable limit values. Two strain dial gauges are installed on the top plate of the steel beam at mid-span. Five deflection dial gages are supported at mid-span, the

supports points, and along the height of the mid-span web plate.

Table 6 lists the strain values of the anchorage beam. As shown in the table, the maximum strain is 852 $\mu\epsilon$ at the mid-span of the anchorage beam under a 225-T load, and the stress is 170 MPa, which is less than the allowable stress of the steel plate Q345 (295 MPa). Therefore, the strength of the anchorage beam meets the requirements, and the anchorage beam is in a good elastic working state. Table 7 lists the vertical deflection of the anchorage beam. As shown in the table, the relative residual of the deflection ranges from -0.5% to 11.2% , which is less than the allowable limit value of 20% .

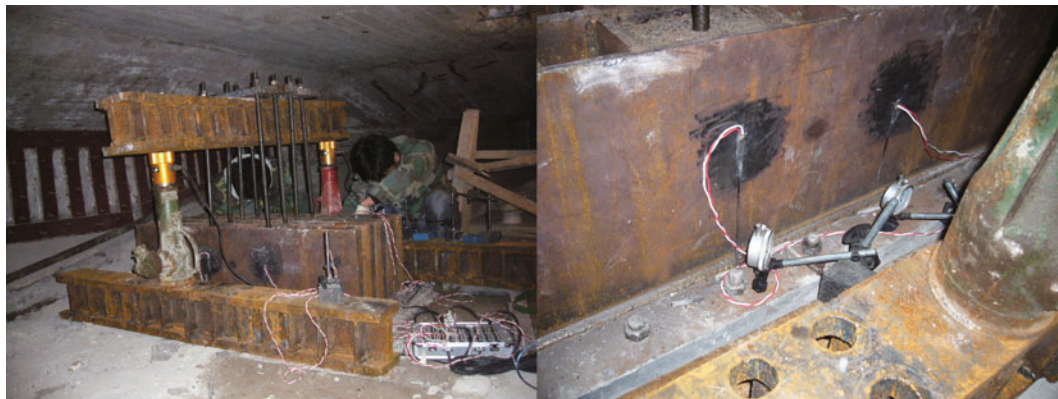
Fig. 16 Dial gauge location

highest stresses occur. Figure 16 shows the locations of dial gauges that were used to measure the strain and the deflection.
