# Polyethylene Duct Cracking on Posttensioning Tendons in Florida Segmented Bridges

**Abstract:** During the past 20-plus years, designs based on the post-tension segmental concrete box concept have evolved to become prominent in bridge construction. Critical to the safety and longevity of such structures is the integrity of post-tensioning tendons. However, during the past five years, several Florida bridges have suffered tendon deterioration and failure because of strand corrosion at grout voids in which bleed water had accumulated. In some cases, the high-density polyethylene (HDPE) ducts within which the grouted strands reside had cracked. Although none of the tendon failures to date have been related to the HDPE duct cracking, left unaddressed moisture, chlorides, and oxygen will invariably corrode strands in the long-term. In order to assess the cause(s) and mechanism(s) of HDPE duct cracking, fatigue tests were performed upon duct samples retrieved from representative bridges and the results were compared with those from (1) material property determinations of the corresponding ducts, (2) experiments on simulated tendons that were subjected to thermal cycling, and (3) finit

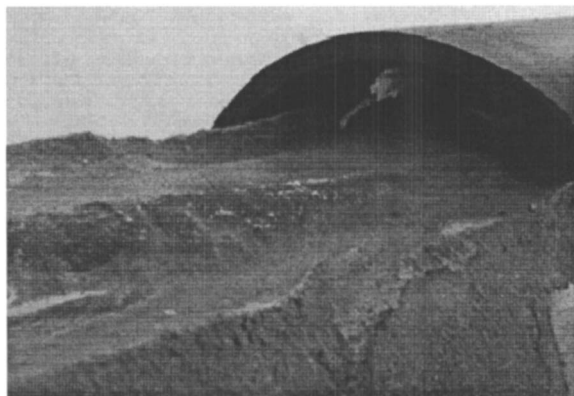
Subsequent to the experiments, the specimens were dissected and the size of the grout void channel along the top of the tendon interior was measured. Fig. 8 shows the grout and void channel at the mid-specimen length (the location of gauges SG1 and SG2) of

**Fig. 8.** Void channel in Specimen B4 at location of strain gauges SG1 and SG2 in perspective to section of duct

Specimen B4. The higher strain range indicated by SG2 for Specimen B2 compared to B4 probably resulted from the larger SDR and smaller grout void for Specimen B2.

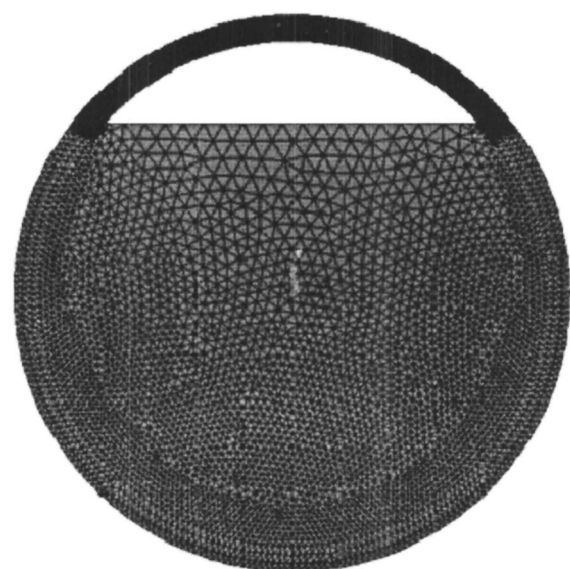
A finite-element analysis was performed using a two-dimensional ANSYS model of a tendon cross-section with an SDR 21 duct and a grout void that comprised either 3, 8, or 10% of the interior. Triangular, six-node elements were employed. A general illustration of the mesh is shown in Fig. 9. An expanded view of the modeled duct section above the grout void is shown in Fig. 10. Stress-strain response of both duct and grout was considered to be linearly elastic with modulus  $1.01 \times 10^3$  MPa (146 ksi) for the former (CSR Company, "HDPE EHMW PE3408 pipe." 2706 N.I-35 (76240), Gainesville, Tex.) and  $2.80 \times 10^3$  MPa (406 ksi) for the latter (Chandrupatla and Belegundu 2002).

**Fig. 9.** FEA mesh
