## **ALTERNATIVE SEALANTS FOR BRIDGE DECKS**

### **Study SD2001-04-D Final Report**

**Prepared by  
AEC Engineering, Inc.  
400 First Avenue North, Suite 400  
Minneapolis, MN 55401**

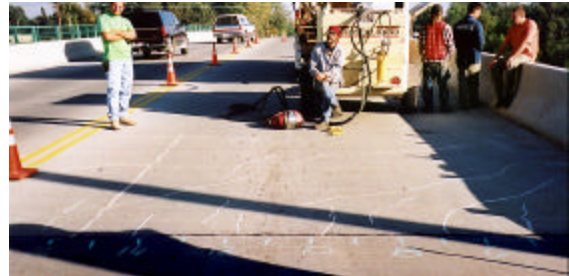
**Figure 1 – Bridge #1/Section #1**

Figure 1 shows the first test section on Bridge #1 after members of the research team mapped and measured the width of existing cracks at various locations. The Mitchell Region Bridge Maintenance Crew (MRBMC) subsequently sandblasted and cleaned each test section after the research team documented the crack information.

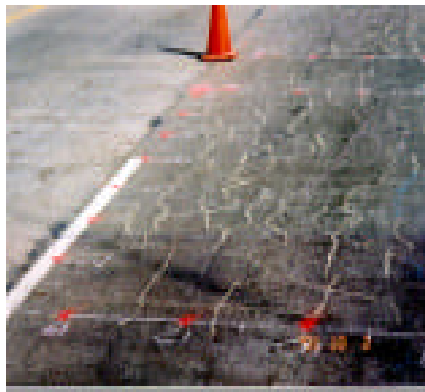
**Fig. 2 – Bridge #2/Crack Pattern**

Figure 2 shows the general deck condition for Bridges #2 and #3. The concrete block sections defined by the cracking are approximately 1½ ft. square. Instead of tracing the cracks with chalk and transferring the crack patterns to field sketches, numerous photographs and crack width measurements, with a crack comparator (See Figure 3), were taken to document the test sections. Figure 4 shows test section schematics for the 3 bridges.

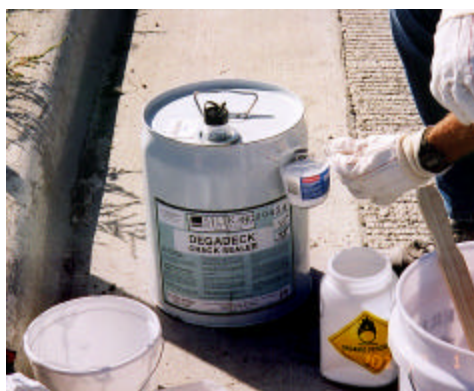
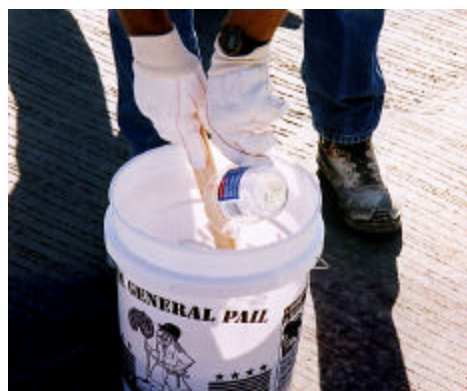
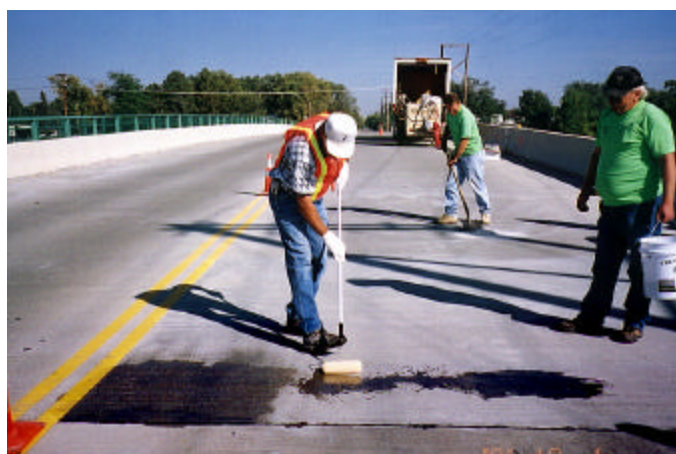
Figures 5 – 7 show the mixing and roller application of the MMA.

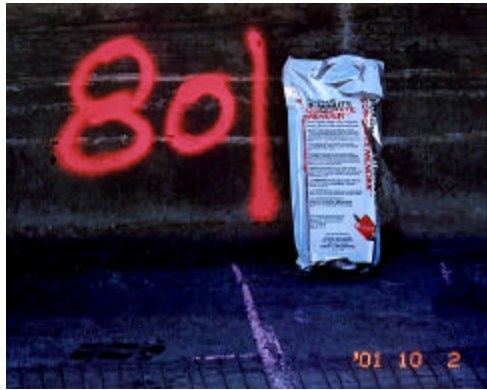
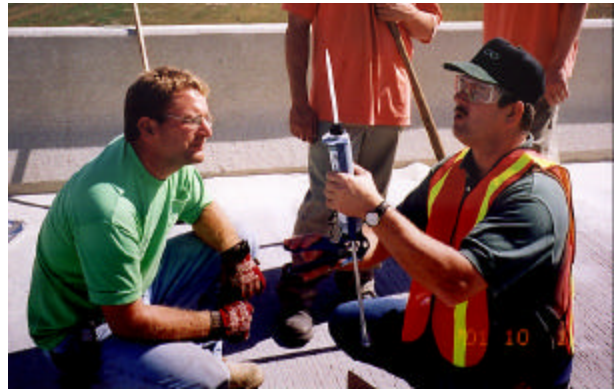
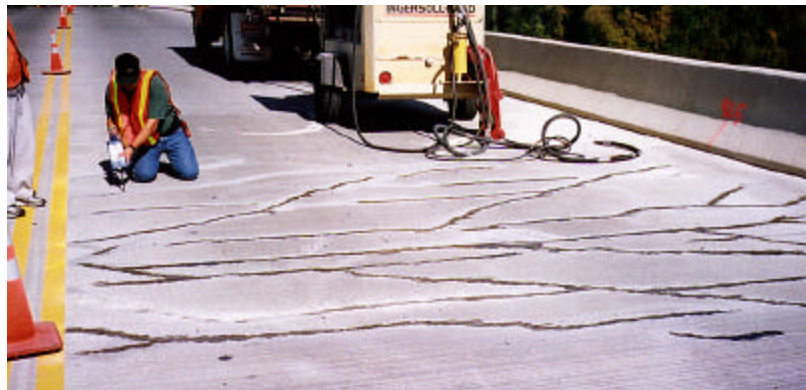
Figures 8 – 10 show the MPU crack sealer packaging, cartridge preparation and installation.

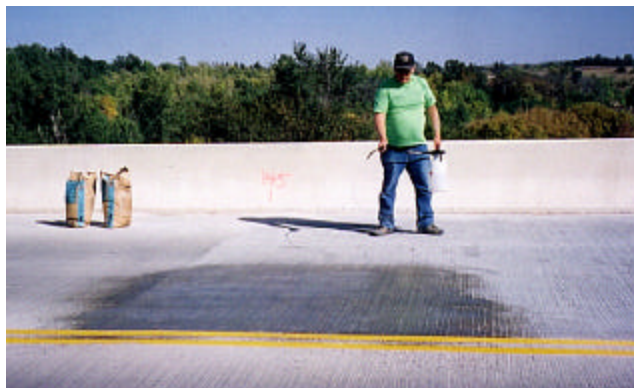
**Figure 11 – Silanes & Epoxy Installation**

Figure 11 shows the installation of the silanes and two-component epoxy.

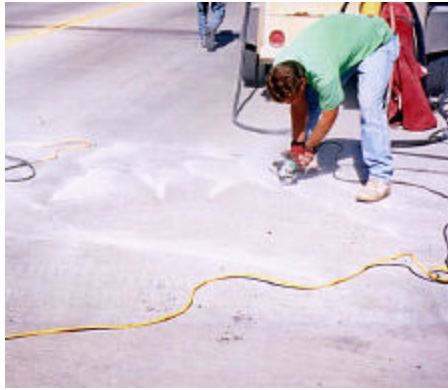
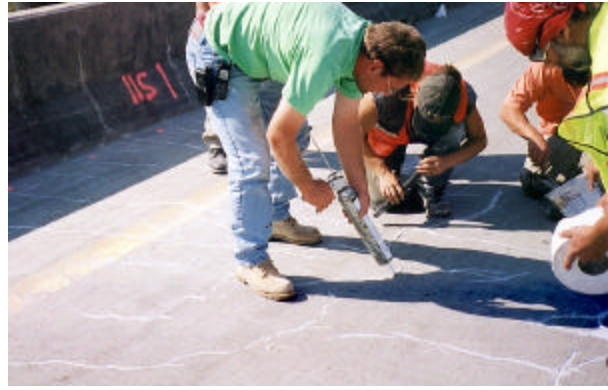
Figures 12 – 13 show the preparation and installation of the silicone crack/joint seal.

A silicate crack and surface sealer (Penetron Waterproofing) was requested for this project, but did not arrive on-site for the trial applications. Therefore, it was decided to apply Dow 888 silicone joint seal in hand-routed cracks on bridge decks based on the positive performance of an accidental rout-and-seal bridge application in the Rapid City Region.
