## **EVALUATION OF NON-METALLIC FIBER REINFORCED CONCRETE IN NEW FULL DEPT PCC PAVEMENTS**

**Study SD96-15  
Final Report**

Prepared by  
Dr. V. Ramakrishnan, Distinguished Professor  
Neeraj S. Tolmare, Research Associate  
Department of Civil and Environmental Engineering, SDSM&T,  
501 East St. Joseph Street  
Rapid City, SD 57701-3995 (605) 394-2439

December 1998

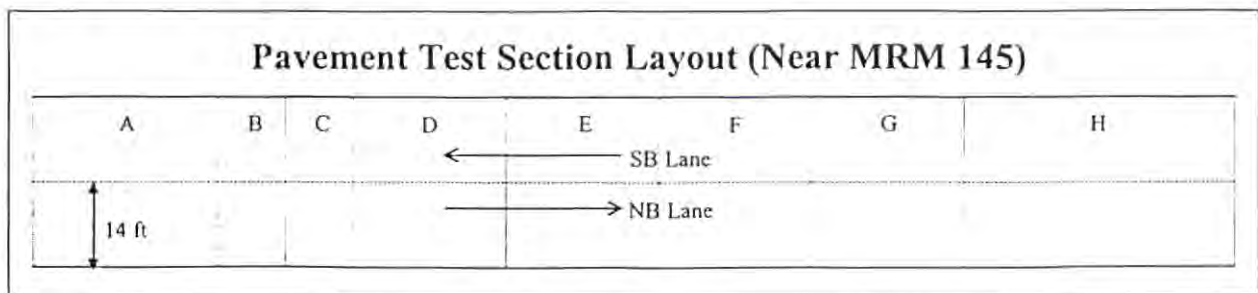
The project involved the construction of full depth NMFRC and control test sections on US 83 northeast of Pierre, South Dakota between mileage reference markers (MRM) 144 and 145. Two lanes, each 14 ft. wide of the following test sections as shown in the figure below were constructed:

A: Doweled Plain Jointed Concrete Pavement (PJCP) control section 305m (1000ft) long, 200mm (8 inch) thick, with 6.1m (20 ft.) joint spacing.

- B: Undoweled NMFRC test section 76m (250 ft) long, 165 mm (6.5 inch) thick, with 7.6m (25 ft.) joint spacing.
- C: Undoweled NMFRC test section 75m (245 ft) long, 165 mm (6.5 inch) thick, with 10.7m (35 ft.) joint spacing.
- D: Doweled NMFRC test section 152m (500 ft) long, 203 mm (8 inch) thick, with 7.6m (25 ft.) joint spacing.
- E: Doweled NMFRC test section 149 m (490 ft) long, 203 mm (8 inch) thick, with 10.7m (35 ft.) joint spacing.
- F: Undoweled NMFRC test section 152m (500 ft) long, 203 mm (8 inch) thick, with 7.6m (25 ft.) joint spacing.
- G: Undoweled NMFRC test section 149m (490 ft) long, 165 mm (6.5 inch) thick, with 10.7m (35 ft.) joint spacing.
- H: NMFRC test section 390m (1290 ft) long, 203 mm (8 inch) thick, with no joints.

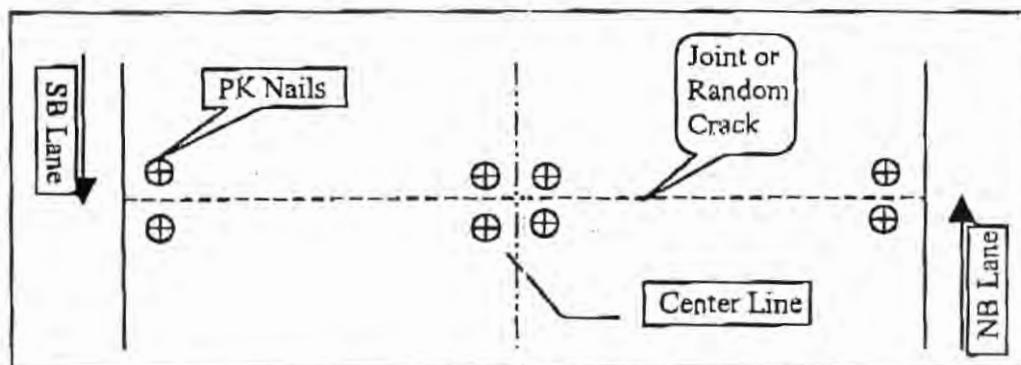
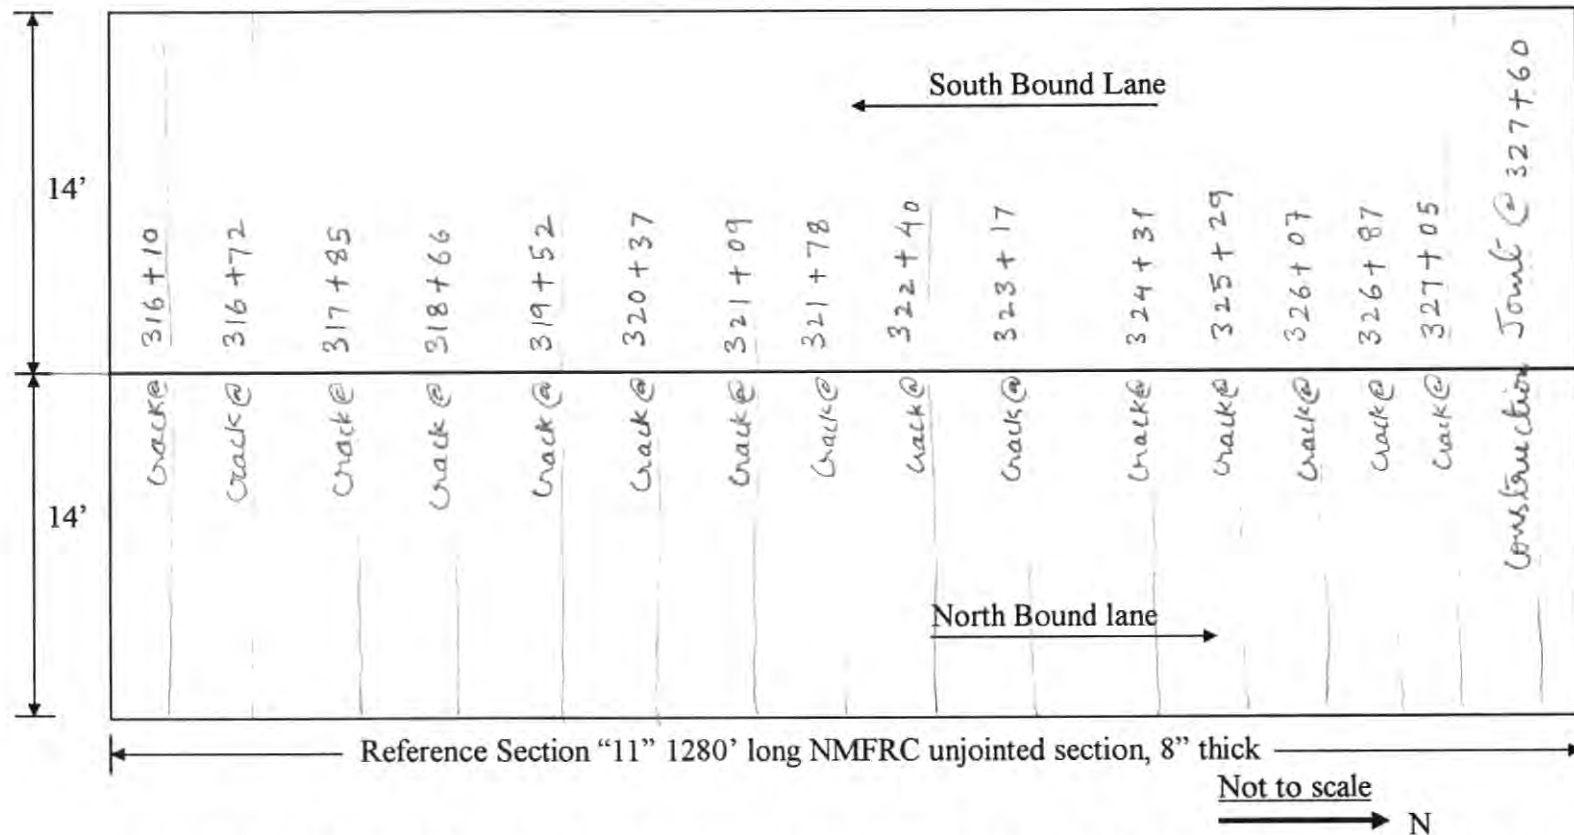
The locations of PK nails are shown below

**Figure C1 Crack Location for unjointed section of the NMFRC Full-Depth Pavement as observed on April 17, 1998**

Periodic inspection of the newly constructed pavement was made. P.K. nails were placed across the joints by the D.O.T. immediately after paving. The distances between the P.K. nails were recorded after placing and during the nine periodic inspections. As expected, random cracks occurred in the unjointed test section. These cracks formed at approximately 26 m (85-ft) intervals and they were almost straight transverse cracks, continuous in both north and south bound lanes. They appeared to be similar to the regular sawed joints. No random cracks were found in any of the other NMFRC or control sections. There were no joint spalling, raveling, cracking, and pop-outs in both control and NMFRC pavements.

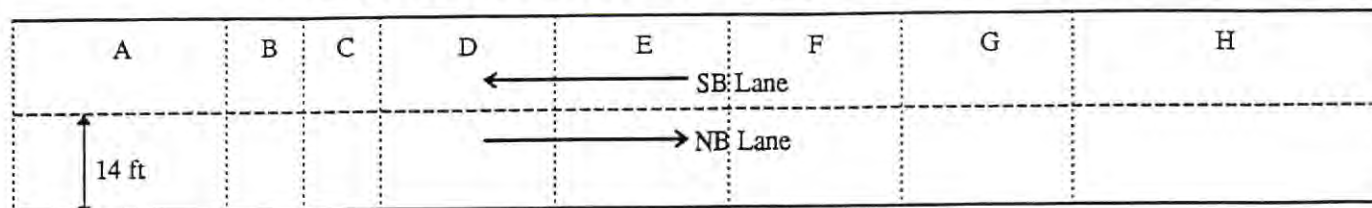
### Pavement Test Section Layout (Near MRM 145)

Test Section	Length (ft)	Type	Thickness (in)	Doweled	Joint Spacing (ft)	Volume of Fiber Concrete (yd <sup>3</sup> )
A	1000	Plain PCCP Control	8	Yes	20	0
B	250	Fiber (25 lbs/yd <sup>3</sup> )	6.5	No	25	173
C	245	Fiber (25 lbs/yd <sup>3</sup> )	6.5	No	35	170
D	500	Fiber (25 lbs/yd <sup>3</sup> )	8	Yes	25	346
E	490	Fiber (25 lbs/yd <sup>3</sup> )	8	Yes	35	339
F	500	Fiber (25 lbs/yd <sup>3</sup> )	8	No	25	346
G	490	Fiber (25 lbs/yd <sup>3</sup> )	8	No	35	339
H	1290	Fiber (25 lbs/yd <sup>3</sup> )	8	No	None	892
Total						2,605

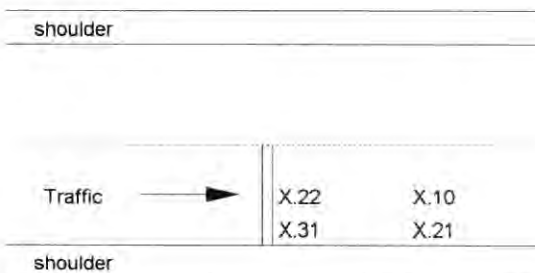
## TEST PATTERN

X is the test panel number (1,2,3 etc)
