**Evaluation of Undersealing of
Undoweled Plain Jointed PCC
Pavements in South Dakota**

**Study SD92-01
Final Report**

**Prepared by
South Dakota State University
Department of Civil Engineering
Brookings, SD 57007**

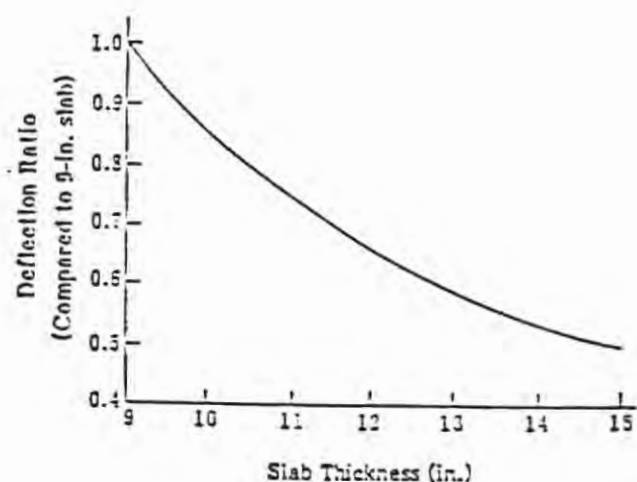
Figure 2.1. Deflection Versus Slab Thickness Based on Westergaard's Corner Theory (5).

When the slab thickness and/or the modulus of rupture of concrete is increased, the slab resistance to deflection will be increased which in turn reduces pumping (5). Figure 2.1 shows that increasing the pavement thickness from 9 inches to 15 inches

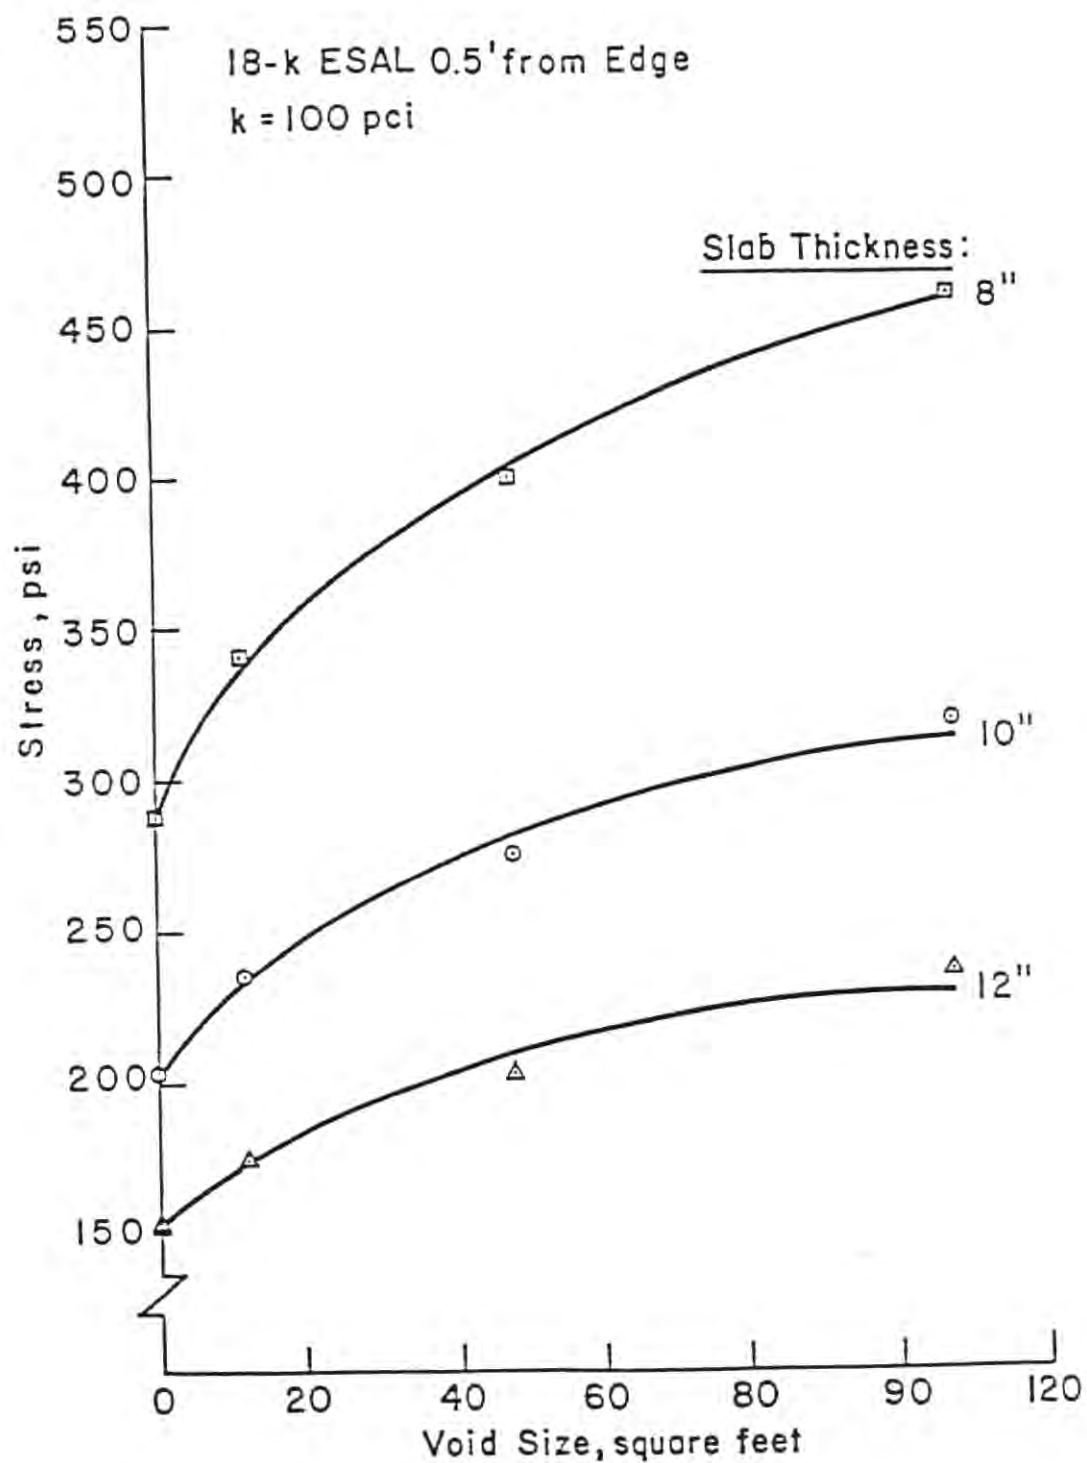
Figure 2.16. The Relationship Between the Void Sizes and Stresses in Concrete Pavements (37).

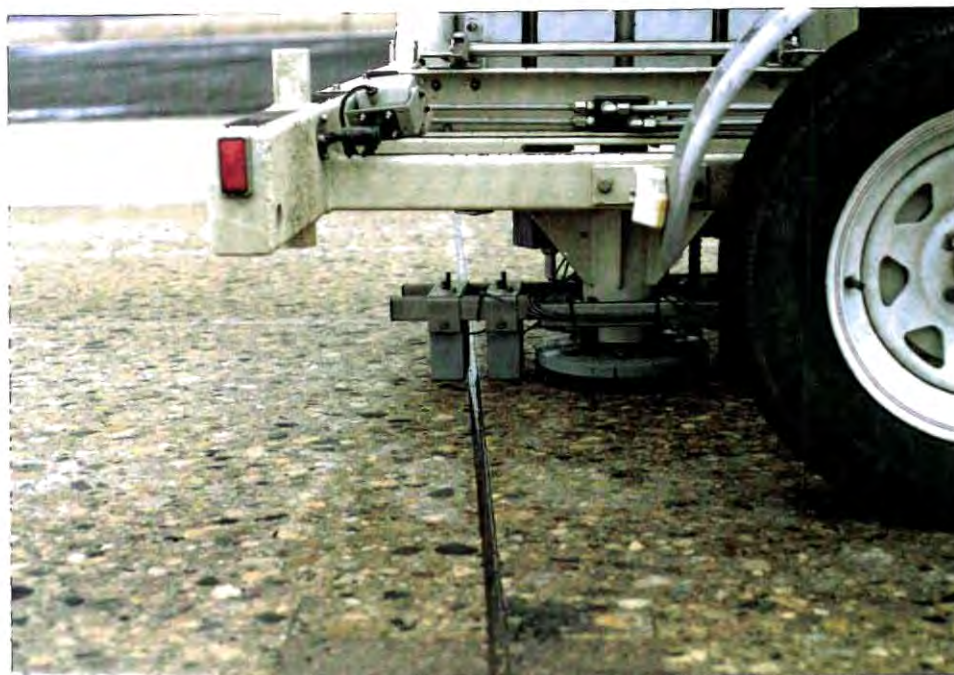
Figure 5.2. Deflection Measurements Taken at Transverse Joints.

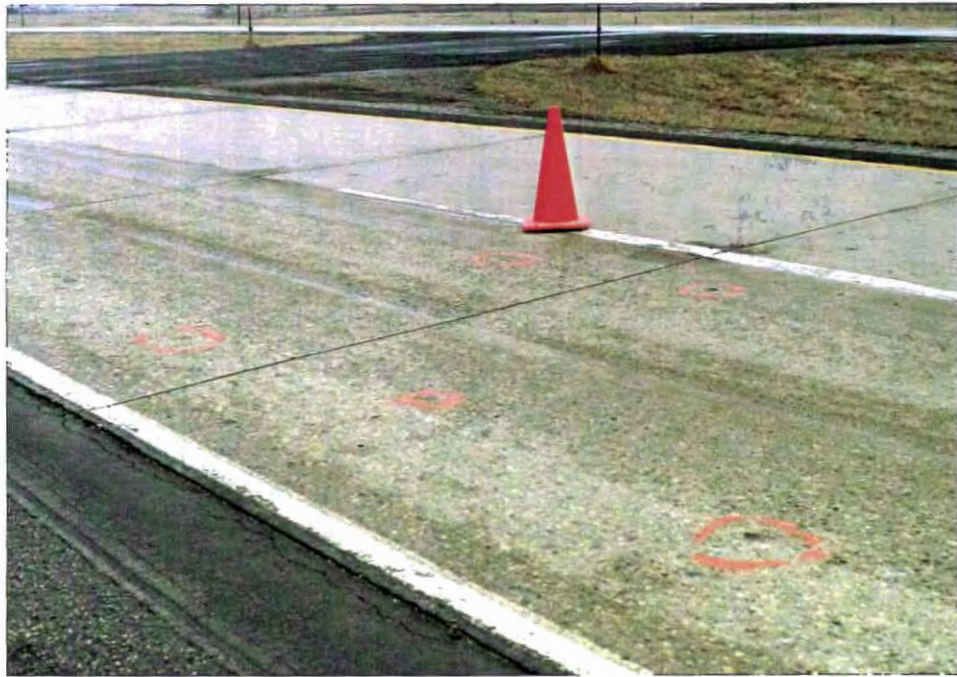
Figure 5.5. Hole Pattern Arrangement Used on US12 in Aberdeen.

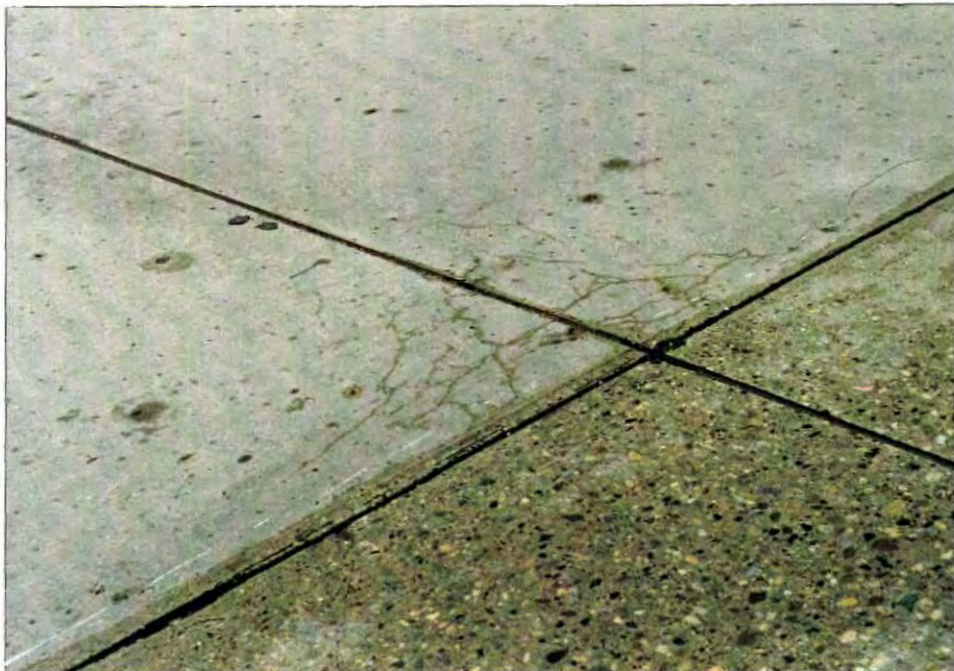
Figure 5.6. Low Severity D-Cracking Observed on US12, MRM 287, WB.

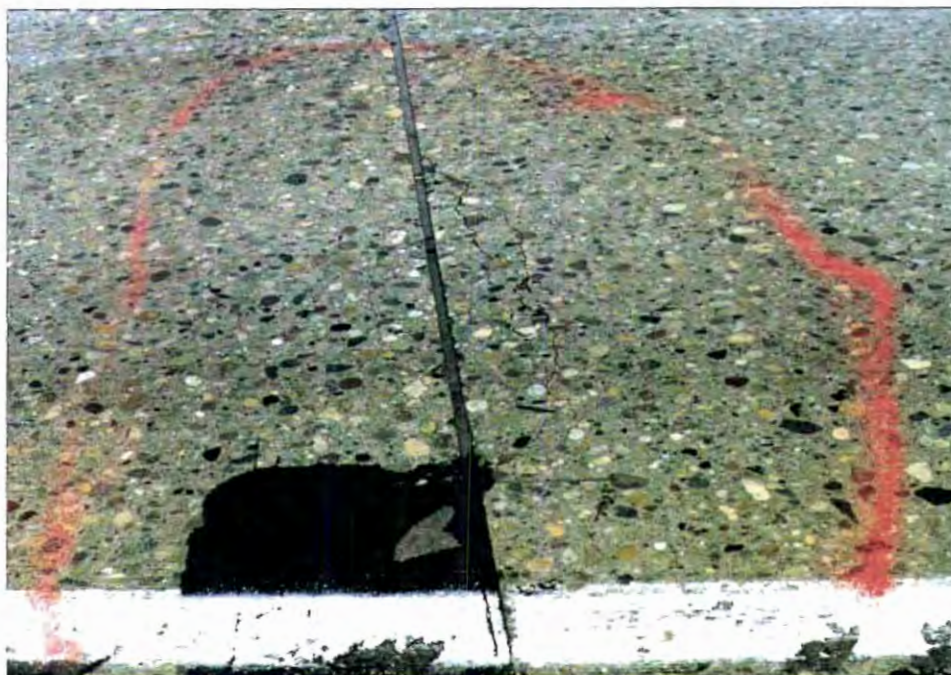
Figure 5.15. Low to Medium Severity Cracking Observed on US12, MRM 283, EB.

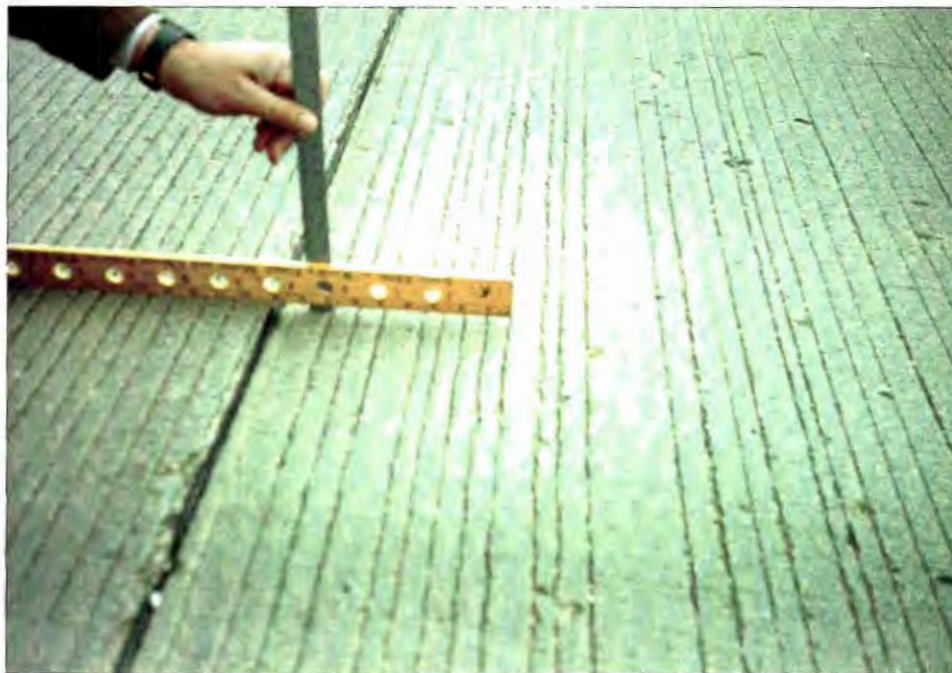
Figure 5.72. High Severity Faulting Observed in SD50, MRM 389, EB.

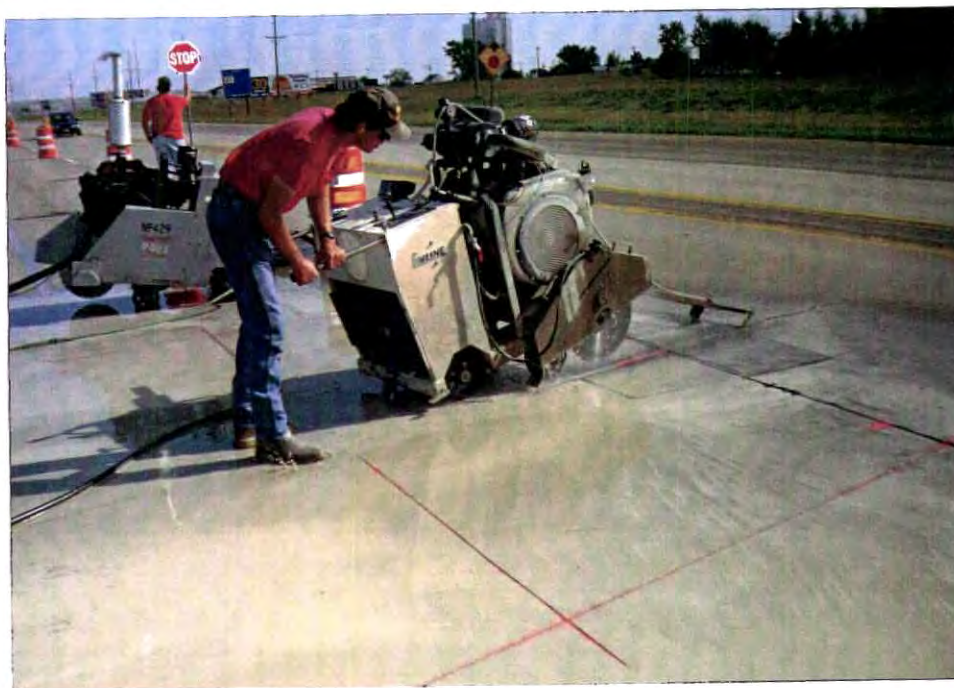
Figure 6.3. Sawing of the Panels Across the Slab.

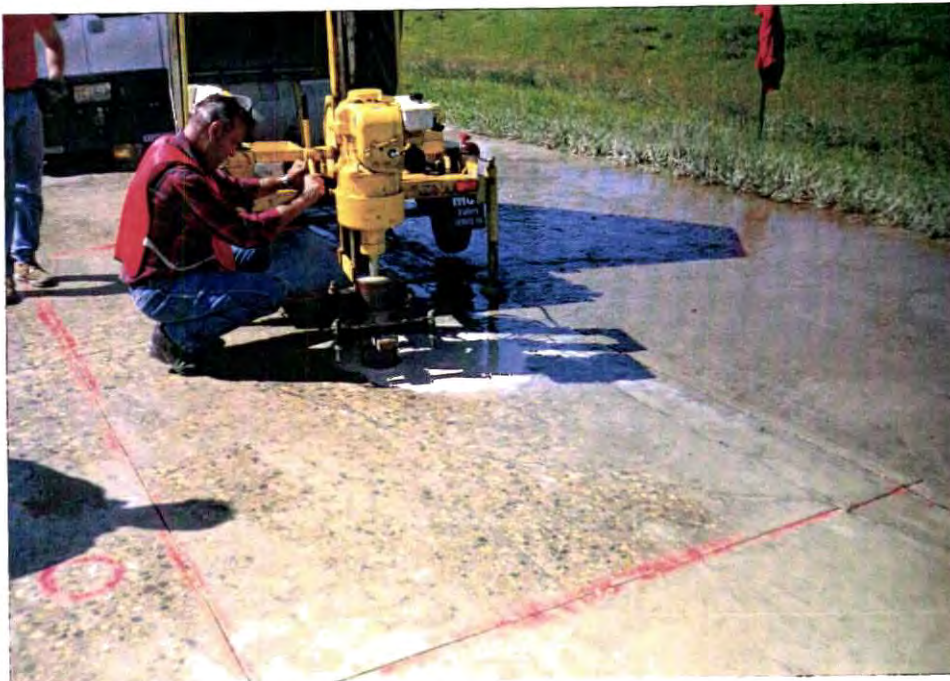
Figure 6.5. Removing Cores From the Concrete Panel.

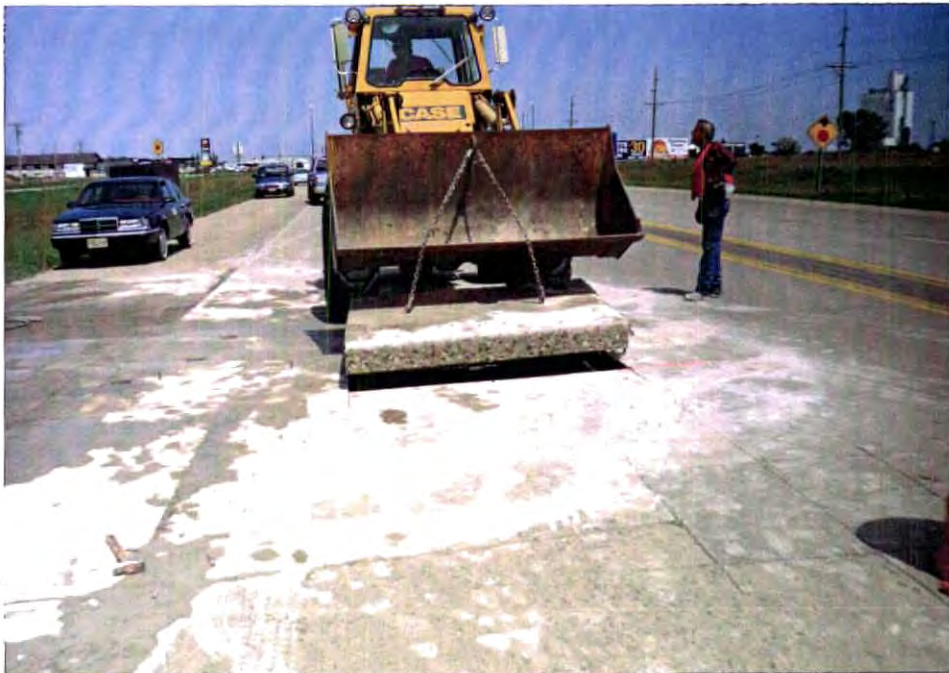
Figure 6.7. Removal of the Concrete Panels With a Front-End Loader.

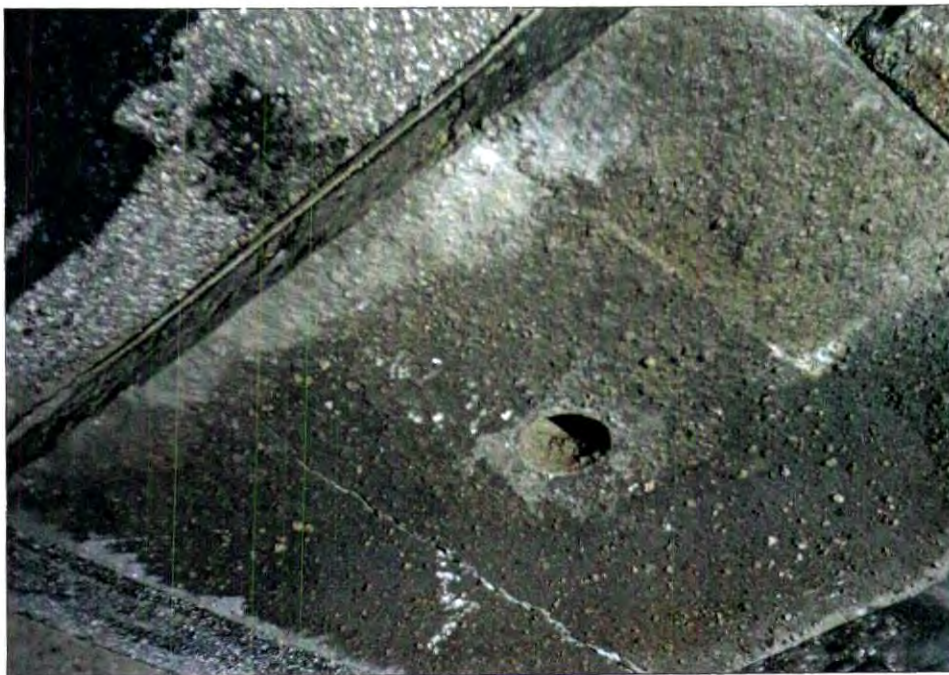
Figure 6.8. Bottom of a Concrete Panel Removed From US12.

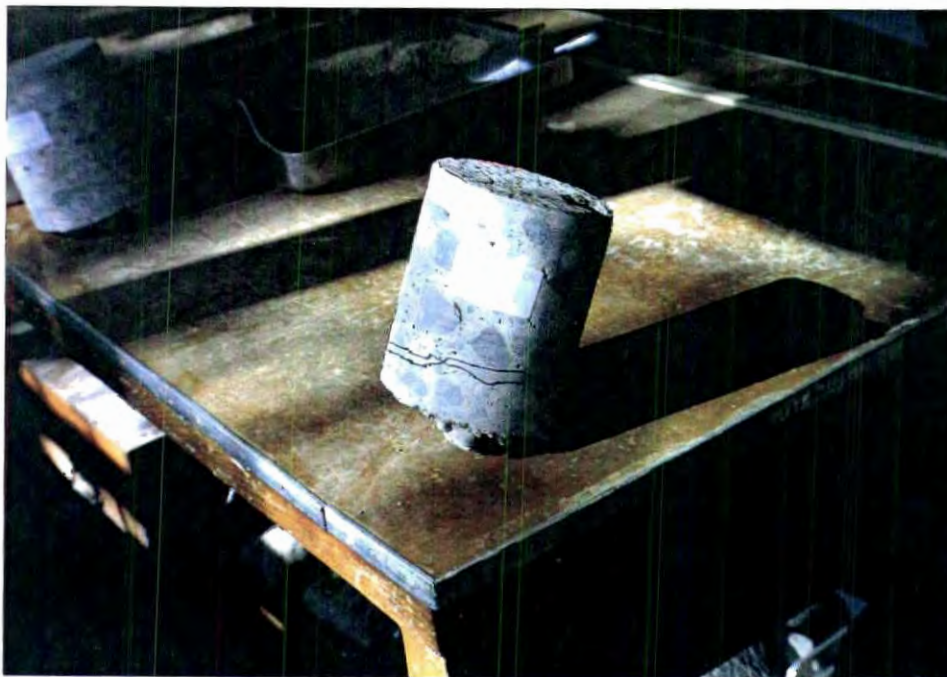
Figure 6.11. Grout Filling the Voids in the Concrete Slab in
Core 9 (US12, MRM 286, EB).

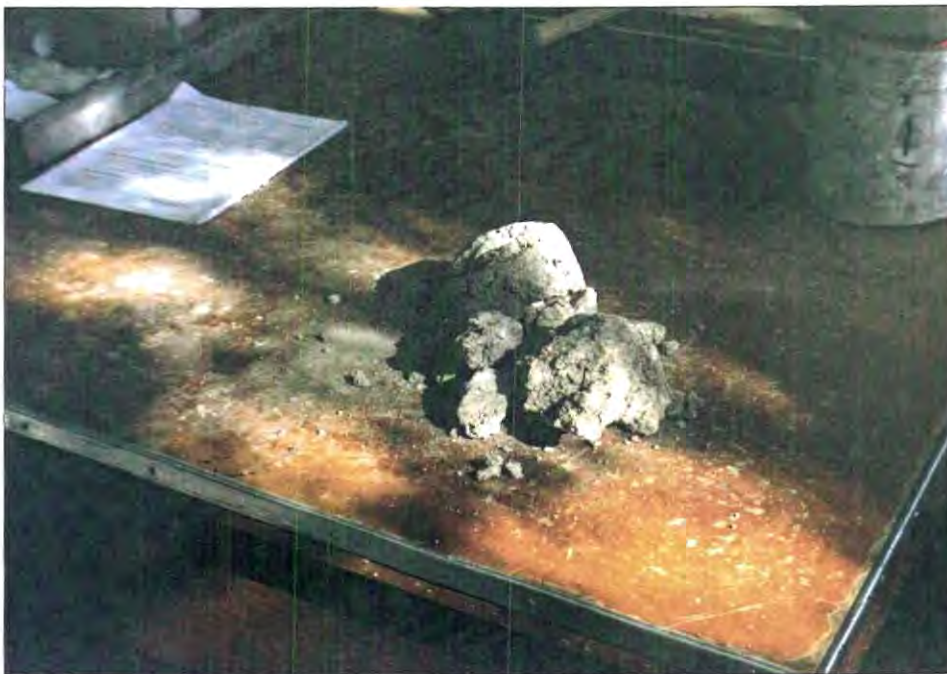
Figure 6.12. Top of the Subbase Removed With the Core (US12, MRM 286, EB).

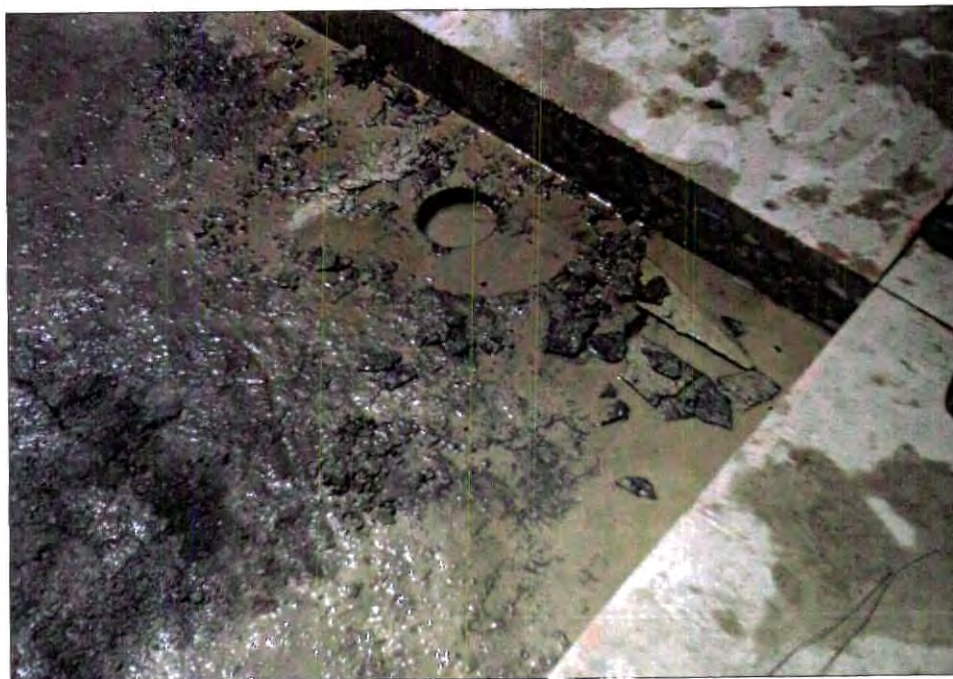
Figure 6.13. Adhesion of the Grout to the Top of the Subbase
(US281, MRM 194, SB).

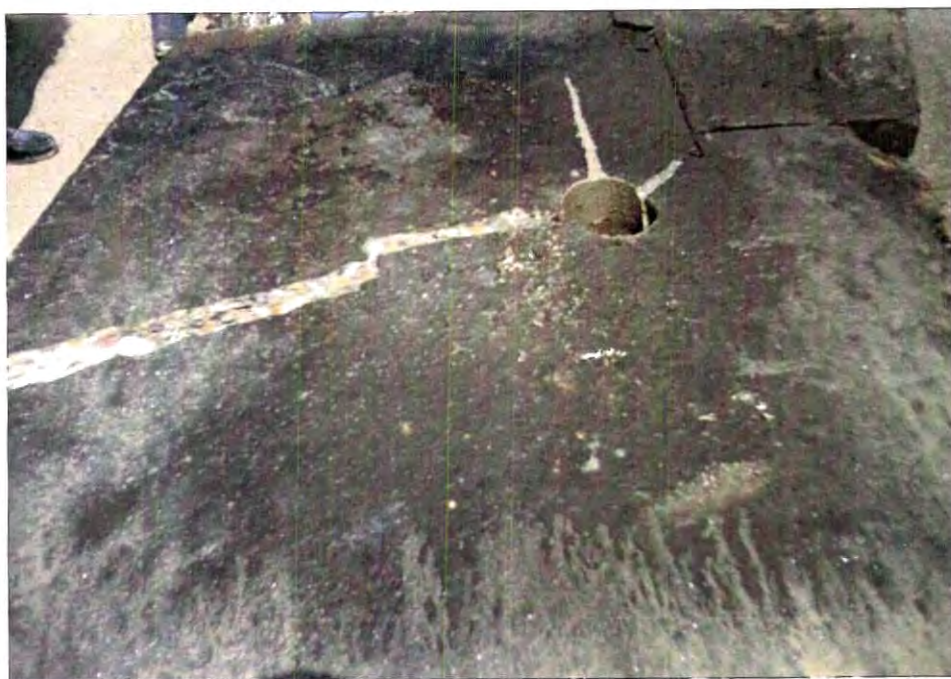
Figure 6.14. Bottom of the Concrete Panel Removed on US281, MRM
194, SB.

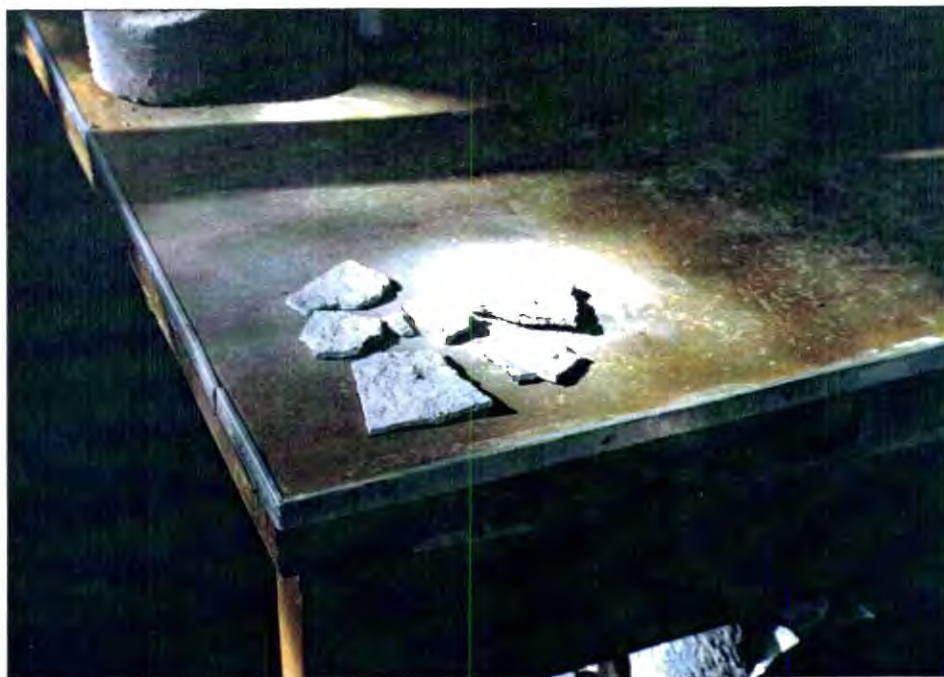
Figure 6.15. Samples of Grout Removed From the Top of the Subbase on US281, MRM 194, SB.

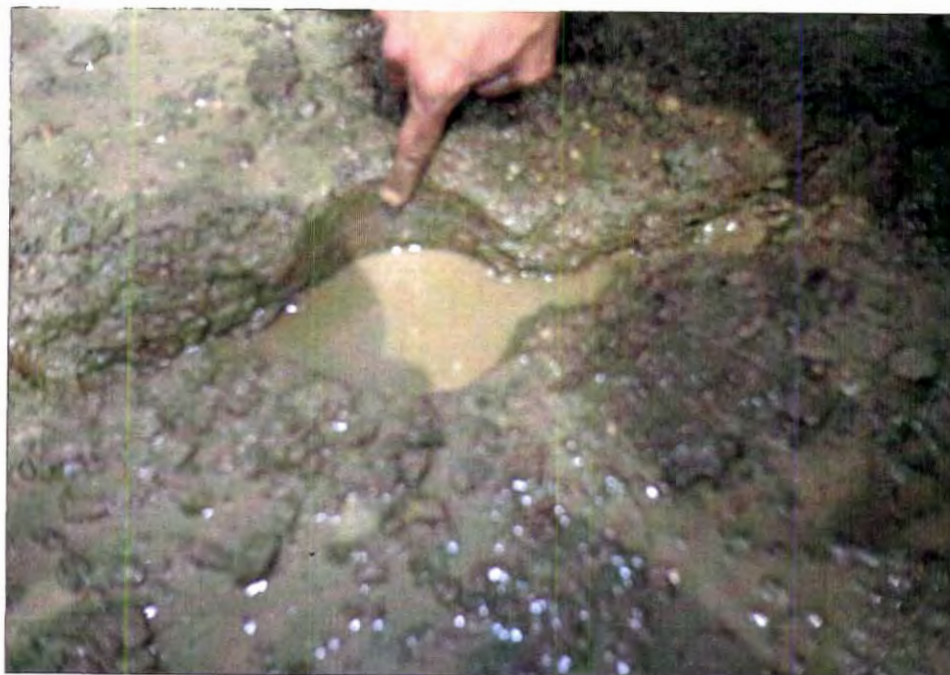
Figure 6.17. Grout Filling the Voids in the Subbase on US281,
MRM 194, SB.

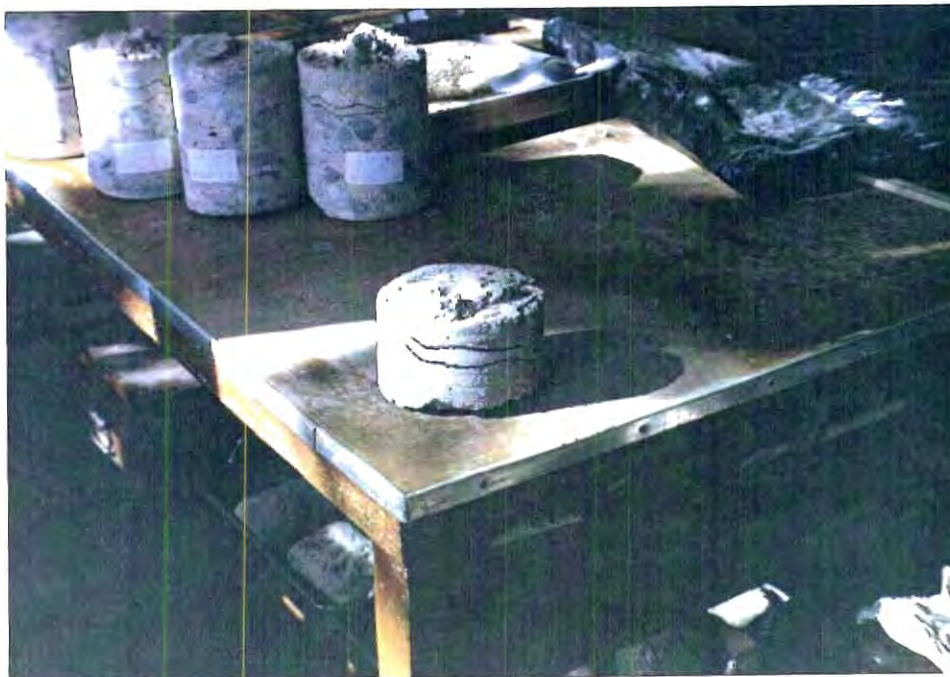
Figure 6.18. Grout Filling the Voids in the Subbase in Core 6
(US281, MRM 194 SB).
