# Evaluation of Non-Metallic Fiber Reinforced Concrete Whitetopping

Study SD96-13 Final Report

Prepared by Dr. V. Ramakrishnan, Distinguished Professor Department of Civil and Environmental Engineering, SDSM&T, 501 East St. Joseph Street Rapid City, SD 57701-3995 (605) 394-2439

August, 1999

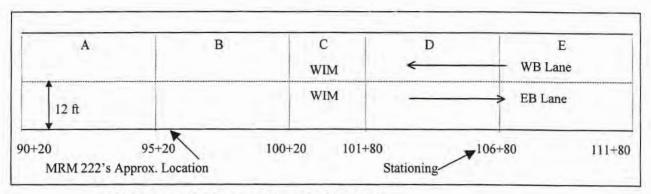
White-topping Layout (Near MRM 222)

The project involved construction of whitetopping test sections on Highway 14 near MRM 222 west of Pierre, SD. At each lane, the following test and control sections were constructed.

Test Section	Length (ft)	Туре	Thickness (in)	Joint Spacing (ft)	Volume of Fiber Concrete (yd³)
A	500	Fiber (25 lbs/yd³)	2.5	50	93
В	500	Fiber (25 lbs/yd³)	3.5	50	129
C	160	Plain	12	20	
D	500	Fiber (25 lbs/yd³)	3.5	No Joints	129
E	500	Fiber (25 lbs/yd³)	2.5	No Joints	93
Asphalt Overlay (Not Shown)	500	Control			
				Total	444

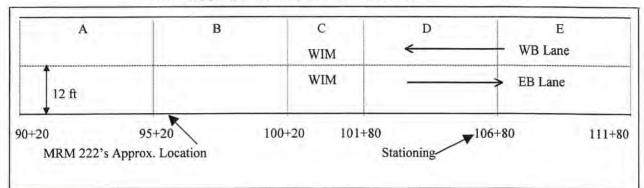
White-topping Layout (Near MRM 222)

UTW test sections were constructed on Highway 14 near MRM 222 west of Pierre. The west bound lane was paved on July 23 and 24, 1996 and the east bound lane was paved on August 7 and 8, 1996. At each lane, the following test and control sections were constructed as shown in the sketch

Test Section	Length (ft)	Туре	Thickness (in)	Joint Spacing (ft)	Volume of Fiber Concrete (yd³)
A	500	Fiber (25 lbs/yd³)	2.5	50	93
В	500	Fiber (25 lbs/yd³)	3.5	50	129
C	160	Plain	12	20	
D	500	Fiber (25 lbs/yd³)	3.5	No Joints	129
E	500	Fiber (25 lbs/yd³)	2.5	No Joints	93
Asphalt Overlay (Not Shown)	500	Control			
				Total	444

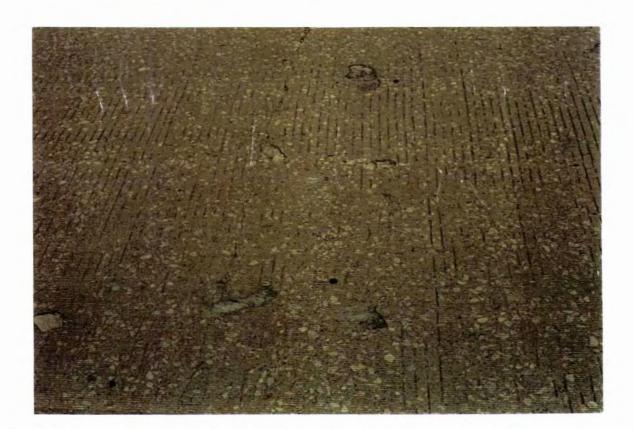
Photo 1. Seven unopened bundles imbedded in the pavement as seen on June 19, 1999. Most fibers are intact in the holes. (Pennies are shown for size comparison.)

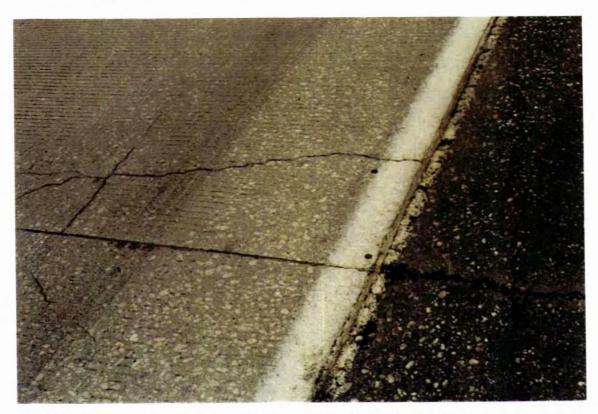
Photo 2. Water pumping action due to a previous night rain. Water was oozing out of the transverse cracks in the shoulder asphalt and along the longitudinal edge of the UTW. This was also the most severe longitudinal crack observed (Pennies are shown for size comparison.)

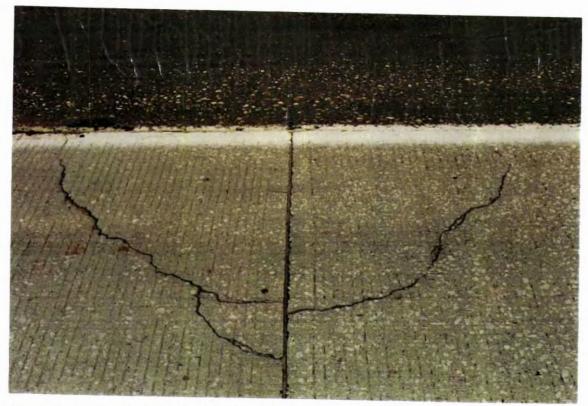
Photo 3. Water was oozing out of a corner crack due to pumping action. This was also the most severe corner cracking observed.

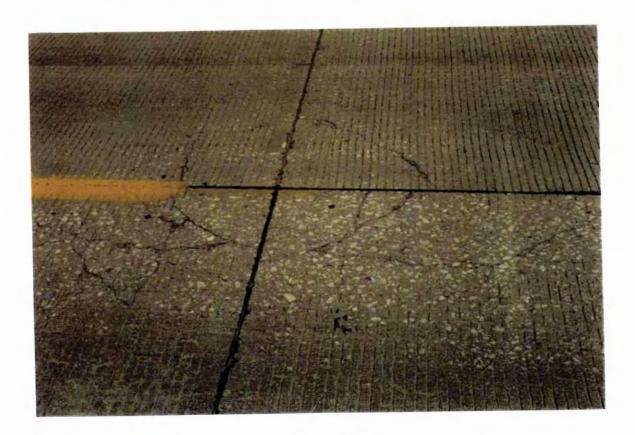
Photo 4. The most severe corner crack noticed in the centerline of pavement. (Pennies are shown for size comparison.)

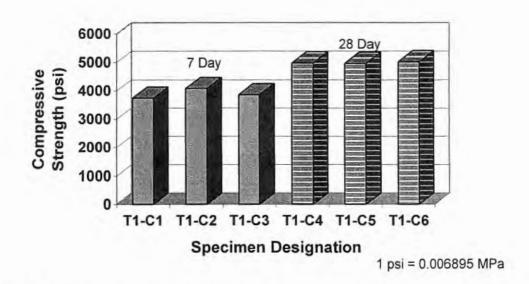
Fig A1: Comparison of Compressive Strength for Different Specimens of the Same mix

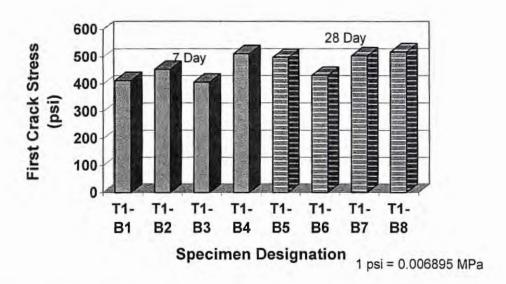
Fig A3: Comparison of First Crack Stress for Different Specimens of the Same Mix

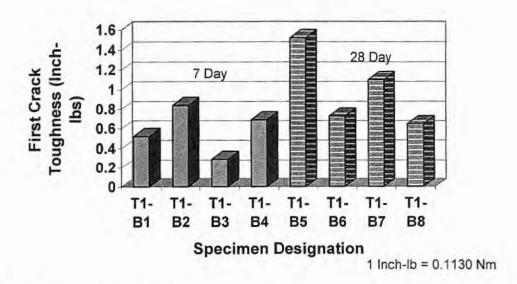
Fig A4: Comparison of ASTM First Crack Toughness for Different Specimens of the Same Mix

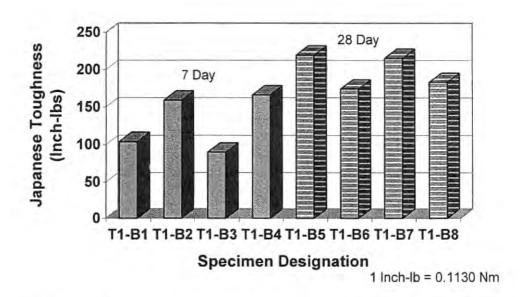
Fig A5: Comparison of Japanese Toughness for Different Specimens of the Same Mix

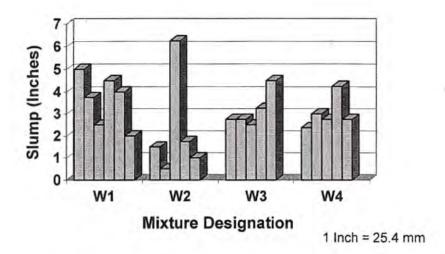
Fig B1: Comparison of Slump Measured During Quality Control Tests

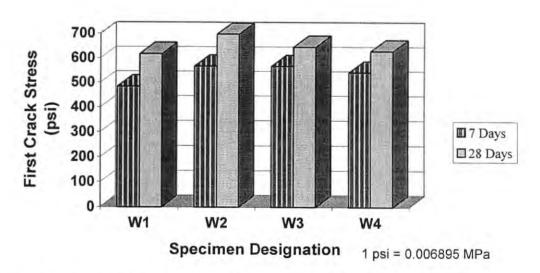
Fig B4: Comparison of First Crack Stress for Different Sections

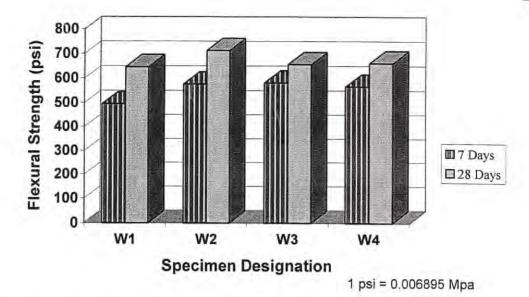
Fig B5: Comparison of Flexural Strength for Different Sections

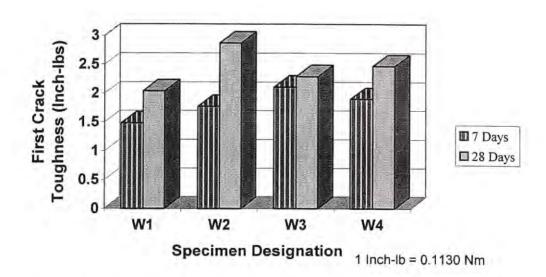
Fig B6: Comparison of ASTM First Crack Toughness for Different Sections

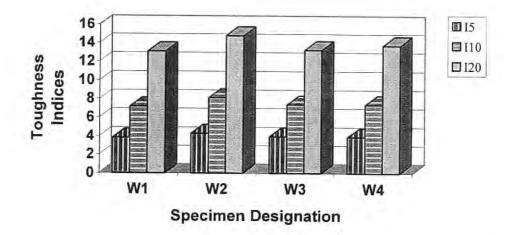
Fig B7: Comparison of 7 Day ASTM Toughness Indices, I5, I10, I20 for Different Sections

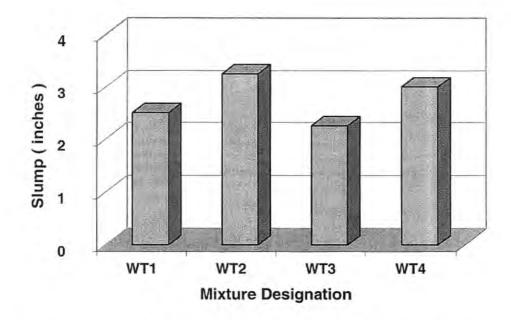
Fig WR1: Comparision of Slump of concrete used in Rapid City

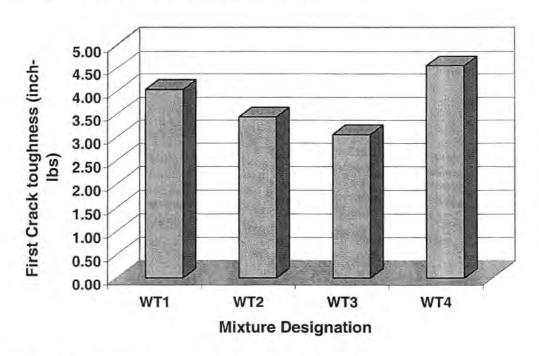
Fig. WR10: Comparision of First Crack Toughness of Concrete used in Rapid City

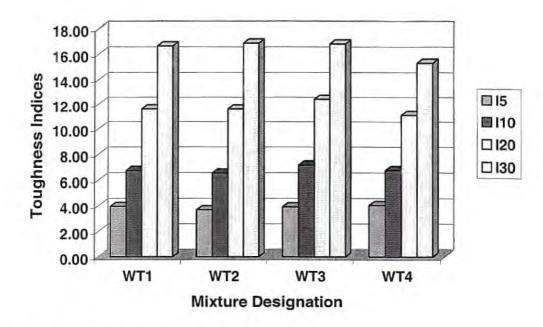
Fig. WR11: Comparision of Toughness Indices of Concrete used in Rapid City

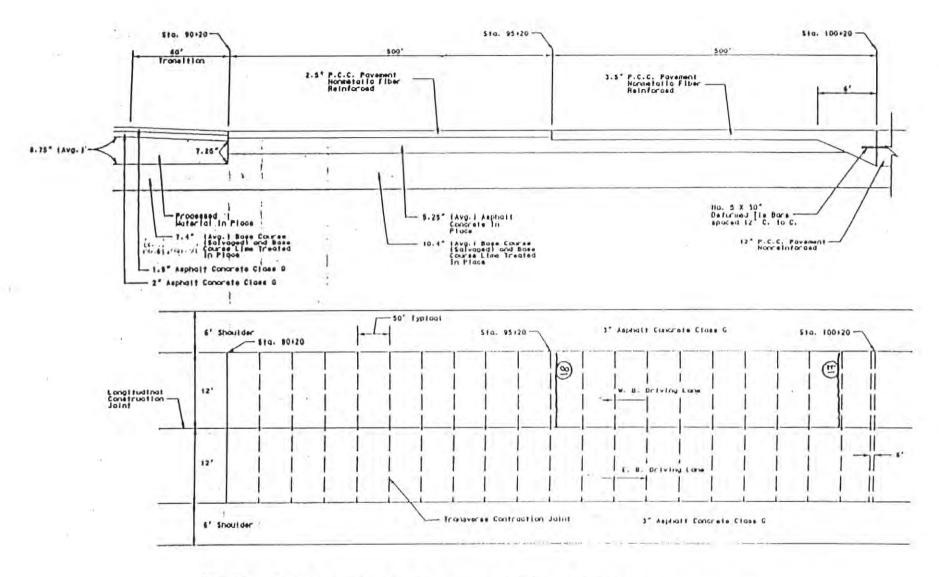
Fig C1: Crack Location for 2.5 inch and 3.5 inch NMFRC White-topping in the Jointed Section

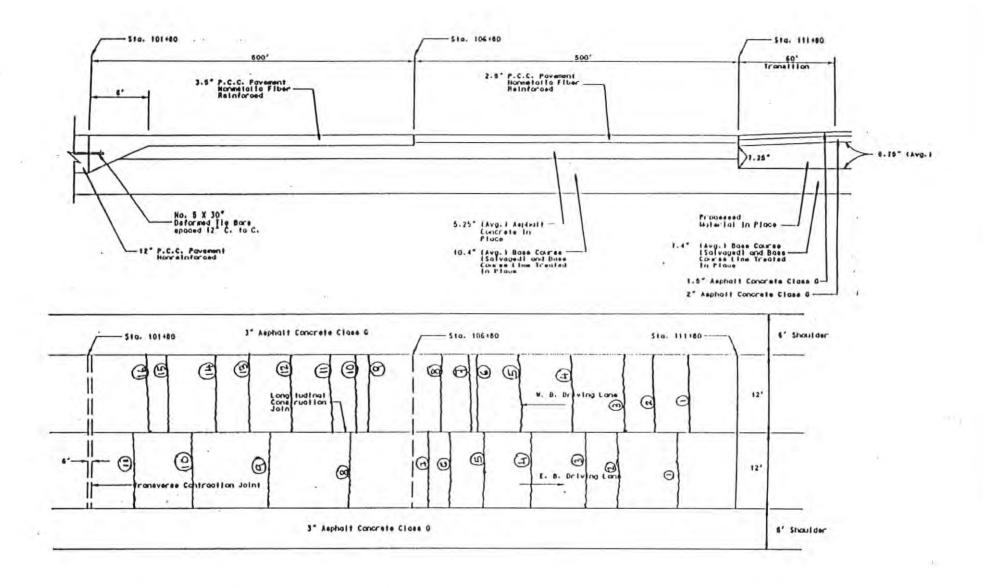
Fig C3: Crack Location for 2.5 inch and 3.5 inch NMFRC White-topping in the Unjointed Section

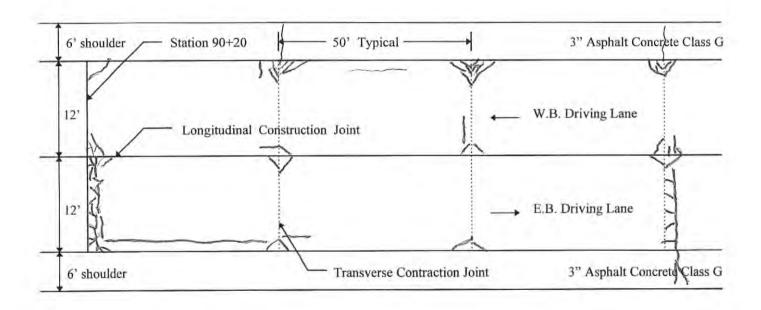
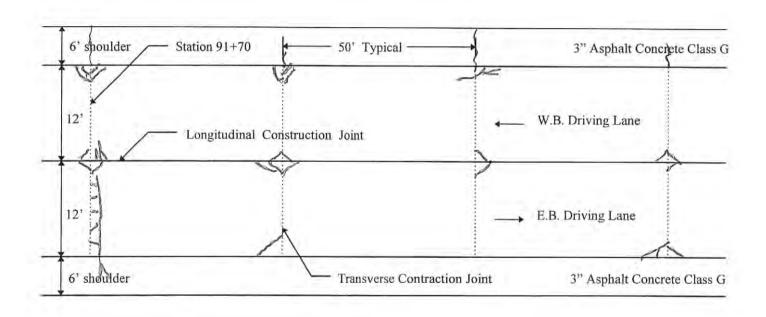
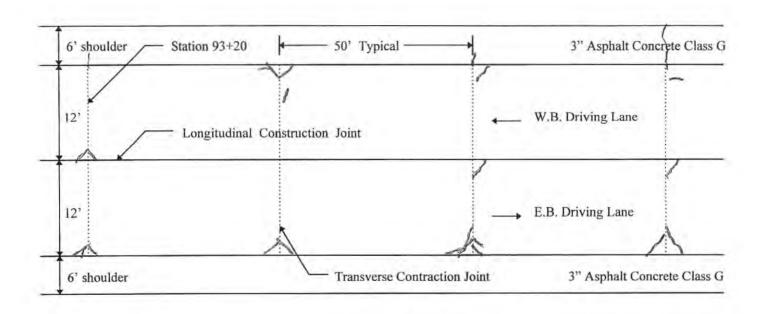
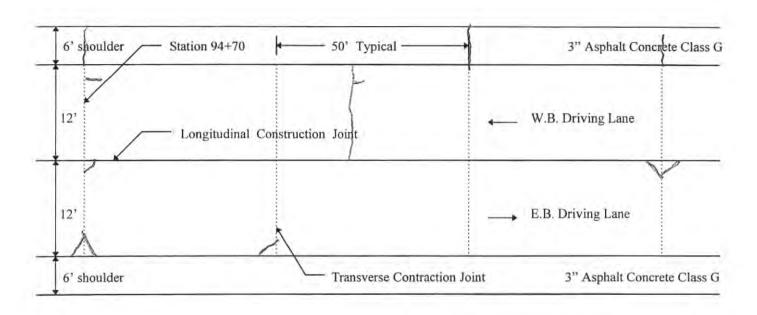
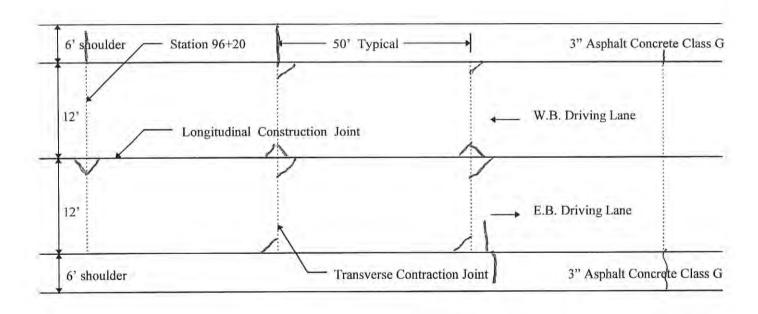
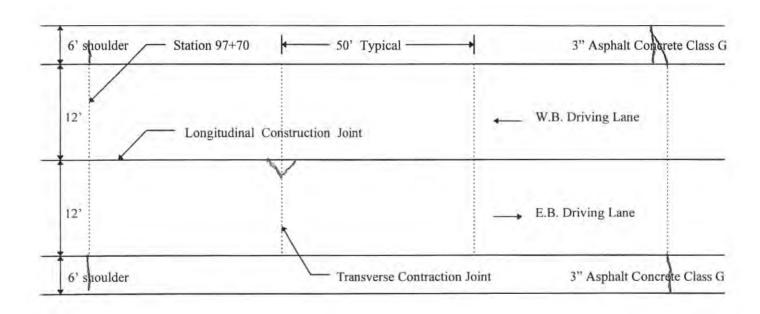
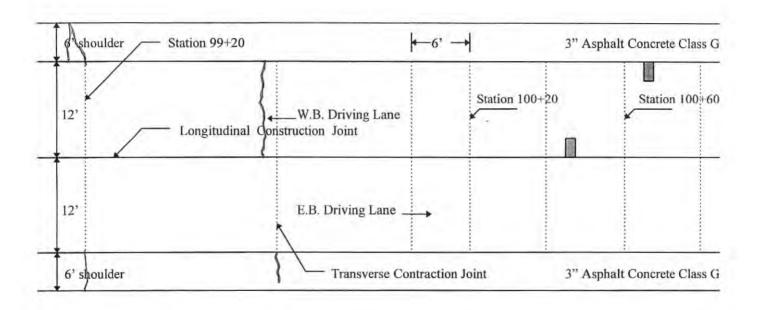
Fig: Crack Location for NMFRC Whitetopping in the Jointed Section as observed on May 28, 1997.

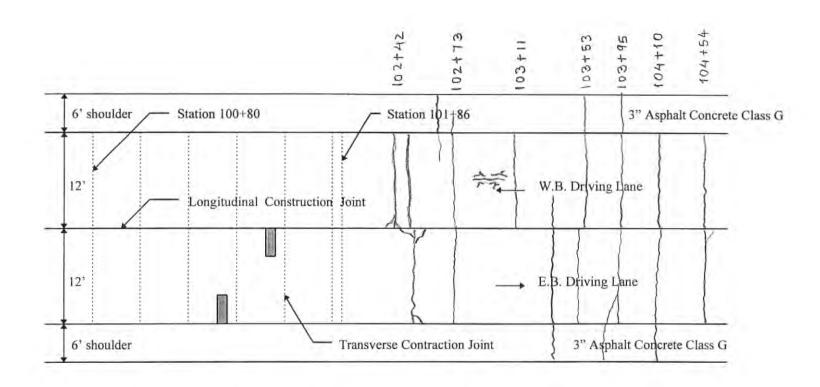
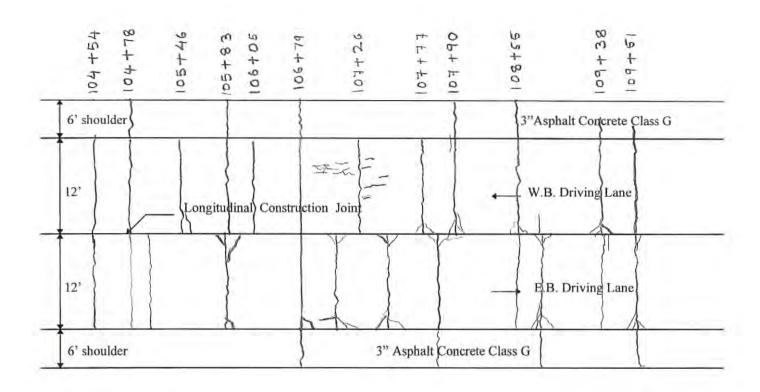
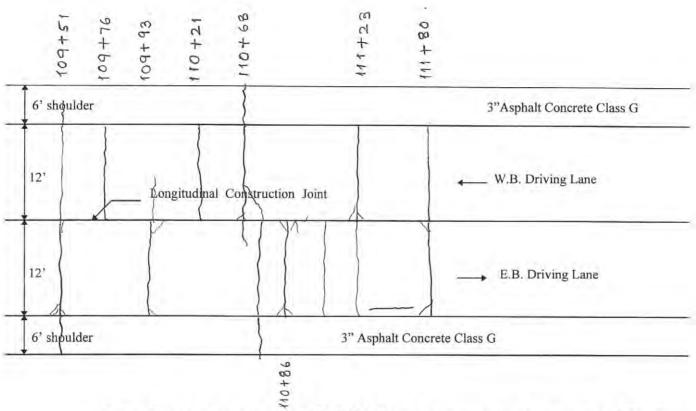
Fig: Crack Location for NMFRC Whitetopping in the unjointed Section as observed on May 28, 1997.

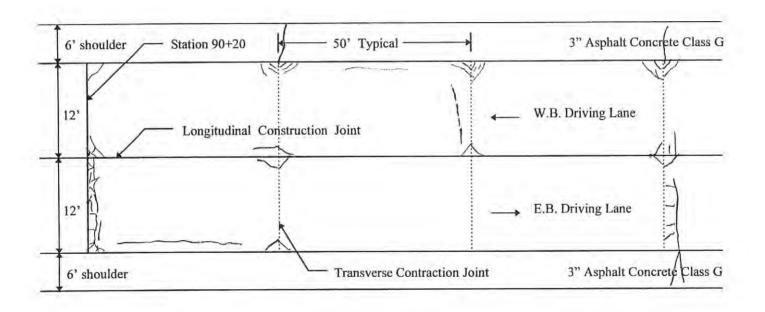
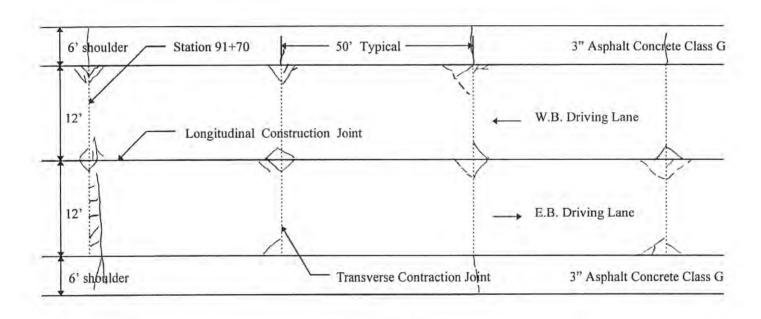
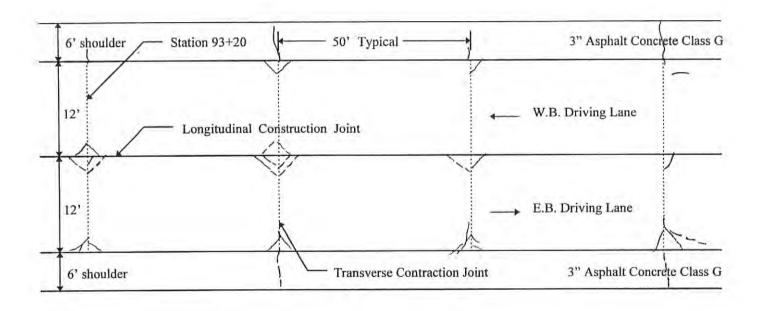
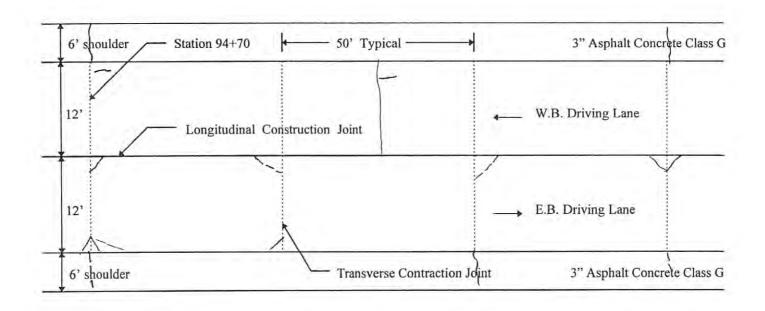
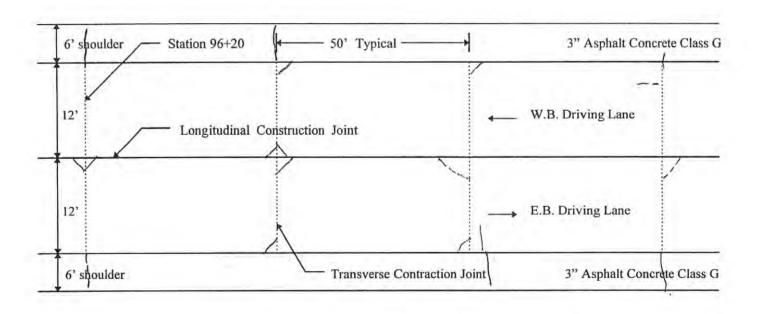
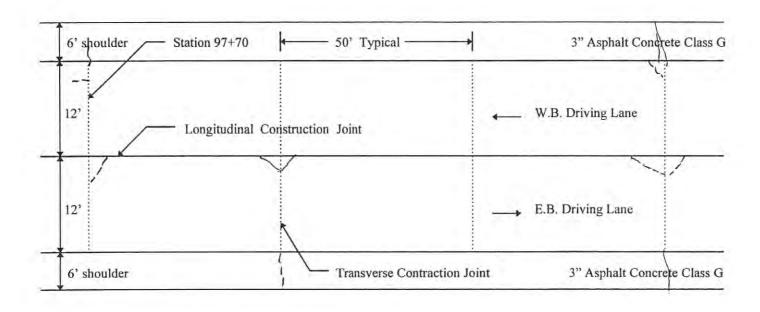
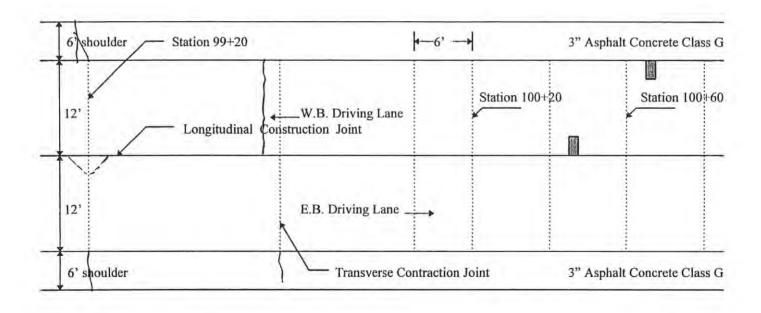
Fig: Crack Location for NMFRC Whitetopping in the Jointed Section as observed on July 28, 1997.

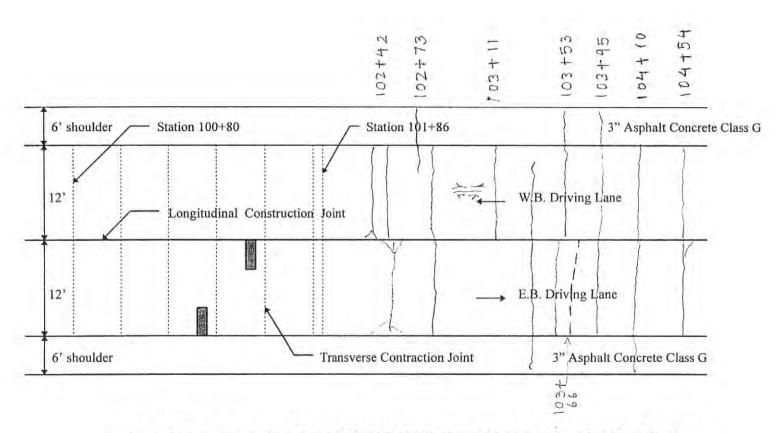
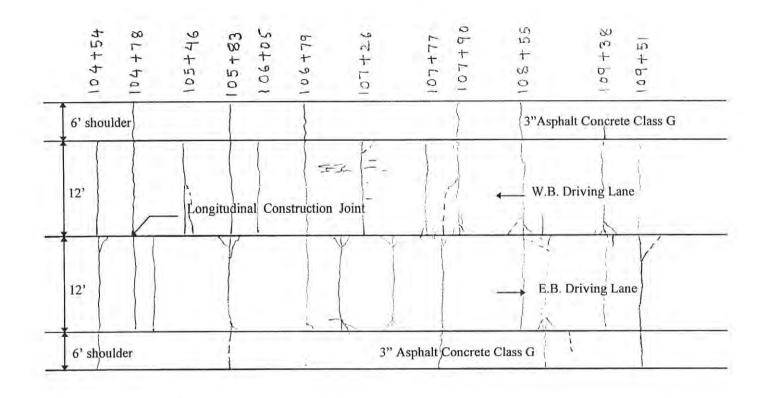
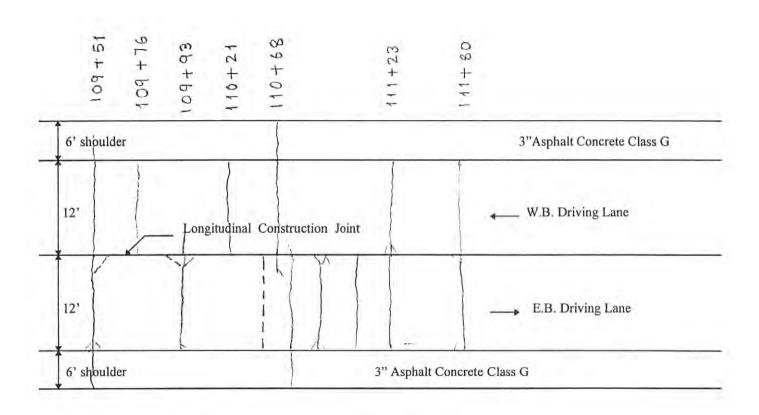
Fig: Crack Location for NMFRC Whitetopping in the unjointed Section as observed on July 28, 1997.

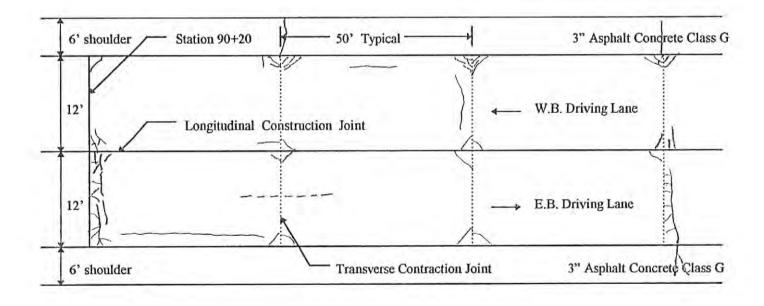
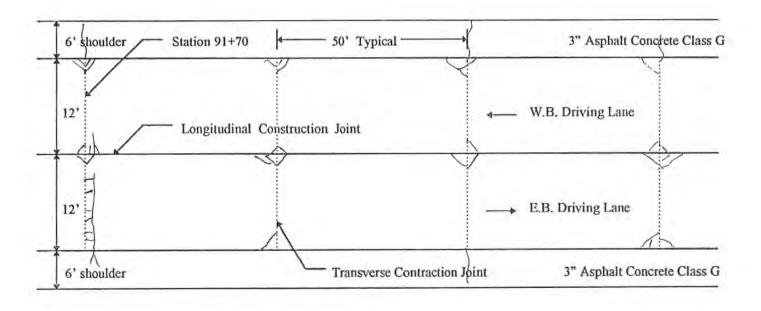
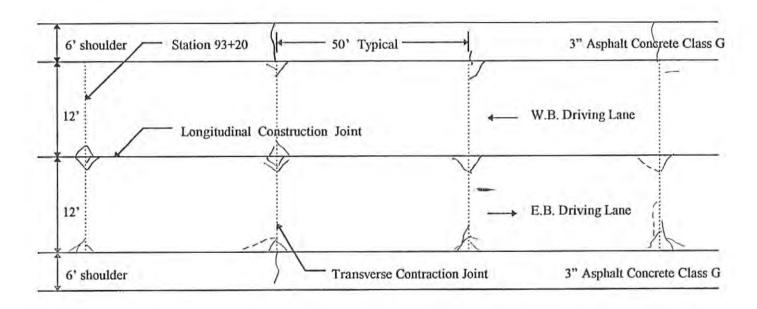
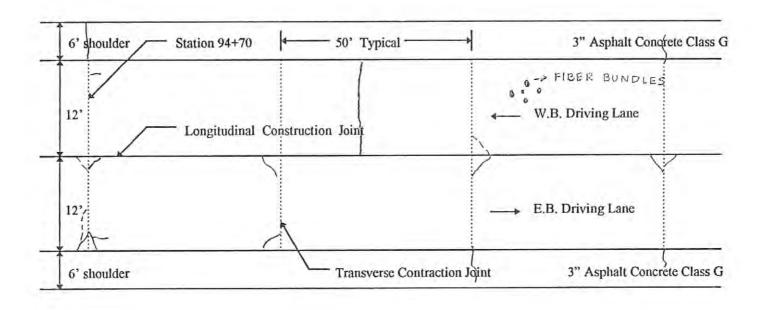
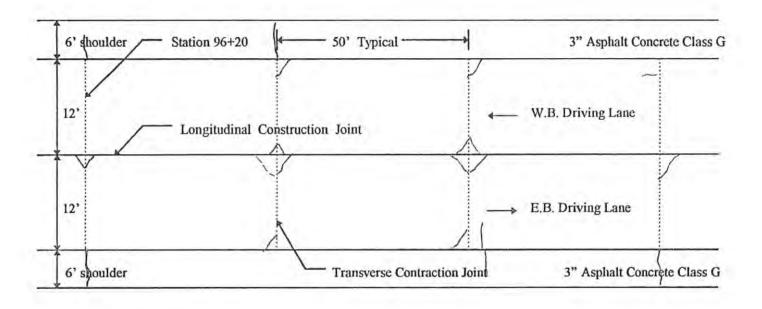
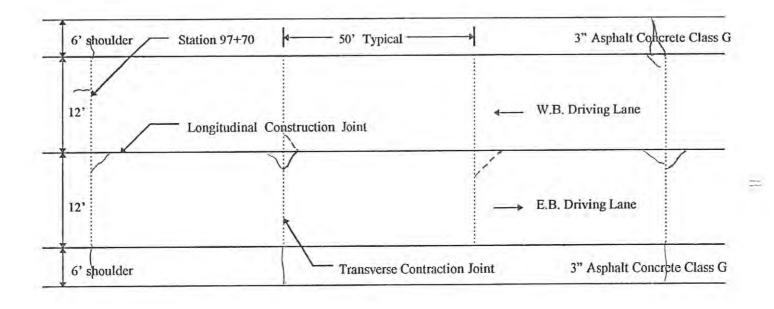
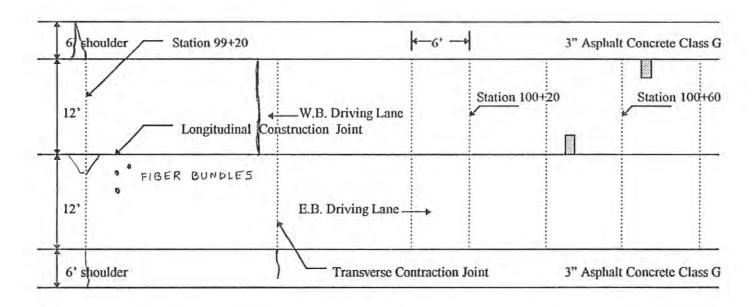
Fig: Crack Location for NMFRC Whitetopping in the Jointed Section as observed on November 7, 1997.

**New Crack Observed**

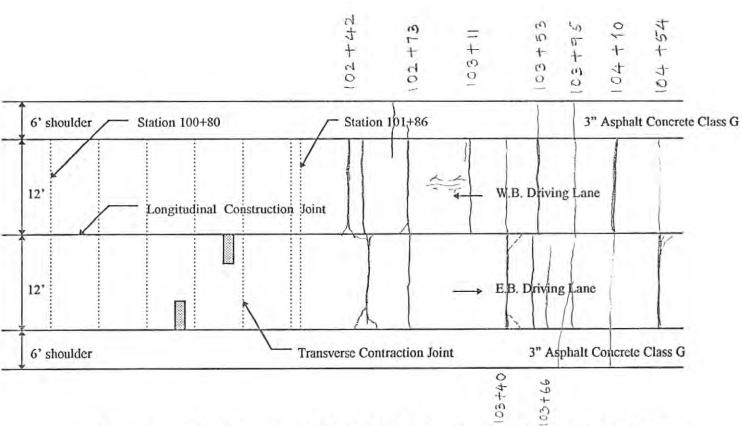
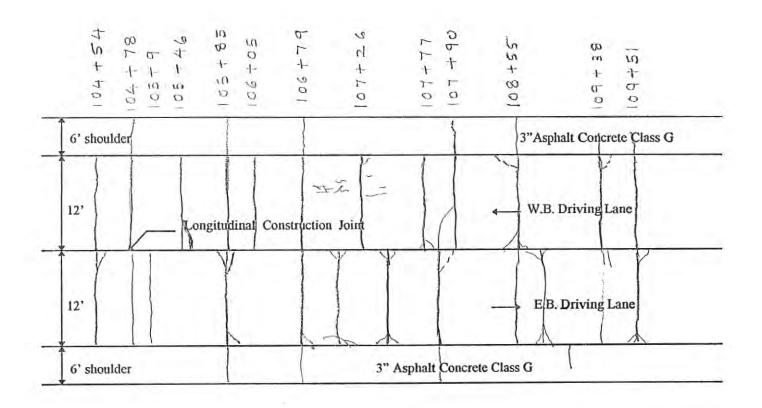
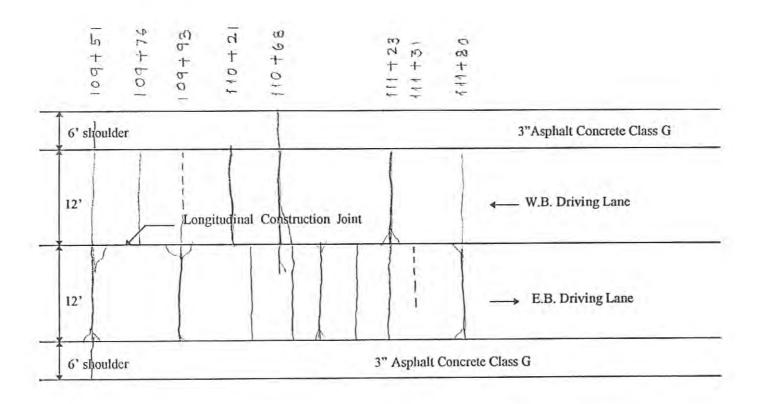
Fig: Crack Location for NMFRC Whitetopping in the unjointed Section as observed on November 7, 1997.

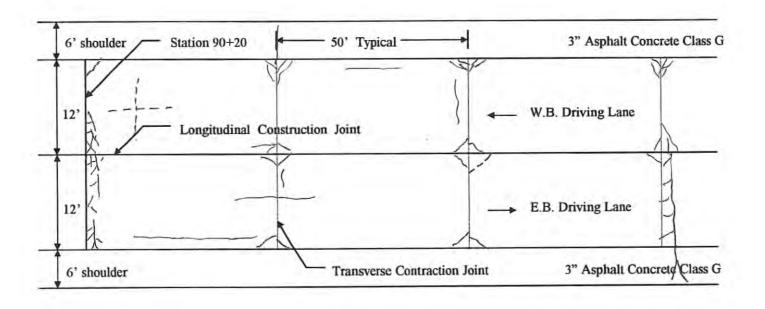
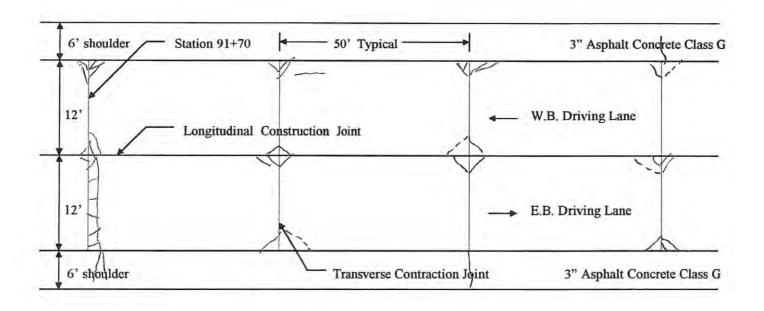
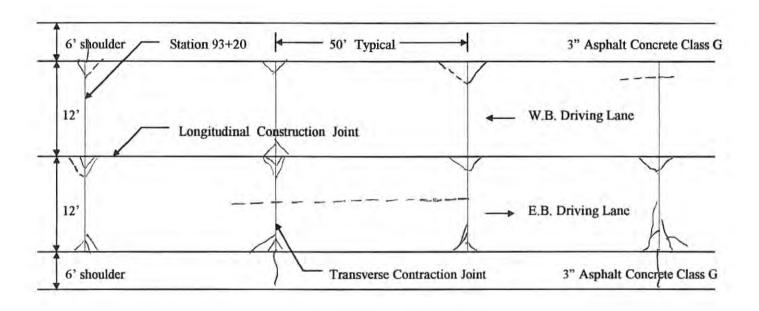
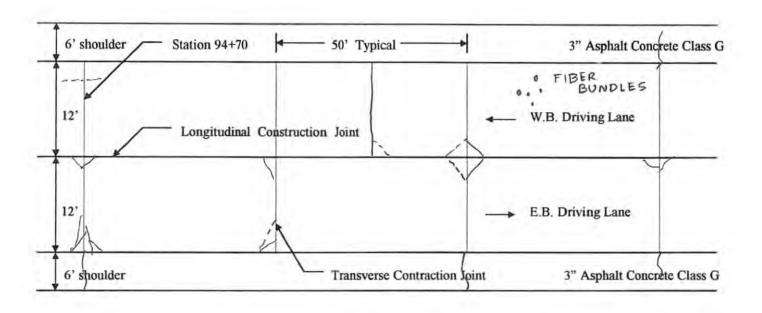
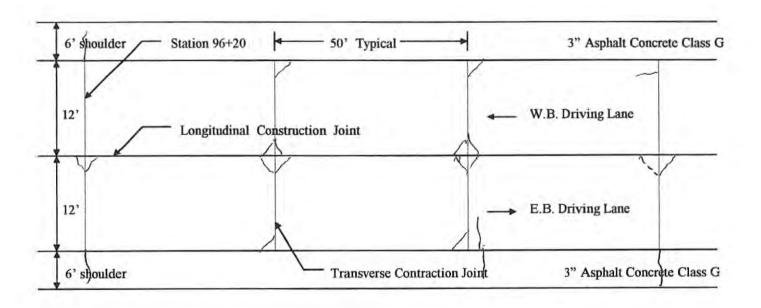
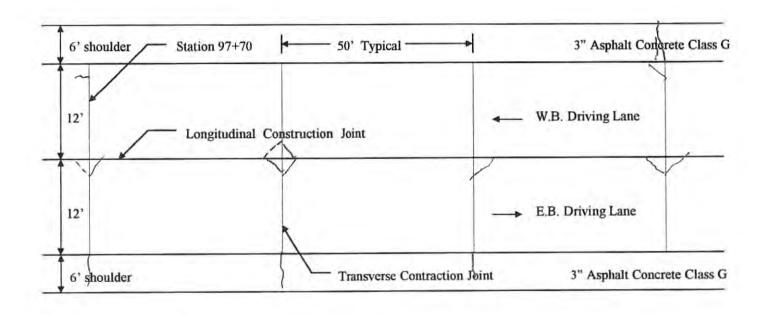
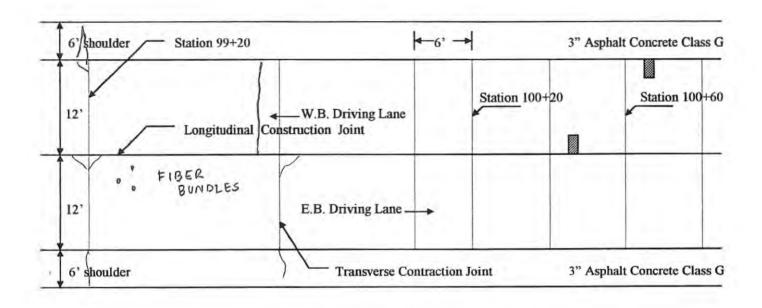
Fig: Crack Location for NMFRC Whitetopping in the Jointed Section as observed on April 17, 1998.

**New Crack Observed**

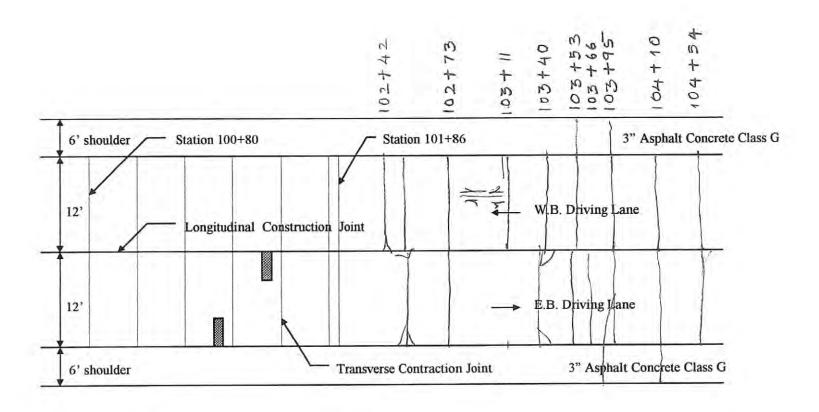
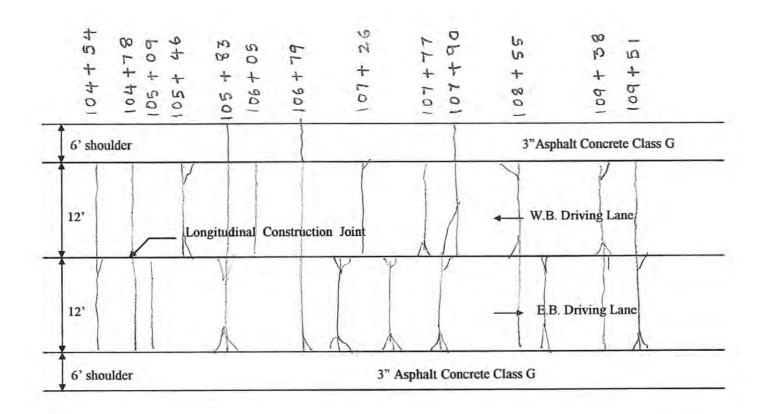
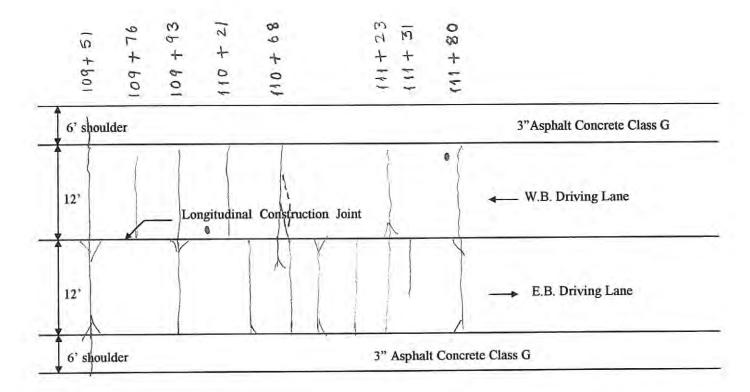
Fig: Crack Location for NMFRC Whitetopping in the unjointed Section as observed on April 17, 1998.
